Docket No. 217 – Development and Management Plan Inspection

Northeast Utilities Service Company Certificate of Environmental Compatibility and Public Need for the construction of a 345-kV electric transmission line and reconstruction of an existing 115-kV electric transmission line between Connecticut Light and Power Company's Plumtree Substation in Bethel, through the towns of Redding, Weston, and Wilton, and to the Norwalk Substation in Norwalk, Connecticut.

Date: September 7, 2005

Location: Transition Stations (Hoyts Hill, Archers Lane)

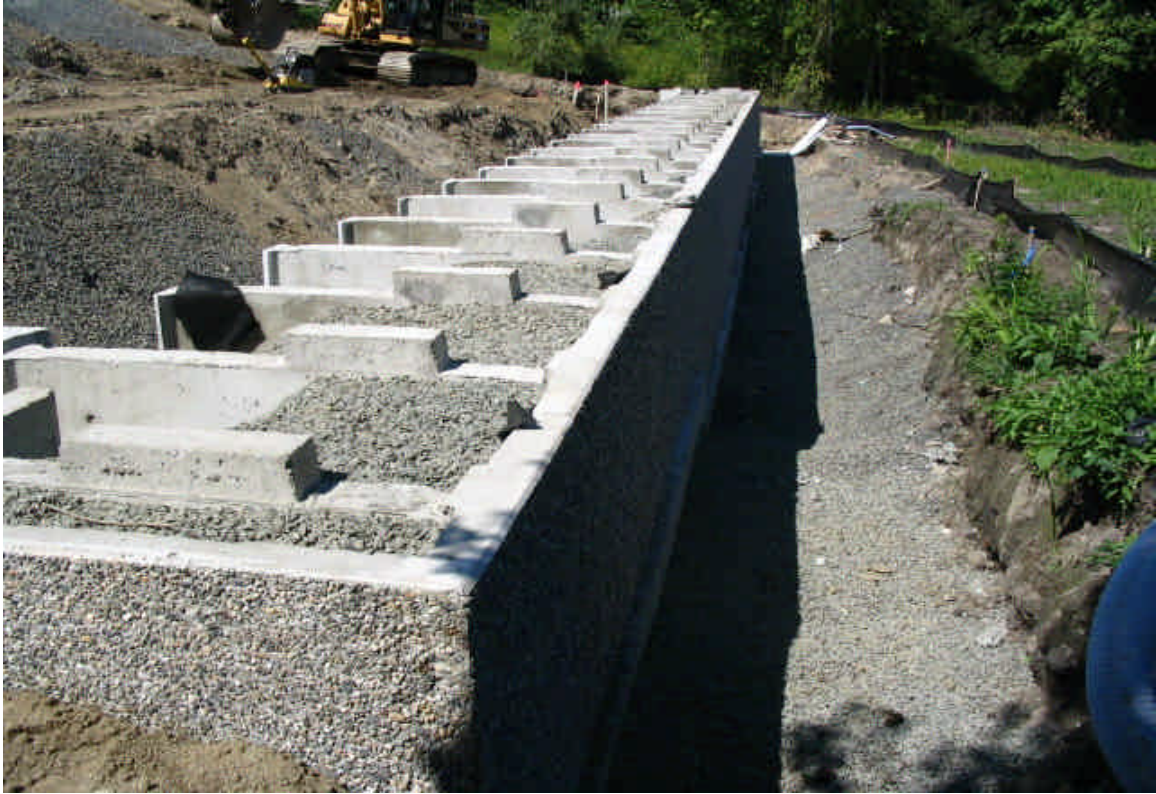
Hoyts Hill Transition Station: Construction continues on the station yard walls and surrounding infrastructure. (9/7/05)

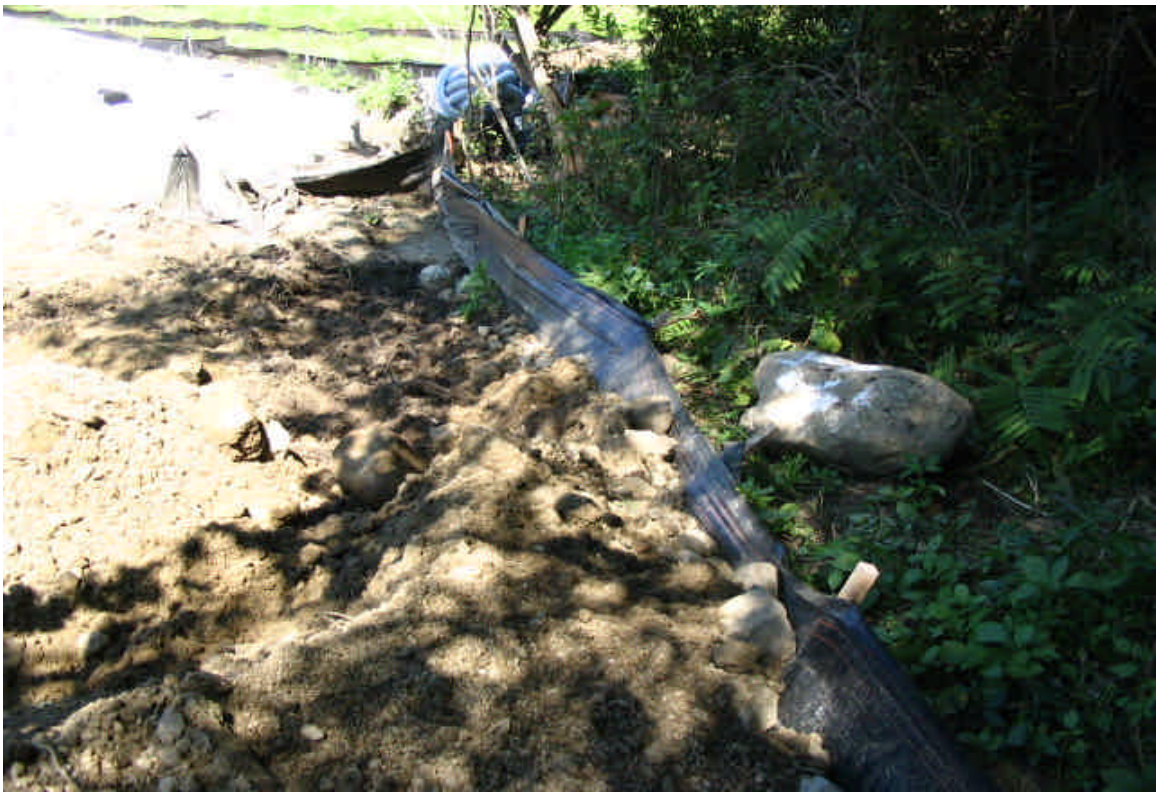
One spot along the silt fence showed some strain due to a soil pile placed too close. The soil will be pulled back and the stakes up-righted. All other controls are in good shape. (9/7/05)

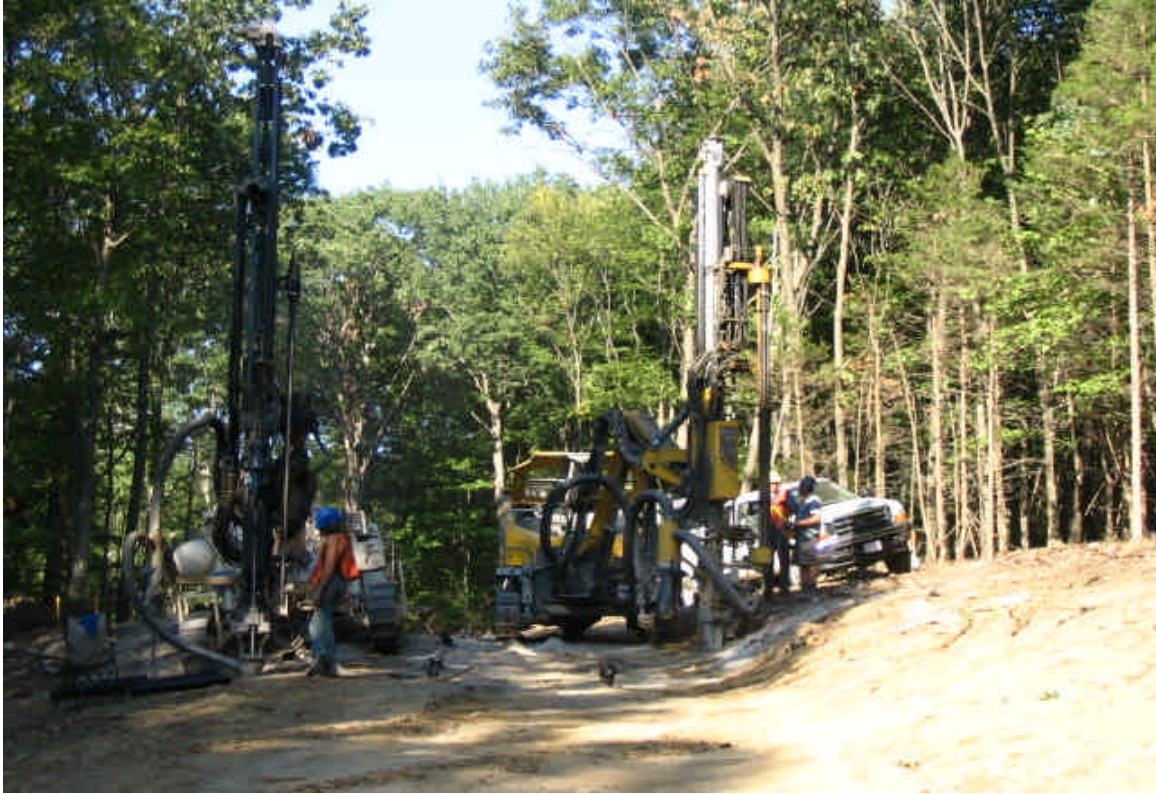
Archers Lane Transition Station: View of the drilling operations in preparation for blasting along the access. Blasting has now occurred in the site. (9/7/05)

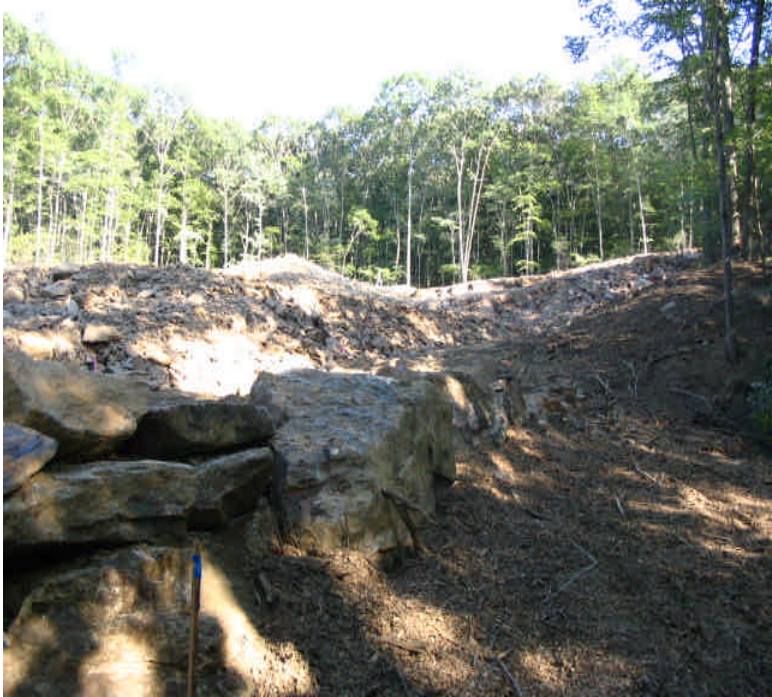
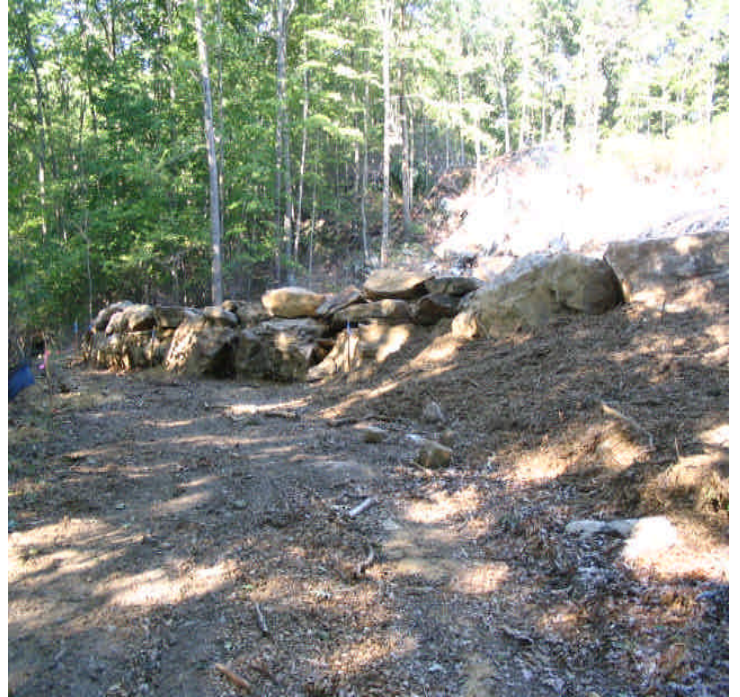
Photo on the left shows an overall view of the station site following some blasting in the area. Photo on the right shows some rocks arranged to create a perimeter area of the site. (9/7/05)
