**Docket No. 217 – Development and Management Plan Inspection**

Northeast Utilities Service Company Certificate of Environmental Compatibility and Public Need for the construction of a 345-kV electric transmission line and reconstruction of an existing 115-kV electric transmission line between Connecticut Light and Power Company's Plumtree Substation in Bethel, through the towns of Redding, Weston, and Wilton, and to the Norwalk Substation in Norwalk, Connecticut.

**Date:** October 4, 2006

**Location:** 345kV Underground Route

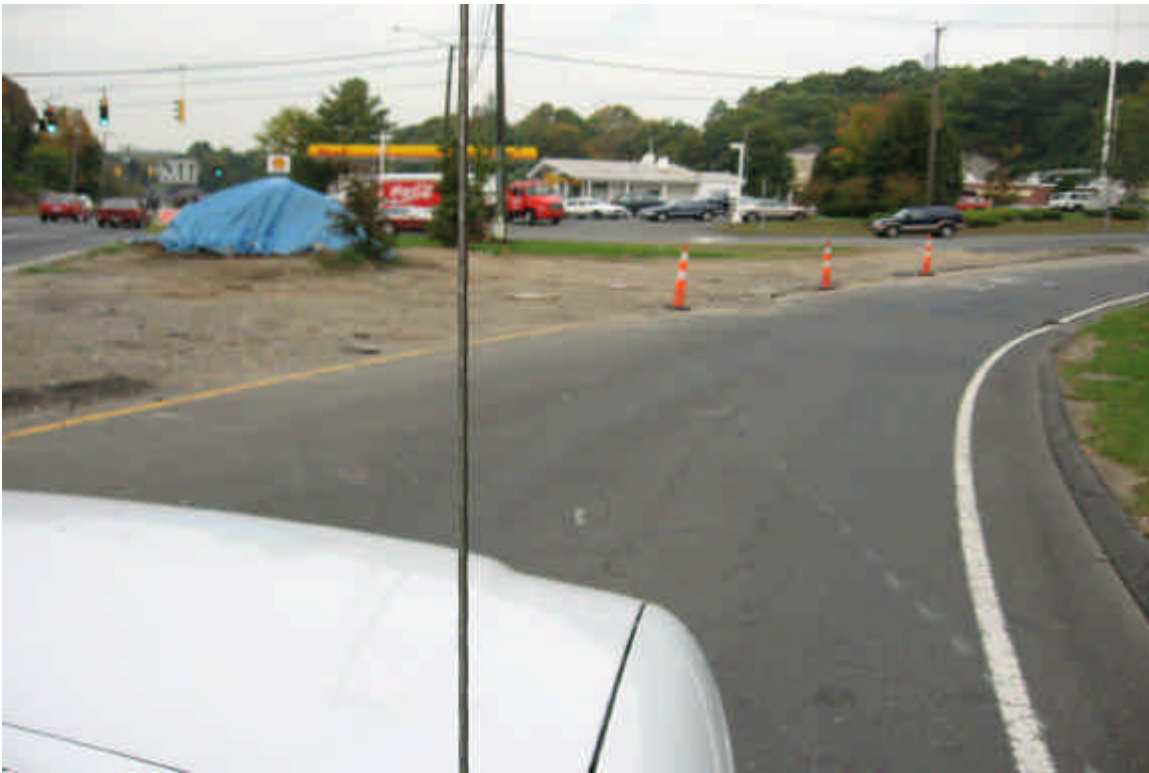
Photo on the shows the Rt 107/7 intersection. Some areas have been seeded/mulched but final restoration is still required. Sedimentation to the roadway is noted. 10/04/06

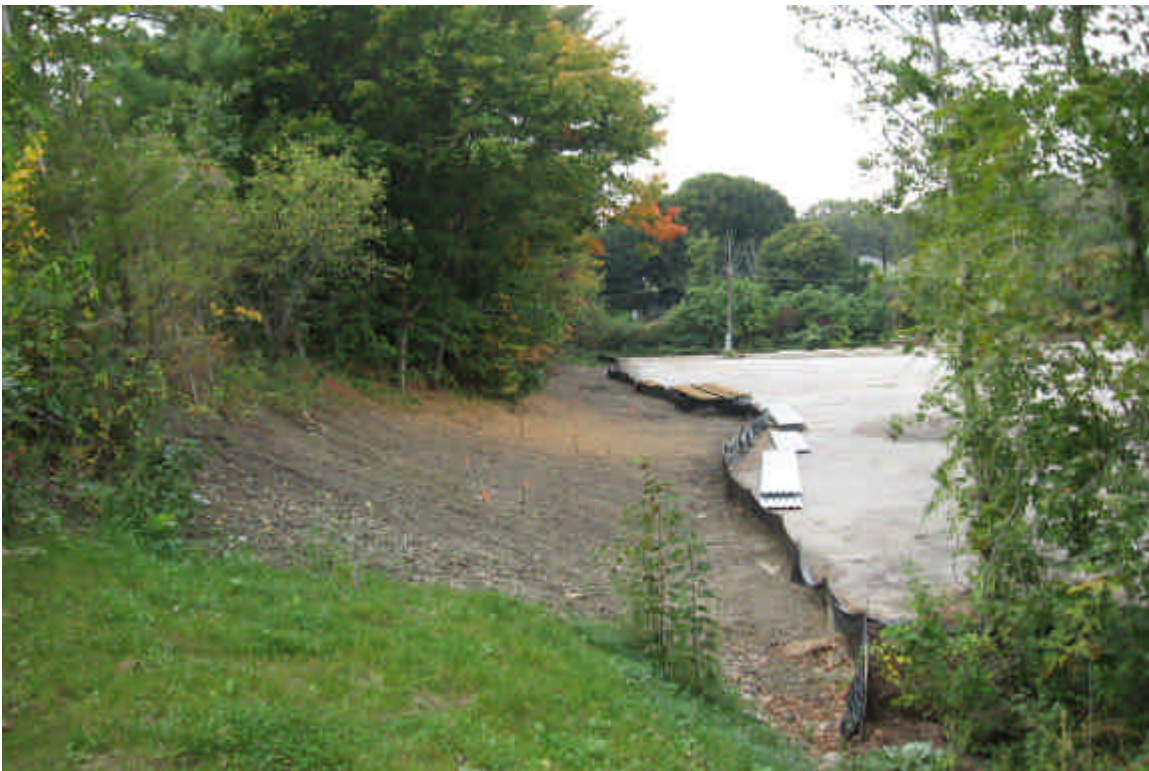
Photo shows a view of the silt fence installed at the Gilbert & Bennett lot. Seed and mulch are still needed here along the slope. 10/04/06
