Docket No. 272 – Development and Management Plan Inspection

Segment 2b Inspection

Date: December 7, 2007

Location: Segment 2b – Cheshire/Hamden Town Line to East Devon Substation

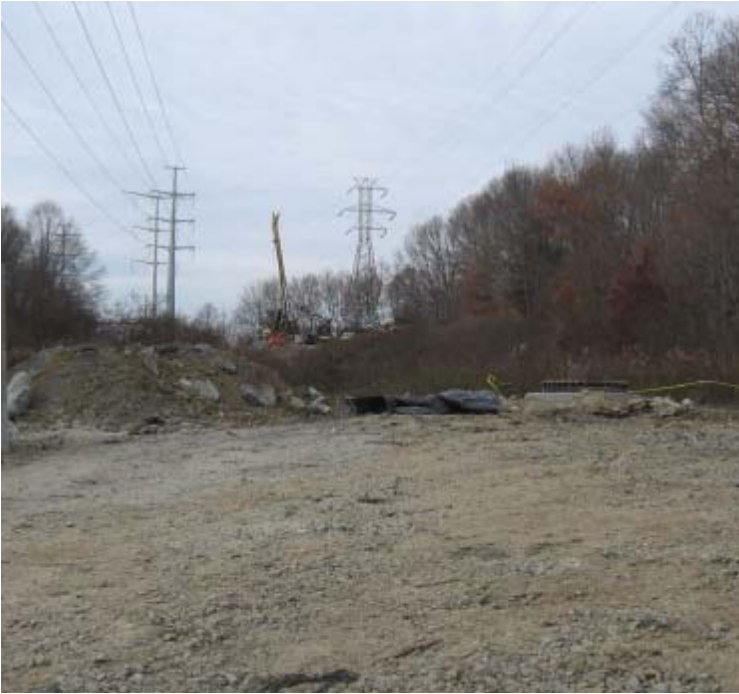
East Rutland (Milford): The foundation has been installed for Structure #24015. Spoils remain contained onsite. Foundation work continues at proposed structure #24014 (seen in the distance).

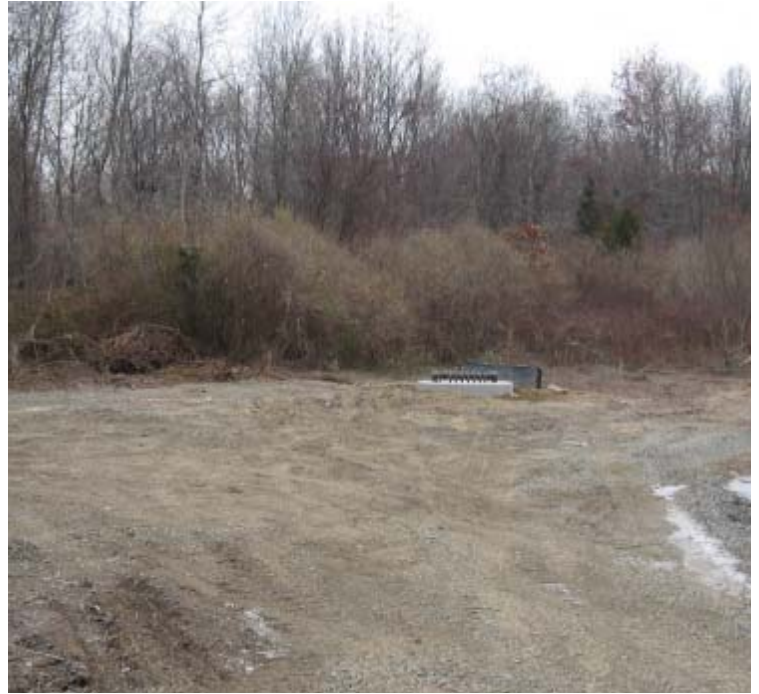
Eisenhower Park (Milford): Foundation work is complete at structure #24029.

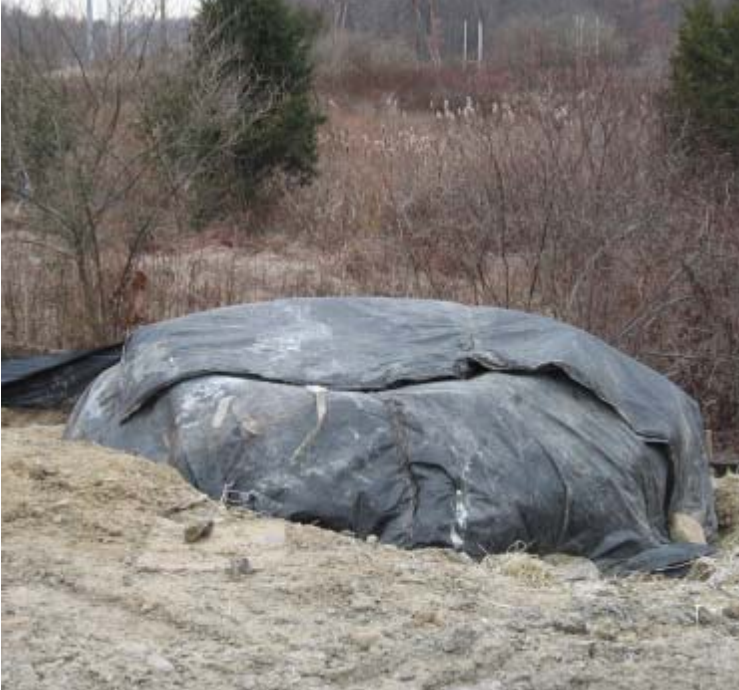
Eisenhower Park: Foundation work is complete at structure #24028. Controls remain intact.

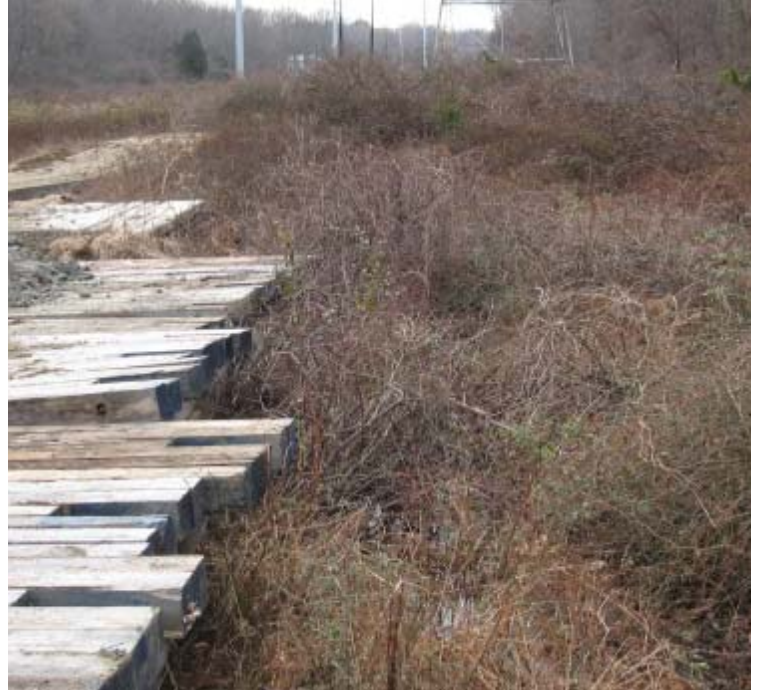
Rimmon Rd (Woodbridge): A timbermat crane pad has been installed at proposed structure #24105. The pad is adjacent/in a tributary of Race Brook. It is recommended that the work area be enclosed with erosion controls.

<p>Sediment was noted in the stream channel near structure #24119 at the JCC (8/7/07). No further accumulation has been observed. 12/7/07</p>	<p>Continue to monitor. Adjust controls as necessary. 12/7/07</p>	<p>NA at this time</p>
	<p>A new timbermat crane pad was installed adjacent/in a tributary stream of Race Brook, near structure #24105. 12/7/07</p>	<p>Continue to monitor. Evaluate sediment accumulation within the stream channel. Carefully remove sediment during the dry season if it is greater than 2" in depth. See EC Section. 12/7/07</p>	<p>Needs evaluation</p>
<p>Timber mat crane pads remain within the wetlands in these sections</p>	<p>Continue to monitor. 12/7/07</p>	<p>NA at this time</p>

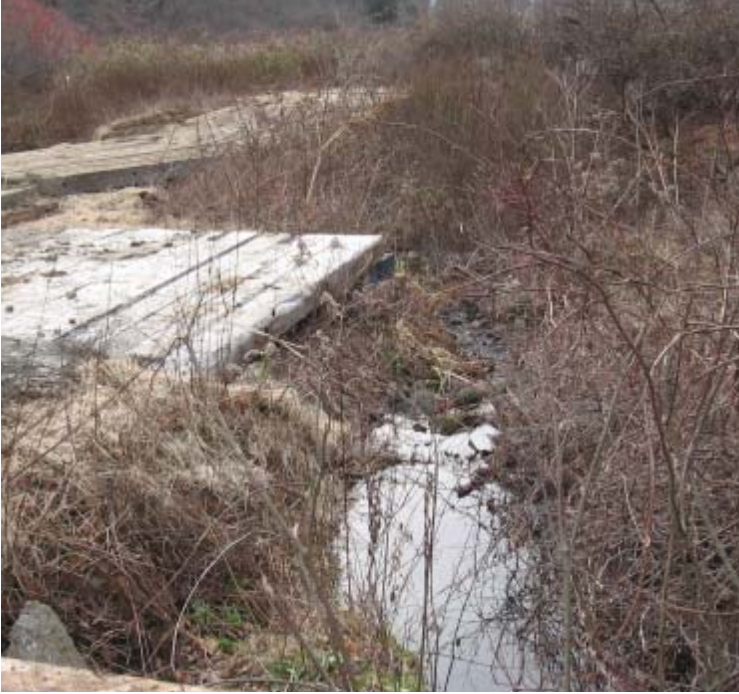
Rimmon Rd: Additional view of the crane pad/ stream.

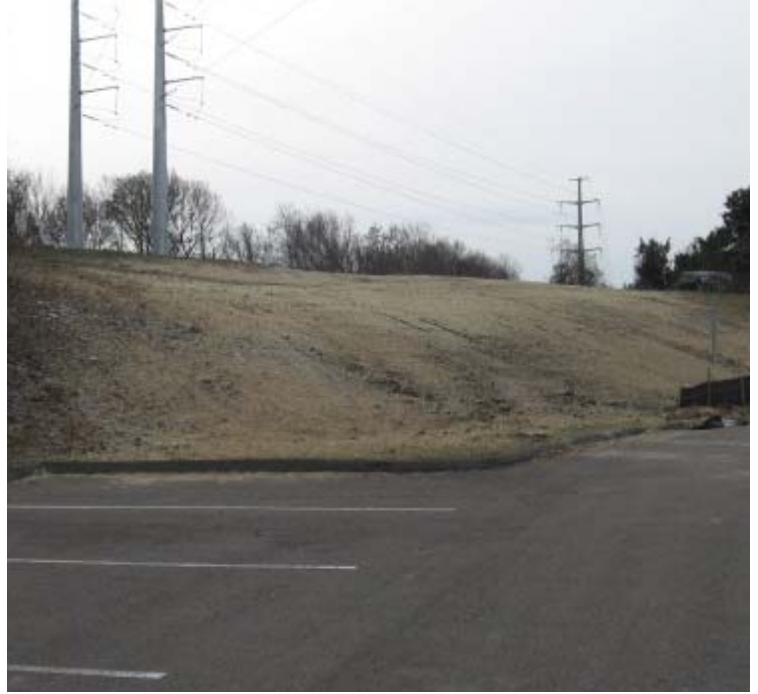
Pease Rd/JCC (Woodbridge): The ruts have been graded and exposed soils have been temporarily stabilized near structures #3931/24118. The silt fence should be extended in this area.

Areas of Inspection	Observation	Recommended Action	Corrected Action
<p>Hamden, CT</p> <p>West Todd Street/ Gaylord Mountain</p> <p>Brooksvale Ave</p> <p>Willow Street</p>	<p>Equipment ruts and exposed soils have been graded and temporarily stabilized at the southern end of the JCC parking lot near structures 3931/24118. The silt fence should be extended in this area. 12/7/07</p> <p>In approximately three areas, stormwater pooled along the perimeter controls and filtered through as concentrated flow off the ROW (4/27/07). This only occurs during large rain events and wetland resource areas were not affected by this off site flow. 12/7/07</p> <p>Some sediment remains in the wetland area located to the southwest of structure #3992. 10/26-12/7/07</p> <p>Excess sediment has accumulated on the timber mat crossing within the access road here. Sediment has seeped through the mats and into wetland #100. 11/16-12/7/07</p> <p>Spoils from foundation/grounding work remain on some of the timber mats at structure #4009. 9/21-12/7/07</p>	<p>Continue to monitor until final stabilization is achieved and adjust controls as necessary. Extend the silt fence to prevent further sediment migration into the parking lot. 12/7/07</p> <p>Monitor during large rain events and investigate additional solutions to prevent stormwater conveyances off site. Although good efforts were made to control stormwater flow, continue to improve on-site containment. 12/7/07</p> <p>Evaluate sediment accumulation within the wetland. Carefully remove sediment from wetland if it is greater than 2” in depth. 12/7/07</p> <p>Continue to monitor. Controls should be installed to prevent further sedimentation to the wetlands. See Wetlands Section. 12/7/07</p> <p>Continue to monitor and stabilize disturbed soils. Remove spoils from timber mats. 12/7/07</p>	<p>Equipment ruts and exposed soils have been graded and temporarily stabilized <i>but further attention is needed</i></p> <p>Good efforts were made but <i>needs additional evaluation/monitoring</i></p> <p>Needs evaluation</p> <p>Needs attention/evaluation</p> <p>Needs attention</p>
