Docket No. 272 – Development and Management Plan Inspection

Segment 1b (Royal Oaks Bypass) Inspection

Date: September 16, 2008

Location: Segment 1b (Royal Oaks Bypass)

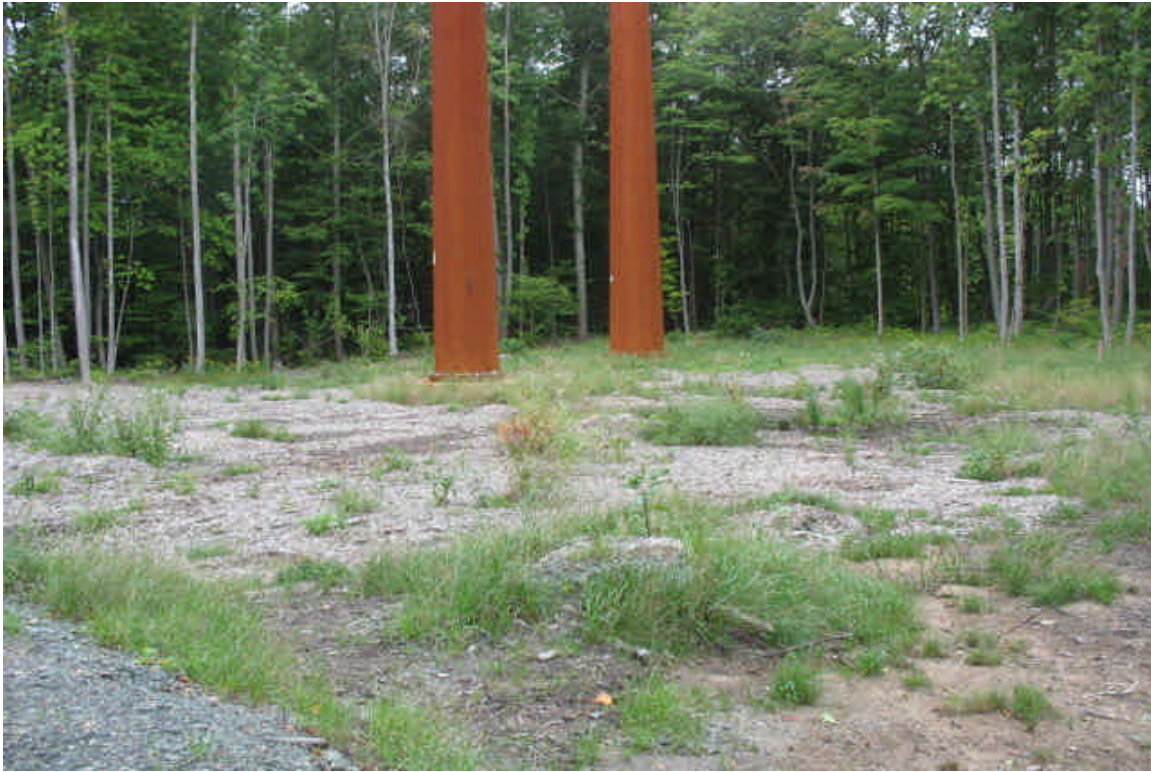
Vegetative cover is still sparse at the pad/angle structure. The area remains stable with thick wood chips but vegetation will not be able to establish fully. The contractor plans to remove the chips and seed the area when feasible.

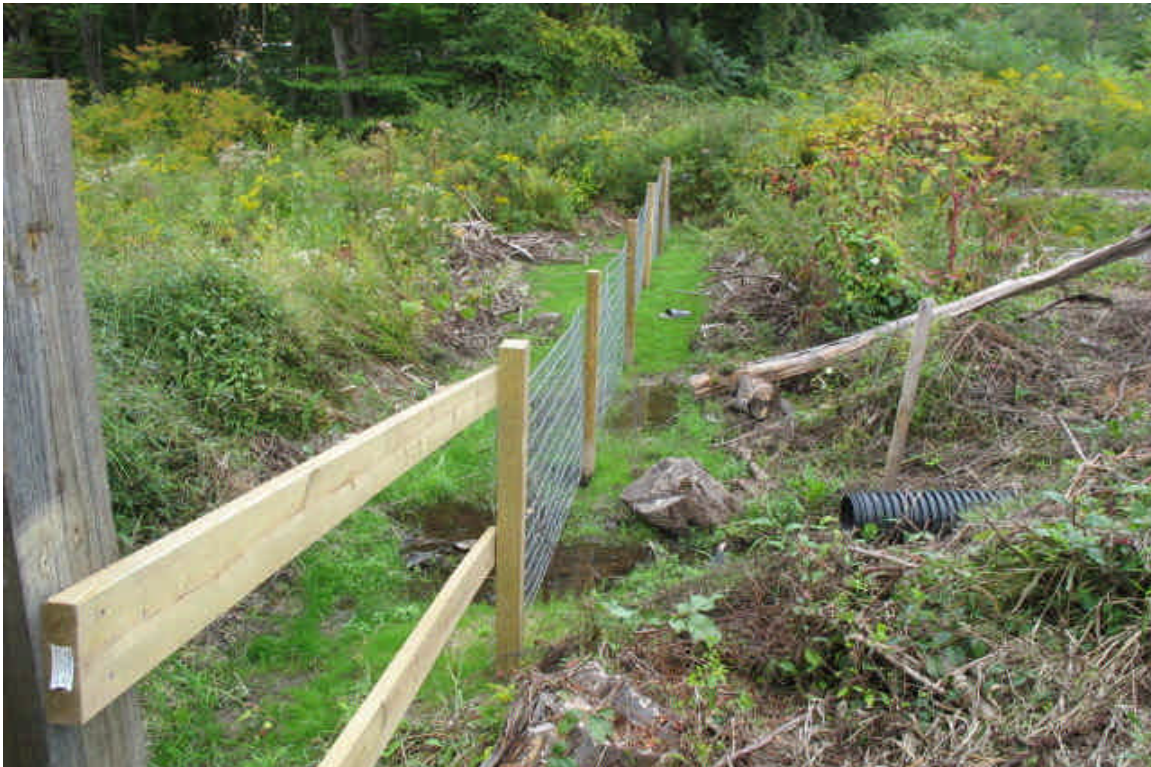
New fence remains upgradient of the wetland and across the access road past the contractor yard. This was likely installed by the private property owner. The area is stable with grass growth.
