**Docket No. 272 – Development and Management Plan Inspection**

**Segment 1b (Royal Oaks Bypass) Inspection**

**Date:** September 29, 2008

**Location:** Segment 1b (Royal Oaks Bypass)

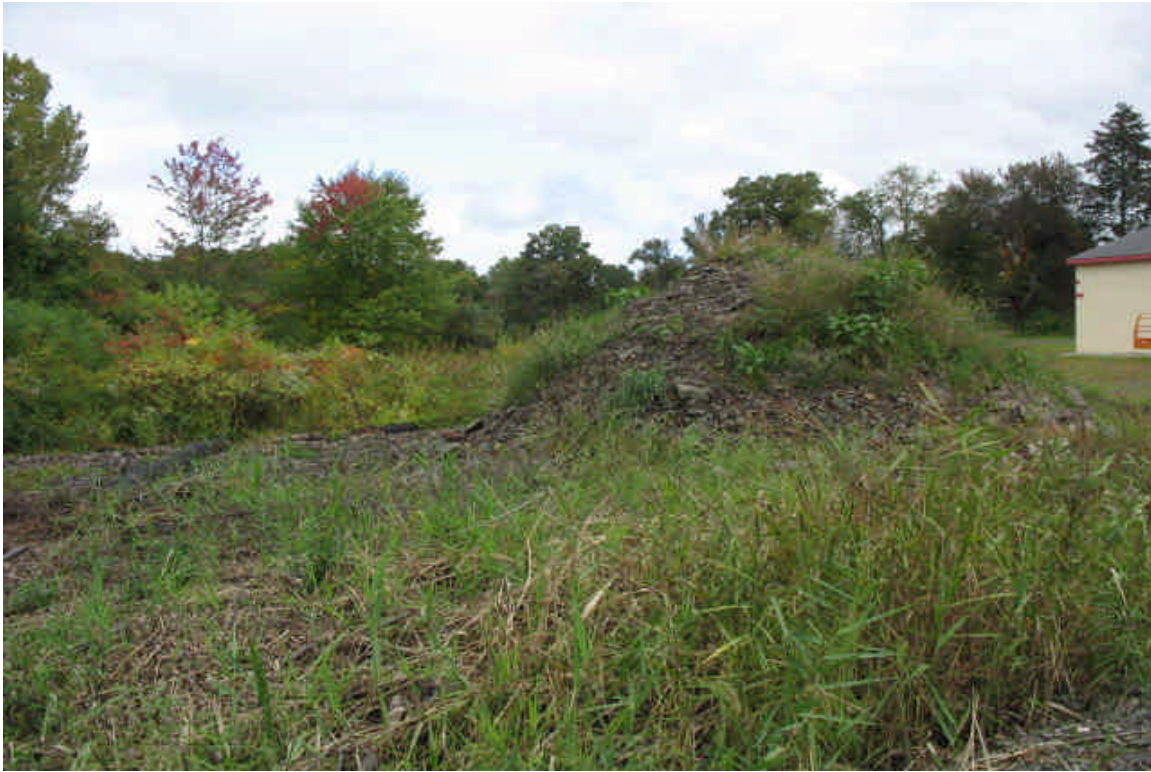
**Stockpile located at the edge of the receiving yard, upgradient from wetlands. BSC was informed contractors would be evaluating this pile to determine if it is the property of the landowner.**

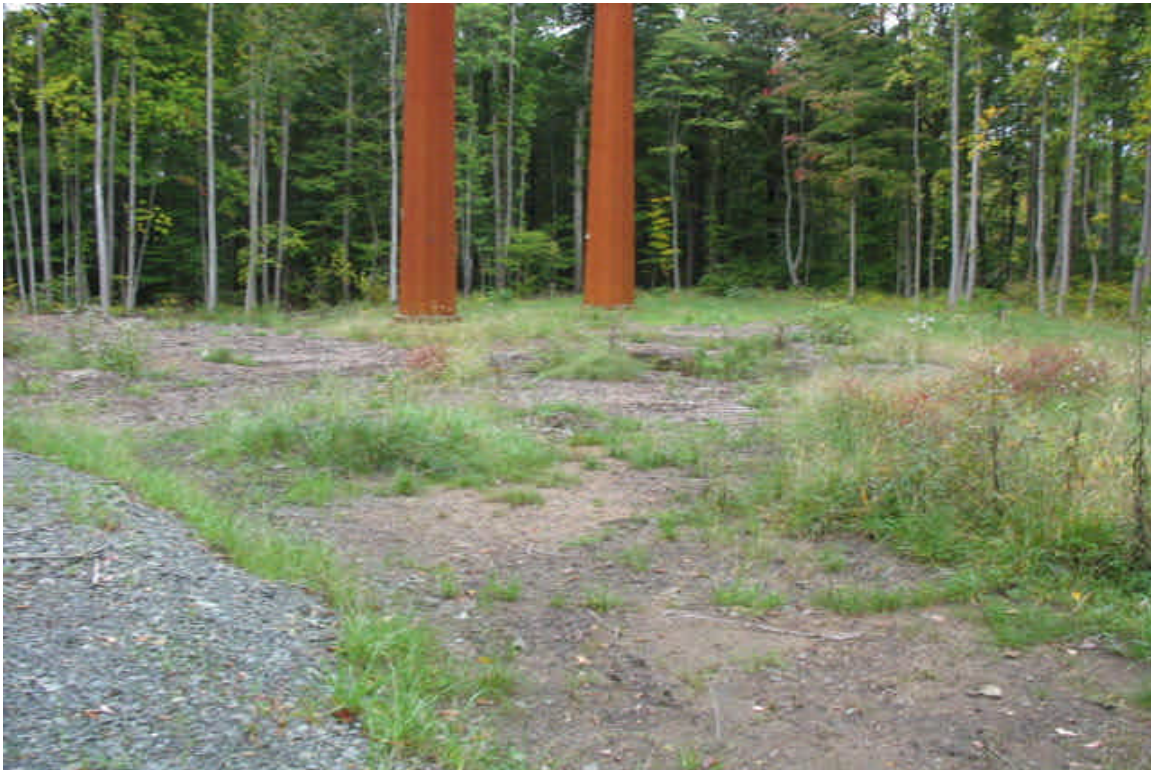
**Vegetative cover is still sparse at the pad/angle structure. The area remains stable with thick wood chips but vegetation will not be able to establish fully. The contractor plans to remove the chips and seed the area when feasible.**
