**Docket No. 272 – Development and Management Plan Inspection**

**Segment 1a Inspection**

**Date:** October 19, 2006

**Location:** Segment 1a – Scovill Rock Switching Station to Chestnut Junction, Oxbow Junction to Beseck Switching Station (excluding Royal Oak Bypass), Black Pond Junction to Beseck Switching Station

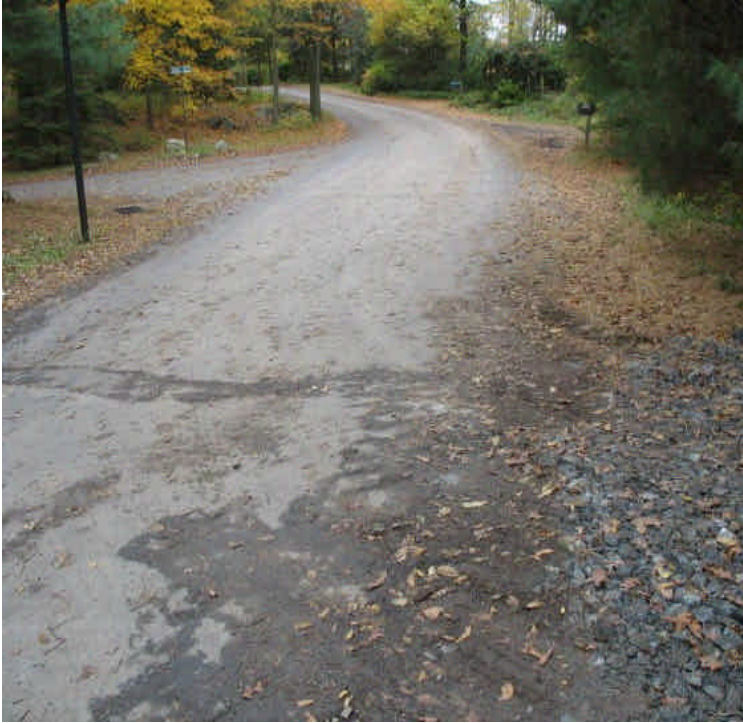
**Minor mud and sediment tracking observed on Oxbow Road.**

<b>Areas of Inspection</b>	<b>Observation</b>	<b>Recommended Action</b>	<b>Corrected Action</b>
<b>Access roads and adjacent roadways</b>			
<b>Oxbow Junction</b>	<b>Traffic is using the entrance off Oxbow Road. Minor mud and sediment tracking were noted and the roadway needs to be swept. Roadway base has been installed on access drive. 10/19/06</b>	<b>The new stone entrance has reduced sediment tracking. Maintain and clean stone entrance as needed. Install silt liner in catch basin across from the site entrance. 10/19/06</b>	<b>Roadway base installed at entrance. Some additional attention needed.</b>
<b>Black Walnut Dr.</b>	<b>Access roadway was under construction (grading and installing stone base). Some minor sediment tracking was noted on Black Walnut Dr., however crews were sweeping the roadway during the inspection. Catch Basin (CB) inlet protection looks good. 10/19/06</b>	<b>Continue to clean the roadway as needed. New access road is on a slope and should be monitored for erosion while the access road is installed. 10/19/06</b>	<b>Roadway being swept as needed. CB protection installed.</b>

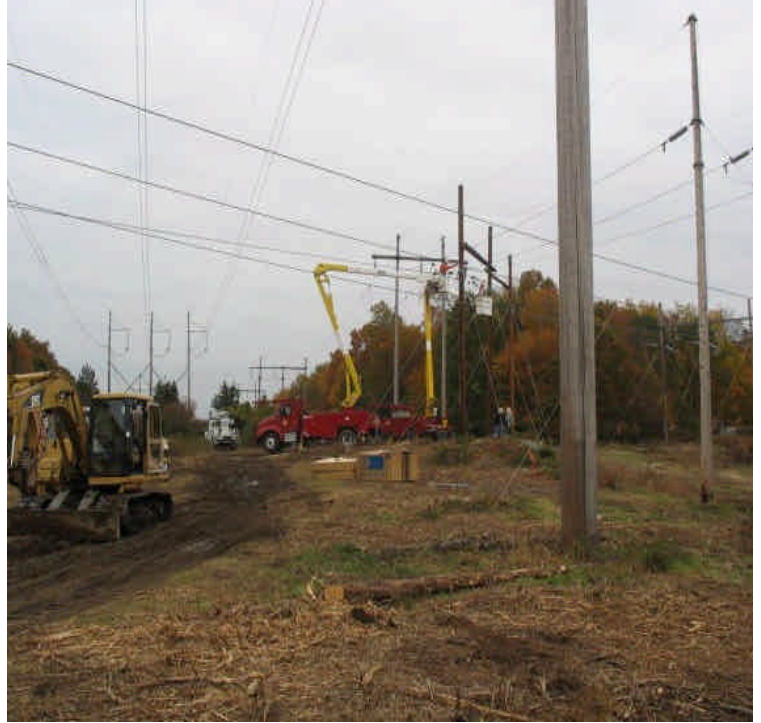
**Pole installation at Oxbow Junction.**

<b>Foundation and site construction</b>			
<b>Oxbow Junction</b>	<b>Pole installation underway at the time of inspection. 10/19/06</b>	<b>None. 10/19/06</b>	<b>NA</b>

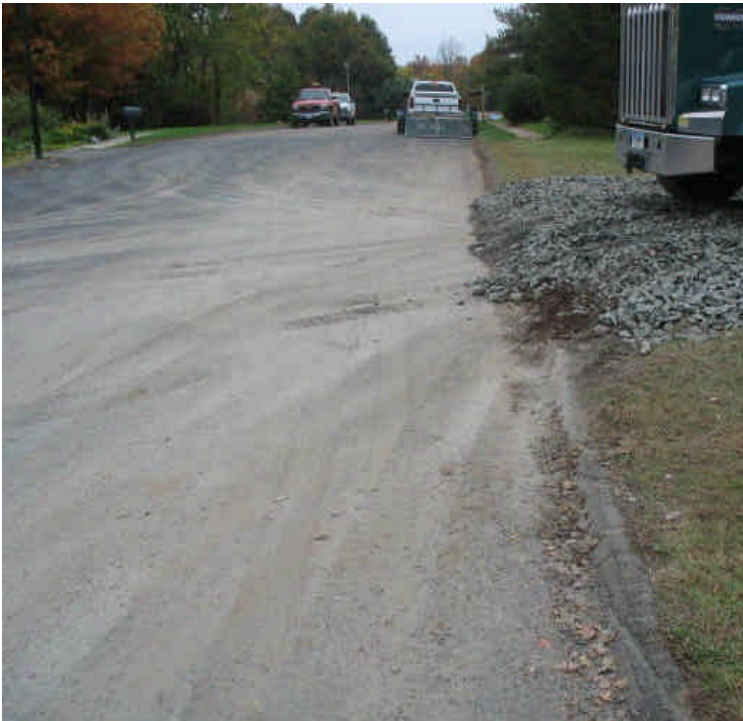
**Minor sediment tracking onto roadway at Black Walnut Dr.**

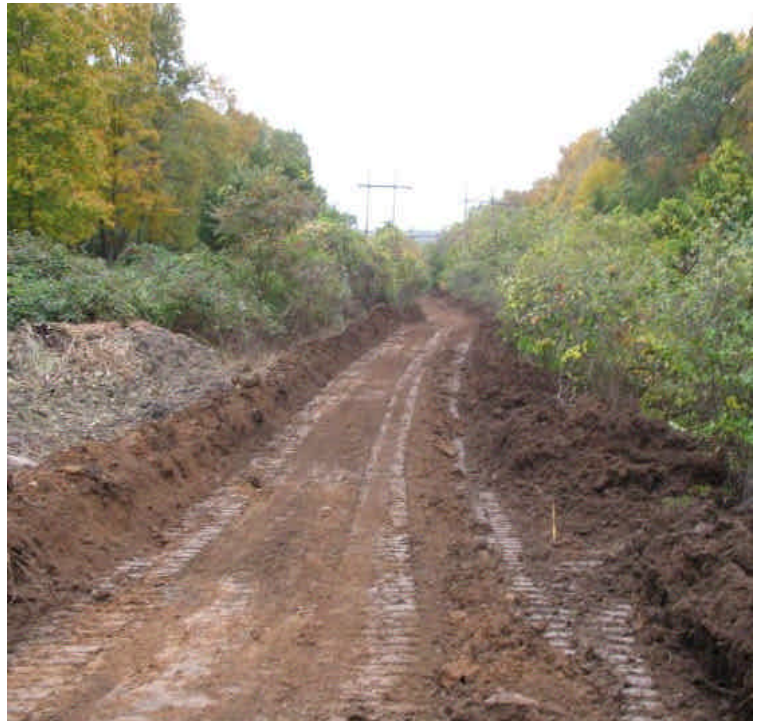
**Access road construction within the ROW off Black Walnut Dr. Work remains outside of all wetland buffers.**

Areas of Inspection	Observation	Recommended Action	Corrected Action
Black Walnut Dr.	Access road construction and some clearing were noted at this time. 10/19/06	None 10/19/06	NA
<p>Erosion and sediment controls</p> <p>Oxbow Junction</p> <p>Black Walnut Dr.</p>	<p>The majority of the vegetation remains intact. Very little potential for soil erosion exists in this area. 10/19/06</p> <p>The majority of vegetation has been removed with some shrubs remaining. Soils held intact by remaining vegetation and roots. 10/19/06</p> <p>Mulch left onsite for erosion control, used as needed along the slope and access drive. 10/19/06</p> <p>Wetlands are protected by a berm located upland of the wetlands onsite. The vegetated buffer is also being maintained. 10/19/06</p>	<p>Continue to selectively cut vegetation in accordance with the D&amp;M plan. 10/19/06</p> <p>Stabilize slopes as needed with seed, mulch, water bars, etc. 10/19/06</p> <p>Continue to use mulch for erosion control. 10/19/06</p> <p>Maintain buffer zone and soil berm. 10/19/06</p>	<p>Most vegetation was left in place; this will help prevent soil erosion.</p> <p>NA</p> <p>Mulch left for use as needed.</p> <p>Existing berm protects wetlands onsite.</p>
