Docket No. 272 – Development and Management Plan Inspection

Segment 2a Inspection

Date: December 18, 2006

Location: Segment 2a – Beseck Switching Station to Cheshire/Hamden Town Line

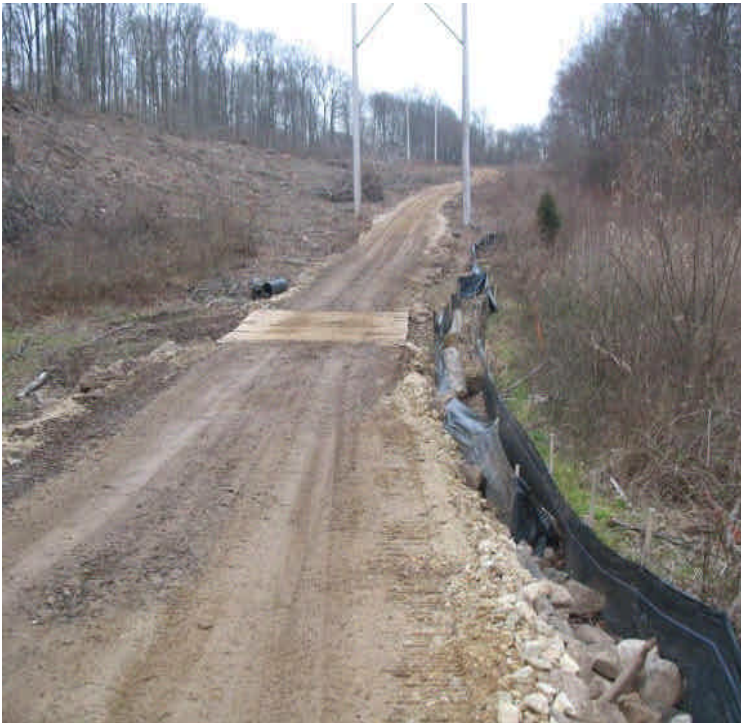
New access road, mats, and erosion controls off High Hill Rd at a non-jurisdictional wetland crossing

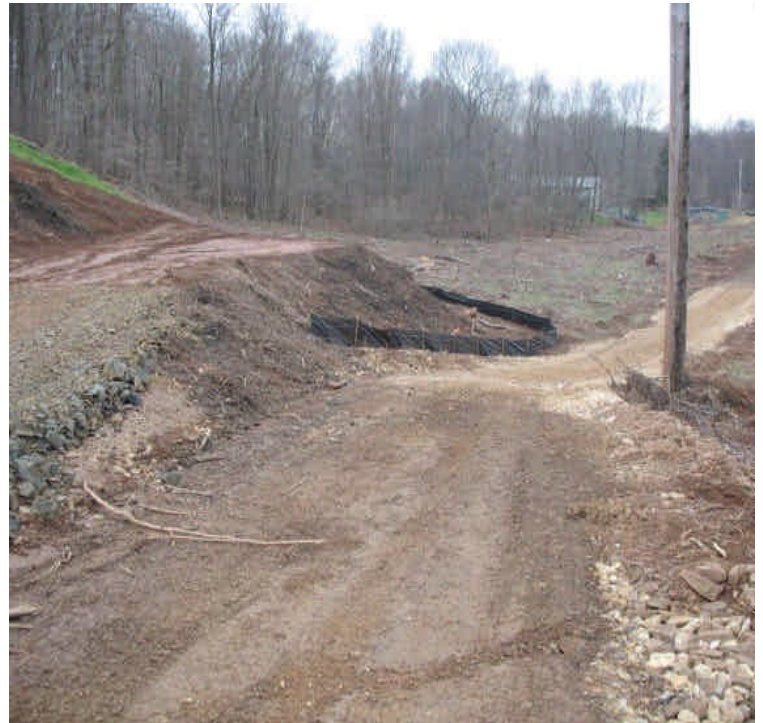
New staging areas prepared for pole construction. Temporary stabilization measures were added.

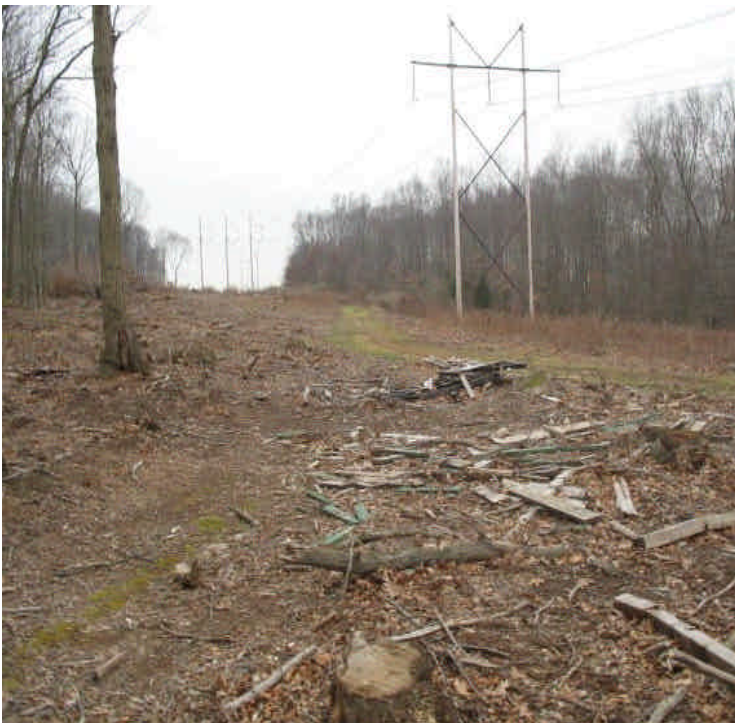
ROW off Stony Brook Rd. Non-project related debris has been dumped in this area.

| Areas of Inspection | Observation | Recommended Action | Corrected Action |
|---|--|---|---|
| | Some non-project jurisdictional debris dumping was noted at a few access points, including off Stony Brook Rd. 11/27-12/18/06 | None. Noted for the record. 12/18/06 | NA |

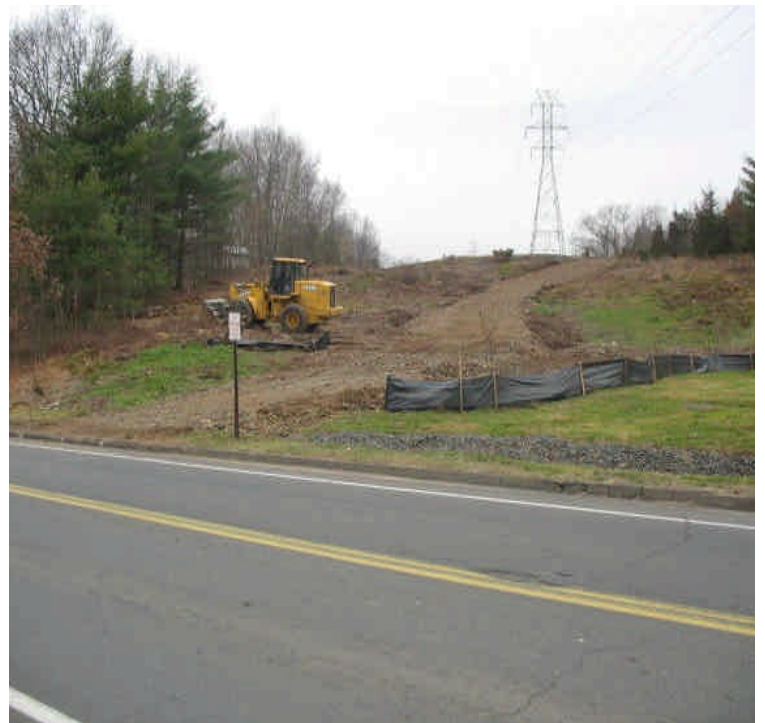
| Areas of Inspection | Observation | Recommended Action | Corrected Action |
|---|--|---|---|
| S. Turnpike + Merritt Parkway Area | No sediment tracking noted on S. Turnpike. New access road is complete. Washouts/gullies along the access road slope were graded with installation of new road. 12/18/06 | Continue to monitor the entrance and sweep as needed. Also, continue to monitor the slope for additional wash-out or run-off issues. Stormwater diversions may be needed. 12/18/06 | Gullies were repaired. |

Eroded gullies/washouts were repaired; the new access road and silt fence were installed off South Turnpike. Continue to monitor this slope for run-off issues.

| Areas of Inspection | Observation | Recommended Action | Corrected Action |
|--|---|---|---|
| <p>S. Turnpike + Merritt Parkway Area</p> | <p>New access road has been installed and washouts/gullies have been repaired. Silt fence was installed above riprap slope and culvert. 12/18/06</p> | <p>Monitor new access road and erosion controls, add controls if needed. 12/18/06</p> | <p>Gullies repaired, silt fence installed.</p> |

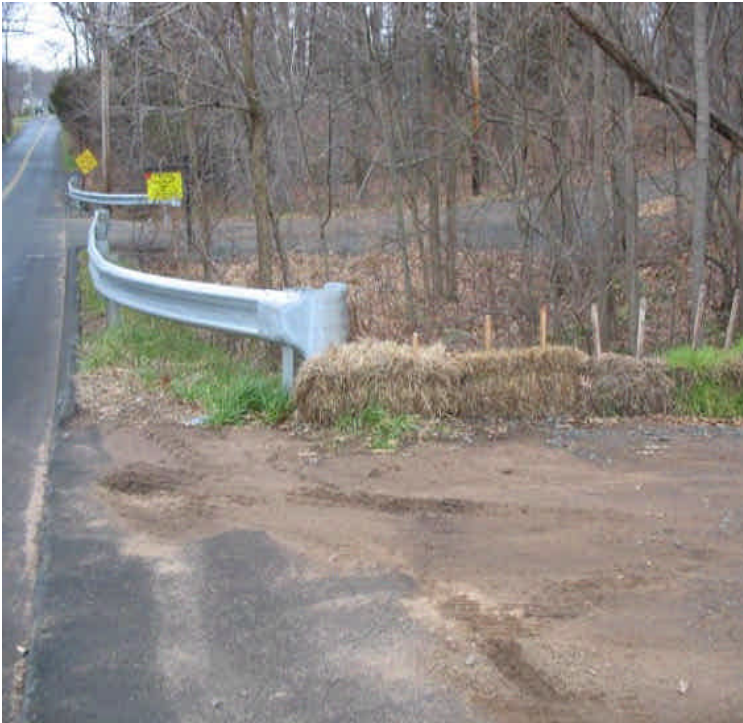
| Areas of Inspection | Observation | Recommended Action | Corrected Action |
|---|--|---|---|
| Mansion Rd | No sediment tracking noted on Mansion Rd. Some sediment build-up | Continue to monitor and sweep entrance as needed. Sediment should | Needs attention when feasible. |

| Areas of Inspection | Observation | Recommended Action | Corrected Action |
|--|---|--|---|
| <p>Old Farm Rd.</p> | <p>downgradient edge of the ROW entrance look secure, however sediment from run-off has accumulated at the haybales and is starting to migrate around them. 11/27-12/18/06</p> | <p>and remove sediment. 11/27-12/18/06</p> | <p>feasible.</p> |

Sediment accumulation should be removed from the haybales at the ROW entrance off Mansion Rd.

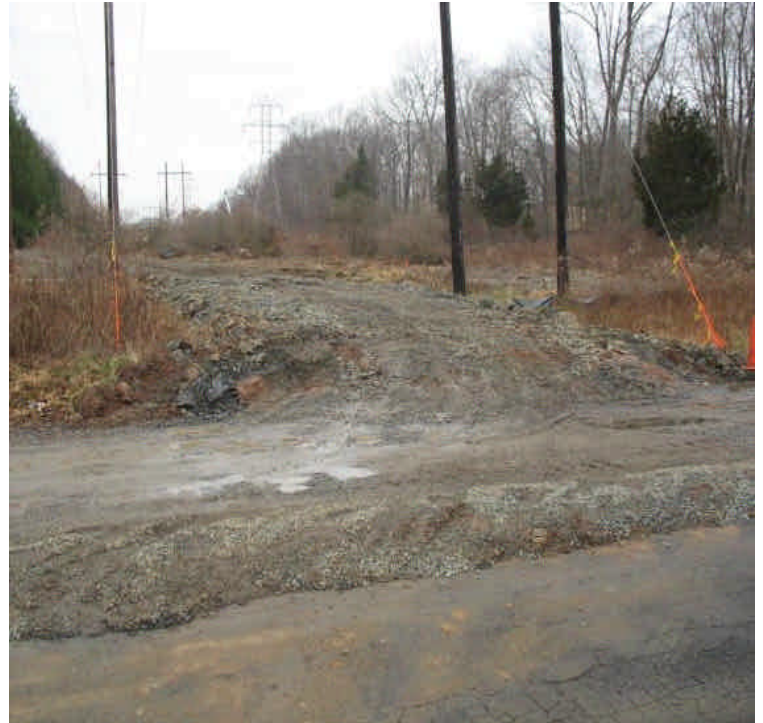
| Areas of Inspection | Observation | Recommended Action | Corrected Action |
|--|---|--|---|
| | <p>Some displaced run-off from the small NFJ wetland finger is flowing along the driveway toward Old Farm Rd. Sedimentation is not an issue at this time. 12/18/06</p> | <p>Monitor potential run-off areas and add controls or diversions as needed. 12/18/06</p> | <p>NA at this time.</p> |

Continue to monitor run-off seeping from non-federally jurisdictional wetland crossing off Old Farm Rd.

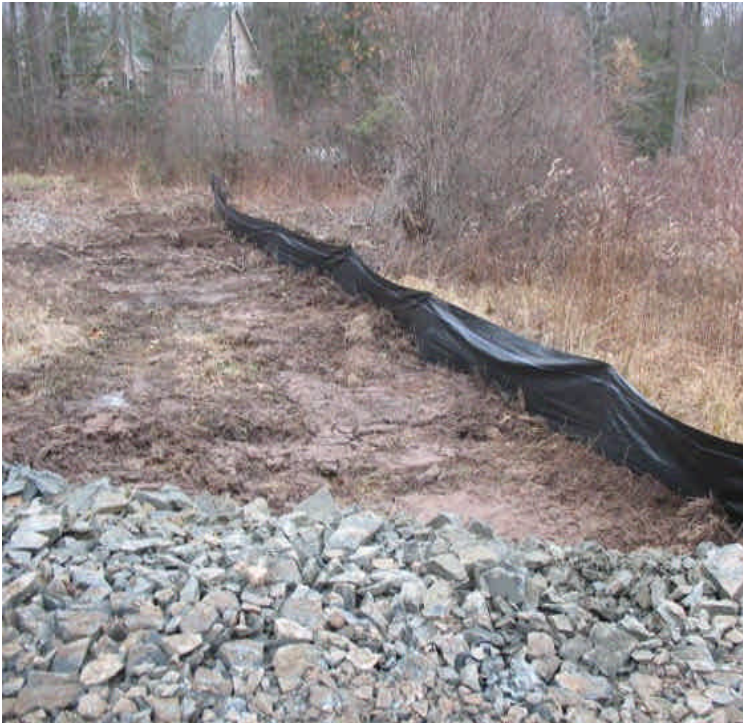
| Areas of Inspection | Observation | Recommended Action | Corrected Action |
|--|---|--|---|
| | <p>Silt fence installed above the NFJ wetland on both sides of the access drive. 12/18/06</p> | <p>Monitor controls and maintain as needed. 12/18/06</p> | <p>Silt fence added.</p> |

Silt fence installed upgradient from the non-federally jurisdictional wetland finger off Old Farm Rd.

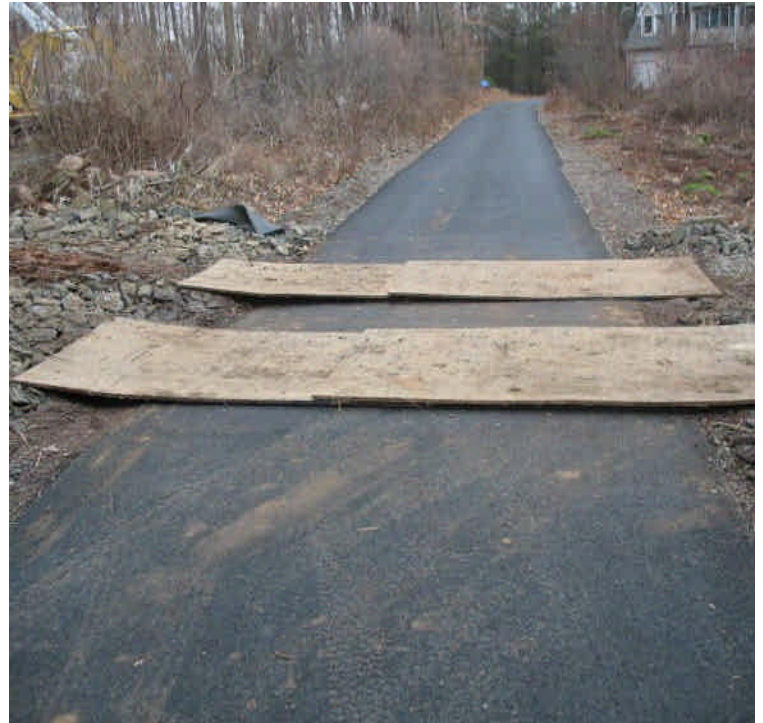
| Areas of Inspection | Observation | Recommended Action | Corrected Action |
|--|--|---|--|
| <p>Old Farm Road</p> | <p>was noted at the entrance to Mansion Rd. This sediment is accumulating at and around the haybales and is migrating towards the roadway. 11/27-12/18/06</p> <p>Old Farm Rd. and driveways on the ROW continue to be swept as needed. Plywood is being used to reduce impact to the driveways from equipment crossing. Two driveways have some minor marks from equipment 12/18/06</p> <p>Access road construction is now complete. Some minor run-off was noted from the filled portion of the small, NFJ wetland. 12/18/06</p> | <p>be removed before it reaches the roadway 11/27-12/18/06</p> <p>Continue to monitor for sediment on roadway and driveways; continue to use rubber mats or plywood to protect driveways. 12/18/06</p> <p>Monitor wetland run-off and controls as needed. 12/18/06</p> | <p>Roadway was swept. Plywood is used to protect driveways from equipment damage (proactively)</p> <p>NA</p> |

Plywood installed to protect driveways from equipment crossing on the ROW off Old Farm Rd. Minimal sediment tracking was noted.
