Docket No. 272 – Development and Management Plan Inspection

Segment 2b Inspection

Date: December, 7 2006

Location: Segment 2b – Cheshire/Hamden Town Line to East Devon Substation

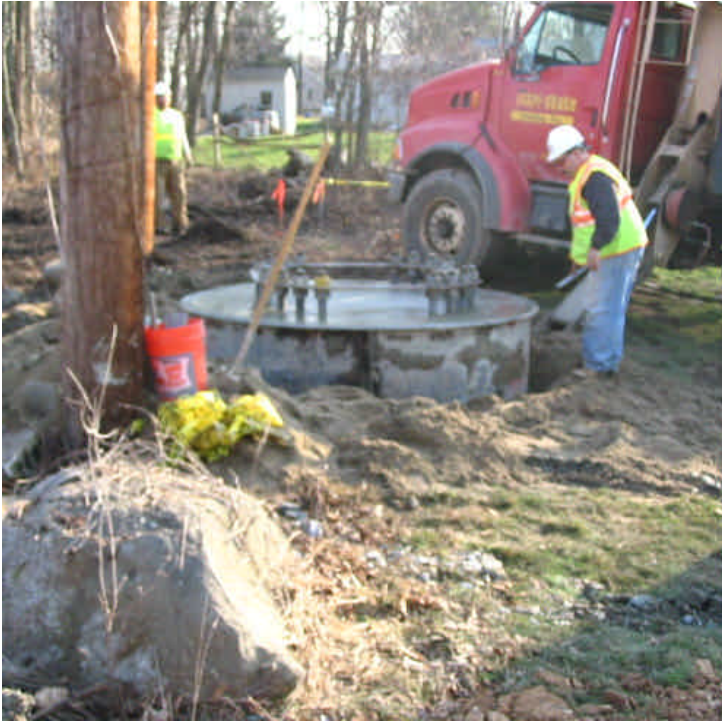
View of the foundation installed at the second proposed structure location off Russell Ave.

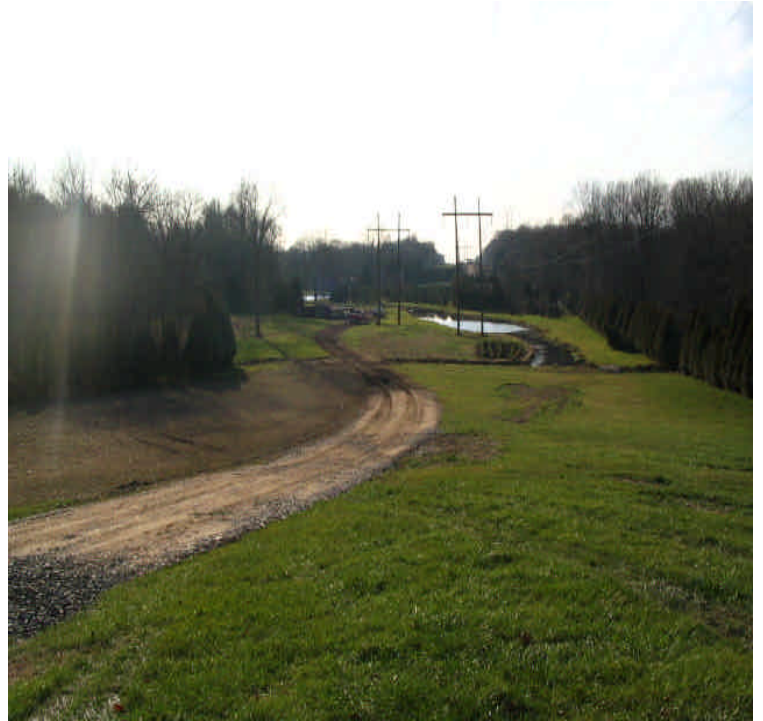
View of the new access road constructed within the ROW off Dogwood Road (west).

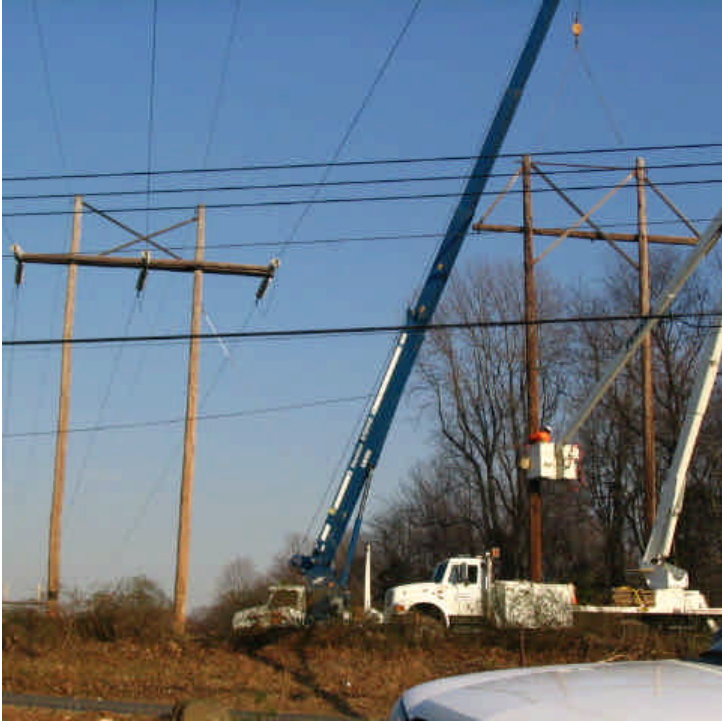
Crews were in the process of removing the existing H-frame structures from the ROW off Dogwood Road (east).

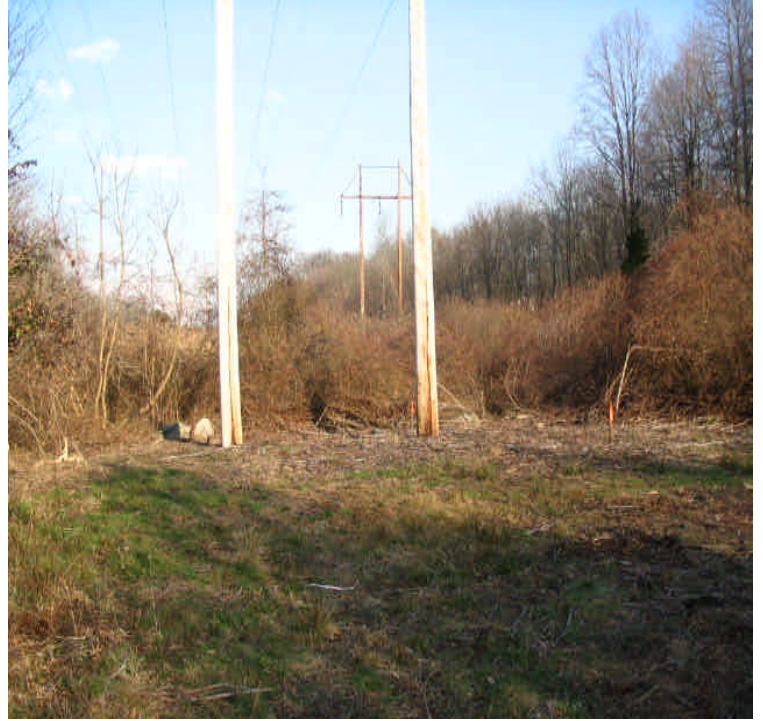
View of the possible wetland area that may have been cleared for proposed structure installation off Dogwood Road (east). Some wetland flags were missing here, making the boundary difficult to identify.

Areas of Inspection	Observation	Recommended Action	Corrected Action
<p>Inland Wetland and Watercourse encroachment and mitigation</p> <p>Orange, CT (Russell Ave, Sunset Drive, Dogwood Road, Orange Center Road/Route 152, Pine Tree Drive and Hunting Hill Place)</p> <p><i>Contractors have stated that all wetlands with current activity are not under federal jurisdiction 11/29/06</i></p> <p>Woodbridge, CT (Pease Road)</p>	<p>Federally jurisdictional wetlands and associated buffers will not be accessed until the ACOE permit is in hand 11/20-12/07/06.</p> <p>A matted crossing is in place at the wetland located in the ROW off Sunset Dr. Silt fence is in place. This wetland is not under federal jurisdiction. 12/07/06.</p> <p>Clearing activities are taking place near the wetlands within the ROW located off Orange Center Road/Route 152 (west) and Pine Tree Drive (west). Silt fence has been installed in both areas. 12/07/06.</p> <p>Clearing activities were also noted near the wetland located off Dogwood Road (east). Some wetland flags were missing here, but it appeared a small portion of wetland may have been cleared for proposed structure installation. Many shrubs and some herbaceous vegetation remain in place along the edges. 12/07/06.</p> <p>A portion of the wetland located off Pease Road has mats in place for stabilization and structure access. 12/07/06.</p>	<p>Maintain federally jurisdictional wetlands and buffer zone until ACOE permits allow access. 11/20-12/07/06.</p> <p>Continue to maintain erosion controls where necessary. 12/07/06.</p> <p>Continue to monitor. Maintain erosion controls as necessary. 12/07/06.</p> <p>Silt fence is not necessary at this time. Continue to monitor. Confirm that this wetland is not under federal jurisdiction. 12/07/06.</p> <p>Continue to install mats and erosion controls where necessary. 12/07/06.</p>	<p>NA</p> <p>NA.</p> <p>NA</p> <p>Needs evaluation</p> <p>NA</p>

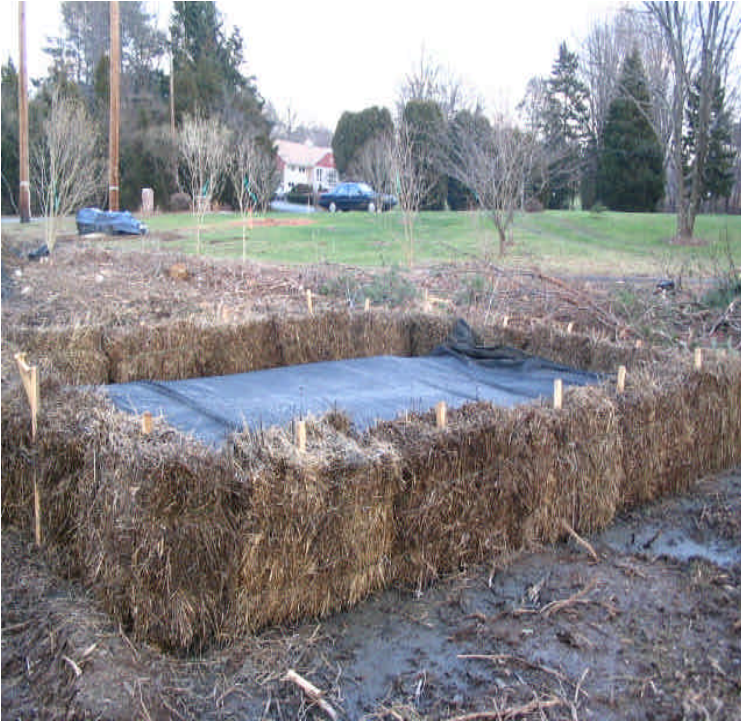
View of the dewatering area placed near the first proposed structure location off Sunset Dr. The filter bag, in combination with the haybales, was effective in retaining sediment prior to releasing the water.

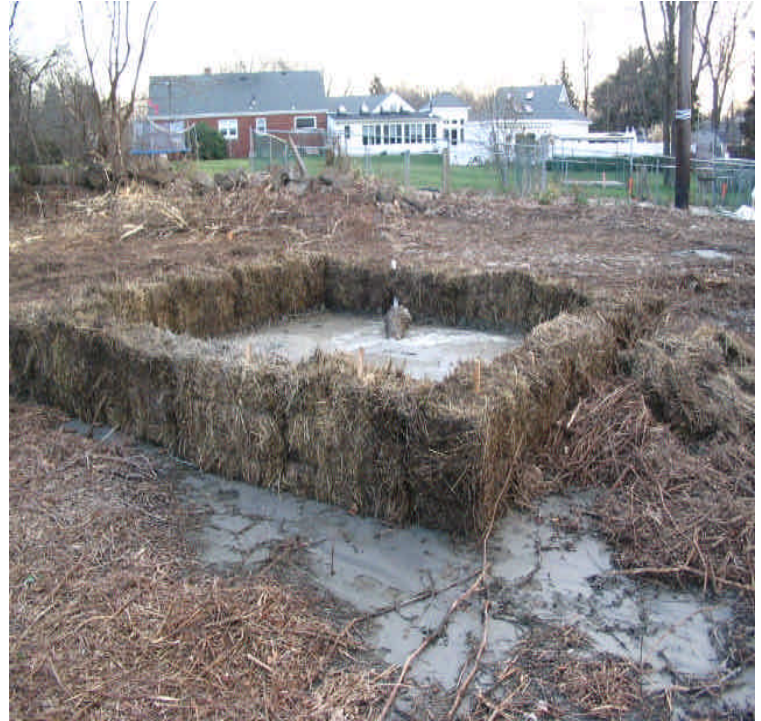
View of the dewatering area near the second proposed structure location off Sunset Dr. A filter bag was not used here, allowing sediment/slurry to escape and flow in the direction of the wetland.

<p>Dewatering</p> <p>Orange, CT (Russell Ave and Sunset Drive)</p>	<p>In general, haybales and filter bags have been pro-actively placed at drilling sites. 12/07/06.</p> <p>Dewatering was occurring off Sunset Dr one of the areas was effectively filtering and releasing water but the 2nd area did not have a filter bag in conjunction with the haybales. Sediment/slurry was flowing toward the NFJ wetland. 12/07/06.</p> <p>Drilling has begun for the 1st and 2nd structures located off Russell Ave. Filter bags were placed near each drilling site but dewatering efforts have been minimal so far. 12/07/06.</p>	<p>None.</p> <p>A filter bag should be installed within the haybale perimeter to effectively filter the slurry if dewatering efforts are to continue here. 12/07/06.</p> <p>None 12/07/06</p>	<p>NA</p> <p>Needs attention if dewatering is to continue here.</p> <p>NA</p>
<p>Blasting</p>	<p>No blasting is proposed at this time. 12/07/06.</p>	<p>None</p>	<p>NA</p>

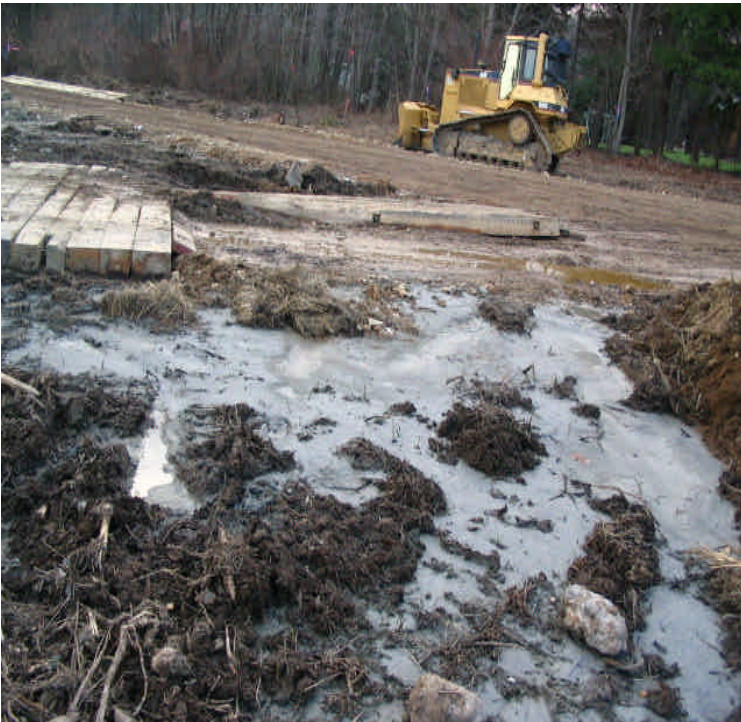
An additional view of the sediment/slurry flowing toward the wetland off Sunset Drive.

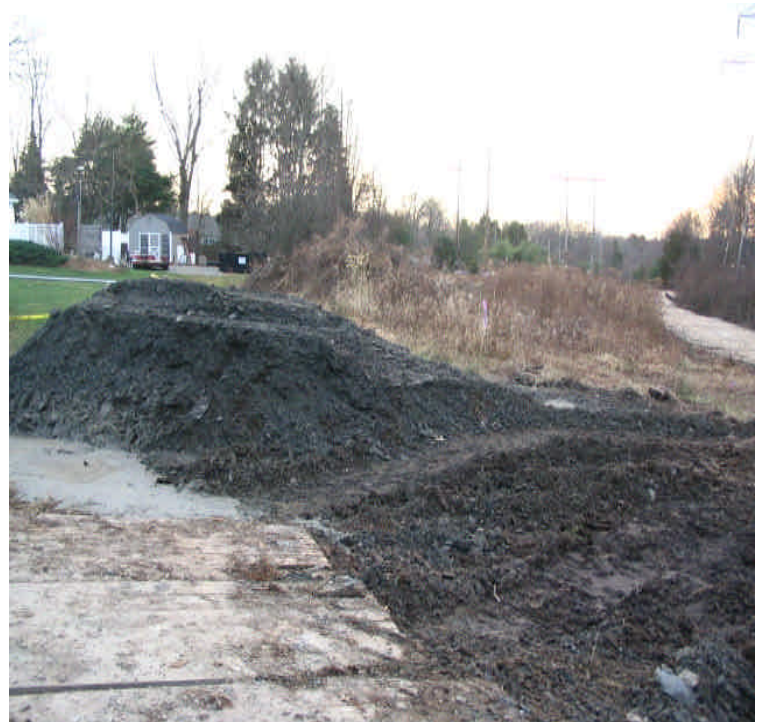
View of the stockpile stored near the wetland off Sunset Drive. Erosion controls should be installed downgradient of the pile to contain potential sedimentation.

Areas of Inspection	Observation	Recommended Action	Corrected Action
<p>Ave, Dogwood Road, Sunset Drive, Orange Center Road/152, Saddle Ridge Road, Hunting Hill Road, Pine Tree Drive, and Treat Lane)</p>	<p>Soils adjacent to the access road off Russell Ave may be too soft to support equipment. Ruts remain within the ROW here. 11/20-12/07/06.</p>	<p>Stabilize soil (tracks) as it becomes necessary. 11/29-12/07/06.</p>	<p>NA</p>
	<p>Silt fence is intact at the wetland crossing accessed from Sunset Dr. 12/07/06.</p>	<p>Continue to monitor and maintain as necessary. 11/20-12/07/06.</p>	<p>NA</p>
	<p>Spoil was placed on a liner in an upland area near the 1st and 2nd structures off Sunset Dr. However, controls were not in place down-gradient of the stockpile adjacent to the NFJ wetland. 12/07/06</p>	<p>Silt fence or haybales should be installed or the spoil pile should be covered in plastic to contain potential sedimentation. See Dewatering Section. 12/07/06.</p>	<p>Needs Attention</p>

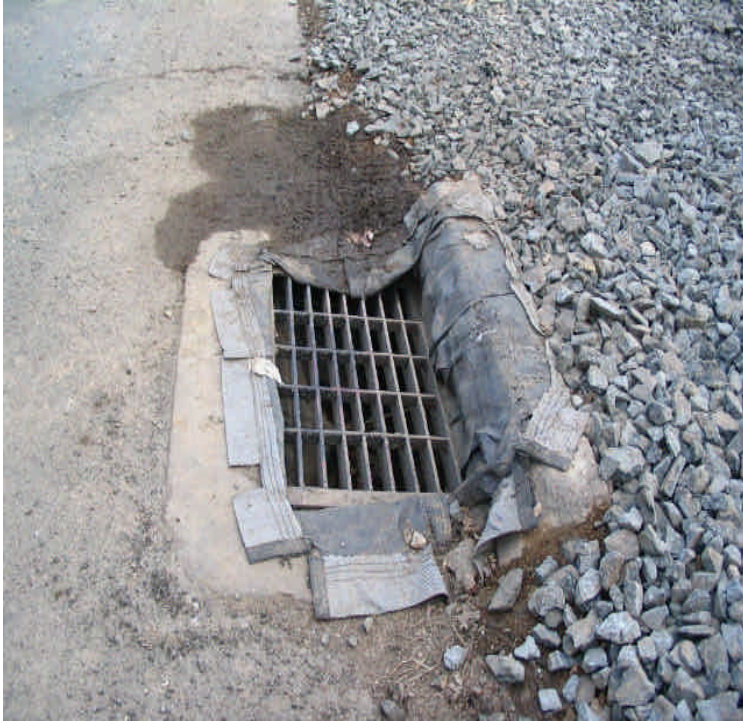
View of the catch basin located immediately adjacent to the access off Sunset Drive. The silt sack was pulled over the curb drop inlet here to provide further protection.

Areas of Inspection	Observation	Recommended Action	Corrected Action
<p>Milford, CT (Shelland Street)</p> <p>Woodbridge, CT (Pease Road)</p>	<p>“Silt saks” (or similar) were installed in all catch basins within the vicinity of the constructed access roads. 12/07/06.</p> <p>Activities associated with the relocation of Shelland St continue. Some clearing and site preparation is occurring at the proposed East Devon Substation site. 12/07/06.</p> <p>Clearing and access road construction continues in this section. A small section of wetland is matted here to provide access to the proposed structure locations. This wetland area is not under federal jurisdiction (NFJ). Active work was not occurring at the time of inspection. 12/07/06.</p>	<p>See Erosion Control Section for more detail. 12/07/06</p> <p>Continue to monitor. 12/07/06</p> <p>Continue to monitor. 12/07/06.</p>	<p>CB controls in place. Improve as necessary.</p> <p>NA</p> <p>NA</p>

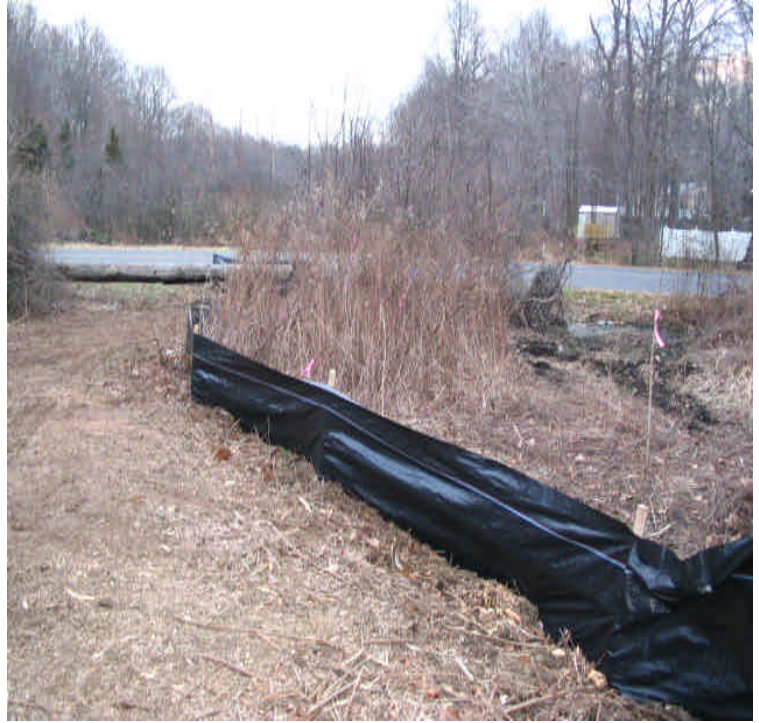
View of the silt fence installed at the wetland within the ROW off Pine Tree Drive (west). Clearing was noted here.

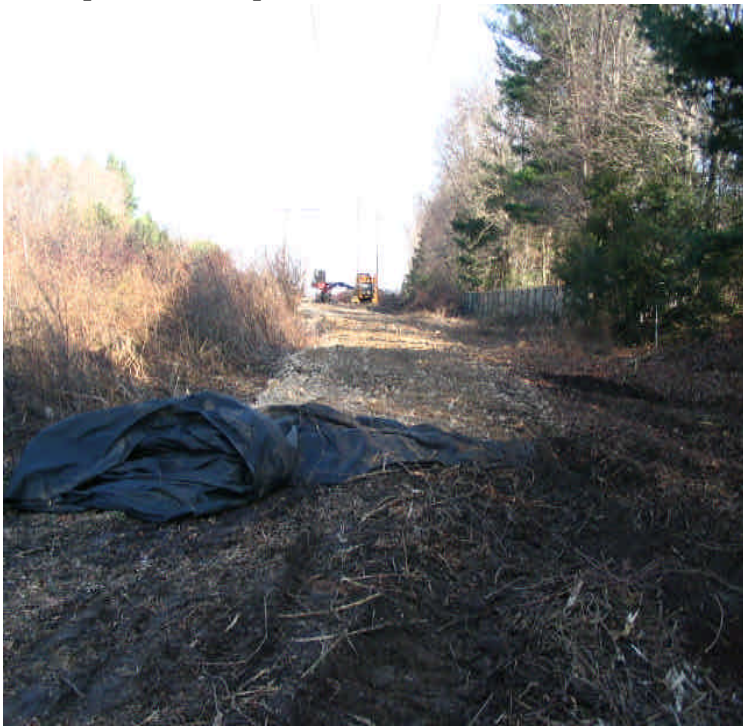
View of the clearing and access road construction occurring in the ROW off Orange Center Road/Route 152 (west).

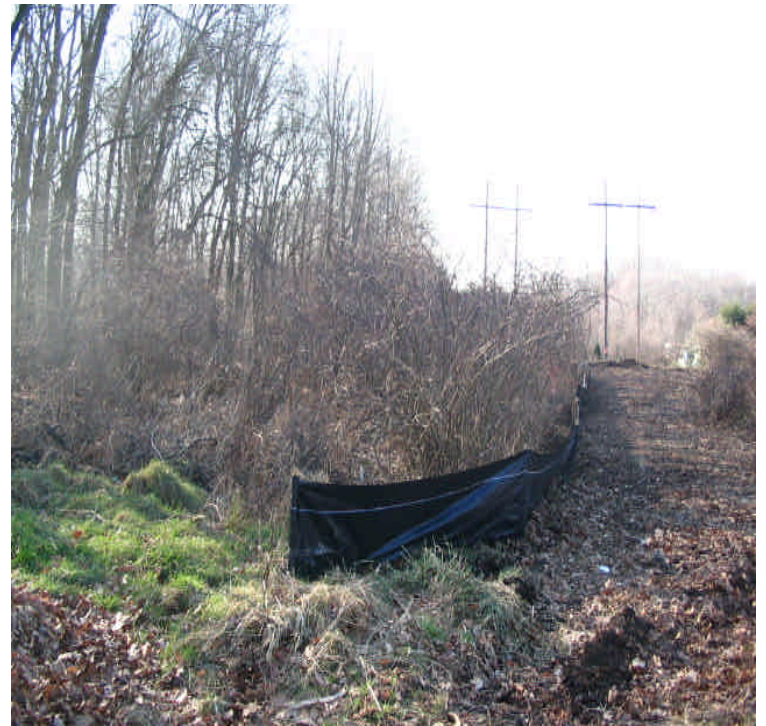
Silt fence was installed along the wetland located within the ROW off Orange Center Road/Route 152 (west). Clearing and access road construction continue in this area.

<p>Silt fence was installed at the small NFJ wetland area located on the western side of Pine Tree Drive. 12/07/06.</p>	<p>Continue to monitor and maintain as necessary. 12/07/06.</p>	<p>NA</p>
	<p>Silt fence has been installed at the NFJ wetlands within the ROW located off Orange Center Road/Rt 152 (west) and Pine Tree Drive (west). Clearing activities were noted here. 12/07/06.</p>	<p>Continue to monitor and maintain as necessary. 12/07/06.</p>	<p>NA</p>
	<p>“Silt saks” (or similar) are in place in all catch basins within the vicinity of the constructed access roads. They were also in place over the curb drop inlets at catch basins. 12/07/06.</p>	<p>Continue to monitor and evaluate methods to protect the curb drop inlet and prevent sedimentation. 11/29-12/07/06.</p>	<p>CB controls in place.</p>
	<p>Milford, CT (Shelland Street)</p>	<p>A large amount of exposed soils remain here during the work but silt fence was in place along the work area 12/07/06</p>	<p>Continue to monitor and maintain as necessary. Temporarily stabilize as feasible. 12/07/06</p>
