Docket No. 272 – Development and Management Plan Inspection

Segment 2b Inspection

Date: December 21, 2006

Location: Segment 2b – Cheshire/Hamden Town Line to East Devon Substation

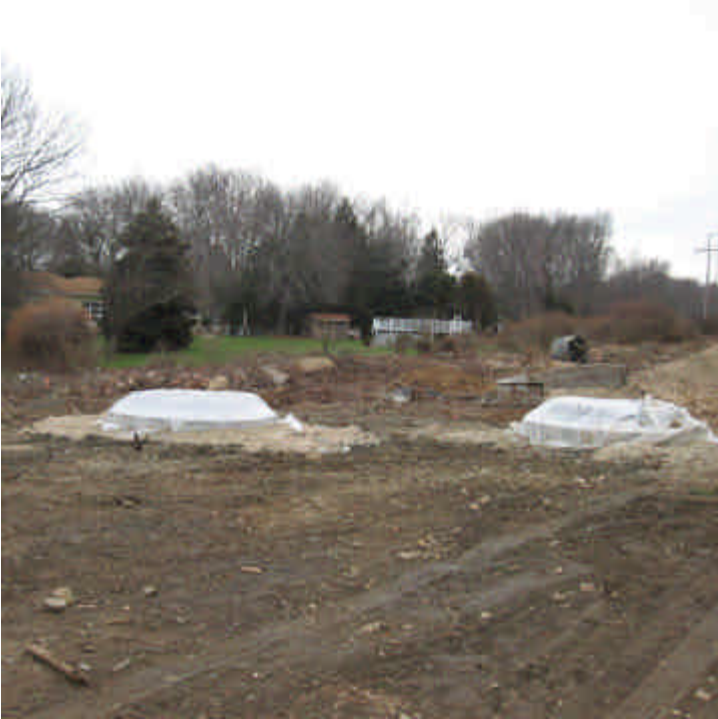
View of the foundation work within the ROW off Russell Ave.

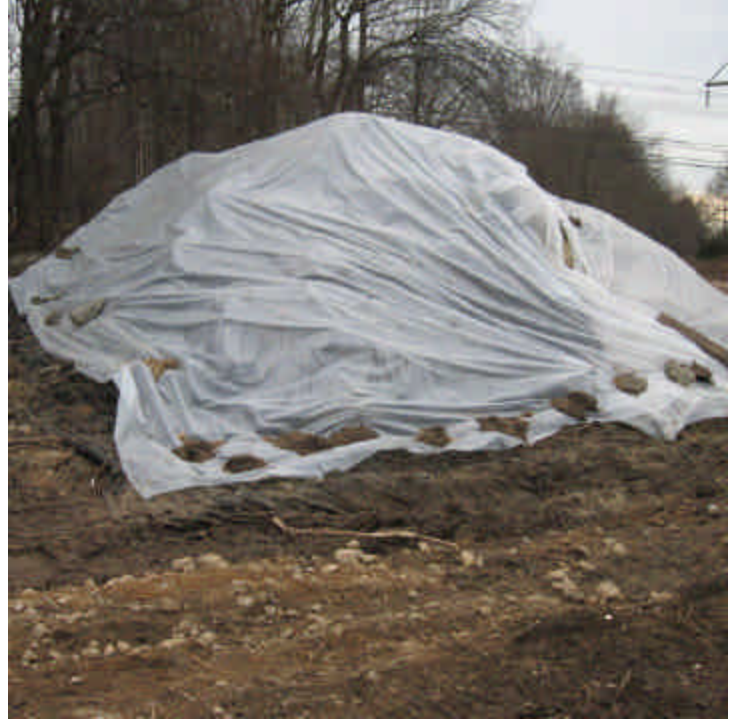
All stockpiles off Russell Ave remain covered with plastic.

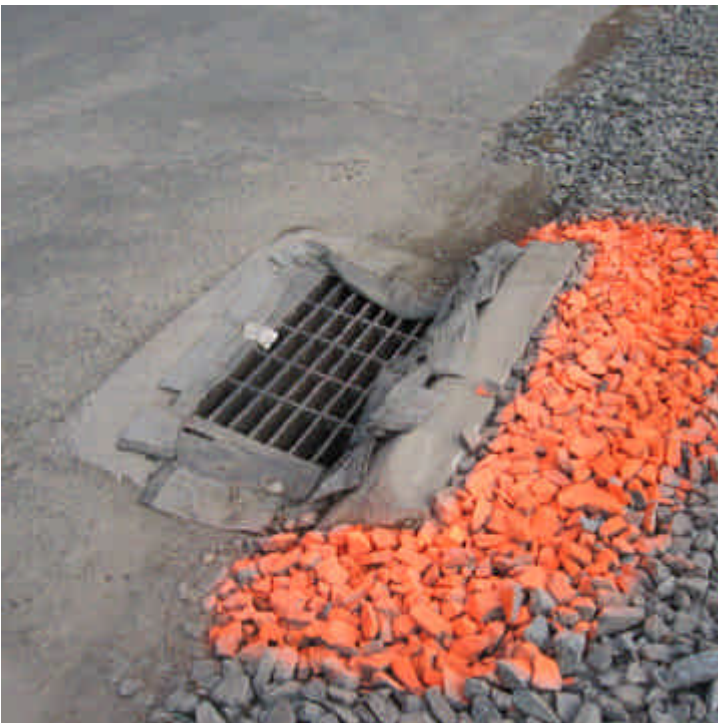
The catch basin on Sunset Drive remains protected. No sediment tracking was observed here this week.

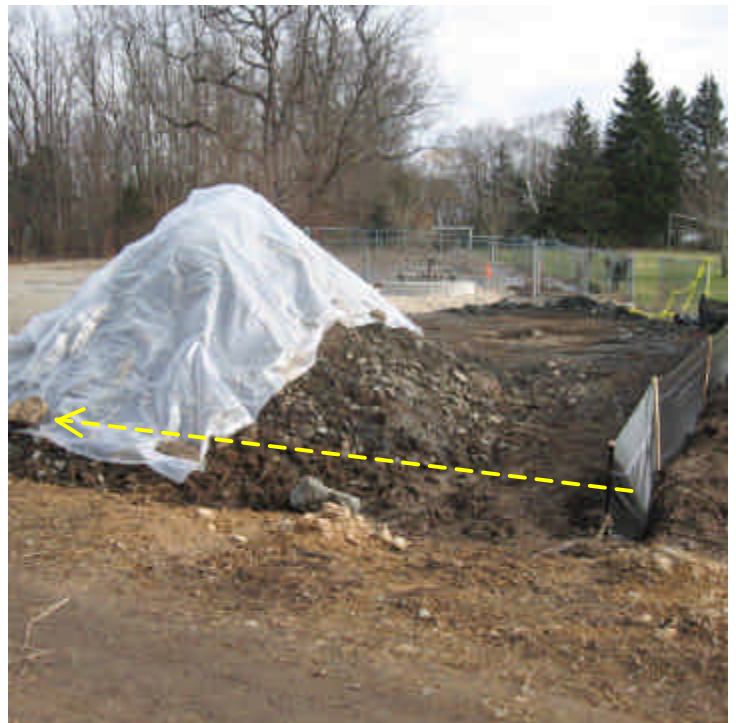
Silt fence was installed between the stockpile and NFJ wetland within the ROW off Sunset Dr. The silt fence should be extended towards Sunset, along the access road.

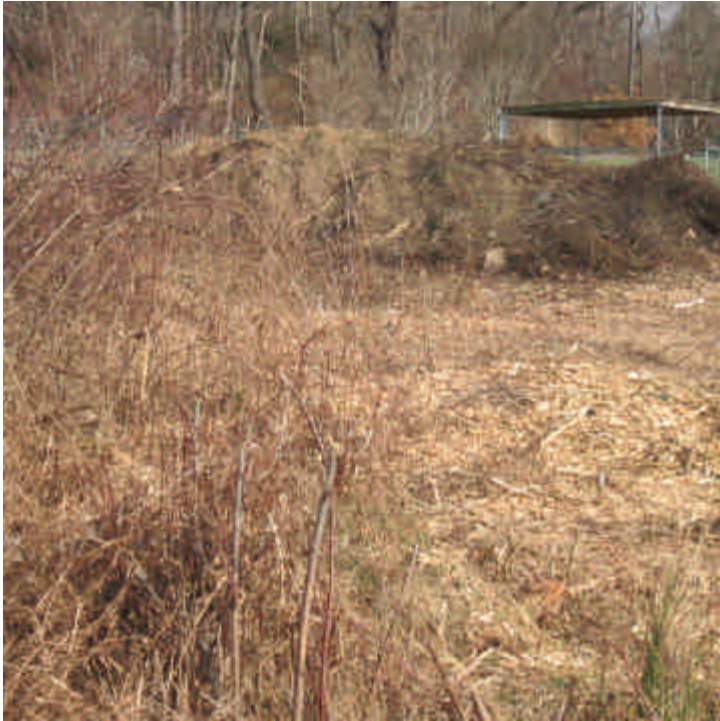
Wood chips were spread along the upland portions of the ROW off Sunset Dr. Take care to keep wood chips out of wetland areas.

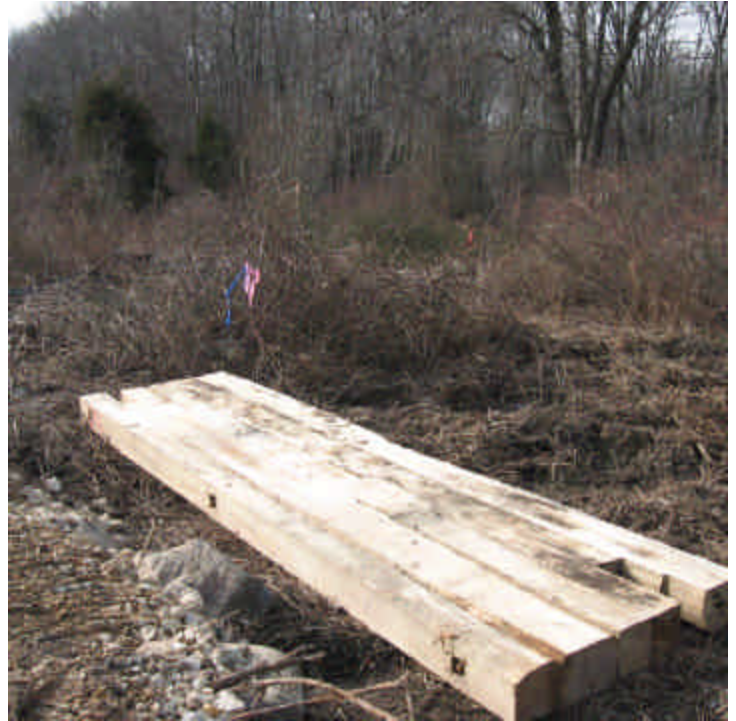
View of materials stored immediately adjacent to the wetland off Sunset Dr. Some equipment ruts were noticed beyond the wetland flags.

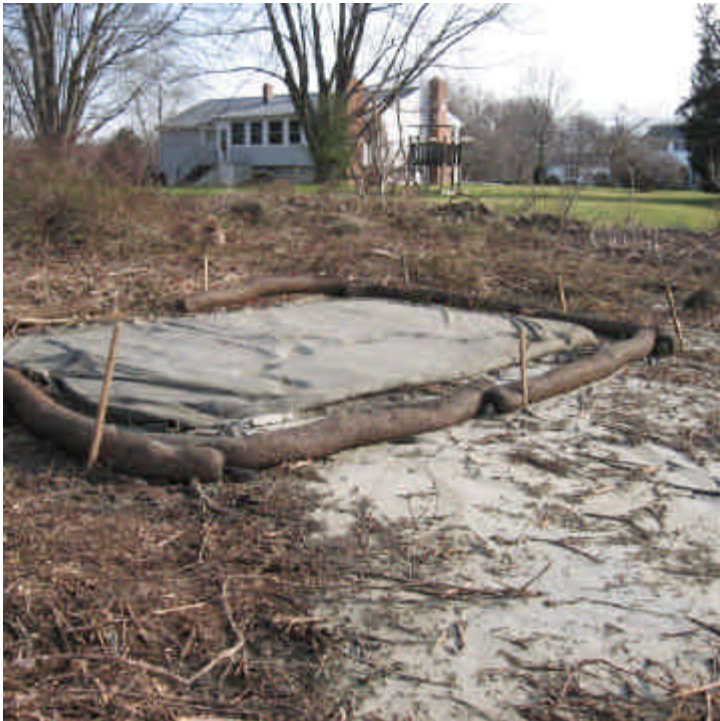
View of the dewatering area located within the ROW off Overland Drive (west). Sediment/slurry has flowed beyond the controls here.

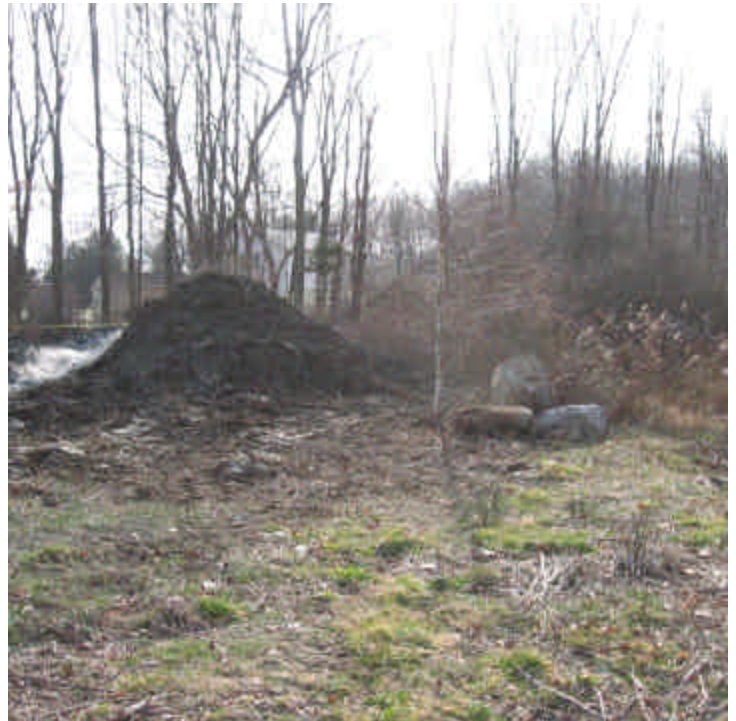
The spoil pile located off Overland Drive (west) is currently stored near the wetland. Silt fence should be installed here.

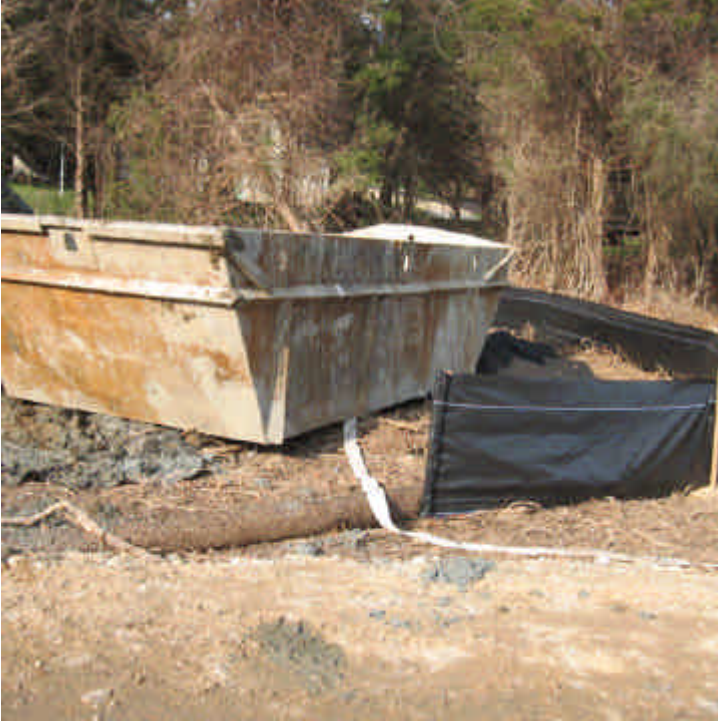
View of the dewatering area within the ROW located off Overland Drive (east). Foundation drilling and pouring continues here.

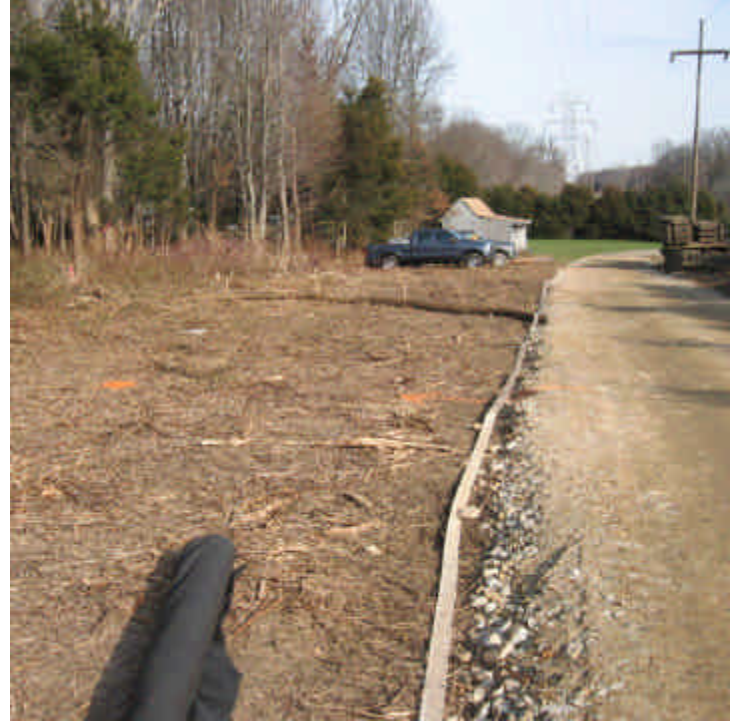
View of the filter sock check dams installed within the ROW off Overland Drive (east).

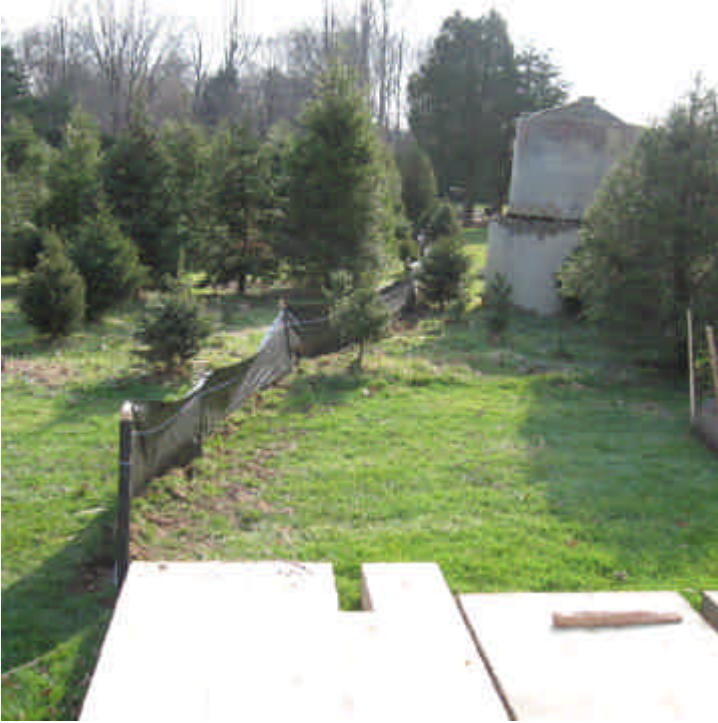
Silt fence was installed upgradient of the wetland near the tree farm located within the ROW off Overland Drive (east).

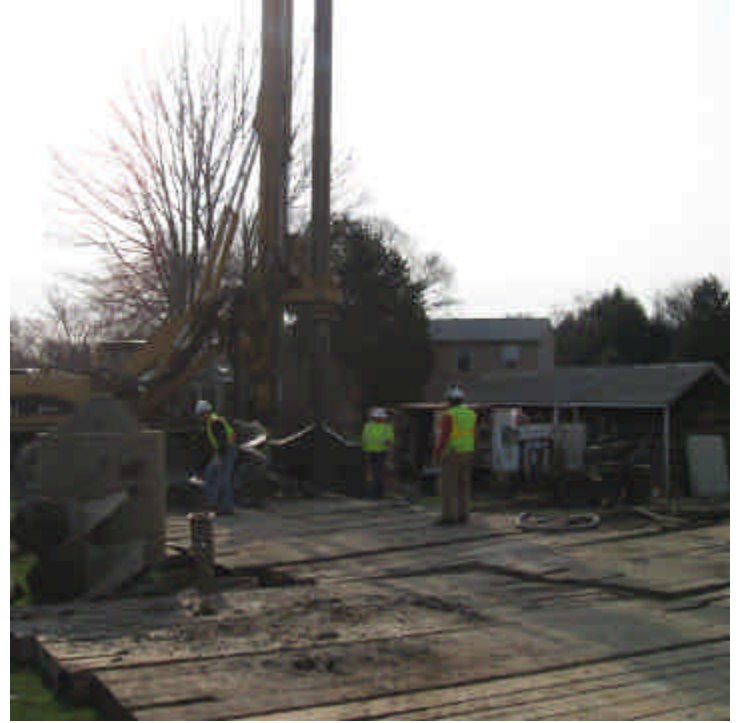
Foundation drilling continues off Overland Drive (east). Timber mats were used where necessary.

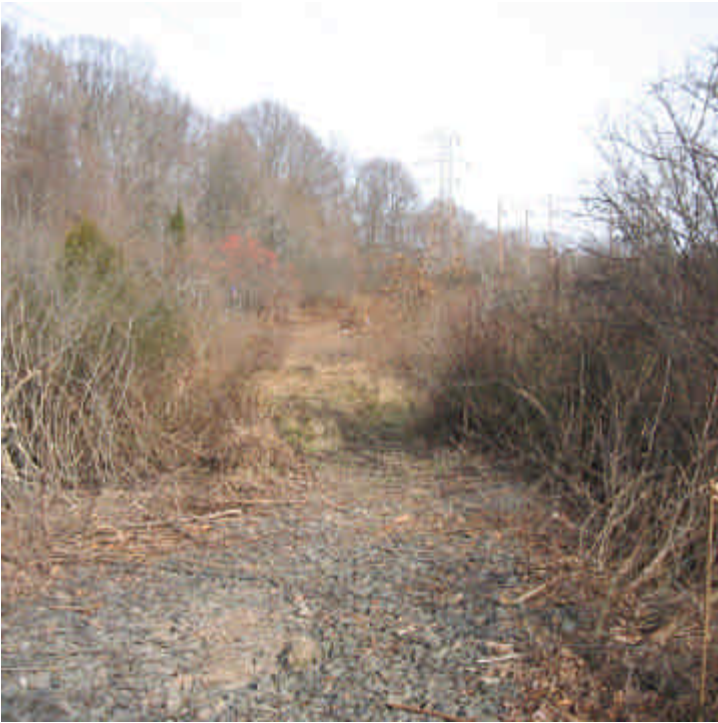
View of the cleared area within the wetland located off Pine Tree Drive (east). Adjacent vegetation was retained.

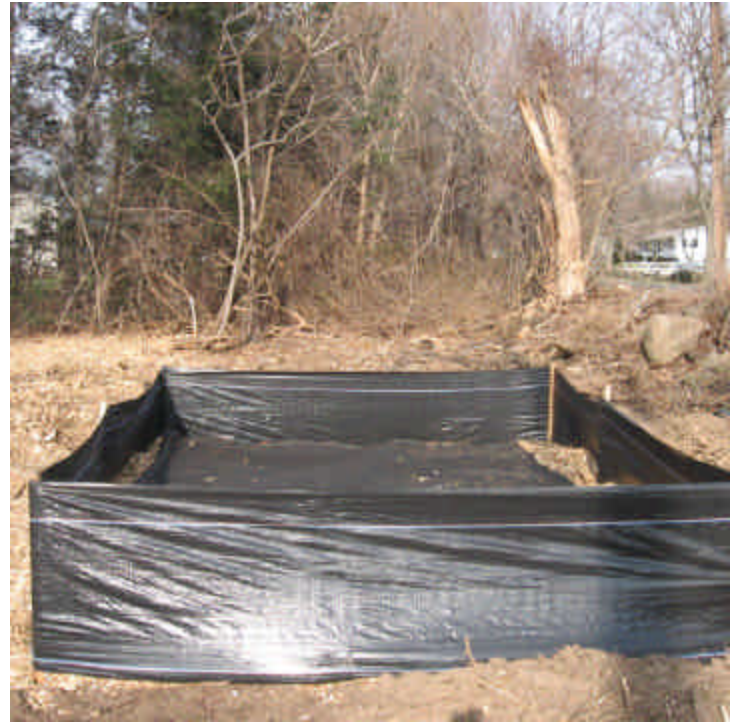
Dewatering containment areas were proactively placed within the ROW off Ridge Road.

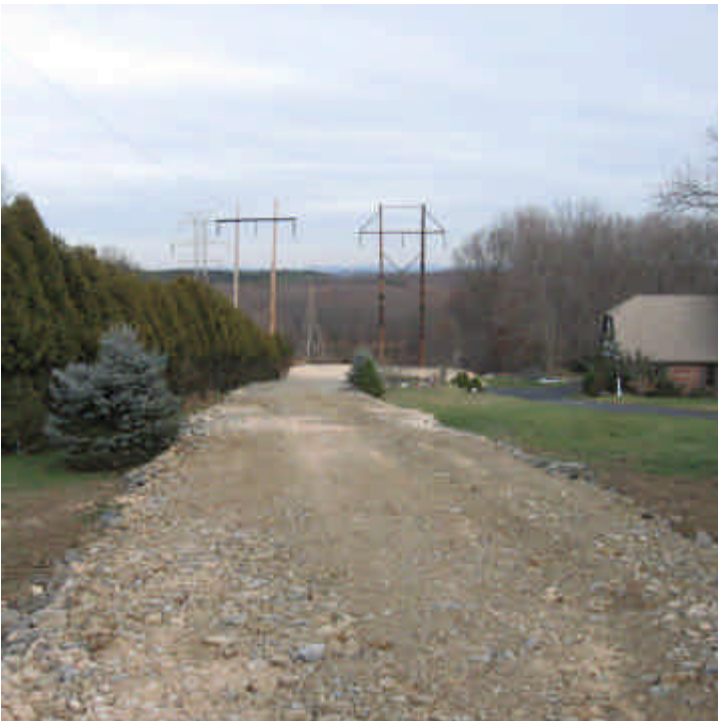
View of the ROW located off Saddle Ridge Road. Clearing and access road construction appears to be complete at this time.

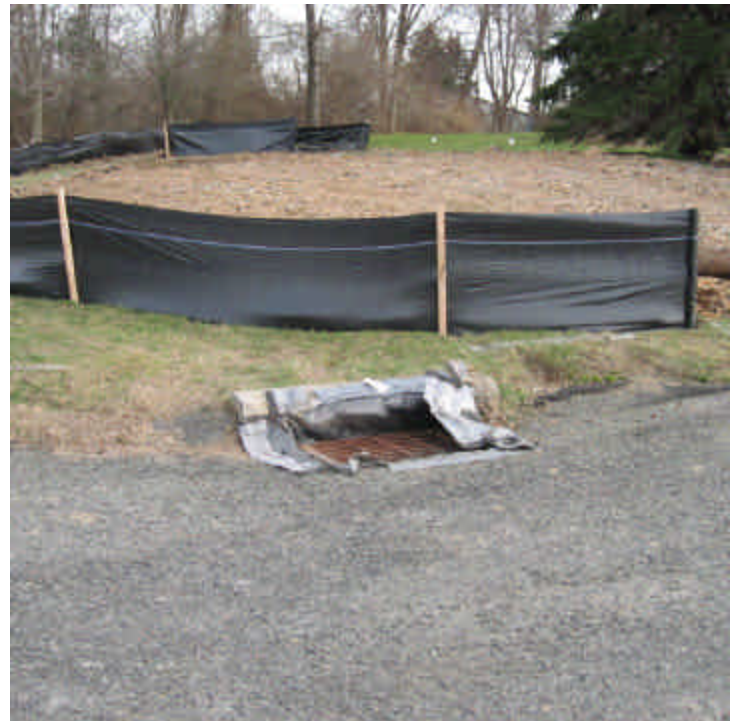
A silt sack, completely protecting the catch basin and curb drop inlet, has been installed at the intersection of Saddle Ridge Road and Harbor View Place. Silt fence was also in place here.
