Docket No. 272 – Development and Management Plan Inspection

Segment 2b Inspection

Date: March 9, 2007

Location: Segment 2b – Cheshire/Hamden Town Line to East Devon Substation

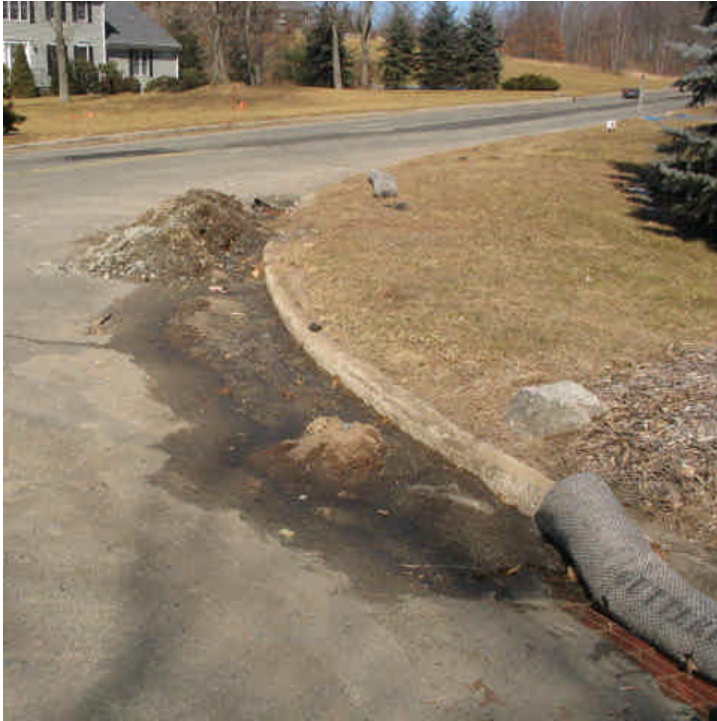
Old Lane Rd (Hamden): Snow/sediment remains along the roadway from plowing activities. Gutter buddies remain at the curb inlets.

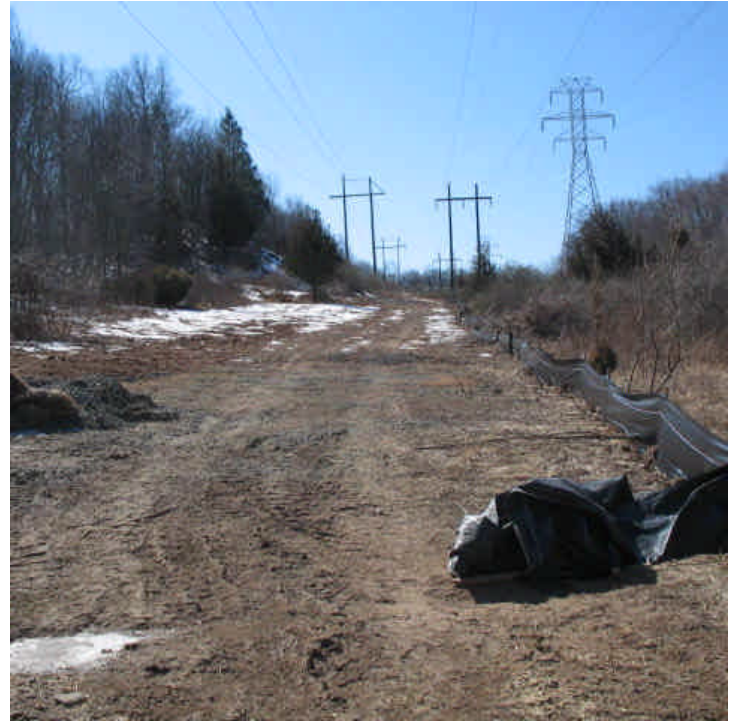
Old Lane Rd: Work within this section of overhead ROW appears to be complete at this time. Silt fence remains intact.

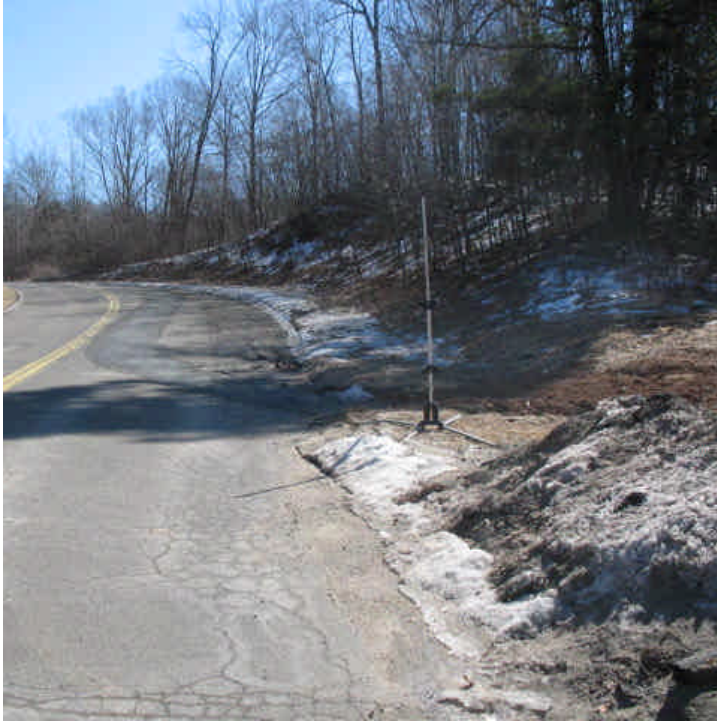
Old Lane Rd: View of the underground line transitioning from the roadway into the overhead ROW. The underground conduit is in place.

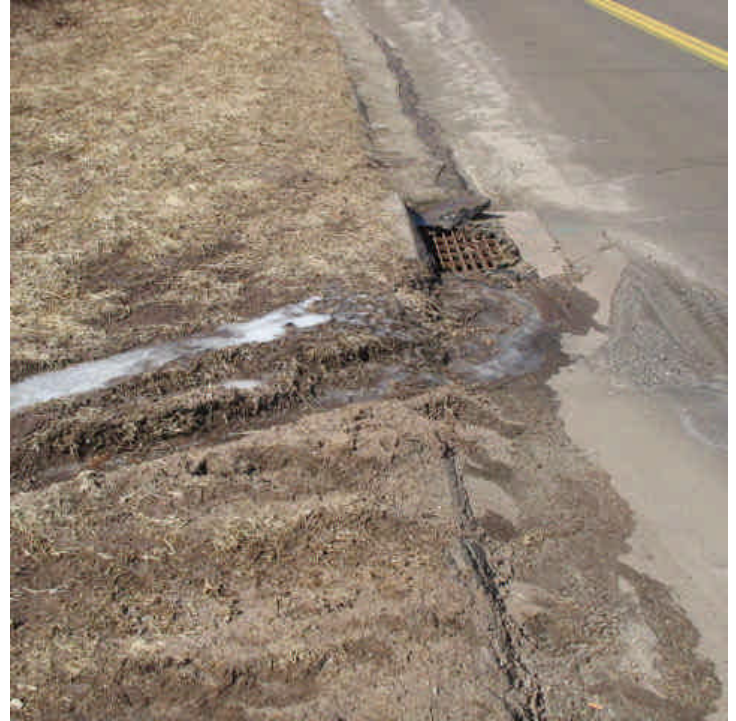
Old Lane Rd: The catch basin at the entrance of the overhead ROW did not have curb drop inlet protection and run-off has a direct path to it.

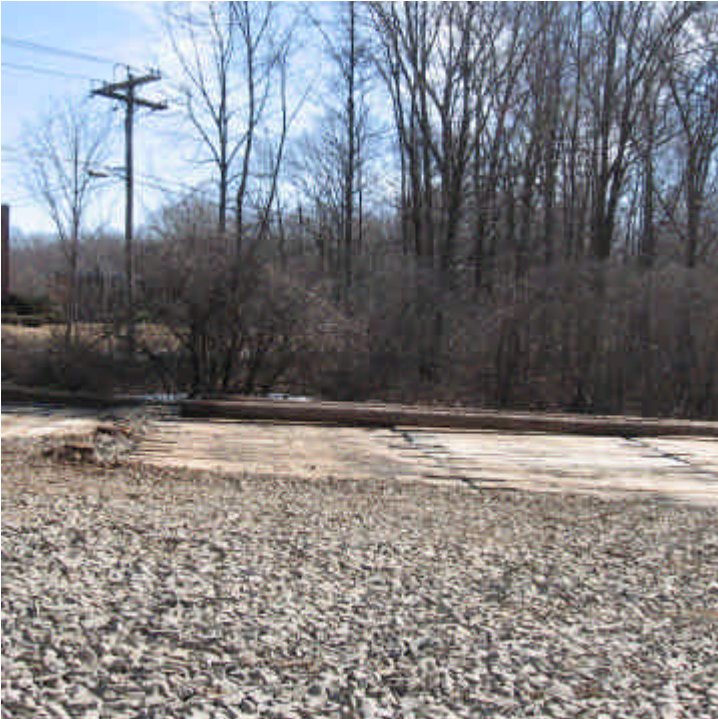
Rimmon Rd (Woodbridge): A stone and timber mat crane pad was installed near the wetland/stream in this location.

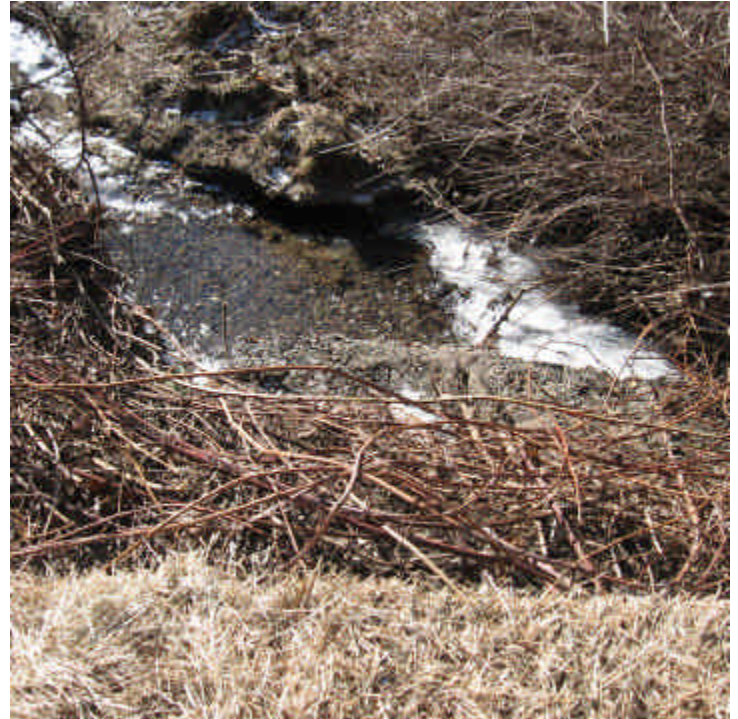
Rimmon Rd: Haybales were installed along the perimeter of the crane pad to protect the adjacent wetland/stream.

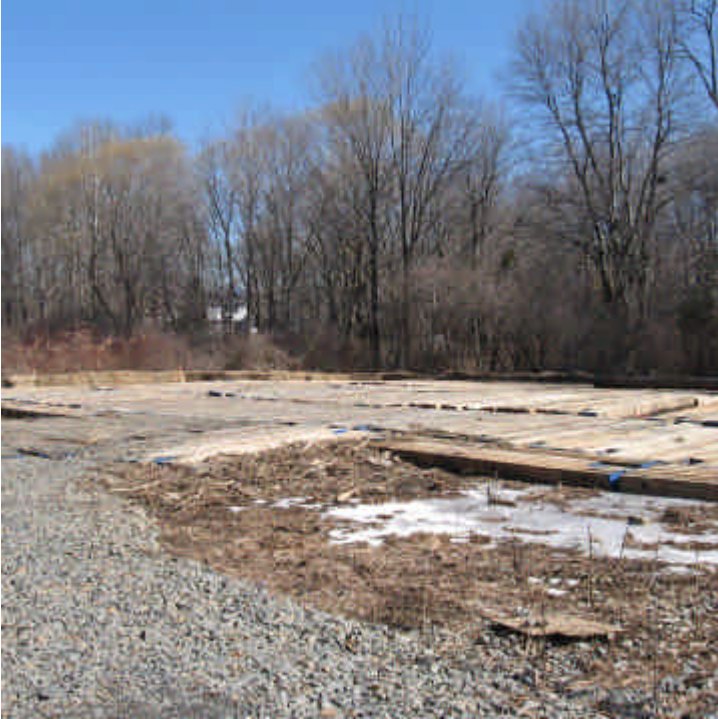
Manville Rd (Woodbridge): The stone access road was extended to the second proposed structure within the wetland here. A timber mat crane pad with haybale perimeter controls was also in place.

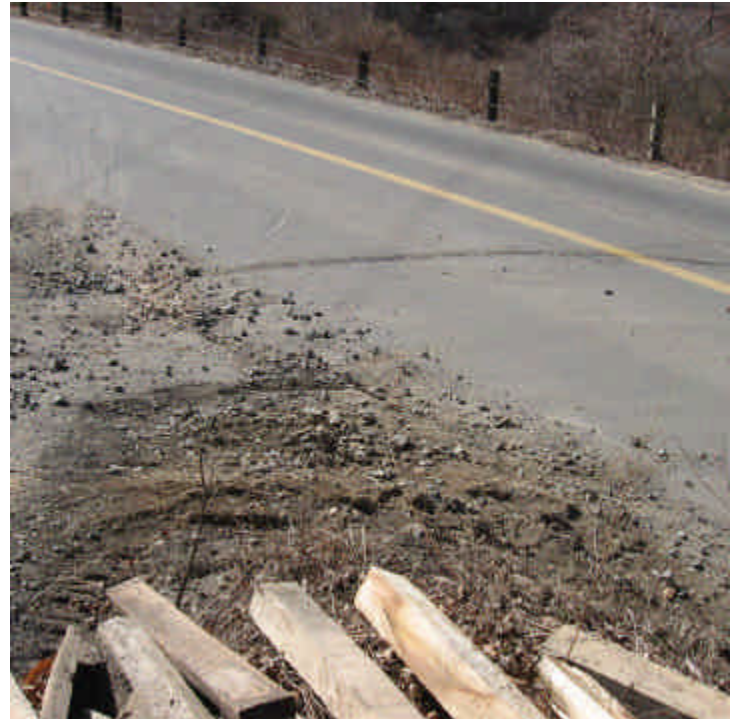
Pease Rd (Woodbridge): Due to heavy vehicle traffic and the sharp turn at the access road, sediment tracking continues to be an issue here.

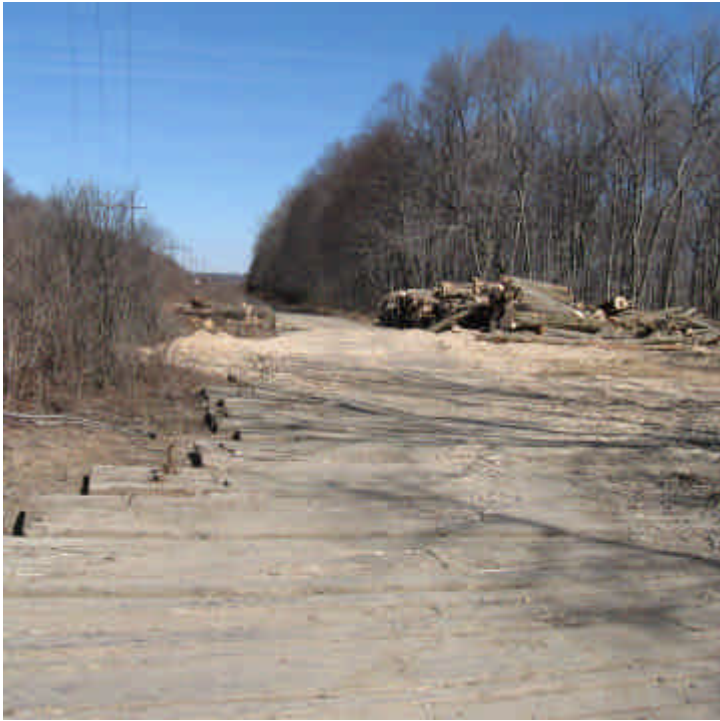
Pease Rd (Woodbridge): Timber mats have been extended along the access road here to prevent rutting.

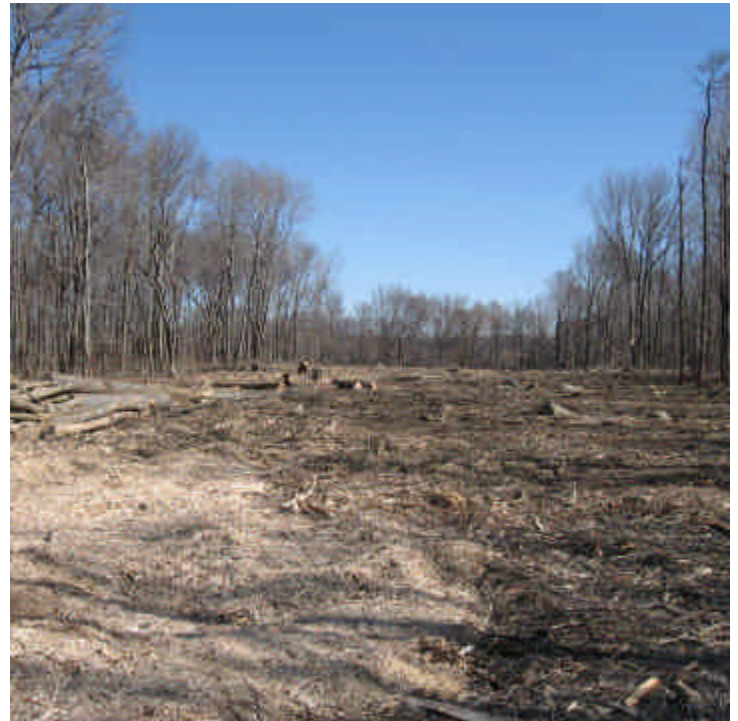
Pease Rd/JCC (Woodbridge): The majority of the clearing necessary for the new section of ROW (JCC bypass) is complete.

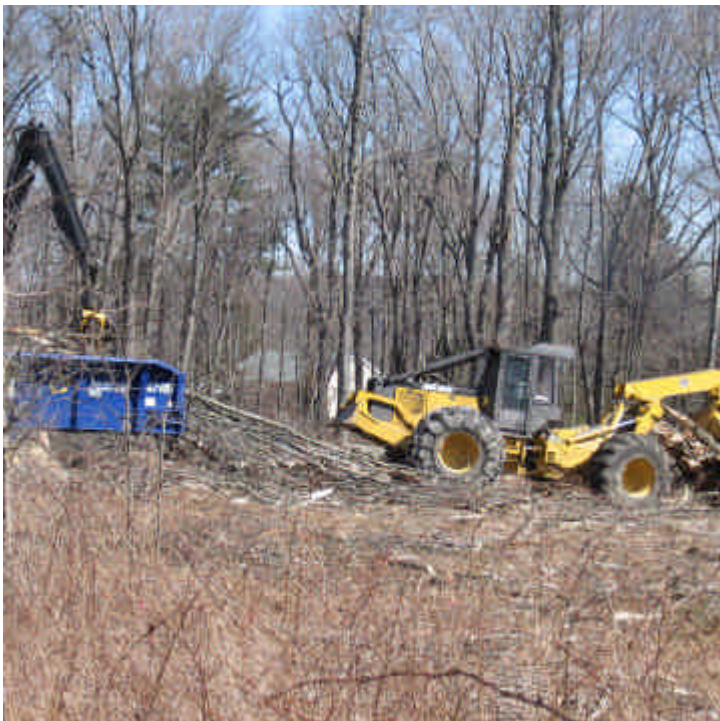
Pease Rd/JCC (Woodbridge): Skidding continues within the ROW.

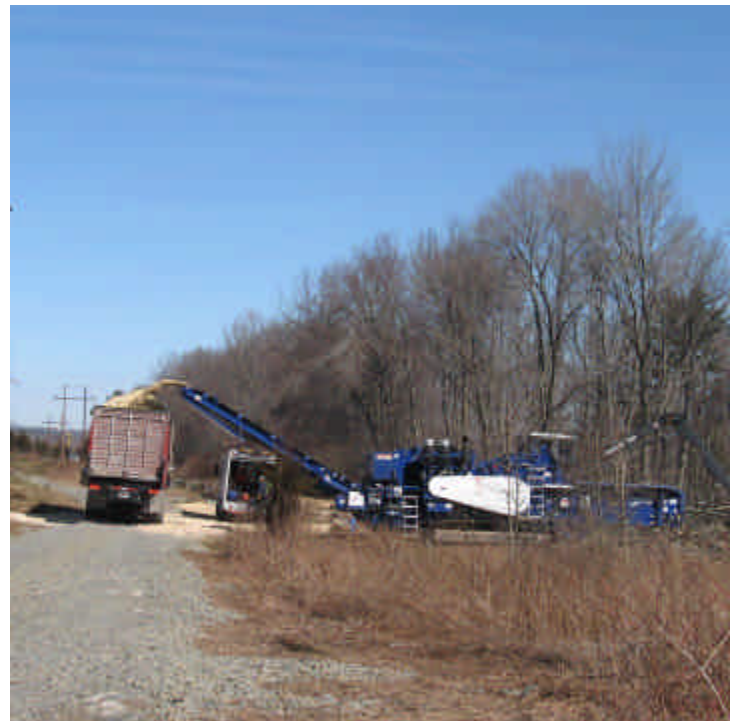
Pease Rd/JCC (Woodbridge): Chipping and stockpiling of timber continued in the ROW this week.

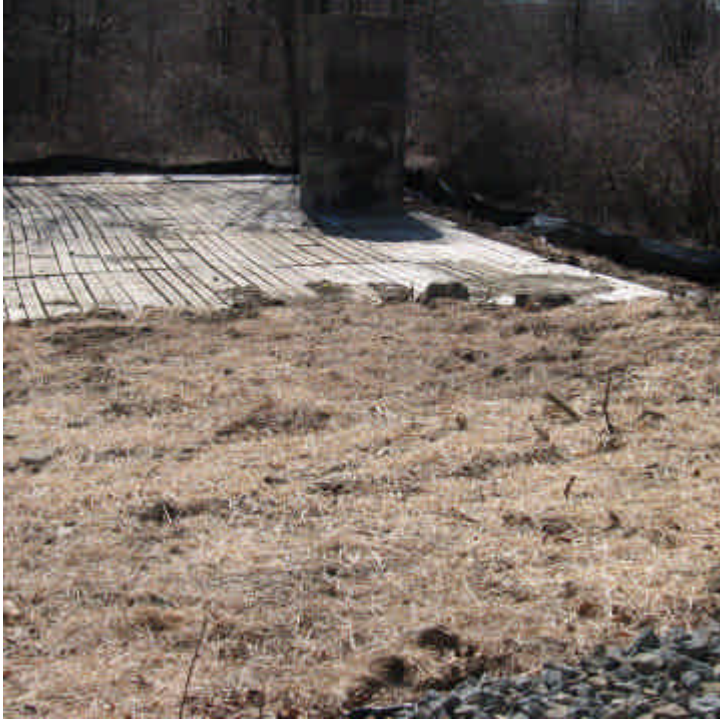
Route 121 (Milford): Erosion controls remain intact at the wetland here. Mulch was is in place along the disturbed slopes.

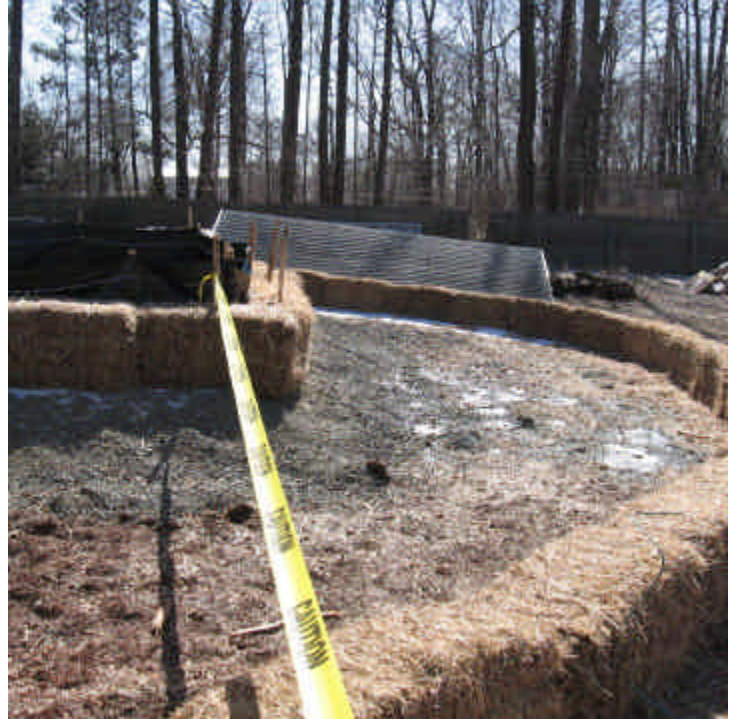
Whealers Farm Rd (Milford): Foundation drilling/poring has begun at this location. A dewatering basin and secondary line of haybales was installed proactively.

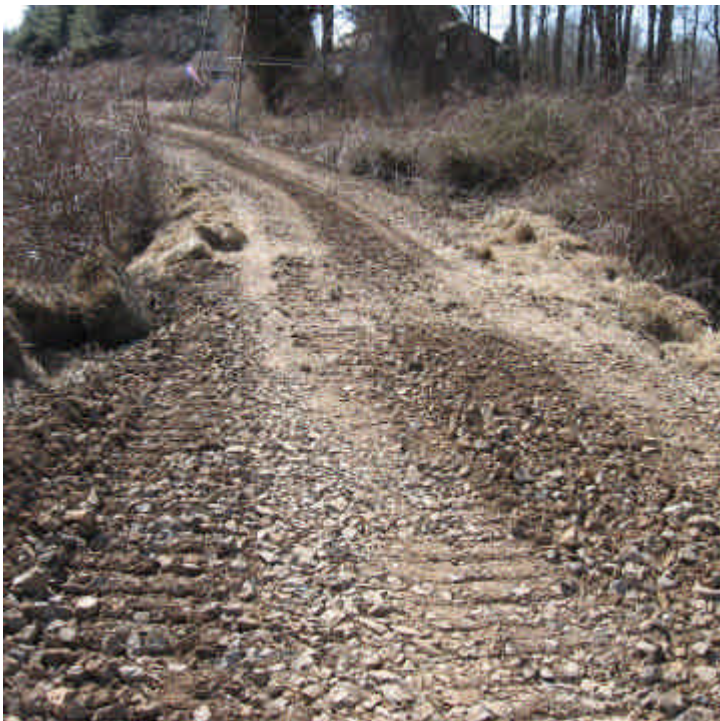
Treat Lane (Orange): Stone was added as a stabilization measure along the access road at the wetland/stream crossing.

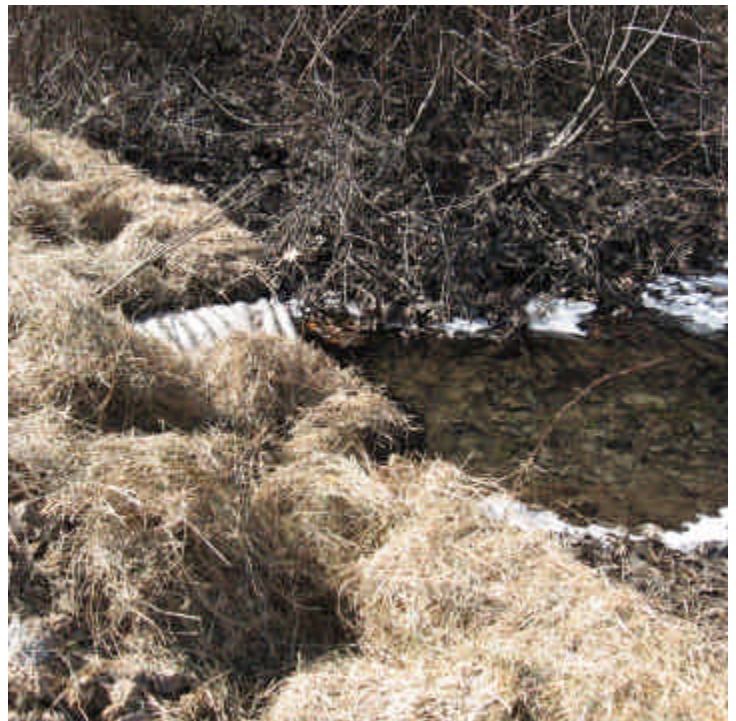
Treat Lane: Haybales were installed at the stream in an effort to further prevent sedimentation.

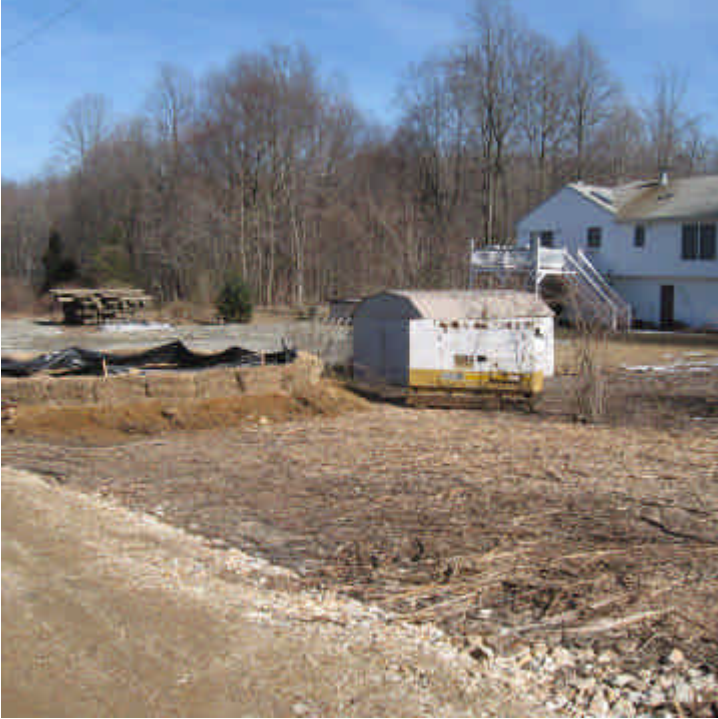
Dogwood Rd (Orange): Controls were breached at the secondary dewatering basin here last week, but sedimentation is not an issue.

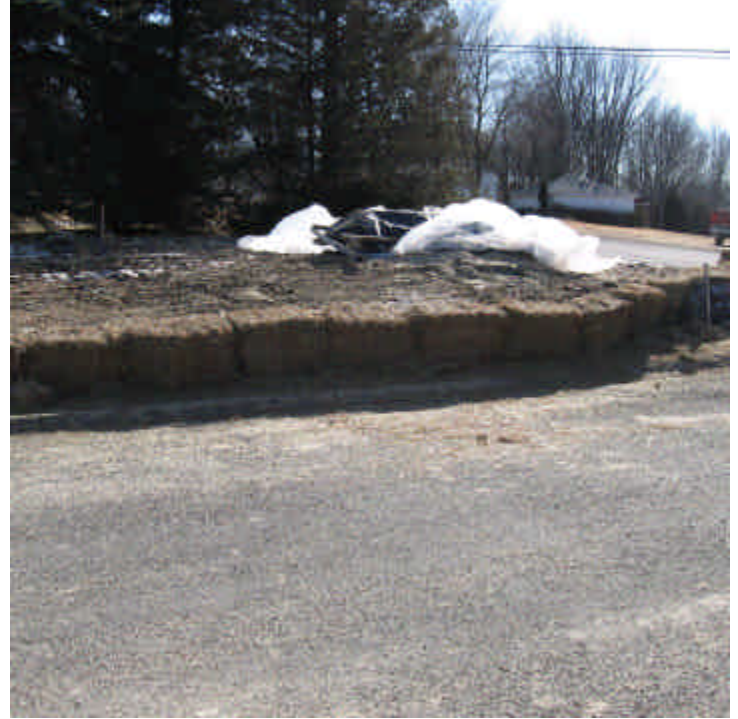
Saddle Ridge Rd/Harborview Rd (Orange): Foundation work has begun here. Haybales were added to control sediment at this roadway intersection.

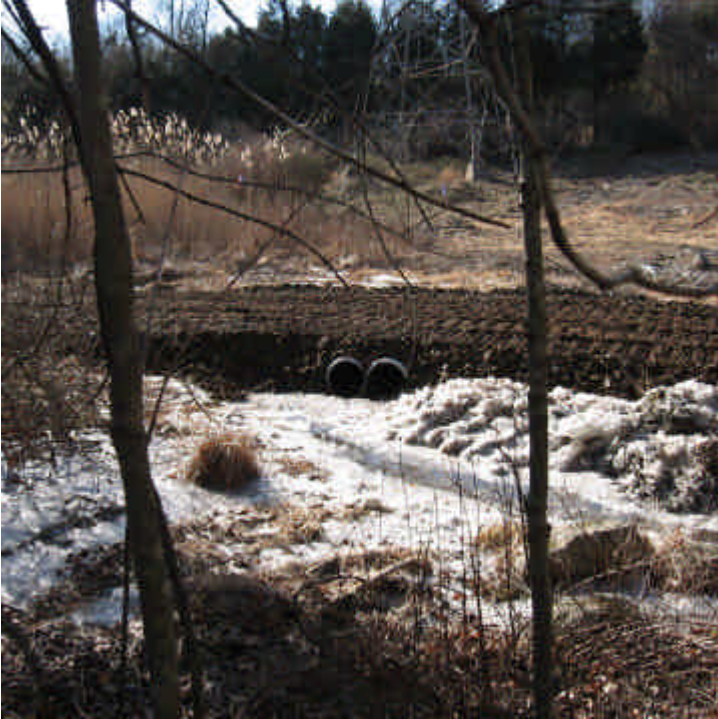
Cowpath Lane (Woodbridge): Clearing and road building has begun within the portion of ROW accessed from Cow Path Lane. Due to high water levels within the wetland and intermittent stream flow here, temporary culverts were installed along the access road.

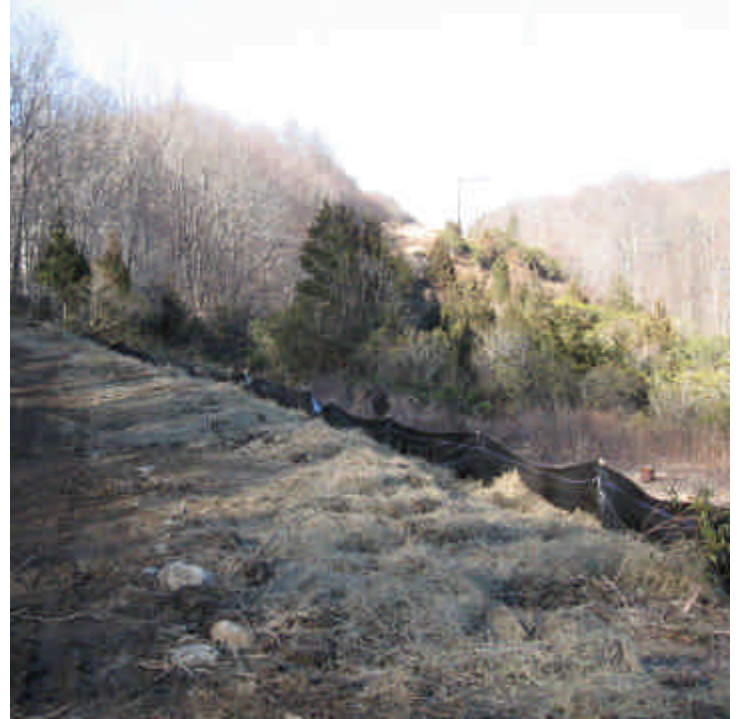
Cowpath Lane (Woodbridge): Silt fence was installed along the access roads and mulch was in place on disturbed slopes.
