Docket No. 272 – Development and Management Plan Inspection

Segment 1b (Royal Oaks Bypass) Inspection

Date: May 29, 2007

Location: Segment 1b (Royal Oaks Bypass)

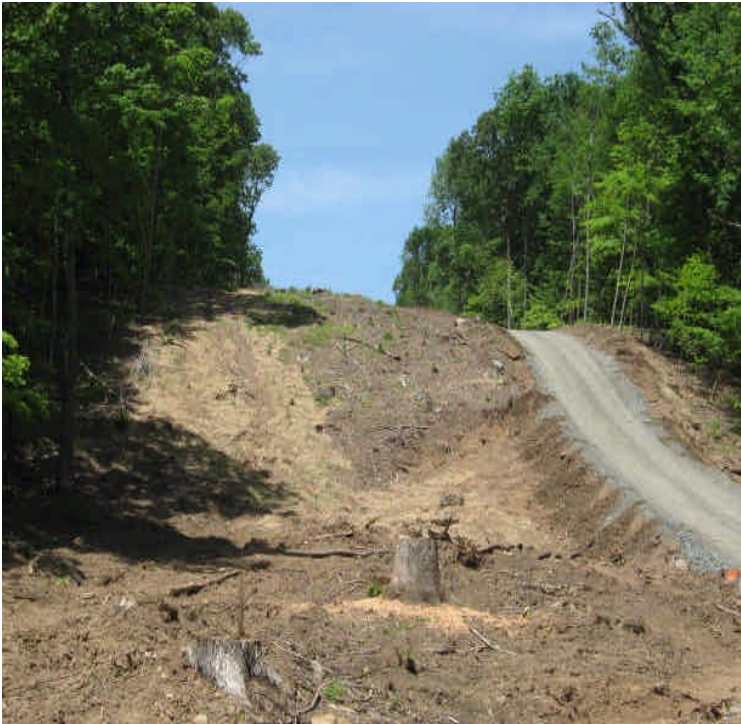
New access road installed, extending from the 1A connection off Black Walnut Drive.

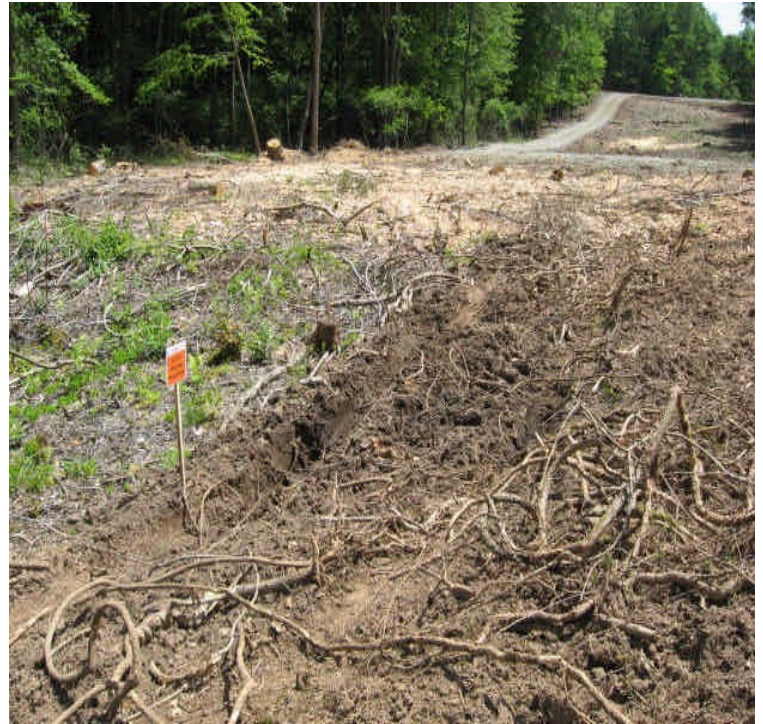
The ponded area in the ROW east of Rt 17, that had been avoided up to this point east, now had adjacent equipment tracks through a contributing channel.

Areas of Inspection	Observation	Recommended Action	Corrected Action
	<p>A piece of equipment has driven through a small channel connecting the two ponds east of Rte 17. This area was previously undisturbed as contractors were using two different access points to avoid disturbing this sensitive area. 5/29/07</p>	<p>Regrade impacted area to original contours and stabilize as soon as possible. Although not specified as a no access area in the D&M, construction fencing should be considered to prevent any future impacts due to the habitat provided and the contractor's intent to avoid it. 5/29/07</p>	<p>Needs attention.</p>
<p>Foundation and site construction</p>	<p>Clearing along ROW, tree removal, and chipping has moved past the contractor yard west of Rt 17. No foundation or line construction underway. Access road installation continues in several locations with stone base applied. 5/29/07</p>	<p>Monitor slopes and wetland for erosion and run-off. Add controls as necessary to protect sensitive areas. 5/29/07</p>	<p>NA.</p>

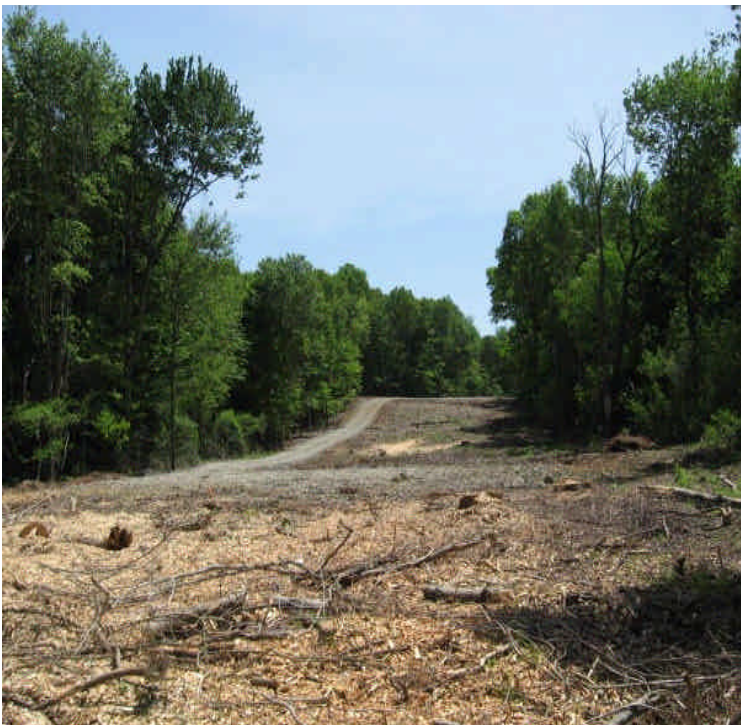
View of ROW clearing and pad construction looking toward the Segment 1A connection off Black Walnut Drive.

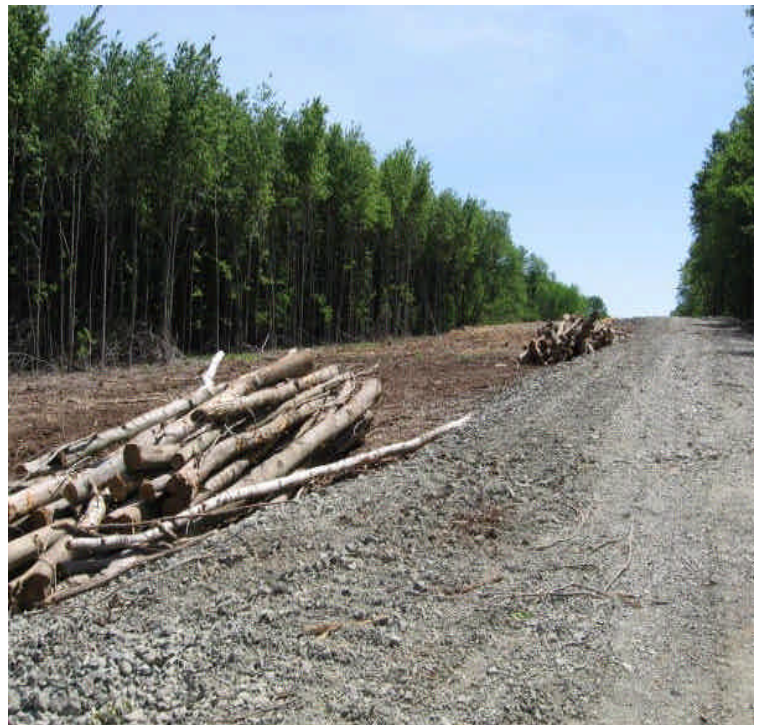
Tree stockpiles along the access, east of Rte 17. Attempt to retain native shrubs and vegetation wherever feasible.

Areas of Inspection	Observation	Recommended Action	Corrected Action
Vegetative clearing or stabilization	<p>Clearing along the ROW appears complete east of Rte 17. Most of the tree stockpiles along the ROW will be removed and taken off site. Very few shrubs were able to be retained here. 5/29/07</p> <p>Clearing continues west of Rte 17 within the watershed protection area with low impact measures proposed. 5/29/07</p>	<p>Monitor slopes and wetland for erosion and run-off. Continue to retain the appropriate low growing vegetation and species to the extent feasible in accordance with the D&M Plan. 5/29/07</p> <p>Utilize low impact clearing techniques as proposed to reduce impacts to wetlands. 5/29/07</p>	<p>NA</p> <p>Low impact measures are proposed.</p>
Dewatering	<p>Dewatering is not being performed at this time. 5/29/07</p>	<p>When dewatering is necessary any detention basins should be monitored twice a week in accordance with the D&M plan.</p>	<p>NA</p>

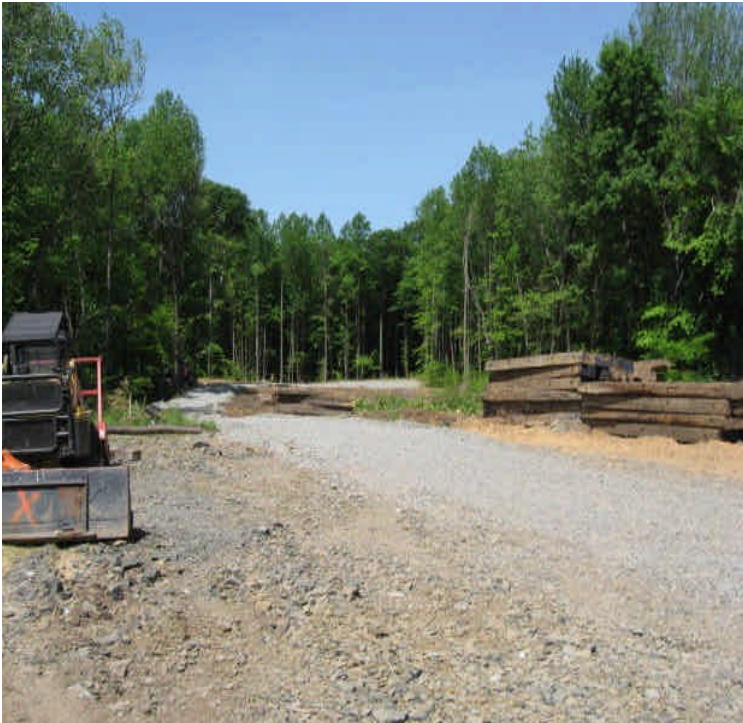
ROW access road installed moving west from the contractor receiving yard.

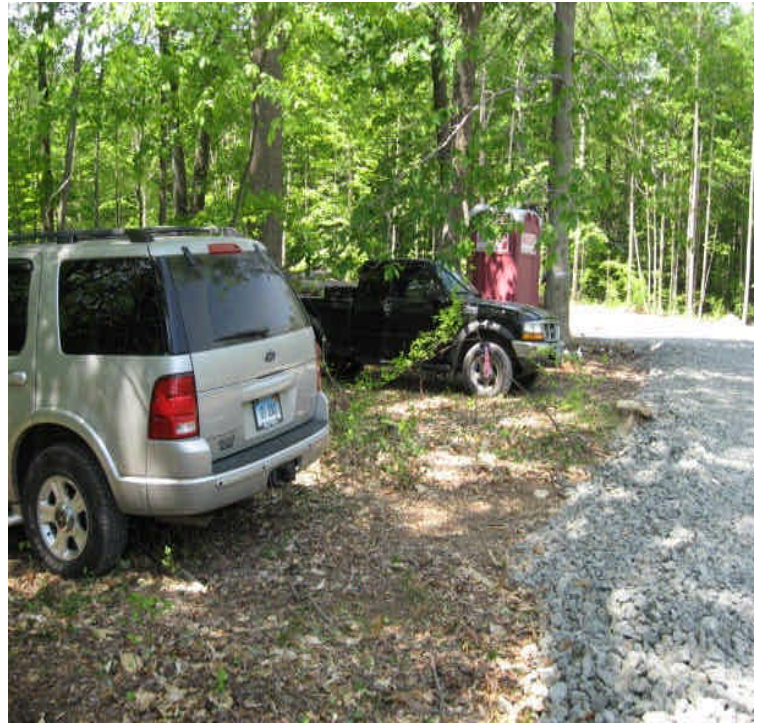
Two vehicles parked adjacent to the wetland boundary within the watershed protection area.

Blasting	<p>No blasting is proposed at this time. 5/29/07</p>	<p>None</p>	<p>NA</p>
Spills, soils and material storage	<p>A few small drips/stains were noted in the shipping/receiving yard within the 1B ROW. Identify the equipment and proactively repair it if feasible. 5/29/07</p> <p>Personal vehicles are being parked immediately adjacent to the boundary of the wetland and the watershed protection area. A portable sanitary facility was also stored here. 5/29/07</p> <p>Spill kits move from site</p>	<p>Always use spill control materials when working on equipment and during refueling. In general, if a leak is observed, contain it and remove equipment from water department property. Never refuel, repair, or store equipment within water department property. Proactively check equipment at least once a day for leaks when working in the protected area. 5/29/07</p> <p>All equipment, vehicles, and sanitary facilities should be located greater than 100 feet from the water department property and wetlands. 5/29/07</p> <p>Continue to use and</p>	<p>Needs proactive attention.</p> <p>Needs attention.</p> <p>NA</p>

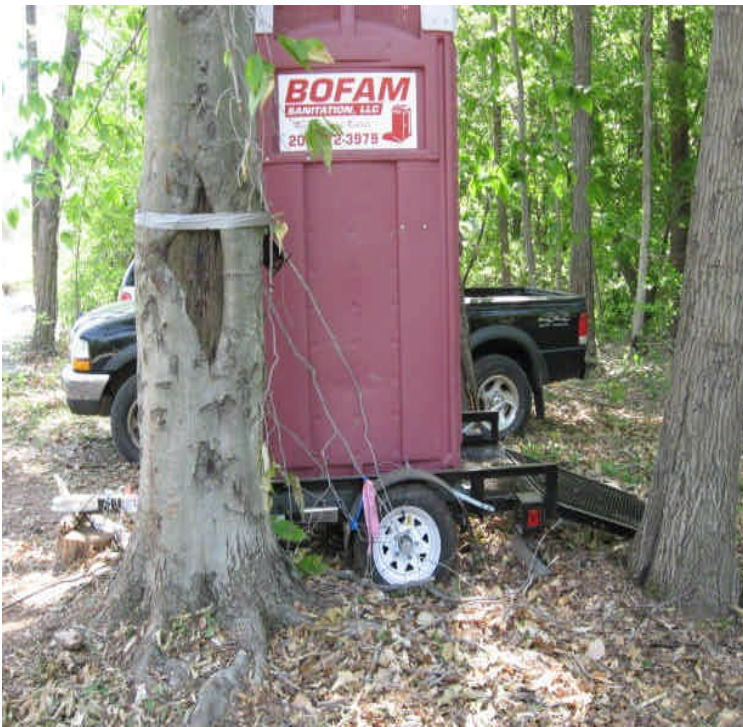
Portable sanitary facility located immediately at the wetland boundary in the watershed protection area. Note pink & blue wetland flagging. Vehicles and facility should be relocated.

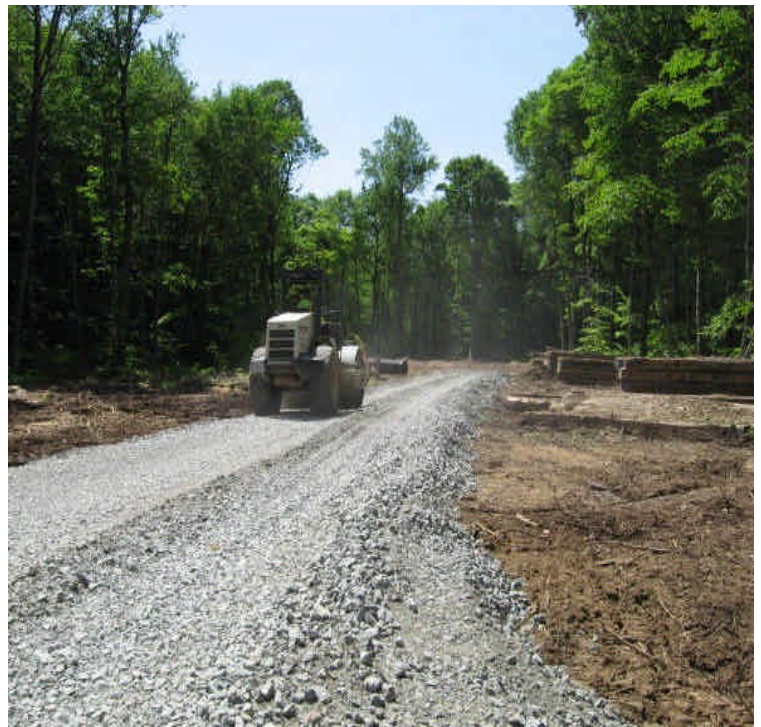
New access road construction into watershed protection area. Clearin has stopped at low impact area after the last pad site from this access.
