THE SECRETARY
OF THE INTERIOR'S
STANDARDS FOR
REHABILITATION &

ILLUSTRATED
GUIDELINES ON
SUSTAINABILITY
FOR
REHABILITATING
HISTORIC
BUILDINGS

U.S. Department of the Interior
National Park Service
Technical Preservation Services

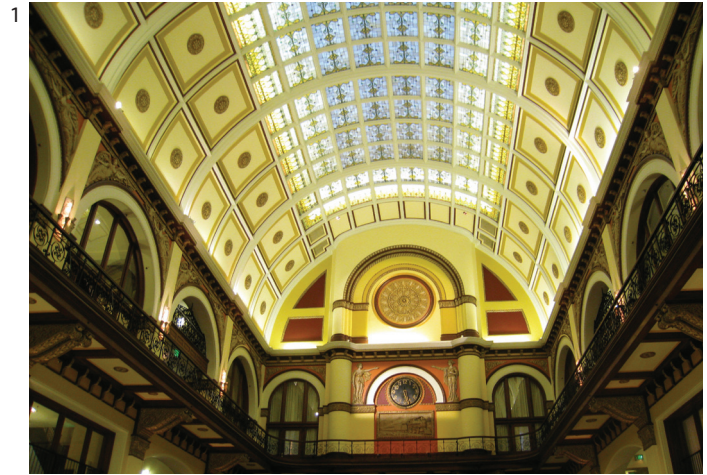
[1] Stained glass skylight provides natural light in a historic train station.

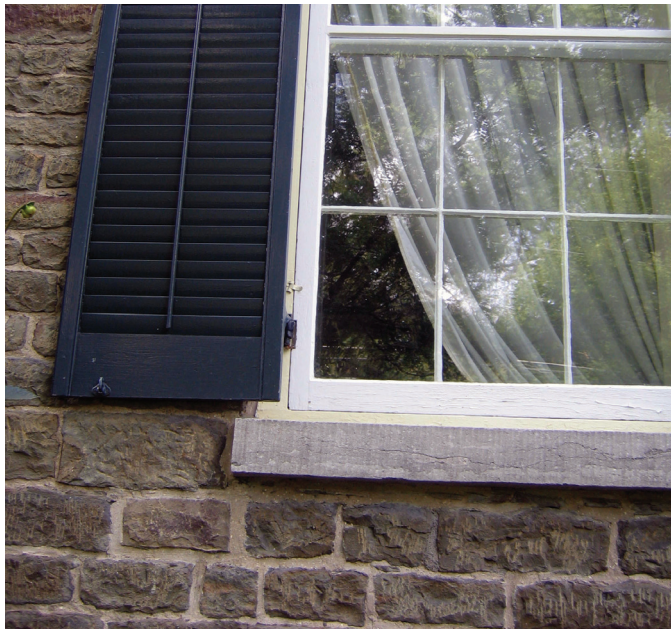
Recommended: [26] The new metal interior storm window was carefully matched to the exterior window as part of the rehabilitation of this historic armory building.

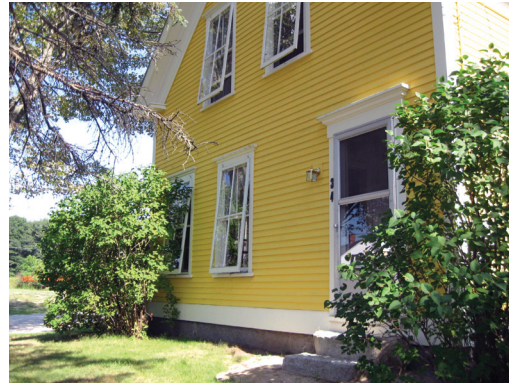
25

Not Recommended: [27] A broken sash cord can be repaired easily and does not justify replacement of the window.

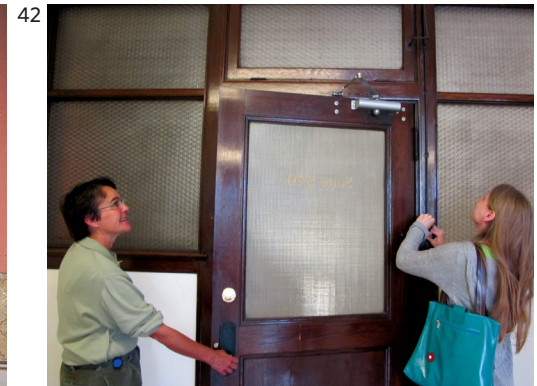
43

Recommended: [43] The wall and door glazing ensures that the corridor receives natural daylight and the operable transom helps air to circulate in this historic office building.

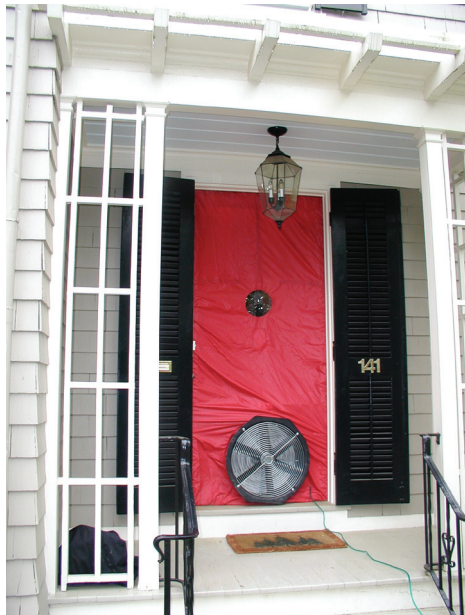
Recommended:
[44-45] A blower door test is a useful tool to help identify air infiltration in a historic building before undertaking weatherization or retrofit treatments.
Top Photo: Robert J. Cagnetta, Heritage Restoration, Inc.

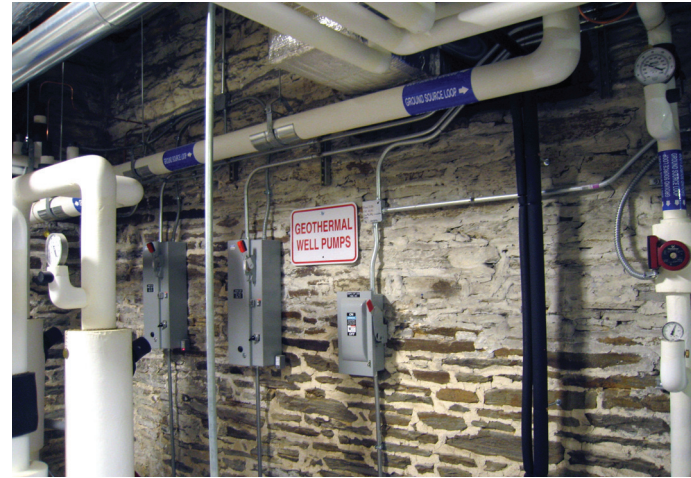
70

Recommended: [70-71] A geothermal system was installed on the property of this historic mansion, but only after an archeological investigation was conducted of the grounds.

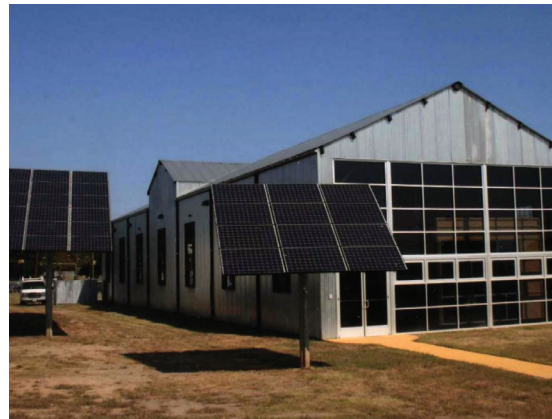
74

Recommended: [74] Free-standing solar panels have been installed here that are visible but appropriately located at the rear of the property and compatible with the character of this industrial site.

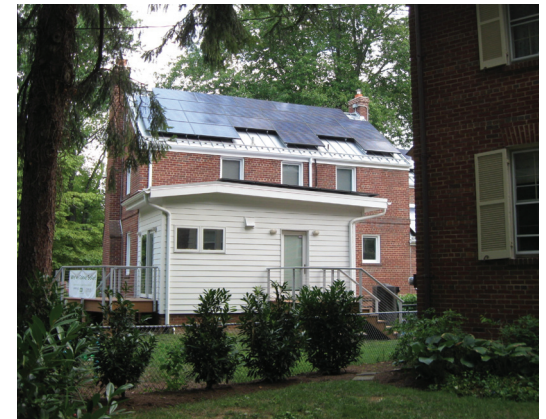
75

Not Recommended: [75] Solar roof panels have been installed at the rear, but because the house is situated on a corner, they are highly visible and negatively impact the character of the historic property.

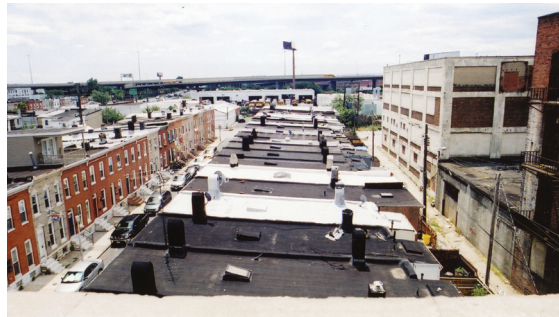
86

Recommended: [85-86] A cool or green roof is best installed on a flat roof where it cannot be seen from the public right of way and will not negatively impact the character of the historic building.

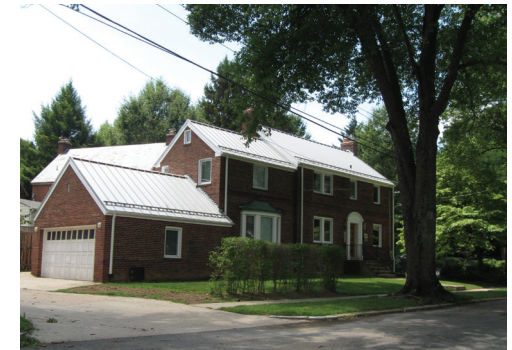
88

Not Recommended: [88] This new, cool white metal roof is not an appropriate material or color for this historic mid-20th century house.

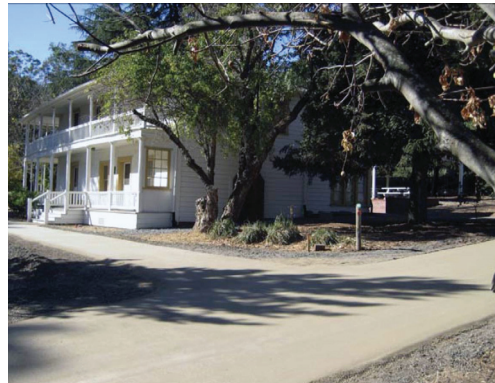
Recommended: [94-95] Permeable pavers were used at this historic residential property for a driveway and parking (above) and a hard-packed, construction aggregate provides environmentally-friendly paths for visitors at this historic site (below).

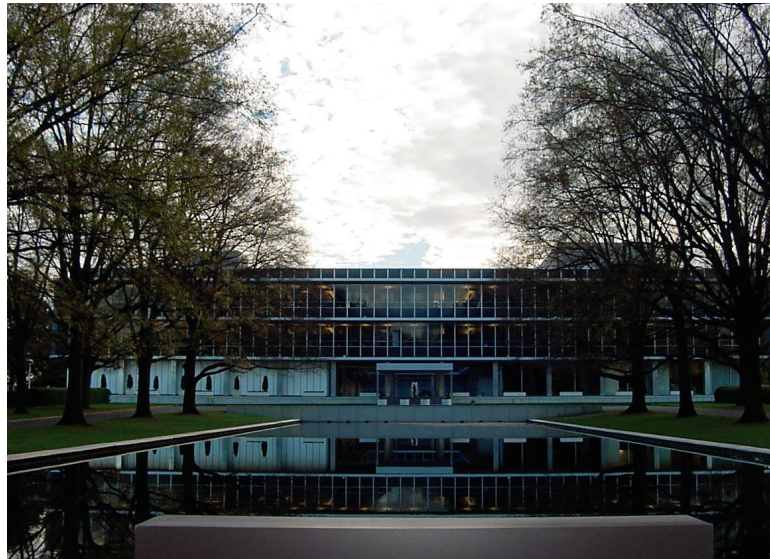
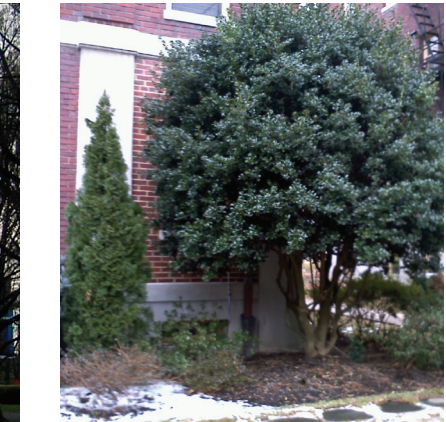
Not Recommended: [97] This tree, which was planted too close to the building, has caused the masonry wall to retain moisture that damaged the mortar and required that the brick be repointed in this area.
