#### **B.1. Review of National Register Status for Property Proposed for Demolition, 25 South Main Street, Norwalk, South Main and Washington Streets Historic District Boundary Increase (NR# 85003505)**

# Historic Property Evaluation Report 25-29 South Main Street, Norwalk, CT

Michael Devonshire, Principal  
08 April, 2024

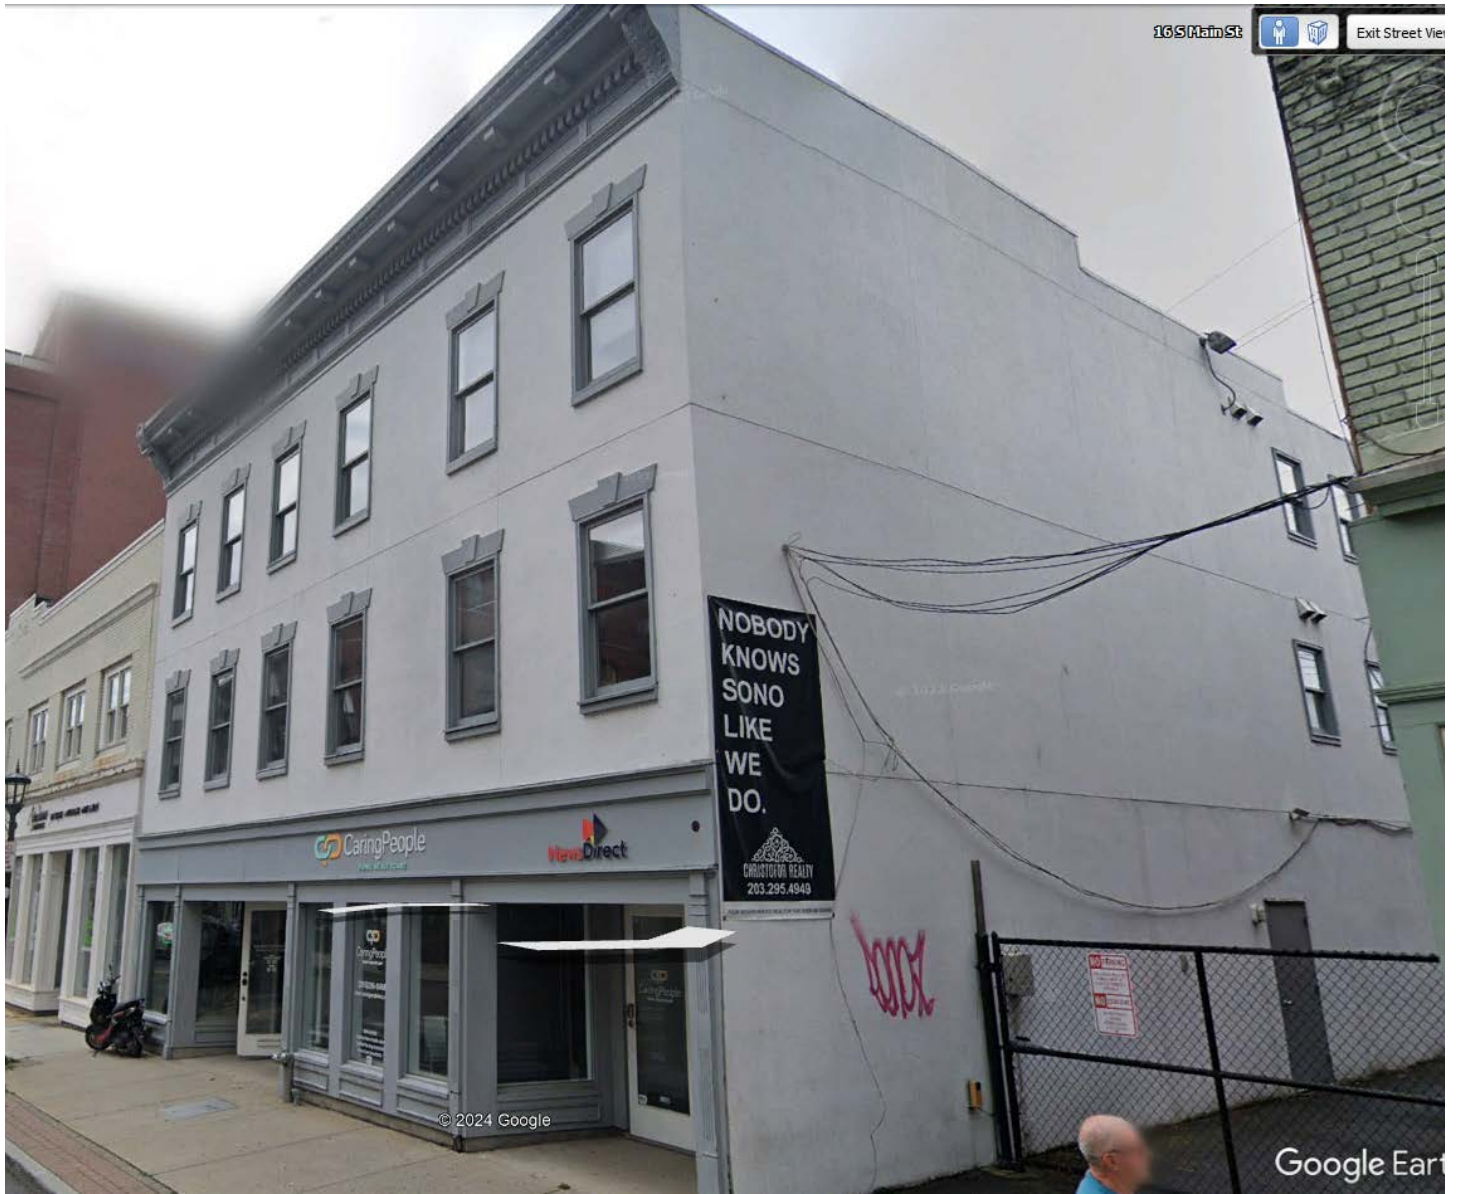
25 South Main Street, Norwalk, camera facing southwest, *google Earth*, July 2023.

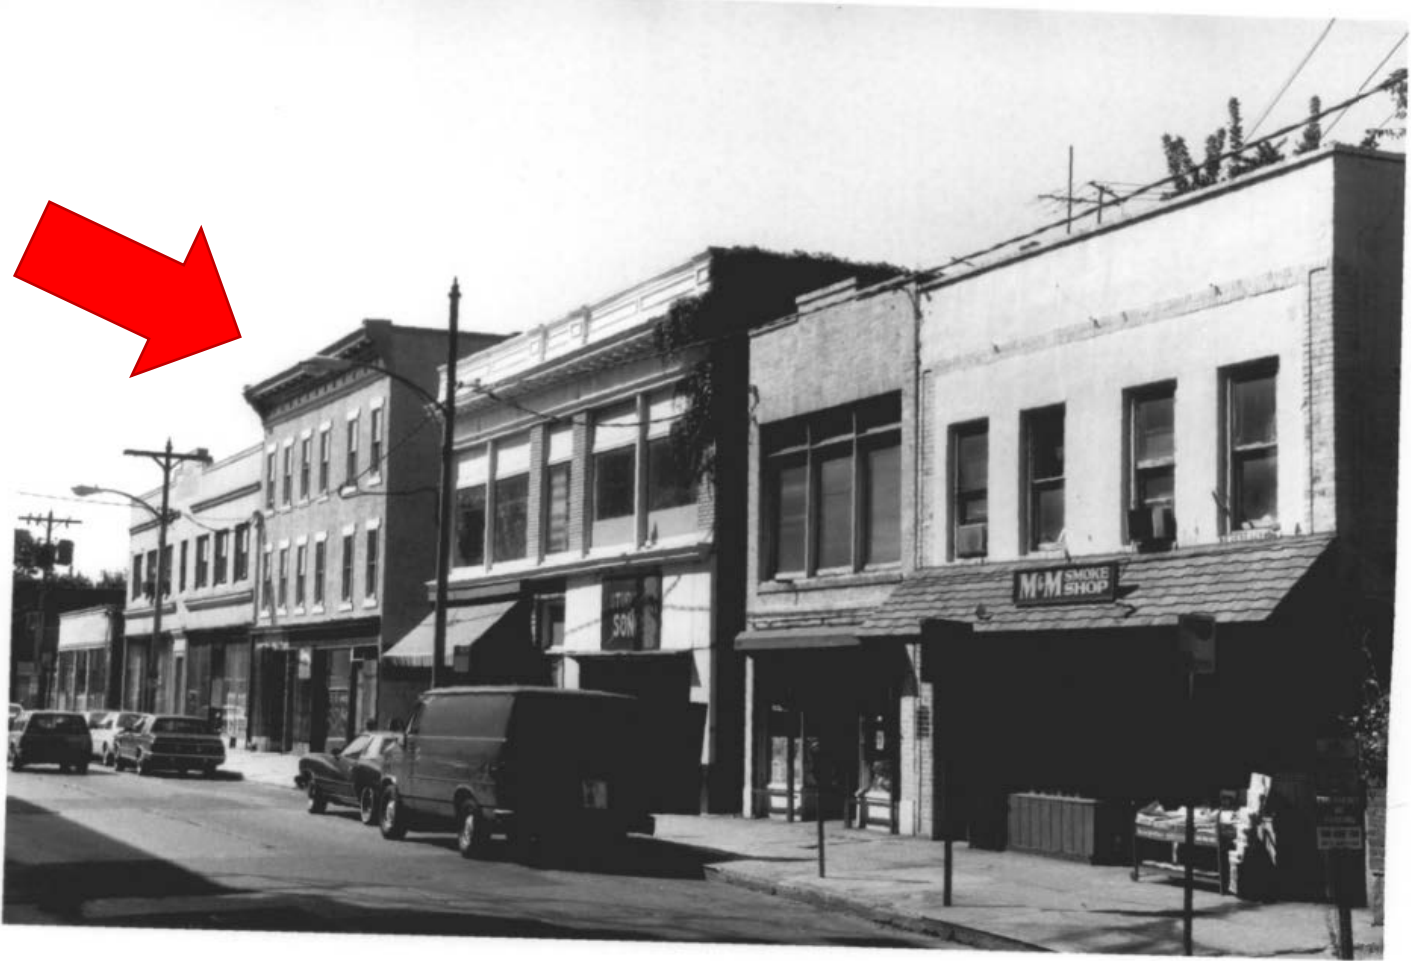
**National Register of Historic Places South Main & Washington Streets Boundary Increase South Norwalk (Norwalk), CT Photograph #1, 25 South Main Street to the left, September, 1984.**

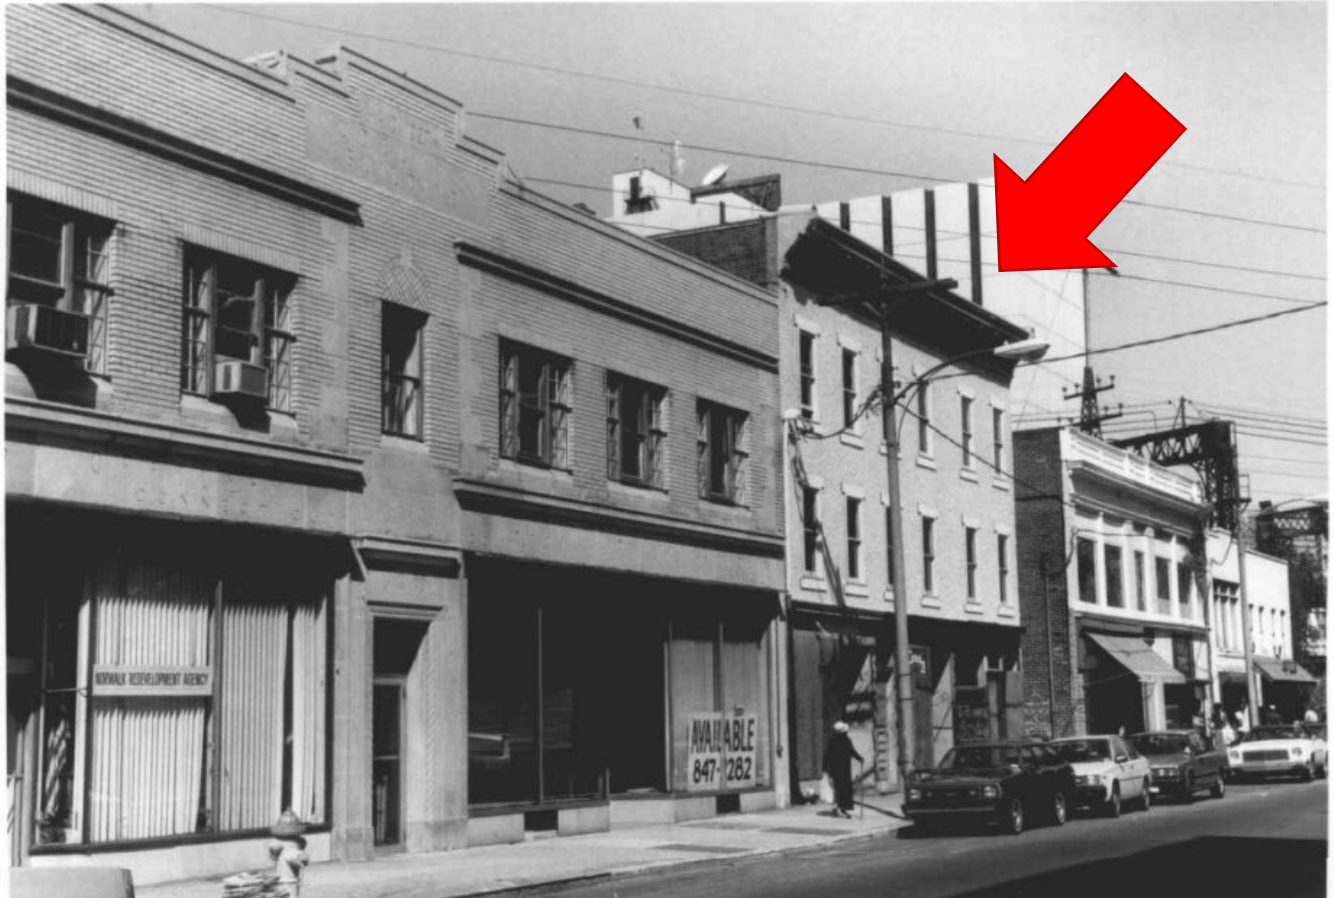
**National Register of Historic Places South Main & Washington Streets Boundary Increase South Norwalk (Norwalk), CT Photograph #2, 25 South Main Street to the left, September, 1984.**

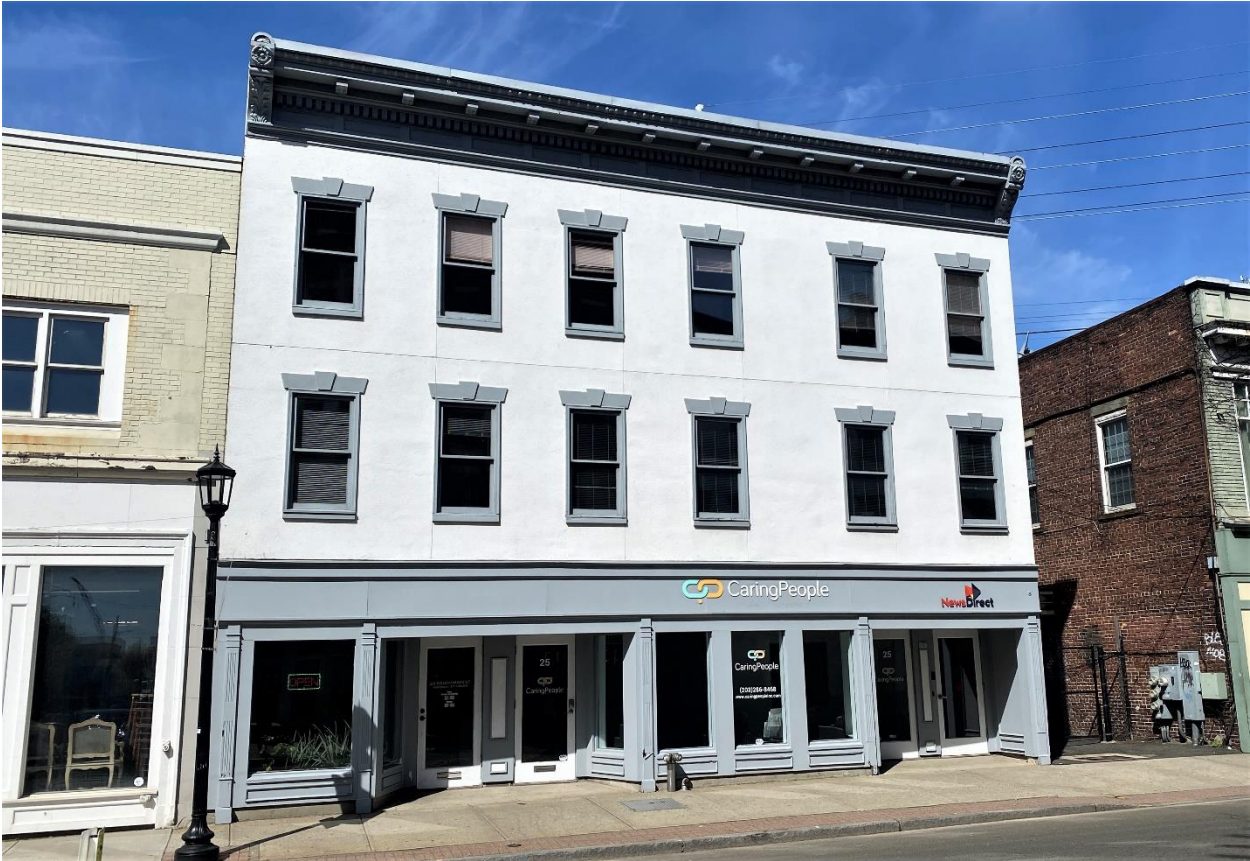
The building main façade appears to have undergone a renovation within the last two decades. The renovation included: alteration of the main façade cladding, removal of the original storefronts and replacement with new wood and glass elements that are much less articulated than the originals, replacement of entry doors, replacement of all windows. (Photo #1)

*Photo 1 With the exception of the cornice, the entire façade of the McMahon Block building has been replaced.*

At the time of designation, the building retained much of its original treatment. Unfortunately, with the exception of the sheet metal cornice, all of the original features of the historic main façade have been removed, and the present treatment is a pastiche of awkward design, poorly executed. The loss of the

historical integrity of the building façade is lamentable, and thus restoration is not possible, only reconstruction, of historic features. With the exception of the original extant cornice, nothing of historical value remains on the façade.

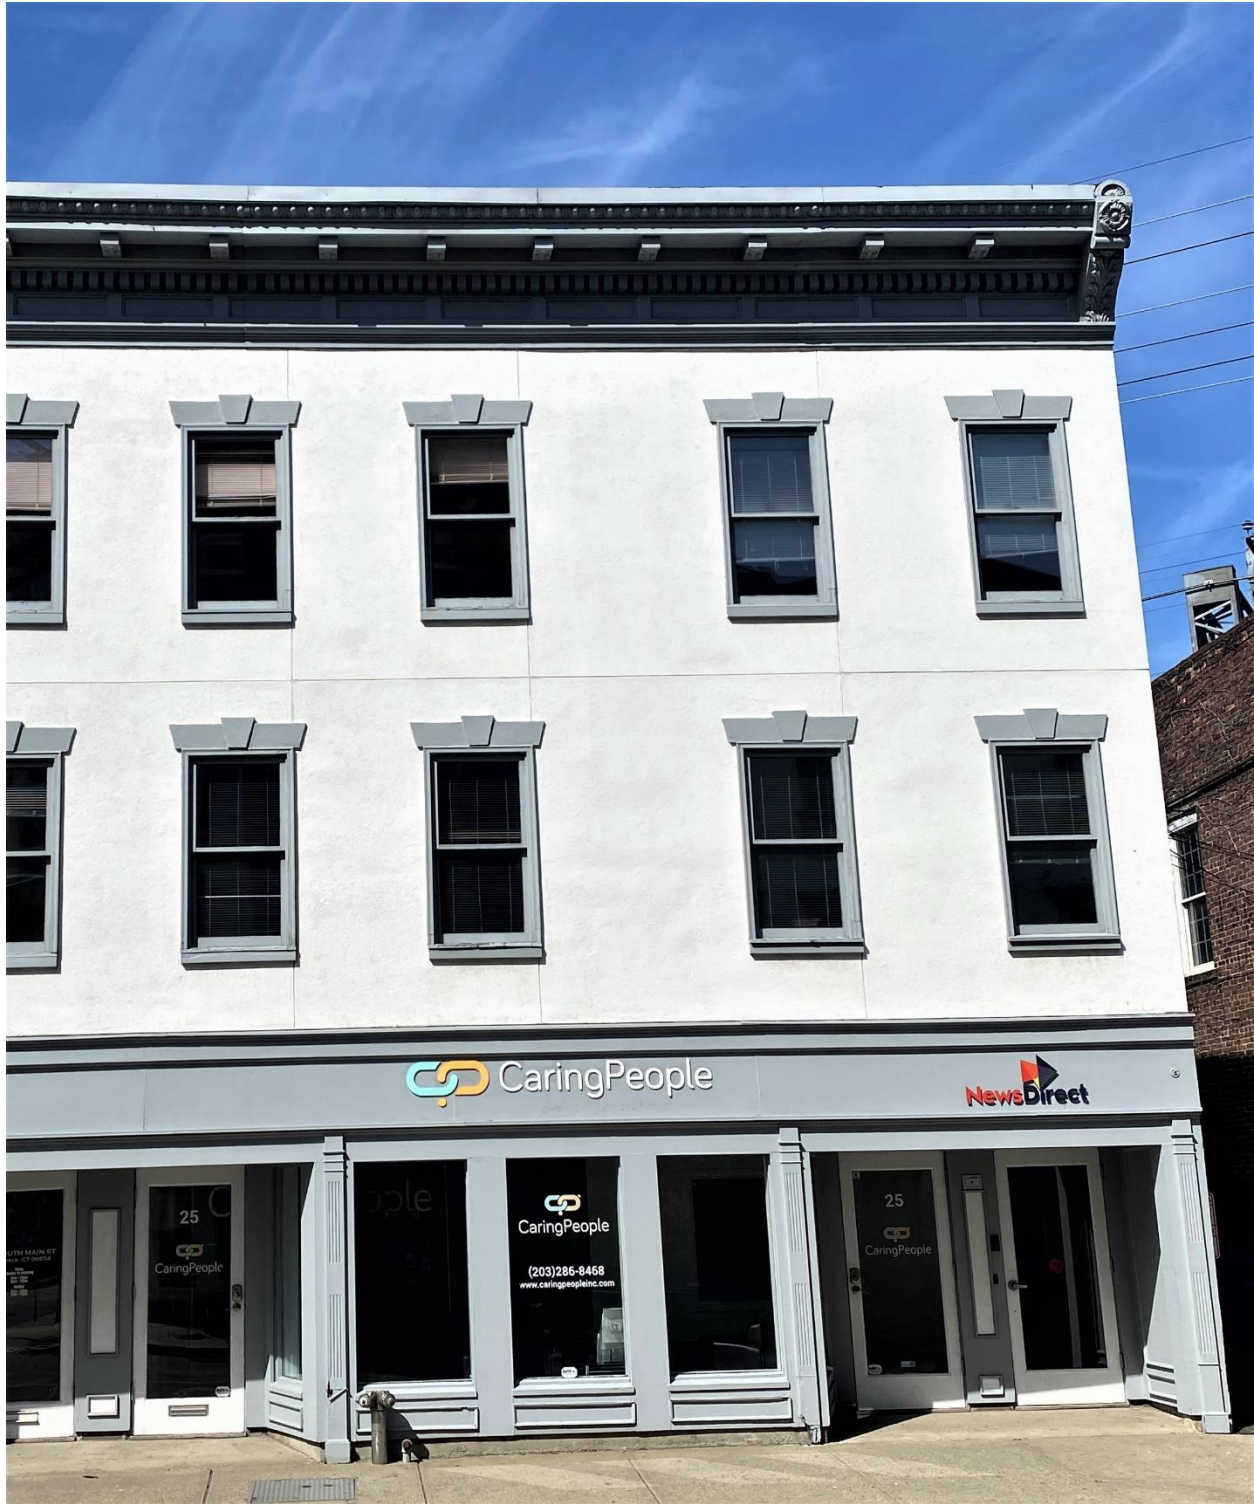
The original stucco cladding of the main façade was removed during the renovation, and replaced with new metal lath and stucco application. The new stucco was applied to metal lath, which appears to be rusting at a few locations. More visually obtrusive, unlike the original stucco application, the new stucco is tooled to a rough textured finish. Additionally, the stucco was applied in a manner that includes expansion joints which remain prominent on the façade, creating an awkward, visually obtrusive “grid”, unlike the original application which would have projected a uniform appearance. (Photo #2)

*Photo 2 Expansion joints in the newer stucco application are not concealed, presenting an awkward grid appearance; the stucco is textured, unlike the original treatment.*

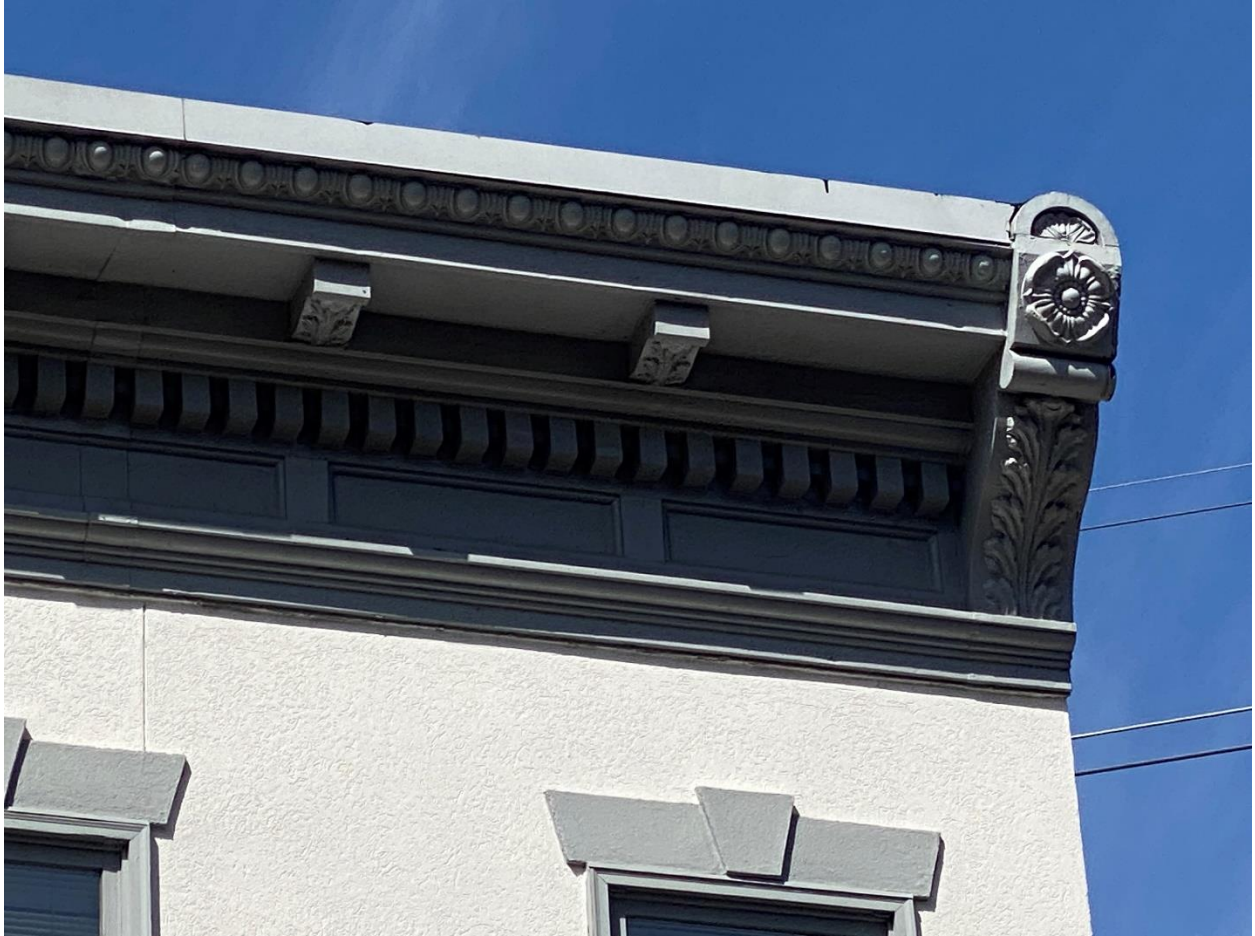
The decorative cornice that surmounts the façade is of stamped and brake-formed sheet metal. Although some deformation was noted, the cornice cladding appears to be in good condition – the wooden support system was not able to be examined for this report. (Photo #3)

*Photo 3 The sheet metal cornice is intact and is the only remaining original feature of the façade.*

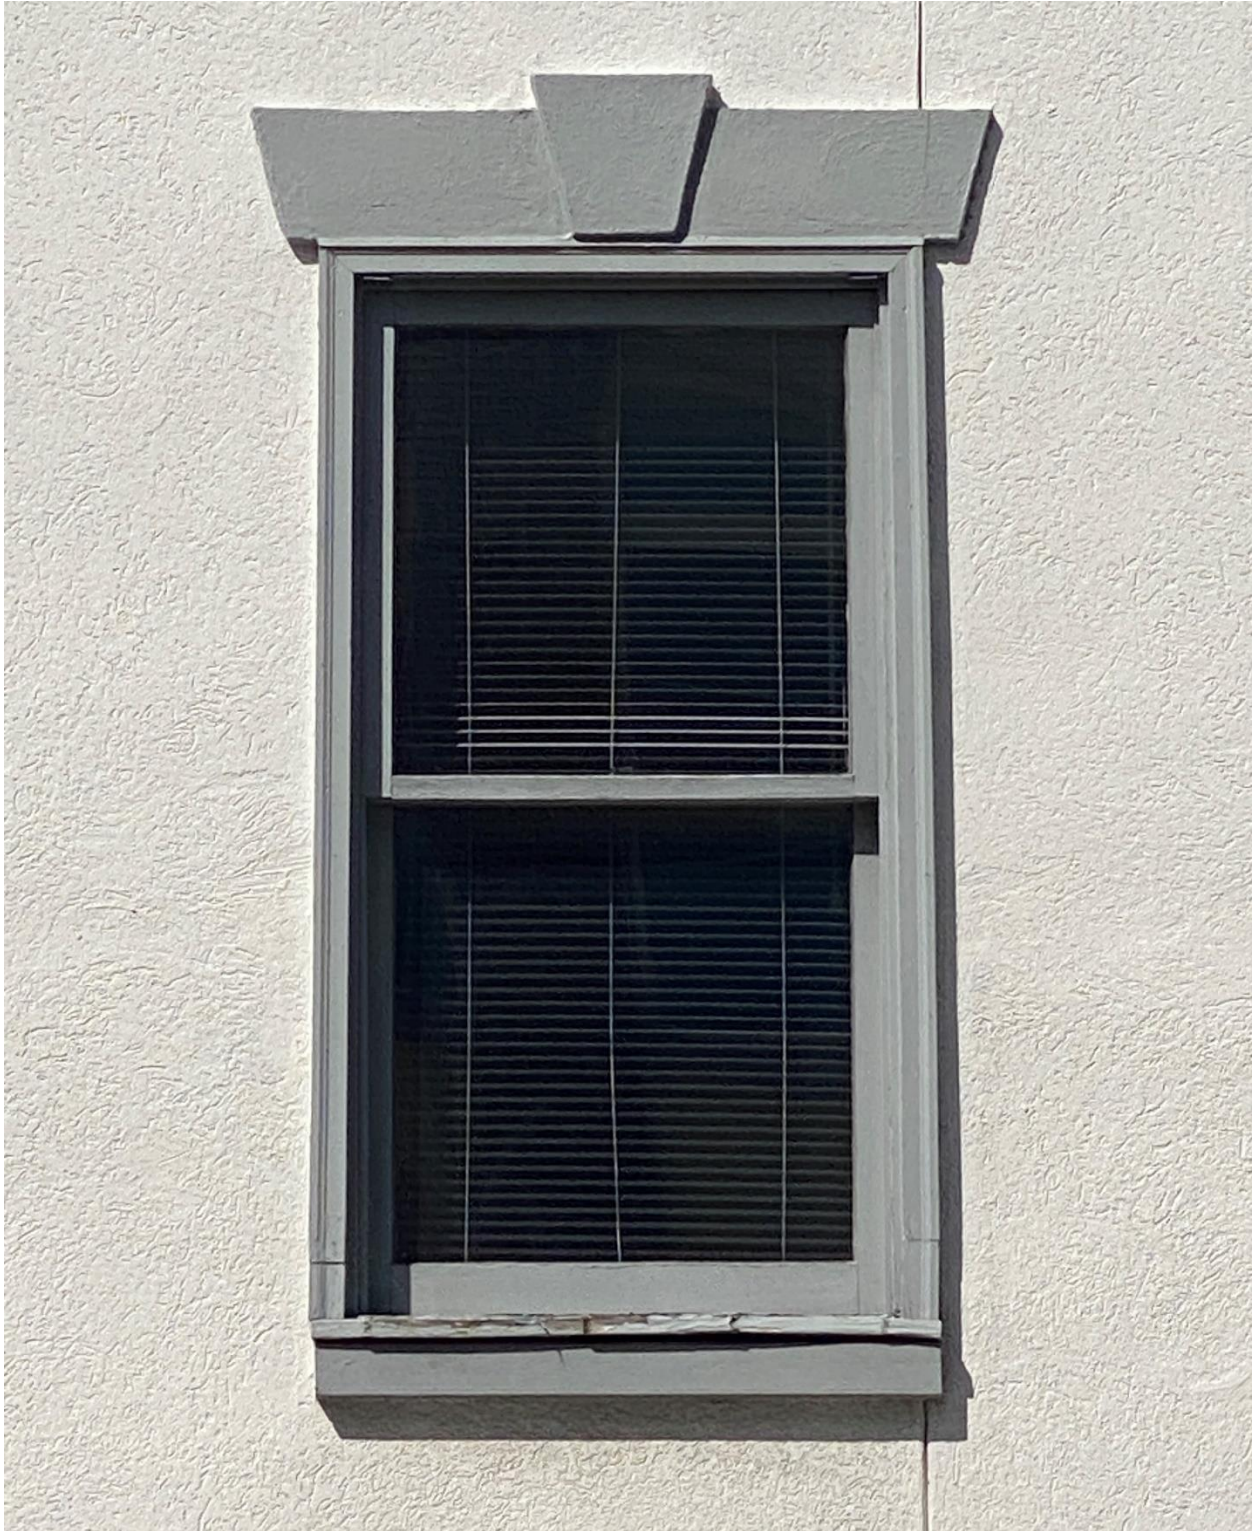
The extant windows are one-over-one wood sash in wood frames. The original projecting masonry sills and “flat” lintels have been removed; false decorative splayed lintels of stucco were applied above the window openings when the façade was re-stuccoed; the sills were not replaced. The lintels and keystones appear awkward on the relatively restrained façade, and the windows appear to “float” on the façade, lacking sills. Unfortunately, the extant windows that replaced the originals are of inferior fabrication, and exhibit a considerable amount of rot. The casing moldings received scarfed replacement repairs, and areas were noted where the finger joints in the wood elements are failing. (Photo #4)

*Photo 4 New windows were fabricated of inferior materials, and are deteriorating. Original flat sills and lintels have been altered in an unfortunate manner. The exterior aprons are of dimensional lumber.*

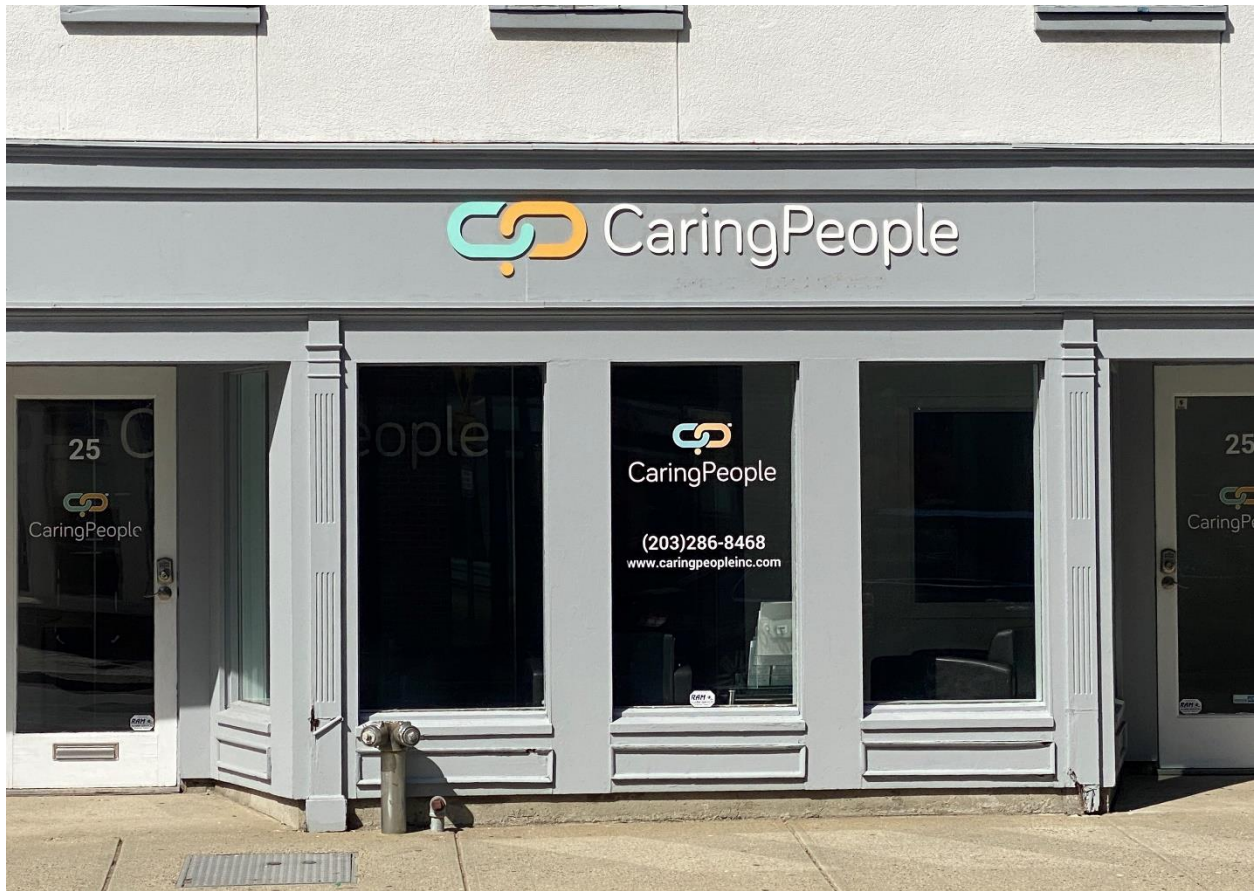
The commercial storefronts at the ground floor appear to have been considerably reconfigured from the original, which featured a prominent supplemental cornice, and sign band. The extant entry doors are non-original, but appear to be serviceable. The decorative wood elements of the storefront do not reflect the variations of the original, and exhibit varying levels of deterioration. (Photo #5)

*Photo 5 The ground floor commercial storefronts have been replaced, and do not match the originals.*
