# National Register of Historic Places Registration Form

Historic name:	D & H Scovil Industrial Historic District
Other names/site	e number: <u>D &amp; H Scovil Inc.</u>
Name of related	multiple property listing:
(Enter "N/A" if p	property is not part of a multiple property listing

Street & number:	11 Candlewoo	d Hill Rd, 11 and	12 Scovil Rd, 529 Brainerd Hill Rd
City or town: Had	ldam	State: <u>CT</u>	County: <u>Middlesex</u>
Not For Publicatio	n:	Vicinity:

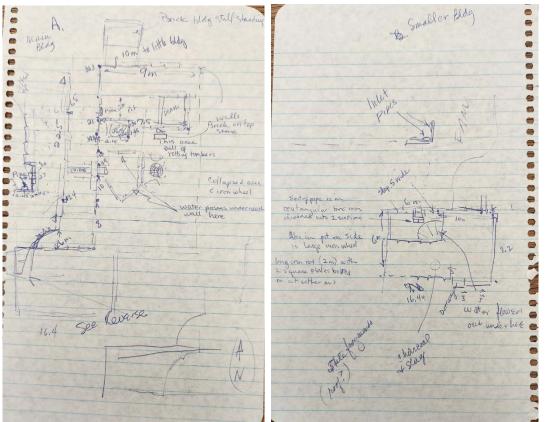
**Figure 14a and b**. Sketch of reservoir canal dike and large foundation at Mill #1 in 1978 (L); sketch of small foundation at Mill #1 in 1978 (R). Wesleyan Archaeology Labs.

This mill site was the earliest location built by and for the D & H Scovil Co. and today consists of an archaeological site that comprises the ruins of a dam, canal, gate mechanisms and foundations of brick forge shops as well as a tailrace bridge beneath the old drive. Wesleyan Archaeology Labs recorded this site in 1978 under two Historic Archaeological Inventory Forms: 061-078 documents features of the waterpower infrastructure and 061-078 documents the foundations of the mill buildings (#061-077). See Figures 8-10 for 19<sup>th</sup> c images and Figures 14a and b for Wesleyan sketches.

The ruins of two buildings were identified in 1978 at the northeastern end of the canal. The larger foundation, approximately 32 ft by 110 ft, sat parallel to the earthen dike; two wheel pits were identified inside its western

wall. The second, smaller foundation, approximately 30 ft x 54 ft, was located off the southwest corner of the larger foundation on the south end of the dyke; its wheel pit was located beneath the northwest corner. Large iron turbine wheels were noted in two of the pits. In addition, rotting timbers were noted within the footprint of the larger building and coal and slag within the footprint of the smaller building.

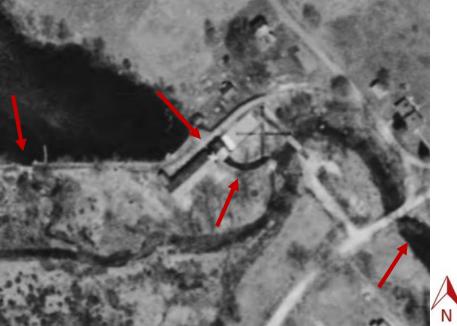
**Figure 19**. 1934 Aerial Survey close-up, Mill #2. From left: waste gate and return to brook; factory buildings (it appears that demolition of the eastern part of the eastern block may already have occurred); tail race; brook entering dam for Mill #3.

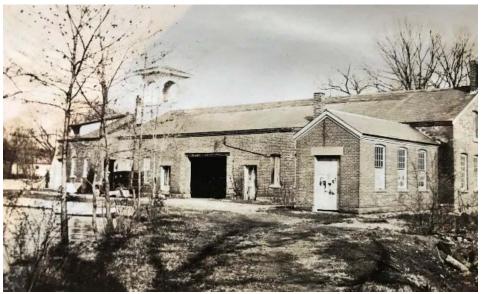
**Figure 20**. Photograph of north elevation of Mill #2, after demolition of most of eastern block, c.1935-40. Benham photo album.

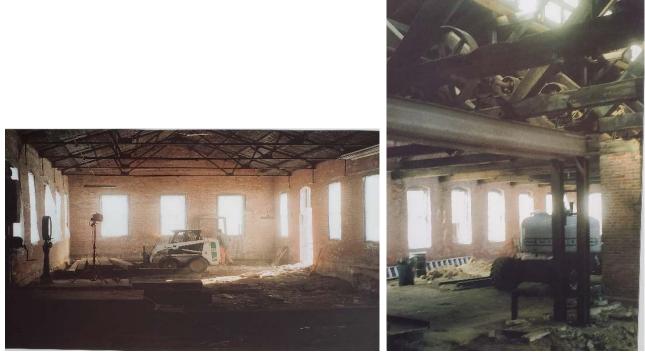
**Figure 30 a & b**. a. Interior of Polish Room showing the metal truss system in c.1905 extension. b. belt and pulley system in forge block. Photographs taken by Ronald Denmam c.2005 after purchase Mill #3 and the Office/Storage properties.

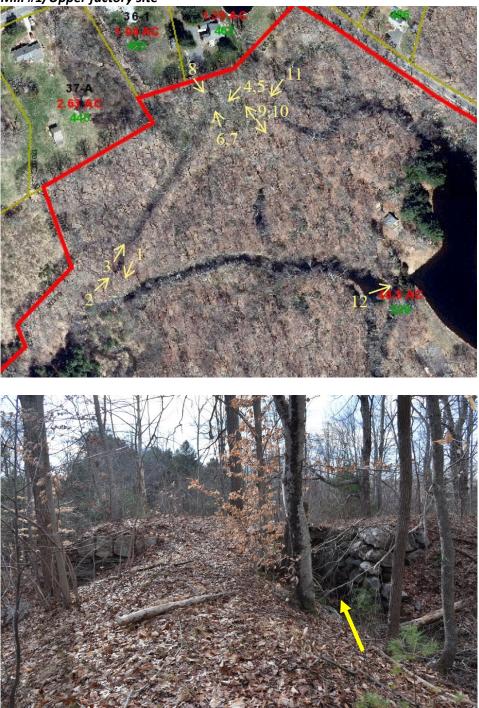
**Photograph 1 of 109**. Looking southwest from canal berm toward dam; canal and headgate at right. The dam wall, though shallow extends northward (to the right) some 60-70 feet; the wall to the south/left was the main face, some 50 feet above the brook bed and approximately 100 feet to the south/southeast. See also Figure 13.

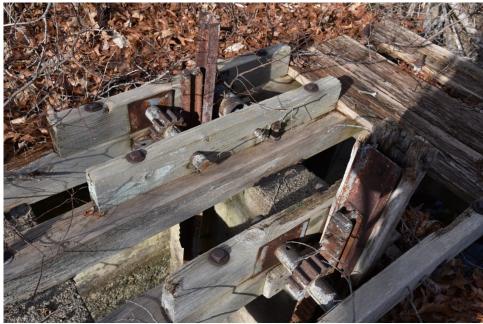
Photograph 2. Close-up of headgate mechanism.

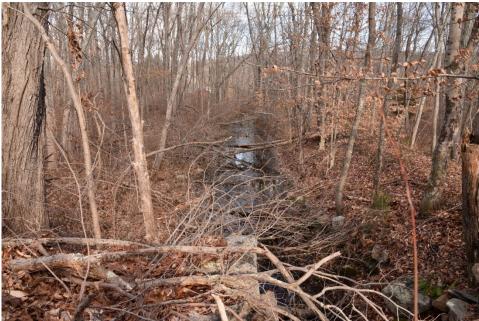
**Photograph 3**. Looking down head race canal from dam toward forge; camera facing northeast.

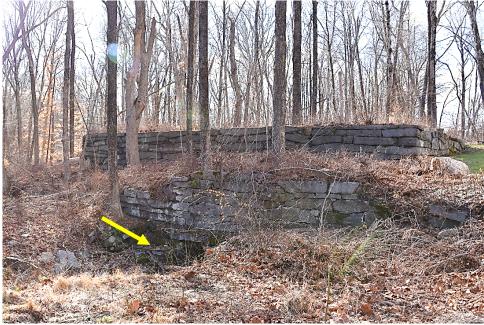
**Photograph 4**. Granite foundation of north/south forge shop; camera facing west toward canal. Flume pipe returns water to the brook.

Both building foundations were located for this project, however neither the earthen dike at the end of the canal, nor the wheel pits were discernable beneath the overgrowth on the west side of the buildings. An iron turbine wheel was leaned up against a tree on the east side of the old road at the site, together with several iron rods. Other iron artifacts observed include connecting bars in the east wall of the large forge shop foundation, riveted flume pipes and some kind of water diverter in one of the pits. A couple of timber frame member with iron strap were noted within the footprint of the larger foundation. Used grinding stones are evident in the area, including atop one of the foundation walls. (Photographs 4, 6, 8-10)

Outfalls for the turbines were not mentioned in the 1978 report but were clearly identifiable during site visits for this project (the area had been cleared of vegetation more than once, including prior to the 1978 site visit and most recently between site visits for this project). A flume pipe and discharge well toward the north end of the east side of the large foundation correspond to the northern wheel pit on the west side of the building and emerge beneath a stone wall beyond the foundation (see the bridged race in Figure 9). A second flume pipe and discharge well are located toward the south end of the large foundation and corresponds to the southern wheel pit on the west side. A third flume discharge emerges from the south wall of the large forge shop foundation at the corner with the small forge shop foundation; in the pit is a metal artifact that may have been a water diverter. (Photographs 4, 5, 7)

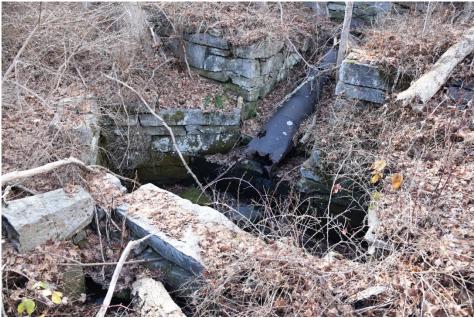
**Photograph 5**. Another flume discharge at the south end of the main forge ruins; camera facing west/southwest.

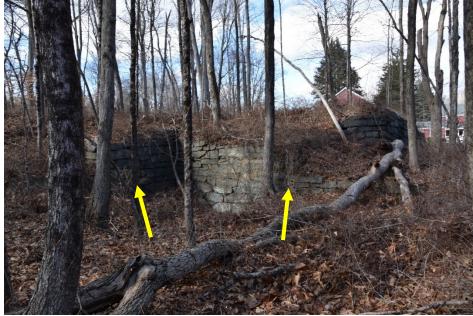
**Photograph 6**. Granite foundation walls of east/west forge at left and north/south forge at right; camera facing north.

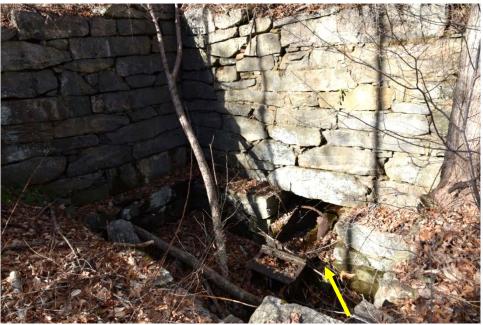
**Photograph 7**. Flume exiting south wall of north/south forge shop, with a metal diverter possibly allowing water to power a shaft to the east/west forge shop and iron cutting building beyond, or back to the brook; camera facing north/northwest.

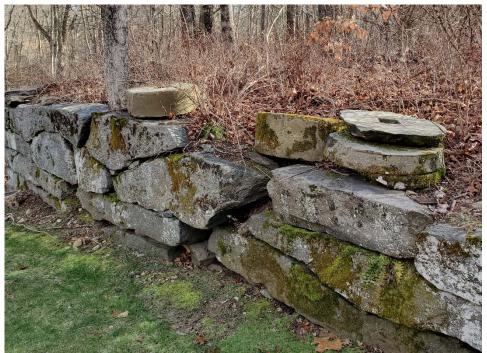
**Photograph 8**. Several of many small grindstones throughout the site used in working iron into hoes; these sit atop the north foundation wall of the north/south forge shop. They were approximately 6 feet in diameter when first used and changed out when reduced to 2-3 feet in diameter.

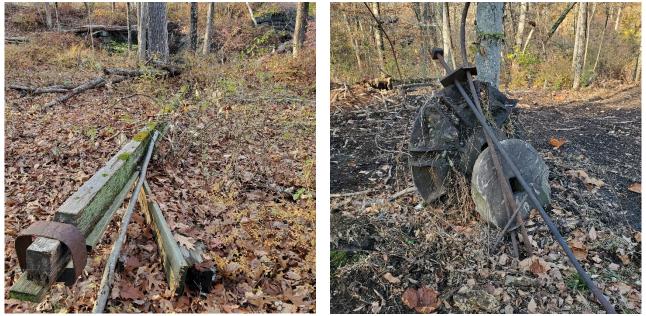
*Photographs 9, 10*. Elements from building, waterpower infrastructure and processing found above ground at Mill #1.

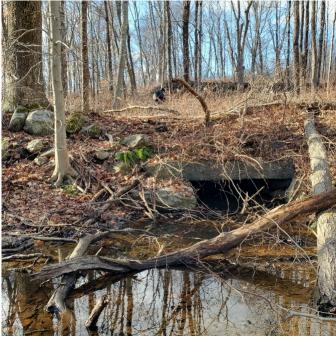
**Photograph 11**. Stone header for tailrace/brook beneath drive on east side of mill ruins in background; camera facing west.

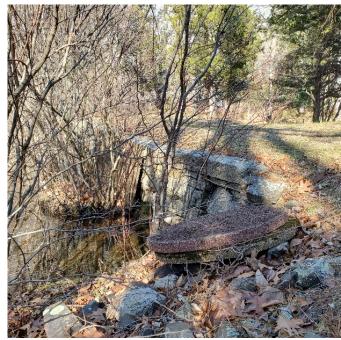
**Photograph 12**. Bridge over brook water where it connects with the pond; camera facing north.

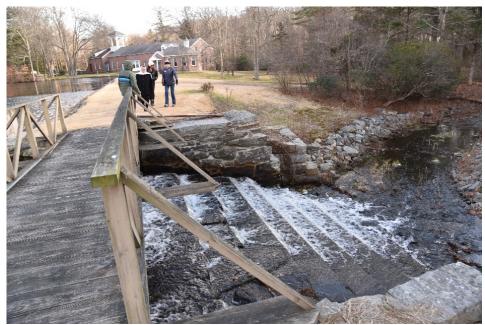
*Photograph 13*. View down the drive from the waste gate toward mill #2 in the background; camera facing east.

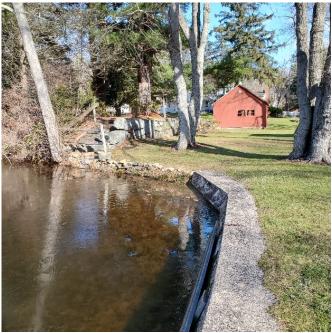
**Photograph 14**. Concrete wall section generally corresponds to the location of the former head race intake for the turbine. Granite block retaining wall runs from the pond to the barn, which sits on the granite foundation of a former horse shed.

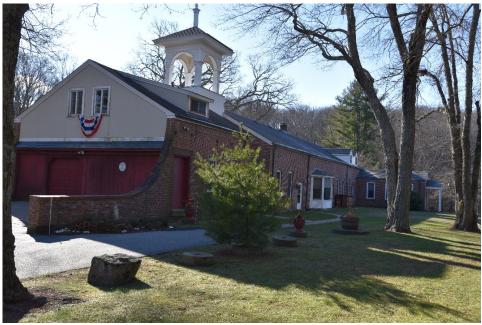
**Photograph 15**. East and north elevations, camera facing southwest; ell is located at far end of buildings, and the pond and drive to Mill #1 just beyond right edge of Photograph.

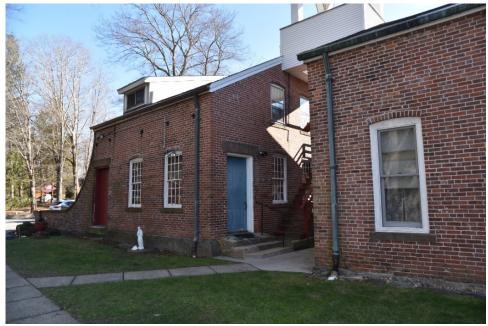
*Photograph 16*. North and west elevations of eastern block; camera facing east.

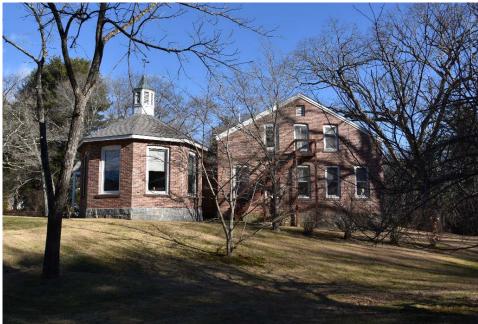
*Photograph 17*. West elevation with chapel addition off ell at left; camera facing northeast.

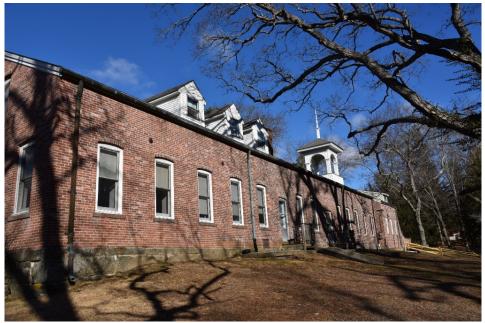
*Photograph 18*. South elevation; camera facing northeast.

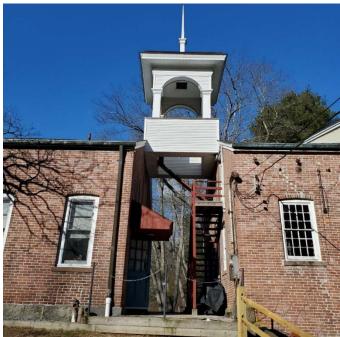
Photograph 19. Bell tower connection between blocks as seen on south elevation.

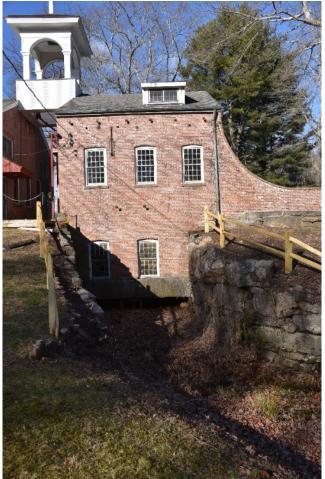
**Photograph 20**. South elevation of extant section of east block. Note massive sill, comprised of two pieces of granite, that supports the south wall above the tail race, and the granite walls of tail race channel.

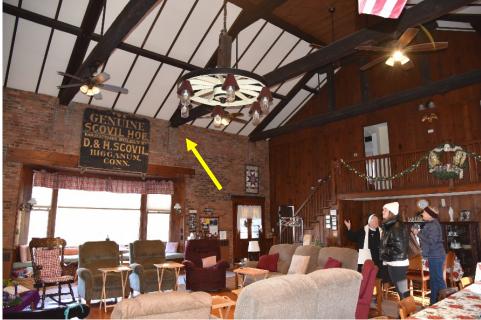
**Photograph 21**. Interior of center space in western block; note how trusses sits on brick corbels in the load bearing brick walls.

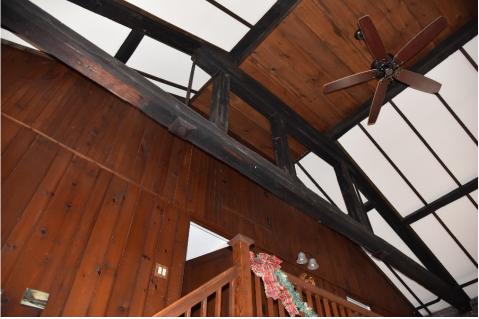
*Photograph 22*. Truss configuration and plank ceiling originally open to clerestory.

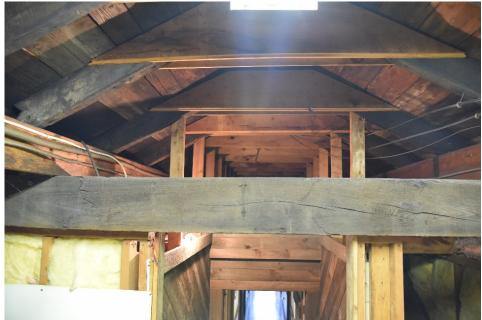
*Photograph 23*. Newer framing in attic corresponding to removal of clerestory and refinishing as gable roof.

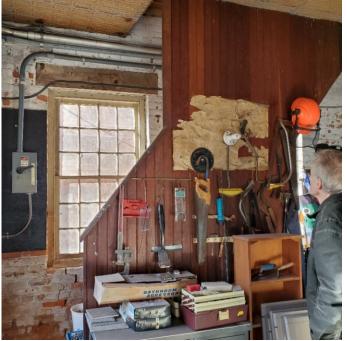
Photograph 26. A vertical bead board stair leads to second level.

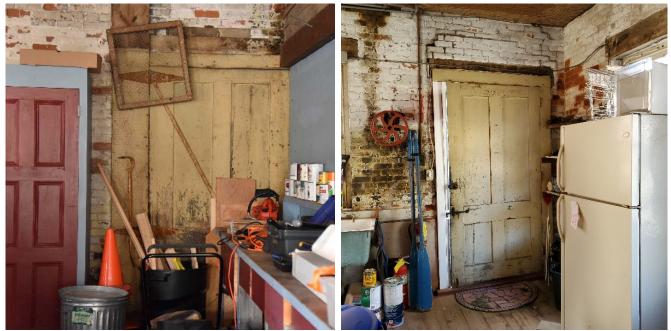
Photographs 27, 28. Early doors in north wall (L; red door is a cabinet) and west wall (R).

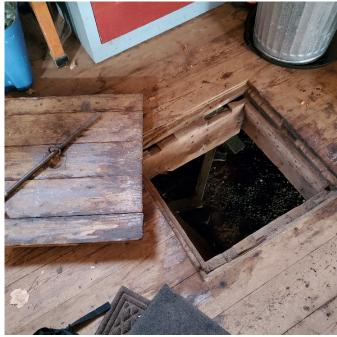
Photograph 29. Hatch to turbine chamber.

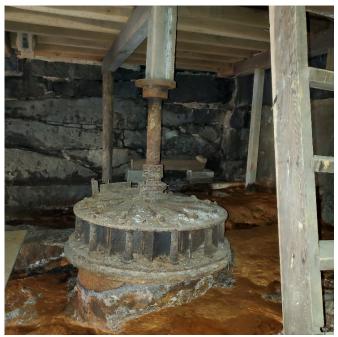
Photograph 30. Remnants of turbine (or steel water wheel).

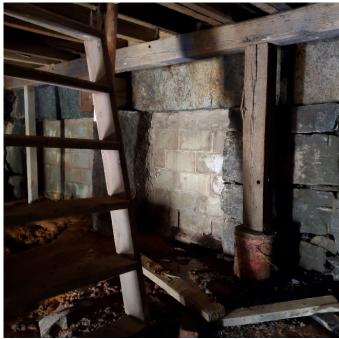
**Photograph 31**. Concrete block in north wall closing off head race; note large granite blocks to carry building across head race.

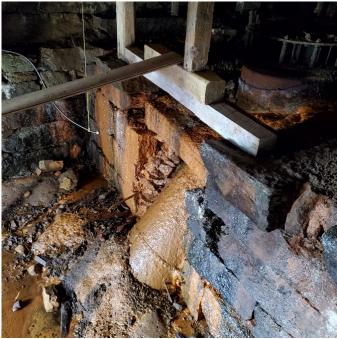
*Photograph 32*. Flume discharge for water exiting turbine.

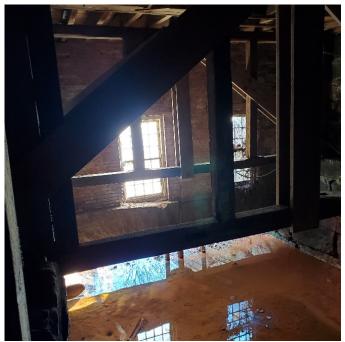
**Photograph 33**. Bay over turbine chamber and tail race; camera facing south.

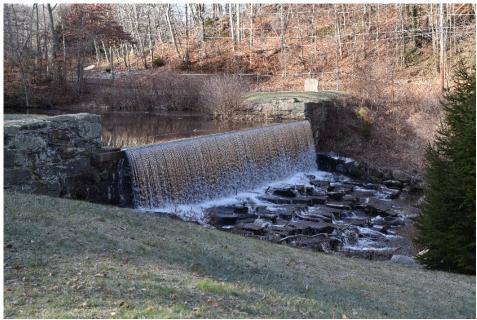
**Photograph 34**. Dam at mill pond for Mill #3; camera facing west. The headgate to the canal is to its left. Candlewood Hill Road is on the north (back) side of the pond.

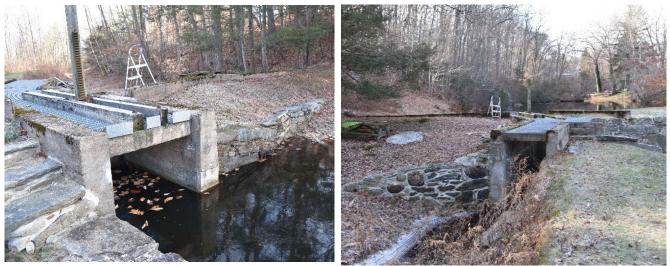
**Photographs 35 & 36**. Modern headgate for reservoir canal within stone wall structure; camera facing northeast (L), downstream side of headgate; camera facing southwest (R).

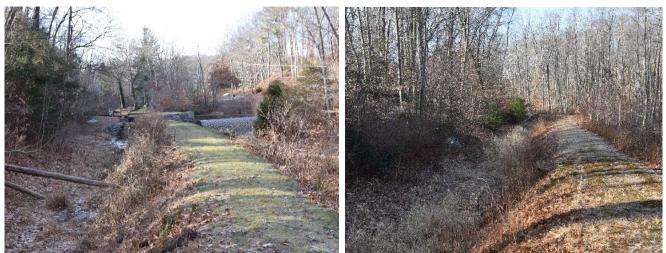
**Photographs 37 & 38**. Two views from berm along reservoir canal: toward dam and pond (L), and further east; camera facing west/southwest.

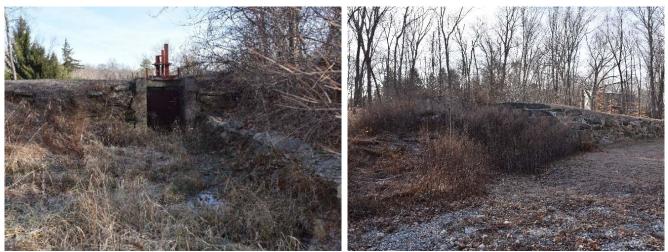
**Photographs 39 & 40**. Interior view of reservoir canal stone retaining walls and sluice gate at its east end (L), exterior of reservoir canal stone retaining walls; camera facing southwest (R).

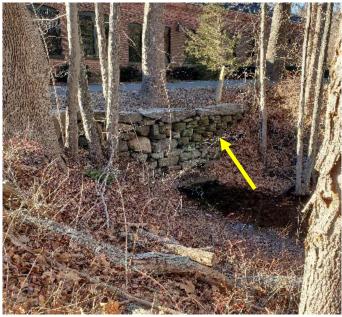
**Photograph 41**. After passing beneath the engine room, the tail race exits to the east, beneath Scovil Road north of the office, to rejoin the brook which runs along Candlewood Hill Road. A close look shows the bridge wall made partly of used grindstones.

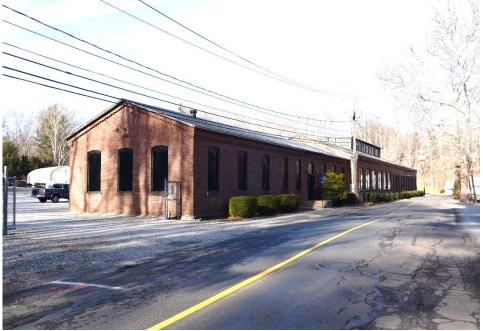
**Photograph 42**. South and front/east elevations of Mill #3 complex along Scovil Road; camera facing north/northwest.

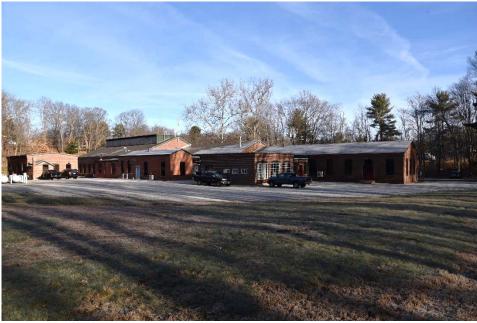
*Photograph 43*. Rear/west elevation of complex; camera facing northeast.

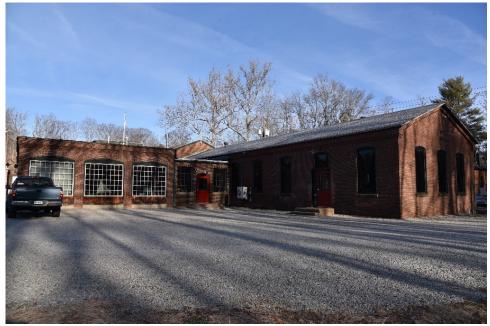
*Photograph 44*. From left: south elevation of auto house, connector to japan house, west and south elevations of japan house.

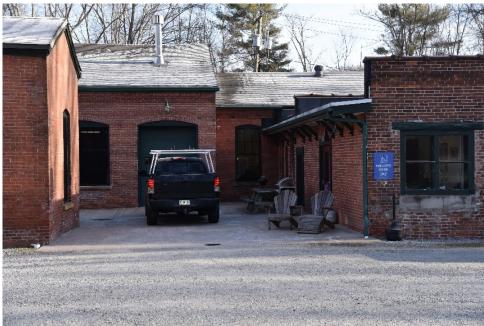
**Photograph 45**. From left: south end of boiler block, south end of polish room, northernmost bay of japan house, north and west elevations of auto house; camera facing east.

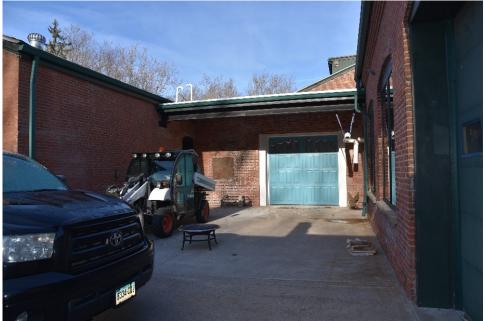
**Photograph 46**. From left: east elevation of engine block, south elevation of boiler block (with modern garage door), with west wall of polish room at R; camera facing north.

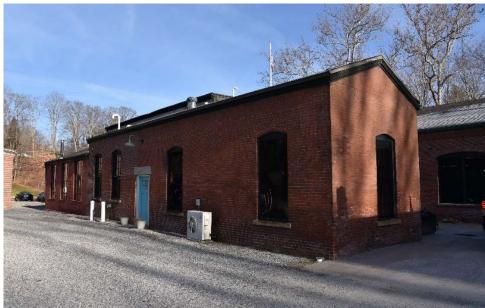
**Photograph 47**. West and south elevations of engine & boiler blocks with concrete block extension at far left; camera facing north/northeast. The architectural features of the boiler block distinguish it as a different construction date than the engine block.

(Photographs 47, 50, 51, 62-67; Figure 30b)

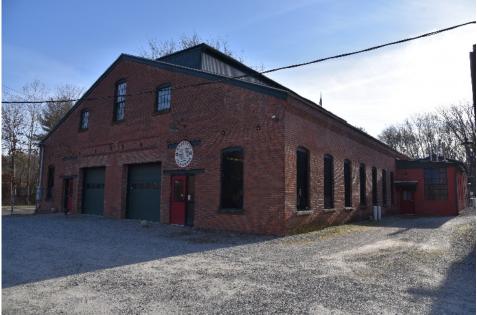
**Photograph 48**. South and west elevations of grinding/forge room (concrete block extension at right); camera facing south/southeast.

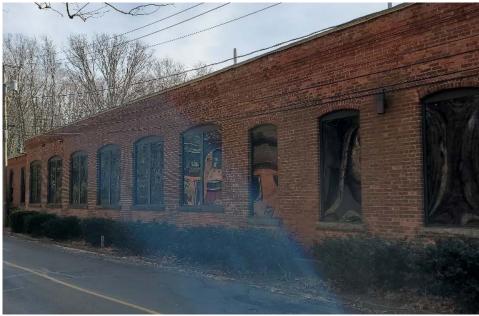
**Photograph 49**. East elevation of grinding/forge room (R) where it joins the polish room (L); camera facing south.

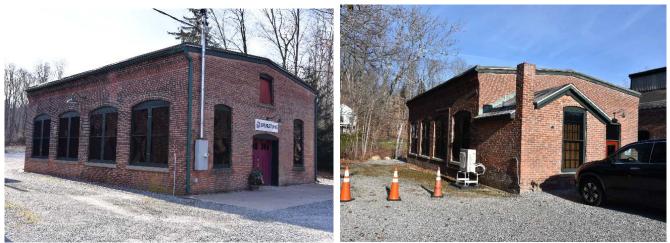
**Photographs 50 & 51**. East and north elevations (L; camera facing southwest) and west and south elevations (R; camera facing north) of free standing machine shop.

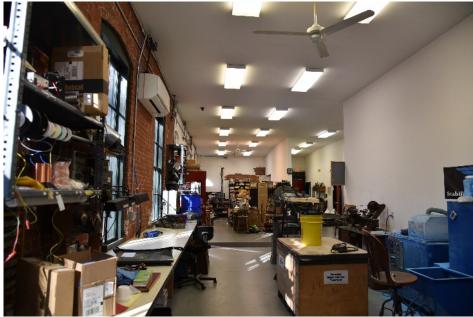
*Photograph 52*. Japan house interior with exposed brick perimeter walls and non-structural partition walls.

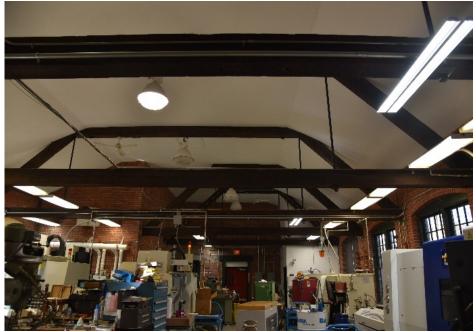
**Photograph 53**. Interior of polish room with partially exposed truss framing and east end of engine block in left background; camera facing north. The framing is built into the engine wall at the far end indicating its construction or expansion postdates the engine block.

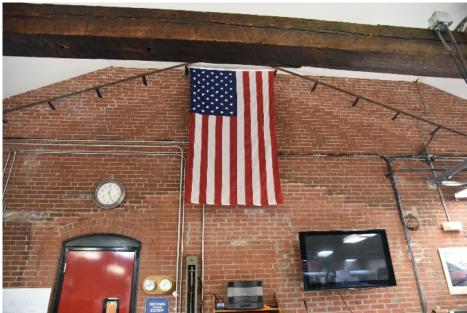
**Photograph 54**. Common wall between the japan house and polish room, taken from inside the latter; camera facing south. Note shadow line of prior building configuration as well as exposed ends of steel truss framing in Japan house.

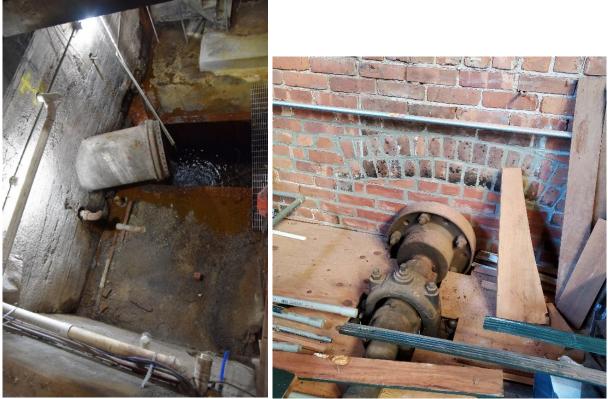
**Photographs 55 & 56**. Inside the engine block: partial view of turbine pit and outflow flume toward street (L), and power shaft coming off turbine (R).

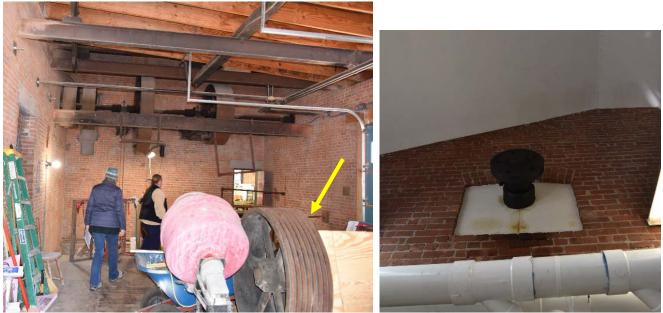
**Photographs 57 & 58**. Belt shaft and pulley system above turbine pit against far (east) wall in engine block, with additional equipment visible in foreground (L); belt shaft emerging from north wall of engine block into polish room (R).

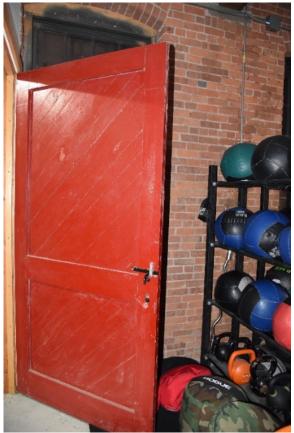
**Photograph 59**. One of only a couple of extant wood doors, between west end of engine room wall and south wall of grinding/forge room.

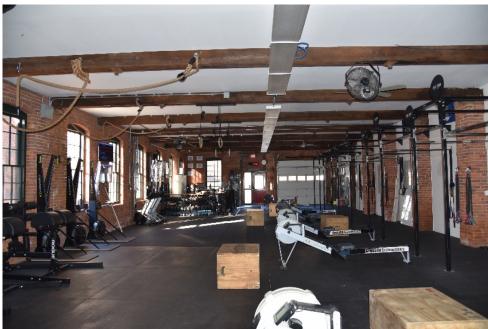
**Photograph 60**. Western side of ground floor of grinding/forge room; camera facing north. Timber frame sits on stones sets in brick bearing wall. Brick columns run down the center of the ground floor to carry the framing load above; non-structural walls between columns separate the eastern half of the space.

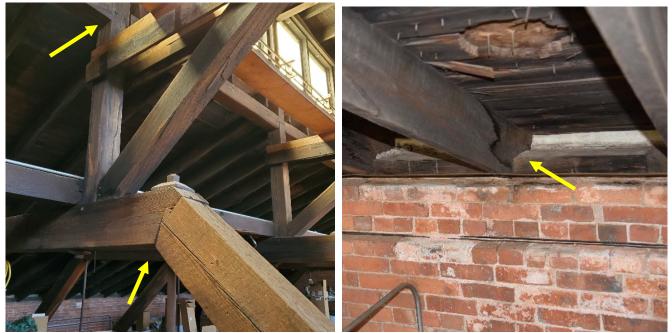
**Photographs 62 & 63**. Truss detail showing at least two periods of construction, from top, mortise and tenon joints, later toe-nailed supports, and notched joints with tie rods (L); main roof rafters seated on plate atop brick bearing wall with bird's mouth joint (R).

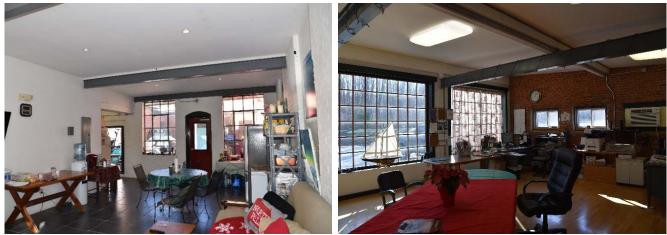
*Photographs 64 & 65*. Interior of connector between japan house and auto house (L) and of auto house (R). Note steel I-beams.

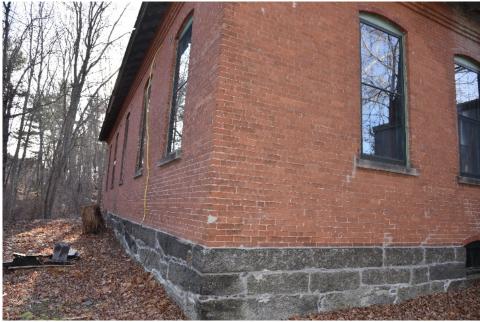
**Photograph 67**. East/rear and part of south elevation showing granite block foundation; camera facing south. Ground slopes down behind building.

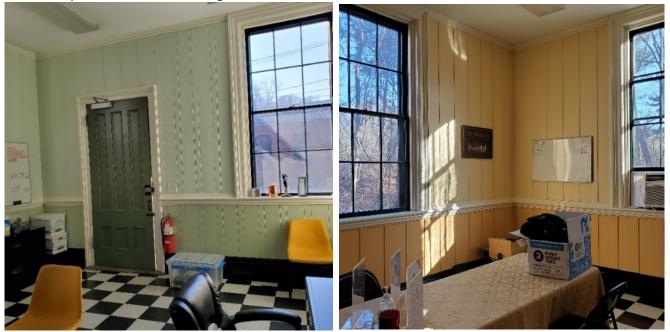
Photographs 68 & 69. Front office room and rear of paneled entry door (L); rear office room.

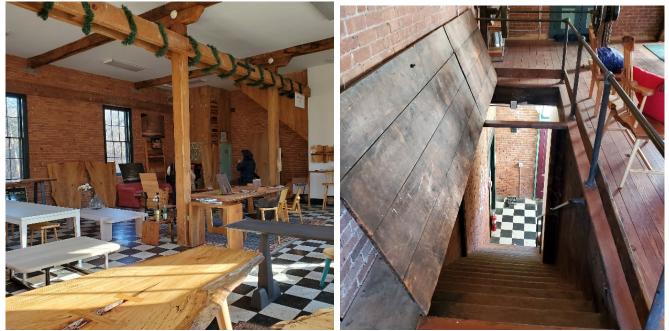
**Photographs 70 & 71**. Storage area interior: first floor space with extra timbers for movement of material (L); looking down hatch opening from loft (R).

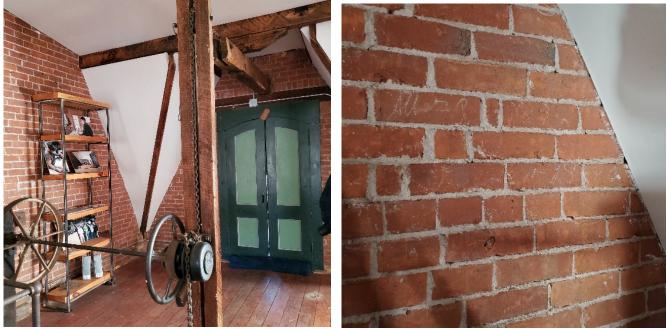
**Photographs 72 & 73**. Extant equipment and features for the movement of material in loft (L); writing on south side of brick wall in loft, date about a year after construction: "Al[bert?] P M[illegible]/ 11-1880" (R).

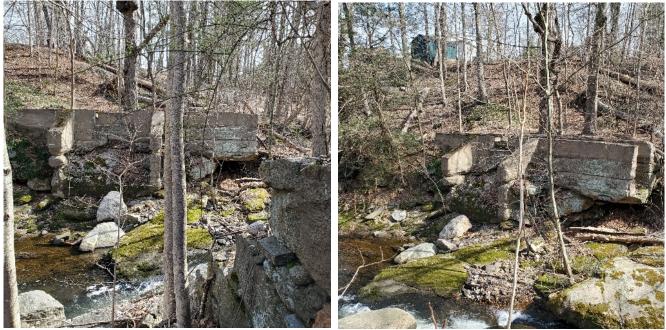
**Photographs 74 & 75**. The dam wall visible lower right at (L), and the concrete flume channel across the brook at non-contributing archaeological site at Mill #4.

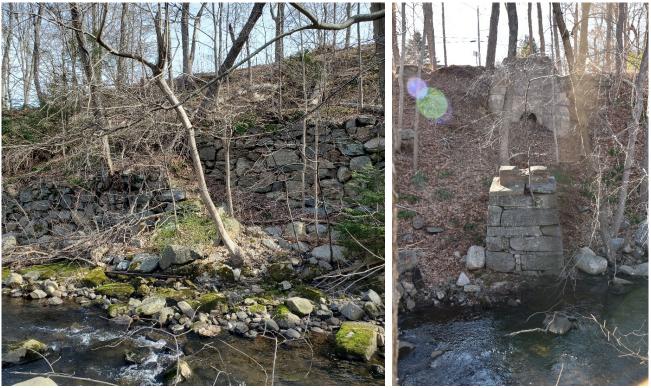
**Photographs 76 & 77**. Stone embankment wall on south side of brook where flume traveled (L) and stone pillars that carried the flume across the brook from the south bank to the 1886 mill (R) at non-contributing archaeological site at Mill #4.

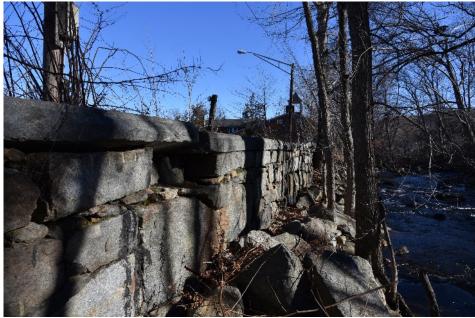
*Photograph 78*. Cut stone retaining wall on mill/north side of brook near flume crossing.

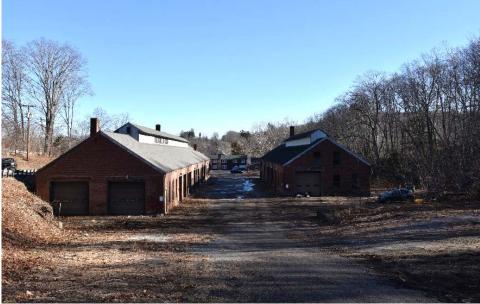
**Photograph 79**. The two forge buildings between Candlewood Hill Road to the left and the brook to the right; camera facing east from the location of former mill pond.

Two parallel forge buildings are oriented east to west between Candlewood Hill Road to the north and Candlewood Hill Brook to the south and sit roughly 50 feet apart. The southern forge building is located along the bank of the brook and the northern forge is against the rise of the road (Photograph 79; Figures 34-35).

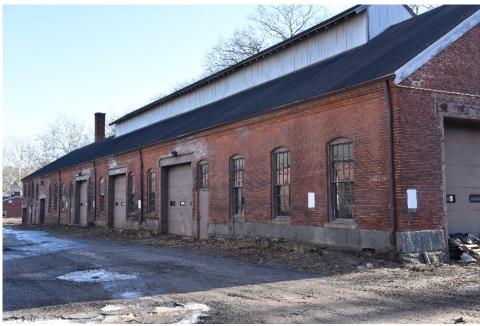
Photograph 80. North elevation of c.1889 forge shop, camera facing east.

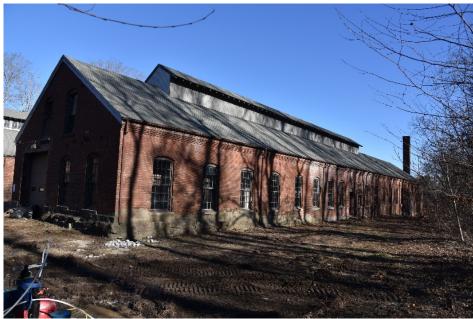
**Photograph 82**. West and south elevations of c.1889 forge shop; camera facing east. Openings on south wall, along brook, have not been altered.

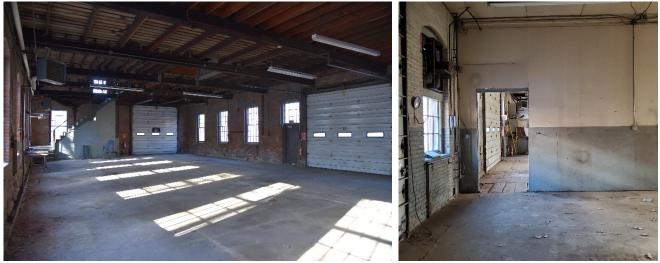
**Photographs 83 & 84**. Open forge shop area at west end; note stair at far wall which provides access to a storage area above the joists. View of non-structural partition wall and plank covered trench or basin looking east from same space (R).

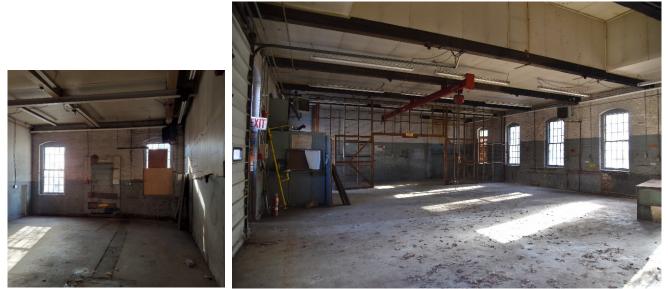
*Photographs 85 & 86*. Looking toward south wall and early door/door opening (L); interior of central section where area above ceiling joists was closed off in mid-20<sup>th</sup> century.

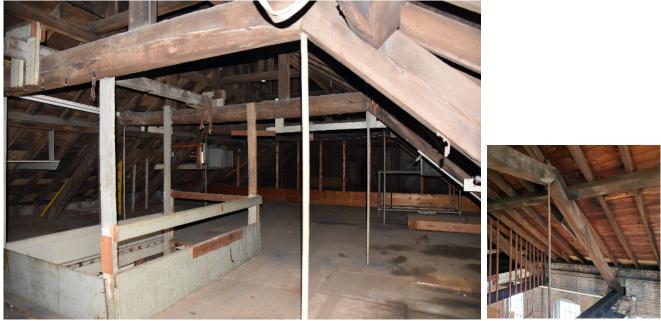
**Photographs 87 & 88**. Upper storage area at west end of building (L); truss and detail of framing sitting in load bearing brick wall (R).

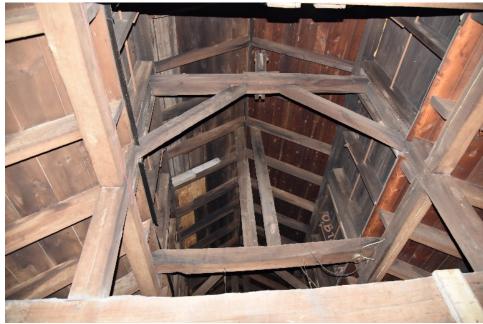
Photograph 89. Monitor framing above upper storage area.

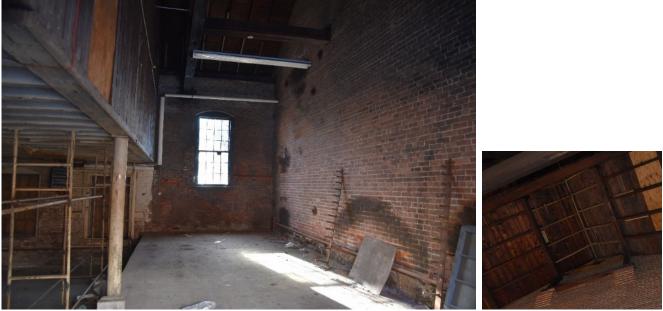
**Photographs 90 & 91**. Former engine room with elevated concrete floor and firewall at right (L). Detail showing extant monitor framing supported by brick corbels on fire wall (R).

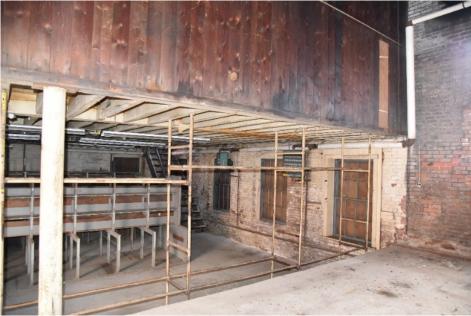
*Photograph 92*. Ground floor machine room open to engine room and enclosed woodworking room above.

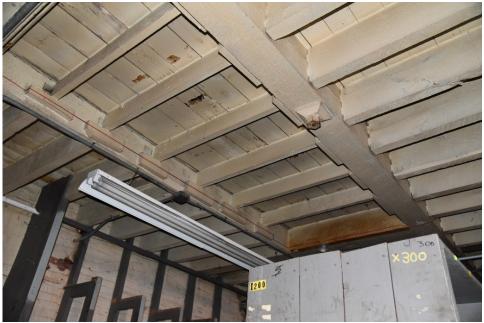
*Photograph 93*. Floor framing for woodworking room with double tenon joints and closely spaced joists.

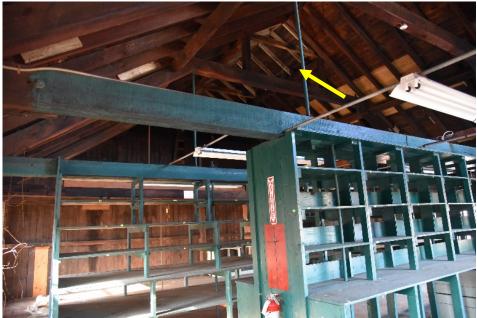
**Photograph 94**. Woodworking room looking toward firewall; section of newer roof framing at the ridge line is in place of former monitor.

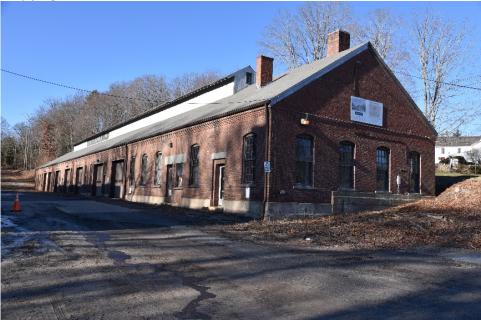
**Photograph 95**. South and east elevations of drop forge building; camera facing northwest. Fenestration on east wall is unchanged.

The northern drop forge shop has a footprint of 40 feet x 260 feet and is four bays wide by 32 bays long. The building has a concrete foundation, at ground level at the west end and exposed as the terrain descends to the east. The east end foundation is stepped up and runs beneath the window sills. An external brick stack is located against the north elevation between the third and fourth bays; the ground in this area is up against the building to just below the window sill. Original door and window openings are largely intact on the east and north elevations, except for fan units mounted in a few window openings in lieu of sash. Windows are twelve over twelve wood-frame double hung sash. Modifications from use of the site by the Department of Transportation (DOT) have been made with the insertion of two steel frame garage door openings on the west elevation and seven on the south elevation. In addition, a window opening has been changed to a door and a modern door opening created between garage doors. The north and south walls terminate in five-course brick corbelling beneath the roof line. An approximately 190 foot long monitor is centered along the ridgeline. Most,

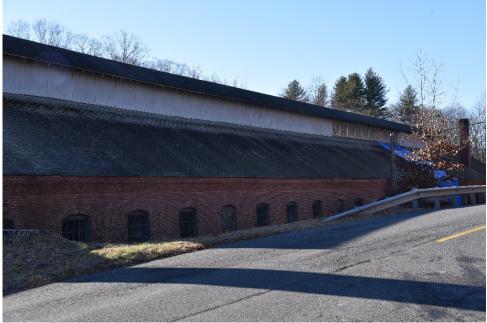
**Photograph 96**. North elevation of drop forge building; camera facing southwest. Openings on north wall, against Candlewood Hill Road embankment, have not been altered.

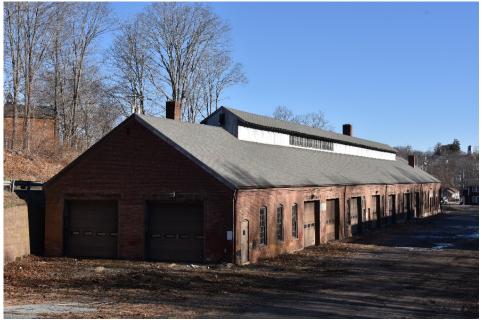
*Photograph 97*. West and south elevation of drop forge building.

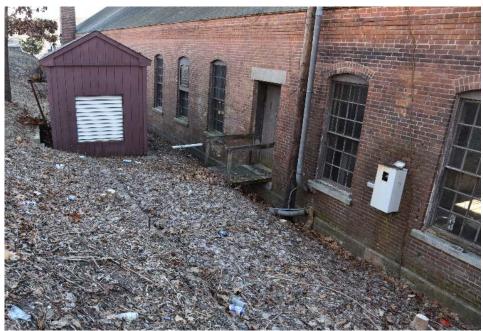
*Photograph 98*. Door and window openings on north elevation; camera facing east.

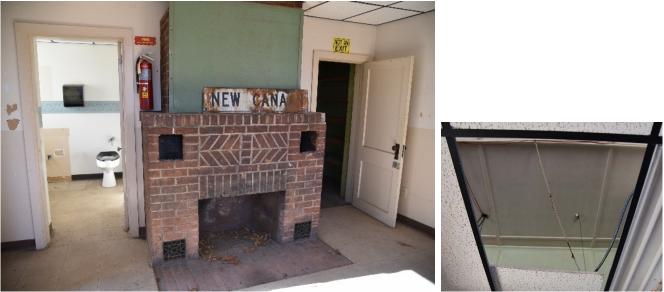
**Photographs 99 & 100**. Fireplace in office space (L); office wall and ceiling panel treatment visible above mid-20<sup>th</sup> century drop ceiling (R).

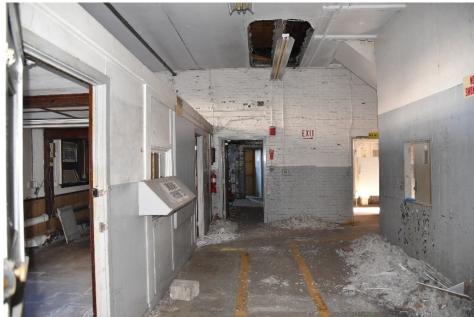
**Photograph 101**. Brick firewall separating office space from workspace and non-structural partition walls in eastern end of building; camera facing east.

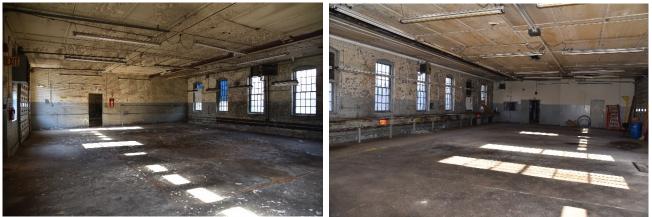
**Photographs 102 & 103**. Open workspace adjacent to office: camera facing west (L) with another brick firewall in background, and camera facing east (R) with non-structural mid-20<sup>th</sup> century wall creating added office space at east end adjacent to office. Ceiling has same treatment as office.

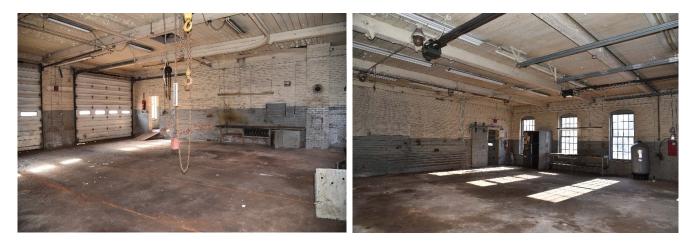
**Photographs 104 & 105**. Center open workspace between brick firewalls: camera facing west with brick chimney base against west wall (L), and camera facing east with heavy lift track on timber framing of upper level (L). Ceiling here is wood plank.

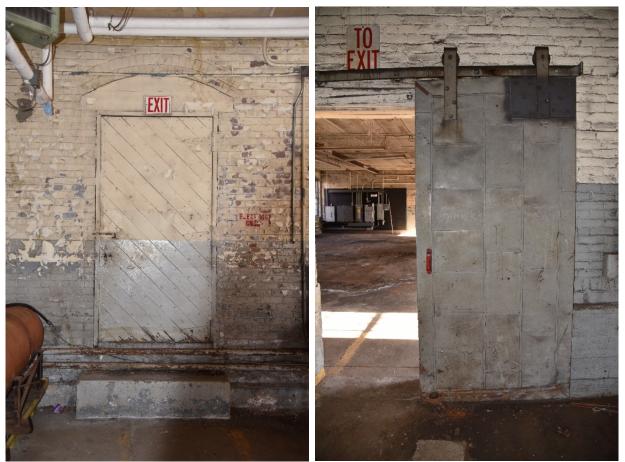
**Photographs 106 & 107**. Exterior door on north wall (L), and one of three metal clad sliding fire doors on brick firewalls in workspace areas.

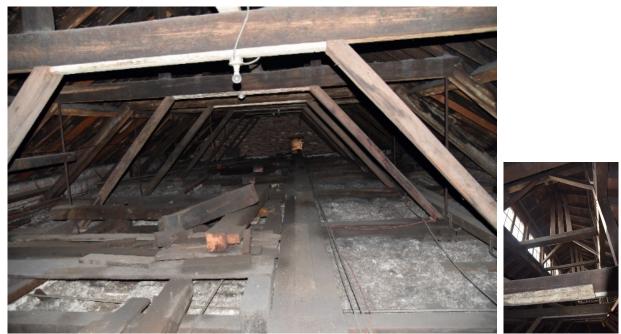
Photographs 108 & 109. Truss system and brick fire wall in background (L), and monitor truss (R).

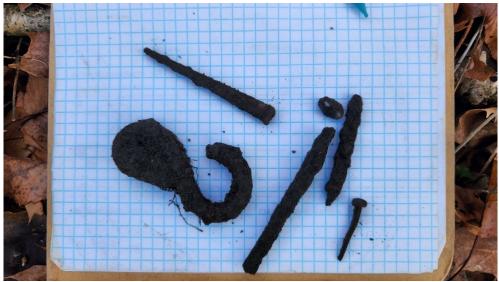
Photograph 110. Metal artifacts found in November 4, 2023, judgmental test pit at Mill #1 archaeological site.

On November 7, 2023, a 50cm-by-50cm judgmental test pit was placed within what is thought to be the footprint of the former iron cutting building (the smaller structure described in 1978) to look for intact archaeological deposits. Underneath a thin strata of duff was a very dark brown soil indicative of burn activity. Within the first 15cm of excavations numerous metal artifacts were found along with slag. (Photograph 110) The test pit was excavated to a depth of 45cm before terminated due to thickly packed gravel and slag. From about 30cm to 45cm, the soil was mostly gravel intermixed with slag and melted metal. Soils around the rest of the factory site appear to have been minimally impacted besides recent vegetation clearing, which did uncover part of the historic turbine used at the factory. These factors all point towards good site integrity that has the potential to yield further information about the manufacturing processes completed on site.

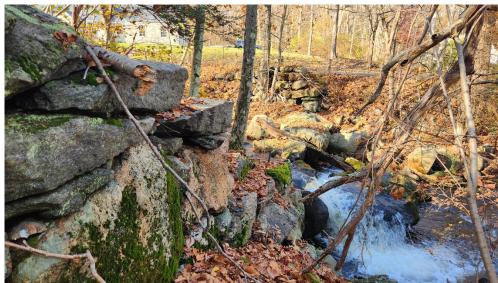
Photograph 111. Dam ruins of non-contributing archaeological site at Mill #3; camera facing north.

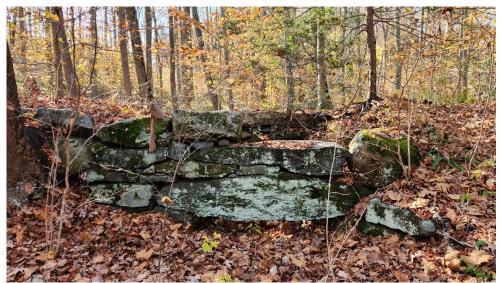
**Photograph 112**. Wheel pit or chamber at non-contributing archaeological site at Mill #3; camera facing west.
