United States Department of the Interior
National Park Service**National Register of Historic Places Registration Form**

1. Name of PropertyHistoric name: Chase Brass and Copper Company Rolling Mill (No. 1) Historic DistrictOther names/site number: Waterbury Manufacturing Company; Chase Metal Works

2. LocationStreet & number: 526 and 730 North Main Street, 40 East Farm StreetCity or town: Waterbury State: Connecticut County: New HavenNot For Publication: ☐ Vicinity: ☐**3. State/Federal Agency Certification**

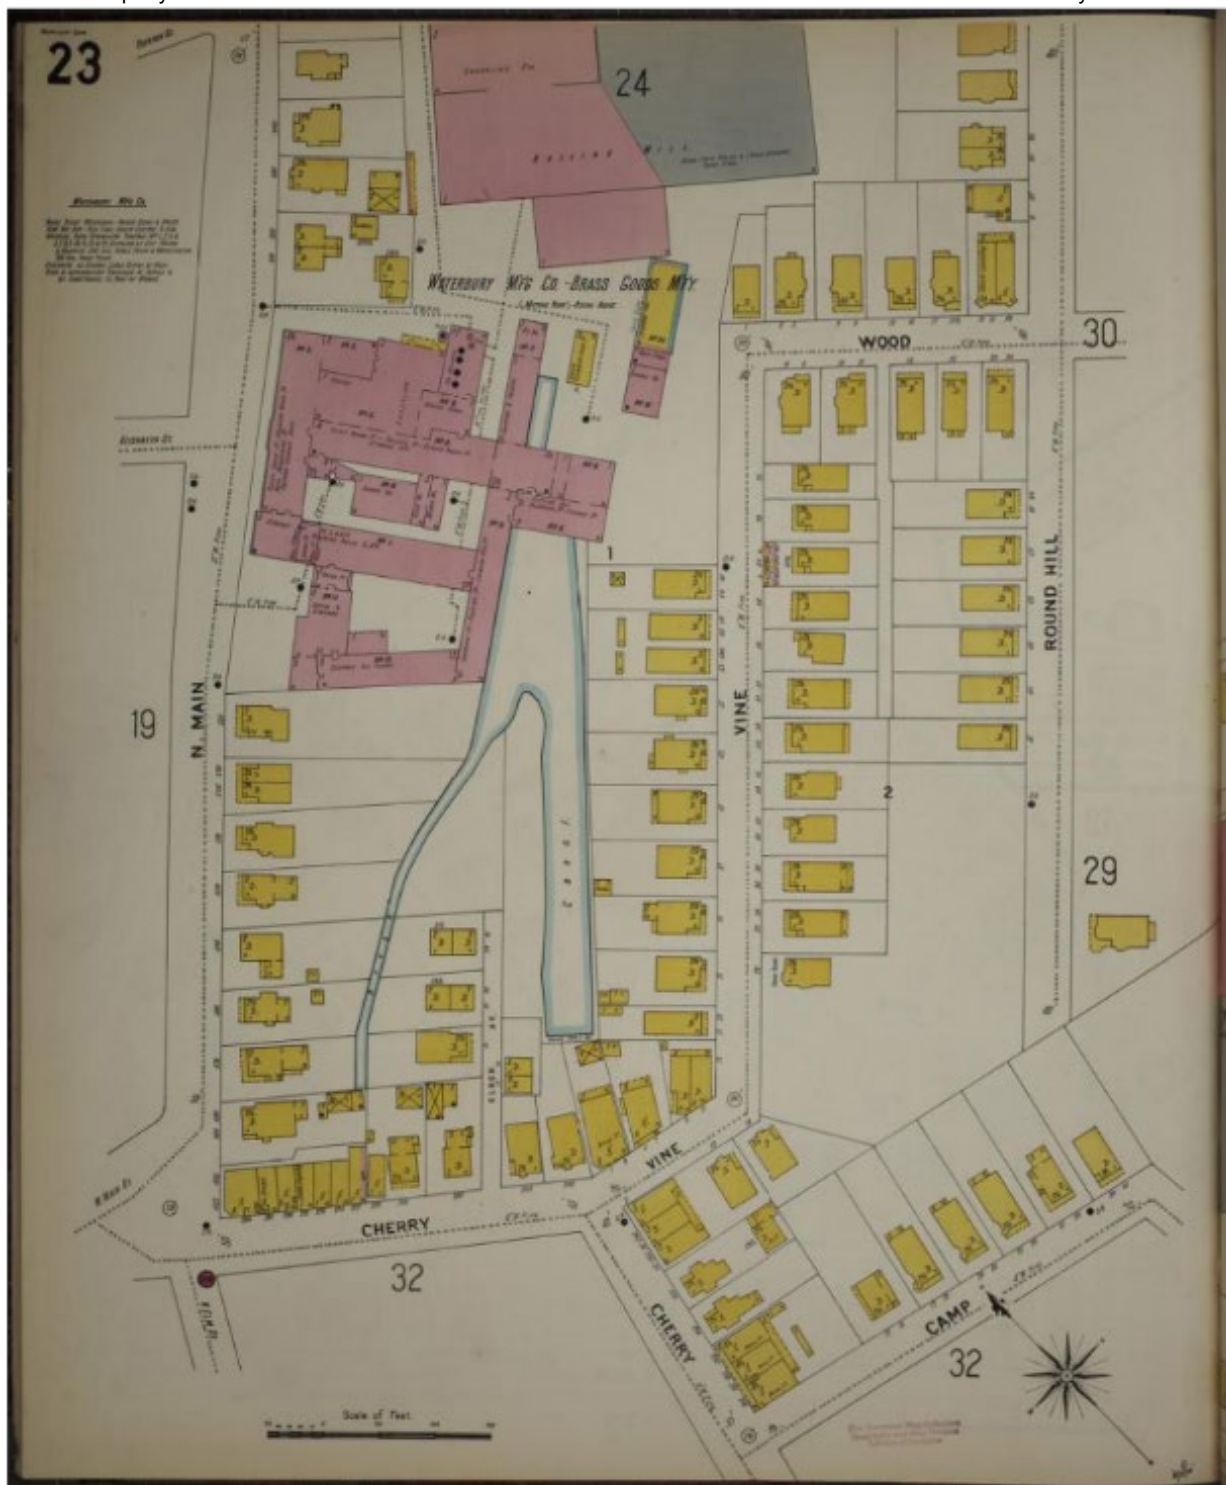
Figure 4: 1901 Sanborn Fire Insurance Map, page 23, loc.gov

Building 34/223 is located northeast of building 30/31/32 and building 5/6. The metal building was constructed between 1895 and 1901. In the 1901 Sanborn map notes, the eastern half of the building is denoted as an iron building with corrugated iron walls and large windows, and the western half of the building is denoted as a brick building used for annealing and casting (photo 20). A small brick addition is located north of the brick annealing room and was used for moulding and casting. On the 1950 Sanborn map, the entire building is marked as the Rolling Mill and noted as having a steel frame and concrete floors. Several small brick additions (building 2323A, 223B, 217, and 247) were attached to the west and north elevations. The additions have since been demolished.

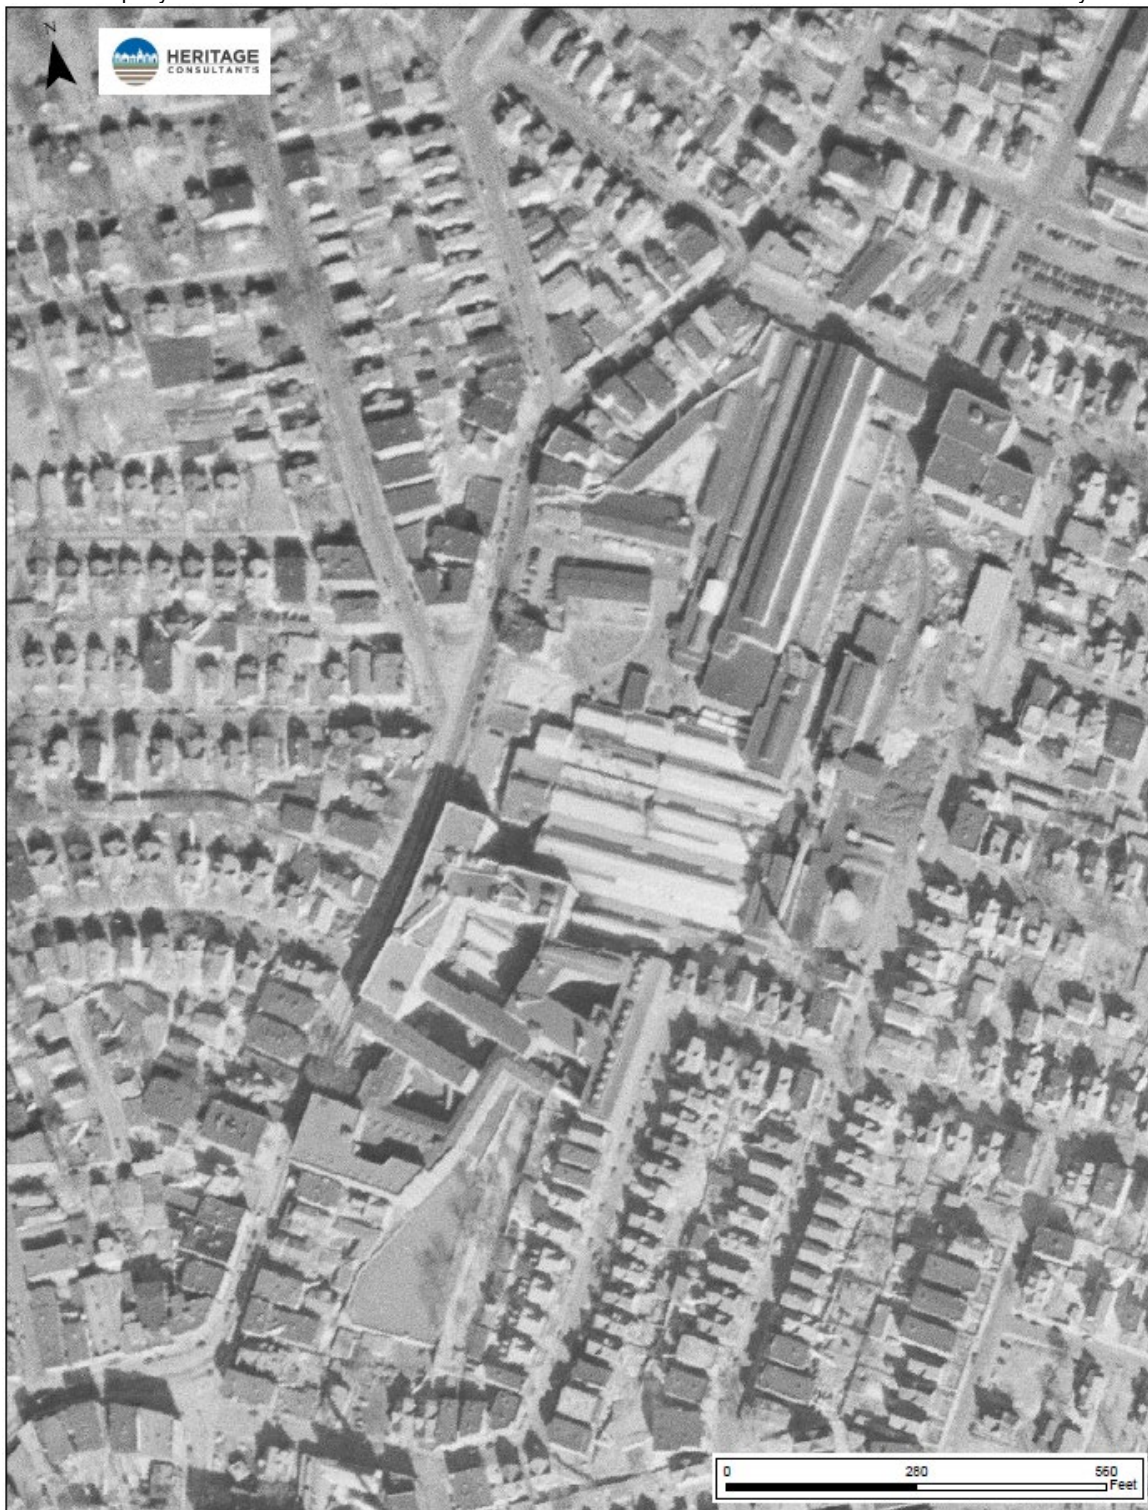
Figure 9: 1934 Aerial Imagery of the Chase Brass and Copper Company Rolling Mill (No. 1)

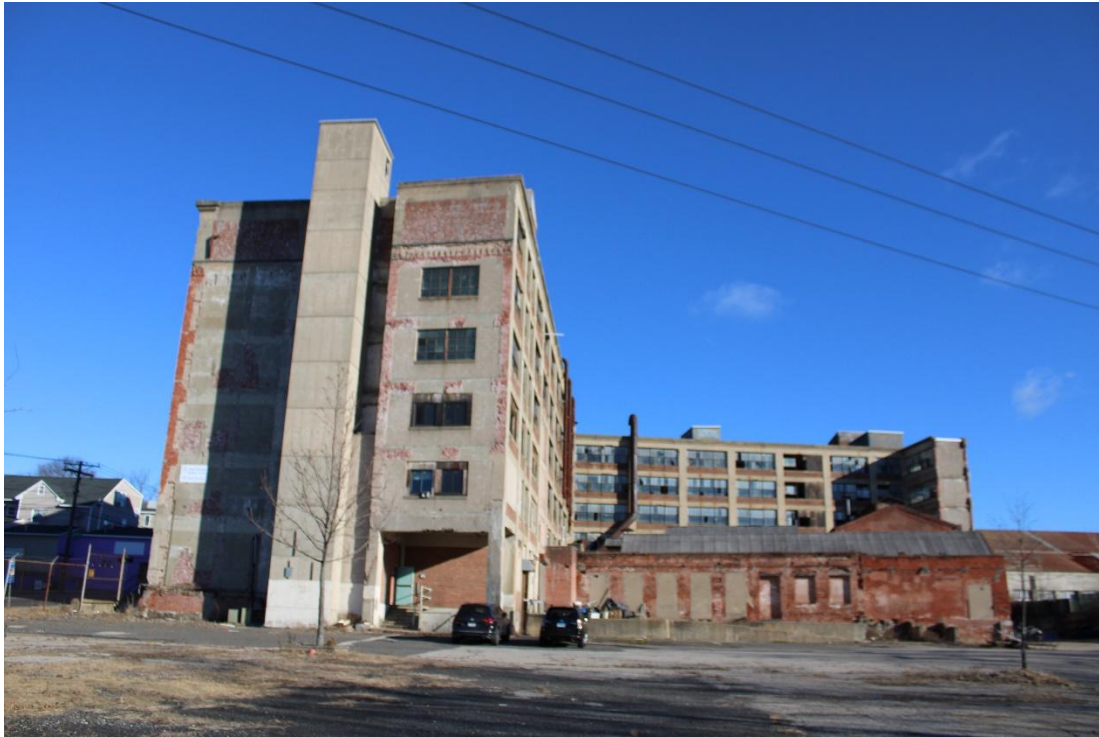
Photo 1: South elevation of the Loft Building (building 30/31/32). Photo facing north.

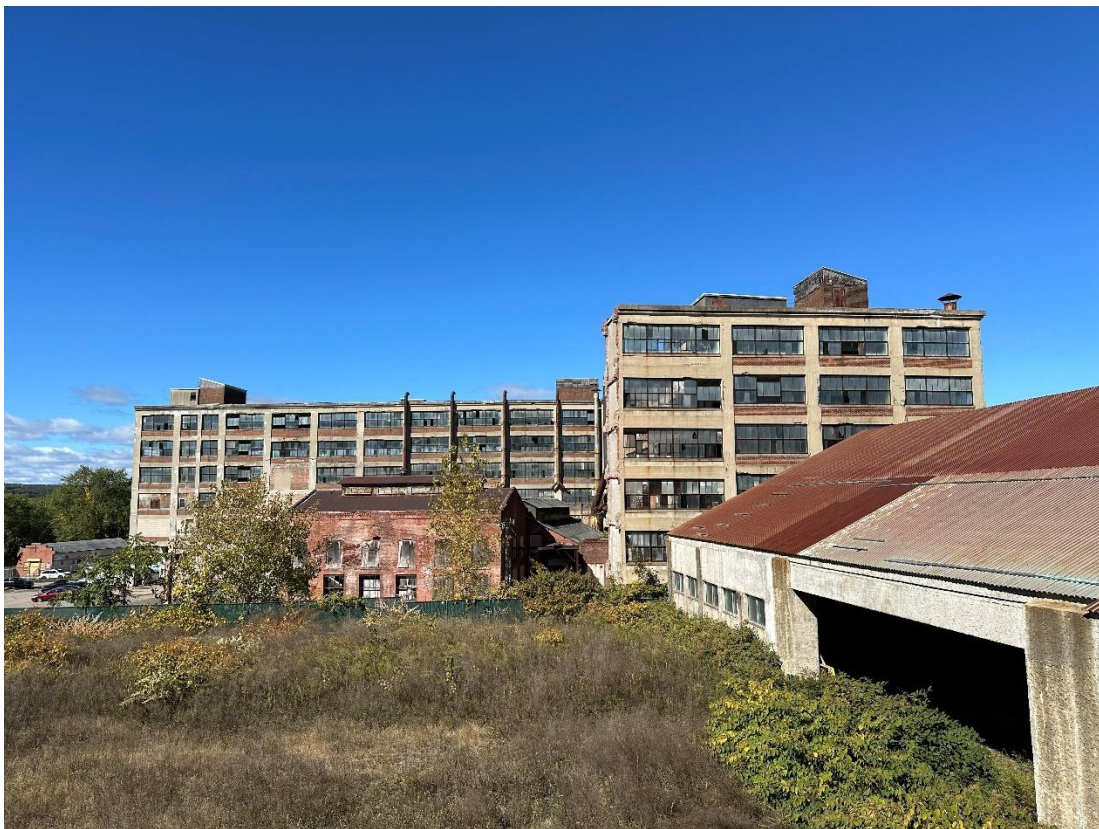
Photo 2: East elevation of the Loft Building (building 30/31/32). Photo facing west.

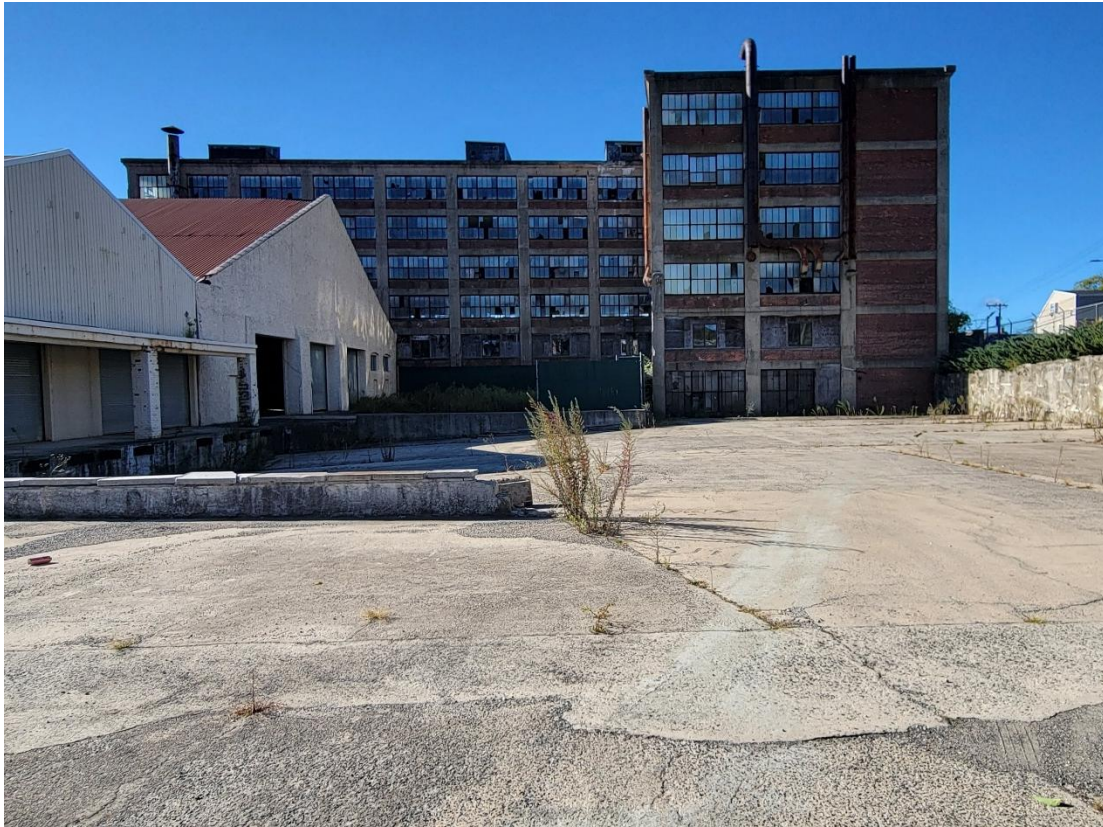
Photo 3: North elevation of the Loft Building (building 30/31/32). Photo facing south.

- Photo 3. North elevation of the Loft Building (building 30/31/32). Photo facing south.
- Photo 4. Photo showing the foundation of the Loft Building (building 0/31/32). Photo facing north.

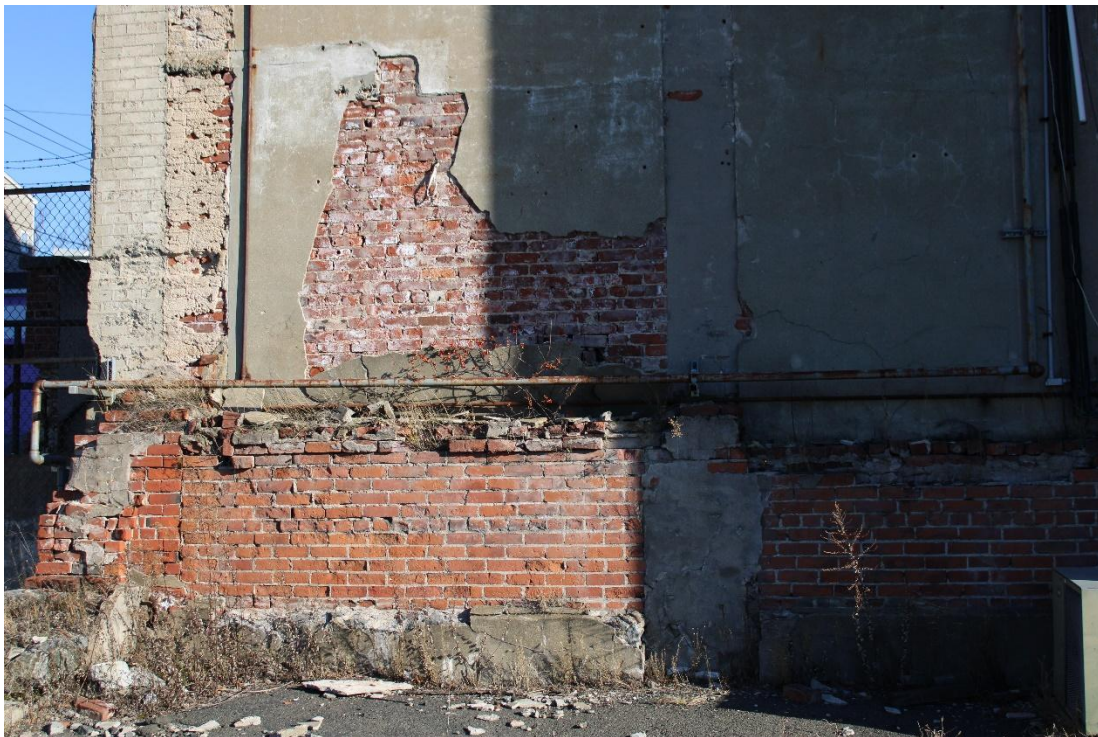
Photo 4: Photo showing the foundation of the Loft Building (building 0/31/32). Photo facing north.

The six-story, seventeen-bay, concrete loft building occupies a T-shaped footprint, sits on a rubble stone and brick foundation, and terminates in a flat roof (photo 4). The main block of the building, running along North Main Street and encompassing buildings 31 and 32, bends slightly to match

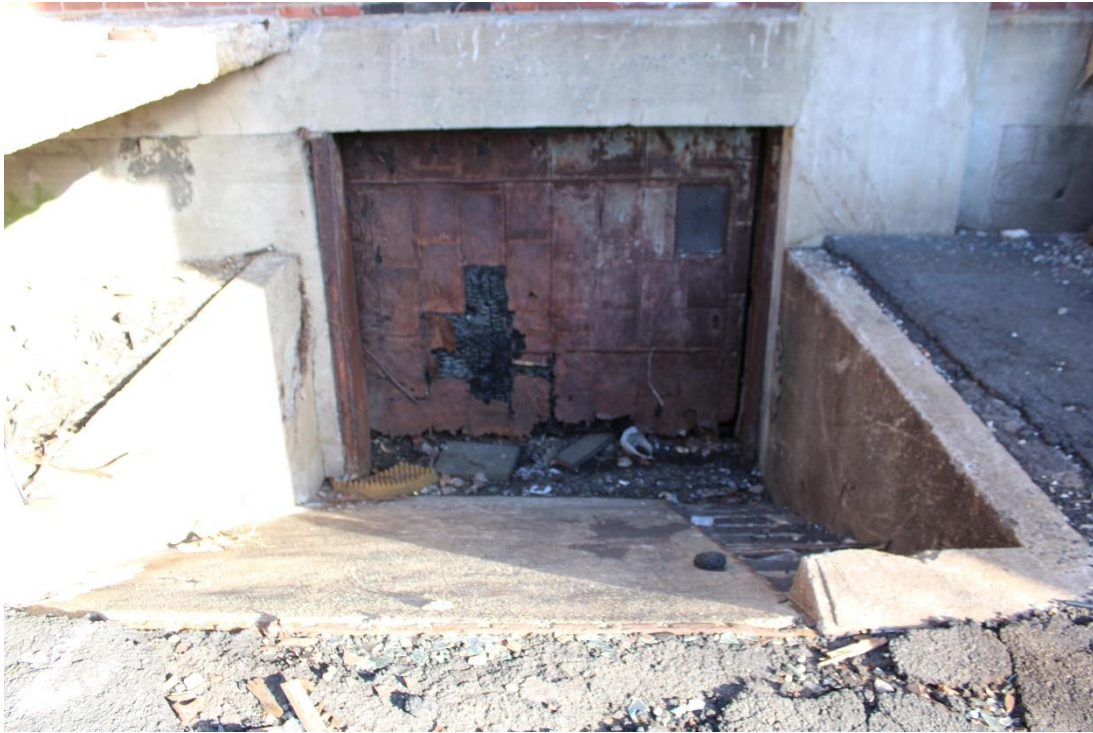
Photo 5: Entrance along the south elevation of the Loft Building (building 30/31/32). Photo facing north.

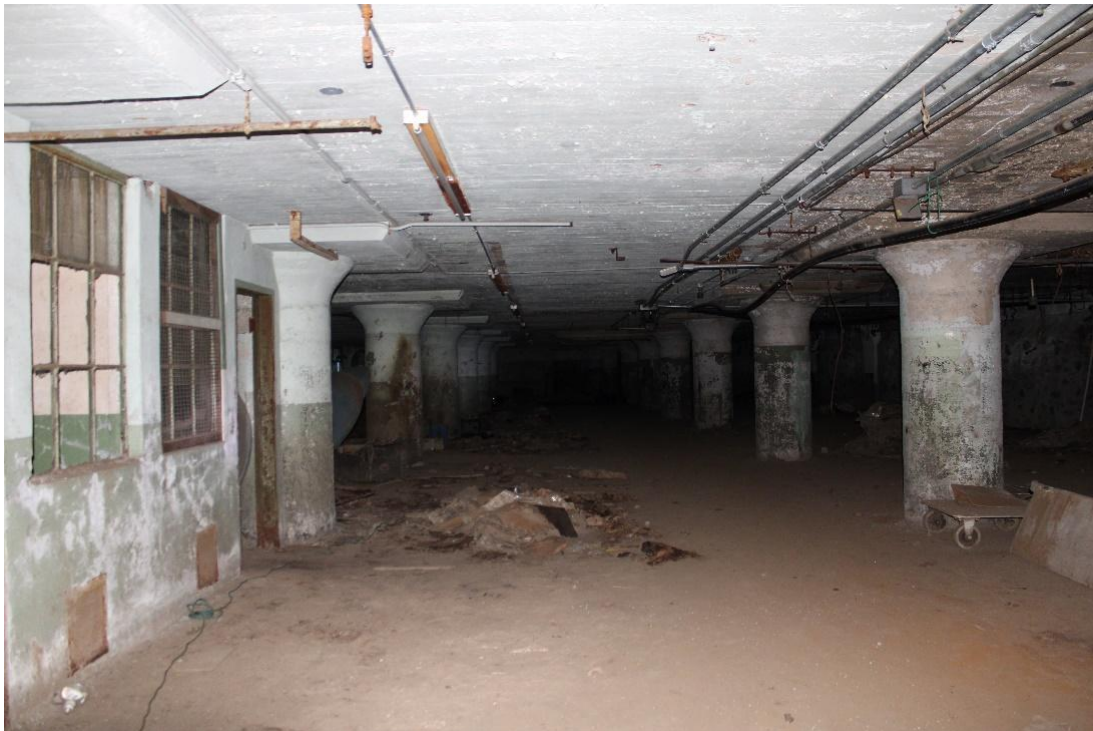
Photo 6: Interior of the Loft Building (building 30/31/32). Photo showing the basement level.

The interior of the building generally comprises large areas of vast, open space with rows of concrete Turner columns running the length of the building (photos 6-8). The cylindrical Turner columns have flared plain capitals and a square connecting plate at the ceiling. The columns along the exterior walls of the building are rectangular with a curved ceiling connection; Turner columns are also present on this floor. The basement has a parged fieldstone foundation that runs the width of the windows; fieldstone is separated by concrete piers that fill the space between the windows (Photo 9). A dirt floor is present. The basement is accessible via a wooden stairwell and a horizontal opening freight elevator. A room is separated from the main space of the basement by a partition wall and doors; it is unknown what the room is used for. The interior walls vary throughout each floor, and include concrete block, brick, and gypsum wallboard. The ceilings are board-formed concrete, and the floor is finished concrete. The building has an interior freight

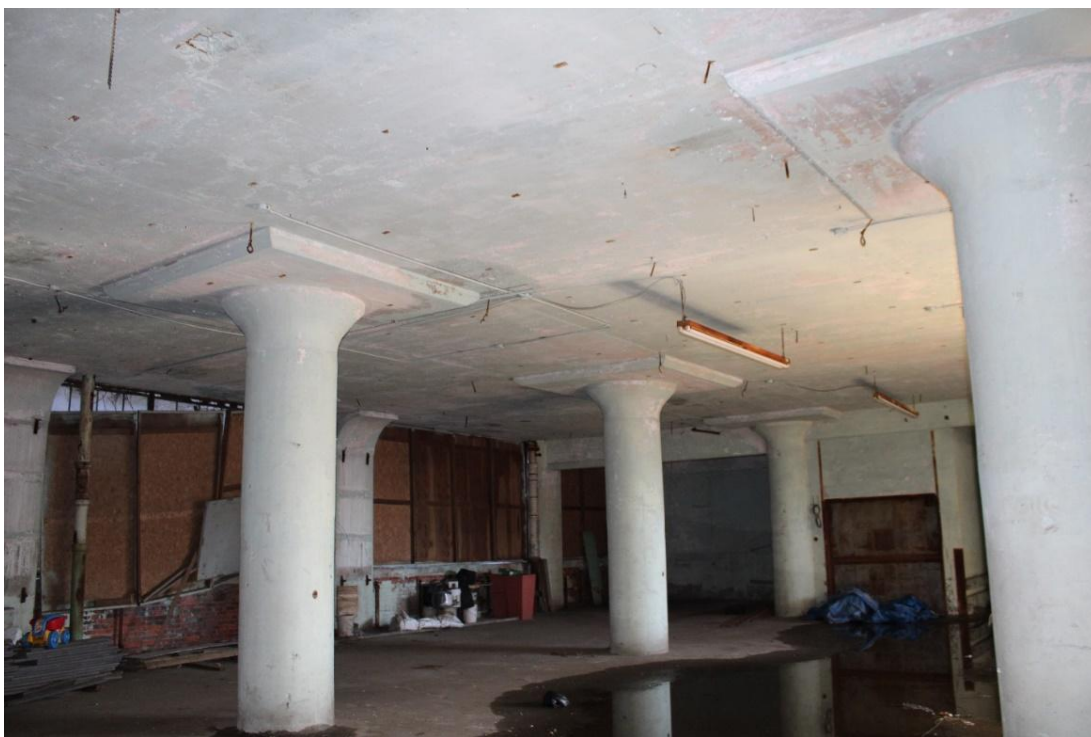
Photo 7: Interior of the Loft Building (building 30/31/32). Photo showing the interior of the first floor.

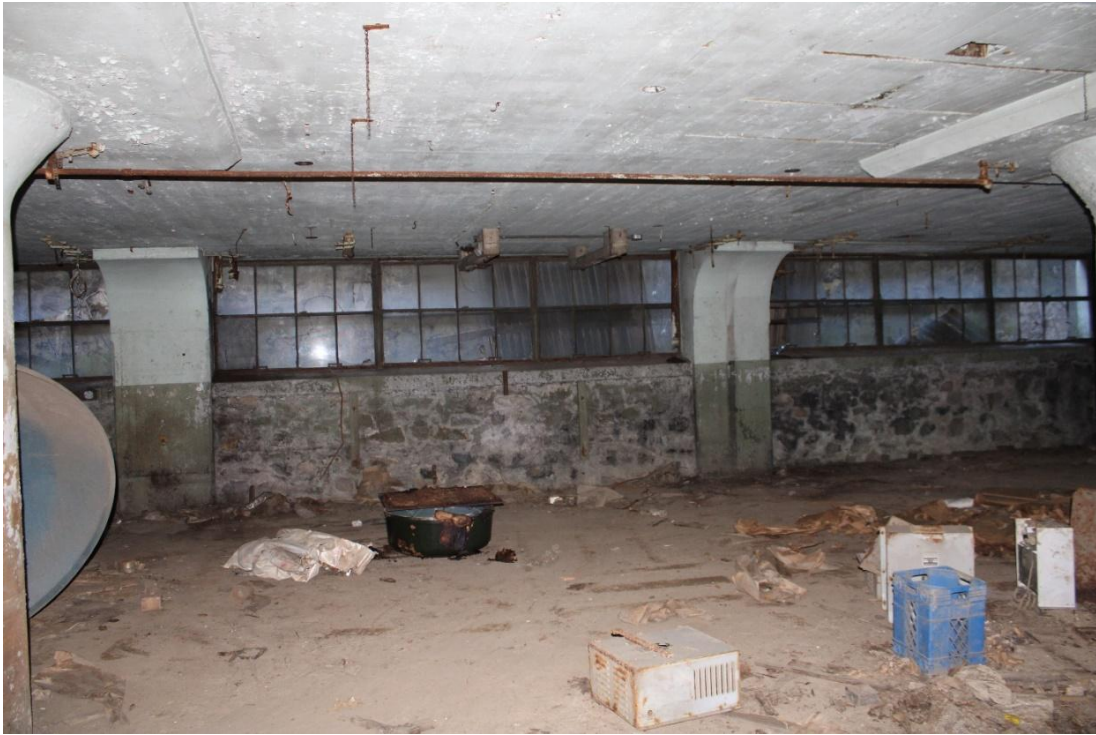
Photo 9: Interior of the Loft Building (building 30/31/32). Photo showing the basement level and foundation.

- Photo 9. Interior of the Loft Building (building 30/31/32). Photo showing the basement level and foundation.

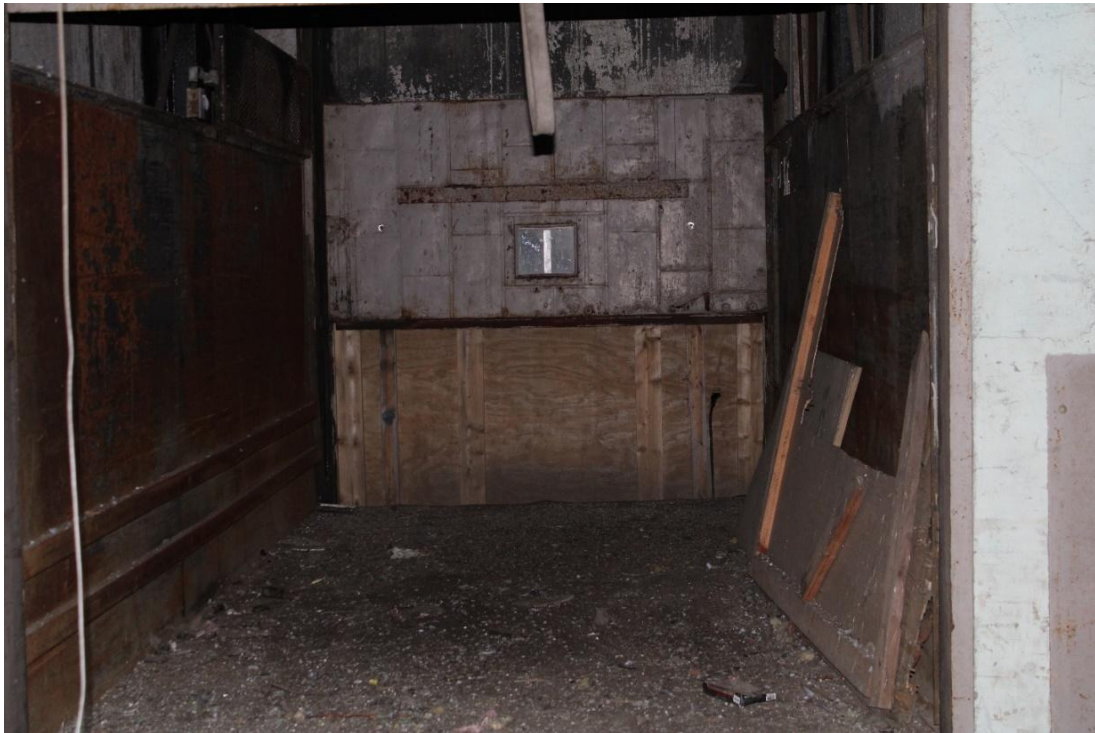
Photo 10: Interior of the Loft Building (building 30/1/32). Photo showing the Interior freight elevator.

- Photo 10. Interior of the Loft Building (building 30/1/32). Photo showing the Interior freight elevator.
- Photo 11. Interior of the Loft Building (building 30/31/32). Photo showing the first floor of the connecting building between the Loft building and the boiler house building 5/6).

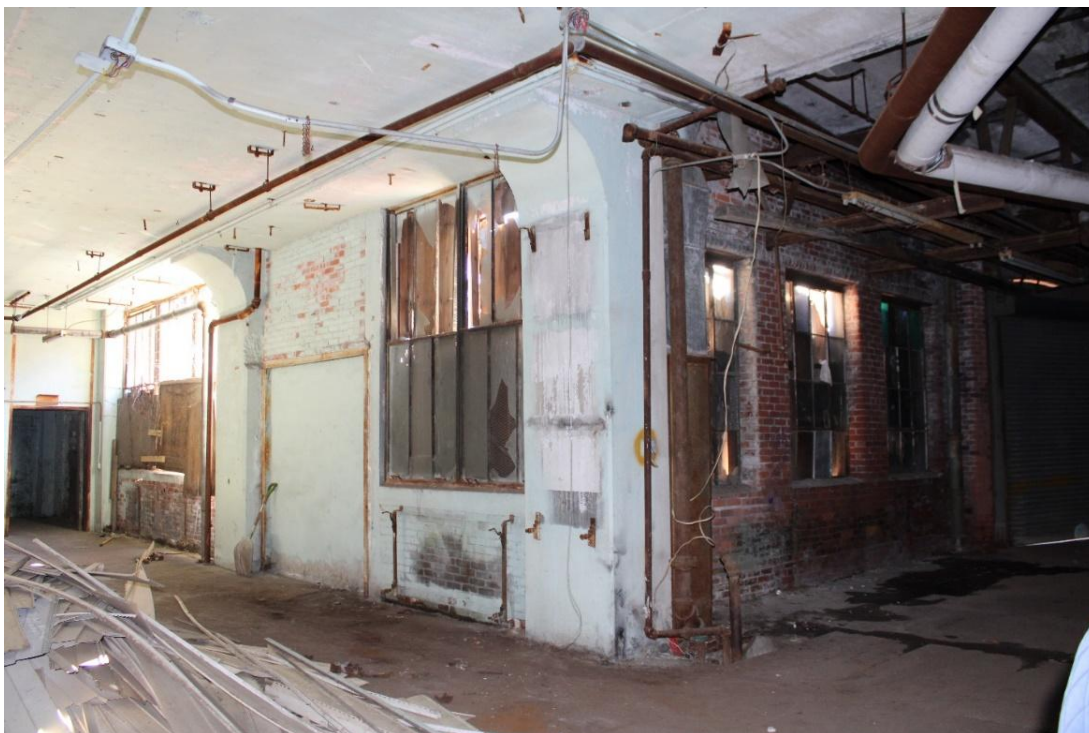
Photo 11: Interior of the Loft Building (building 30/31/32). Photo showing the first floor of the connecting building between the Loft building and the boiler house building 5/6).

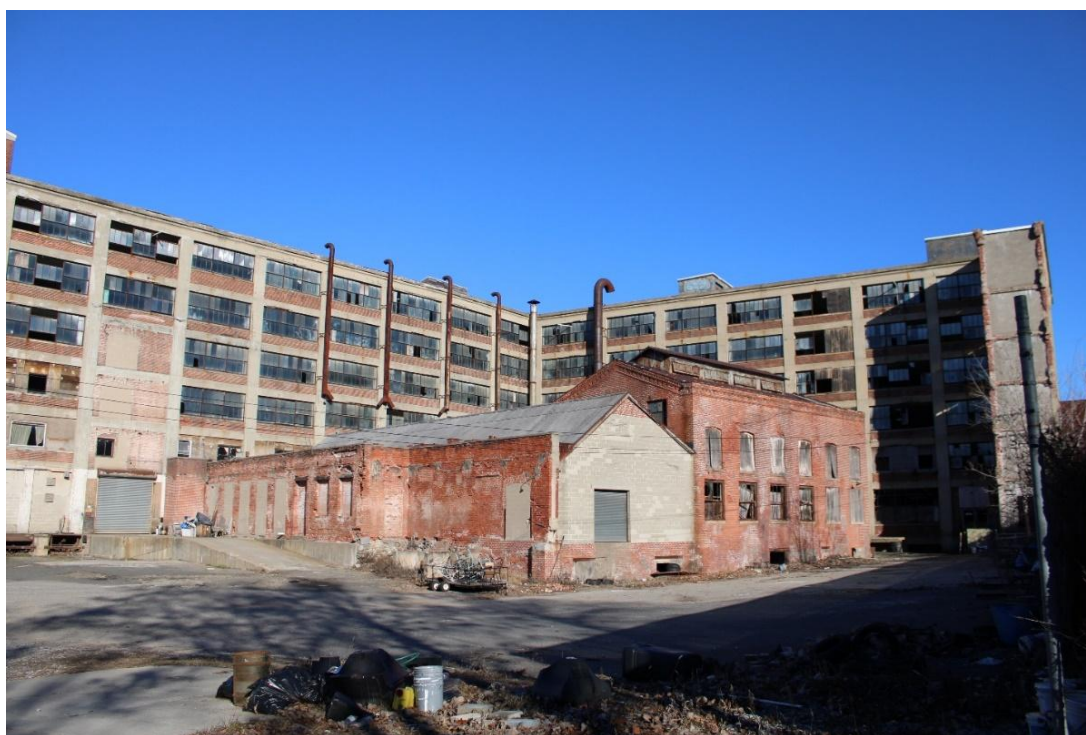
Photo 12: South and east elevations of the original boiler house (building 5/6). Photo facing northwest.

- Photo 12. South and east elevations of the original boiler house (building 5/6). Photo facing northwest.
- Photo 13. South elevation of the original boiler house (building 5/6). Photo facing north.

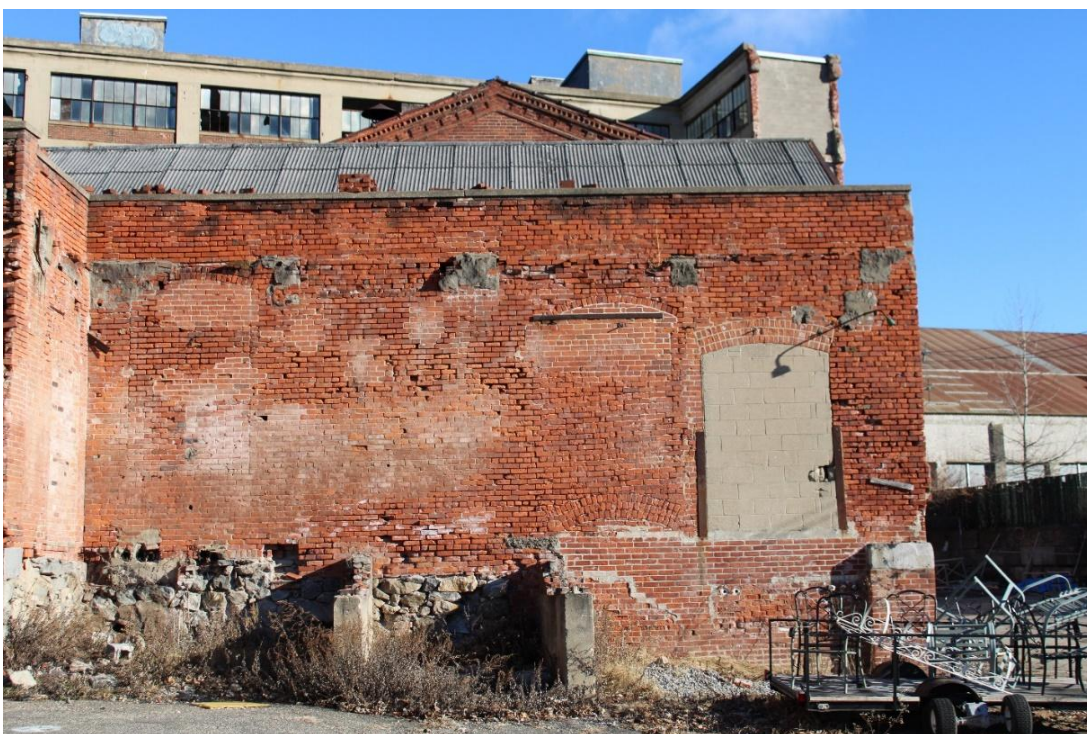
Photo 14: South elevation of the original boiler house (building 5/6). Photo facing north.

- Photo 14. South elevation of the original boiler house (building 5/6). Photo facing north.
- Photo 15. East elevation of the original boiler house (building 5/6). Photo facing northwest.

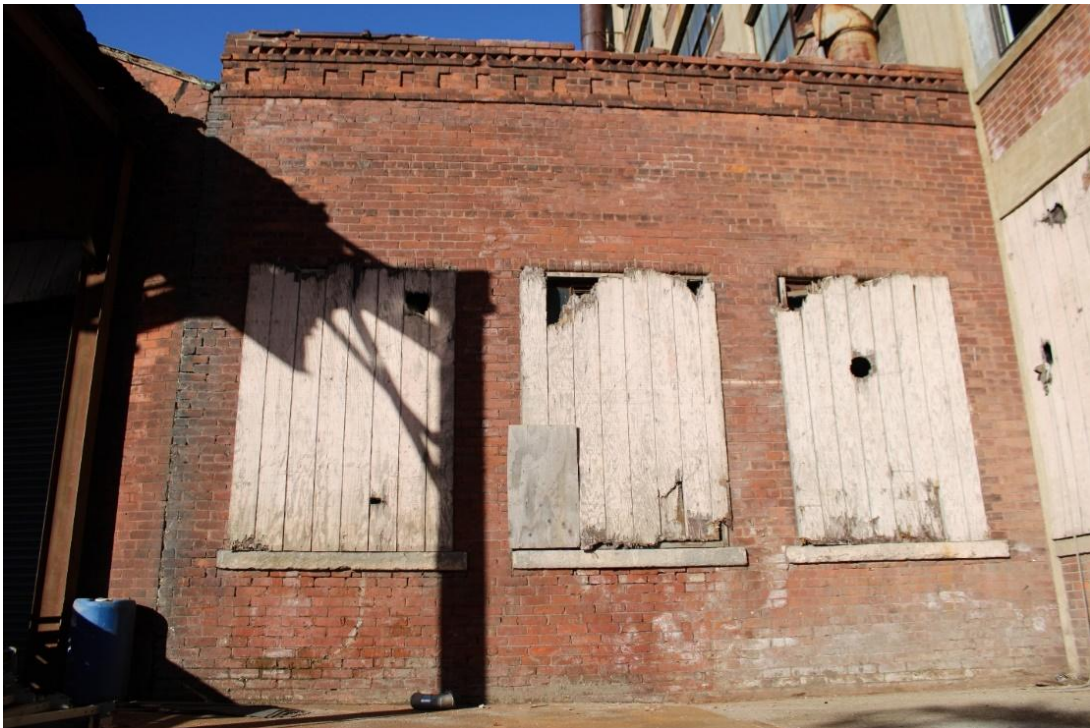
Photo 16: East elevation of the connecting building between the Loft Building (building 30/31/32) and the original boiler house (building 5/6). Photo facing west.

- Photo 16. East elevation of the connecting building between the Loft Building (building 30/31/32) and the original boiler house (building 5/6). Photo facing west.

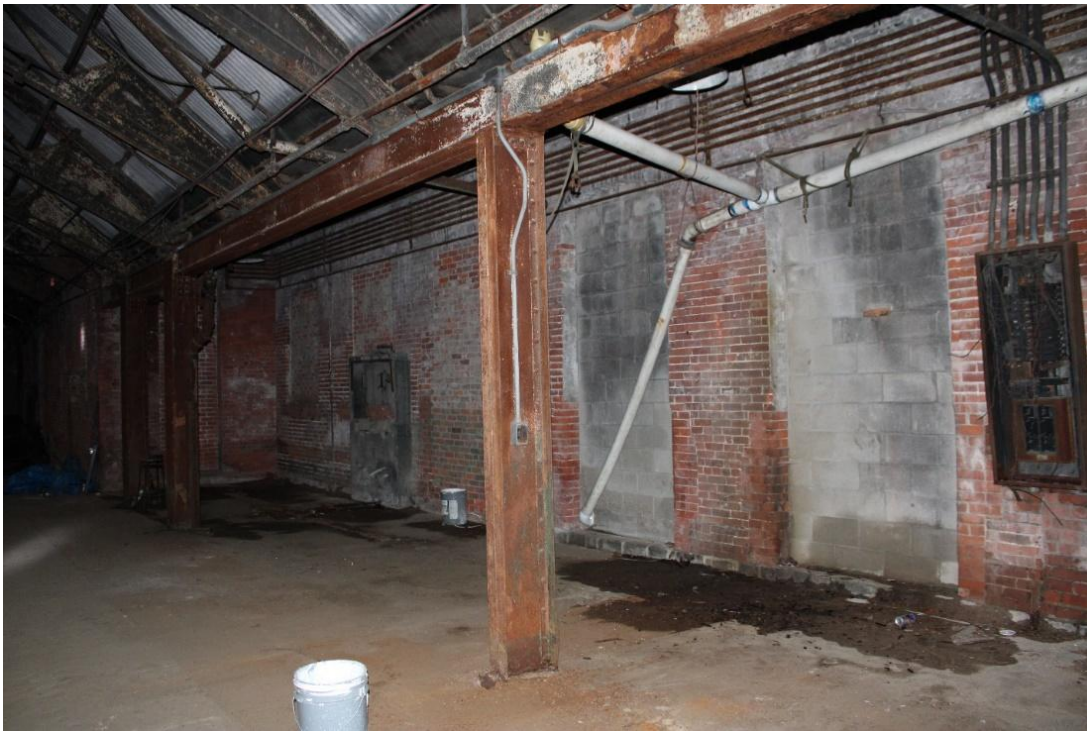
Photo 17: Interior of the original boiler house (building 5/6).

- Photo 17. Interior of the original boiler house (building 5/6).
- Photo 18. Interior of the original boiler house (building 5/6) showing the south elevation. Photo facing north.

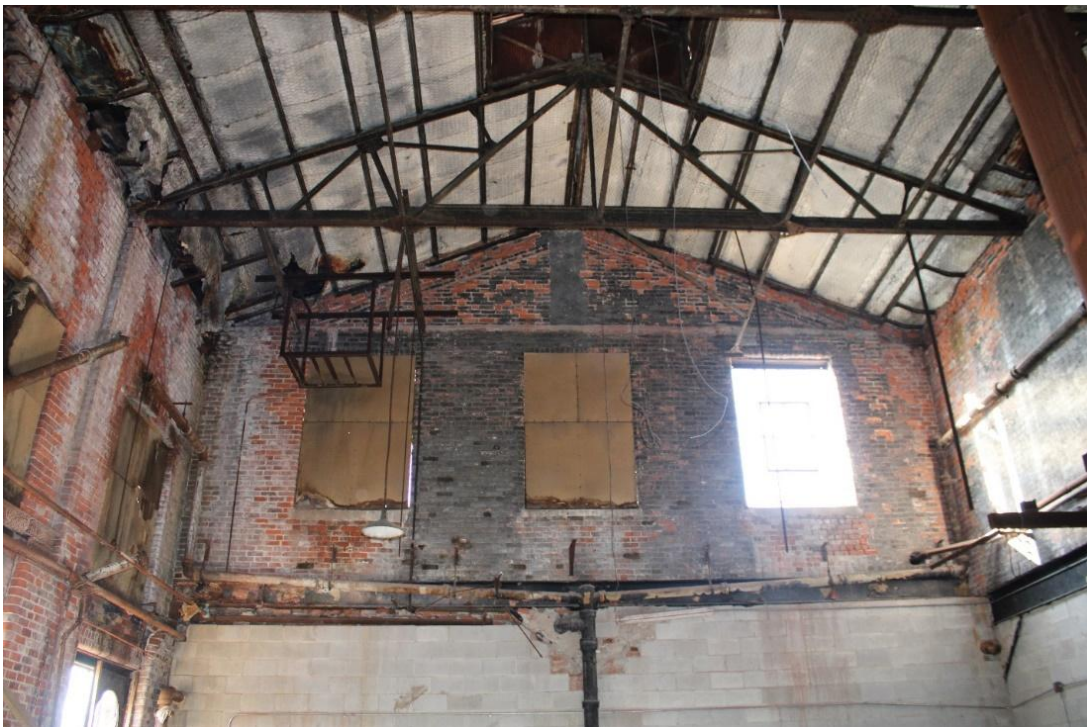
Photo 18: Interior of the original boiler house (building 5/6) showing the south elevation. Photo facing north.

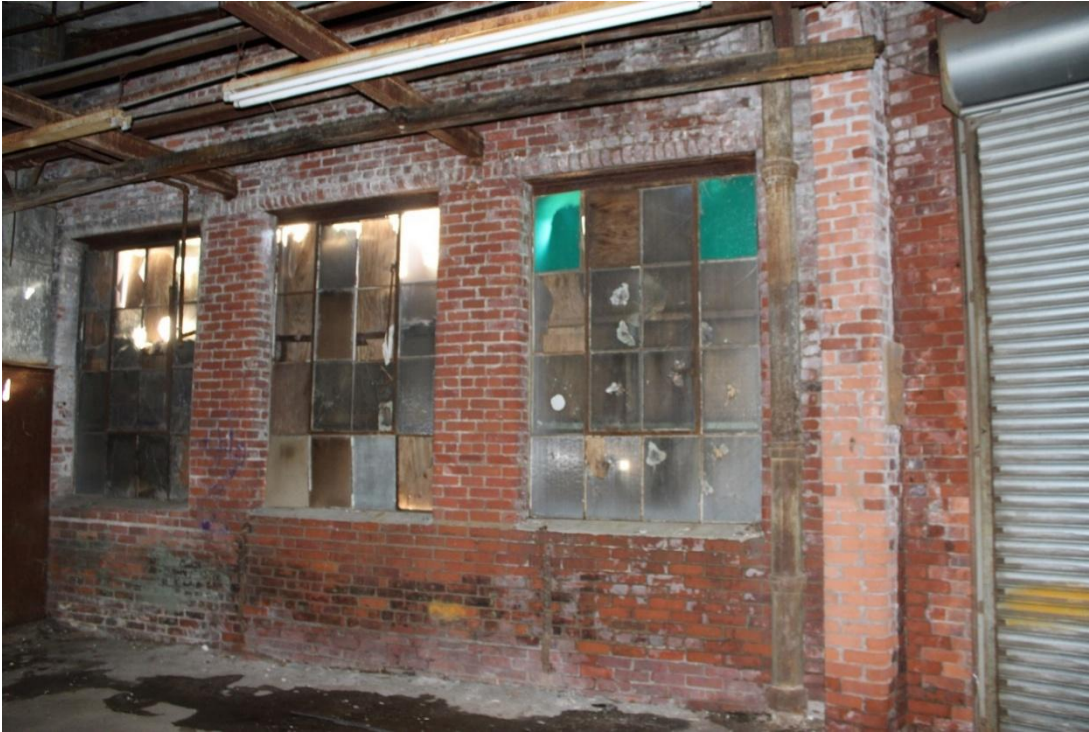
Photo 19: Interior of the connecting building between the Loft Building (building 30/31/32) and the original boiler house (building 5/6).

- Photo 19. Interior of the connecting building between the Loft Building (building 30/31/32) and the original boiler house (building 5/6).
- Photo 20. West elevation of the Rolling Mill (building 34/223). Photo facing east.

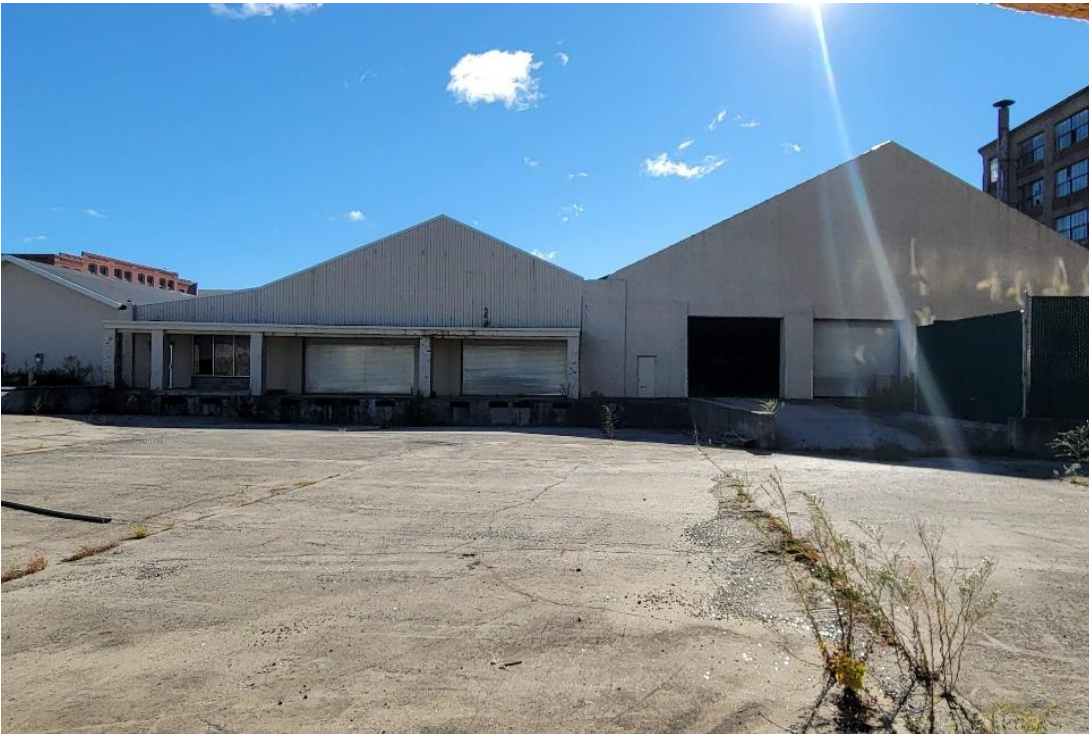
Photo 20: West elevation of the Rolling Mill (building 34/223). Photo facing east.

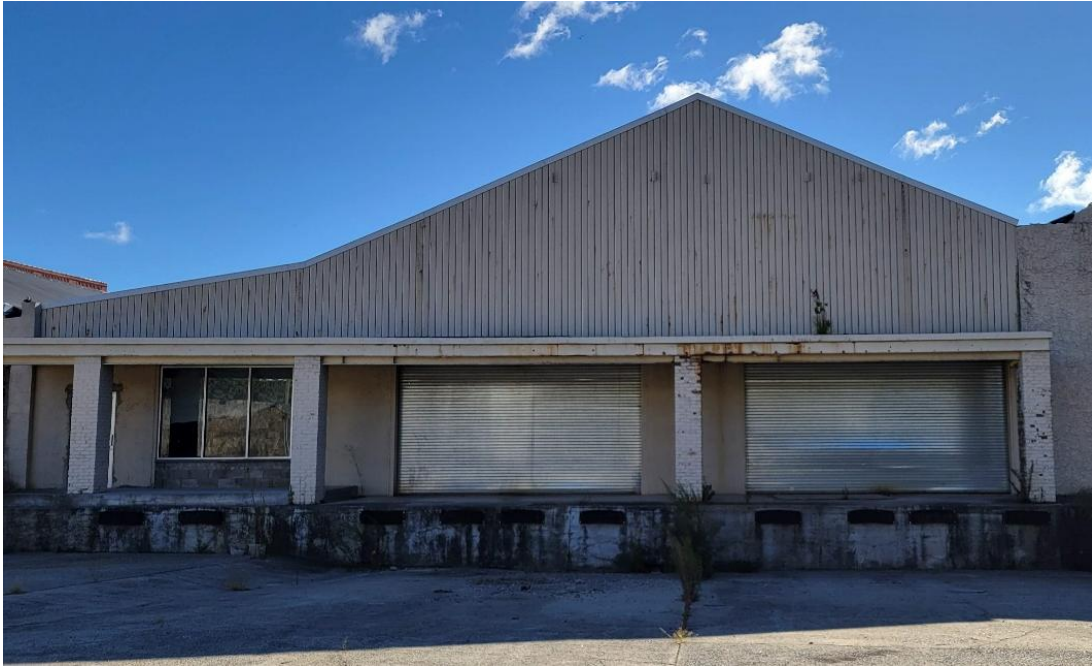
Photo 21: Photo showing entrances on the west elevation of the Rolling Mill (building 34/223). Photo facing east.

- Photo 21. Photo showing entrances on the west elevation of the Rolling Mill (building 34/223). Photo facing east.
- Photo 22. Detail of the west elevation of the Rolling Mill (building 34/223). Photo facing east.

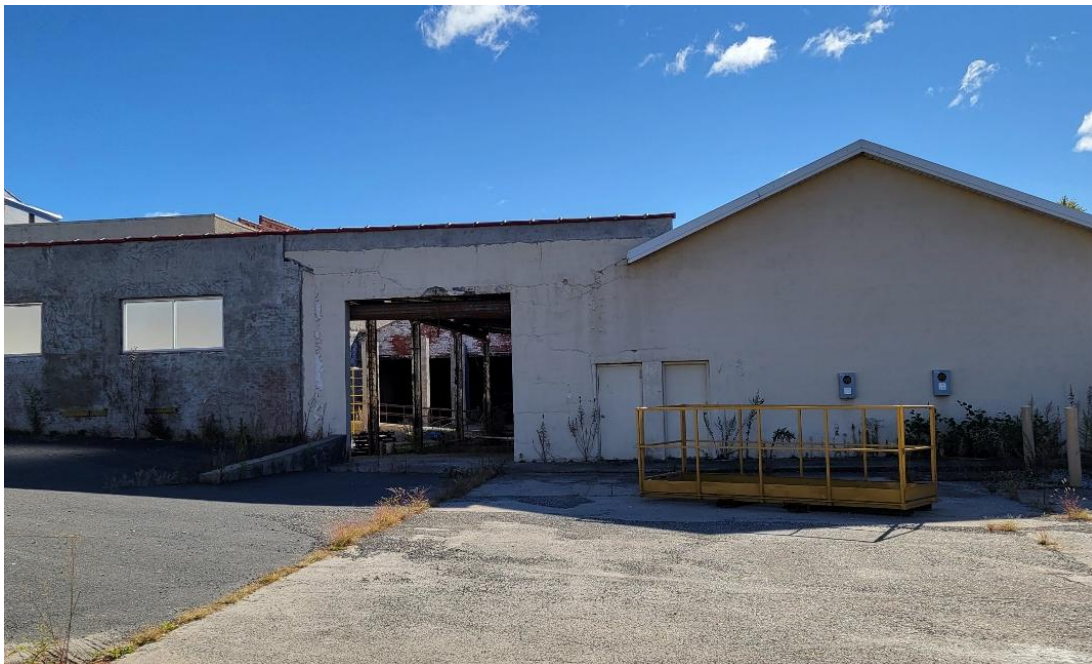
Photo 22: Detail of the west elevation of the Rolling Mill (building 34/223). Photo facing east.

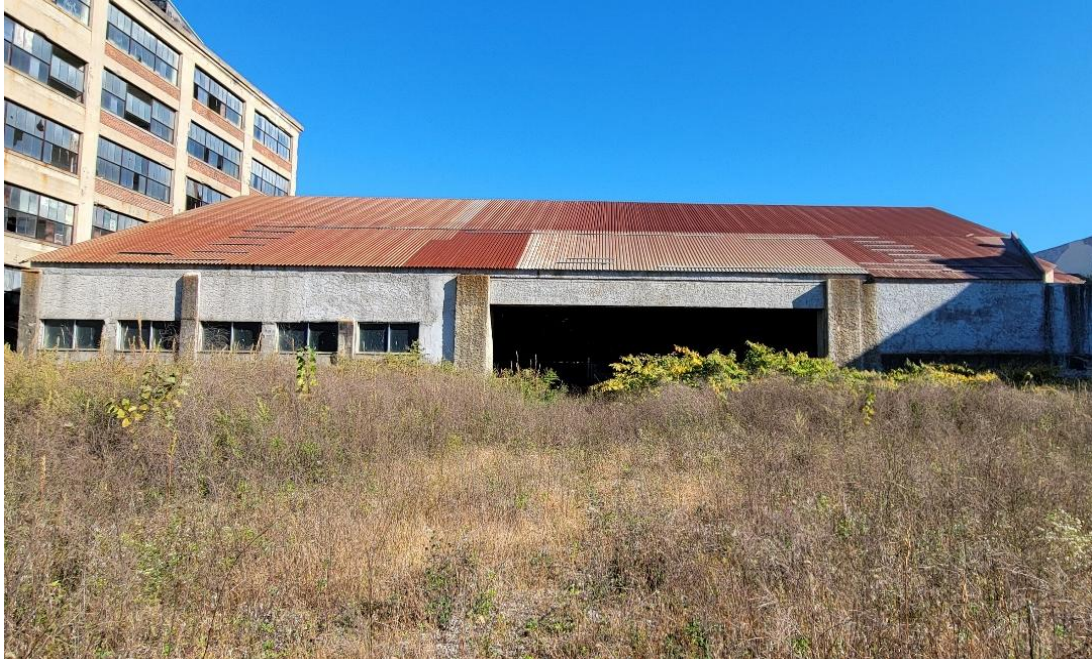
Photo 23: South elevation of the Rolling Mill (building 34/223). Photo facing north.

- Photo 23. South elevation of the Rolling Mill (building 34/223). Photo facing north.
- Photo 24. North elevation of the Rolling Mill (building 34/223). Photo facing south.

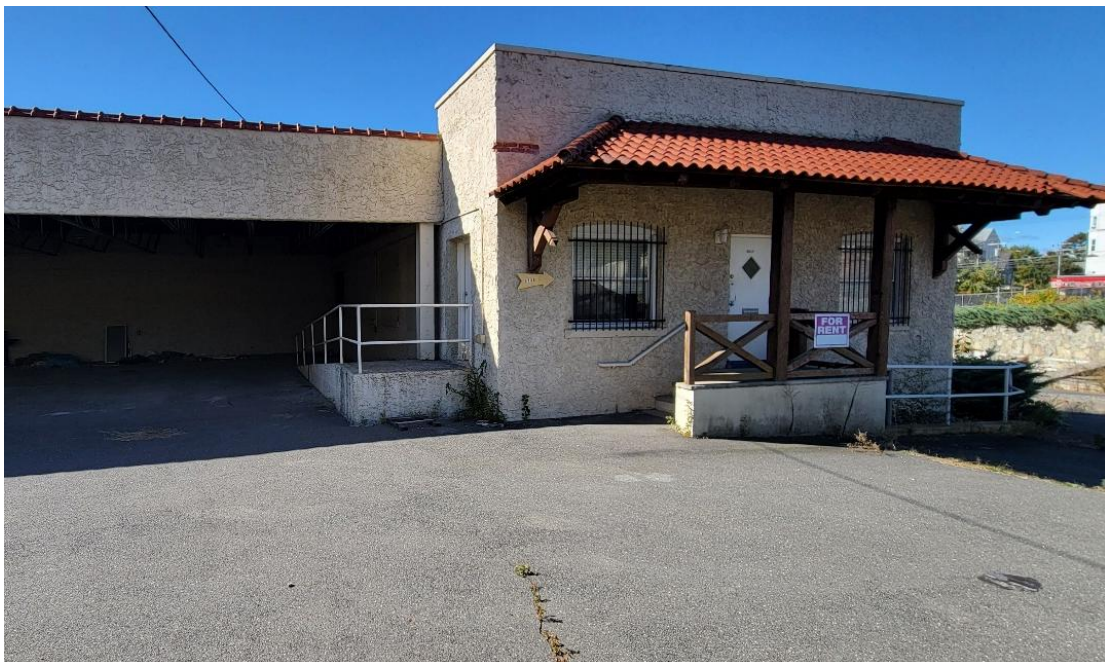
Photo 24: North elevation of the Rolling Mill (building 34/223). Photo facing south.

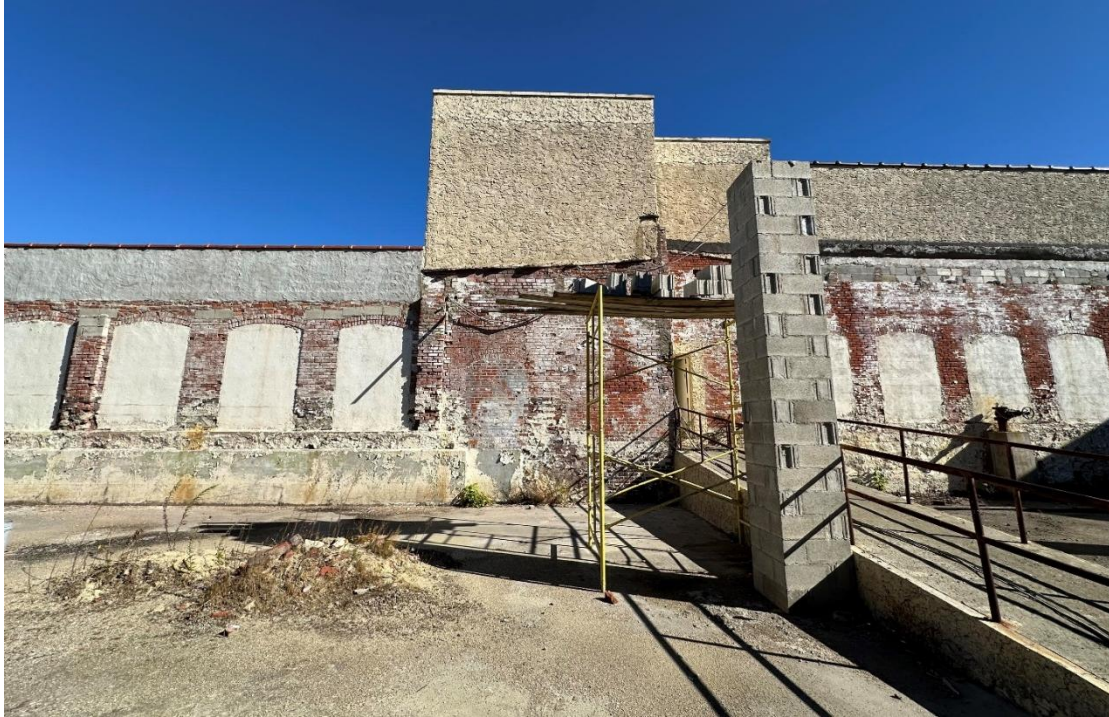
Photo 25: North elevation of the Rolling Mill (building 34/223). Photo facing south.

- Photo 25. North elevation of the Rolling Mill (building 34/223). Photo facing south.
- Photo 26. North and east elevations of the Rolling Mill (building 34/223). Photo facing southwest.
