United States Department of the Interior
National Park Service**National Register of Historic Places Registration Form**

1. Name of PropertyHistoric name: Chase Brass and Copper Company Rolling Mill (No. 1) Historic DistrictOther names/site number: Waterbury Manufacturing Company; Chase Metal Works

2. LocationStreet & number: 526 and 730 North Main Street, 40 East Farm StreetCity or town: Waterbury State: Connecticut County: New HavenNot For Publication: ☐ Vicinity: ☐**3. State/Federal Agency Certification**

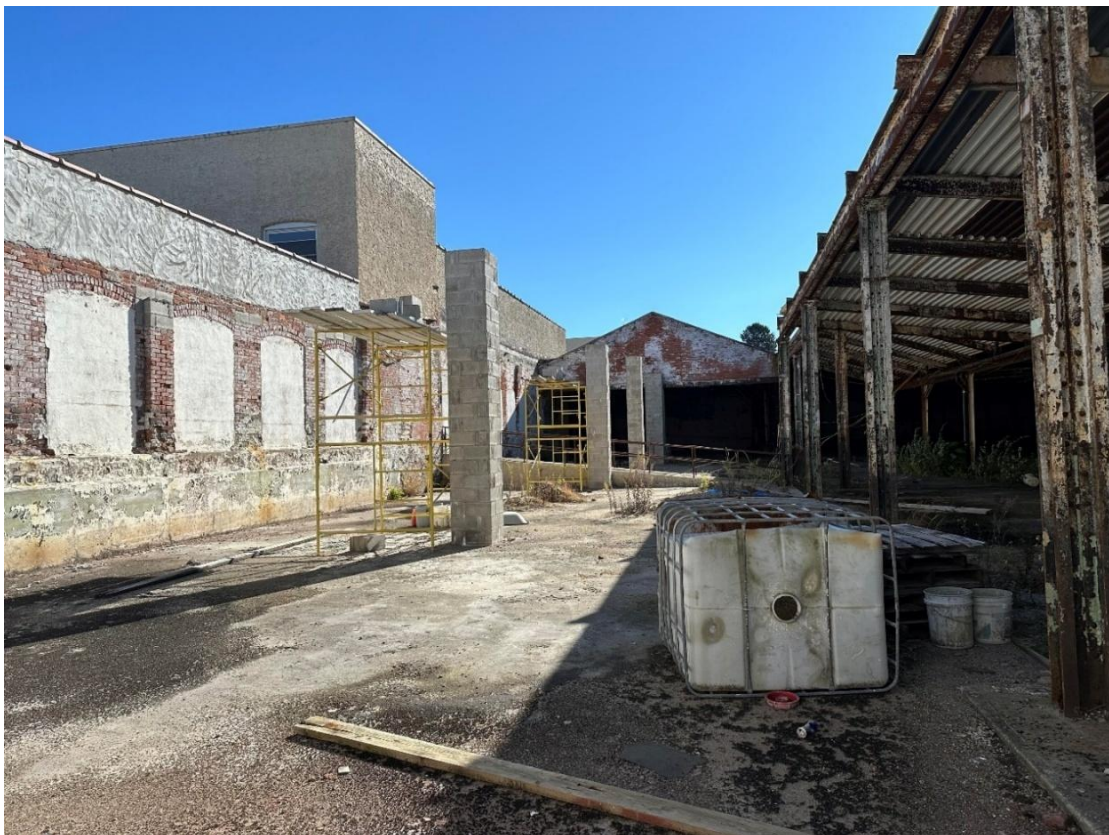
Photo 26: North and east elevations of the Rolling Mill (building 34/223). Photo facing southwest.

- Photo 25. North elevation of the Rolling Mill (building 34/223). Photo facing south.
- Photo 26. North and east elevations of the Rolling Mill (building 34/223). Photo facing southwest.

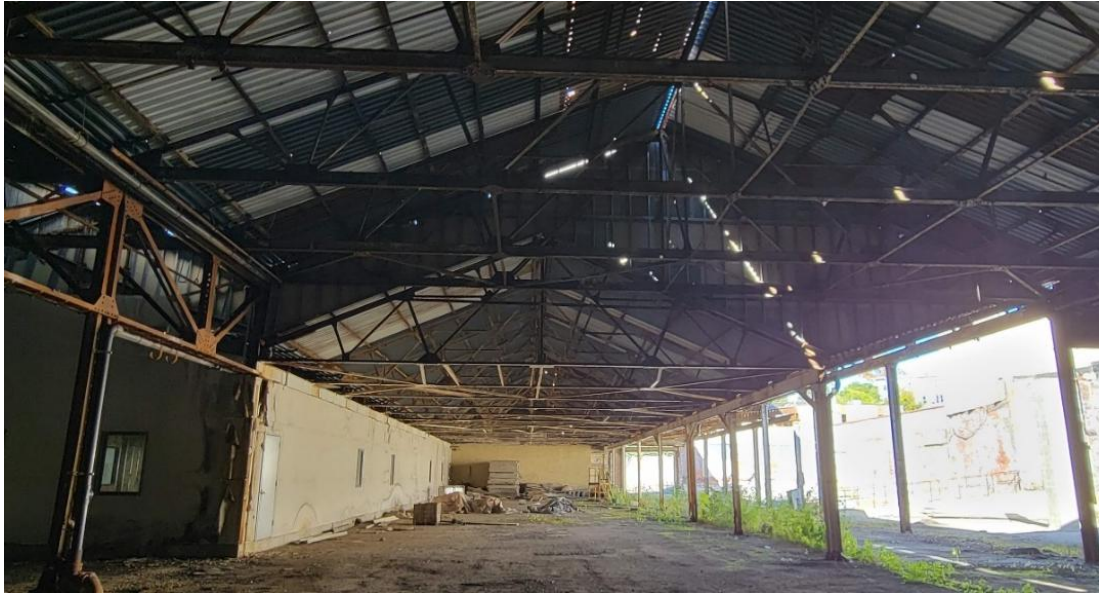
Photo 29: Interior of the Rolling Mill (building 34/223). Photo facing west.

- Photo 29. Interior of the Rolling Mill (building 34/223). Photo facing west.
- Photo 30. Interior of the Rolling Mill (building 32/223) showing west elevation. Photo facing east.

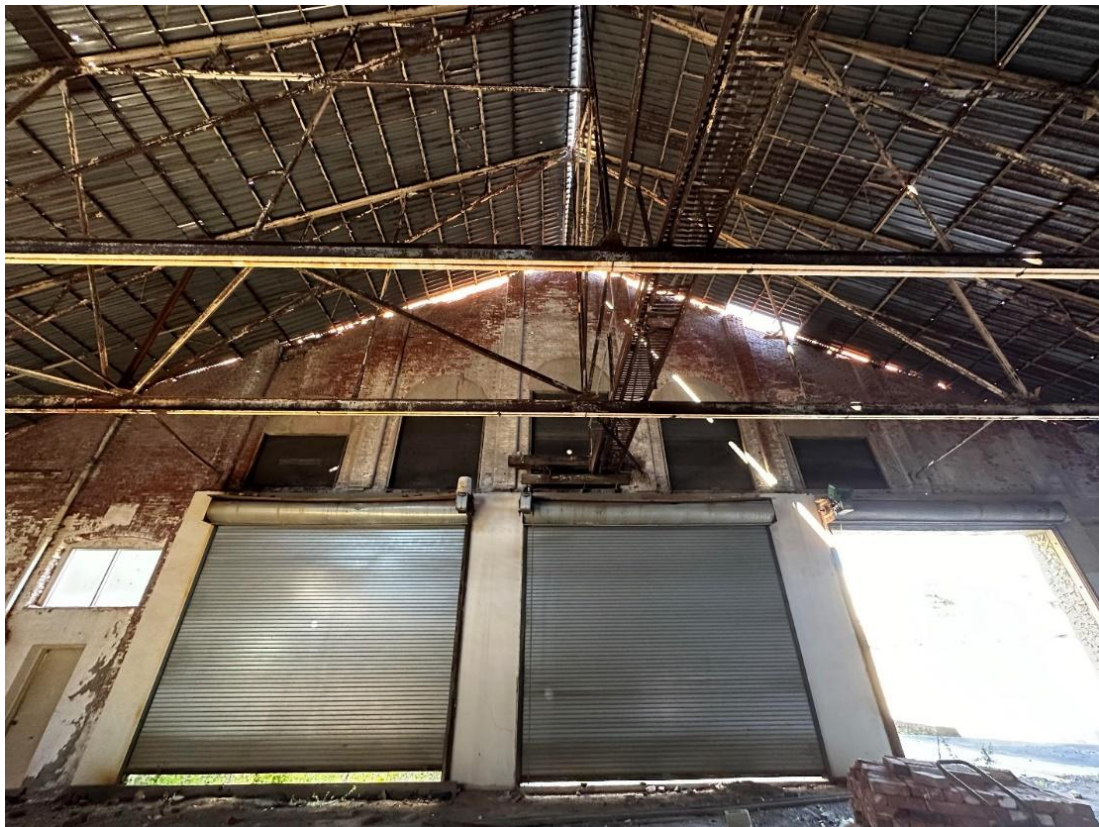
Photo 30: Interior of the Rolling Mill (building 32/223) showing west elevation. Photo facing east.

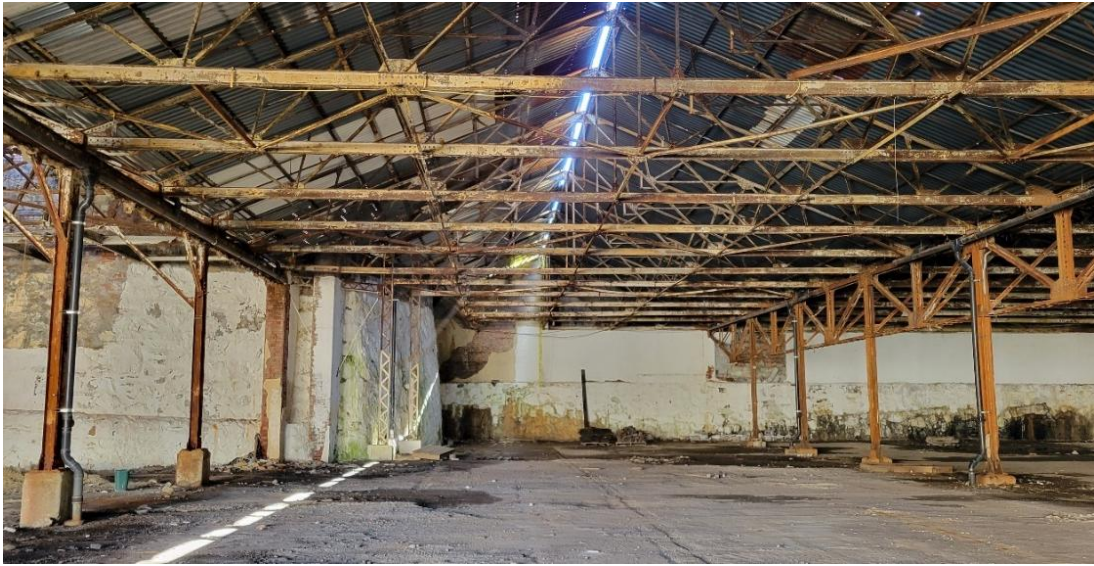
Photo 31: Interior of the Rolling Mill (building 34/223). Photo facing east.

- Photo 31. Interior of the Rolling Mill (building 34/223). Photo facing east.
- Photo 32. North elevation of the boiler house (building 237). Photo facing south.

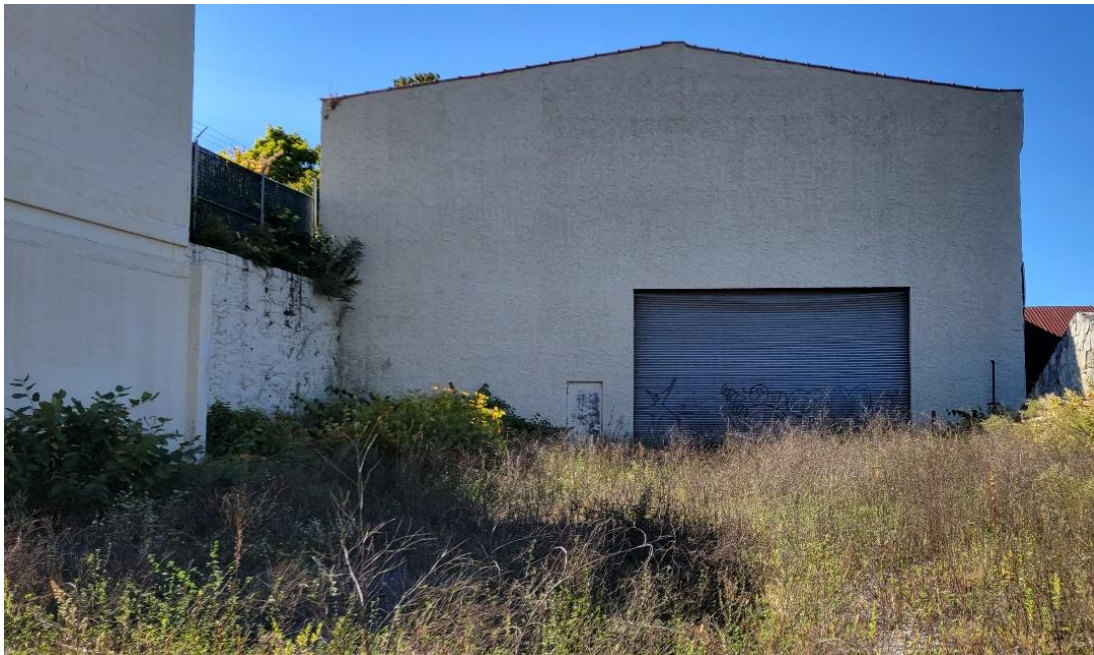
Photo 32: North elevation of the boiler house (building 237). Photo facing south.

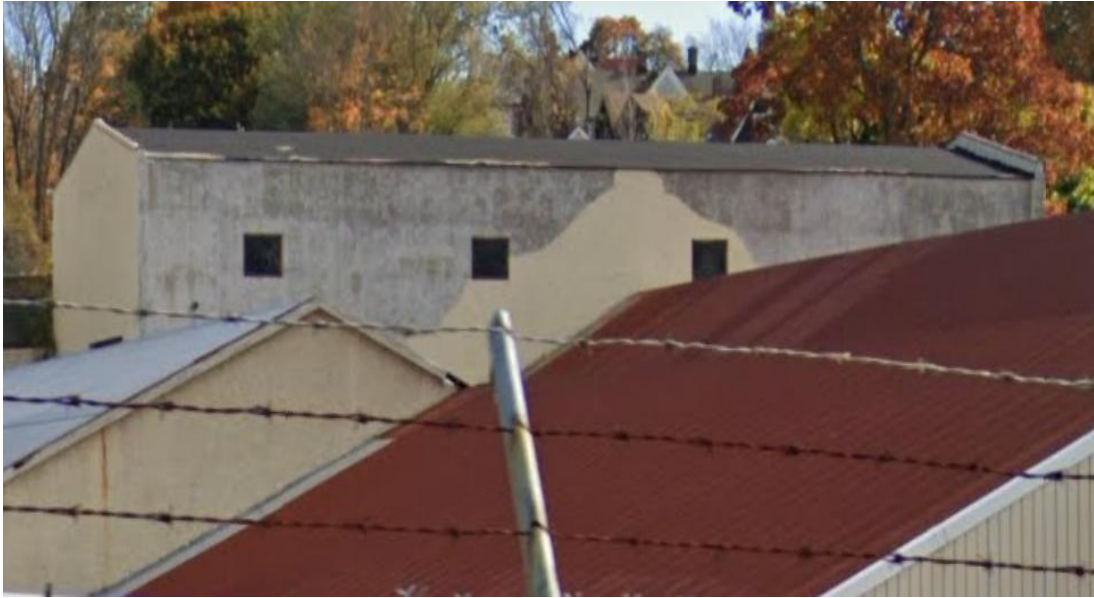
Photo 33: West elevation of the boiler house (building 237). Photo facing east.

- Photo 33. West elevation of the boiler house (building 237). Photo facing east.
- Photo 34. South and east elevations of building 239. Photo facing northwest.

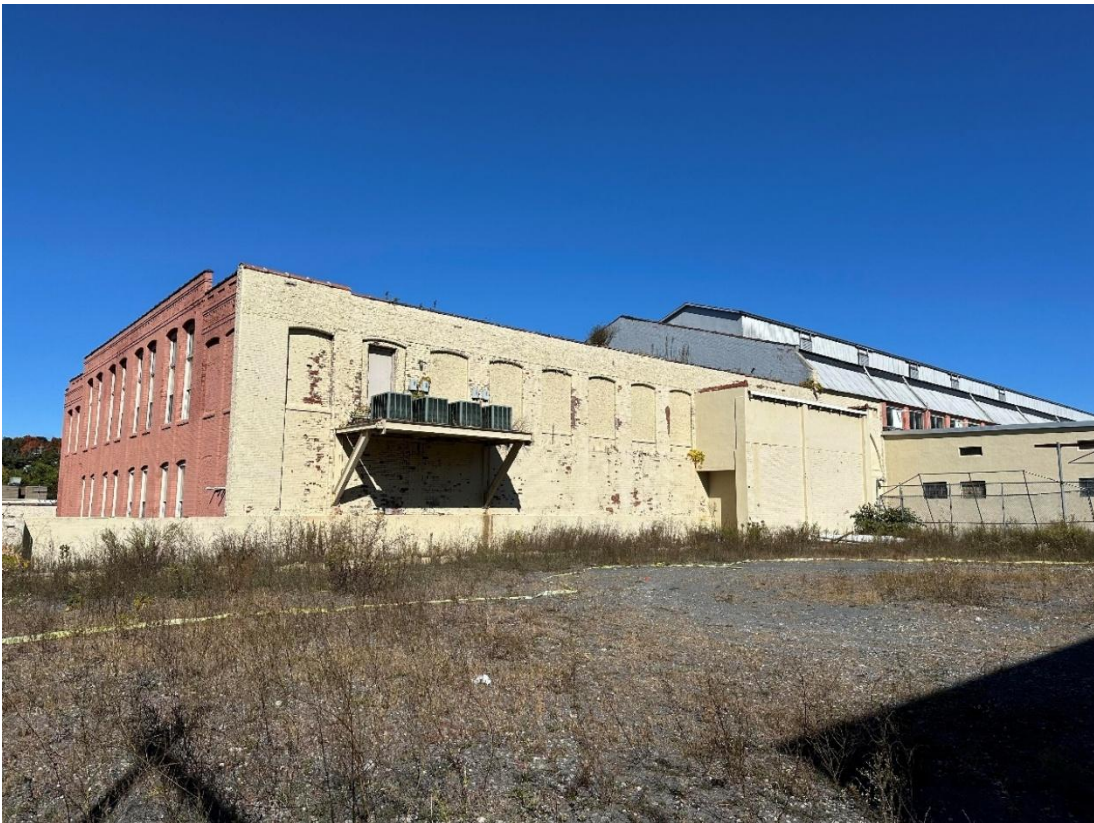
Photo 34: South and east elevations of building 239. Photo facing northwest.

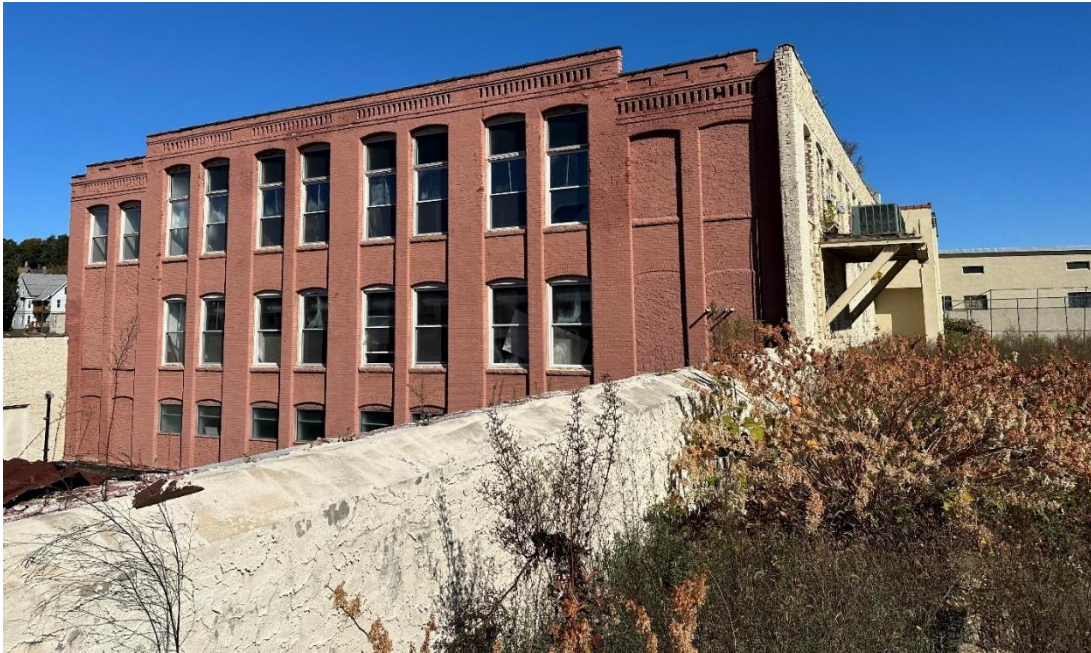
Photo 35: South elevation of building 239. Photo facing north.

- Photo 35. South elevation of building 239. Photo facing north.
- Photo 36. Photo showing brick detailing on the west elevation of 239. Photo facing west.

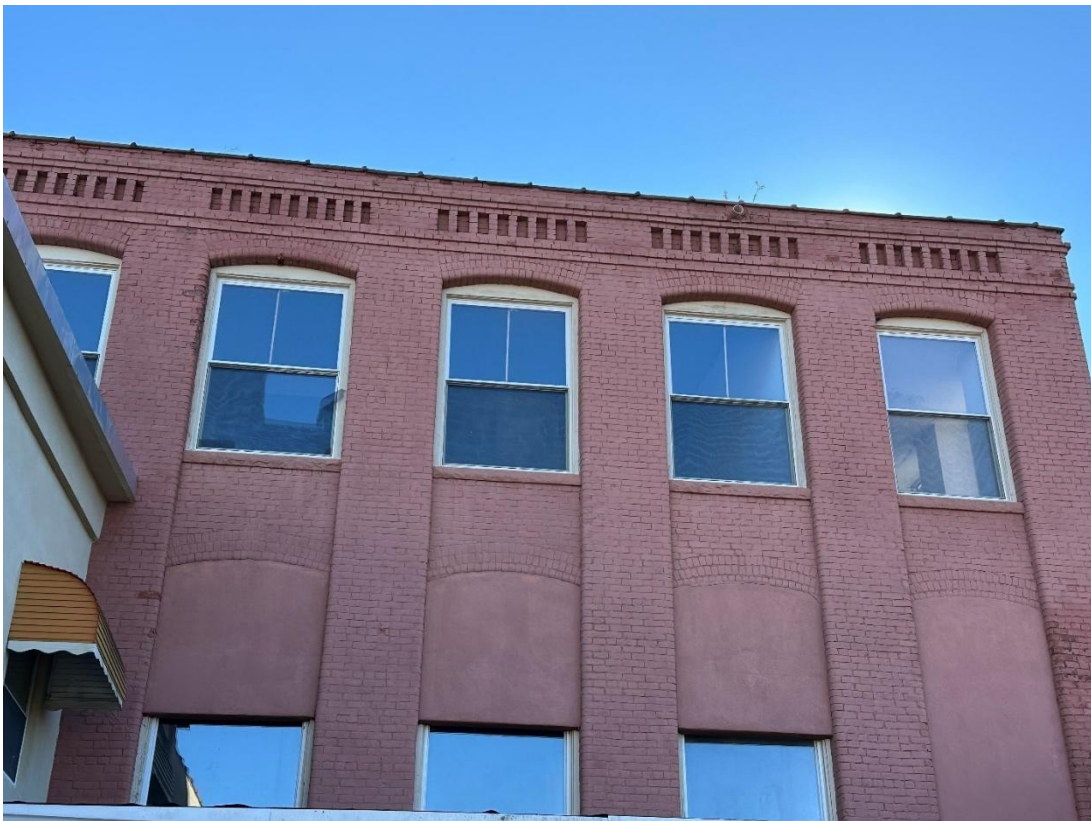
Photo 36: Photo showing brick detailing on the west elevation of 239. Photo facing west.

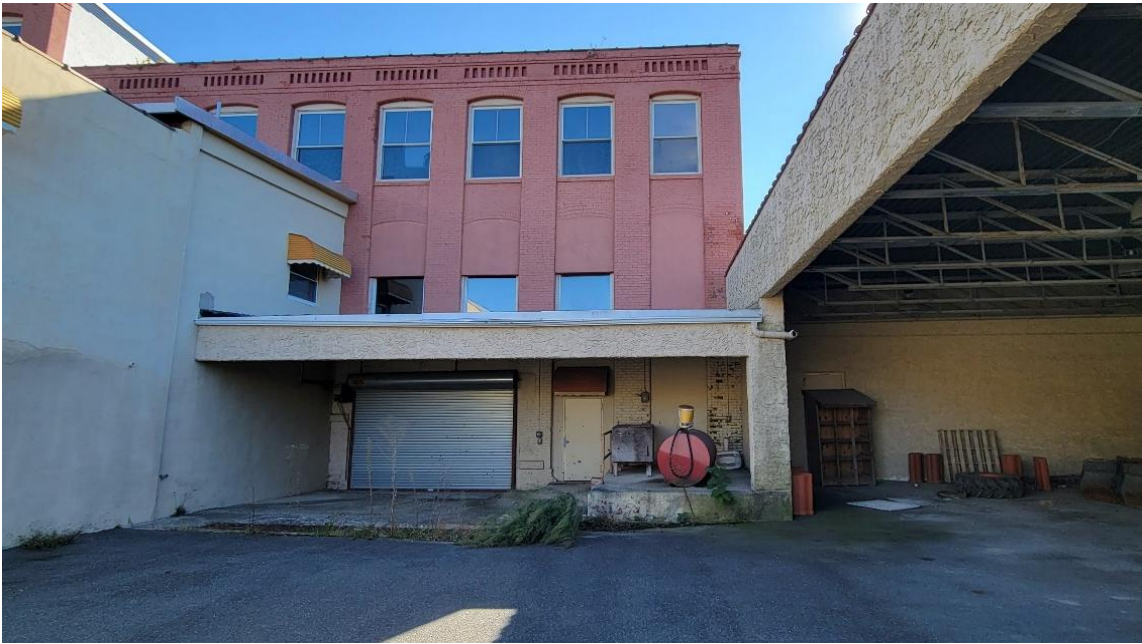
Photo 37: West elevation of building 239. Photo facing west.

- Photo 37. West elevation of building 239. Photo facing west.
- Photo 38. South elevation of connecting building between building 239 and the factory building (building 238/238A/238Ext/274/276). Photo facing north.

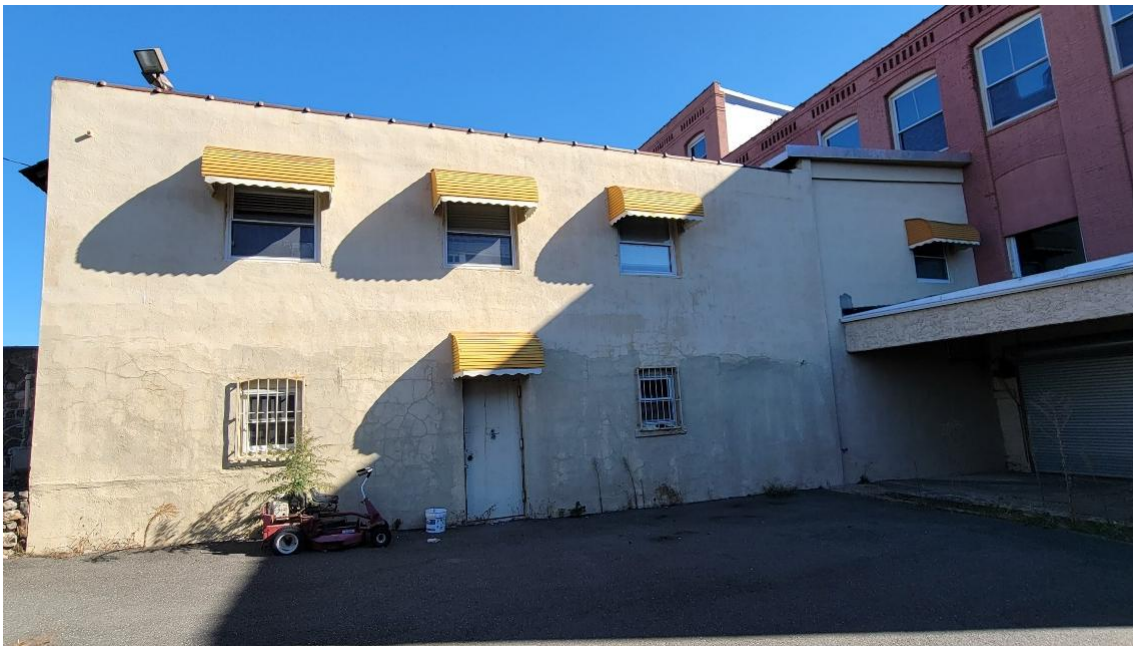
Photo 38: South elevation of connecting building between building 239 and the factory building (building 238/238A/238Ext/274/276). Photo facing north.

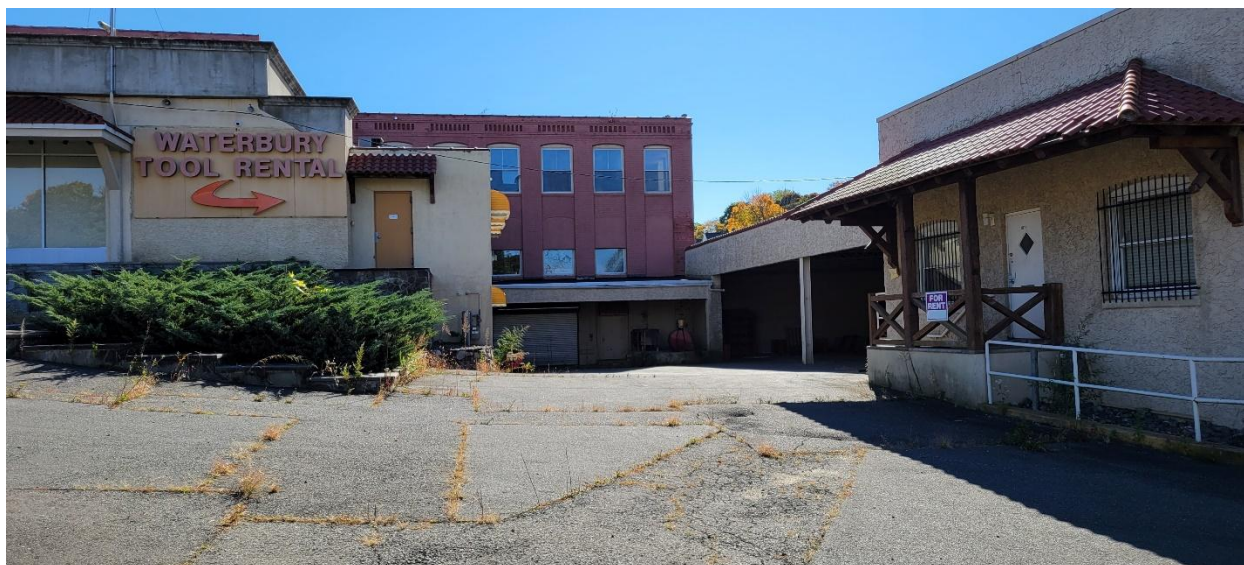
Photo 39: Photo showing connection between the Rolling Mill (left), building 239 (center), and the factory building (left). Photo facing east.

- Photo 39. Photo showing connection between the Rolling Mill (left), building 239 (center), and the factory building (left). Photo facing east.
- Photo 40. Interior photo of the ground floor of building 239.

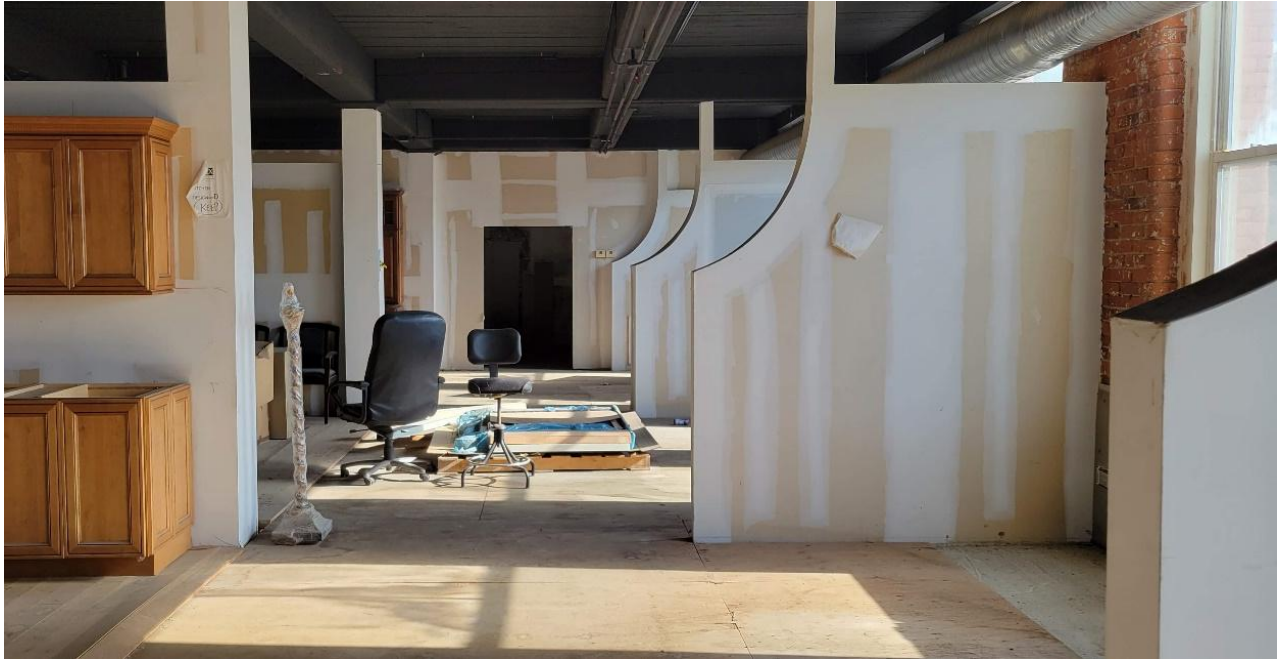
Photo 41: Interior of building 239.

- Photo 41. Interior of building 239.
- Photo 42. Interior of building 239. Photo facing west.
- Photo 43. North elevation of the Factory building (building 238/238A/238Ext/274/276). Photo facing southwest.

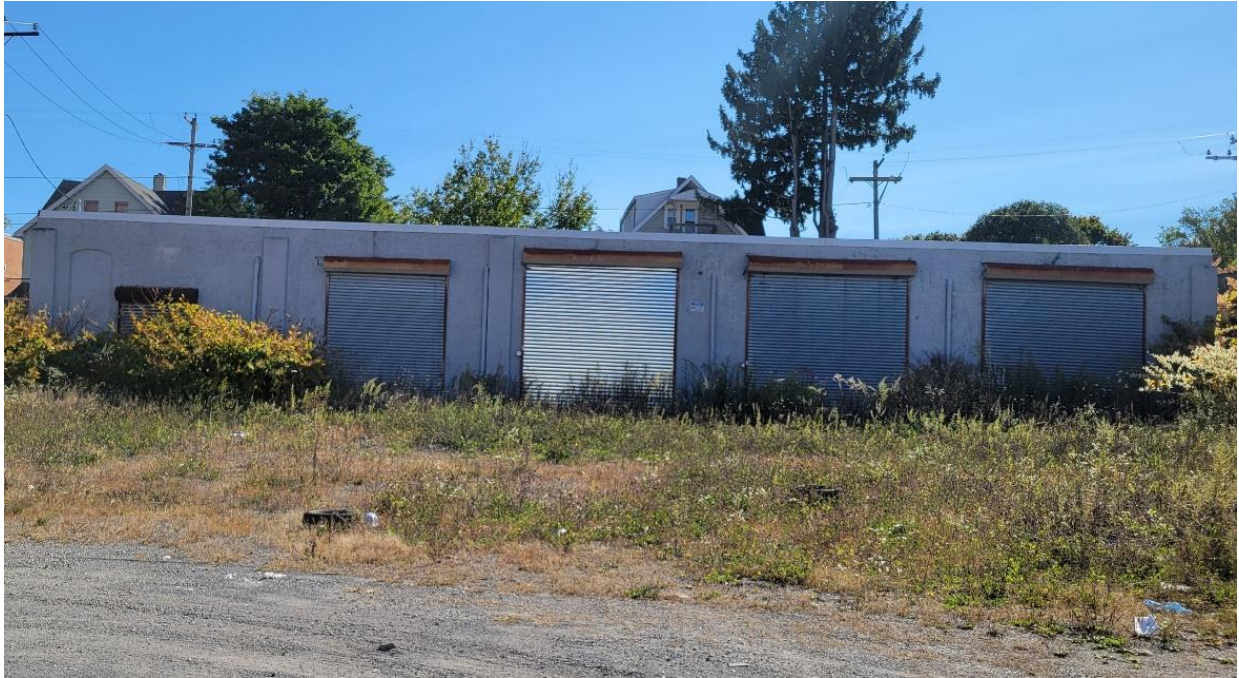
Photo 65: West elevation of building 231. Photo facing east.

The one-story, five-bay by two-bay, rectangular, brick building occupies a rectangular footprint and terminates in a flat roof (photo 65). Bays are separated by brick piers that have been truncated at varying heights before they reach the roofline. The entire building is coated with thick stucco and painted grey. The condition of the brick underneath is unknown. Five modern overhead metal rolling doors are located on the façade (west elevation); these correspond to the original purpose of the building, although the size of the doors may not be original. The remaining three elevations have single, segmental arched window openings, with brick lintels and sills. Window openings on the north and south elevations are taller in height than those on the east (photos 66-67). All window openings have been filled in and stuccoed over; the original glazing is unknown. Door openings are located on the north and south elevation. The opening on the north elevation has been filled in with CMU. The opening on the south elevation is partially obstructed from public view by a privacy fence but appears to generally match the north elevation. The condition of the interior of the building is currently unknown.

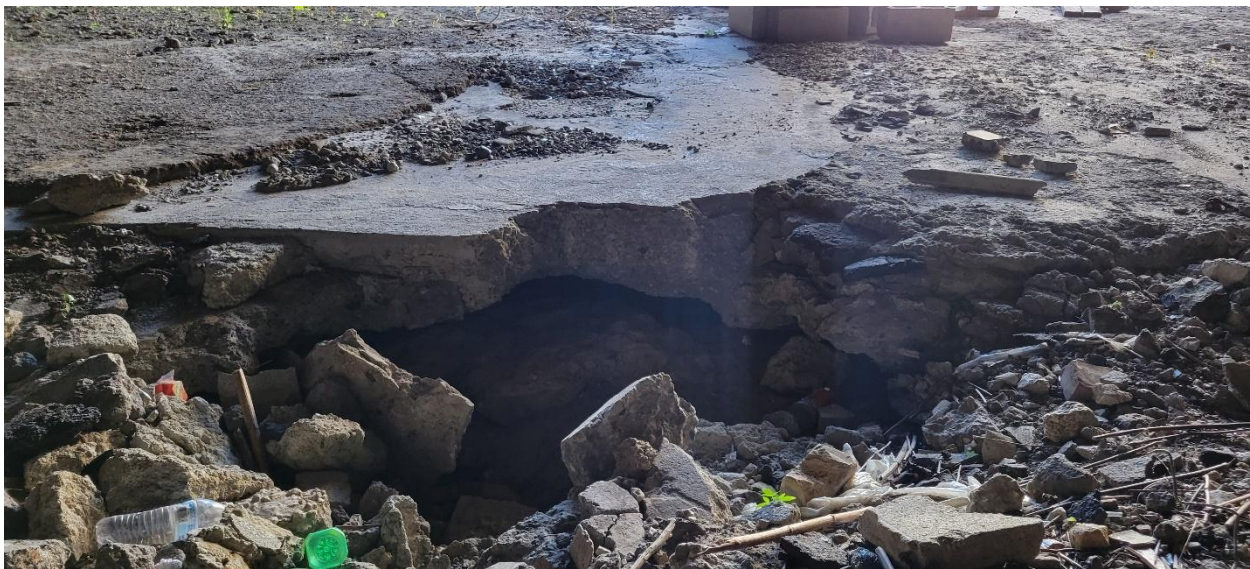
Photo 73: Photo of the flooring types and entrance to the buried canal at the Rolling Mill (building 34/223).
