194 Bank Street images from historic maps

REGULAR MEETING MINUTES

Re: Pre-Demolition Asbestos Survey and Lead TCLP Analysis (1/6/26)
194 Bank Street; New London, CT

Project/Test Address: 194 Bank St; New London, CT

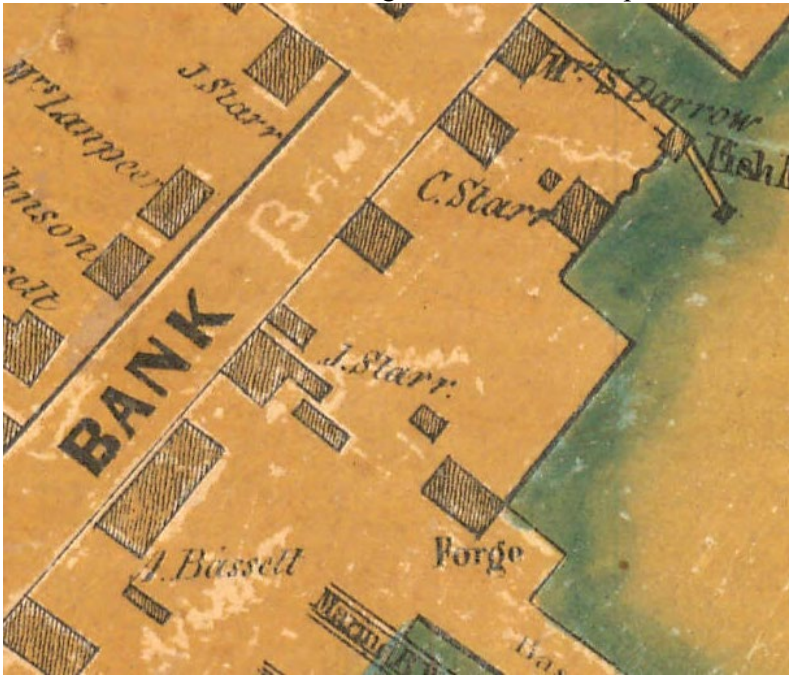
On this map, from 1850, in the inner vault of City Hall, the J Starr building is square, with an extension toward the water.

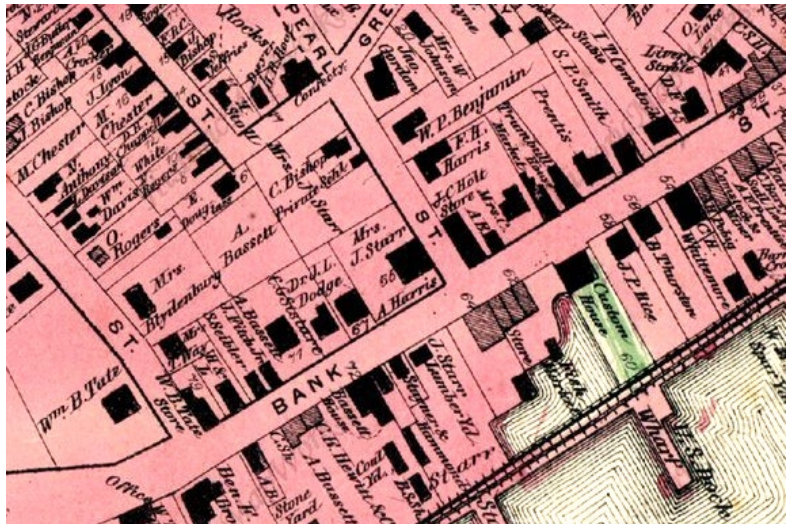
On the 1868 map, the building in question (J Starr, lumberyard) quite clearly has the long side to the street—so evidently not the present one.

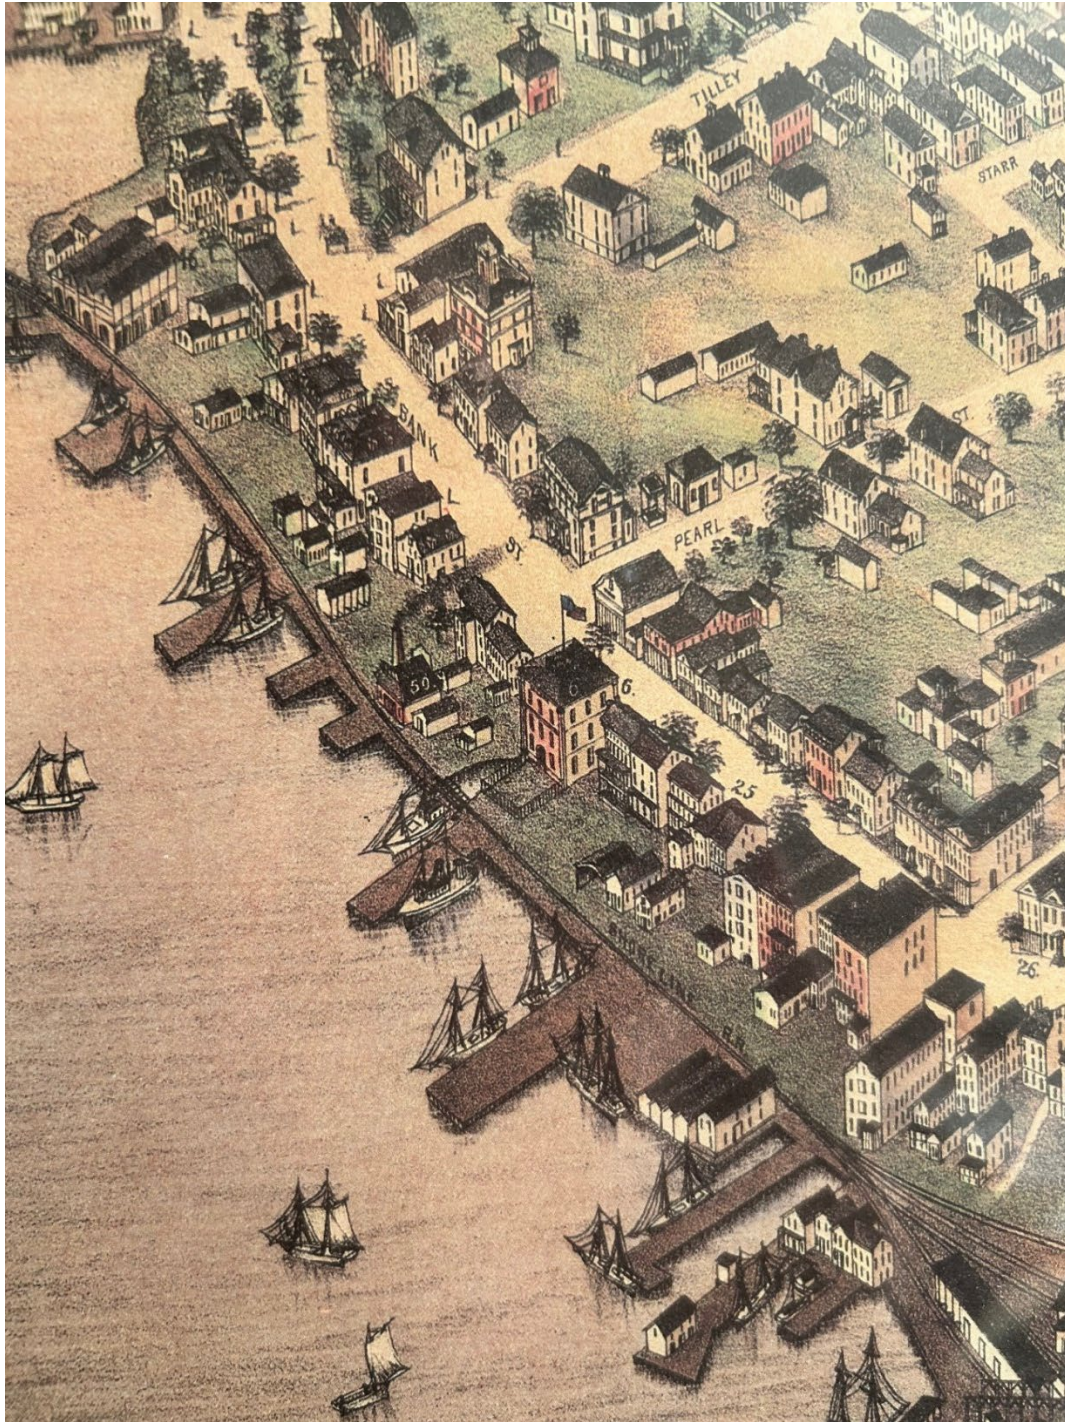
This image from the 1876 birds'-eye view seems to show a building like the present one: gambrel-roofed with dormers on the sides. I conclude that the current building was erected between 1869 and 1876. It was later extended toward the river and modified several times, but I think the current shape survives from the 1870s.

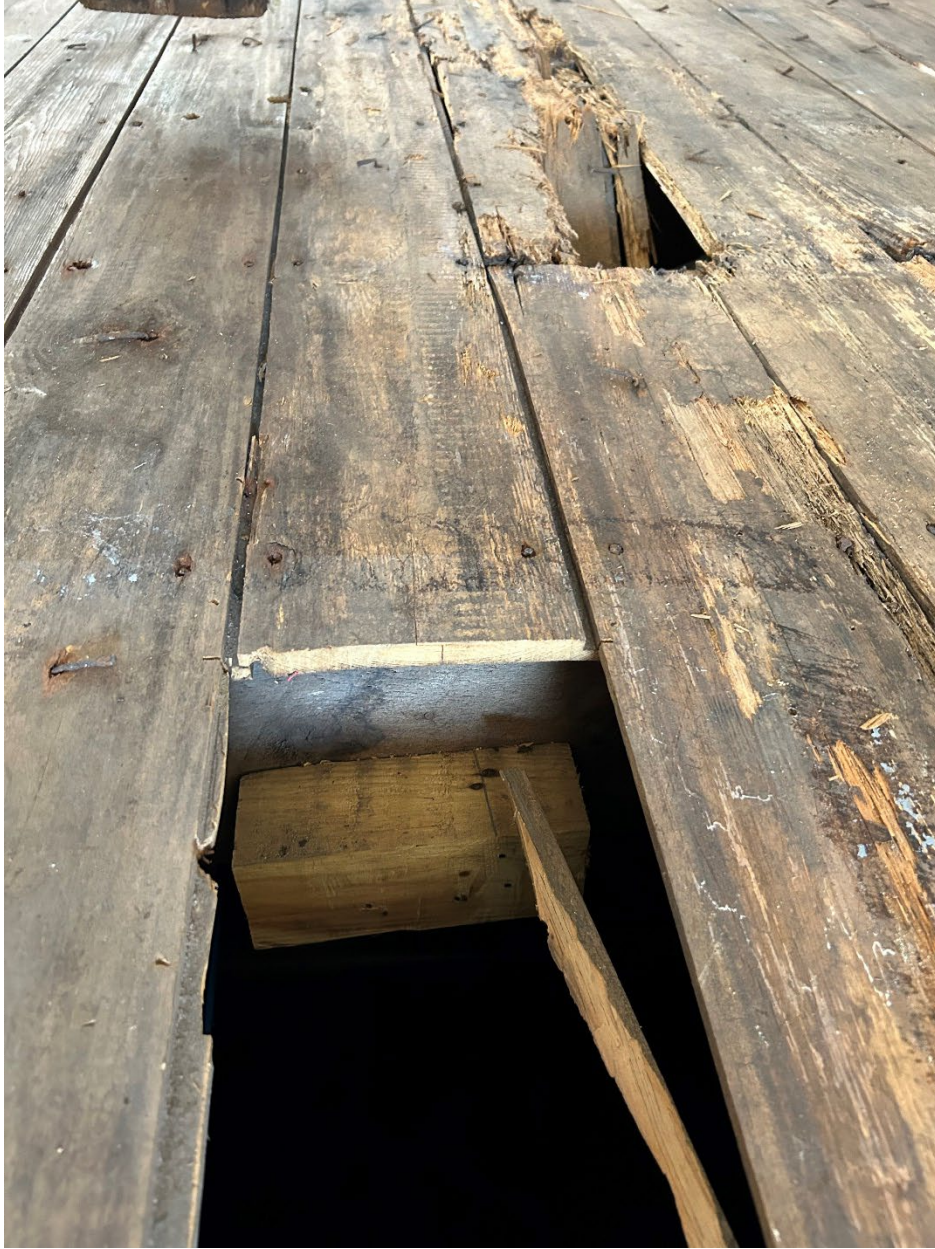
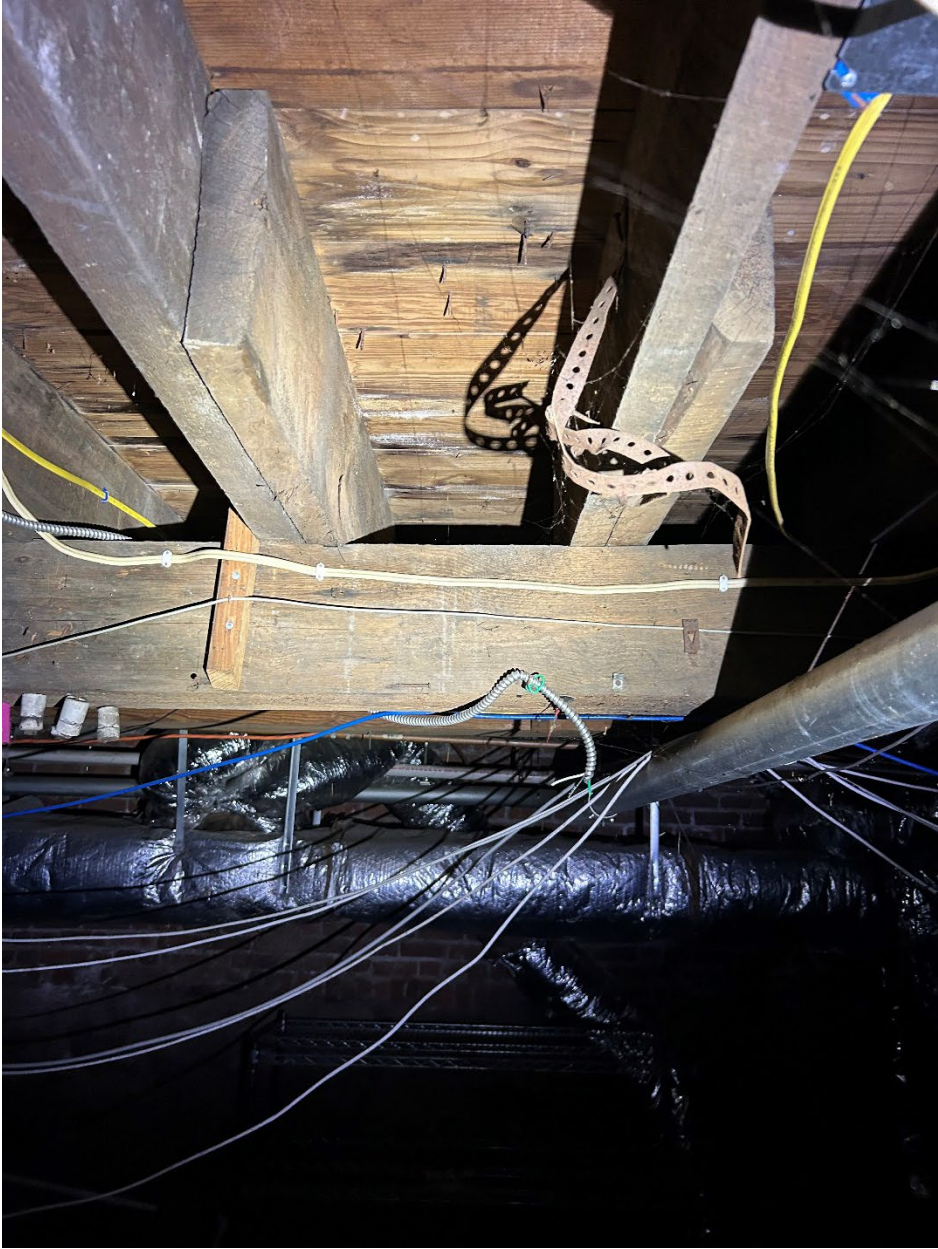
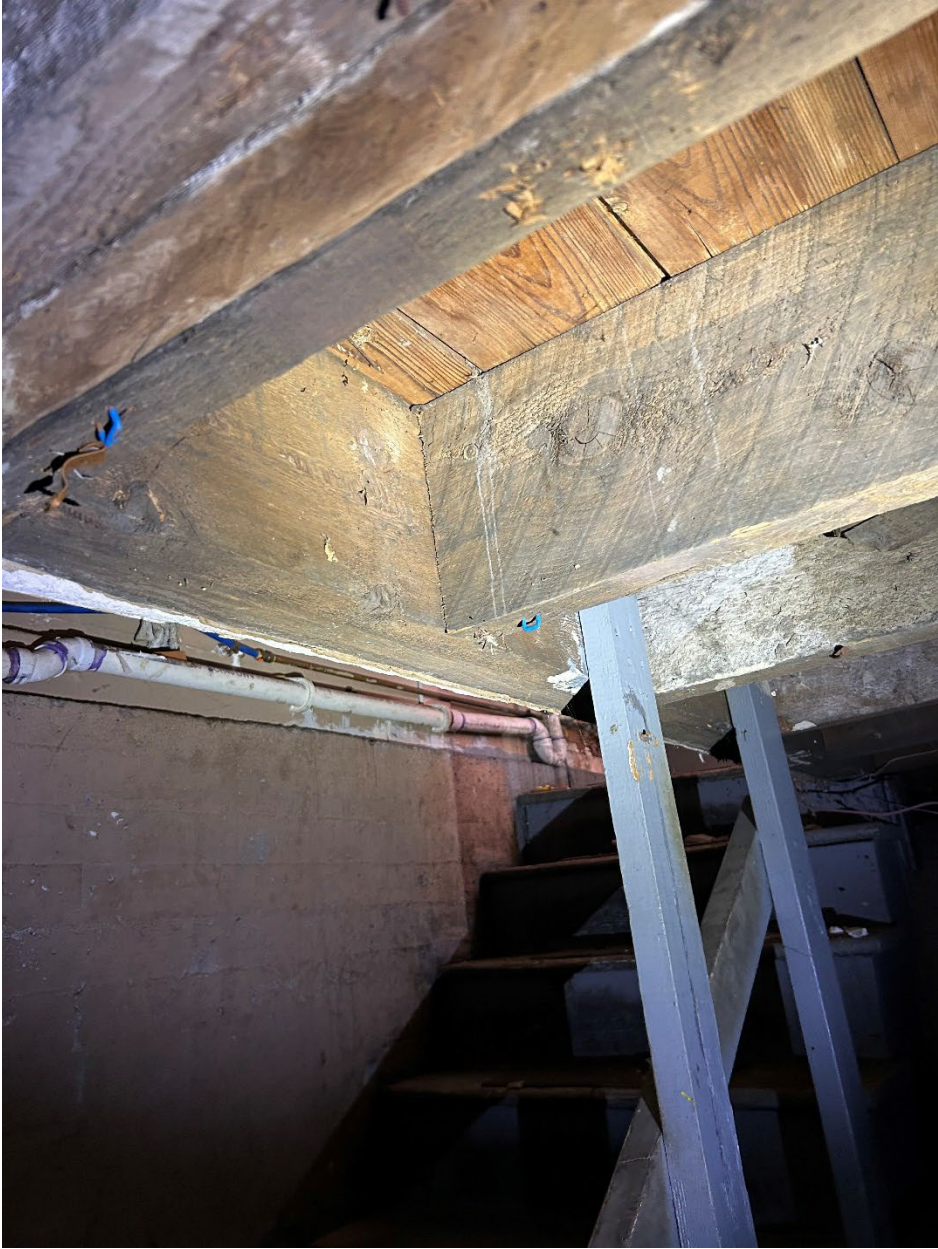
194 Bank Street

Photos showing subfloor after asbestos was removed; provided by Eric Goodman on 3/12/26.
