National Register of Historic Places Registration Form

Historic name: Uncasville Mill Historic District

City or town: Montville	State: CT	County: New London
Not For Publication:	Vicinity:

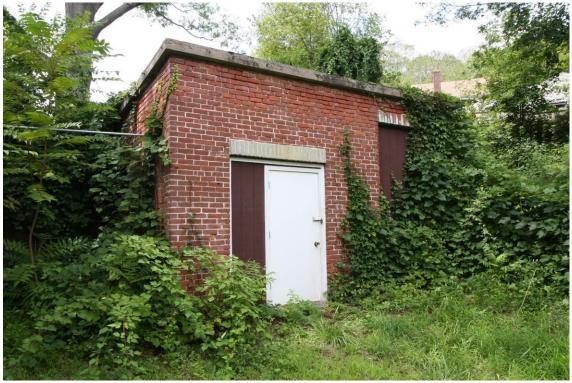
Photo 1. View northwest of Building M-2 showing the east and south elevations.

Building M-2 (Pump House, 1924) is a small one-story brick building located to the north of the western end of Building M-4 (Photograph 1). It is built into the hillside and has a shed roof. An opening with modern door is located at the south side of the east wall and a second opening, now overgrown, is located at the north end of this wall. Both opening have flat, brick lintels. No other openings are visible.

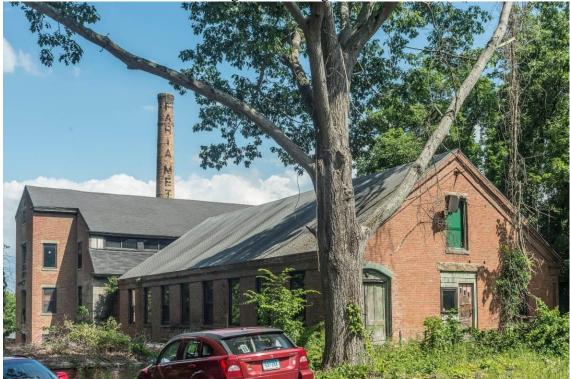
Photo 2. View south showing west and north elevations of Building M-4; tower and part of west elevation of original mill building and smokestack.

Building M-4 (Sorting and Scouring Building¹, 1860) is a two-and-one-half story, end gable, brick building with an ashlar granite foundation and a gable roof covered in asphalt shingles (Photograph 2). It has a rectangular footprint that measures 7' x 38' and it is eight bays wide by three bays deep. The building faces west. A single window with rusticated granite lintel and sill is located in the façade gable. Below this, there is a doorway surmounted with a stone arch on the north side of the façade and a window opening surmounted by a granite lintel in the center of the façade. The opening has been filled with modern materials: wood shingles at its top, a window on its north side and a door on its south side. Eight windows with granite sills are evenly spaced across the north and south elevations. A corbelled brick cornice is located under the roof on all sides. It is composed of three parts that step out as one moves up the cornice, with bands four courses tall flanking a central, single course band. This building is connected to Building M-4A at its east elevation. (Photograph 3).

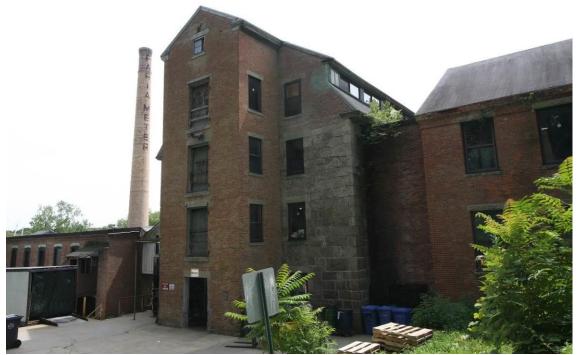
Photo 3. View southeast of the connection between Buildings M-4 and M-4A. (087)

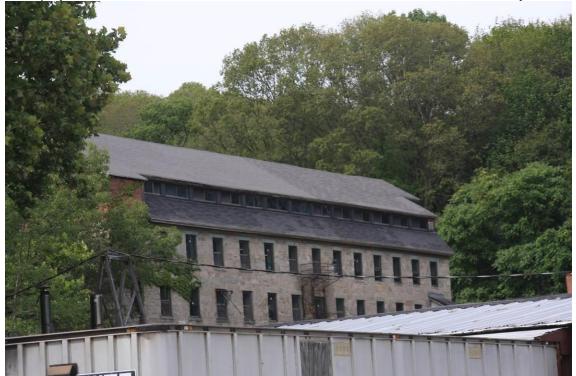
Photo 7. View west of exterior of Building M-4A.

Building M-4A (Stone Mill, 1823) is the original mill loft, constructed in 1823 (Photograph 7). It is five stories tall and measures 42 feet wide by 122 feet long. The foundation and walls of the lower four stories are of random ashlar granite with a rough finish. The upper section of both gable ends are brick

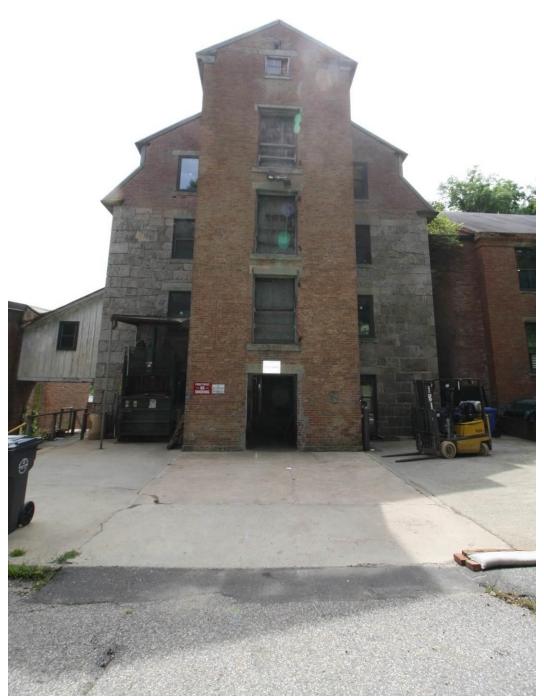
Photo 8. View south of north gable of Building M-4A.

and there is an added full height brick stair tower on its north elevation. This now serves as the entrance to the building (Photo 8). It has a gable roof covered in asphalt shingles with a monitor that runs nearly the full length of the roof on the east and west slopes. The building is three bays wide by 14 bays deep. The regularly spaced window openings are rectangular with granite lintels and sills. This building is connected to Building M-4 on its west elevation and to Building M-5 on its east elevation.

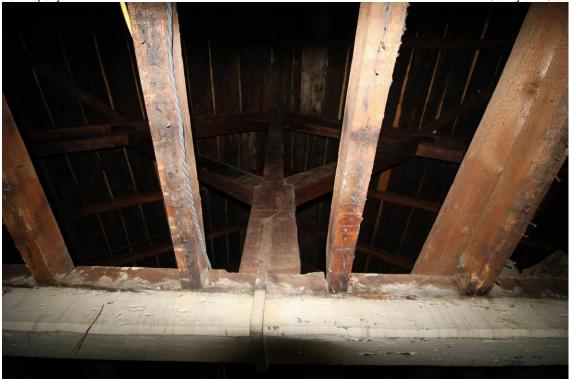
Photo 11. Interior of the top floor of Building M-4A looking to the kingpost roof truss.

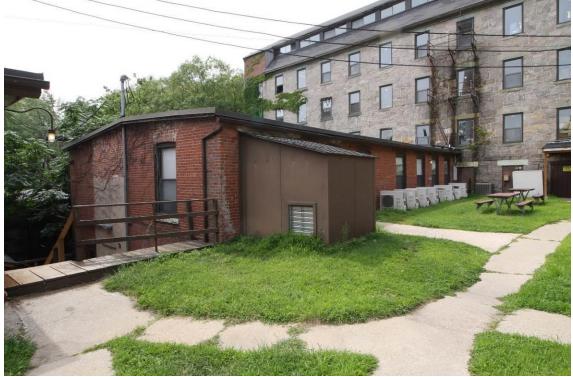
Photo 12. View looking southwest of the exterior of Building M-5.

Building M-5 (Machine Shop, 1877) is a brick, two story, former machine shop with a flat roof. It has a 50'x 30' footprint. There are seven bays with single. evenly spaced windows with rusticated granite sills and arched lintels on both stories of its north and south elevations and two identical windows on each story of its east elevation. This building is attached to Building M-4A on its west elevation.

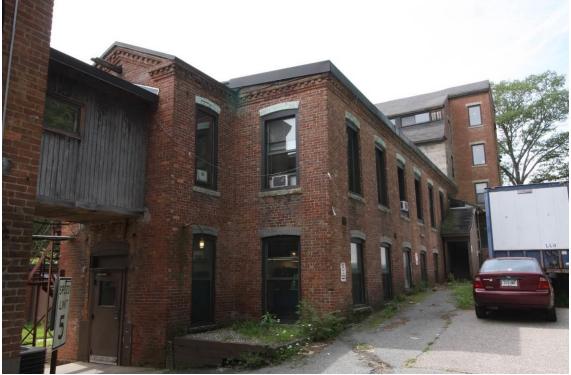
Photo 14. View looking souhwest at the exterior of Building M-7.

Building M-7 (Office/Supplies, 1865) is a two story, end gable, brick building with a low-pitched roof covered in roll roofing material (Photo 13). The building is 60'x30' and 2 bays wide by 6 bays deep. It has a corbeled brick cornice with rows of dentils. The eastern gable has a central projecting section that runs from grade to the ridge of the roof. There are rows of six windows with rusticated granite sills and arched lintels on both stories of its north and south elevations and two identical windows on each story of its east elevation. This building is attached to Building M-4A on its west elevation and to Building E by an enclosed bridge on the center of the second story of its east elevation. The entrance is located on the ground floor, beneath the bridge to Building M-8. (Photograph 4).

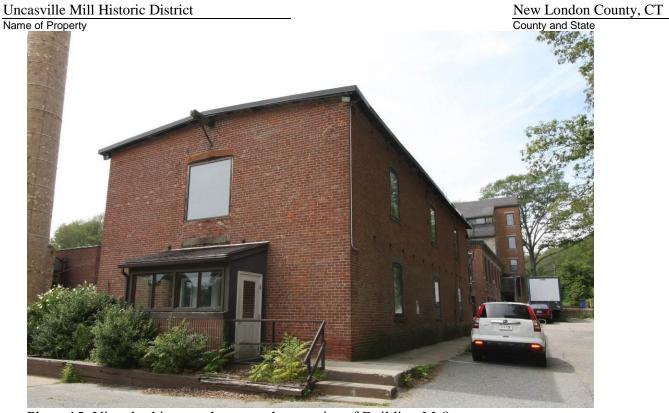
Photo 15. View looking southwest at the exterior of Building M-8.

Building M-8 (Store House, 1897) Building M-8 is a two story, end gable, brick building built into the hillside with a low-pitched roof and exposed rafter tails (Photograph 14). It has a 65' x 30' footprint and is 1 bay wide by 3 bays deep. The roof is covered in roll roofing material. It has three, widely spaced windows with rusticated granite sills and arched lintels evenly spaced along both stories of its north and south elevations. A row of round iron wall ties are located at the cornice and in the center of these elevations. There is a modern enclosed entrance centered on the east gable and a single, modern window in the gable. The window opening has been reduced in height with area below the window infilled with brick. This building is attached to Building M-7 by an enclosed bridge on the center of the second story of its west elevation. (Photo 15). A photograph by Jack Delano for the Office of War Information shows the building in 1940 (Figure 7).

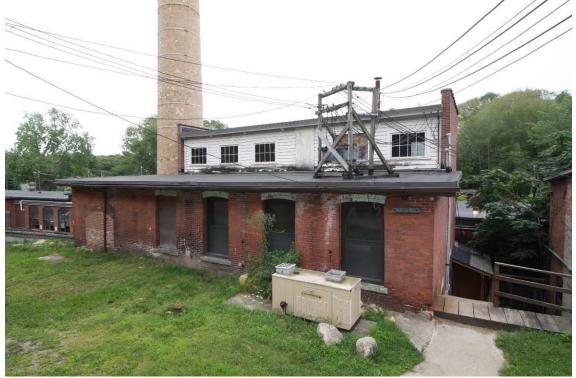
Photo 18. View southeast of the exterior of Building M-6.

Building M-6 (Boiler House, 1894, remodeled 1924) is a brick, two-story, former powerhouse built into the hillside with a two-level, flat roof (Photograph 17). It is 51'x39' and 5 bays wide by 2 bays deep. The southern third of the building rises a story above the northern two-thirds. The east, south, and west walls of this section are brick; the northern wall is clapboarded with six openings in it. Three square

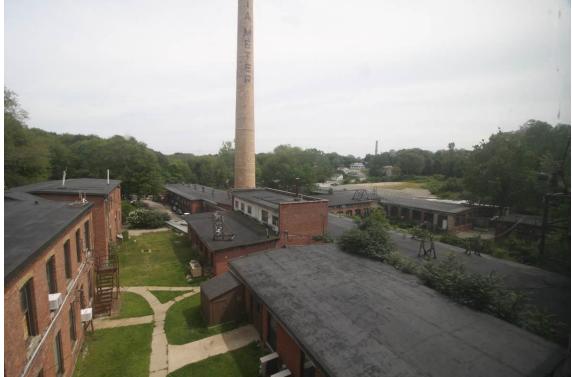
Photo 21. View southeast over the complex from building M-4A. Buildings M-11, M-10, and M-10A run from the lower right corner to the left side of the middleground.

Building M-11² (Weaving, 1916) along with Building M-10 and 10A (Winding and Weaving, 1915), form a continuous structure that extends east from Building M-4A (Photograph 20). The buildings have a long, narrow footprint with and a stepped facade and a slight bend near the middle. They have combined length of approximately 400' and a width that varies between 50' and 57'. The eastern end (Building M-10 and M-10A) is 16 bays wide and four bays deep (Photograph 21). The central section, the eastern part of Building M-11, is eight bays wide, and the western section, the western end of Building M-11, is ten bays wide and three bays deep (Photograph 22). The buildings have three distinct low-pitched roofs covered in EPDM. The longer end sections have side gable roofs with the center section perpendicular to them. A narrow passageway runs from the center of the south elevation of Buildings M-10 and M-10A to connect it to the north elevation Building M-13. Oxoboxo Brook runs under the center of the passage. BUidlings M-10, M-10A, and M-11are connected one story brick buildings with low-pitched gable roof covered in built-up roll material. Bays of wide modern replacement windows with rusticated granite sills in arched openings are evenlyspaced along the north and south elevations, with four similar windows on the east elevation (Photograph 23). Entrances through openings that match the size and shape of the windows (but run from the ground up, are located at the northeast and northwest corners of the eastern section and in the second bay from the east in the cetural section. These buildings are also relatively unchanged since 1940 (Figure 8).

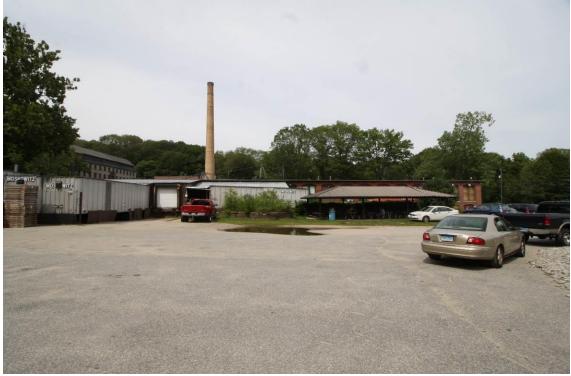
Photo 28. Exterior looking north at Building M-13.

Buildings M-13 (Weave Mill, 1892, remodeled 1915) is to the south of and paralell to, the Building M-10 and M-11 complex, to which it is connected on its north elevation by Buildings M-12 and a second bridge from Building M-10. It is a brick, one story building with a low pitched roof covered in EPDM,

and a 220'x53' footprint (Photograph 27). It is 20 bays wide and 5 bays deep. It has rows of modern windows with rusticated granite sills in arched openings on all elevations. Beneath the windows on southern wall is a row of arched openings that at one time held a pair of six-light windows to illuminate the cellar. Most of these are now missing or boarded over. A modern loading dock is attached to the western end of the south elevation. There is an entrance centered on its façade (east elevation). A ramp to the lower level of the building has been added at the north east corner of the building. A brick bridge connects the northeastern corner of the building to building M-10. The eastern side of the bridge to Building M-10 has been widened on the south with modern terra cotta blocks for the portion not spanning the river. (Photograph 28).

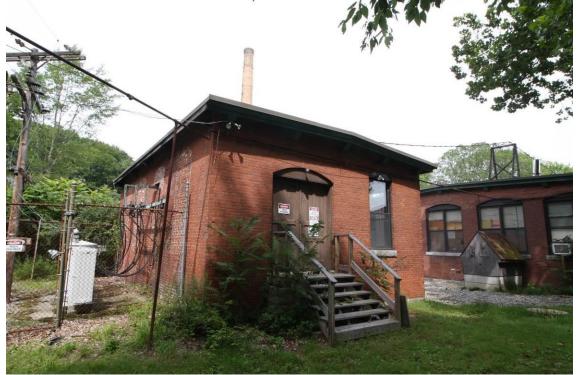
Photo 31. Exterior view looking southwest at Building M-14.

Buildings M-14 (Switch House , 1892, remodeled 1915) is a brick, one-story, free-standing building with a low pitched roof covered in EPDM and an ashlar granite foundation (Photograph 30). It has a rectangular footprint that measures 27' x 37' and is two bays wide and four bays deep. The building is oriented to the south, with a pair of five-panel doors in an arched opening next to a modern window with a rusticated granite sill. The window openings on the west side have all been bricked in. The east wall has three modern windows in arched openings with rusticated granite sills evenly spaced along the southern two-thirds of the wall; the northern two windows sit over arched basement window openings. One window is boarded up while the other has a two-light window in it. The rest of the east wall is blank. The northern wall has one arched window opening with a rusticated granite sill and a lows door opening (currently obscured by vegetation).

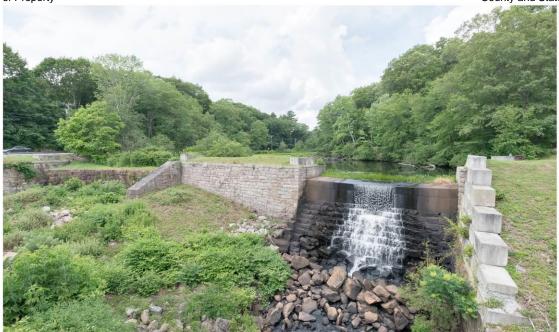
Photo 32. View southwest showing dam, spillway and Picker Pond.

The Uncasville Mill was originally powered by water from Oxoboxo Brook. The brook falls 350 feet in the six miles from its source at Oxoboxo Lake to its mouth at the Thames River. The system is centered on a granite dam and spillway located west of the mill on the west side of Route 32 (Photograph 31). A granite retaining wall extends south from the spillway toward Route 163 (Photograph 33).³ The granite-strewn remains of the head race are located north of the spillway (Photograph 32). As noted above, the head race has been almost completely filled in. A small portion of it is visible north of Route 32.

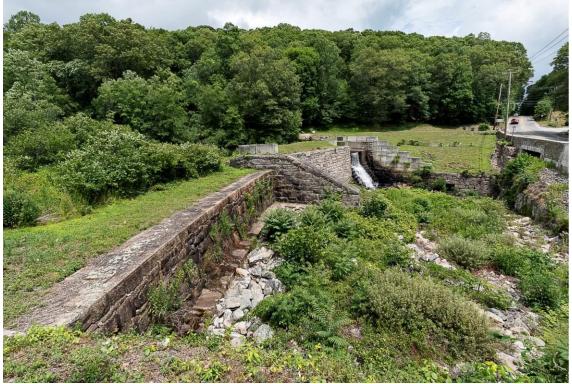
Photo 33. View north showing southern section of dam, spillway and part of Route 32.

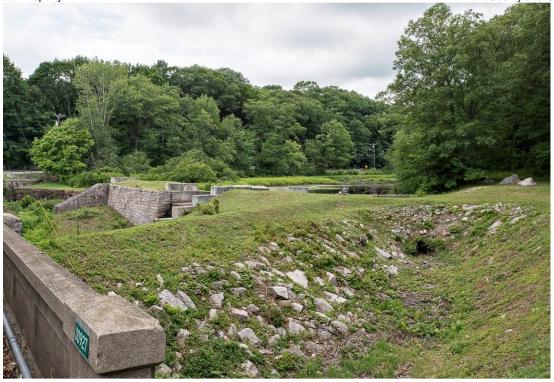
Photo 34. View south from Route 32 bridge showing dam, Picker Pond and abandoned head race.
