Resilient Stewardship:

Preserving Your Historic Property In an Era of Climate Change

Kathryn M. Kuranda, R. Christopher Goodwin & Associates, Inc.

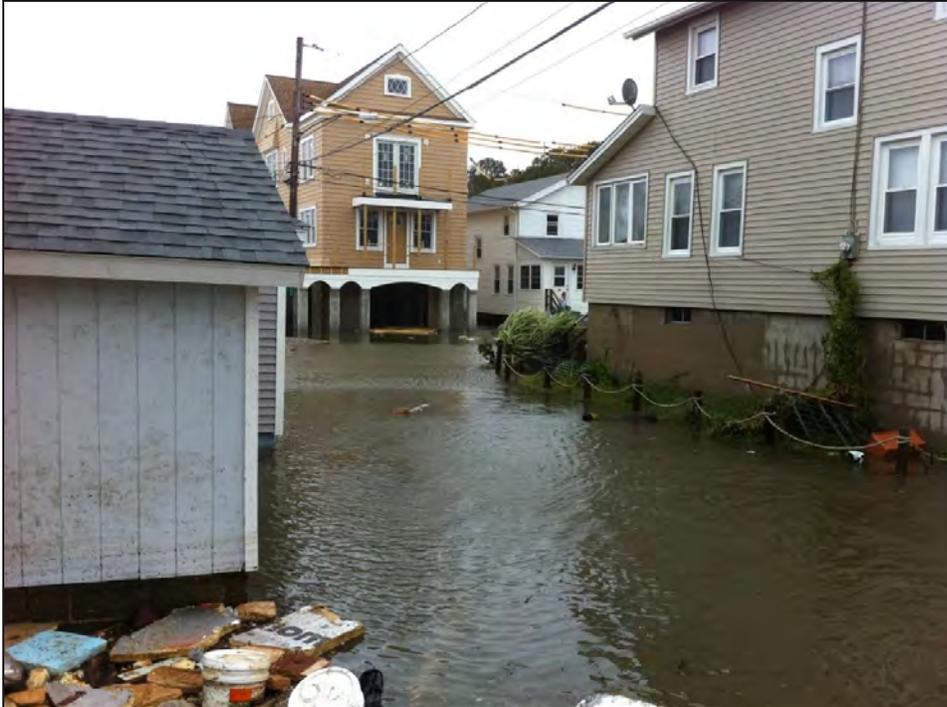
Superstorm Sandy brought storm surge, high winds, and flooding to Milford's shoreline, much of which was developed in the early twentieth century. Credit: SHPO file photo.

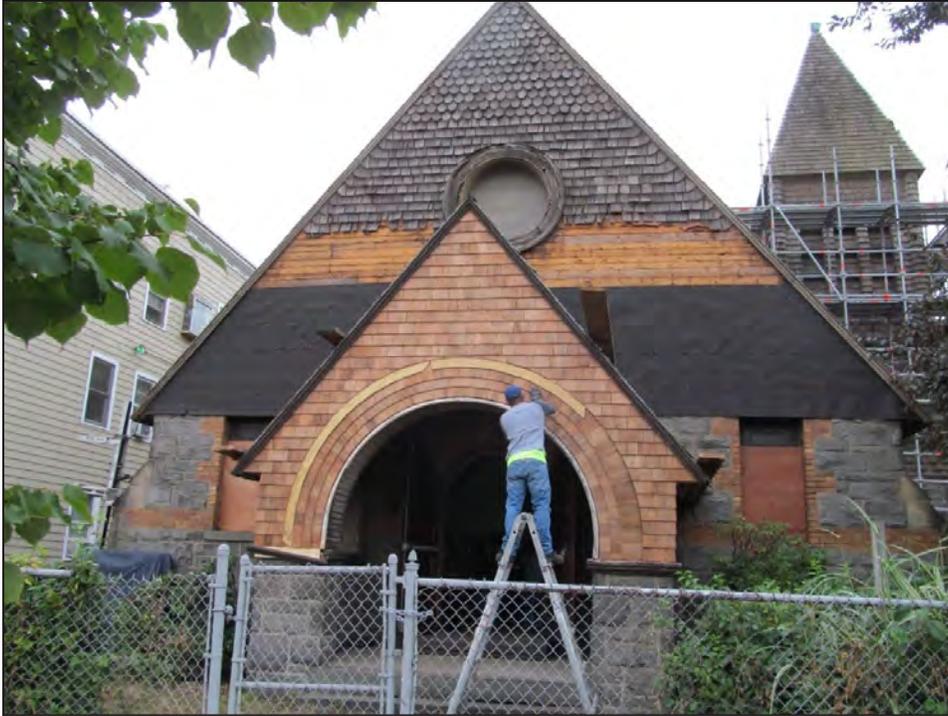
After Superstorm Sandy damaged St. Luke's Chapel in Stamford (1891, NR), the building's wood-shingle cladding was replaced in kind with a grant from the SHPO's Hurricane Sandy program. Credit: Douglas Royalty/SHPO.

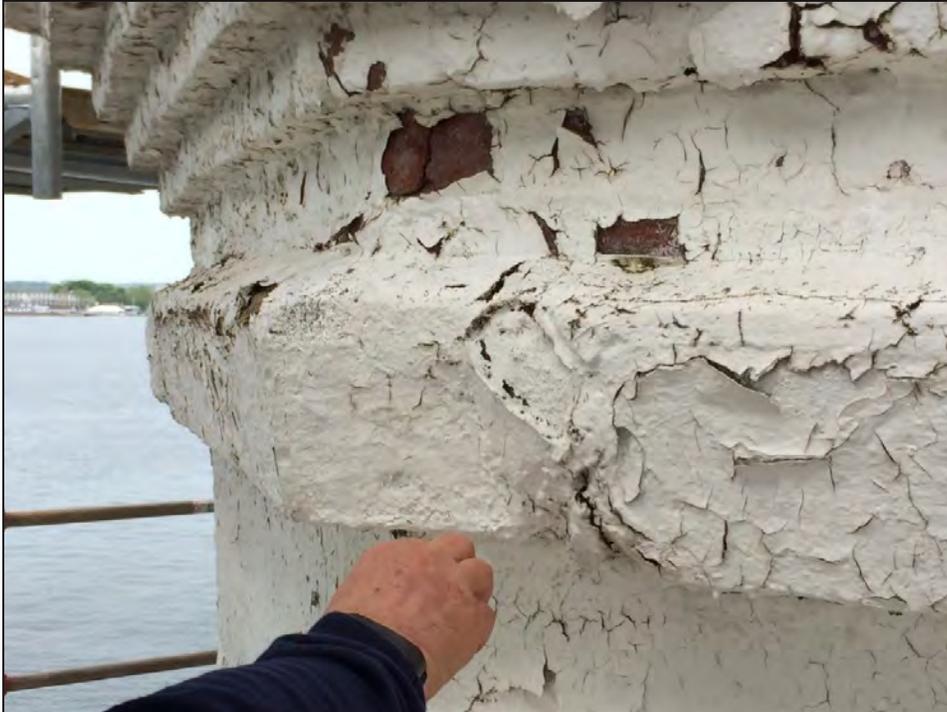
Blistering or peeling paint, as at the Fayerweather Lighthouse in Bridgeport (1823, NR), indicates trapped moisture—in this case, at least partly the result of infiltration from a cracked lantern slab atop the brick corbelling. Credit: Douglas Royalty/SHPO.

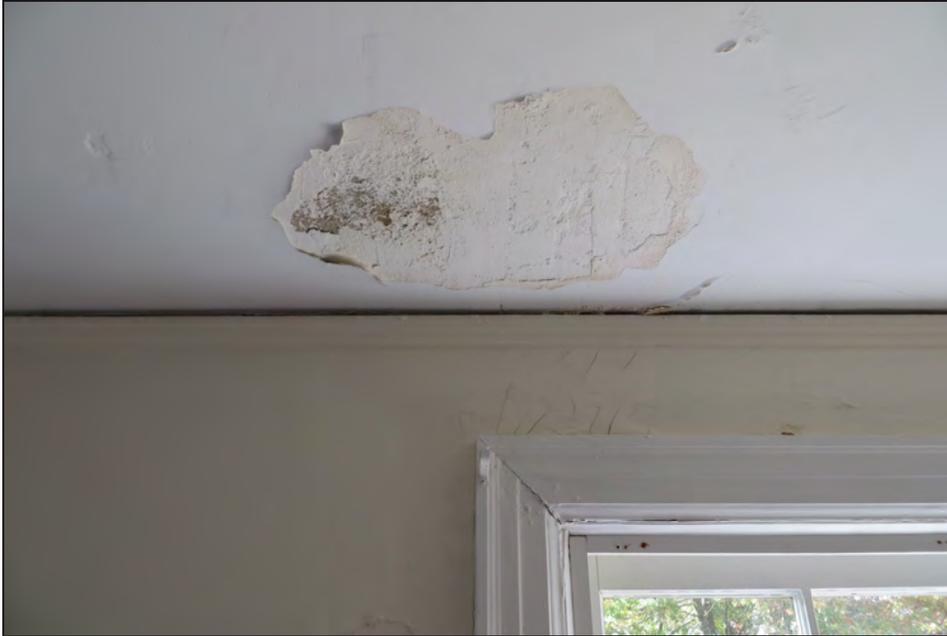
After Superstorm Sandy damaged the roof of a historic house in Greenwich, water infiltrated the building. Left unattended, such damage can lead to mold or even weaken the structure. Credit: Greenwich Historical Society.

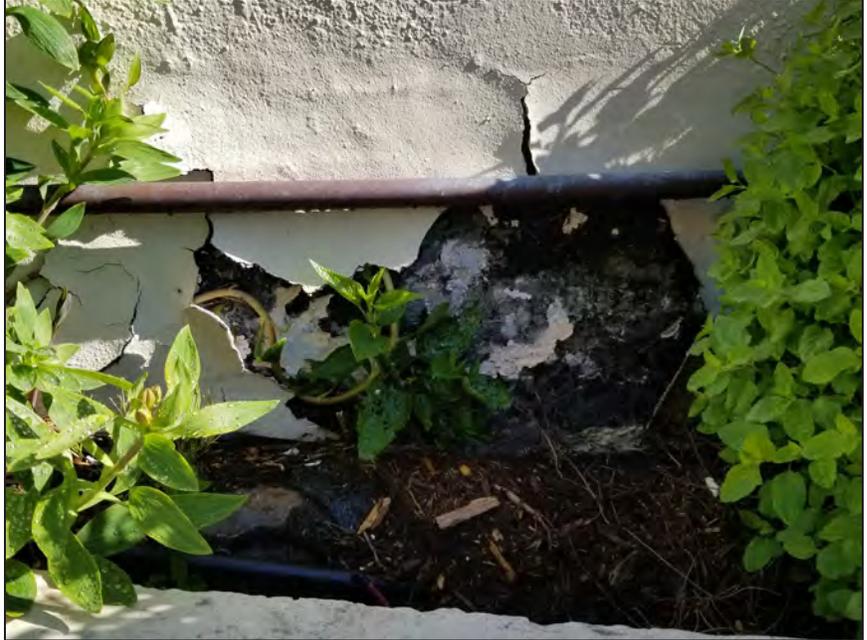
Leaking pipes can create environments that support mold and other vegetation. Credit: RCG&A.

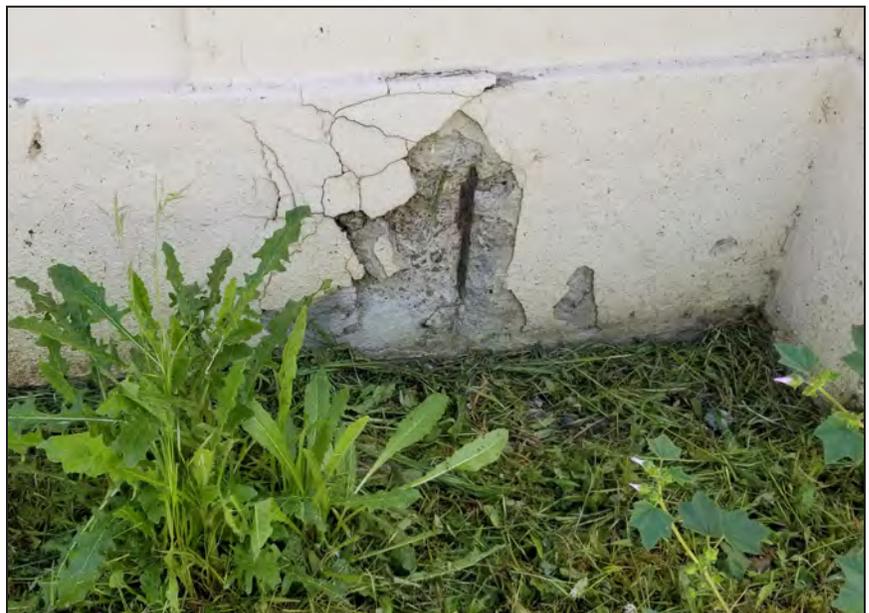
Site conditions can direct water into building foundations, resulting in deterioration. Credit: RCG&A.

Surface water is a probable source of moisture in buildings whose foundations rise above the high-level mark of the water table. Damp walls are more likely with rising water tables and storms of greater intensity and frequency. Surface water can penetrate a building envelope from failed gutter systems and through site conditions that direct water into the foundation. Roof design can also contribute to water problems: Water channeled by roof eaves can create a trench around the perimeter of the foundation and seep into the building.

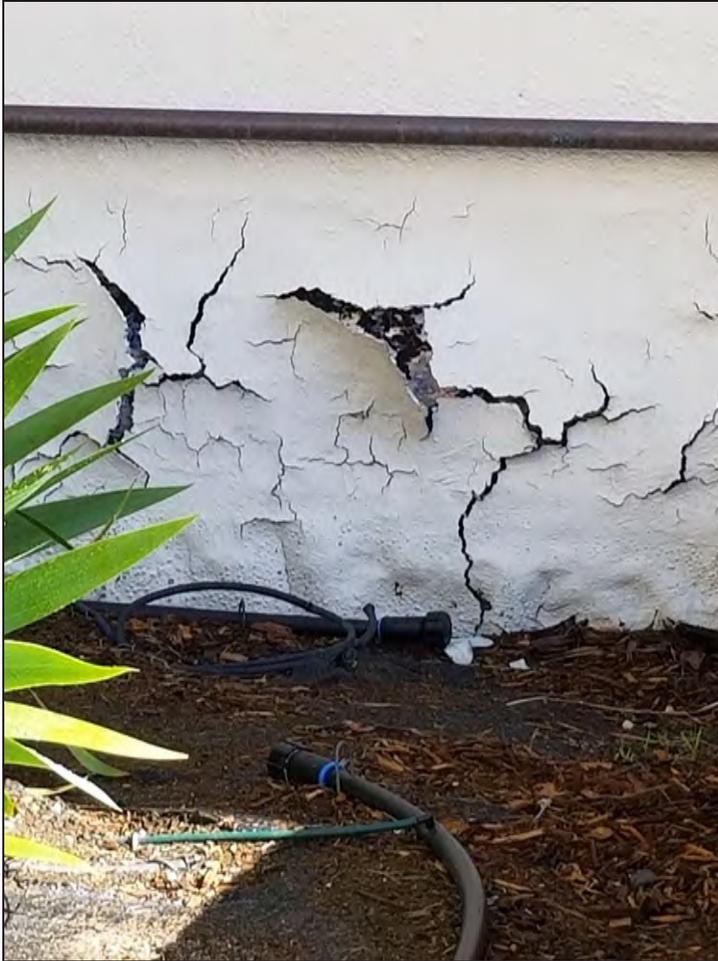
Sprinkler systems can unintentionally direct water toward a building foundation. Credit: RCG&A.

Surface water frequently leaves an irregular pattern of staining, known as a high-tide mark, on a wall's surface. A regular pattern more often is associated with rising damp from groundwater or from splash-back, in which water is redirected into the building or onto the building face after hitting the ground. Splash-back from sidewalks, patios, or other hard surfaces can saturate a building's foundation and face. With climate change, greater volumes of water will be directed toward the building.

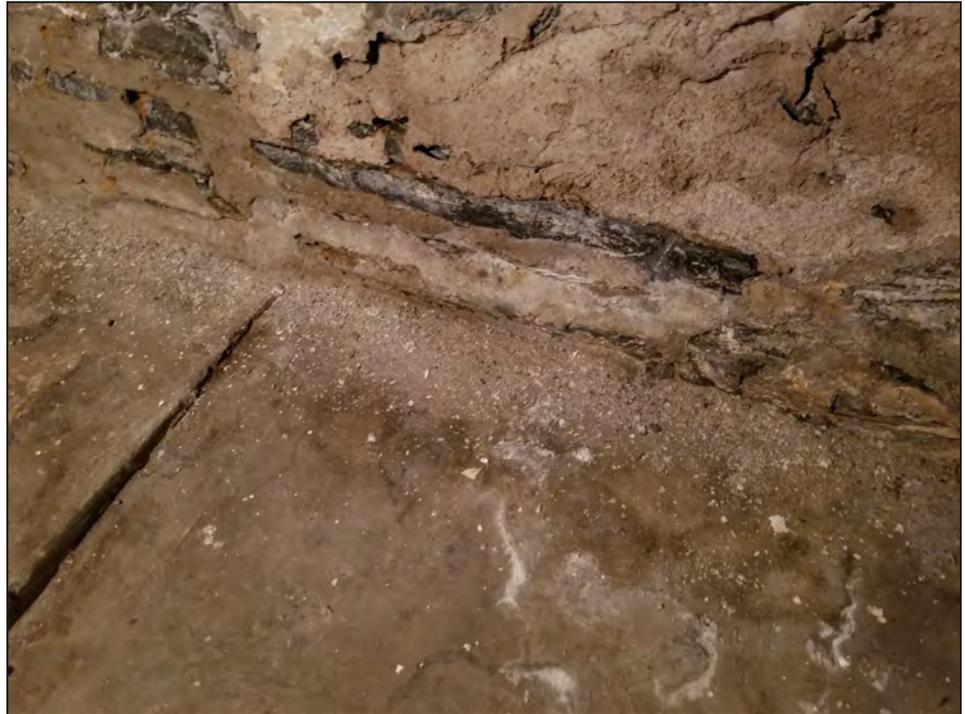
Repeated water infiltration can erode lime mortars and deposit salts during evaporation. Credit: RCG&A.

As groundwater migrates into the basement of a historic building, it carries salts from the soil. Concentrated salts are deposited in the lower building wall and attract greater moisture levels, while soluble salts migrate to the outer wall face as water evaporates. Salt crystals form in masonry foundation walls and over time can deteriorate the masonry unit.

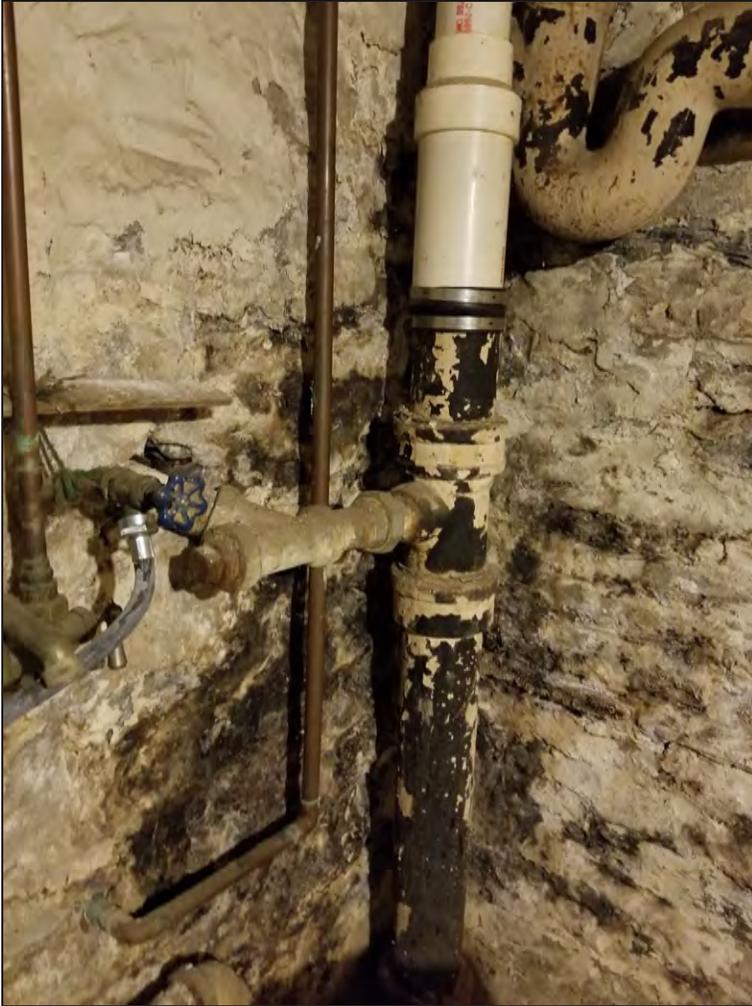
Uninsulated pipes can create humid conditions that support mold. Credit: RCG&A.

Condensation occurs when water vapor in the air comes in contact with materials that are lower in temperature than the dew point. When moist air reaches its dew point, it condenses in liquid form. Condensation forms on the coldest surface available. These materials have the highest density and thermal conductivity.

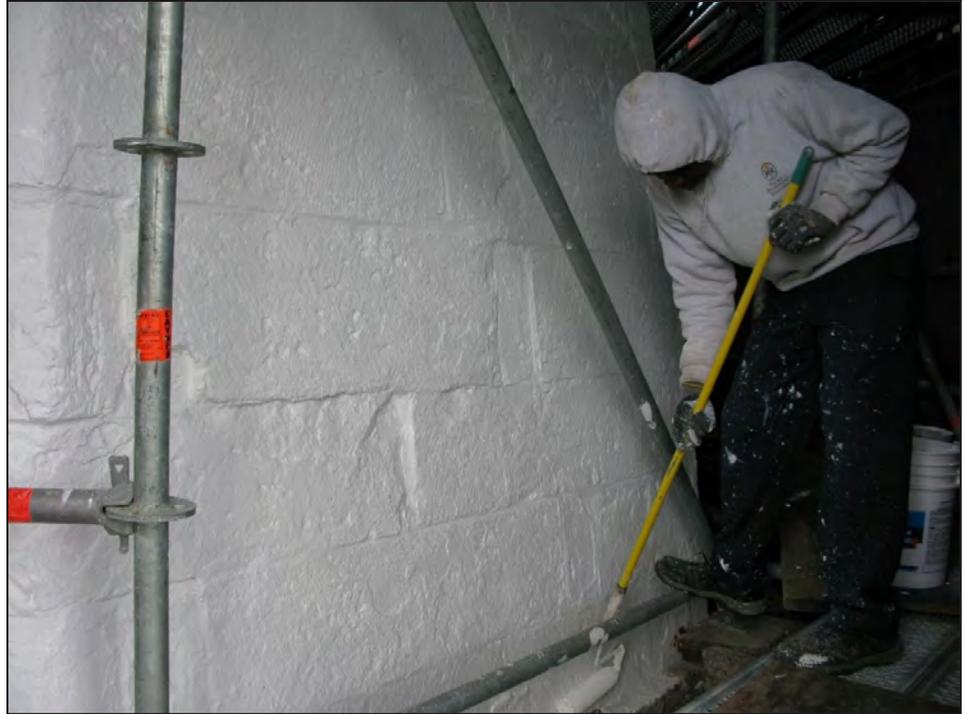
Masonry buildings may or may not be painted. However, if painting or repainting a brick or stone building, be sure to use a vapor-permeable coating. Credit: Douglas Royalty/SHPO.

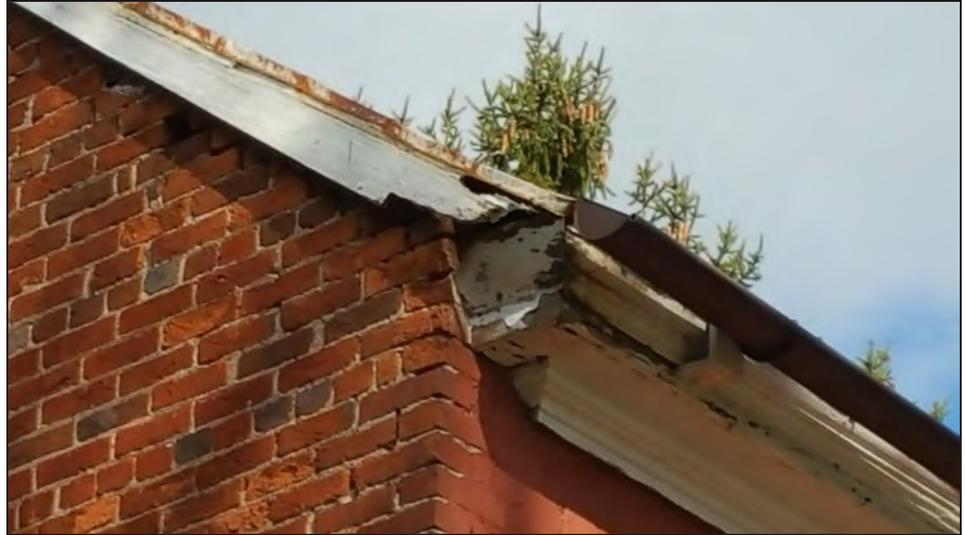
Effective gutter and downspout systems can avoid cornice and raking board deterioration. Credit: RCG&A.

- Installing larger gutters and downspouts to accommodate increased volumes of water.
- Installing additional sub-grade drainage systems, such as French drains, to direct water away from buildings.
- Modifying hardscape surrounding the building to control or eliminate splash-back onto the face of the building.
- Correcting drainage on architectural elements where water and snow may collect, melt, and saturate horizontal surfaces, and refreeze. This pattern often occurs at the top courses of brick chimneys, on brick window sills, and on masonry fences. Consider minor design modifications or the addition of a cap course to slant surfaces to direct water away from the element.

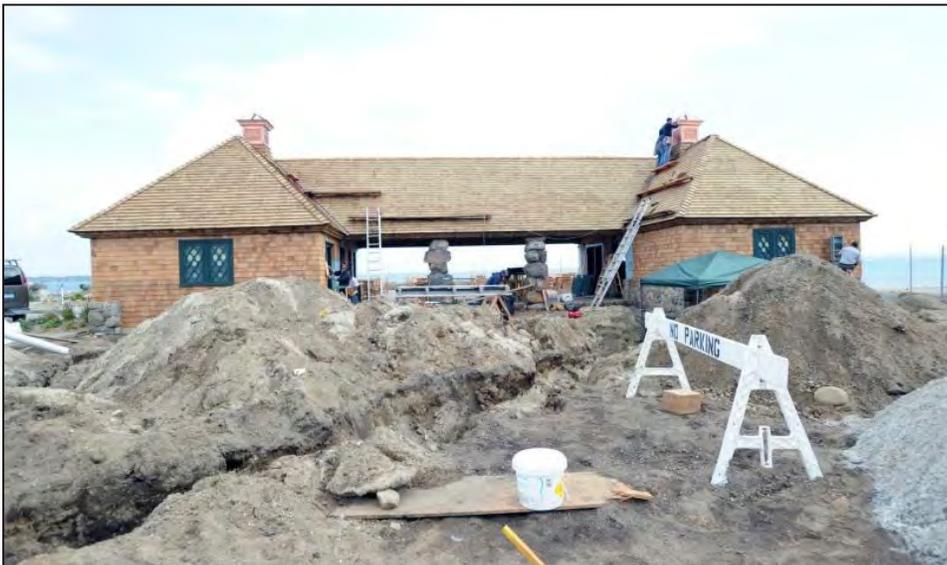
After Superstorm Sandy, contractors installed helical piles to anchor the Old Barn at Greenwich Point (1887), which had been knocked off its foundation. Credit: Christopher Franco/Greenwich Point Conservancy.

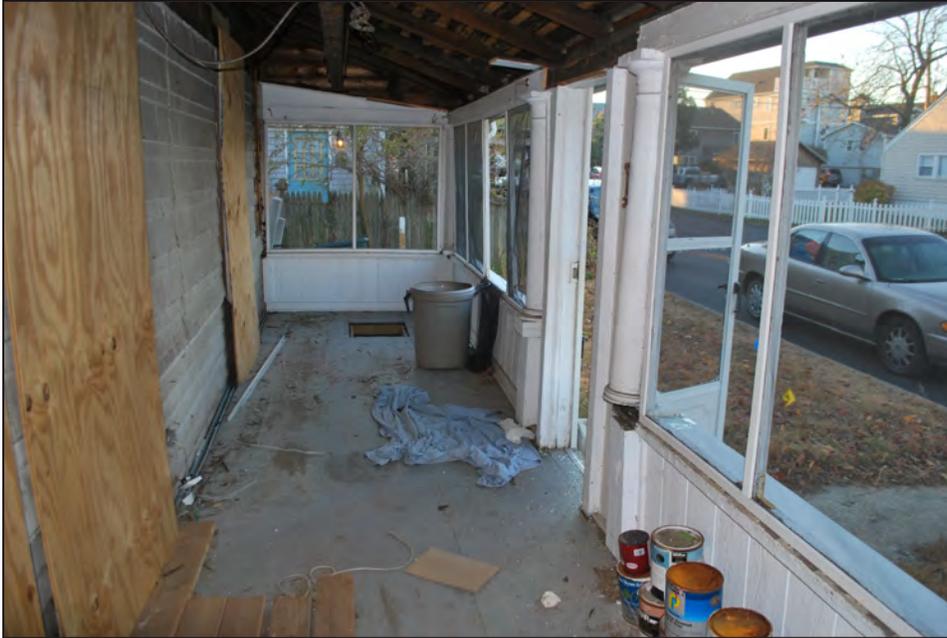
Houses up and down Connecticut's shoreline were damaged during Superstorm Sandy after floodwaters entered basements, porches, and ground floors. Credit: SHPO file photo.

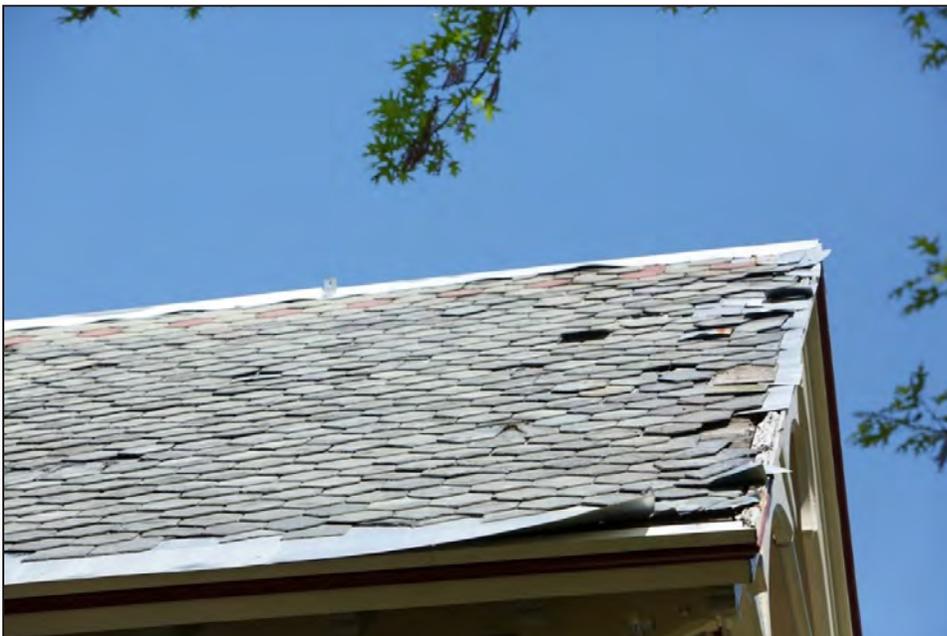
Winds from Superstorm Sandy damaged the slate tile roof of the Mary Moody House (a.k.a. Chetstone; 1875, NR), a Victorian Gothic mansion in New Haven's Fair Haven Heights section. Credit: Ian Christmann.

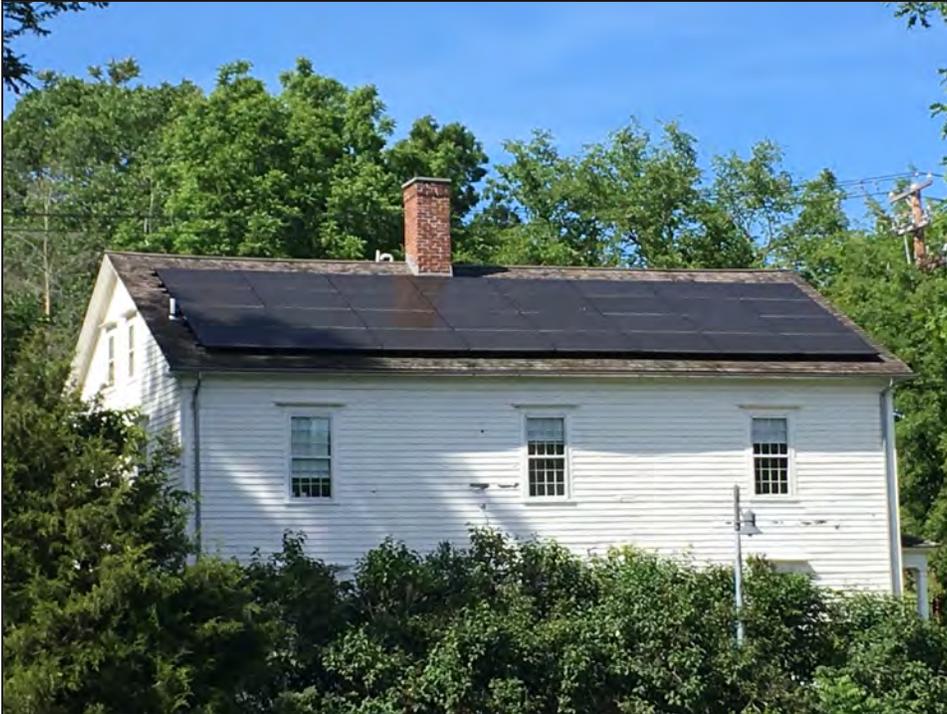
Rooftop solar arrays can be compatible with historic preservation standards, as at the Eli Whitney Boarding House in Hamden (1827, NR), the headquarters of the Connecticut Trust for Historic Preservation. Credit: Douglas Royalty/SHPO.

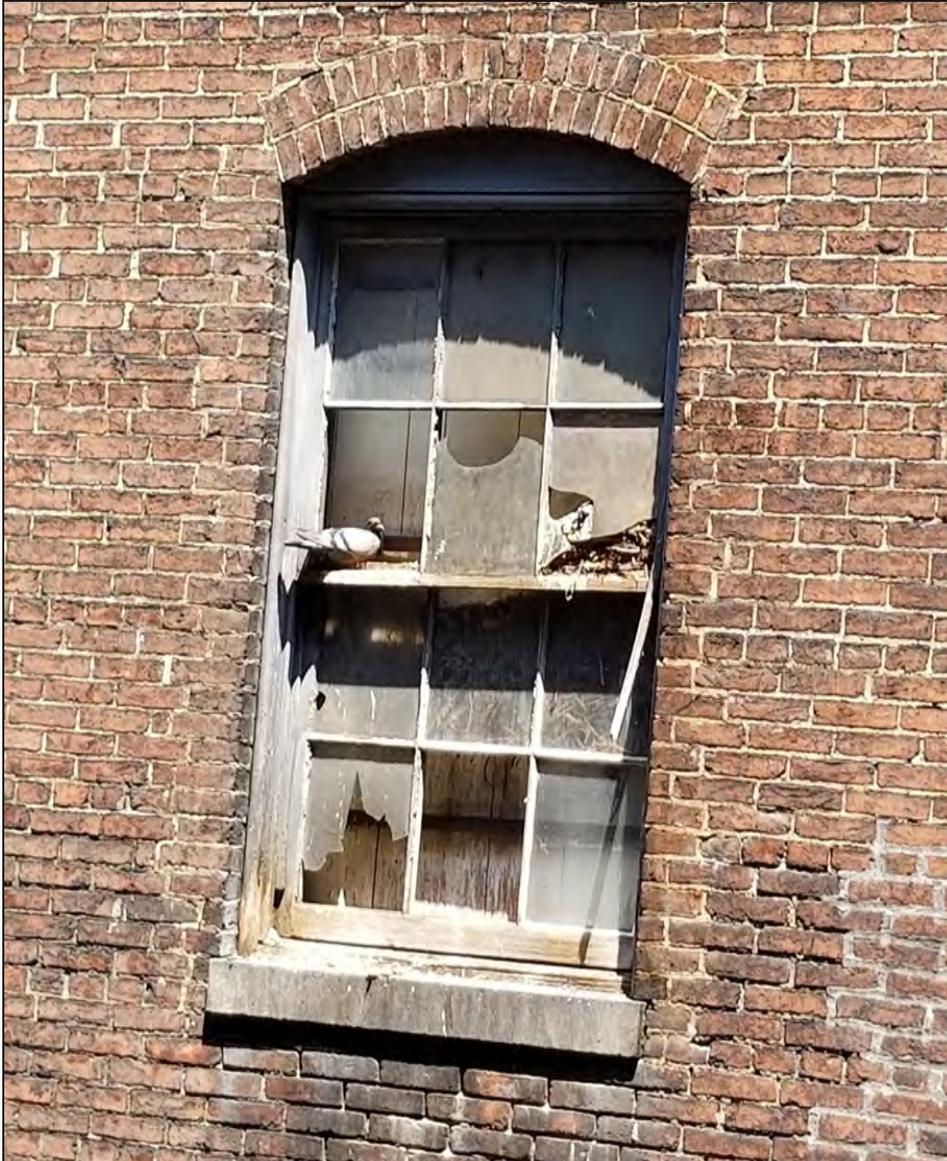
Even the most neglected windows often can be repaired and made as energy efficient as new windows. Credit: RCG&A.

- Prioritizing window repair for energy efficiency. Leaking windows can account for up to 15 percent of a building's energy loss; the U.S. Department of Energy estimates that deteriorated windows can be responsible for up to 25 percent of heating or cooling bills. Original windows contribute substantially to the design of historic buildings. They are likely constructed of high-quality materials that are no longer available. Windows that predate ca. 1950 were built from old-growth wood, which is denser, more rot- and warp-resistant, and holds paint better than modern wood. Repairing historic windows generally is more cost-effective than replacement and can achieve the same level of energy efficiency. Consider adding storm windows to supplement historic windows. The design of storm units should not detract from or obscure the design of historic windows.

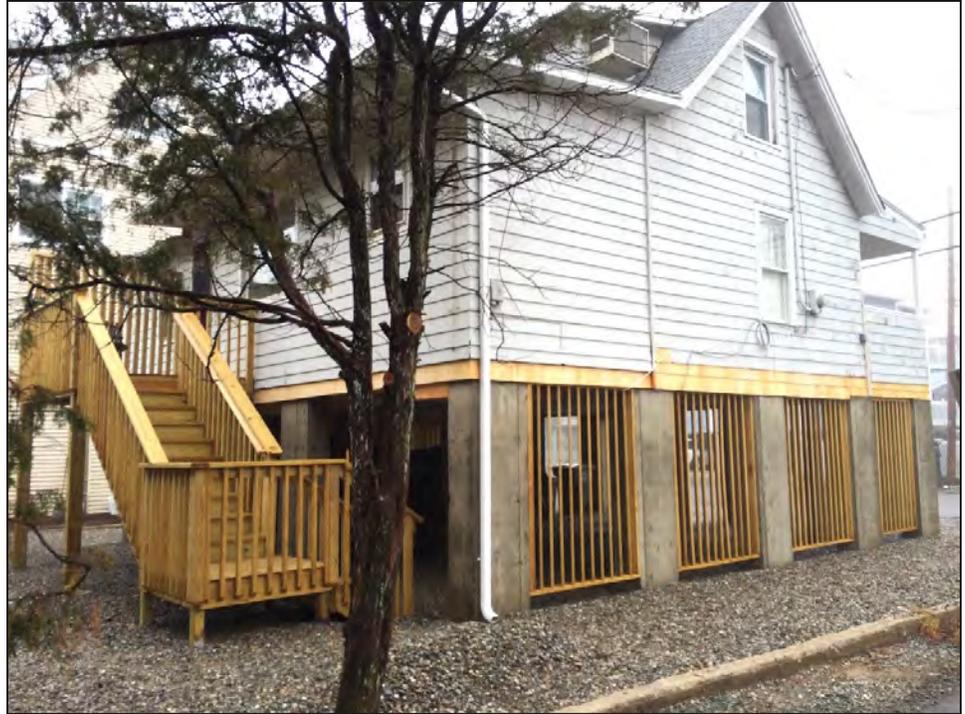
How high can a building go before it loses its integrity? Can well-designed entries and porches, screens, and landscaping mitigate the potential impact of elevation? The answers are often unclear. Credit: SHPO file photo.

Building elevation is among the most controversial and debated topics in historic preservation. The strategy, which elevates a structure above the BFE, can affect the design of a building and its relationship to its setting. These changes can be substantial enough for a building to lose its historic integrity. Retaining a building's historic integrity while elevating it sufficiently to provide flood protection can present conflicting priorities. Preservation seeks to minimize alterations to building scale, design, workmanship, materials, and setting, while elevation, as an adaptation measure, often requires changes in height, design, and site relationship to be effective. Despite these challenges, historic buildings have been successfully elevated with minimal loss of historic integrity. Elevation projects are evaluated on a case-by-case basis, and standardized approaches appropriate for non-historic buildings likely will not be successful in minimizing impacts. Seeking technical assistance from the SHPO during the preliminary planning stages of any elevation project is strongly recommended.

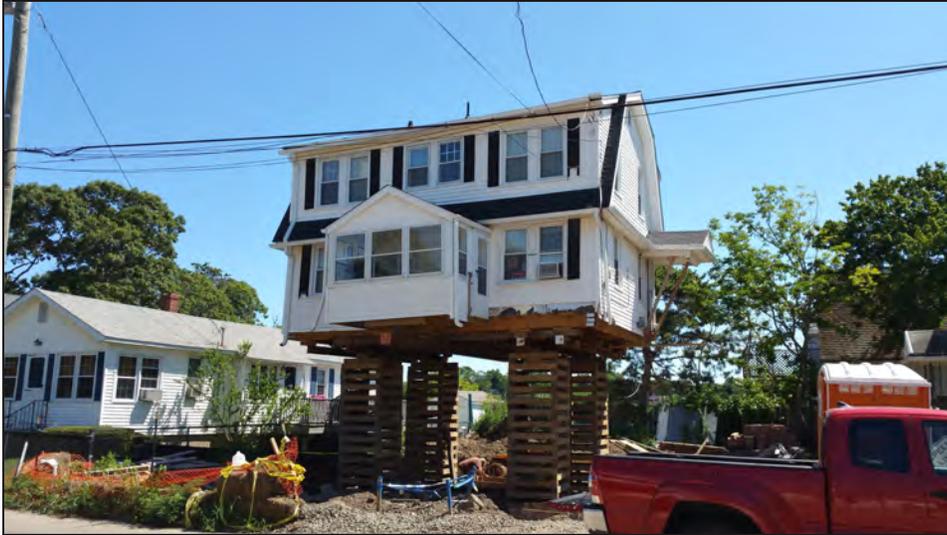
Elevating a house after Superstorm Sandy. Credit: RCG&A.

Elevating a structure can affect the building's design and its relationship to its setting. Such changes can cause a building to lose its historic integrity

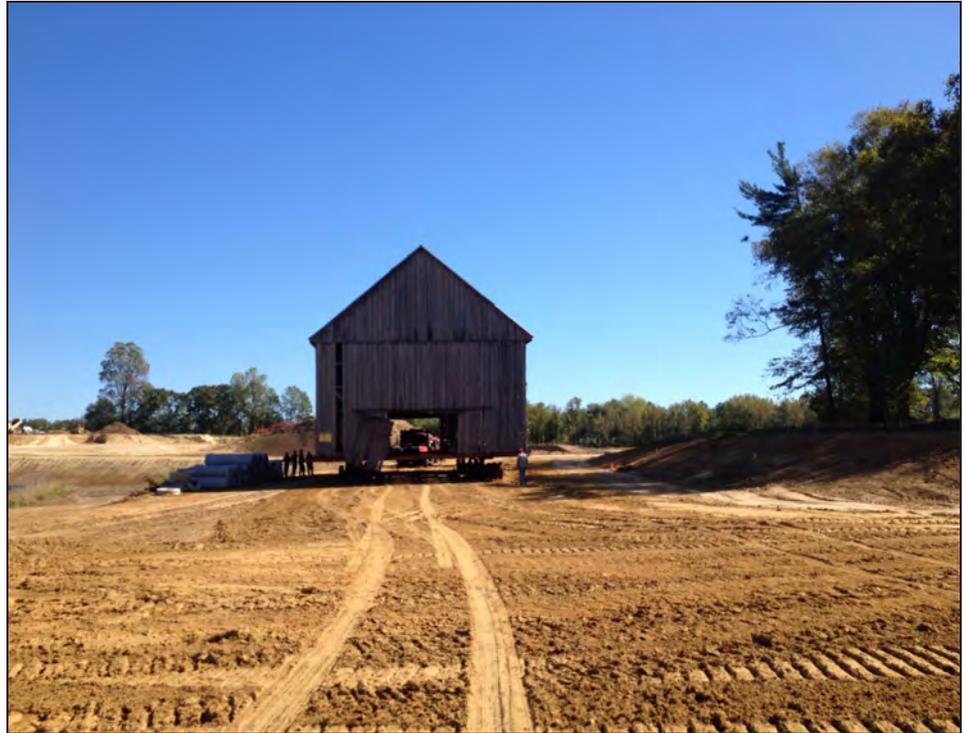
Sites for moved structures should be selected to replicate the historic relationship between building and site as closely as possible. Credit: RCG&A.

Moving a historic building generally is not a preferred preservation strategy. However, relocating a building from an area of extreme hazard to ensure its preservation may be an option to consider. Recreating the relationship between the building and its original site in a context similar to its original setting is key. Moving a building is a major undertaking that requires substantial planning and exacting staging. Research, site preparation, building preparation, and post-move rehabilitation are critical to success.
