INVESTIGATING THE DETERIORATION OF BASEMENT WALLS MADE OF CONCRETE IN CT

Department of Civil and Environmental Engineering

Advanced Cementitious Materials and Composites (ACMC) Laboratory

**This report was produced for the
Attorney General of the State of Connecticut.**

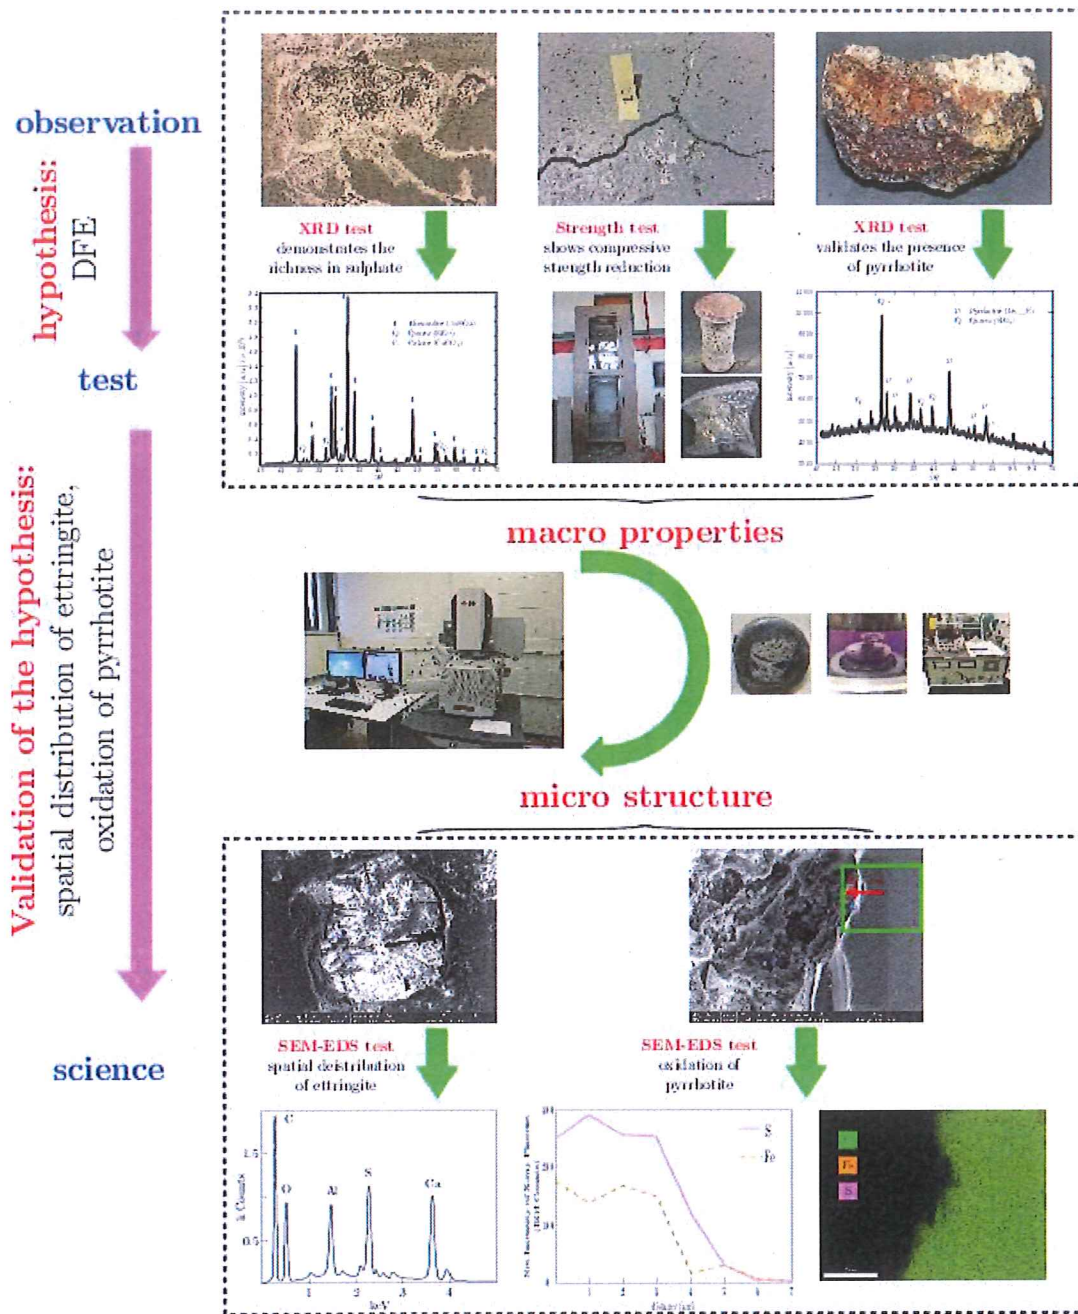
Fig. 1.1 Research Approach

Fig. 1.1 schematically summarizes the research approach, in which visible macroscopic properties are linked to scientific microstructural parameters.

Based on visual inspection typical deterioration symptoms can be identified, such as map cracking, whitish formation of minerals at the vicinity of the cracking surface and reddish - brownish discoloring. After experimental testing and microstructural investigation the results were analyzed and correlated to the deterioration symptoms of the visual inspection. Based on the

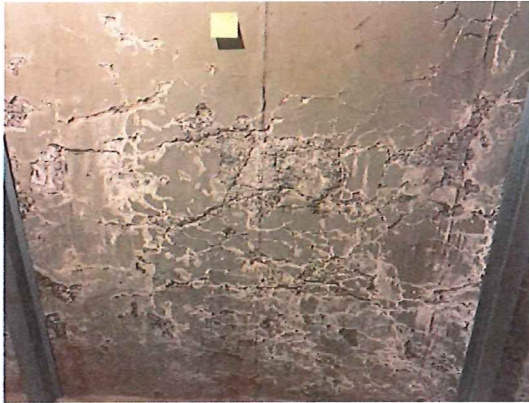
a) map cracking

- map cracking with wide opening and/or significant deformation of the wall
- whitish formation of minerals at the vicinity of cracking surface
- reddish - brown discoloring

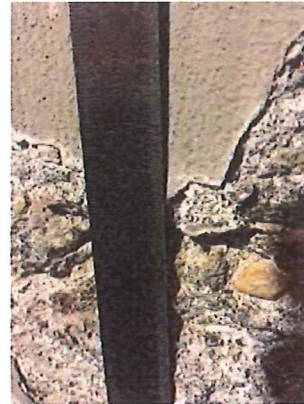
Fig. 3.2 Typical symptoms of deteriorated foundation

d) crack opening (>4mm)

e) significant deformation of the concrete foundation wall

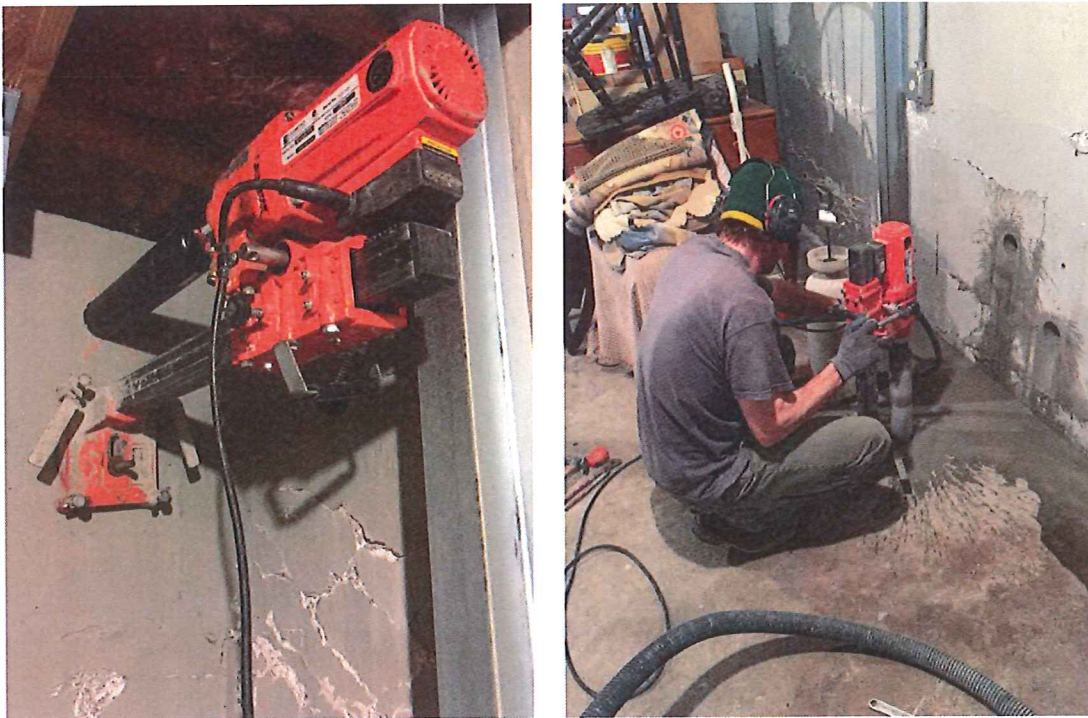
Fig. 4.1 Coring process carried out by a third party contractor

Cylinder cores with a diameter of 3 inch and a minimum length of 6 inch were drilled out of the walls both at relatively intact and deteriorated areas for compressive strength test. The lengths of the cores drilled out of slabs were restrained by the actual thickness of the slab and ranged from 3 to 4 inches. An experienced third party contractor was hired to carry out the coring process (Fig. 4.1). In general, at least 9 concrete samples were cored from the foundation wall of each house.

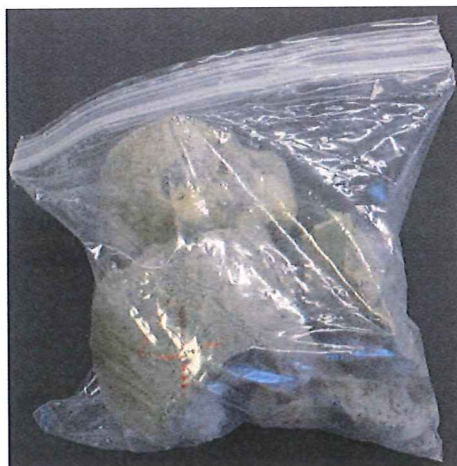
Fig. 4.4 Completely disintegrated core sample of concrete foundation wall– house 1

The compressive strength of individual specimens is summarized in **Table 4-1** along with the average (AVG), standard deviation (STD) and coefficient of variation (CV). It can be seen that most of the CV for intact (IT) zone is smaller than 9% as required by ASTM C42. The CV for severely deteriorated (SD) area is significantly higher than 9% while the CV for moderately deteriorated (MD) zone lies in between. It is worth noting that due to the severe deterioration of the concrete foundation wall, some of the collected core samples are just a group of pieces of disintegrated aggregates with attached matrix (**Fig. 4.4**) thus the compressive strength of such samples are 0 MPa and the compressive strength reduction is considered as 100%. As summarized in **Table 4-1**, the compressive strength reduction of concrete foundation wall ranges from 27% to 100%.

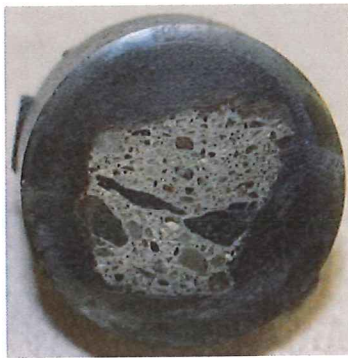
a) samples impregnated with low viscosity resin

Sub-samples were separated from the coarse quarry aggregate and then dried and impregnated with low viscosity resin (**Fig. 5.10a**) which facilitates the grinding and polishing process. The resin impregnated sample was then ground and polished. To avoid damage to concrete during grinding and polishing, water was used as lubricant and excessive heating was avoided. The polished resin impregnated sample was dried at environmental temperature for 24 hours. To increase the conductivity, the surface of samples was sputter coated with a thin layer of gold/palladium (Au/Pd) alloy (**Fig. 5.10b and c**) prior to SEM micro structural examination and EDX elementary analysis. **Fig. 5.11** shows the Teno Field Emission SEM used in this research. Operating conditions were set at 10~15 kV under secondary electron mode.

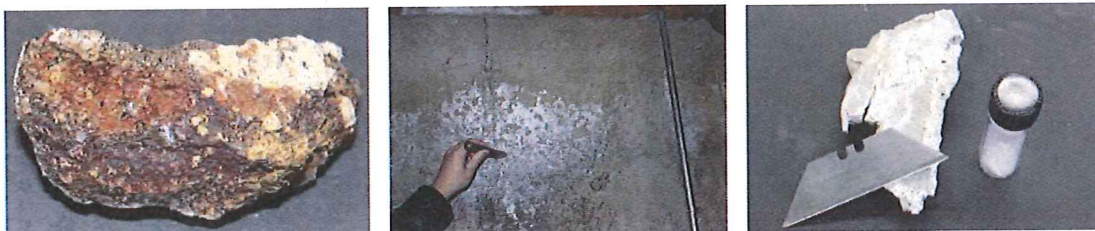
a) separated aggregate

Brown aggregate, which is a sign of iron sulfide oxidation, were selected for this investigation. Aggregates were separated from cement matrix (Fig. 6.1a). Similar procedures described in section 5.1.1 were followed. The whitish formation was scratched off the surface of the deteriorated concrete foundation for XRD testing (Fig. 6.1b). All specimens were step-scanned as random powder from 11° to 80° at $0.02^\circ 2\theta$ steps integrated at 1 s step^{-1} .

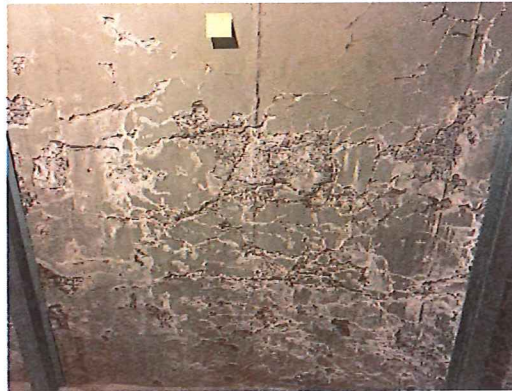
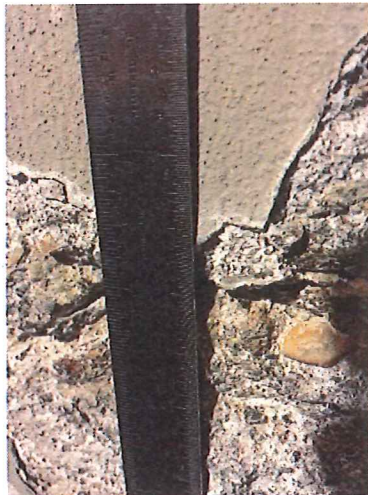
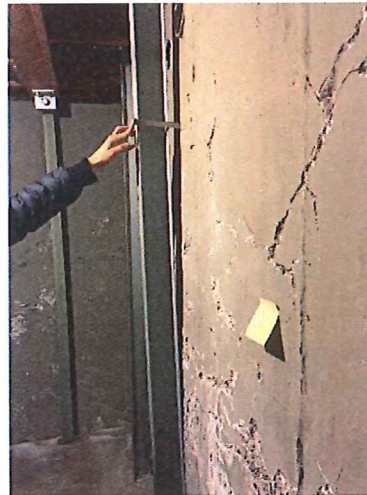
Fig. A- 1 House 1

(a) whitish powder

(c) map cracking

(d) wide crack opening

(e) large deformation
