**Public Meeting
Norwalk River Site 2
Dam Rehabilitation Project**

February 27, 2020

Paul Welle
Melinda Dirdal
Schnabel Engineering

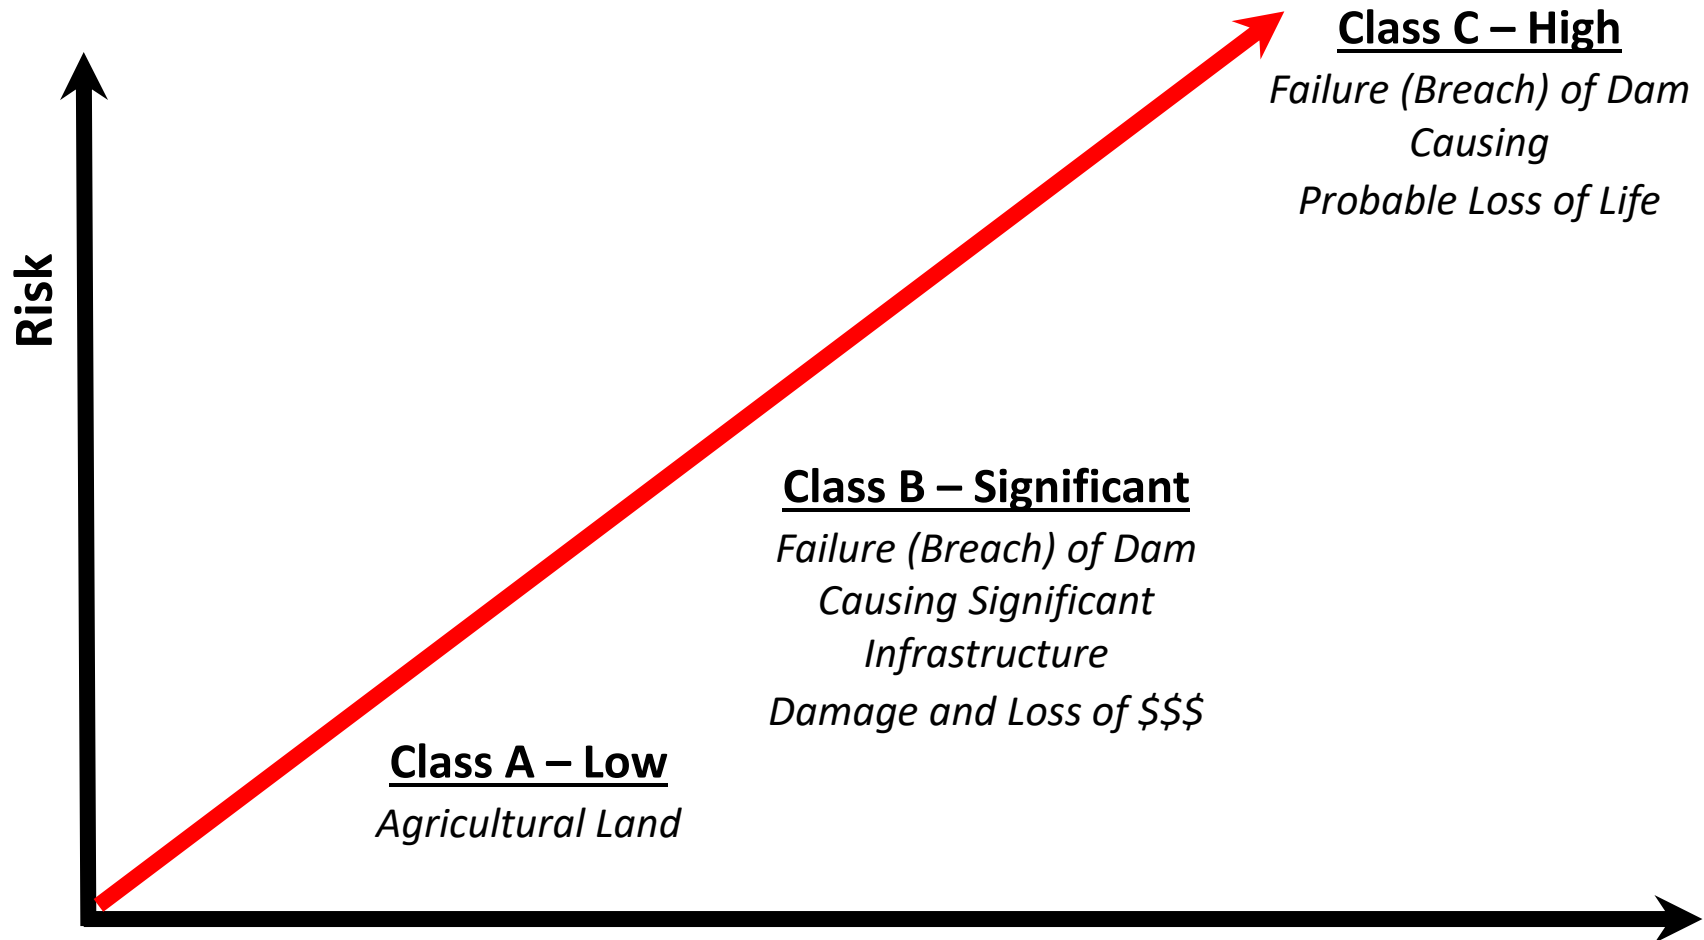
NRCS Hazard Classes of Dams

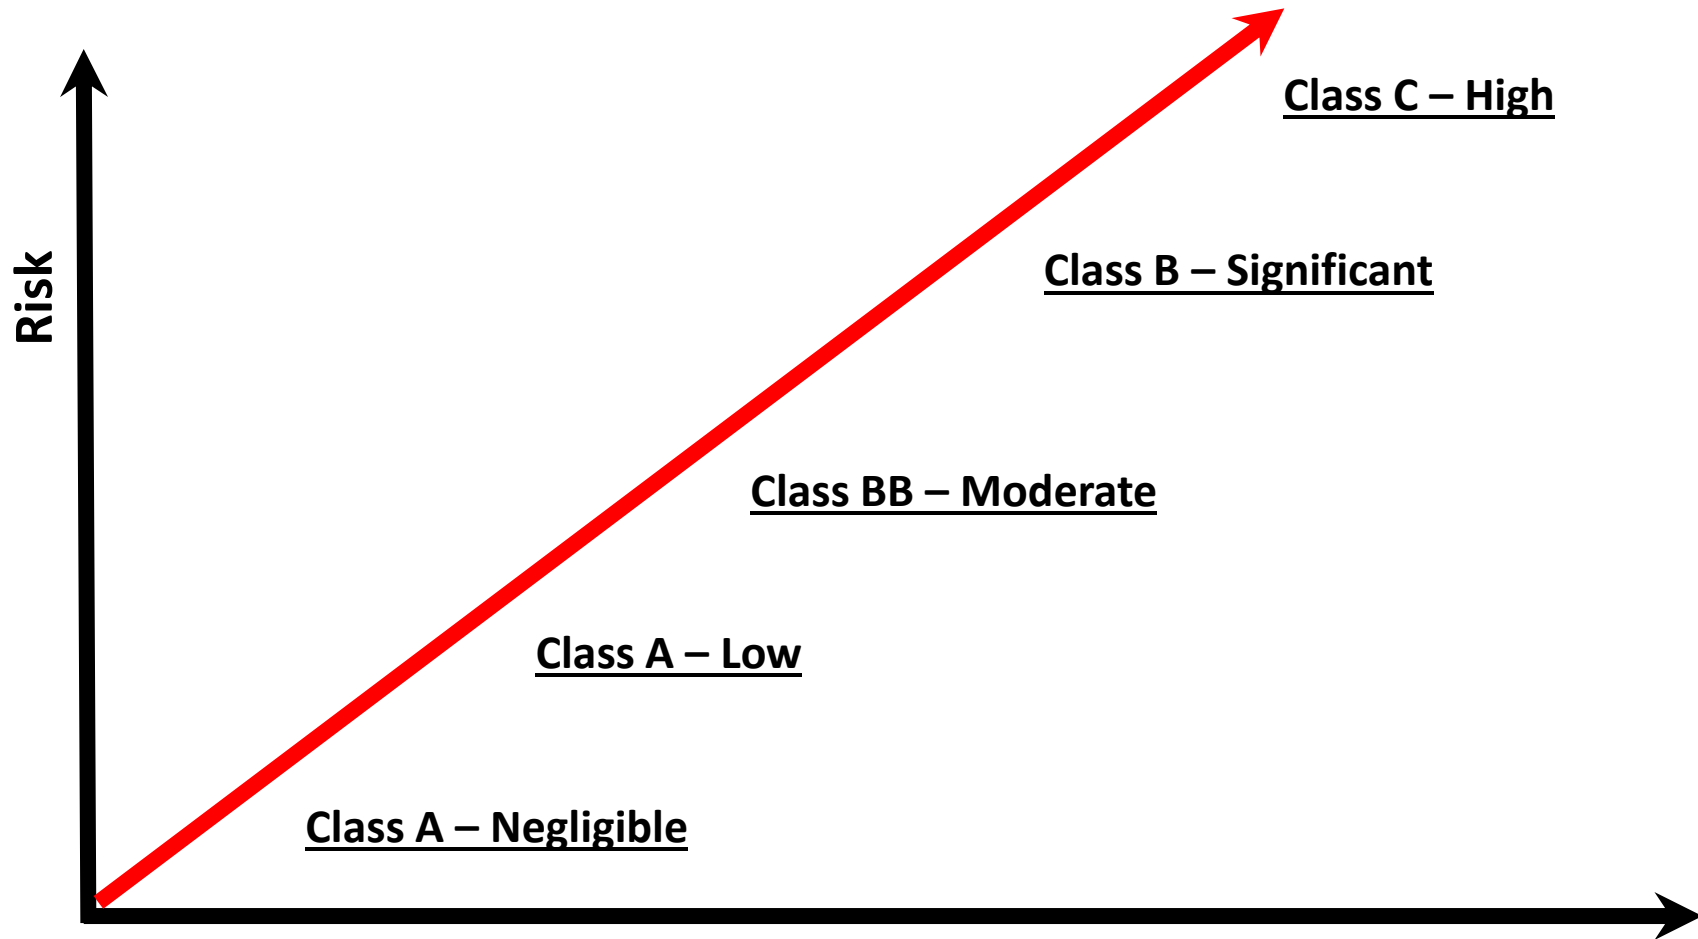
CT DEEP Hazard Classes of Dams

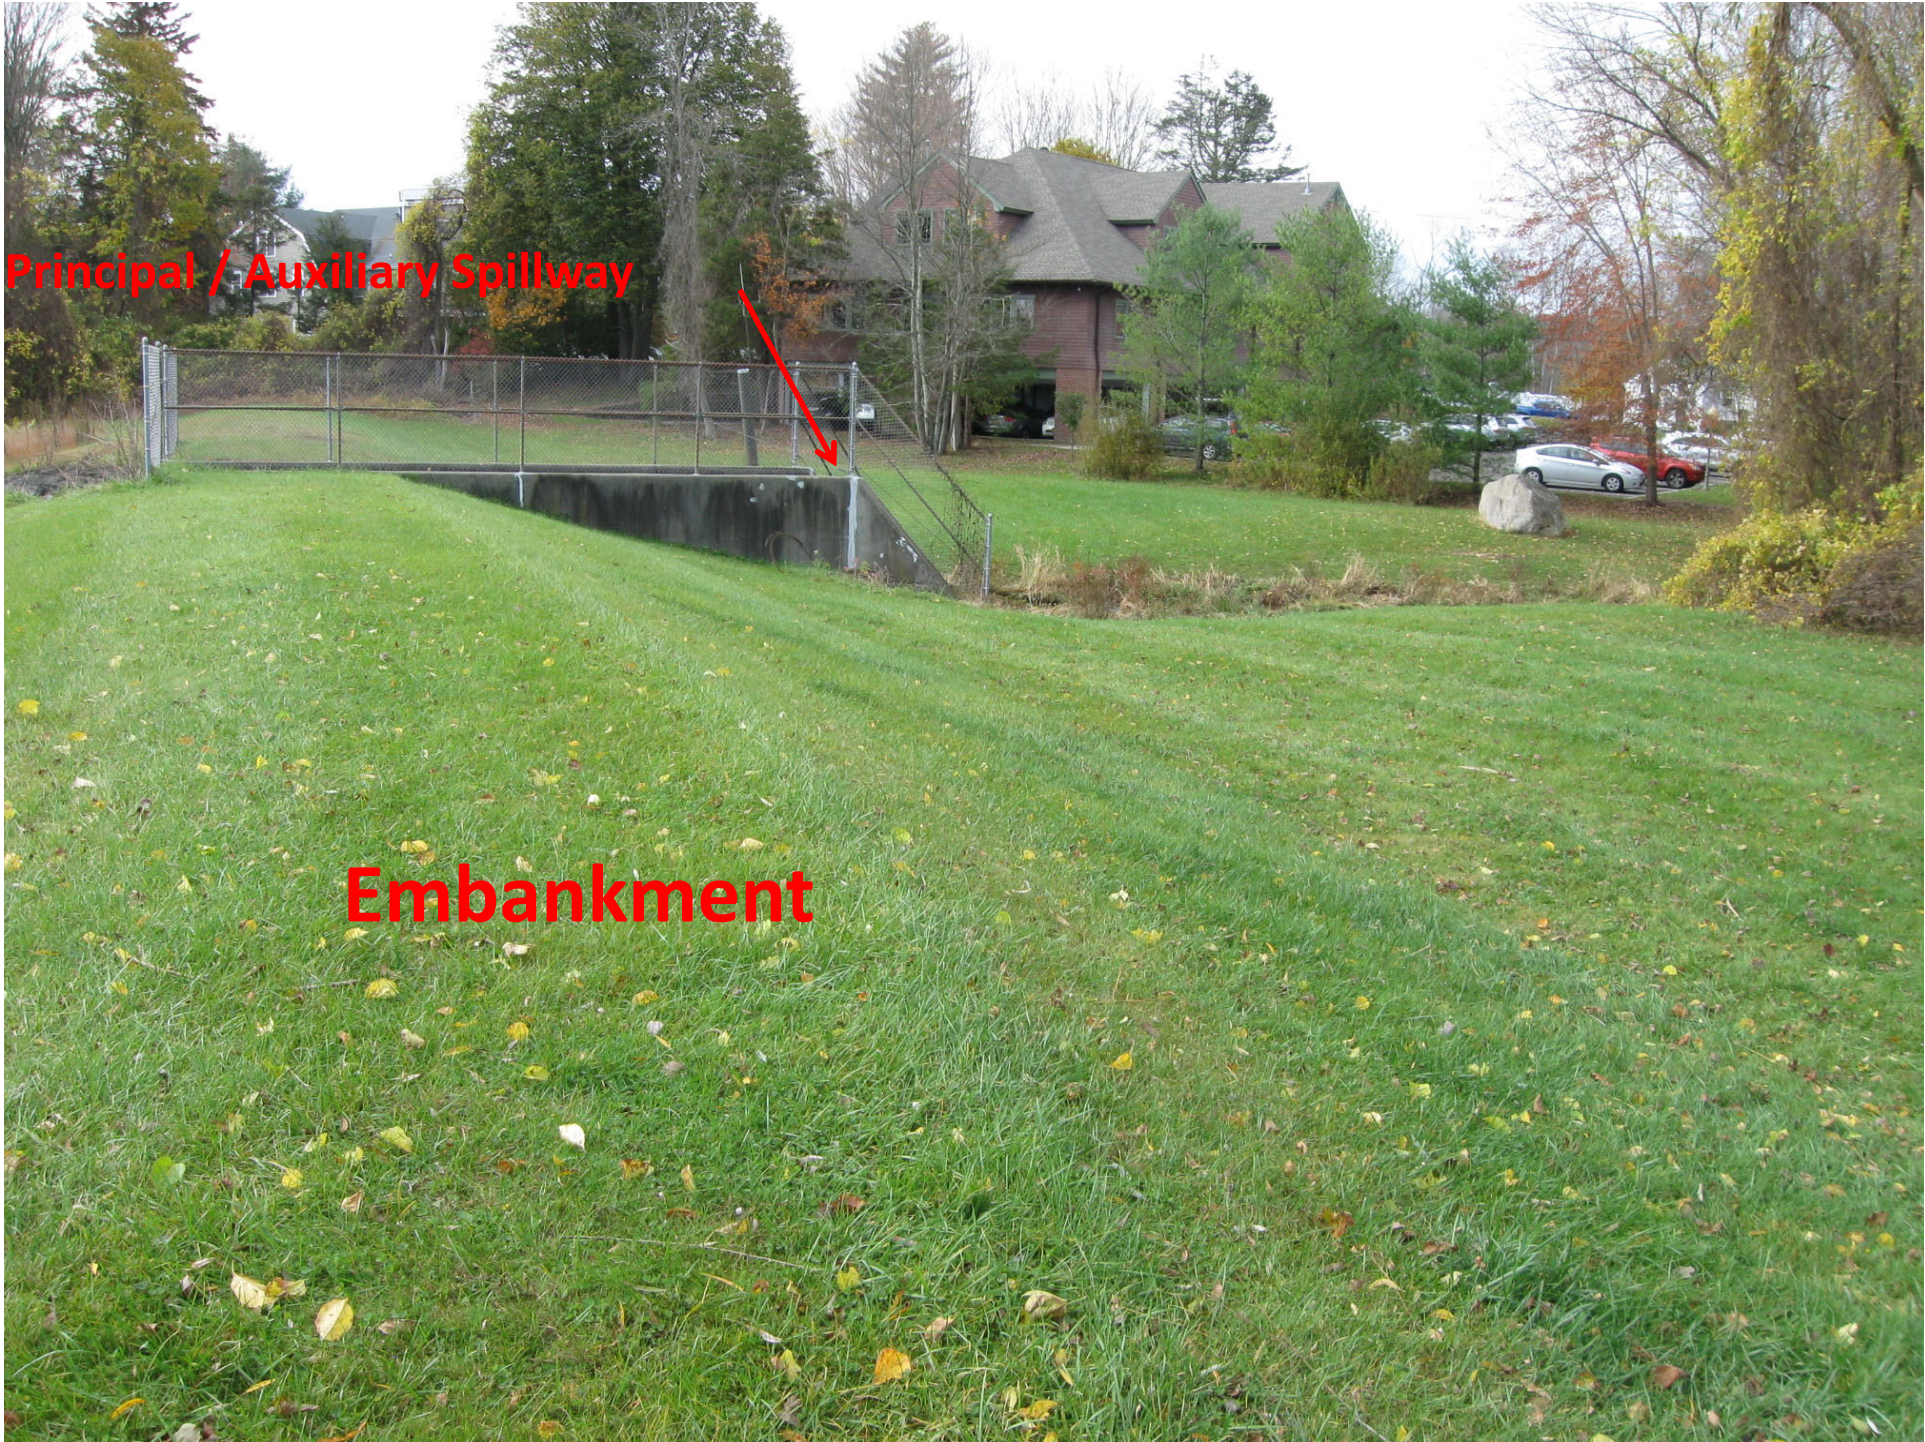
Embankment

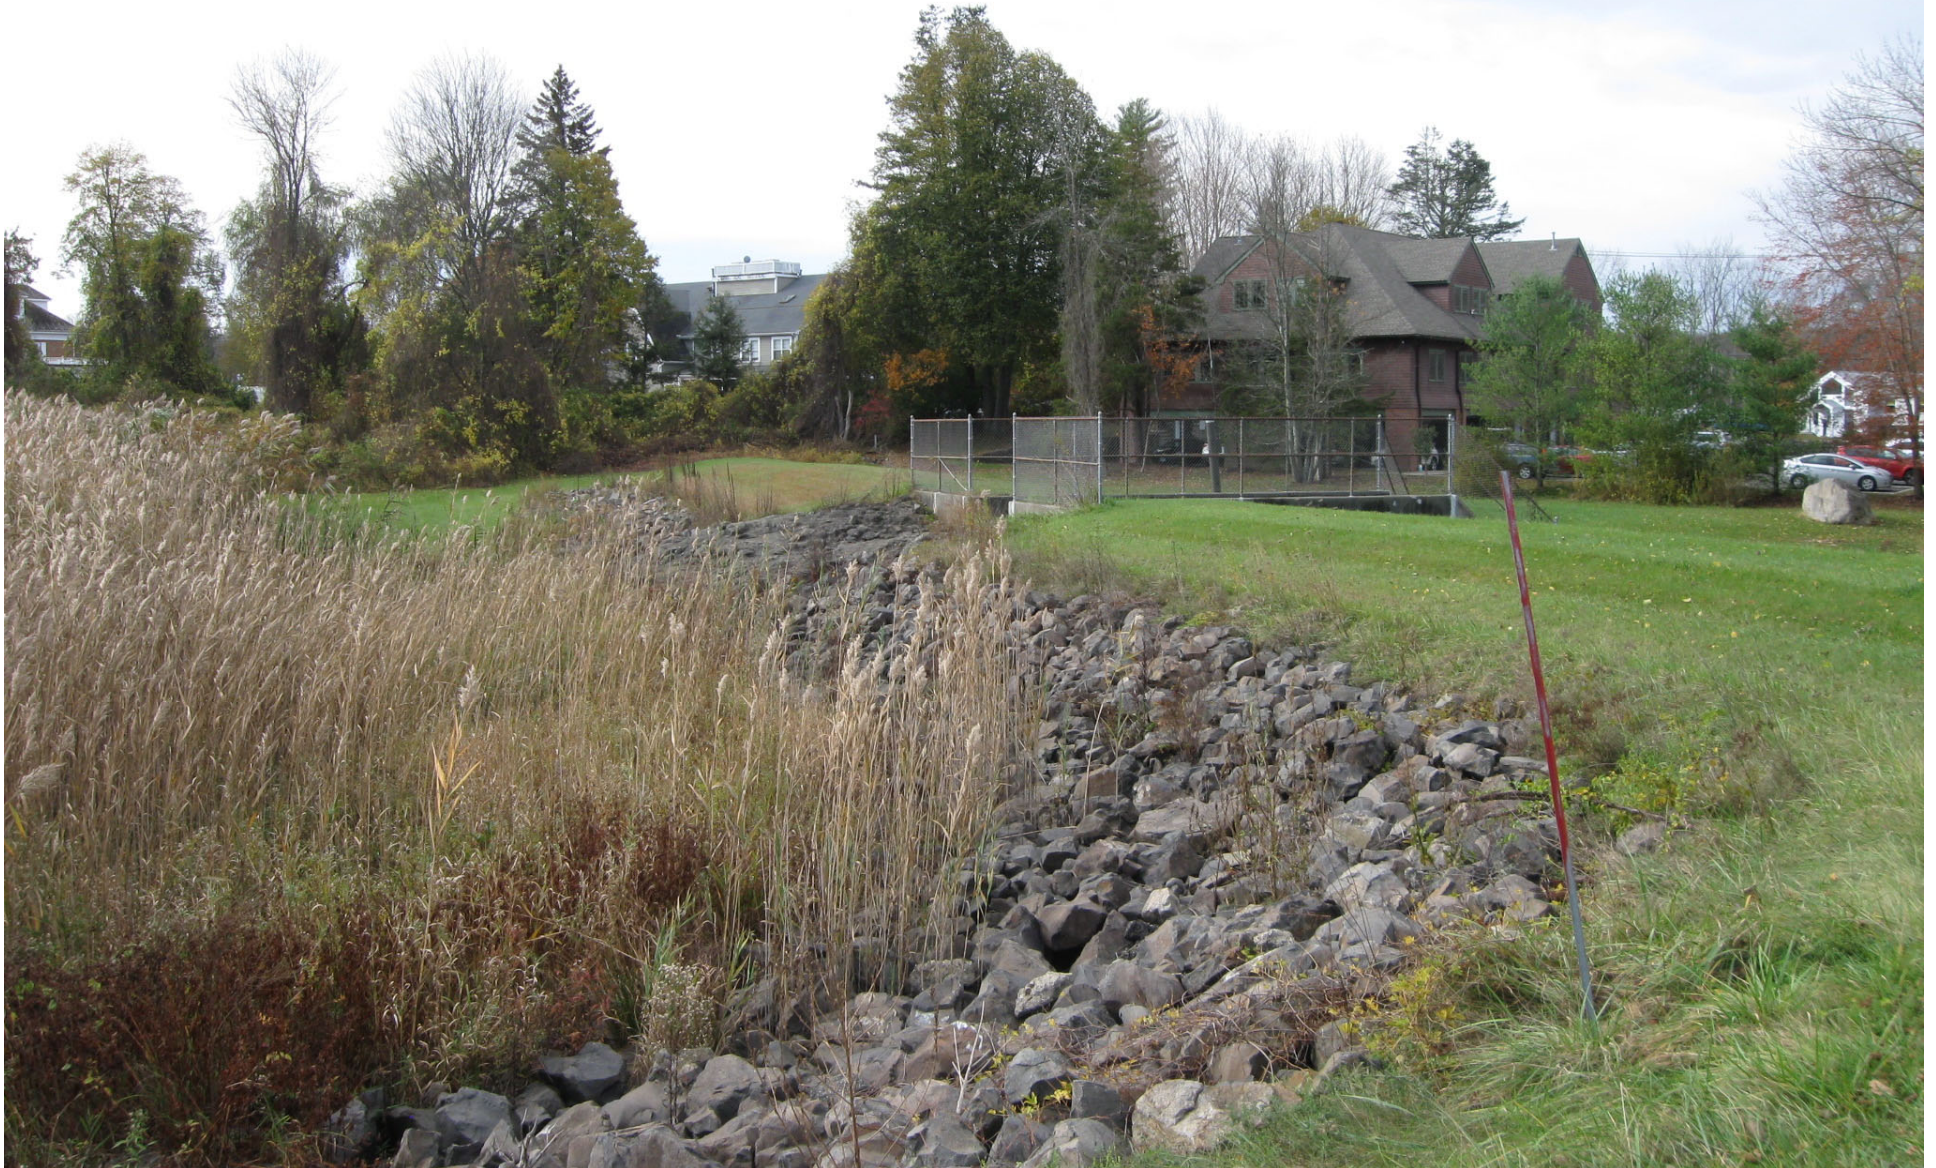
**Upstream Embankment
– Looking From Right Abutment**

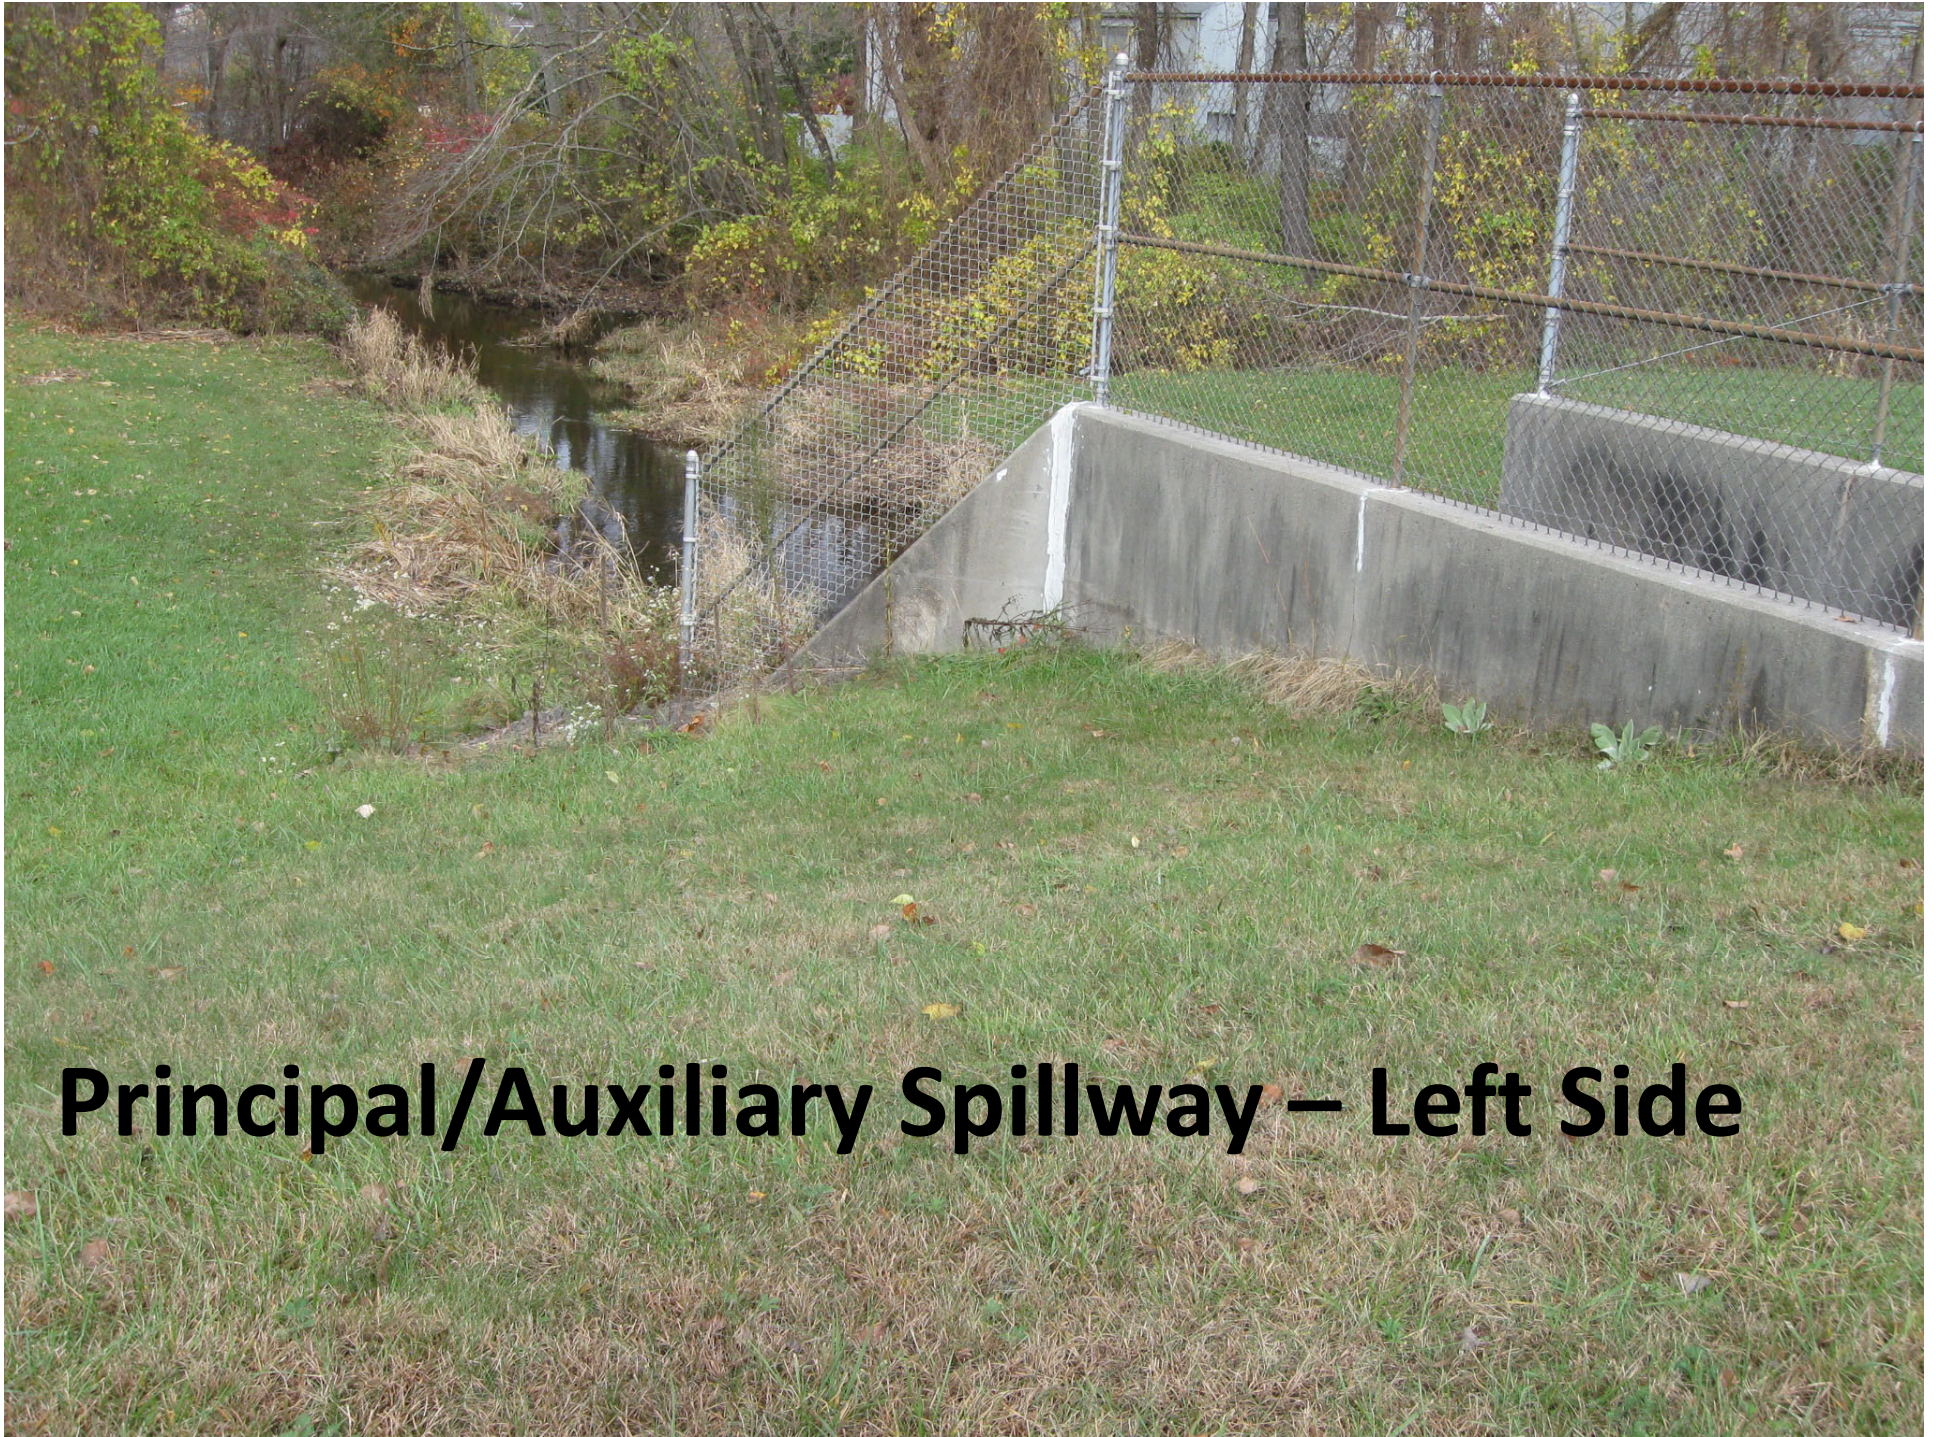
Principal/Auxiliary Spillway – Left Side

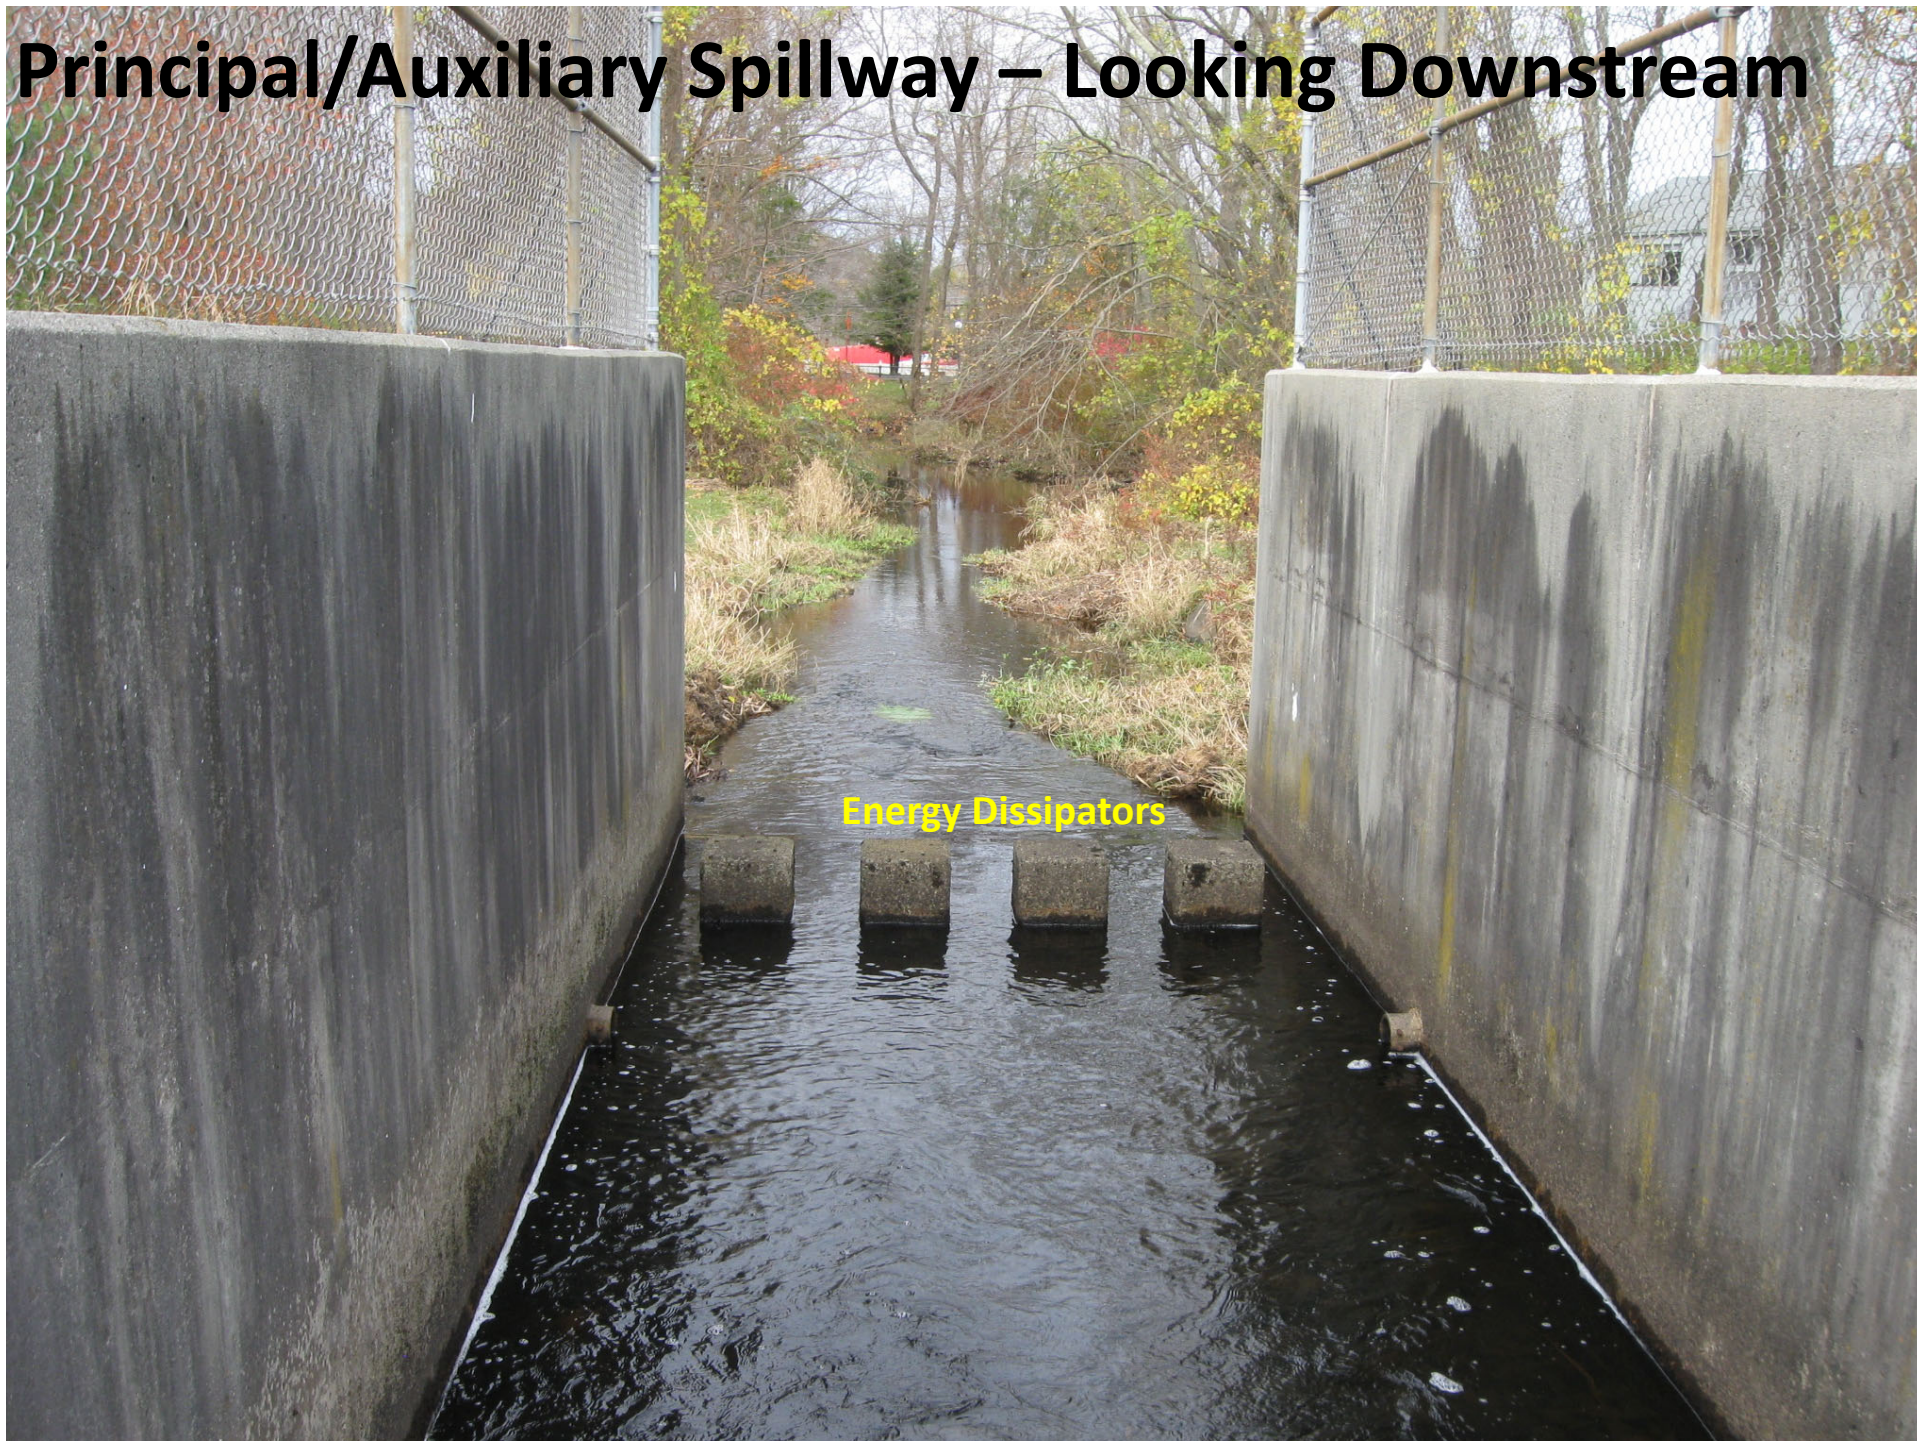
Principal/Auxiliary Spillway – Looking Downstream

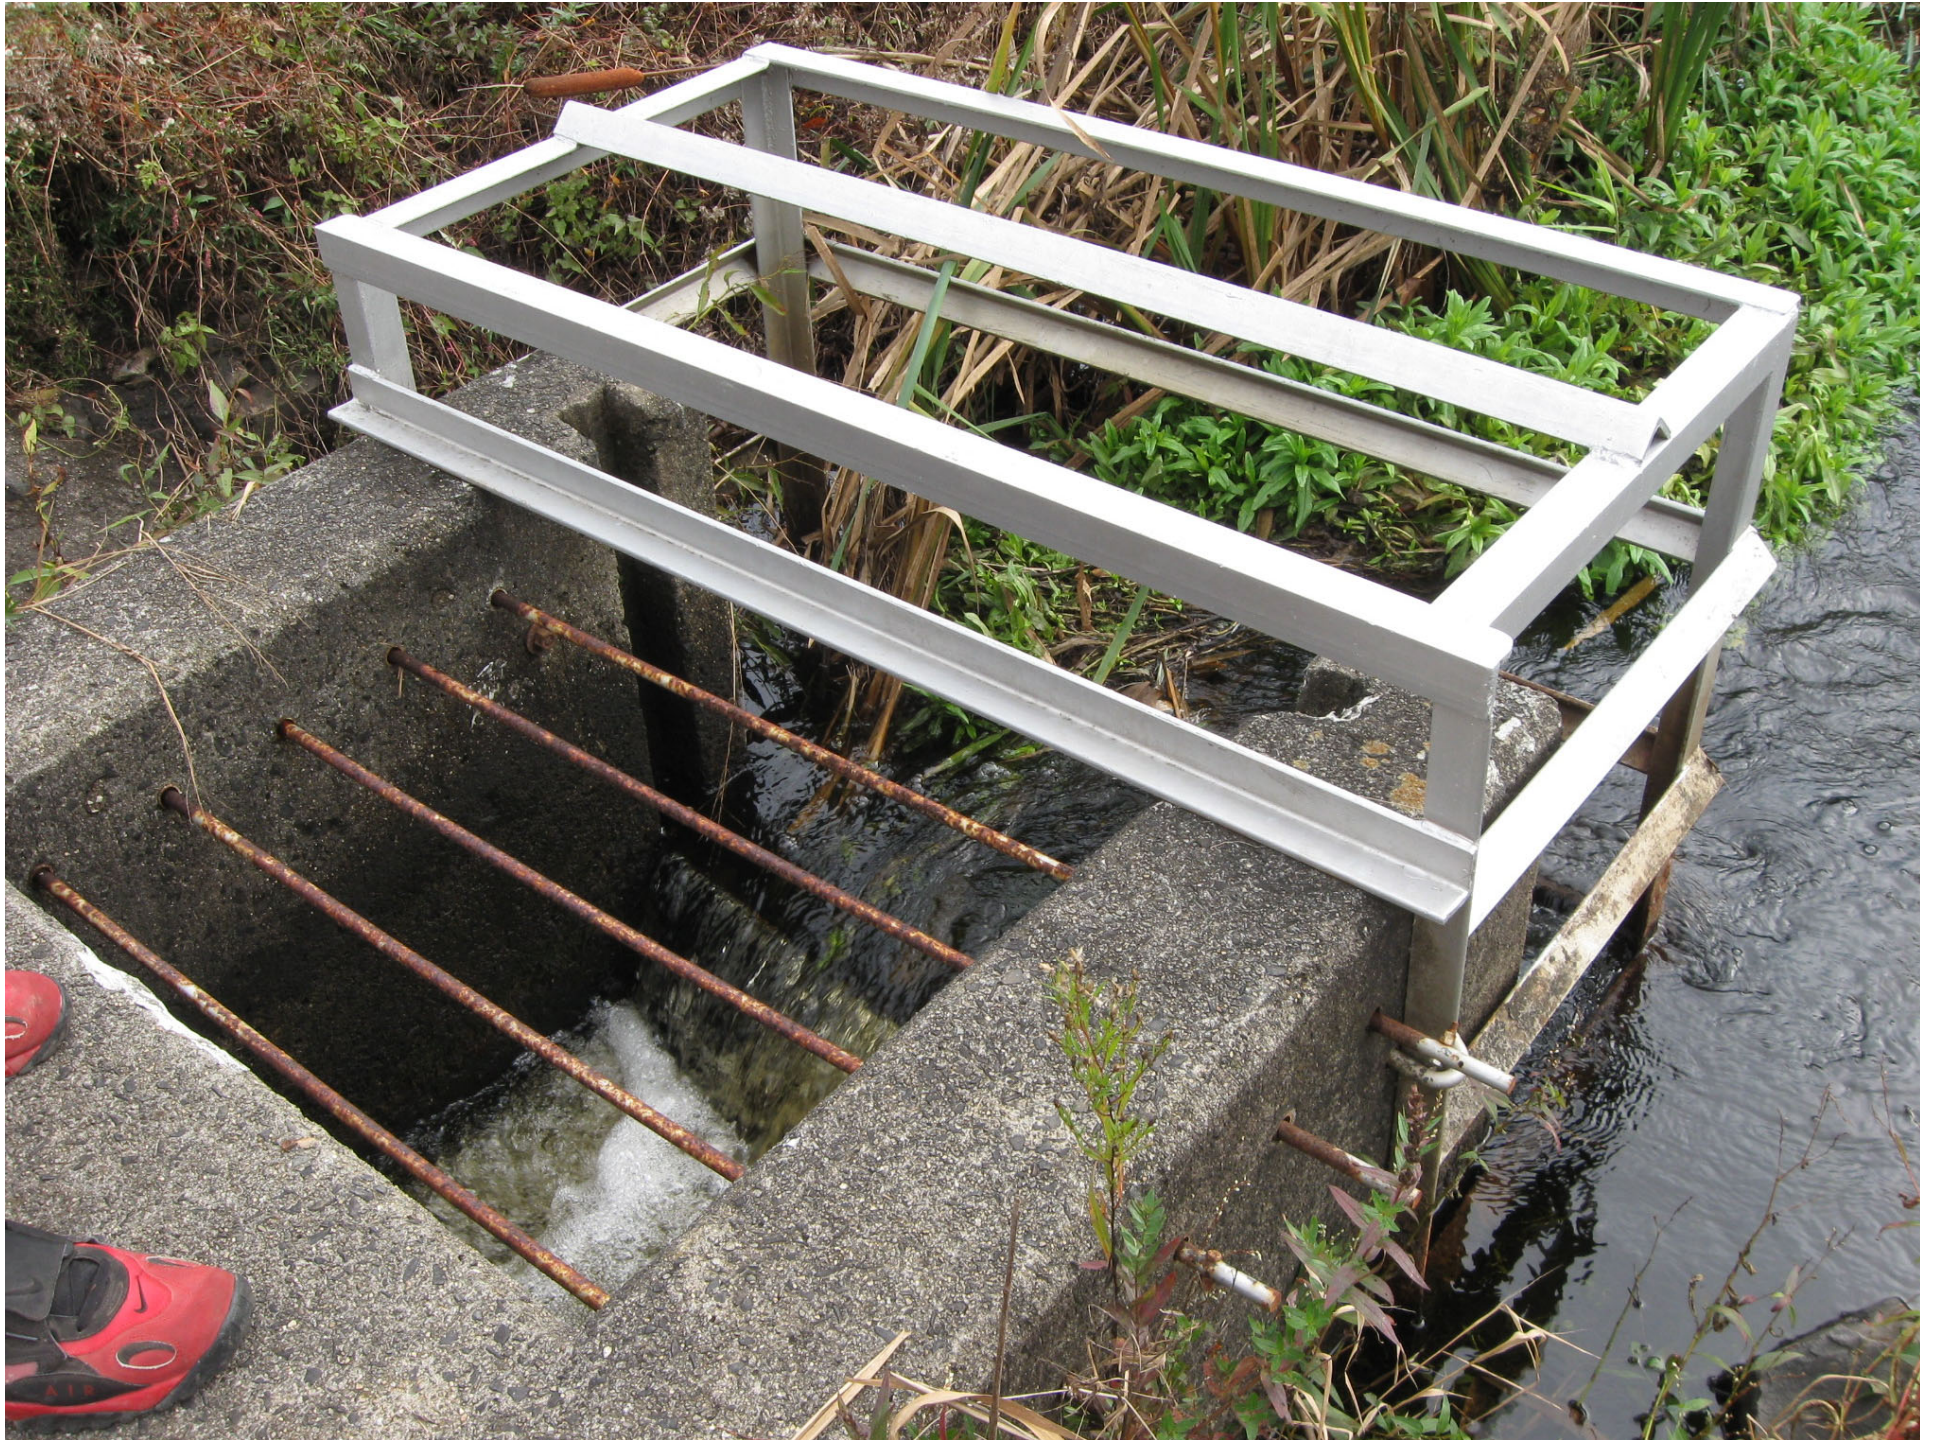
Low Flow Inlet

- Inspected annually
- Regularly mowed and maintained
- Overall good condition
- High hazard classification now
(Significant when constructed)
- The dam assessment performed by NRCS in 2011 indicates inadequate auxiliary spillway capacity
- This study confirmed inadequate capacity

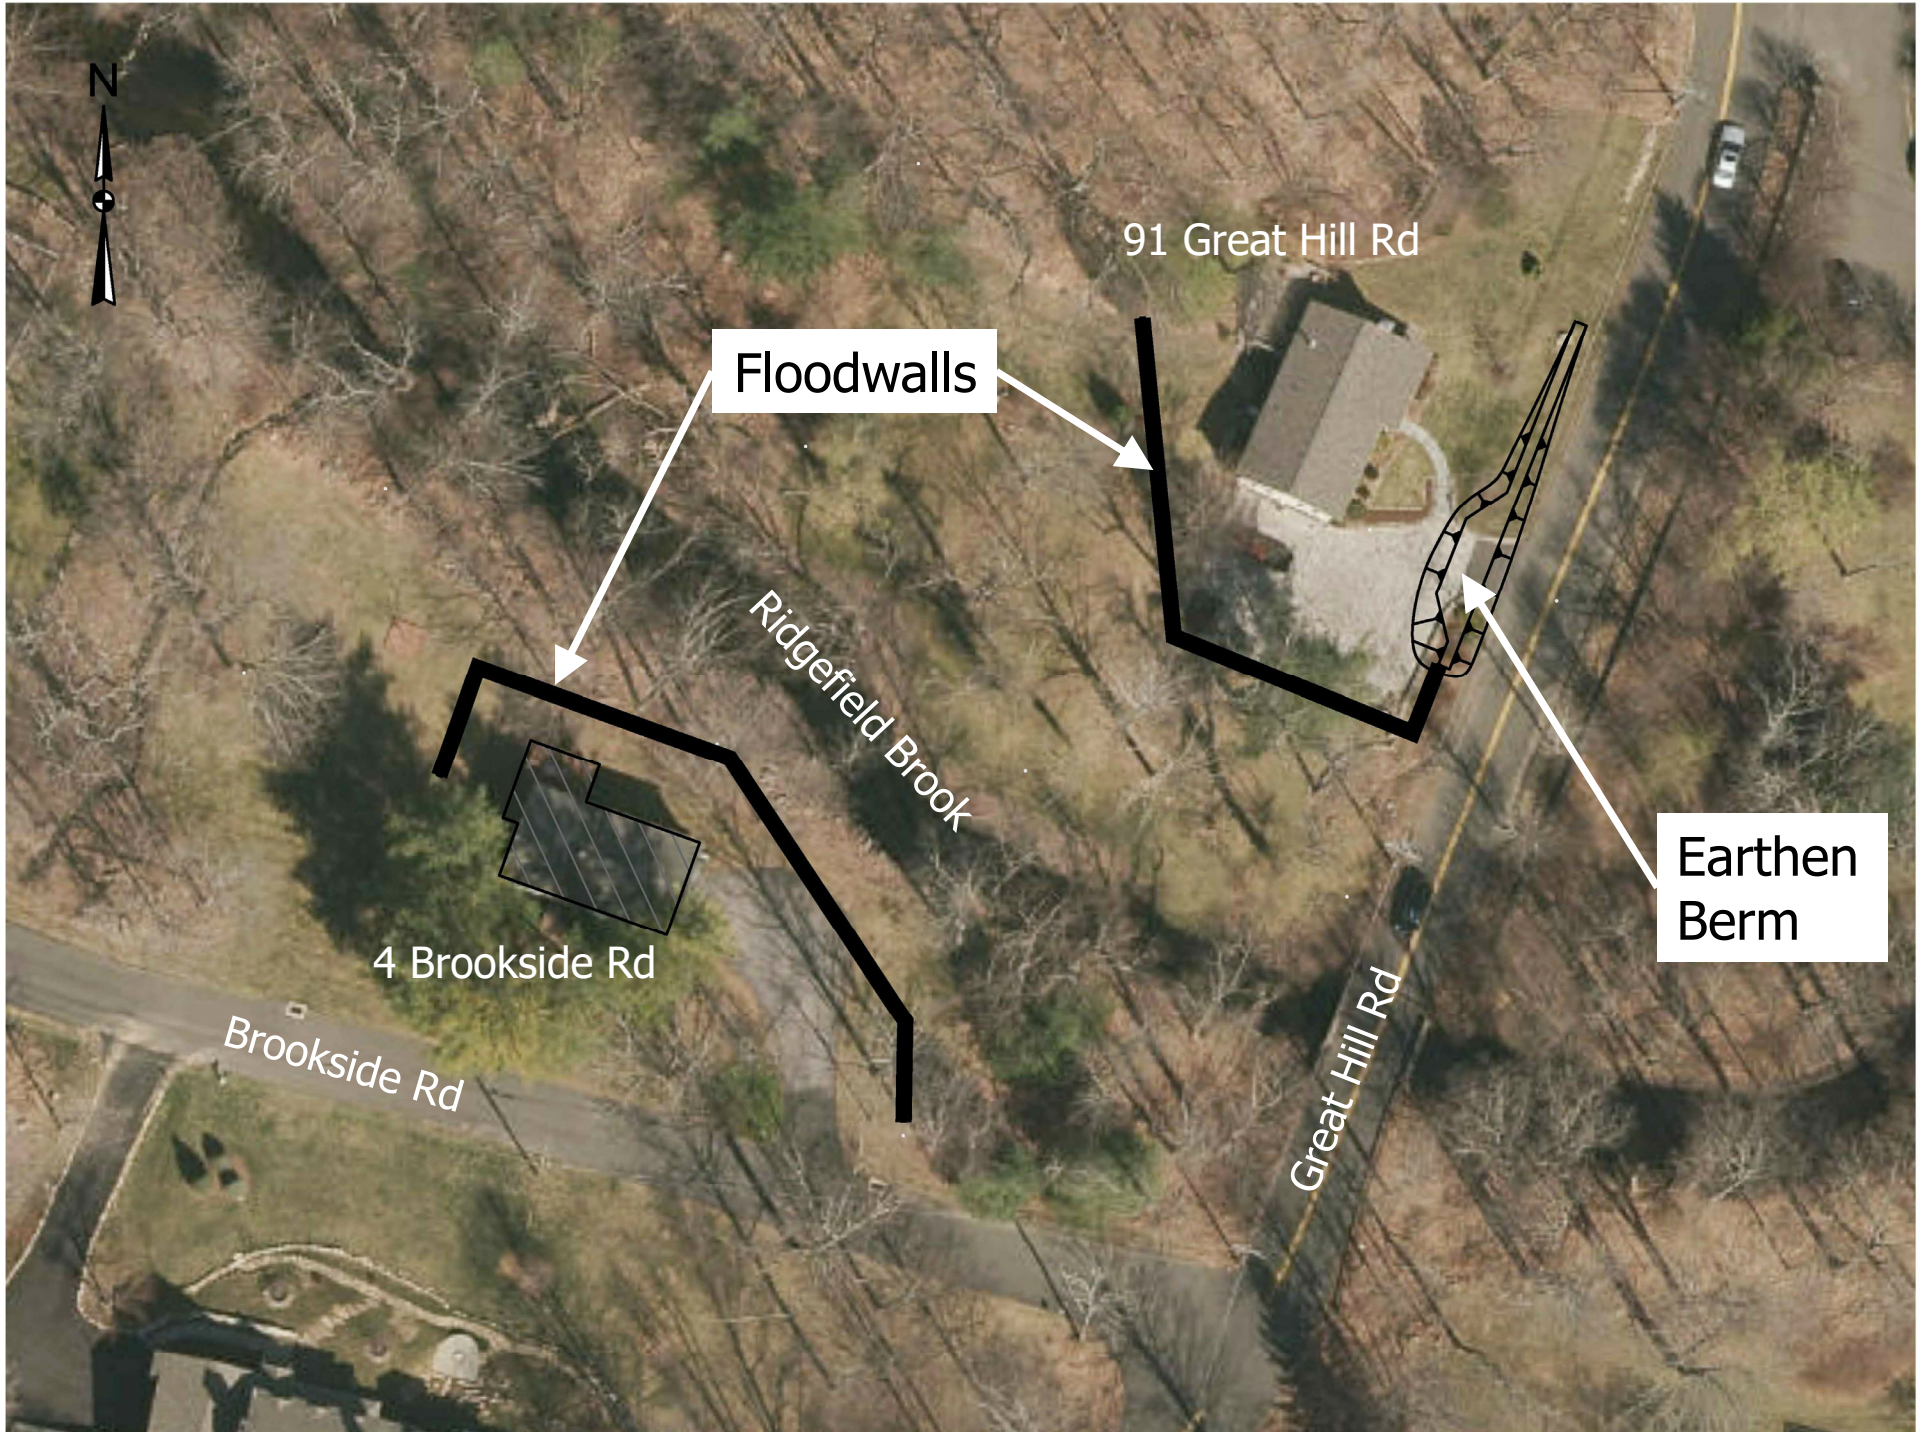
Floodwalls

Earthen Berm

91 Great Hill Rd

4 Brookside Rd
