Section 4

Wastewater Treatment Plants – Existing Conditions

4.2 West Side Wastewater Treatment Plant

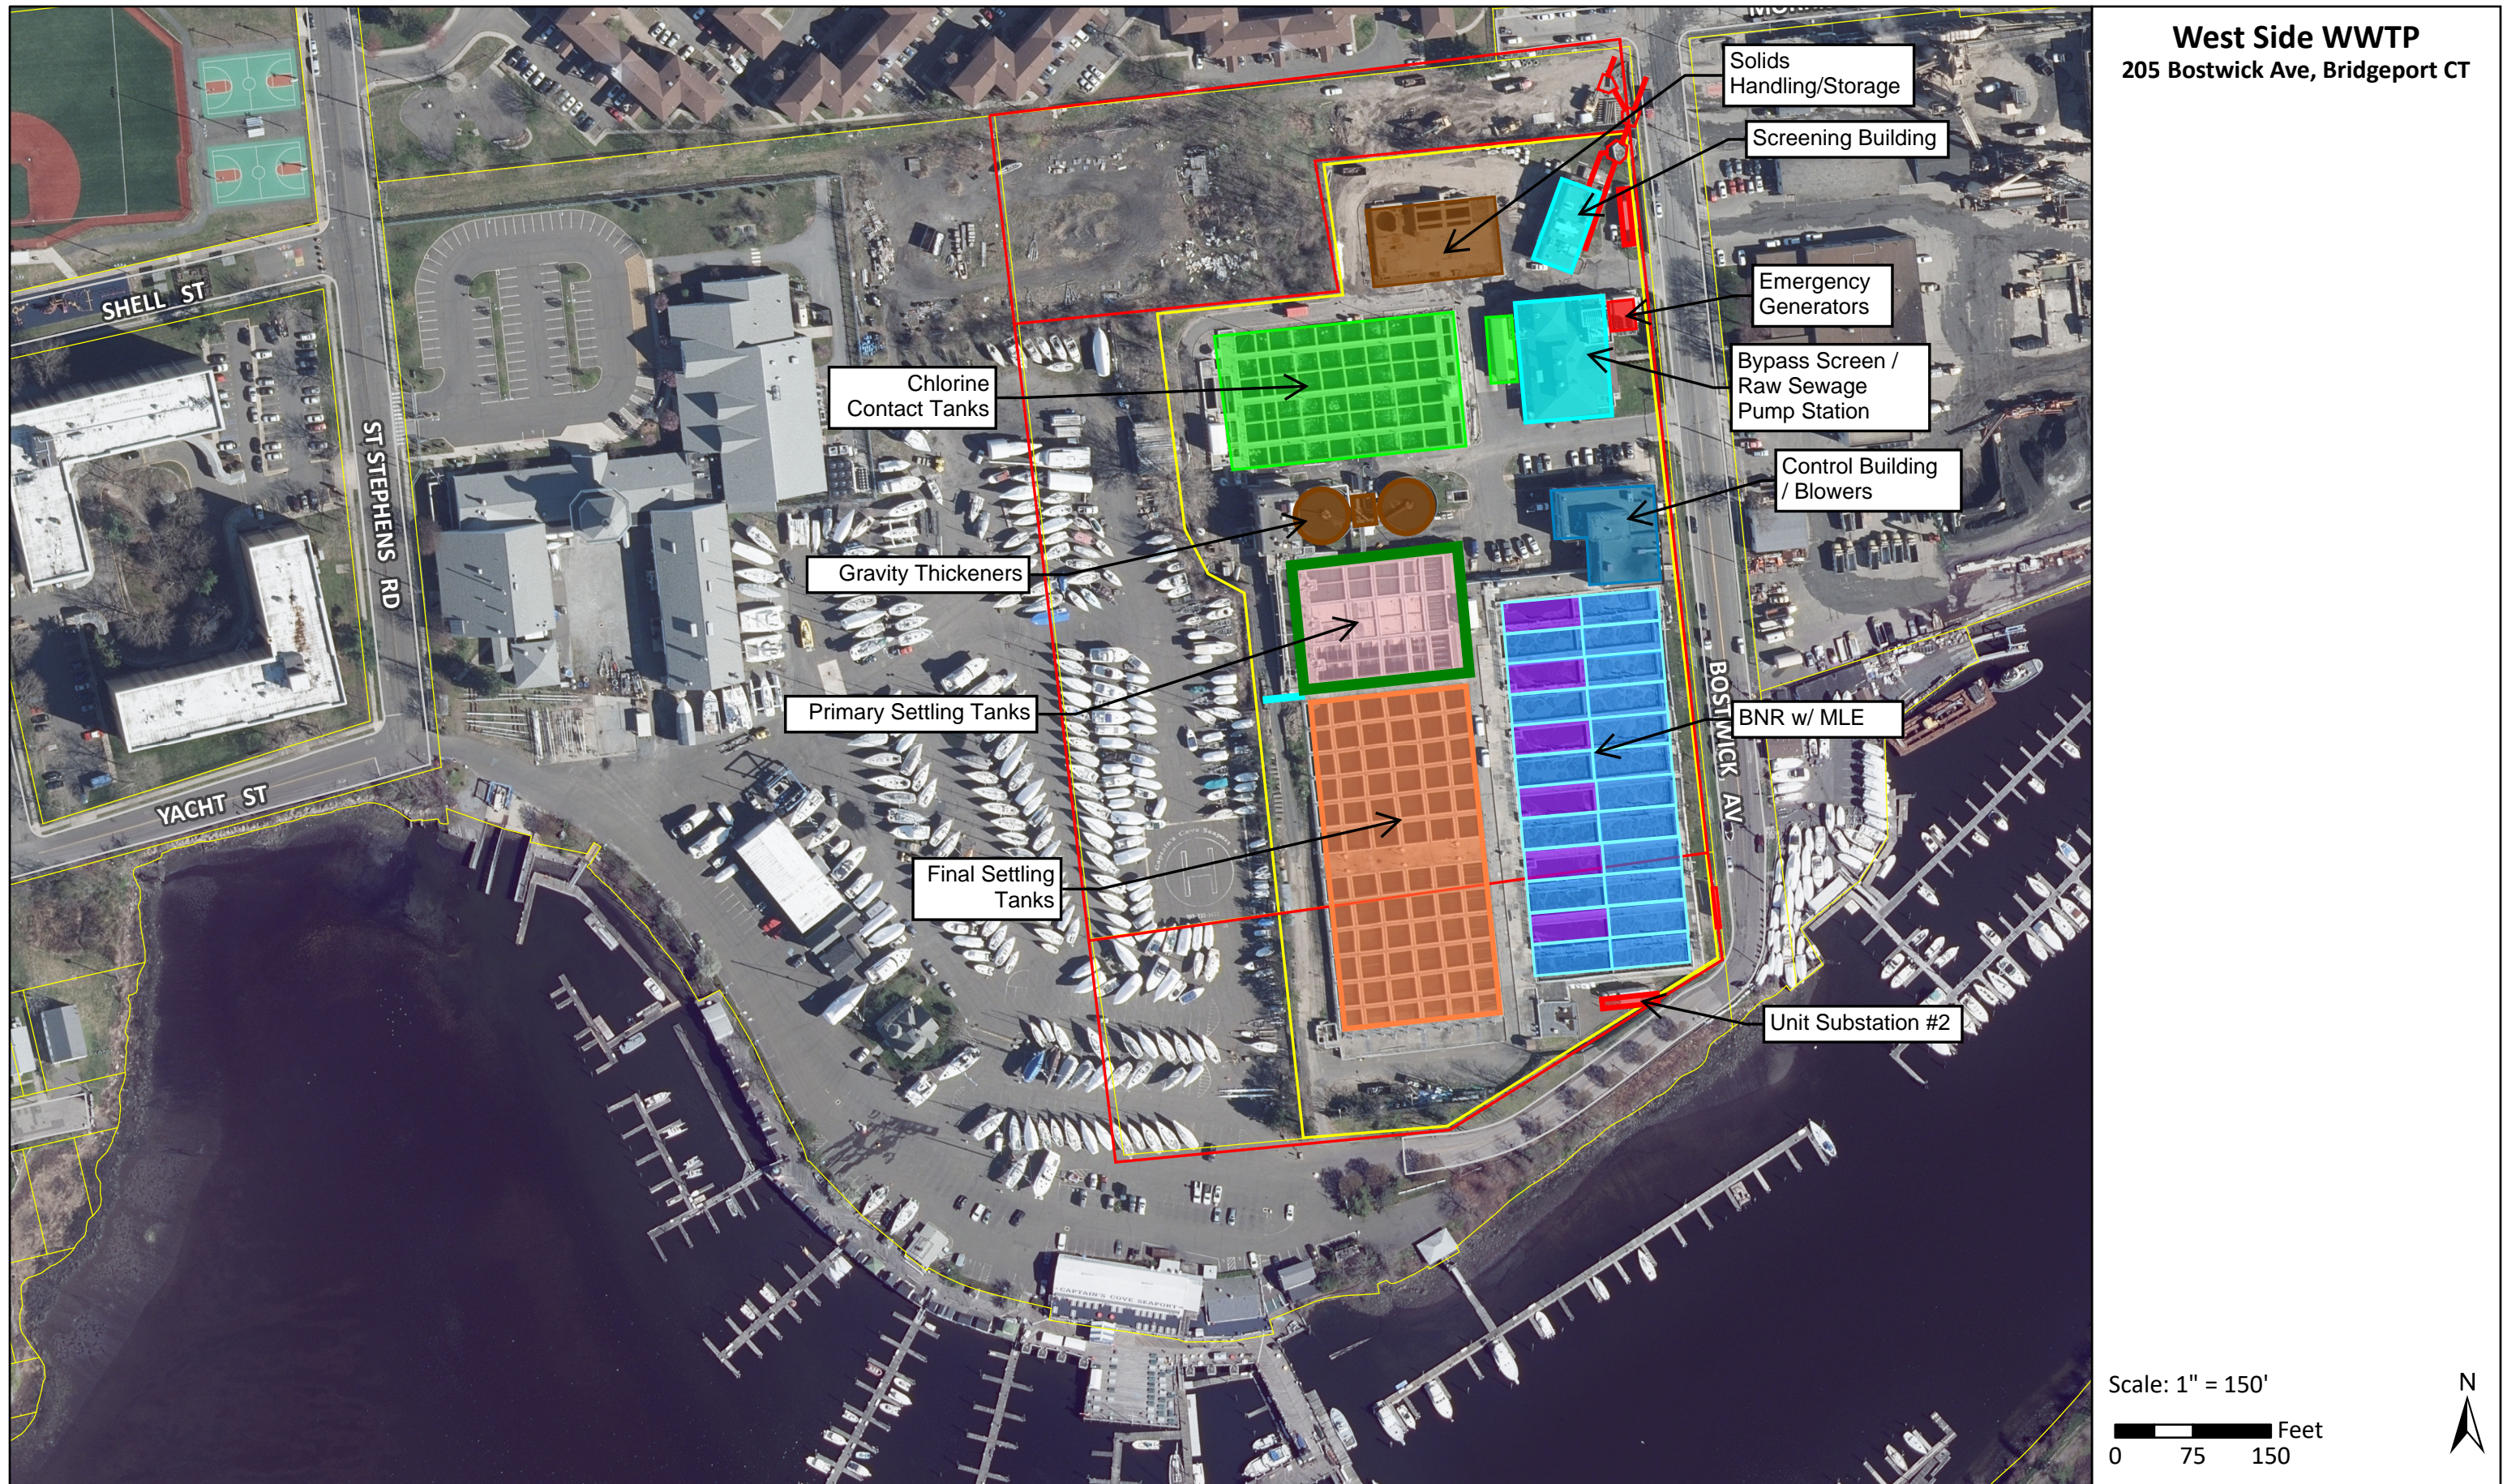
Figure 4.2-2
Existing Conditions - West Side WWTP

Wastewater infrastructure has existed on this site since at least the early 1900s. In 1969 the facility was upgraded from a primary treatment plant to a secondary treatment plant under the "Additions and Alterations to Wastewater Treatment Facilities" project. The treatment facility had significant mechanical system upgrades under the 1992 "Rehabilitation of West Side Wastewater Treatment Plant" project. Under the 2001 "Interim BNR Retrofit" project the activated sludge system was converted to an MLE process to impart some level of nitrification and denitrification in accordance with the DEEP's General Permit for Nitrogen Discharges. In addition, dechlorination was incorporated in 2004 under the "Dechlorination Facilities Project No. 3100". An aerial of the West Side WWTP site is presented in **Figure 4.2-2**.

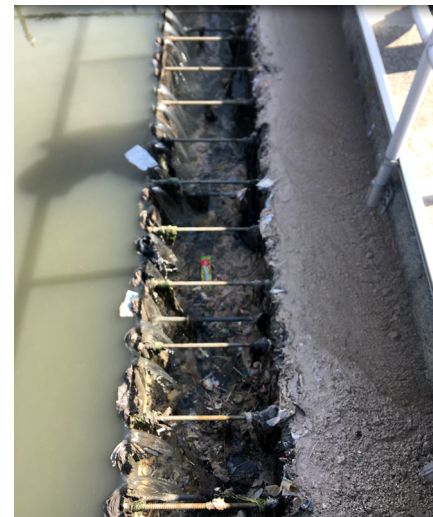
Figure 4.2-4
Scum Accumulation on Primary Clarifier Weirs

Primary scum was designed to be conveyed from the manually operated rotating scum trough to a primary scum pit located adjacent to the primary tanks. According to WWTP staff, the scum removal system never operated well and the system has since been abandoned, resulting in scum accumulation at the primary effluent weirs as shown in **Figure 4.2-4**.

Plant operators currently remove scum periodically from the surface of the primary tanks using a vactor truck. Despite this periodic scum removal, a significant amount of scum passes to downstream processes. The scum collected in the vactor truck is transported to the East Side WWTP where the liquid is decanted and discharged at the headworks and the solids are discharged in the solids handling tent at the East Side WWTP until they can be disposed of. Operators have noted that this decanting

No grit removal system currently exists. Grit settles in the sewers, wet well, and primary influent channels under low flows. During peak flows, settled grit is flushed into the primary tanks, increasing the risk of collector failures, over-loading the sludge hopper and clogging primary sludge pumps and discharge piping. The scum collection system is defunct, therefore scum, rags and other floating debris accumulates along the weirs and get flushed to downstream processes during peak flow events.

The existing conventional primary settling tanks are grossly undersized for design average day and peak flow conditions, and most equipment and piping is past its useful life. It is recommended that the system be rehabilitated and expanded or replaced in its entirety. Tankage could be reused if feasible.

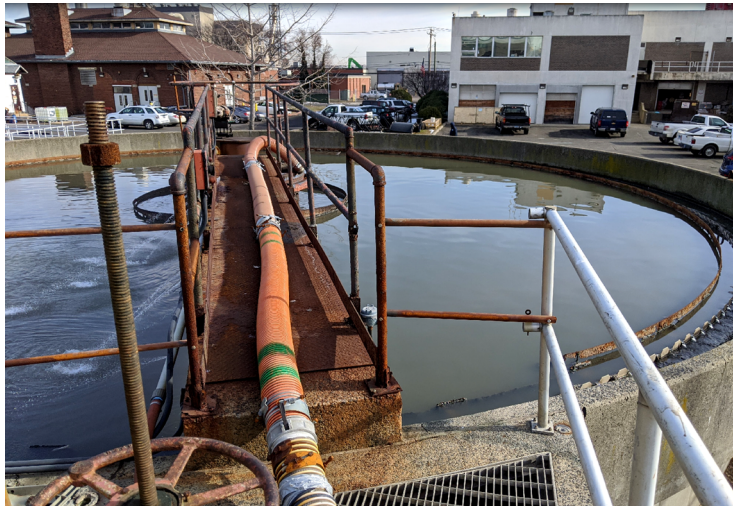
Figure 4.2-6
Gravity Thickener Tank #1 (temporary WAS pipe on walkway)

The GT tanks each have a center drive mechanism that moves a rake arm and scraper around the tank. The rake moves the sludge towards the center of the tank for withdrawal and releases gases from the sludge to improve thickening. The thickened sludge at the bottom of each tank is pushed to a center hopper by the squeegee blade scrapers.

The GTs at the West Side Plant are uncovered with no associated odor control system. There have been no known reported issues of excessive odors from the thickeners. The mechanisms on both of the GTs have reached their useful life. The concrete, over 50 years old, appears to be in fair condition but is showing some cracking and wear.

The GTs are over 50 years old but appear to be in fair condition structurally, exhibiting some cracking and concrete deterioration. The GT equipment in GT No. 1 was recently replaced but the remainder of the equipment is nearly 30 years old and has reached the end of its useful life. Furthermore, the GTs are not sized adequately sized for co-settling primary and WAS.

The existing sludge processing and disposal system is inadequate and is in need of replacement, to upgrade existing equipment and to provide permanent, reliable solution to sludge management. The newly installed RDT should be relocated and reused as part of the upgrade.

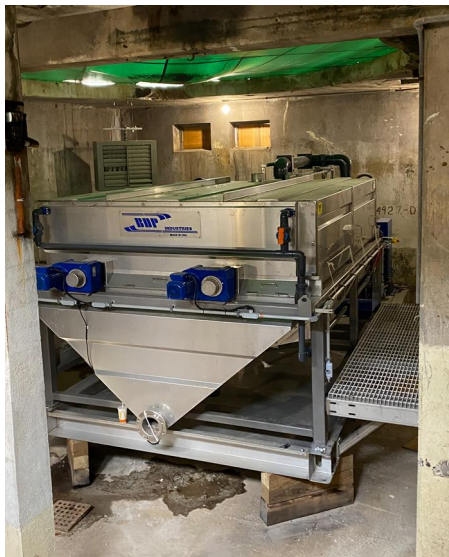
Figure 4.2-8
Rotary Drum Thickener Skid

The contract operator has recently (summer 2020) rehabilitated the Sludge Storage Tanks and installed thickening/pumping equipment in the lower level of the partially demolished Sludge Disposal Building. The temporary thickening of WAS in GT No.1 is no longer practiced and the West Side WWTP has returned to mechanical WAS thickening and co-storing thickened sludge (WAS and Primary) in the Sludge Tanks. Combined thickened sludge is then pumped and hauled for disposal. The packaged thickening system includes a dual drum RDT, WAS feed pump, washwater booster pump, polymer system and associated electrical, instrumentation and control panels. The RDT is manufactured by BDP Industries and sized to thicken up to 250 gpm of WAS with 1.0 to 1.5% solids content to a final solids content of up to 7%. The sludge feed pump is a Borger rotary lobe pump capable of pumping 415 gpm at 30 pounds per square inch (psi). This pump, equipped with a magnetic flow meter, is used to control the WAS sludge feed rate and controls polymer dosing. The thickened sludge is then pumped into the Sludge Storage Tanks by a 6-inch double disc Penn Valley Pump. The skid mounted equipment, prior to startup/connection is shown in **Figure 4.2-8**.

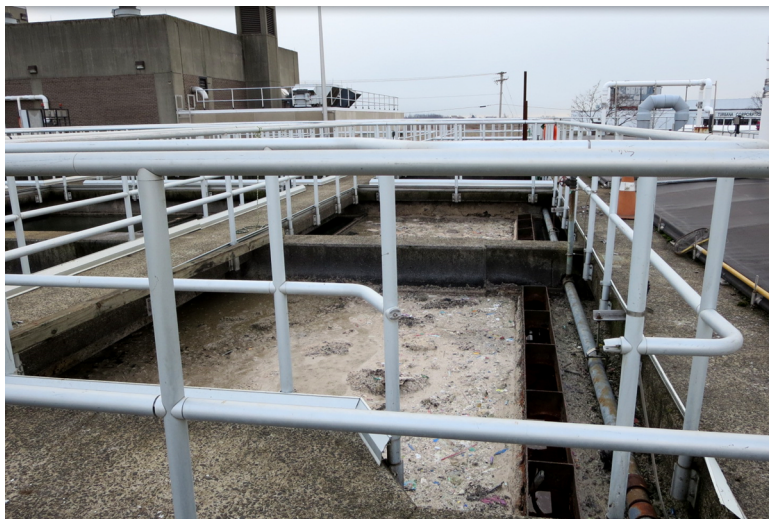
Figure 4.3-3
Inoperable Primary Scum Collection Troughs and Accumulated Scum

Primary scum was designed to be collected from the top of the primary settling tanks and conveyed to a primary scum pit adjacent to the primary settling tanks. The rotating scum collection troughs at the effluent side of the primary settling tanks were intended to be periodically rotated (manually) just below the water level to collect and convey the scum to the scum pit. Scum was intended to be decanted in the pit and the remaining solids would be collected by vactor truck and discharged to the sludge holding tanks.

In practice, there were multiple issues with the operation of the primary settling tank scum removal system rendering the system inoperable. Today, WWTP operators are required to periodically remove scum from the surface of the primary tanks directly using a vactor truck. The lack of proper scum removal in the primary tanks results in the accumulation of large amounts of floating scum on the surface of the primary tanks that pass through to the subsequent unit processes under high flows. **Figure 4.3-3** shows a photograph of such accumulation observed during a site visit.
