Bantam Lake Watershed Based Plan Project

Summary of Project Kickoff Webinar May 7, 2020

Watershed-Based Plan Project

Webinar:
May 7, 2020

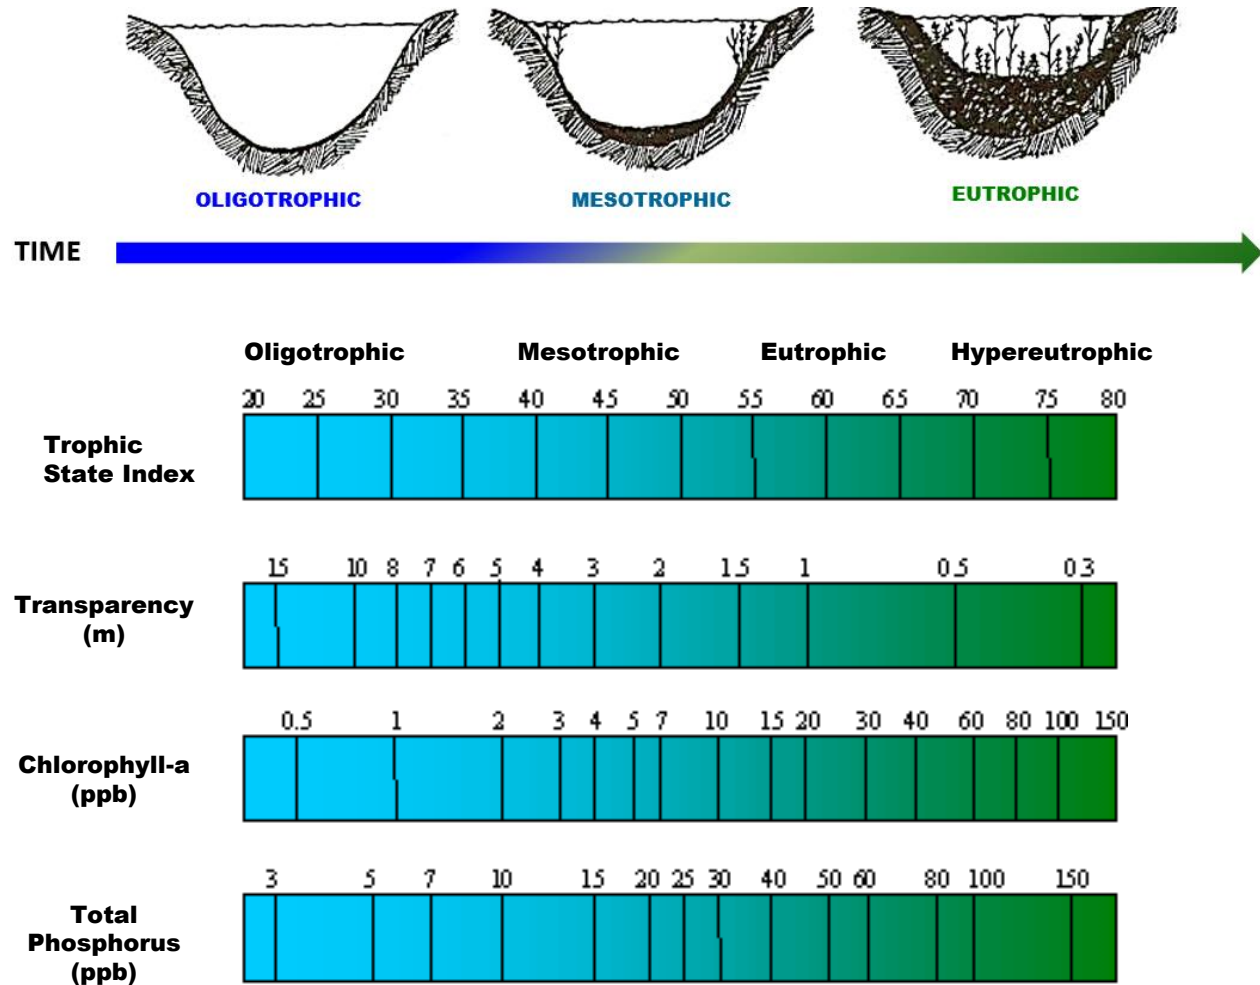
Carlson Trophic Status Index (TSI)

**Each 10 point TSI increase = doubling of phosphorus,
2.8 fold increase in algal biomass**

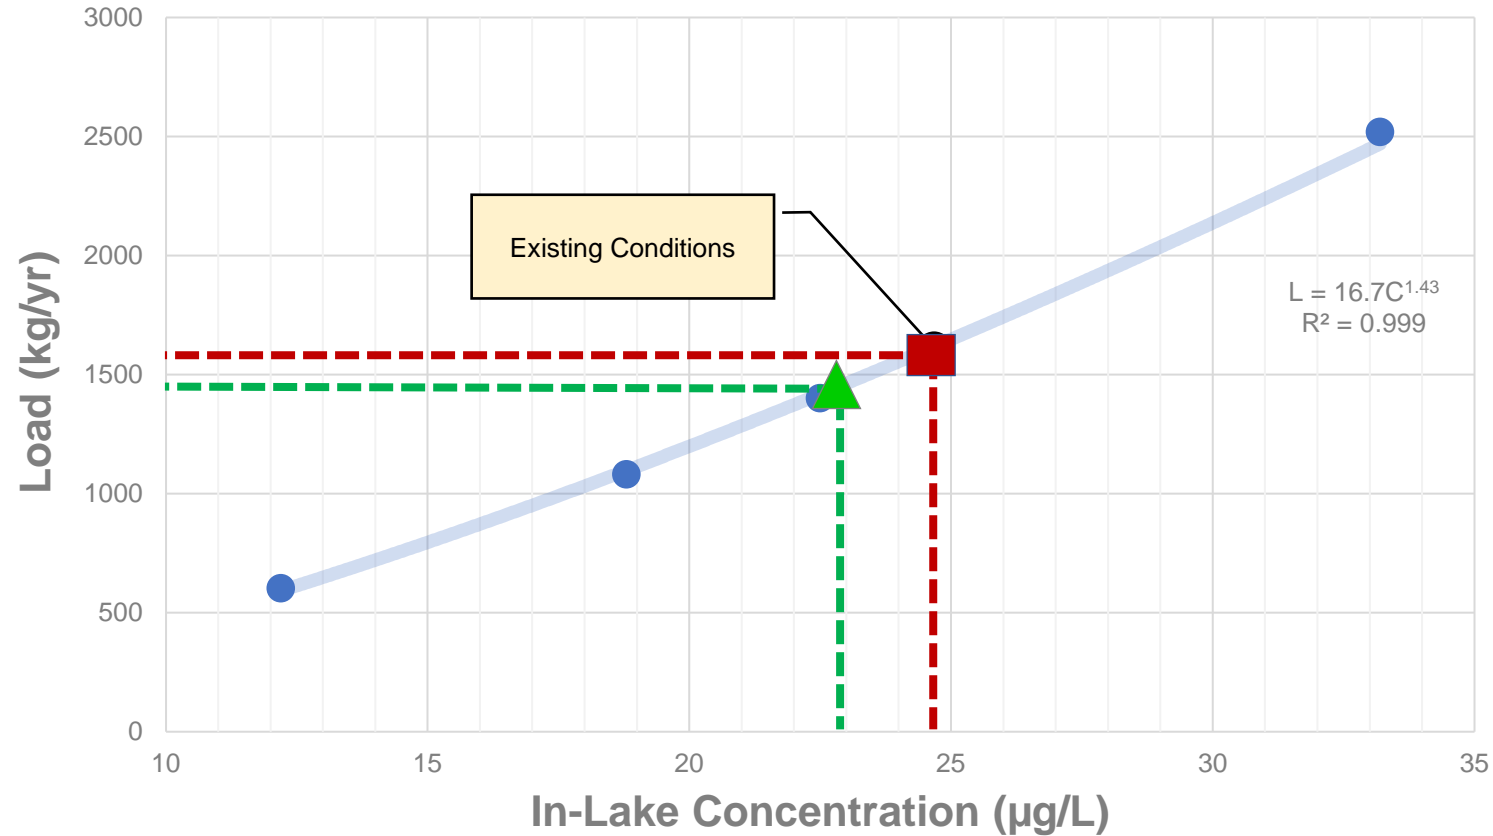
Nutrient Load Reduction Analysis

Current Conditions

■
Conc = 24.7 ug/L
Load = 1,606 kg/yr

Target Conditions

▲
Conc = 23 ug/L
Load = 1,479 kg/yr
(- 127 kg/yr of P)

8.6% Reduction in P

Goal = Reduce P by 127 kg/year

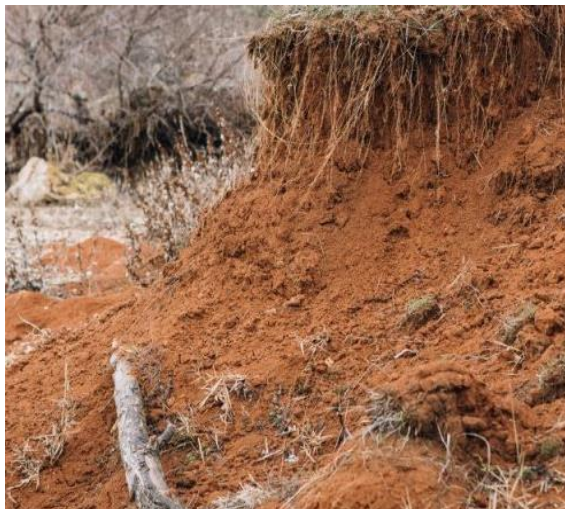
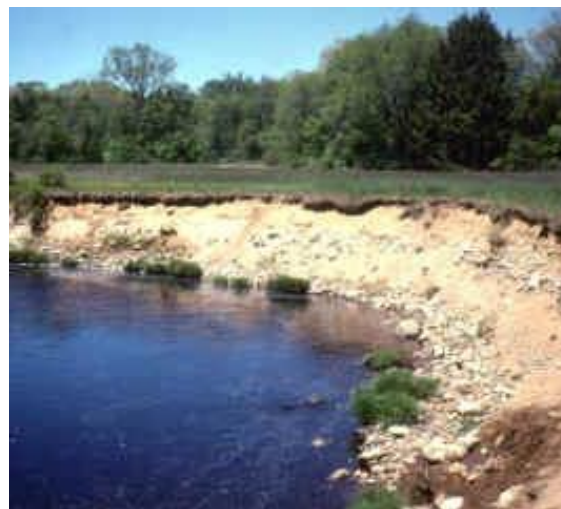
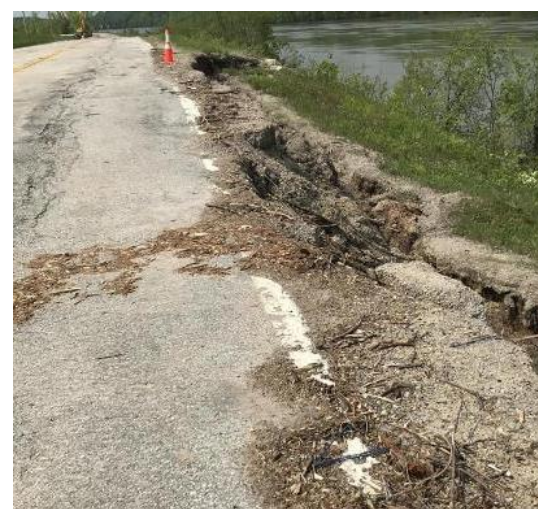
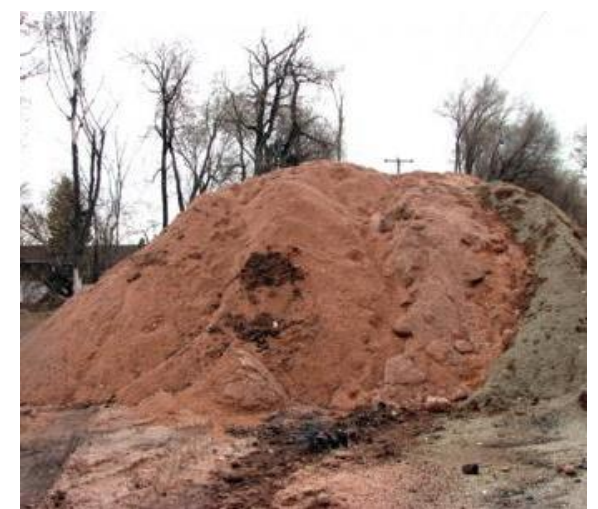
Problem Type	Description
EROSION <ul style="list-style-type: none">- Surface Erosion- Road Shoulder Erosion- Ditch- Shoreline / Stream Bank- Bare/uncovered soil/sand/salt stockpile	Severity: Slight, Moderate, Severe Size: Length/Width, Area

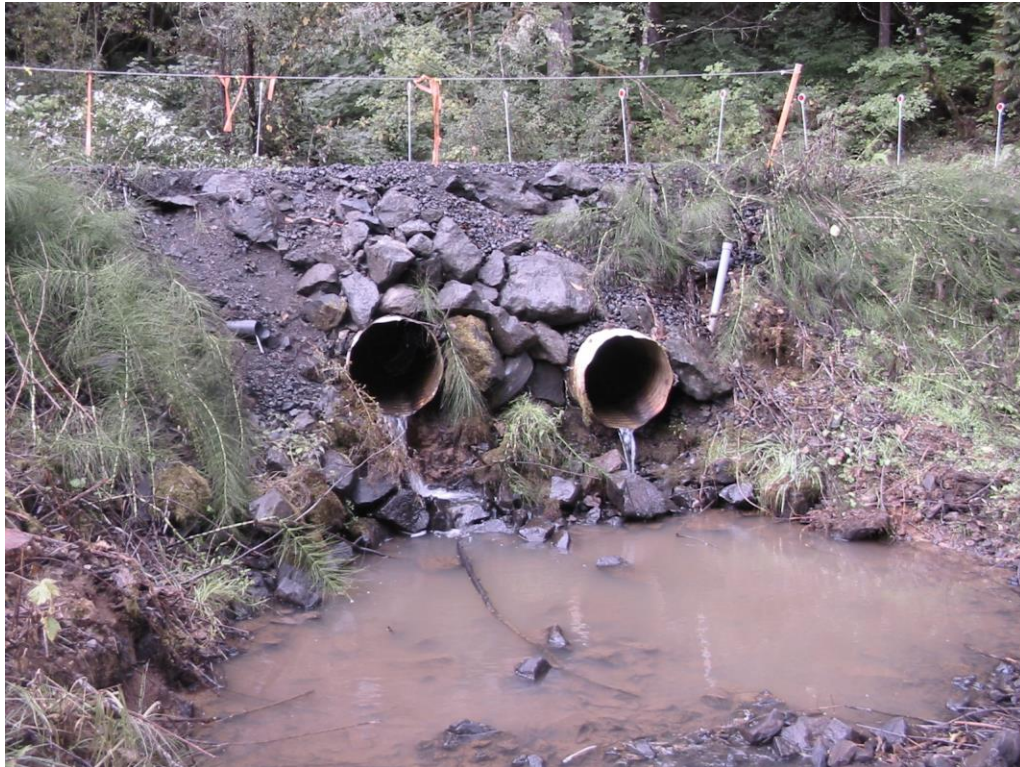
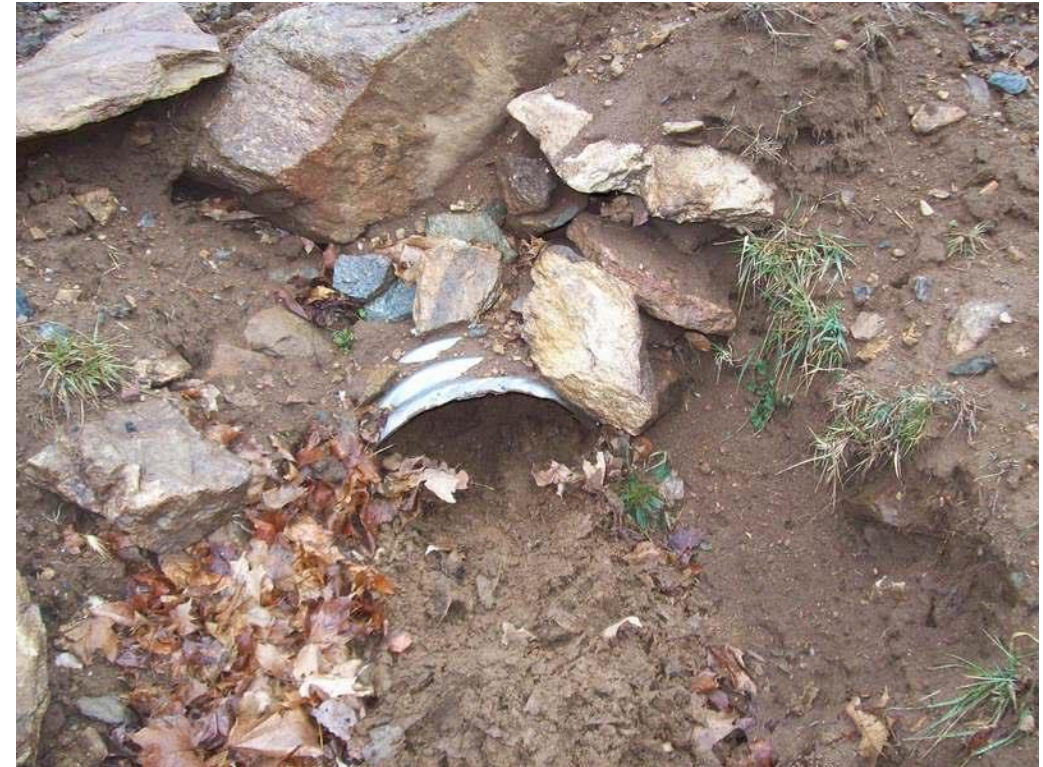
Problem Type	Description	
Culverts/Infrastructure	Unstable Inlet/Outlet Clogged/Buried	Crushed/Broken Undersized

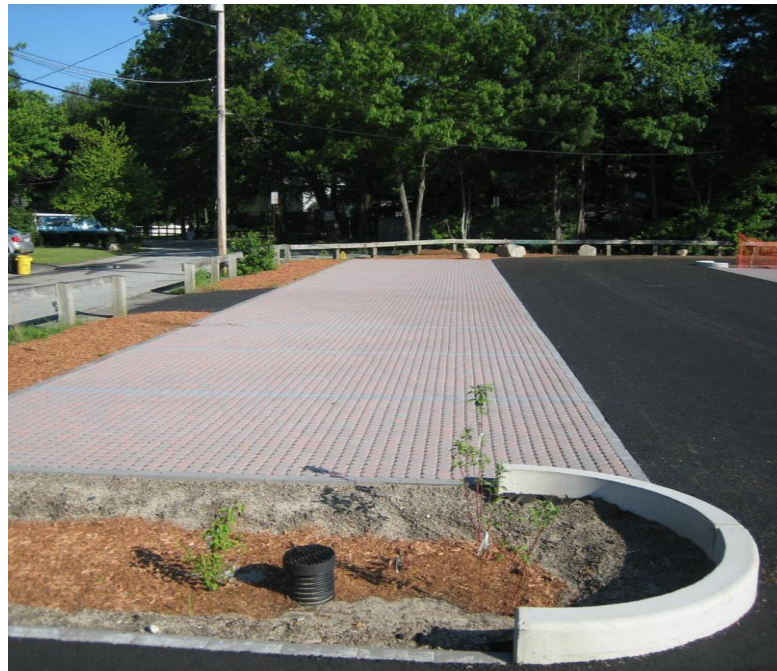
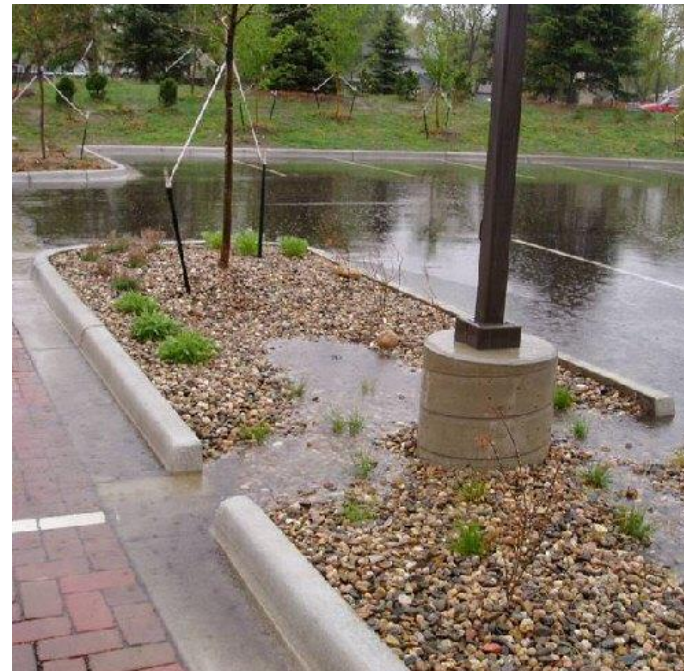
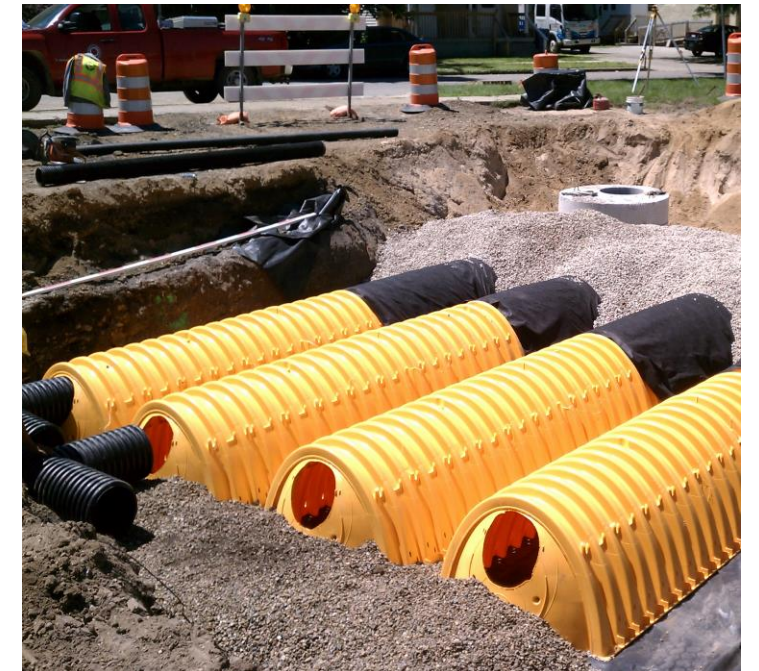
Problem Type	Description
Parking Lots	Drains Directly to Waterbody Evidence of Concentrated Flow

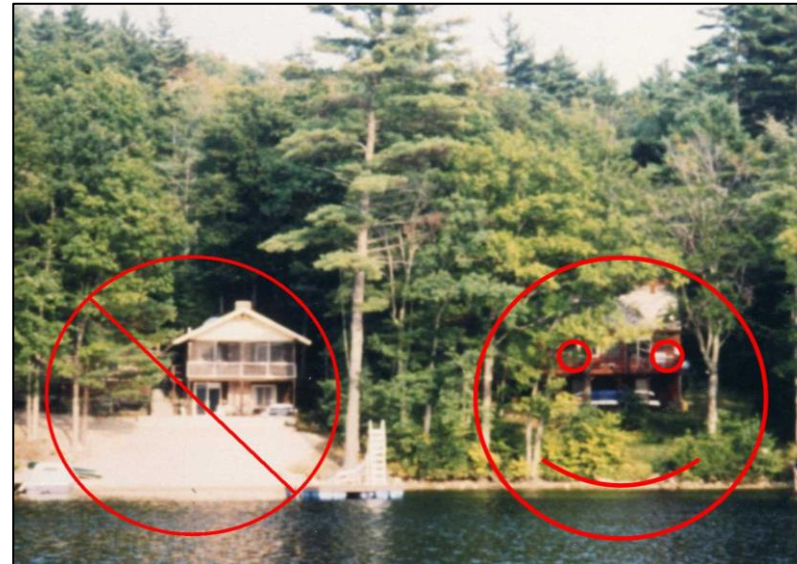
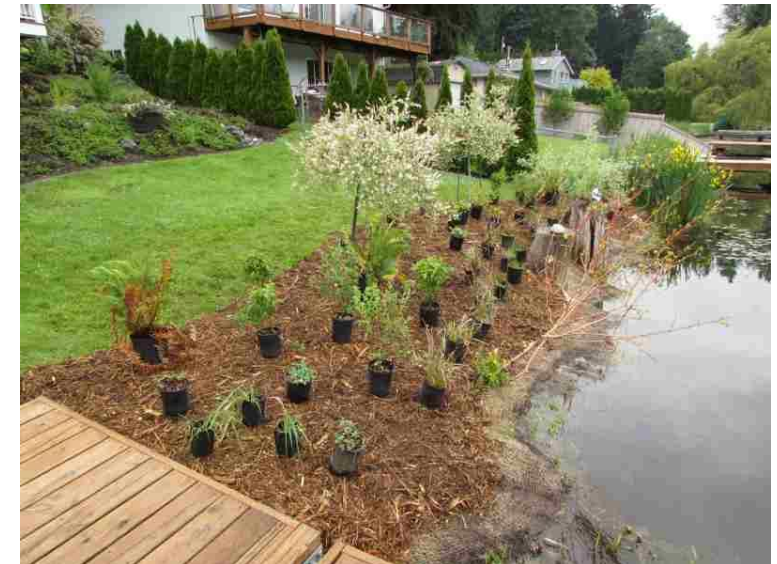
Problem Type	Description	
Shoreline	Undercut Lack of Shoreline Vegetation	Erosion Unstable Access

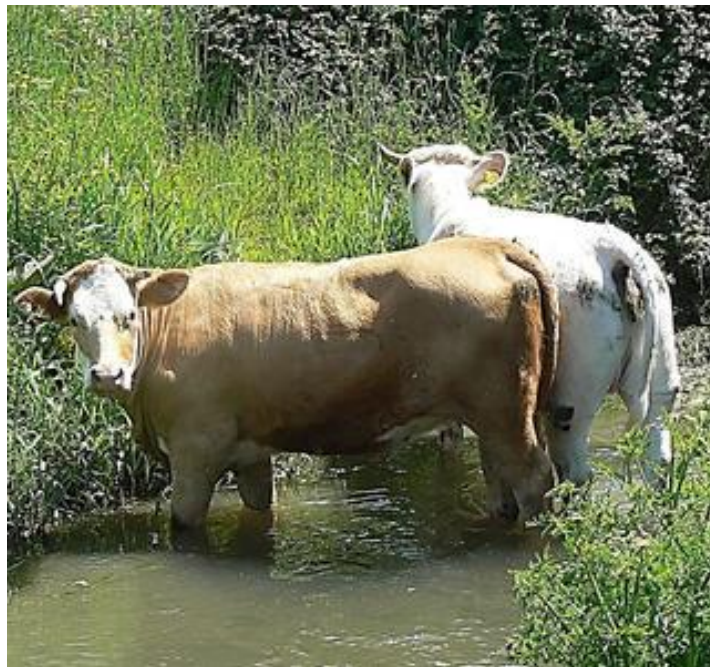
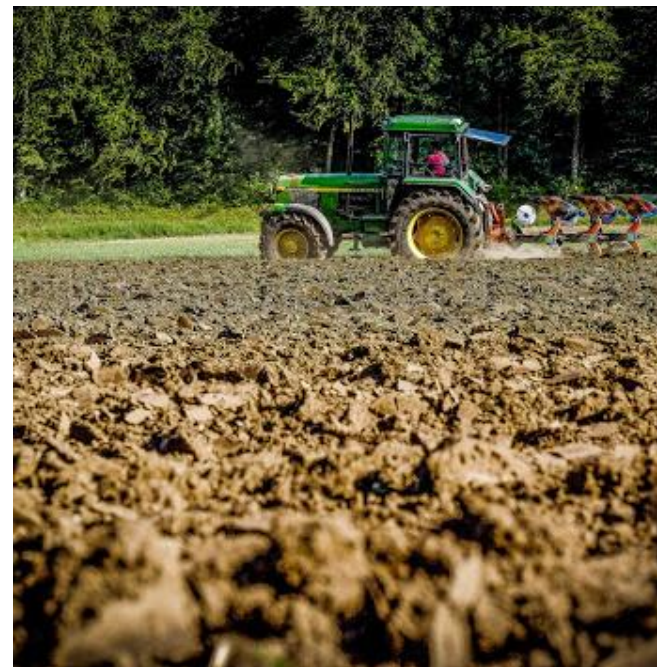
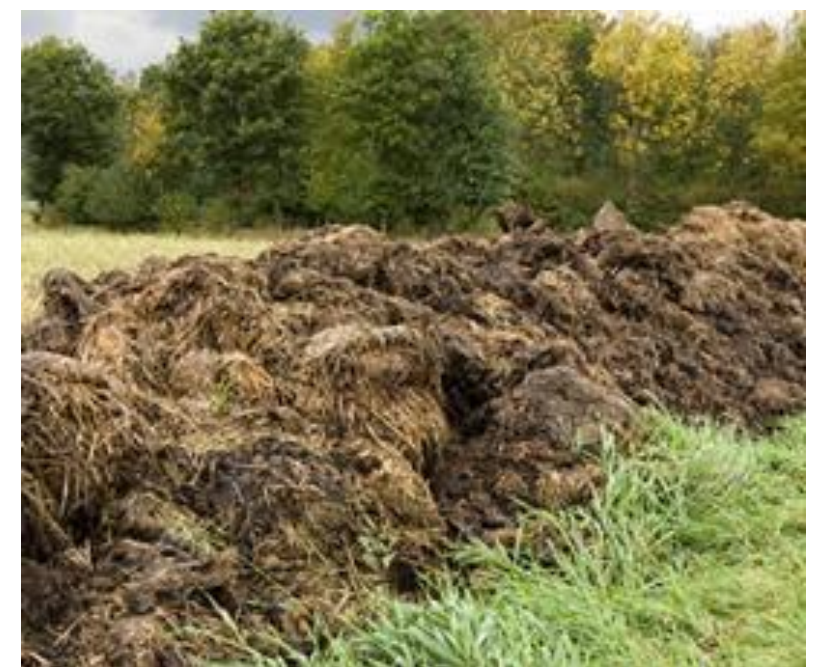
Problem Type	Description
Agriculture	Livestock Access to Waterbody Manure Washing Off-Site Tilled Eroding Fields Inadequate Buffer
Other (e.g., area to improve stormwater treatment)	Improve treatment; reduce flooding; increase infiltration; re-vegetate
