Bantam Lake Watershed Based Plan

EPA Contract Number: BPA-68HE0118A0001-003

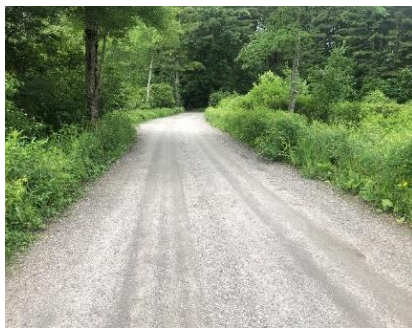
Photo 1-1: Section of Whitehall Road that floods multiple times per year.

A 24" culvert directs water beneath Whitehall Road from a wetland to the Bantam River. This portion of the road floods multiple times per year. The upstream wetland was previously used by CTDEEP as a fishery breeding area and is no longer in use. Whitehall Road is used for access to recreation on White Memorial Foundation trails. This culvert is one of approximately 70 culverts identified through the White Memorial Foundation field survey located throughout the watershed.

1. The above culvert is a 24" inch culvert that drains an approximate 147.2-acre watershed, including Duck Pond. It is likely that this culvert would require upsizing and replacement. Depending on overall priority, replace culvert to meet stream crossing sizing standards for passage of peak flows and wildlife passage (1.2 times bankfull width).

Note: *There are likely numerous culverts in the watershed that require upsizing and replacement. To ensure that funds are spent with the appropriate prioritization, a **watershed-wide culvert assessment** is recommended to identify potential culvert issues that contribute to nutrient loading via transport of sediment and attached phosphorus. The assessment should also include consideration of overall structure condition, aquatic organism passage compatibility, geomorphic compatibility, and hydraulic vulnerability (flooding). Inspect all culverts, identify potential issues (e.g., undersized, scour, bank erosion, etc.), and develop prioritized replacement / maintenance plan.*

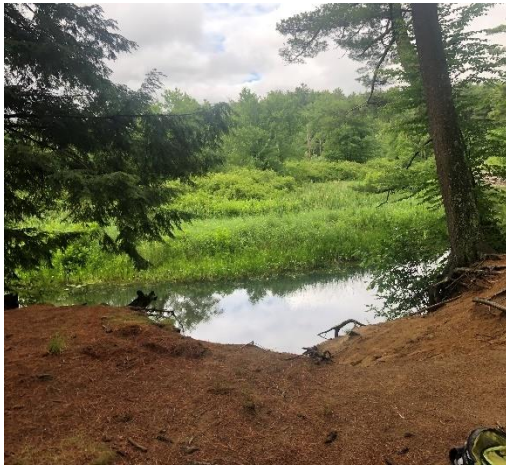
Photo 2-1: Canoe/kayak launch to the Bantam River.

An unofficial canoe and kayak boat launch on Whitehall Road has led to severe bank erosion on the Bantam River. Whitehall Road is used for access to the White Memorial Foundation trails. The shoreline has eroded severely into the river and the banks on either side of the site are beginning to be undercut.

1. Regrade the canoe/kayak launch and install safe access point such as large steps with handrail (Photo 2-3). Approximate extent of proposed improvement area is 20' wide by 25' long.
2. Armor the soil with a combination of stone stabilization and vegetation to prevent additional erosion into the river (Photo 2-2 and 2-3). Where appropriate, native rock/stone and vegetation should be used.
3. Re-vegetate the sides of the ramp; stabilize area with biodegradable erosion control blanket.
4. Stabilize undercut areas at base of slope.

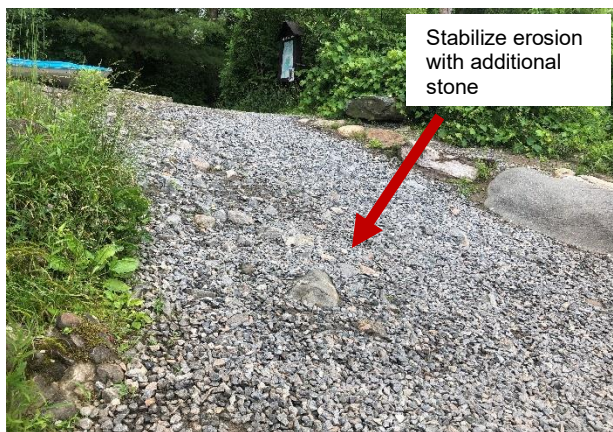
Photo 3-1: Erosion of gravel on east side of boat launch

A town-owned boat launch for canoes and kayaks with an adjacent gravel parking lot is located on the Bantam River directly downstream of the bridge on Mattatuck Trail. The bridge and boat launch were replaced in 2017 by the Town of Litchfield. The new gravel boat launch is beginning to show wear, exposing the larger base layer rock on the east side of the launch. The parking area above the launch is relatively flat and bordered by forest and trails within the White Memorial Foundation trail network. Runoff from the parking area flows down the boat launch and enters the river or flows to the adjacent forest.

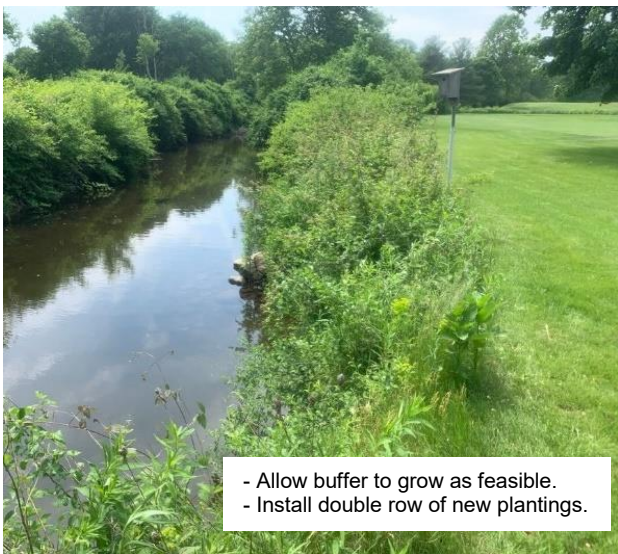
Photo 4-4: Limited vegetated buffer at LCC2.

The fairway is mowed very close to the shoreline. Geese were also seen in in this area. As this area is not located directly on the fairway, it may be possible to enhance the buffer in this area. This section of shoreline is approximately 100' in length. Expand width of “no-mow” buffer as feasible. Install double width row of plantings to accelerate process.

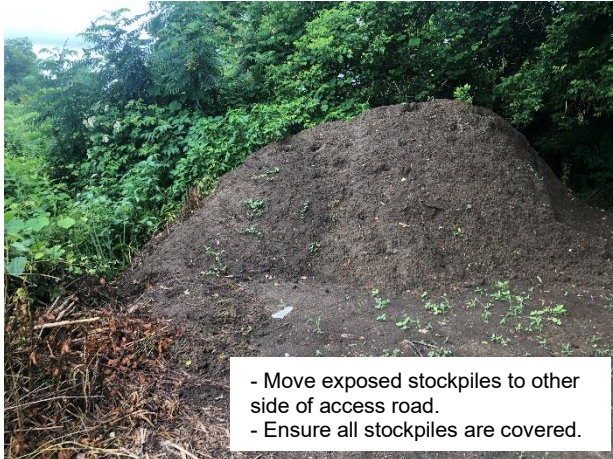
Photo 4-6: Exposed soil stockpile at LCC3.

Stockpiles of exposed soil are stored in a maintenance area adjacent to Bantam River. Some are covered with a tarp while others are not. The stockpile in Photo 4-6 is located directly adjacent to the river and is not covered. Sediment from these stockpiles can runoff into the river during rain events. Recommend moving the stockpiles to the adjacent side of the access road and ensuring all piles are covered or surrounded with perimeter controls such as coir waddles.

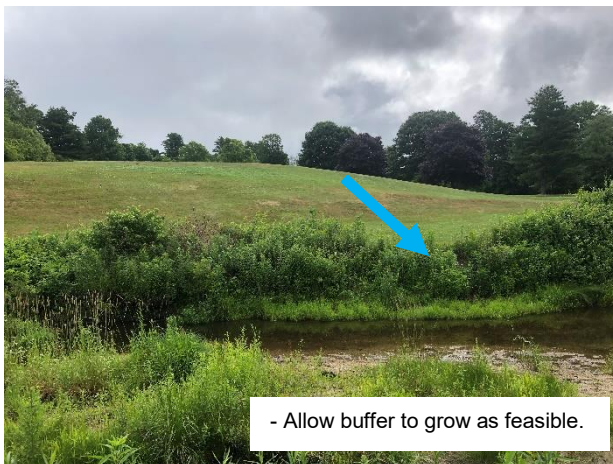
Photo 4-8: Steep slope at LLC4.

The fairway is mowed very close to the shoreline and has a steep slope in this area. The bank is beginning to be undercut in some areas, but the extent was unclear. Recommend expanding the width of a “no-mow” buffer area to the extent practicable. This section is approximately 100’ in length.

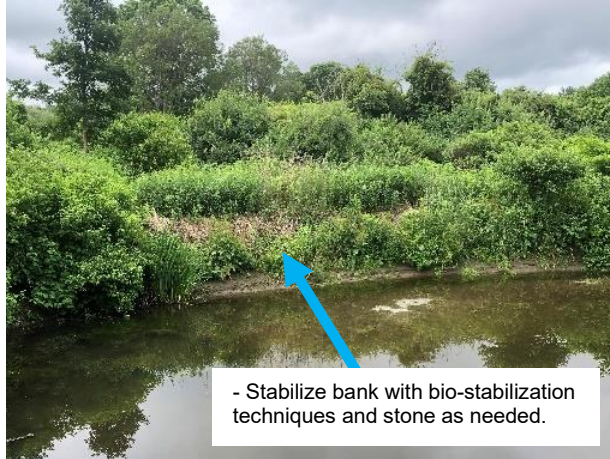
Photo 4-10: Eroding banks at LLC5.

The shoreline along the bank is eroding as shown by Photo 4-10. Areas of erosional material are concentrating at specific locations along the bank as shown in Photo 4-11. Recommend stabilizing the bank with stone and bio-stabilization techniques. This section of shoreline is approximately 100' in length.

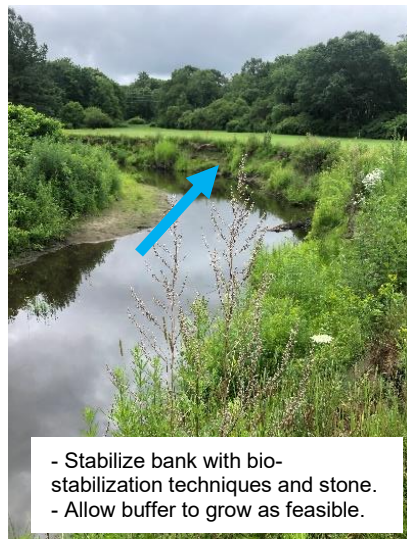
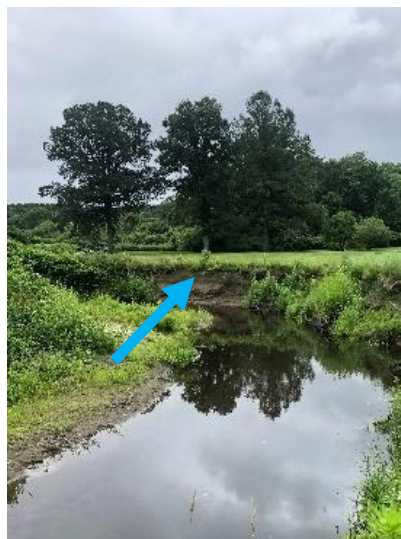
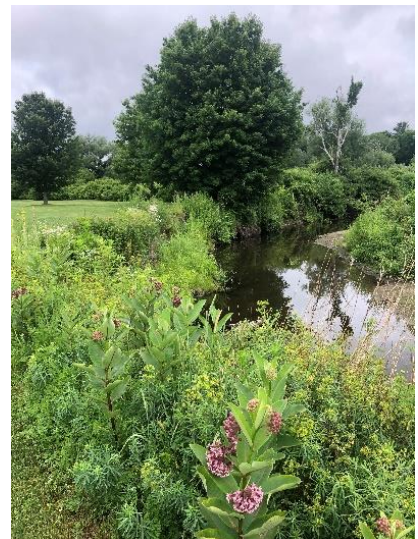
The shoreline along the bank is eroding as shown in Photos 4-12 through 4-14. There is an inadequate buffer along most of this area. Recommend (1) stabilizing the bank with armoring stone and bio-stabilization techniques and (2) increasing the unmowed vegetated buffer width where feasible. This section of the shoreline is approximately 200' in length.

Photo 4-12: Eroding bank along Bantam River at LCC6.

Photo 4-13: Eroding bank at LCC6 with inadequate buffer.

Photo 4-14: Bank beginning to undercut at LCC6.

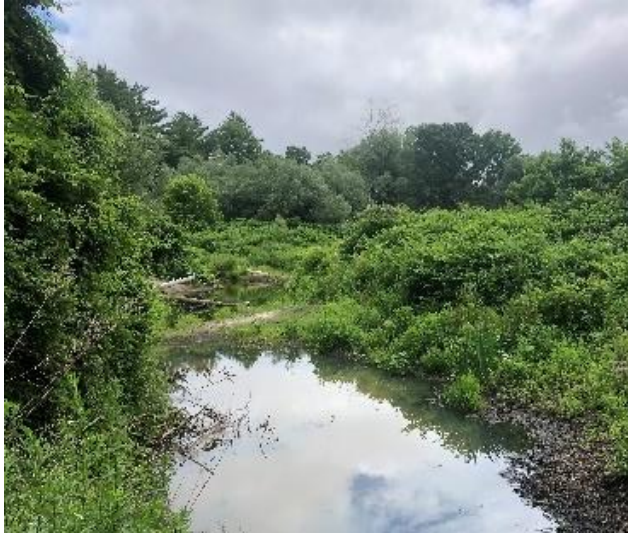
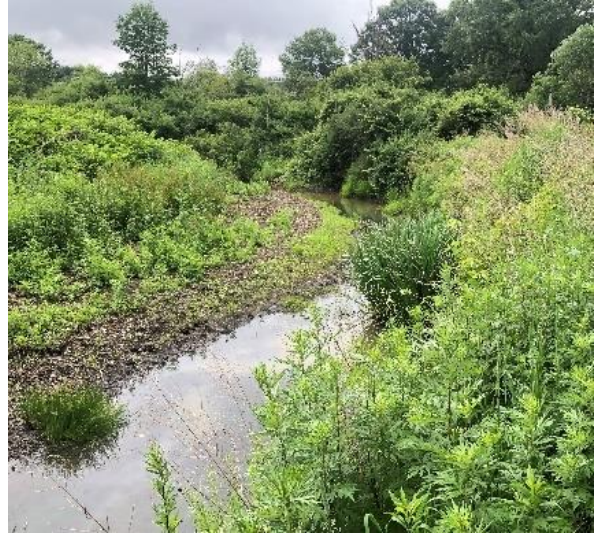
An oxbow has formed along this section of the Bantam River. The oxbow is now completely cut off from the rest of the river and has stagnant water in its bed. Recommend allowing the oxbow to proceed naturally as the river begins to form its new course. When left to natural processes, over time, the “cut off” section of river can filter and process excess nutrients and increase flood storage capacity of the river.

Photo 4-15: Debris and sediment in river from LCC-7 oxbow.

Photo 4-16: Cut-off section of oxbow at LCC7.

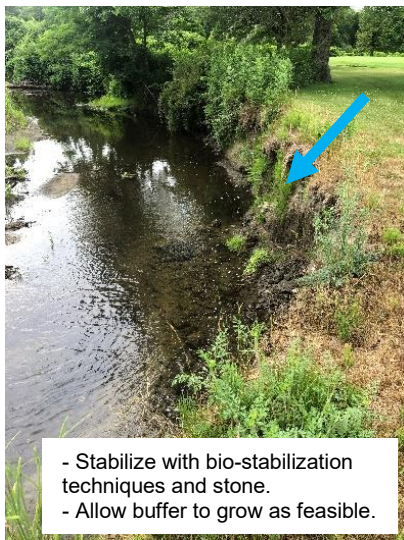
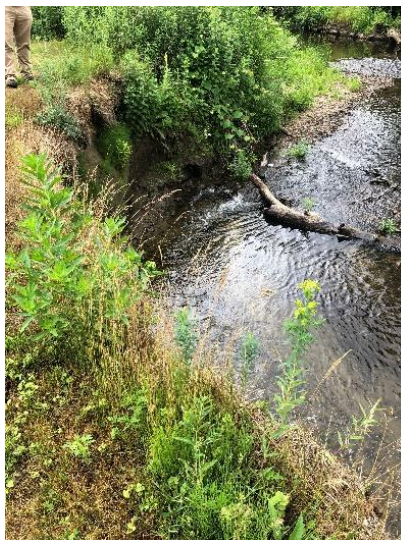
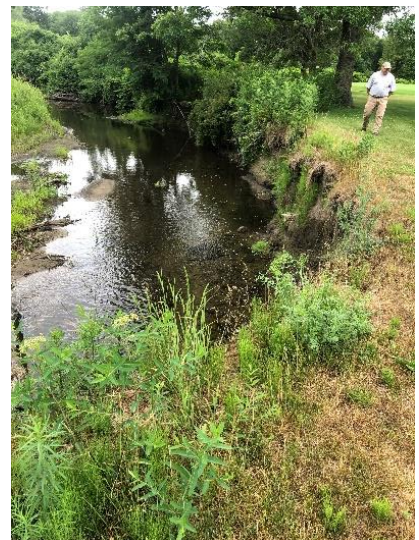
Photo 4-17, 4-18, and 4-19: Eroding bank with inadequate buffer along Bantam River at LCC8.

The shoreline along the bank is eroding as can be seen in Photos 4-17 through 4-18. There is an inadequate buffer along most of this area. Recommend (1) stabilizing the bank with stone and bio-stabilization techniques and (2) increasing the unmowed vegetated buffer width where feasible. This section of the shoreline is approximately 50' in length and 6' deep.

- Stabilize with bio-stabilization techniques and stone.
- Allow buffer to grow as feasible.

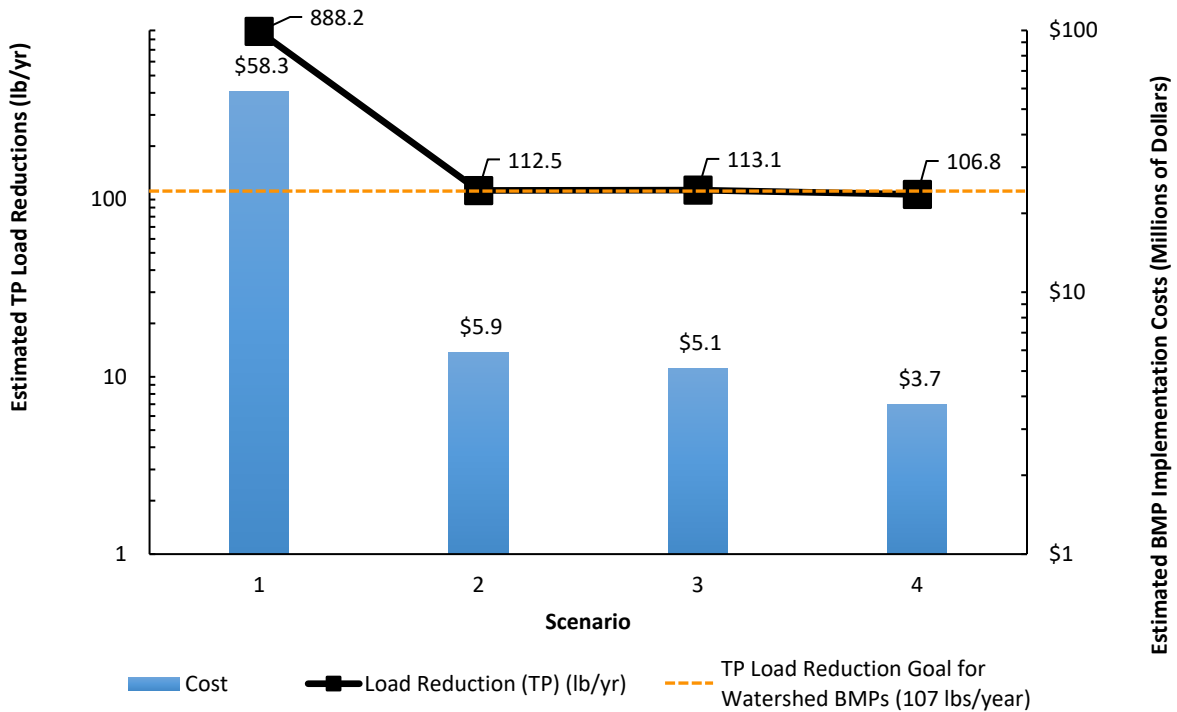
Figure 3. Summary of Results by Scenario

The findings presented in Section 6 depict several BMP implementation scenarios, including maximum potential implementation, realistic implementation, and optimized realistic implementation. Results were sequentially improved by each scenario as depicted by **Figure 3**. Based on these findings, Scenario 4 provides the “best” mixture of BMPs to meet pollutant load reductions at the lowest cost.
