12-05b NCCD (P) – Broad Brook Watershed Based Plan Phase 2

Introduction/Context

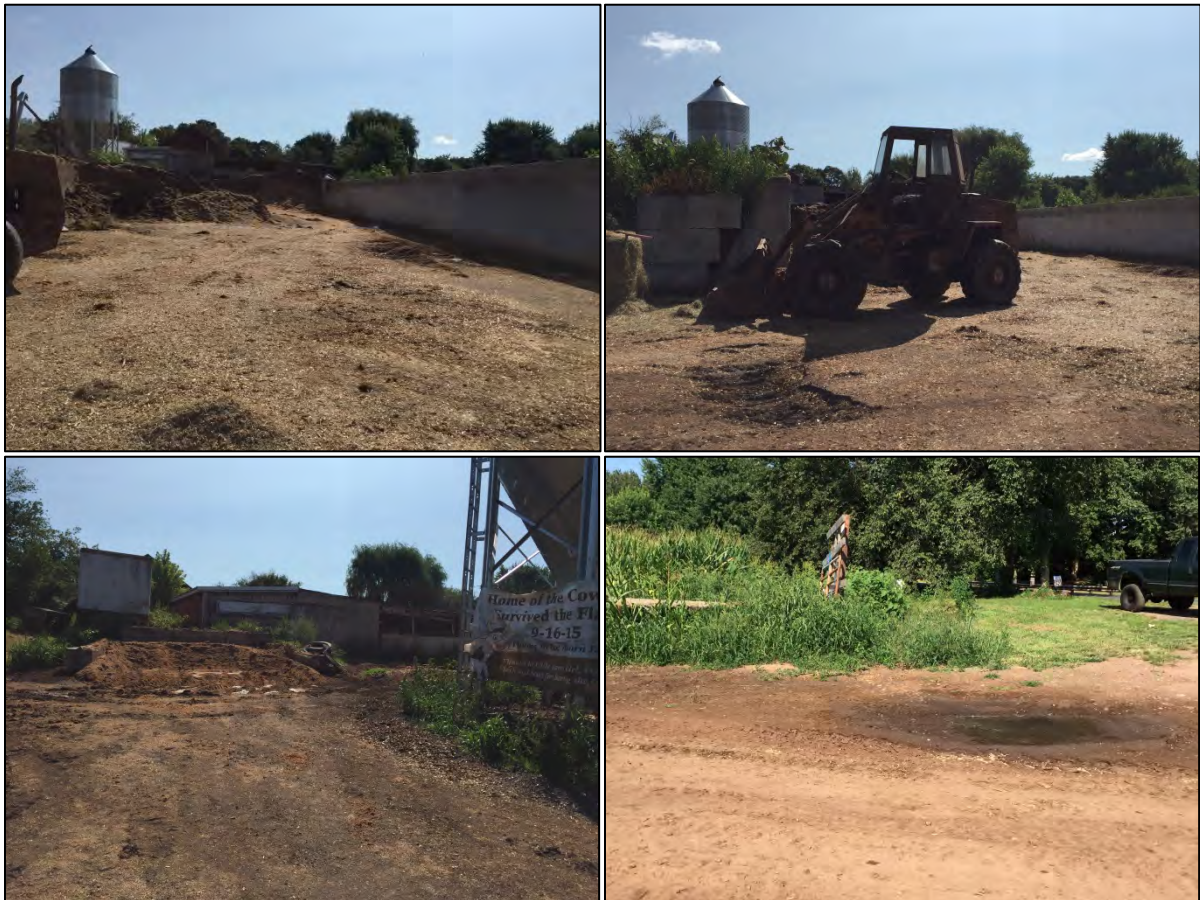
(1) Silage Bunker-replace/regrade and collect leachate

The primary silage bunker is deteriorating, and during the winter, the silage expands outside of the old silage bunker. The old silage bunker does not contain a leachate collection system. Regrading the silage area plus replacing the old bunker would allow enough storage for silage for the year. The new bunker could also contain a leachate collection system, minimizing the amount of silage lost and would minimize runoff of silage leachate. Silage leachate has an extremely high biochemical oxygen demand and is also very high in nitrates. Once it enters waterbodies, it can lead to fish kills, algal blooms, and eutrophication. See photos below depicting the primary silage bunker, overflow silage pile, and the roadway that the silage leachate drains across, toward the adjacent corn field.

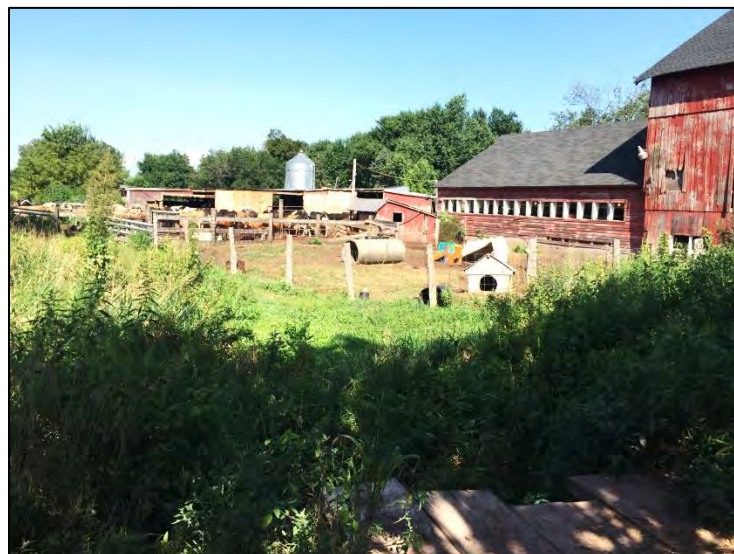
(2) Stanchion Barn Milking Parlor – Riparian Planting/Milk Wash Wastewater Treatment

The area surrounding the Stanchion Barn Milking Parlor lacks a riparian buffer, and the landscape consists of mowed grass up to the stream bank. A vegetated riparian buffer of native plant species would minimize the effect of the adjacent heavy use areas on the stream while also benefiting wildlife. The buffer would work best using a variety of woody and herbaceous native plants to slow runoff and trap/uptake pollutants along the northern edge of the brook.

In addition, there is currently no system in place for collecting and treating milk wash wastewater, a byproduct of the constant cleaning of equipment that is necessary in the milking parlor. This wastewater has a tremendous volume, estimated at 5 gallons per cow per day, and would contain milk, cleaning chemicals, and various contaminants from the cows (manure, bedding, feed). Left uncollected and untreated, milk wash wastewater represents a source of pollution in the Broad Brook watershed. The creation of a bark bed or vegetative filter bed for collection of the milk wash wastewater from the milking parlor is recommended. This would serve as an effective outlet of waste that is not easily treated by traditional waste disposal systems and would prevent milk wash waste water from draining into the stream and contributing pollution to adjacent waters. Photo below depicts the back of the Shanchion Barn Milking Parlor, with the inadequate milking cow freestall barn and laneway visible in the background. This photo is taken from the main driveway, and in the foreground, the crossing over Kimballs Brook is visible.

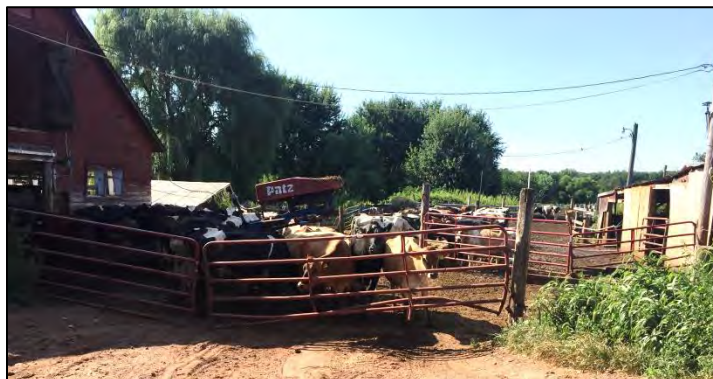
The laneway (viewed from north in photo below) is in close proximity to the brook. The area east of the laneway may currently be used for hay production, in which case it would be recommended that manure not be spread in this area to improve water quality of the brook. This area would ideally be converted to a vegetated riparian buffer of native shrubs and herbaceous plants. If the new barn is constructed as recommended, the lane way could possibly be relocated or removed to further increase the vegetative buffer of the brook.

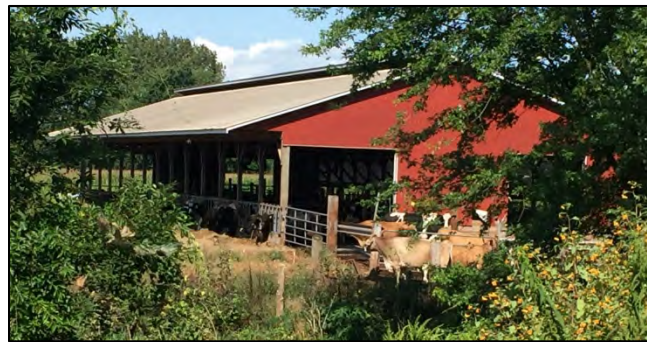
(6) Free Stall Barn (heifers)

The existing Free Stall heifer barn (depicted below) would benefit from an animal waste system, as the scrapings from the barn are currently spread on-site daily. By constructing a convenient covered manure storage facility, time spent spreading manure would be greatly reduced while also improving the quality of stormwater runoff into the adjacent streams.

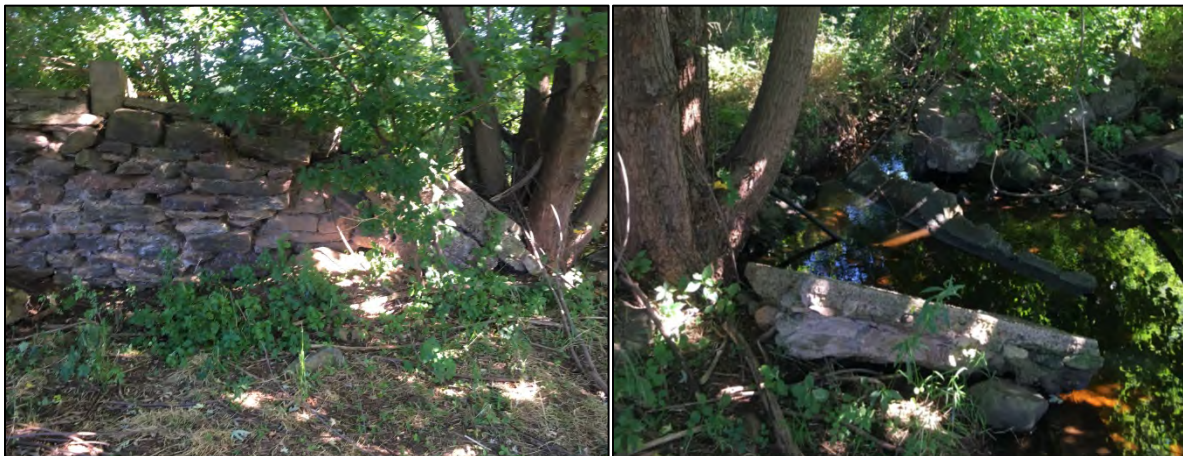
(7) Old Dam

There is an old dam that was used for ice production, which was breached many decades ago. Remnants of the dam that still remain, which partially block the natural stream flow. Consider removing remnants that interfere with the stream and restoring the natural stream channel. Photos below show an in-tact portion of the dam, and remnants of the breach within the stream channel.

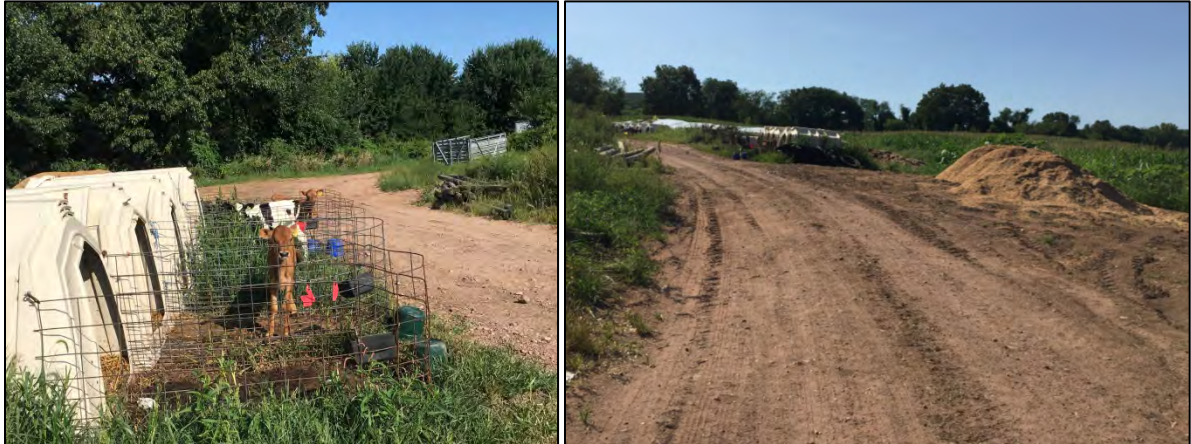
The hutches have no bottoms and are moved regularly around the farm. Those currently placed near the machinery shed are surrounded by minimal vegetation that drains down a dirt road toward the brook. Additional vegetation near the stream would aid water quality.

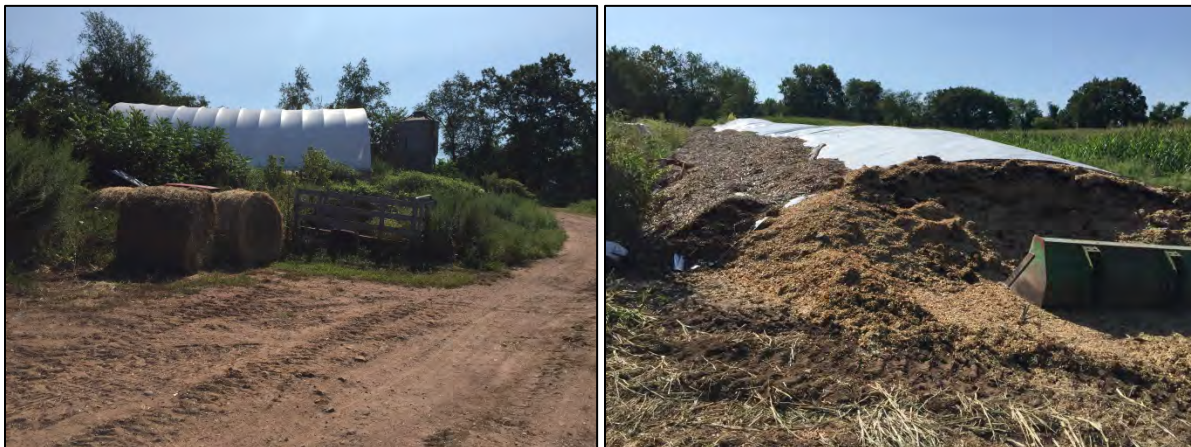
(10)/(11) Calf hoop house / Calf exercise yard

Ensure that surface water drainage from both the calf hoop house (photo bottom left) and exercise yard flows to the appropriate catchments and collection systems. A vegetated buffer around the exercise yard would allow filtration prior to runoff reaching the stream.

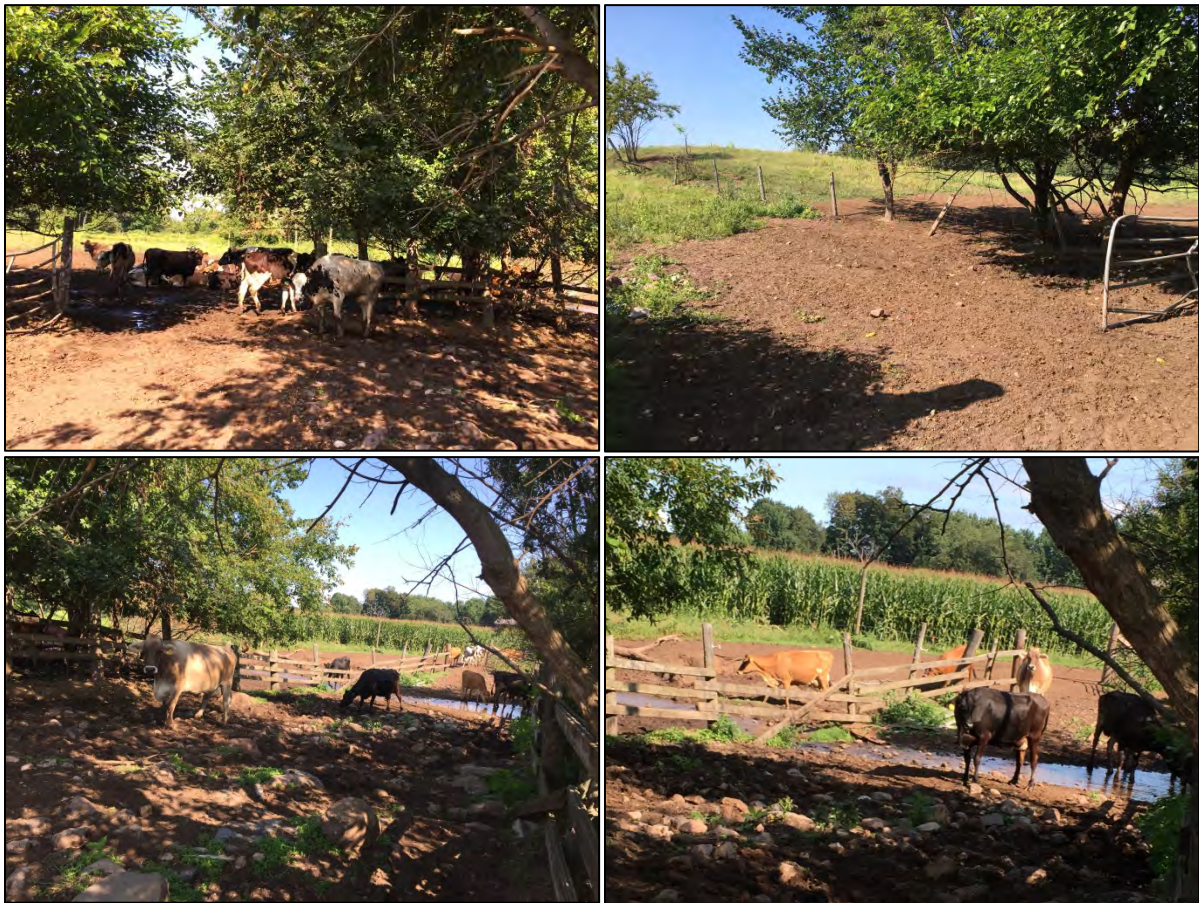
The bottom two photos show the cows accessing Kimballs Brook directly, using it not only as a crossing into the pasture, but also as a water source and a place to linger, directly introducing bacteria and nutrients into the watercourse. In the background of the bottom two photos, the Winter Heavy Use Area, which at the time of the photos was planted with corn for the summer, is visible. A new barn constructed within the northern portion of this field would exclude the cows from the brook and would allow adequate separation between the pollutant source and the brook.

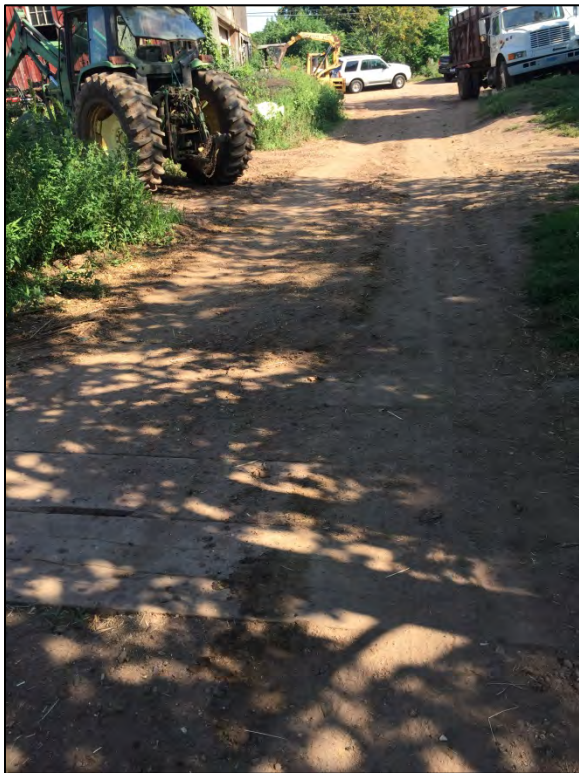
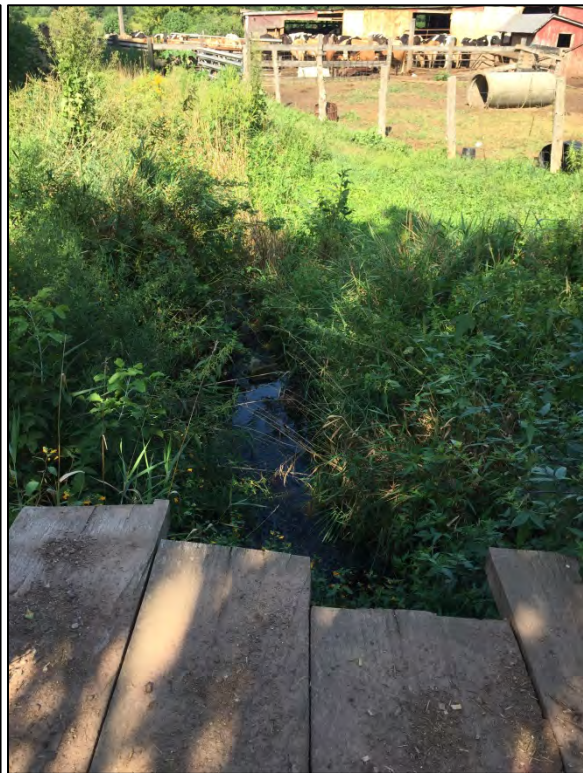
The stream crossing for the main dirt road, which crosses the northernmost point of Kimballs Brook on the farm, could be improved to better prevent sediment from entering the brook, which would improve water quality downstream. The surrounding slopes should be stabilized with vegetation and/or riprap and/or permanent turf reinforcement mats to prevent sediment from entering the stream at the location of the main roadway crossing.

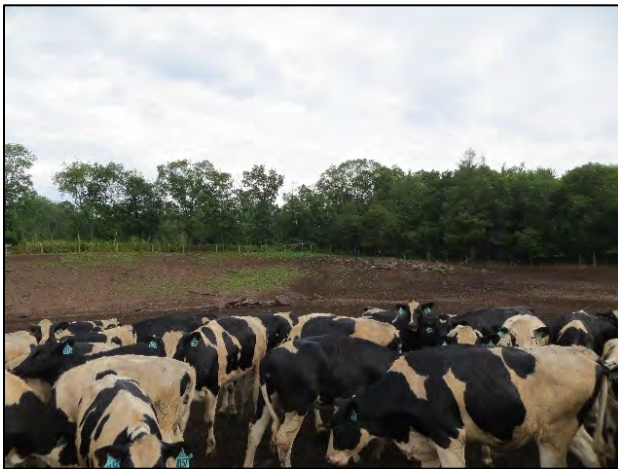
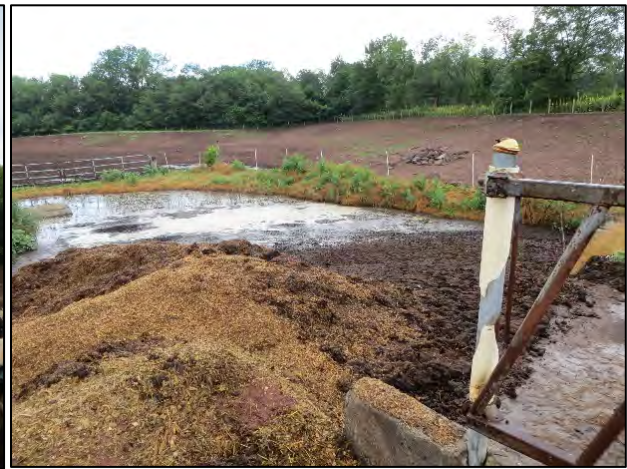
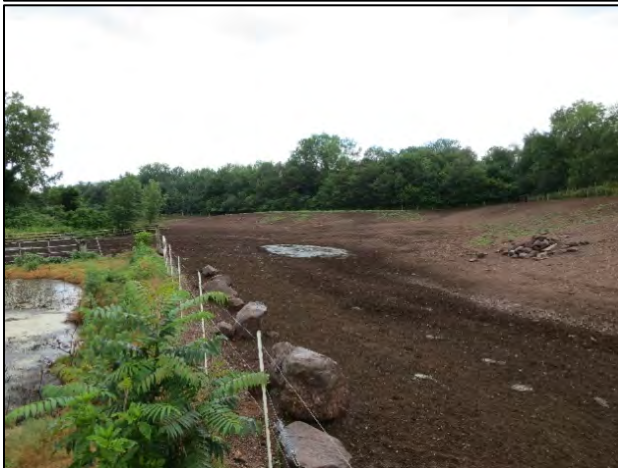
Area (39) encompasses 6.9 acres of bare ground with substantial manure accumulation from its function as a heavy use area for cows. An intermittent watercourse, which ultimately drains to Broad Brook, runs through this lot. The goal for water quality improvement would be to stabilize and revegetate slopes that are too steep for agricultural equipment to operate, converting these slopes to permanent vegetative cover. The remaining acreage of this outside lot should be regraded and planted in a permanent grass for hay production. Approximately 3,550 feet of fencing would need to be removed in this area.

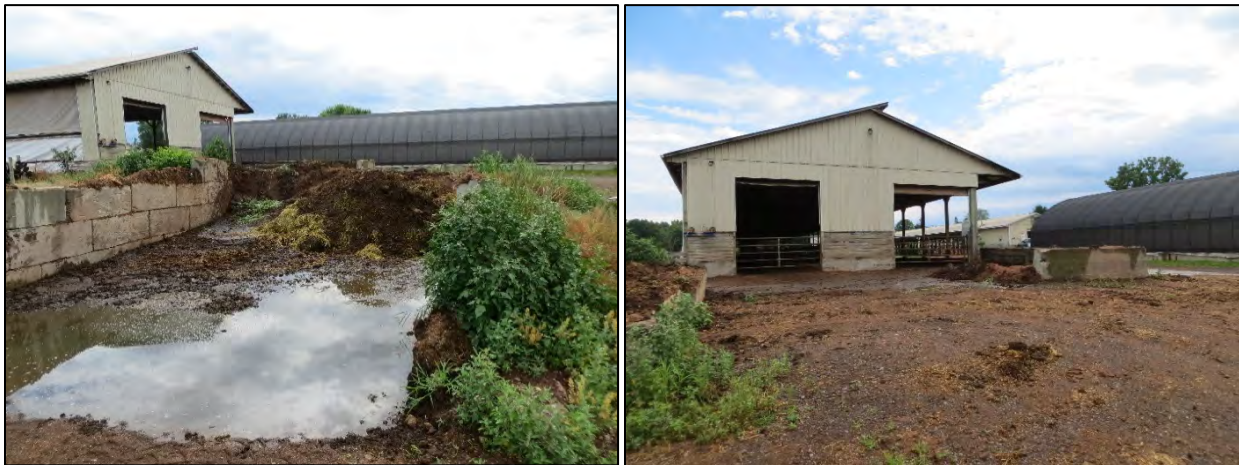
There are two manure storage areas in this location, adjacent to a barn. The first is a 28' x 12' walled area located just outside of the barn, which contains relatively dry manure. The second, lower storage area, depicted in the photo above on the left, is an uncovered, unlined manure structure with large concrete block walls that allow surface and groundwater into the storage area. This lower area collects the wetter materials that are scraped into it, and also collects rainwater from the concrete apron and from the dry manure area. The barn's roof area is 2,264 square feet, which generates significant stormwater runoff that flows through the manure storage areas, where it accrues excessive quantities of nutrients and bacteria and transports them to other areas in the form of polluted runoff. Both the manure storage structure and the barn apron area should be roofed and the surrounding area regraded to prevent surface water from entering the storage area.

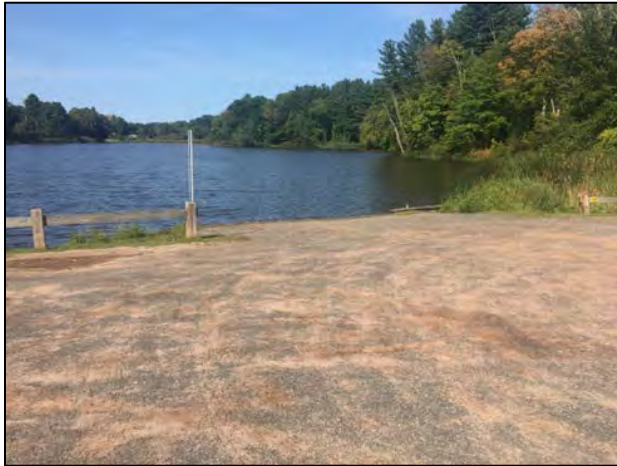
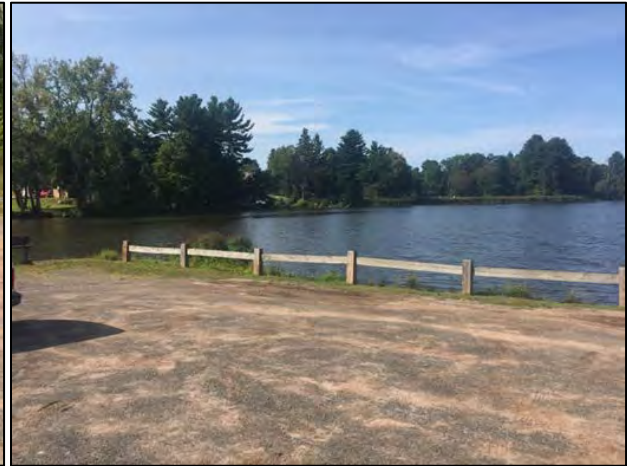
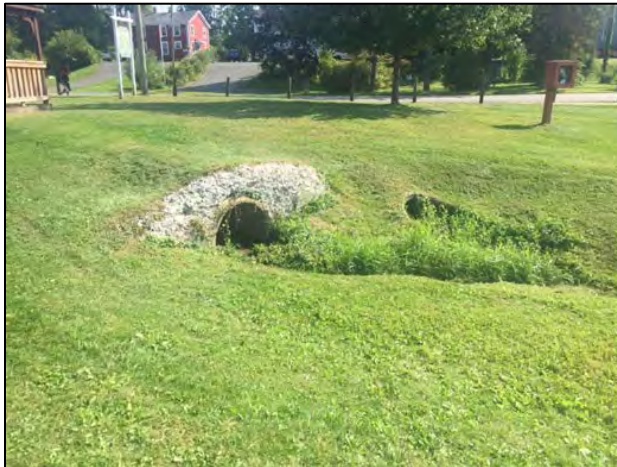
The photos below depict the dirt/gravel public parking area and boat access at Broad Brook Millpond, as well as stormwater outfall pipes containing significant sediment buildup.

The following options for addressing the sources of pollution, identified within the Broad Brook Watershed Report, still apply today:

- “Install catch basin filters in each catch basin that is part of the network discharging to the pond. The filters should be properly maintained to ensure maximum efficiency.”

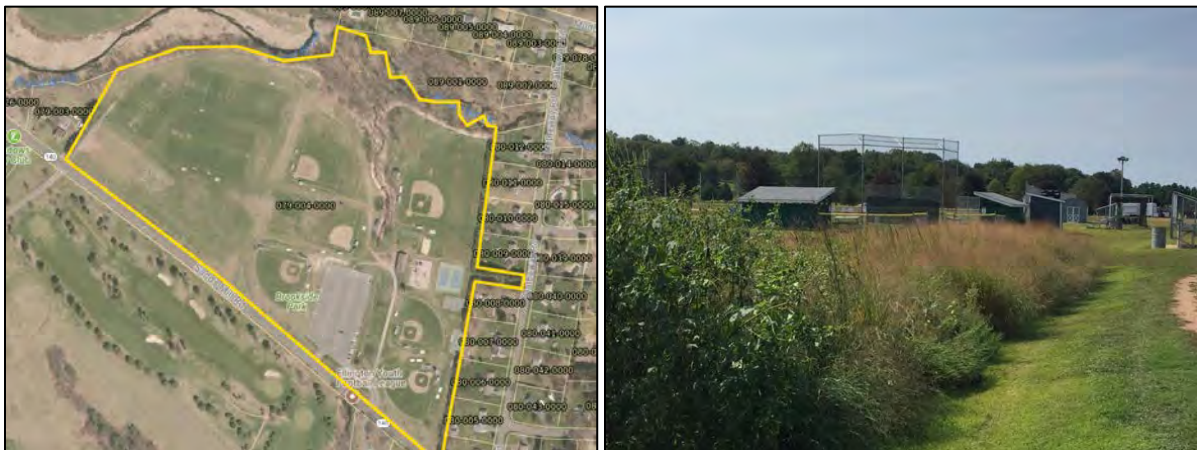
In 2011, the North Central Conservation District was awarded Supplemental Environmental Project (SEP) funds through the CT Department of Energy and Environmental Protection (CT DEEP) to correct some water quality concerns along the stream that bisects Brookside Park. Through this effort, NCCD excavated and planted a vegetated bioretention area, consisting of native grasses and perennials, to filter and infiltrate stormwater runoff from the large parking area before it discharges to the stream. In addition, NCCD planted three shrub buffer areas along the stream, and also installed a footbridge across the stream to resolve the streambank erosion that was resulting from many pedestrians routinely crossing the stream by foot. While there has been some shrub mortality along the eastern edge of the parking lot, the majority of the SEP work remains functional (current view of bioretention area in photo below on right).

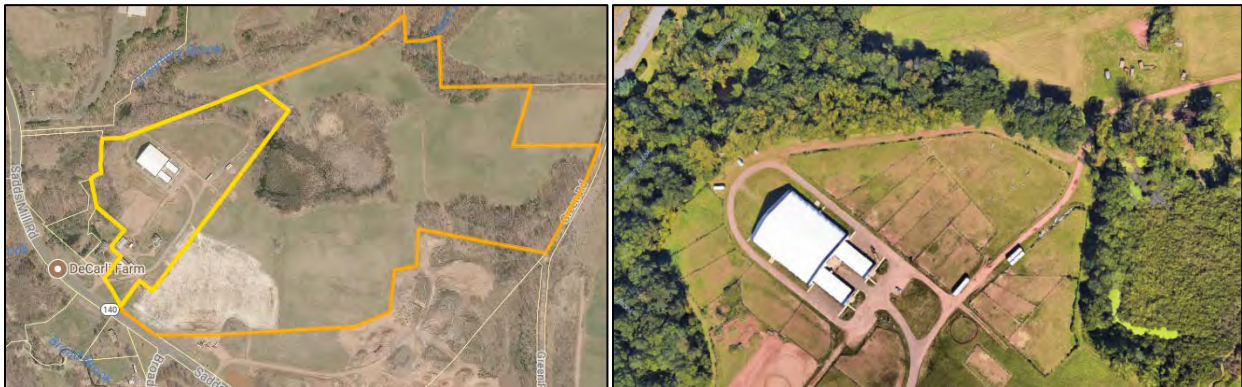
A large horse farm/equestrian center is located at 189 Sadds Mill Road, also known as Route 140, in Ellington. The farm is in the northwest corner of Ellington and just north and west of the center of the Broad Brook Watershed. This farm comprises approximately 18 acres, and includes a large equestrian barn which occupies approximately 2/3 of an acre. Creamery Brook, a slow running tributary of Broad Brook, is largely located north and west of the farm. Additionally, there is a large wetland area located east of the large barn, and a dirt farm road crosses over a stream that connects the wetland area to Creamery Brook. This private equestrian facility offers horse boarding, training, and sales. The farm has a large amount of pastureland, an outdoor sand arena, as well several heavily used areas. If not properly disposed of, the significant horse manure generated on-site could contribute to pollutant loading in the watershed.

There are several practices that could aid in the reduction of NPS pollution on the farm

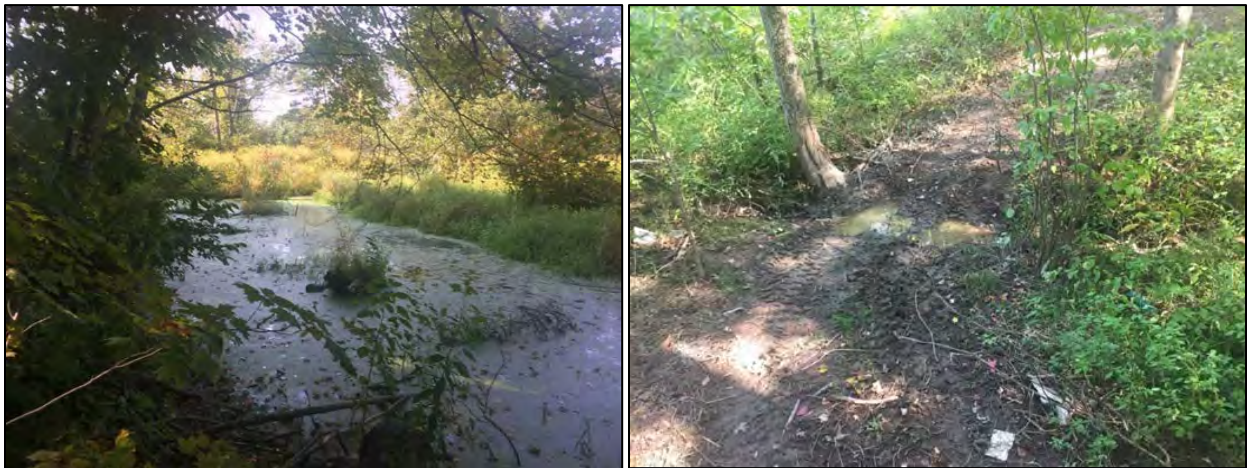
There are trails along the northern portion of the property that follow Broad Brook, including both walking trails as well as trails created by all-terrain vehicles (ATVs). There is a considerable amount of trash behind the complex and some of the debris has spread into the river. In the northern portion of the property, aquatic duckweed is prominent and covers a slow moving channel within a braided portion of Broad Brook. While this aquatic plant can be a nuisance to humans engaging in recreational activities, it actually helps to filter and uptake excessive nutrients that run off from agricultural and other lands.

- There was a cylindroid object sticking out of the ground, which is likely associated with a stormwater outfall drop structure. Further investigation is needed to observe the discharge point, which we were unable to access.
- The roof surface between all the buildings is quite large and can collect an ample amount of water. This water is presumably drained directly into a storm drainage system and/or discharged to Broad Brook. Downspout disconnection is a simple

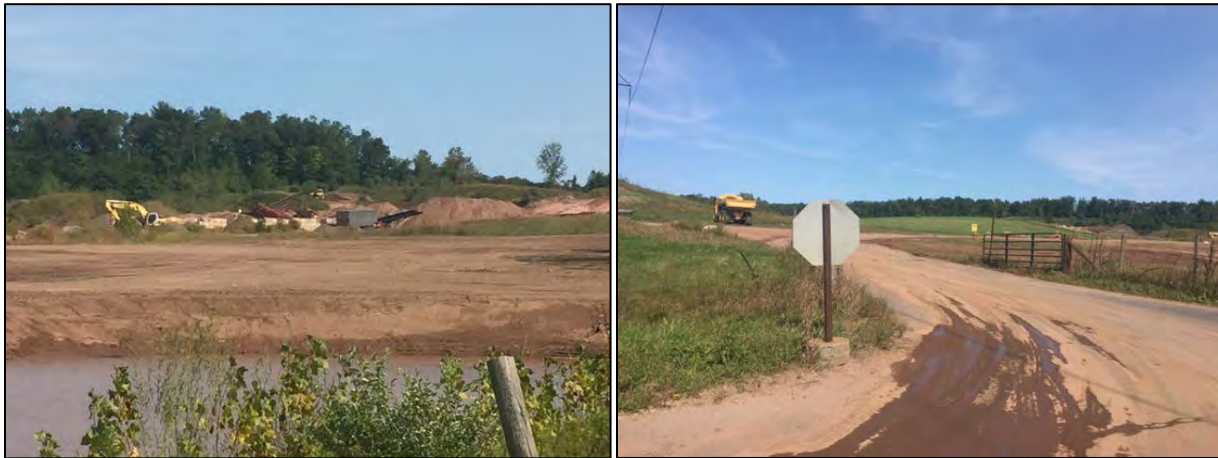
The parcel is located northwest of the intersection of Sadds Mill Road (Route 140), Muddy Brook Road, and Green Road in Ellington, CT. The facility is primarily within the main stem of Broad Brook, yet some of the land is within the Creamery Brook local basin, very close to the confluence with Creamery Brook (on adjacent property), with Broad Brook directly across Sadds Mill Road. The company has been in operation since 2001 and expanded in 2004. It consists of 3 parcels totaling 52 acres; of which proximately 45 acres are currently open, exposed earth.

- There is one approximately 0.4-acre sediment basin on-site. The sediment basin appears very cloudy both in person and in aerial photographs, and does not appear to be allowing sediment to settle out before discharging as it should. It is unclear if the sediment basin has an overflow. The large, open site could use either more sediment basins or a larger sediment basin. Additionally, the use of measures such as flocculants, to allow fine particles to settle out more effectively, may be beneficial.

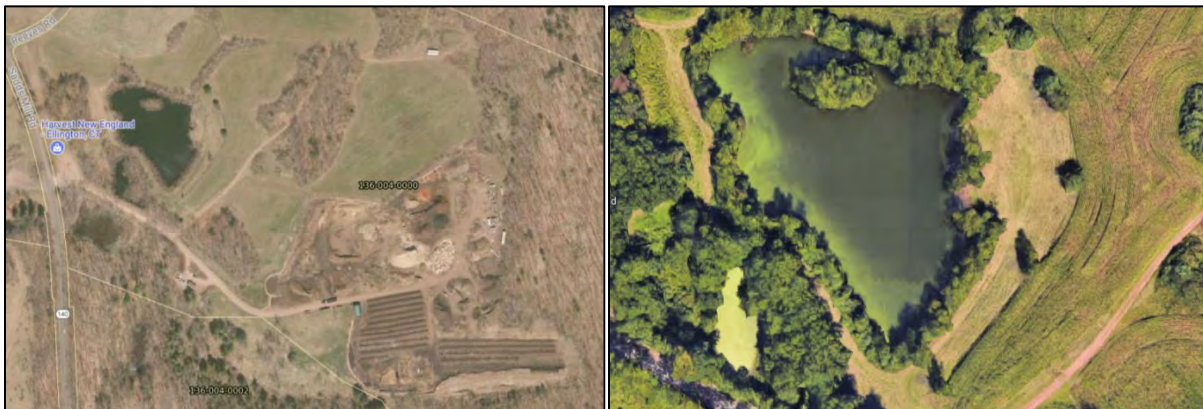
This facility is located at 277 Sadds Mill Road, Ellington, on the corner of Sadds Mill Road and Reeves Road. The location within the Broad Brook watershed splits between the Creamery Brook local basin and the main stem Broad Brook basin. The operation mainly produces landscaping products such as mulch, soil, compost, and organic/recycled materials, and also recycles/composts yard waste and food scraps and leases equipment. About 13 acres are open and actively used for material stockpiles and compost windrows. Most of the remaining acreage is vegetated, either agricultural or forested, with forestland on adjacent parcels.

- The approximately 2-acre pond located on the property has minimal vegetation surrounding it, particularly on its eastern side. The pond appears to be accessed by an area of occasional bare ground. There is also a dirt roadway that runs along the entire eastern edge of the pond. The summer of 2016 aerial imagery displays the 2-acre pond to be an opaque green color, indicating excessive nutrient loading. A wide vegetated buffer would benefit this pond.

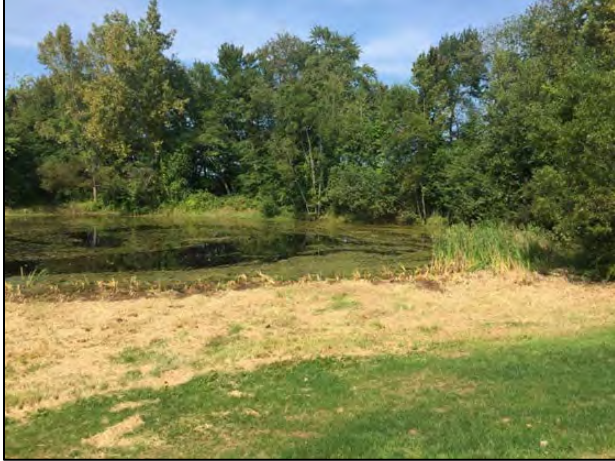
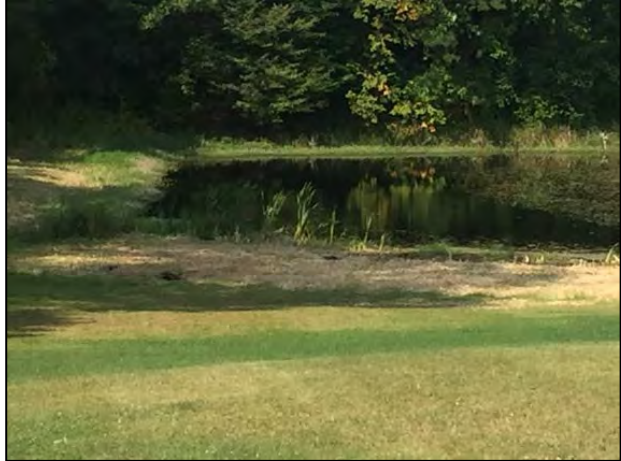
The public golf course is located south of Route 140 at 76 Sadds Mill Rd, Ellington, in the south central portion of the watershed. The country club consists of an 18-hole golf course, as well as a bar and a golf store. The golf course is 184.8 acres and relatively hilly with mostly grassland. There are 2 water hazards, as well as a pond that pre-dates the course, to the north and adjacent to the main parking lot (photos of pond and recommendations on following page).

- Due to the many golf greens, there is most likely a great deal of fertilizer used to maintain the grass. Excessive fertilizer will eventually make its way into bodies of water, such as rivers and lakes, contributing to pollution. Although the overuse of fertilizers on farms poses a considerably larger environmental impact, golf courses remain a concern. Often, more fertilizer is applied than is needed; and implementing changes to use less fertilizer would be beneficial to the environment.

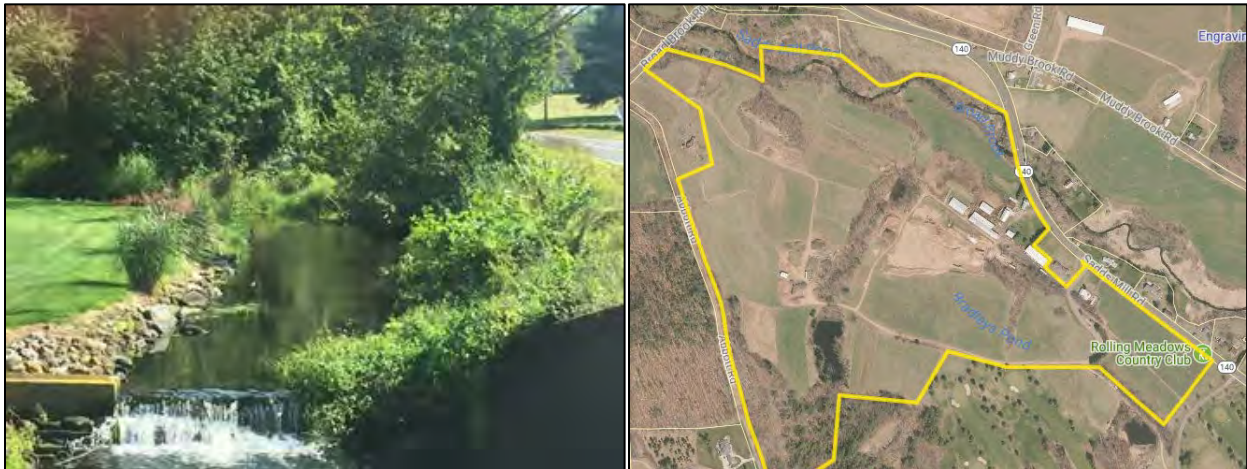
This dual-purpose facility is located in the south central boundary of the watershed. The businesses are both located on Route 140 at 90 Sadds Mill Rd, Ellington. The dairy farm, a small local provider of milk since 1971, is the primary use of the land, and the other use at this site is a small stone and gravel mining operation that produces raw materials for construction. The property consists of approximately 106 acres and is largely surrounded by agricultural fields and residential buildings. There are two ponds on the property located along Bradleys Brook, which runs south-north through the center of the property until its confluence with Broad Brook, which flows along the northern edge of the property as well.

- The northern portion of the property would aid from a larger buffer area for both Bradleys Brook and Broad Brook. The lack of vegetated buffers allows for sediment from the mining operation and nutrients from the farm to travel into the brooks. There is ponding occurring in the northeastern field, where a natural floodplain would be. This area would be best restored as a riparian buffer.
- There is stockpile located very close to the smaller pond and Bradleys Brook. These areas appear as though they are being filled in from sediment contained in runoff from the stockpile. Moving the stockpile to a different location, away from water, or covering/vegetating the pile when not in use could prevent the pond and stream from being filled in.
