Hatch Pond Watershed Based Plan

South Kent School
South Kent, Connecticut

December 2014

Project No. 20110148.A20

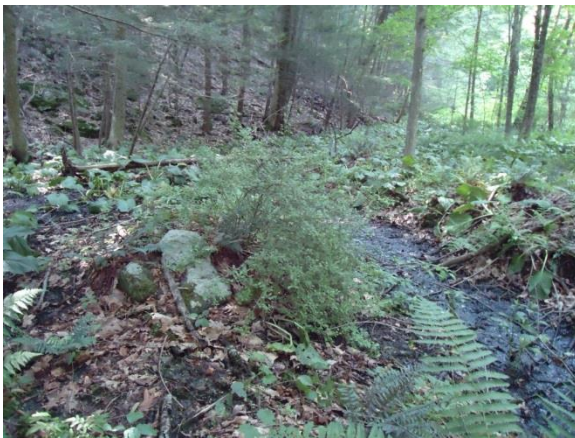
Womenshenuk Brook originates in a wetland area adjacent to Segar Mountain Road, which was formerly a small impoundment for the town's water supply. Stream reach HW-02 begins at the outlet of the small wetland area located on Aquarion Water Company property in the northern portion of the watershed and travels parallel to Segar Mountain Road (Route 341). The stream segment is generally in excellent condition. The stream is braided and has excellent canopy cover, in-stream habitat, and floodplain connection. The riparian area along this reach is typically greater than 200 feet in width. Evidence of fill was observed along the reach associated with the construction of the utility right-of-way for the water line. There were several stockpiles of abandoned 12-inch iron pipes leading up to the Aquarion Water Company-owned tank at the end of the right-of-way. The stream segment ends at a private road crossing downstream of a small forested wetland.

Photo 84: Braided stream with good canopy and in-stream habitat

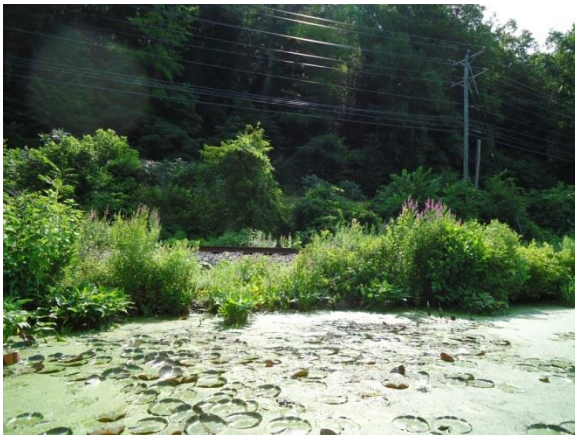
Shoreline segment HP-07 and HP-08 were evaluated as one segment because their characteristics were similar. The segment is influenced by the presence of the railroad embankment. Several drainage outfalls from South Kent Road pass underneath the railroad and discharge to the pond (CTDOT, 1935); however, none were observed due to the heavy vegetation growth along the shore. A dock is located along this reach, which may be used by local residents (see Photo 317 below).

Photo 315: The shoreline is created by the railroad embankment in some locations along the eastern side of the pond.

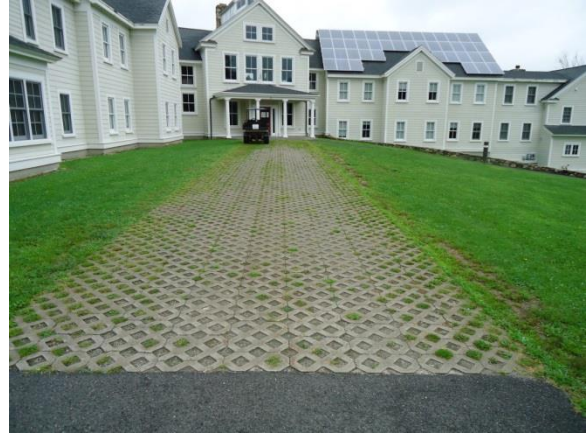
Photo 143: Grass pavers on a parking area in front of Gilder Hall Dormitory

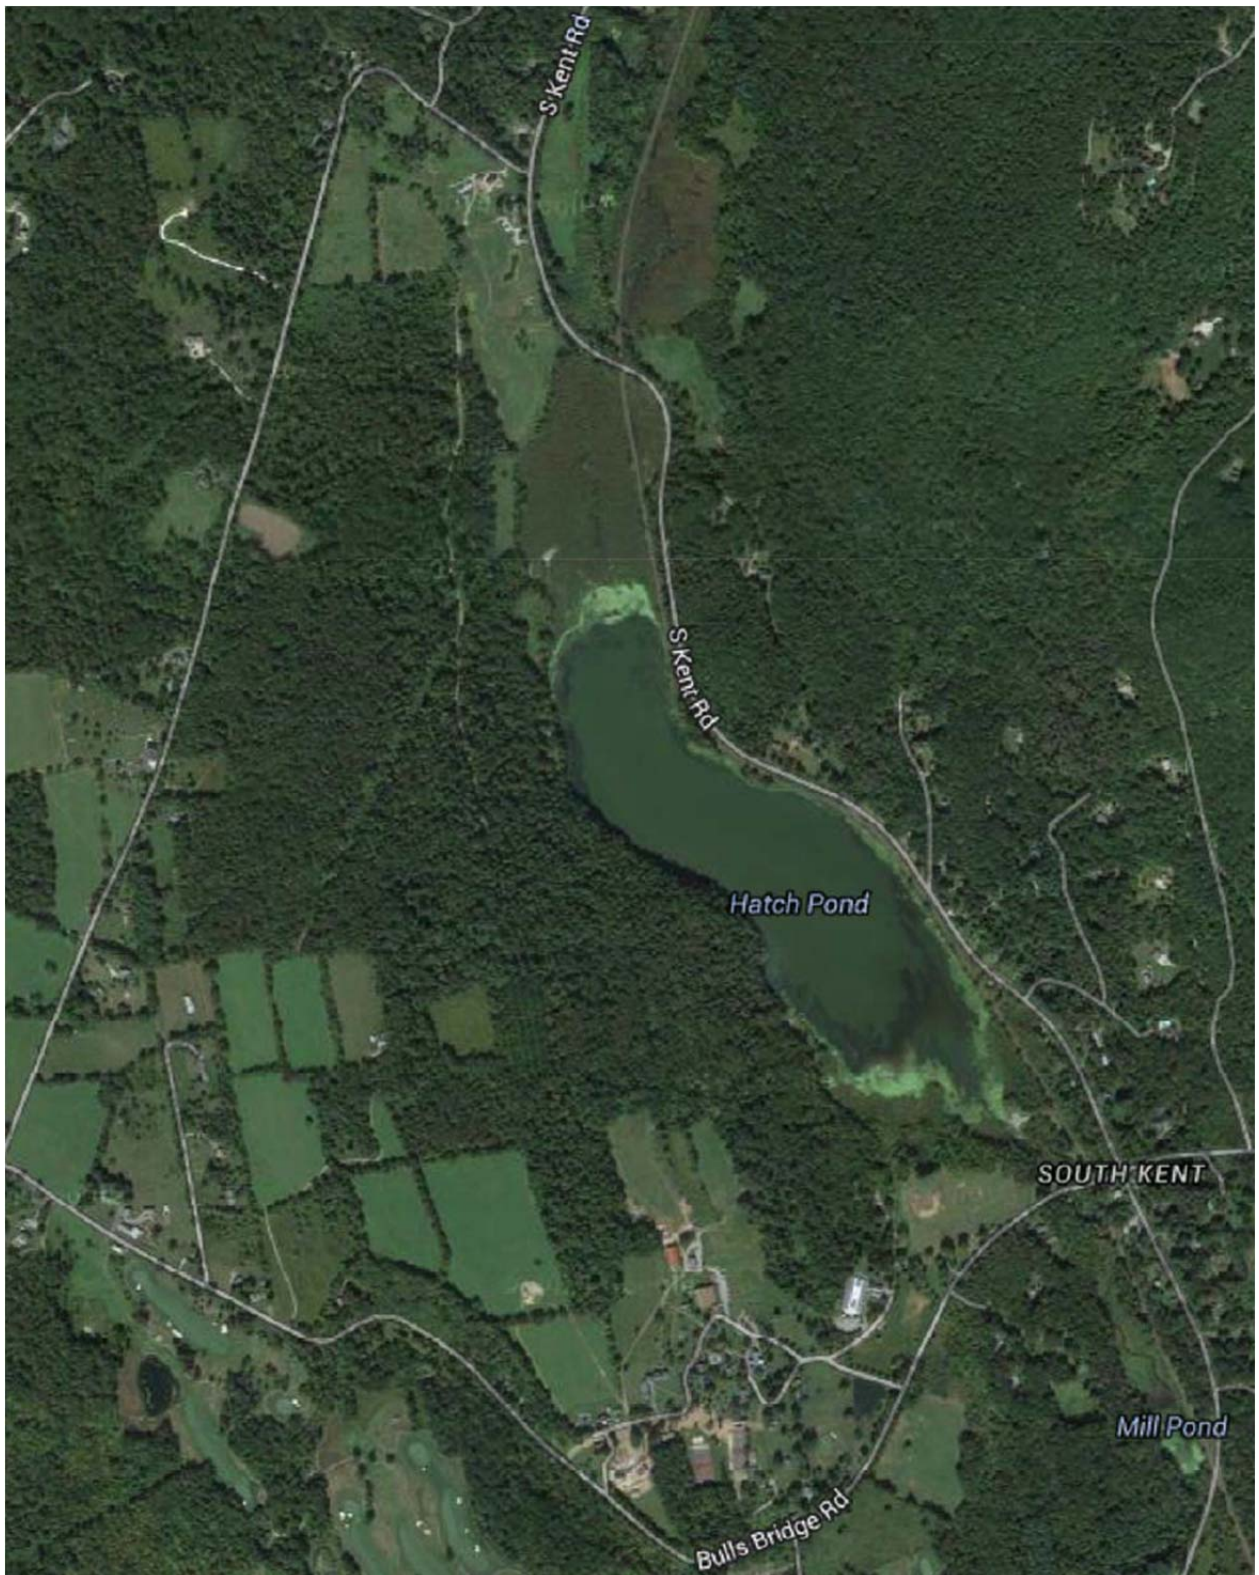
Figure 3. Hatch Pond bathymetry as of 2014.

Current bathymetry data (*Figure 2-1*) indicate a maximum pond depth of approximately 14 feet (WRS and NEAR, 2014). Other physical characteristics of Hatch Pond can be found in *Table 2-1*, including the ratio of watershed area to lake area. If a lake is small relative to the size of its watershed (e.g., has a large watershed/lake area ratio, as does Hatch Pond), the watershed can potentially have a large influence on in-lake water quality, which is the case for Hatch Pond.

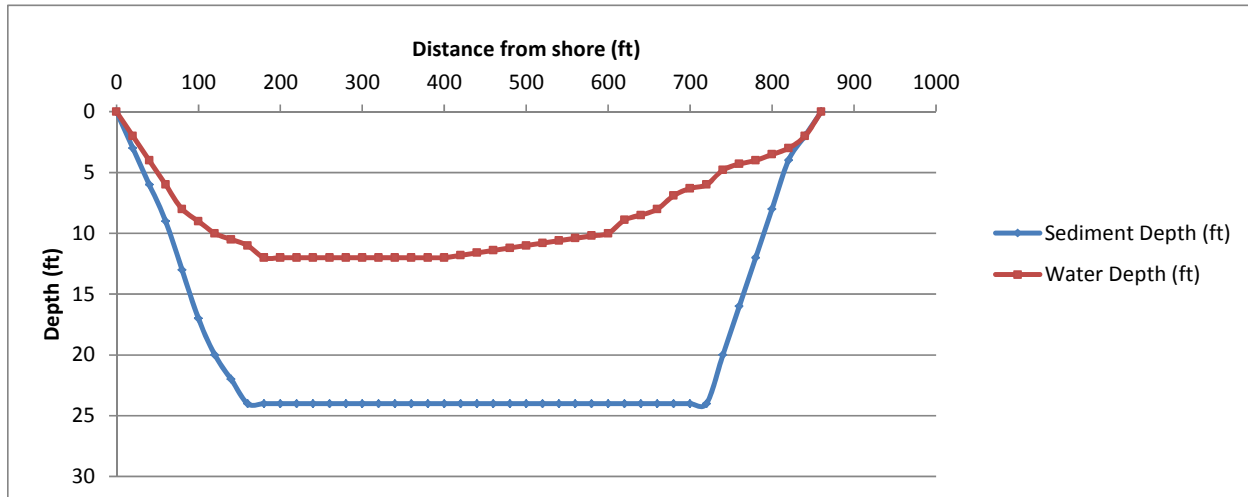
Figure 17. Hatch Pond central area cross section from 2014
