SUBJECT: FORMER HART AND HEGEMAN MANUFACTURING COMPANY-2 – RESULTS
AND CONCLUSIONS OF THE U.S. NUCLEAR REGULATORY COMMISSION'S
INITIAL SITE VISIT

**OAK RIDGE ASSOCIATED UNIVERSITIES:
SITE STATUS REPORT FOR THE FORMER HART AND HEGEMAN MANUFACTURING
COMPANY AT
340-342 CAPITOL AVENUE, HARTFORD, CONNECTICUT**

Property: Former Hart and Hegeman Manufacturing Company
340-342 Capitol Avenue
Hartford, CT 06106

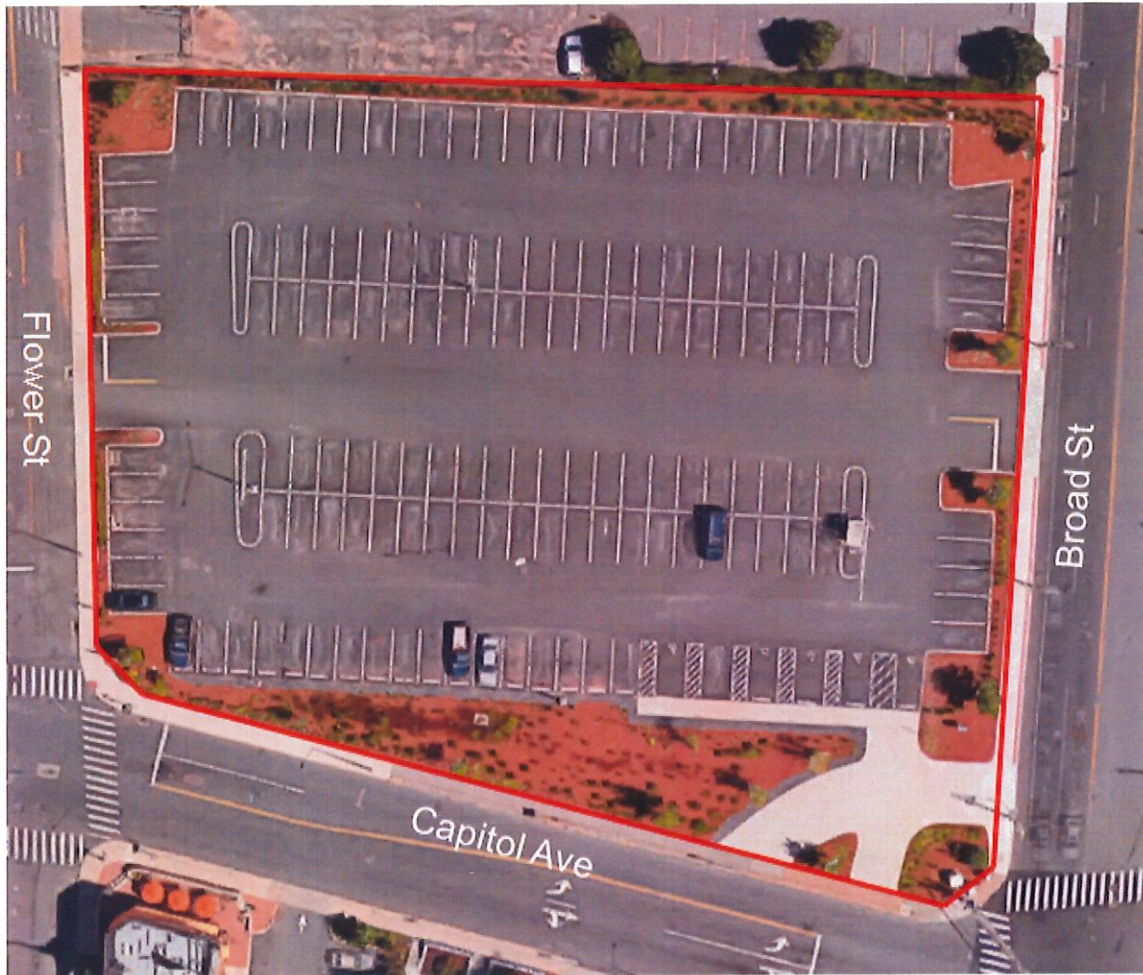
Figure 2. Aerial View of Former Hart and Hegeman Property (Google Maps, June 2017)

The 1.6-acre property is now comprised of an asphalt parking lot with flowerbed areas and sidewalks along the perimeter, as illustrated in Figure 2. Although the original building was demolished, radium contamination from historical operations may be present in surface soils, subsurface soils, and original piping that is currently covered by the asphalt parking lot. An extensive internet search of public records did not reveal any information about radium cleanup of the facility, if present (ORNL 2015).

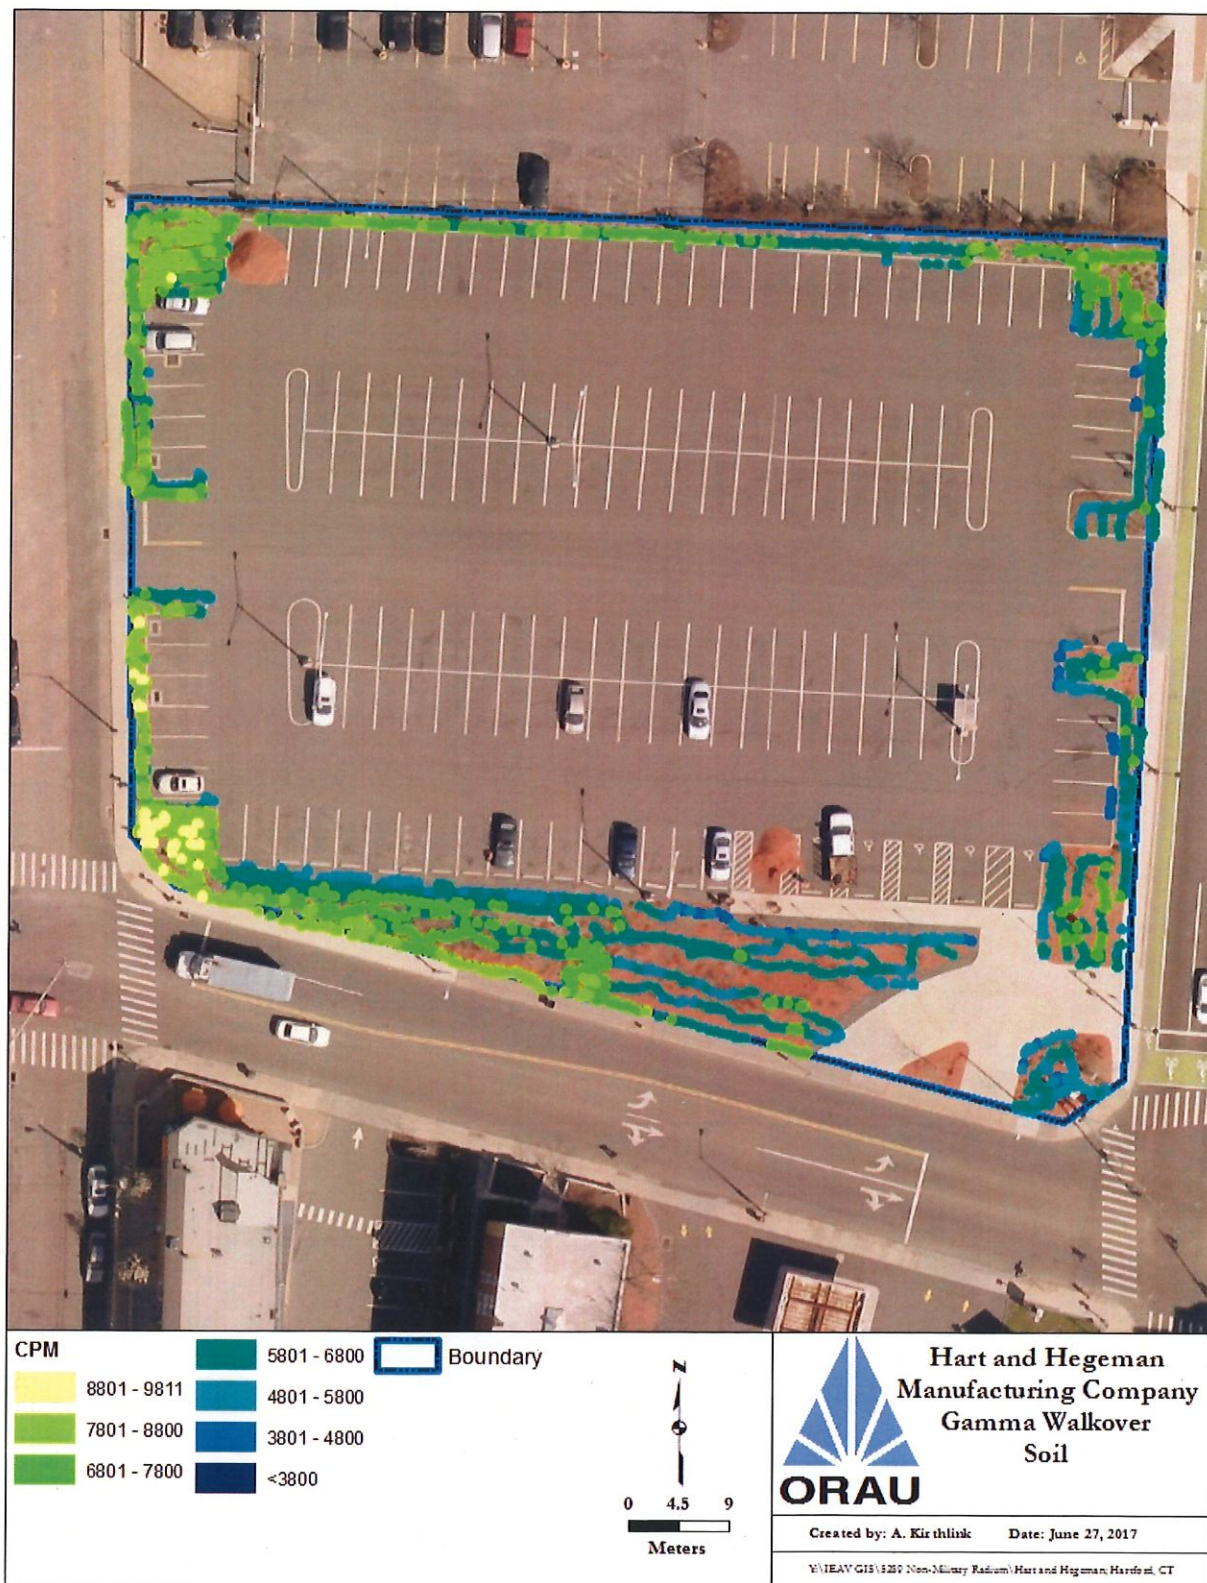
In general, detector responses were lower over parking lot areas and higher in the flowerbed areas containing soil. These results are not unexpected given the differences in naturally occurring radioactive materials (NORM) associated with these media. Table 2 presents summary statistics of survey data collected during the initial site visit. For the 2x2 sodium iodide detector measurements, the mean is close to the median; there are no anomalies; and over 99 percent of the data points fall within three standard deviations of the mean. Likewise, exposure rate measurement data exhibited similar statistical characteristics with 100 percent of the data points falling within three standard deviations of the mean. These results are consistent with survey data from an un-impacted (background) property. Gamma radiation measurements using the 2x2 sodium iodide detectors, and exposure rate data using the model 192, are mapped in Appendix B, noting asphalt and soil area results are shown separately due to dissimilar detector responses from NORM.

- Gamma radiation levels across the site were consistent with background; the absence of gamma radiation anomalies suggests there are no sources of Ra-226 present.
- Risk of potential contamination on the site is low and, if present, would most likely be found at a significant depth in the subsurface soil.

Based on the above observations, it is recommended that the NRC not perform a more detailed scoping survey. The rationale behind this recommendation is that the initial site visit generated a robust dataset that already meets the scoping survey purpose. Furthermore, it is also recommended that the NRC staff should not pursue additional action at the former Hart and Hegeman Manufacturing Company property given no elevated radiation levels (relative to background) were identified in the surface soils.
