RE: Applicant 1247, 12 Jacob Street, Norwalk, CT

This letter is to provide a summary description of the Statutory Checklist for CDBG-DR Applicant – 1247 – Matthew Hessian.

Attachment 10 – Checklist Item 13C, 13D, 13E, 13F Documentation – Hazardous Material Inspection
Report

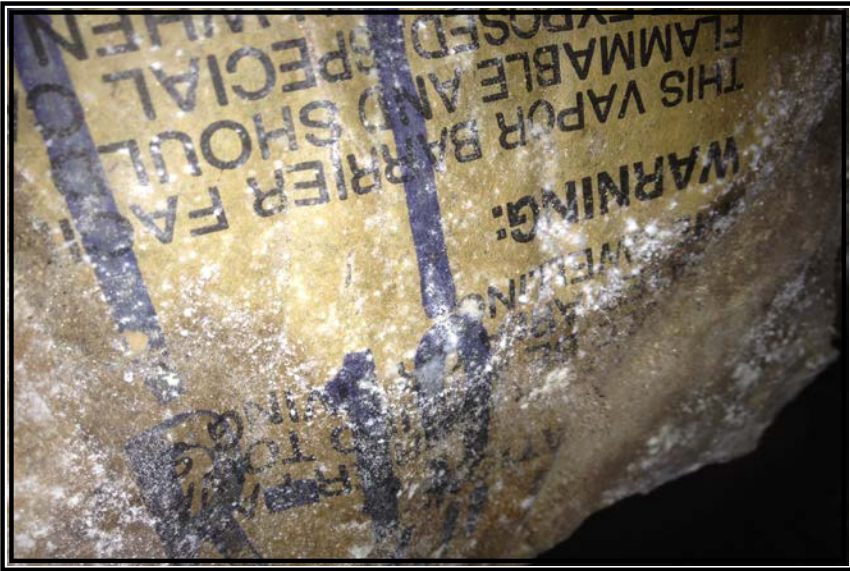
Photograph 5
Mold on insulation in basement

Triton completed a visual mold inspection of the work area on April 7, 2014. Mold was observed on concrete walls of the basement, on the wooden ceiling joist in the basement,

on insulation in the basement, and possibly on untreated wooden roof beams in the ground floor. Although not directly observed, it is possible that mold is present on both wooden surfaces and insulation behind walls on the ground floor. Photographs of the apparent mold are provided in Appendix B.

4. Mold – Mold was observed on various concrete and wooden surfaces in the basement, on insulation in the basement, and possibly on untreated wooden ceiling beams in the ground floor. Mold may be present in areas that could not be observed during the inspection (i.e. behind walls). Additional mold impacted surfaces may be encountered during renovation in spaces that were inaccessible or not apparent during the inspection. Due to the intended demolition of the dwelling, abatement for mold does not appear to be necessary. Triton recommends that the demolition contractor be advised of the presence of mold within the structure such that workers can be prepared with appropriate health and safety protection.
