## Study 1: Hydrologic and Hydraulic Planning Study of Eight Major Streams

Town of Westport, Connecticut

May 30, 2018

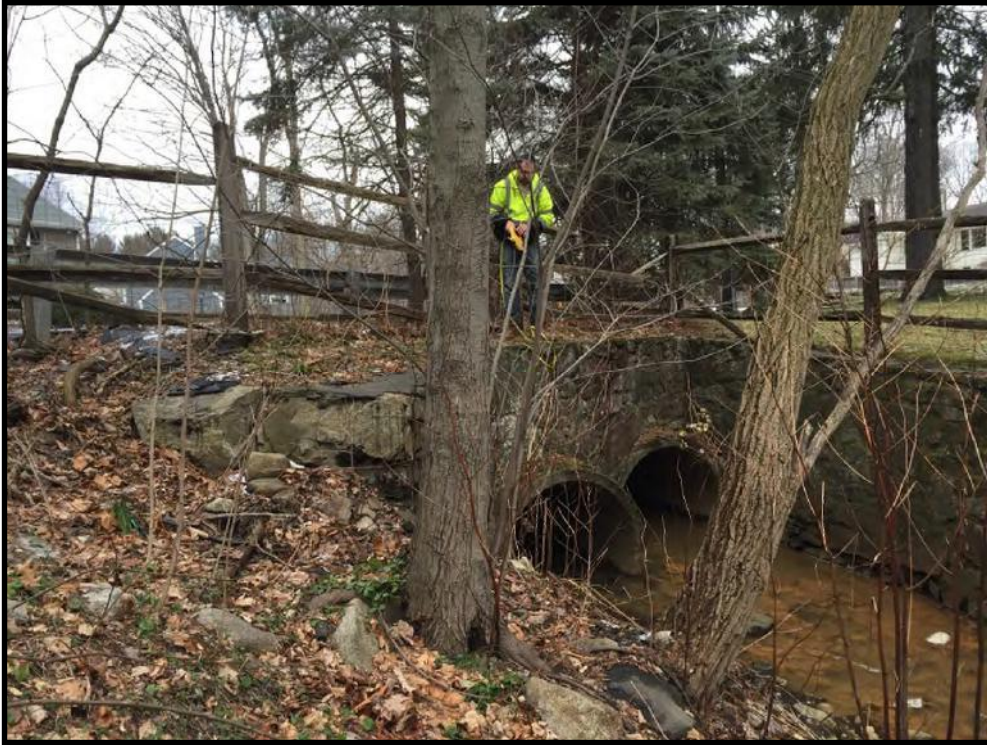
**Photo No. 1**

Crossing Name	Conveyance Structure Type	Approximate Opening Dimensions (feet)	Data Sources Other Than Field Data
Kings Highway S [Photo #1]	RCP Culvert	Two openings; 4.5' diameters	Upstream invert elevation from contours. Length from aerial/contours.
Tarone Drive [Photo #2]	RCP Culvert	Two openings; 4.5' diameters	Length from aerial/contours.
Hogan Trail [Photo #3]	RCP Culvert	Two openings; 3.4' diameters	Length from aerial/contours.
Interstate 95 <sup>(1)</sup> [Photo #4]	RCP Culvert	Single opening; 3.4' diameter	Length, diameter, and construction material from Town Engineer. Upstream invert elevation from contours. Construction material from photo.
Hiawatha Drvwy [Photo #5]	RCP Culvert	Two openings; 2.3' diameters	Length from aerial/contours.
Hiawatha Lane [Photo #6]	RCP Culvert	Two openings; 2.2' diameters	Length from aerial/contours.
Gillette Drvwy [Photo #7]	Elliptical CMP Culvert	Single opening; 2.9' height with 5.1' span	Length from aerial/contours.

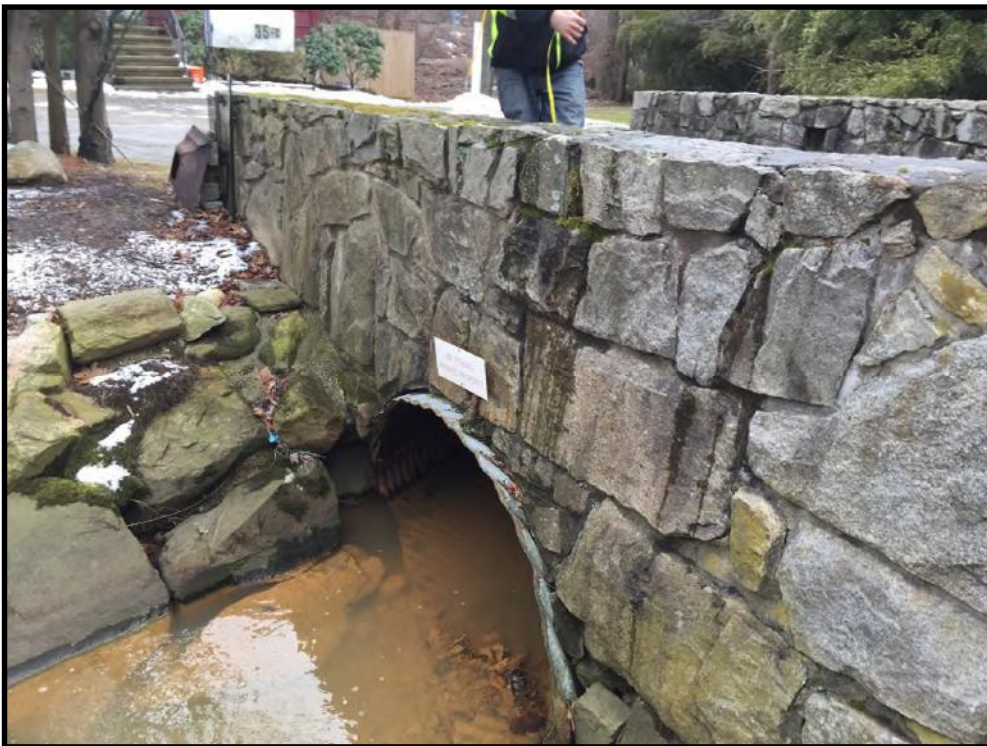
**Photo No. 8**

Hiawatha Ln Ext [Photo #8]	Elliptical CMP Culvert	Single opening; 2.9' height with 5.4' span	Length from aerial/contours.
Railroad <sup>(2)</sup> [Photo #9]	RCP Culvert	Two openings; 7' diameters	Length, dimensions, and construction material from CTDOT inspection report. Invert elevations from contours/inspection report.
RR Access Road <sup>(3)</sup> [Photo #10]	Circular Culverts	Culvert #1: 3' diameter RCP; Culvert #2: 3' diameter RCP; Culvert #3: 4.5' diameter RCP; Culvert #4: 3' diameter CMP	Dimensions and construction material from photos. Length from aerial/contours. Invert elevations from contours/terrain.
IR Green Road [Photo #11]	Concrete Box Culvert	Two openings; 2.1' height with 10.2' and 10.4' spans	Length from aerial/contours. Invert elevations from terrain.
Saugatuck Avenue <sup>(4)</sup> [Photo #12]	RCP Culvert	Single opening; 6.3' diameter	Length from aerial/contours.

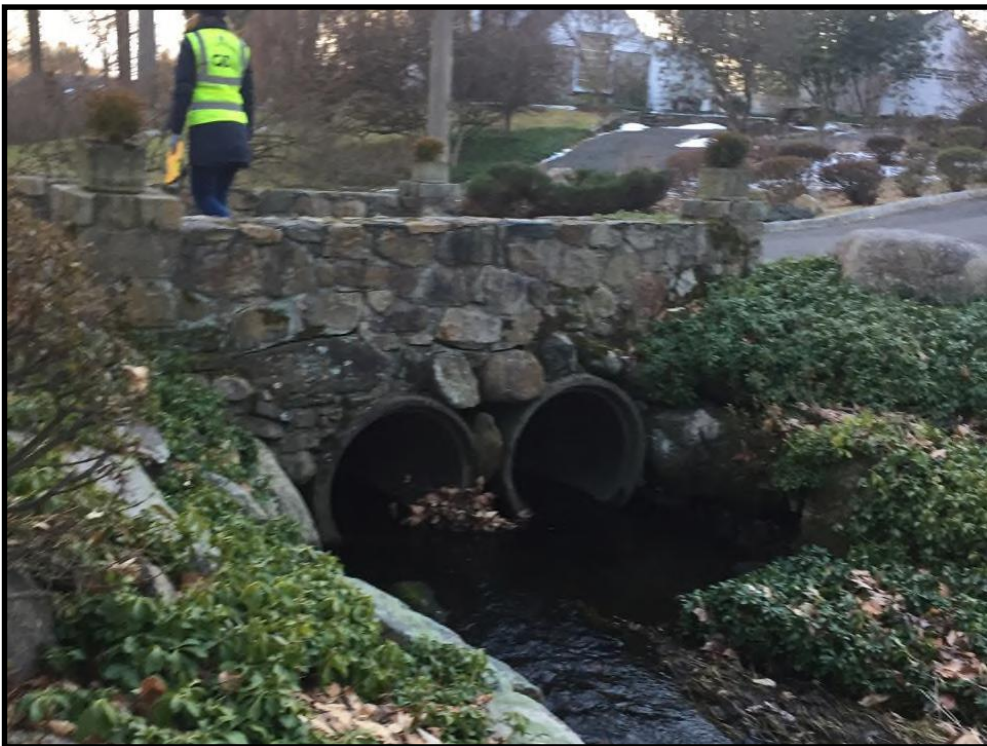
**Photo No. 20**

Bayberry Drvwy 2 [Photo #20]	RCP Culvert	Two openings; 3.3' diameters	Length from aerials.
Bayberry Drvwy 1 [Photo #21]	Mason Bridge	Single opening; 3.5' height with 6.5' span	Length from aerials.
5 Angora Dam <sup>(2)</sup> [Photo #22]	Dam	8' total span; 1' depth	Dimensions from aerials/field photos. Length from field photos.
4 High Pt Rd (Driveway) [Photo #23]	Concrete Bridge	Single opening; 4.2' height with 6.2' span	Length from aerials.
High Point Road [Photo #24]	Concrete Bridge	Single opening; 3.7' height with 8' span	Length from aerials.
Long Lots Rd [Photo #25]	Mason Bridge	Single opening; 3' height with 10' span	Length from aerials.
Meadowbrook Lane [Photo # 26]	RCP Culverts	Two openings; 4' diameters	Length from aerials.
4 Meadowbrook (Driveway) <sup>(3)</sup> [Photo #27]	RCP Arch Culvert	Two openings; 2.7' height with 2.8' span	Length from aerials.
8 Meadowbrook (Driveway) [Photo #28]	RCP Culvert	Two openings; 3.7' diameters	Length from aerials.

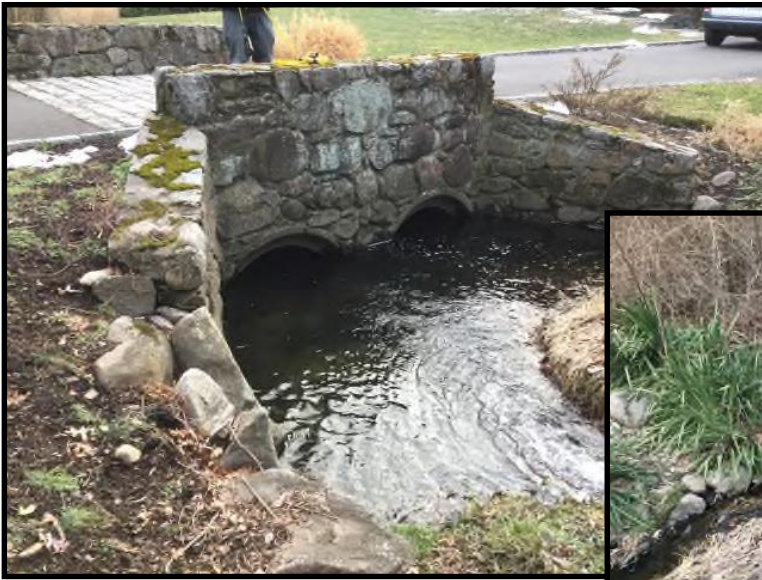
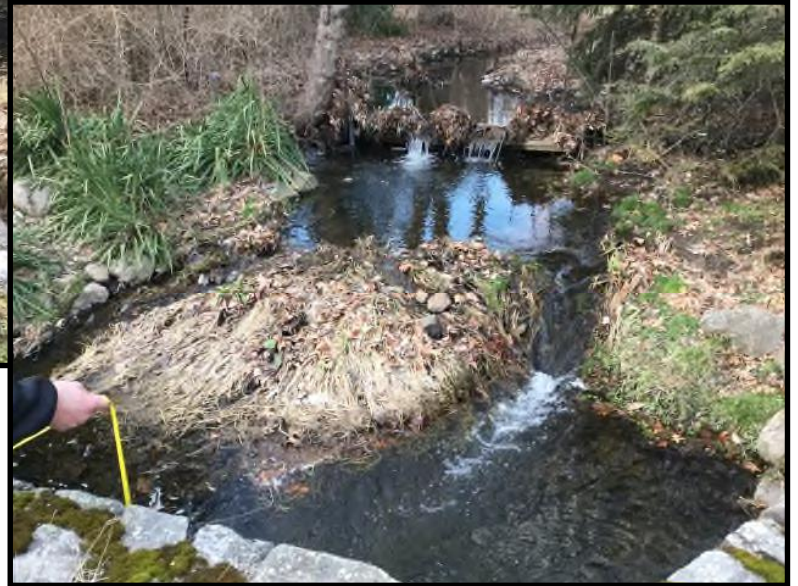
**Photo No. 27  
(Upstream above, downstream right)**

3. **4 Meadowbrook (Driveway):** A small dam feature was present just upstream of the culvert, however, it appears the feature is a platform for a wire fence (Photo #27). The feature was not considered significant nor modeled.

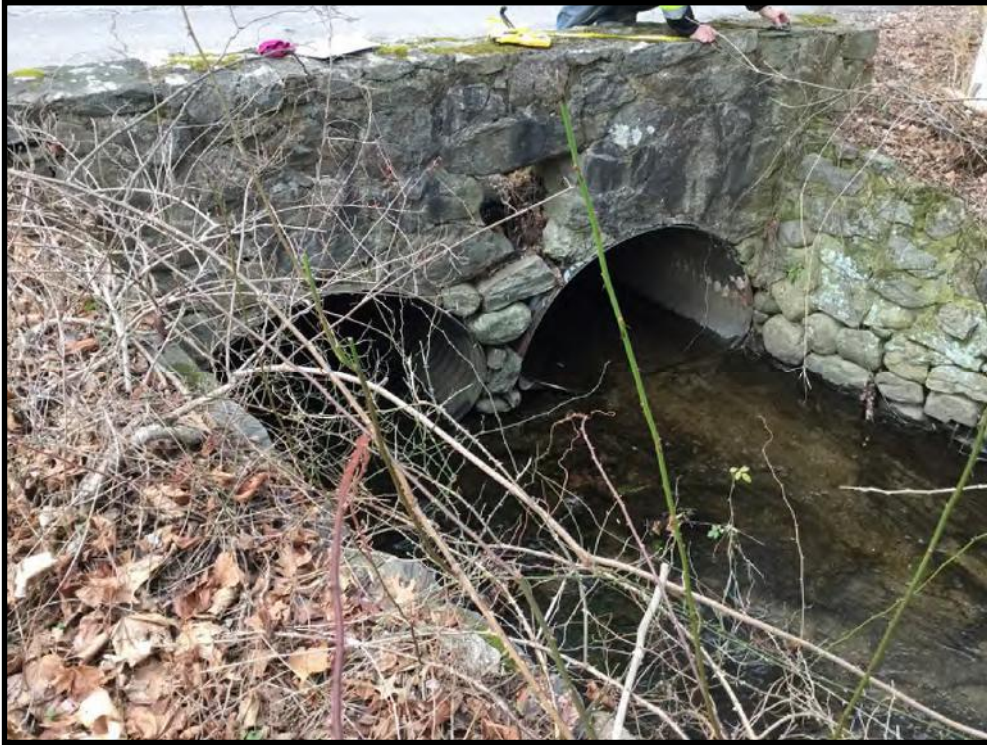
**Photo No. 29**

Ambler Road [Photo #29]	Elliptical CMP Culvert	Two openings; 2.9' height with 4.5' span	Length from aerials.

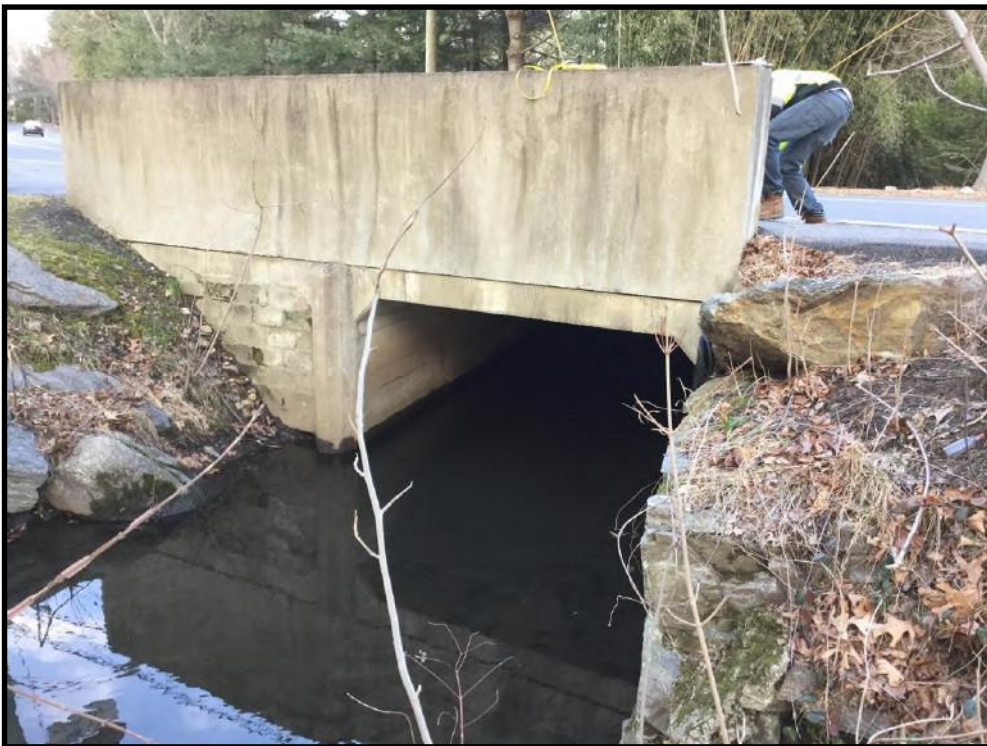
**Photo No. 30**

Turkey Hill Road [Photo #30]	Concrete Box Culvert	Single opening; 4.7' height with 8.2' span	Dimensions and length from CTDOT inspection report.
US Rt 1 (Post Road East) <sup>(4)</sup> [Photo #31]	Concrete Box Culvert	Single opening; 4.6' height with 7.3' span	Dimensions from CTDOT inspection report. Length from aerials.
Morningside Drive <sup>(5)</sup> [Photo #32]	Concrete Box Culvert	Single opening; 3.2' height with 8.5' span	Length from aerials.
Hillandale Street [Photo #33]	Mason Bridge	Single opening; 4.2' height with 11.3' span	Length from aerials.
Center Street [Photo #34]	Concrete Bridge	Two openings; 6.6' height with 7.8' span and 1.3' spacing	Length from aerials.
Center St Drvwy [Photo #35]	Concrete Bridge	Single opening; 8' height with 10' span	Length from aerials.
Greens Farms Road [Photo #36]	Concrete Bridge	Single opening; 4' height with 11.7' span	Dimensions from CTDOT inspection report/photos. Length from aerials.

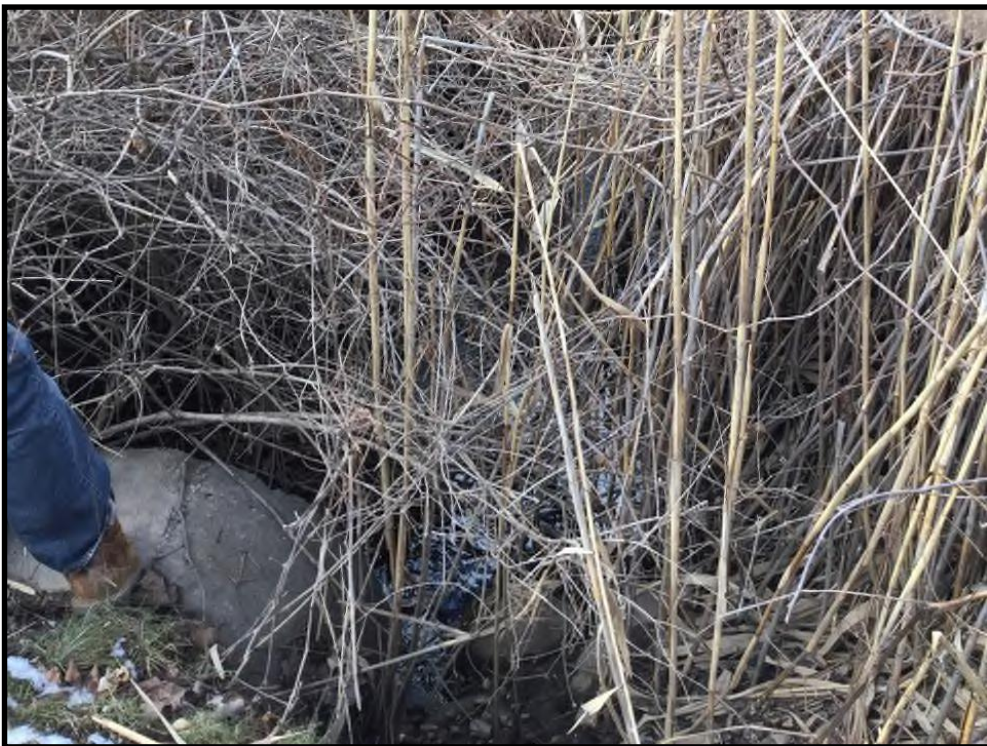
**Photo No. 42**

Private Road [Photo #42]	CMP Culvert	Single opening; 4' diameter	Length from aerials.
Railroad <sup>(4)</sup> [No Photo Available]	CMP Culvert	Single opening; 5.1' diameter	Dimensions and construction material from CTDOT inspection report. Length from aerials. Invert elevations from terrain/contours.
Maple Lane [Photo #43]	Concrete Bridge	Single opening; 4.7' height with 7' span	Length from aerials.
Beachside Ave [Photo #44]	Concrete Bridge	Two openings; 5.5' height with 6' span	Length from aerials.

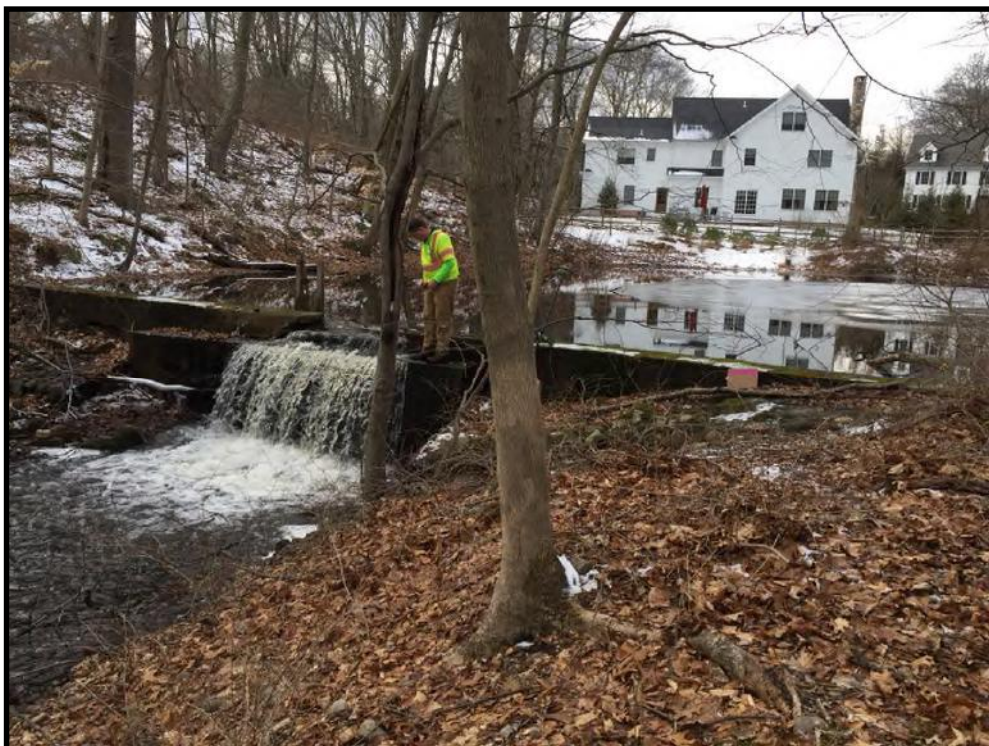
**Photo No. 50**

FEMAProfile Dam3 [Photo #50]	Dam	67' total span; 6.3' spillway span with 0.5' depth	Top of dam and top of spillway/water surface elevations from terrain. Total span of dam from photos.
FEMAProfile Dam2 <sup>(2)</sup> [Photo #51]	Dam	40' total span; 7' spillway span with 0.3' depth. 2.5' width and 0.5' depth of eroded portion.	Top of dam elevation from terrain. Total span of dam from photos.
FEMAProfile Dam1 <sup>(3)</sup> [Photo #52]	Dam	31' total span; 3' spillway span with 0.25' depth. 2.5' width and 1.25' depth of eroded portion.	Spillway and erosion dimensions from photos. Top of dam elevation from terrain. Total span of dam from aerials/contours.
Rices Ln Bridge [Photo #53]	Concrete Bridge	Single opening; 2.7' height with 7.3' span	Height of bridge measurement included approximate 2.7' thick support beam beneath bridge deck. Length from aerials/contours.

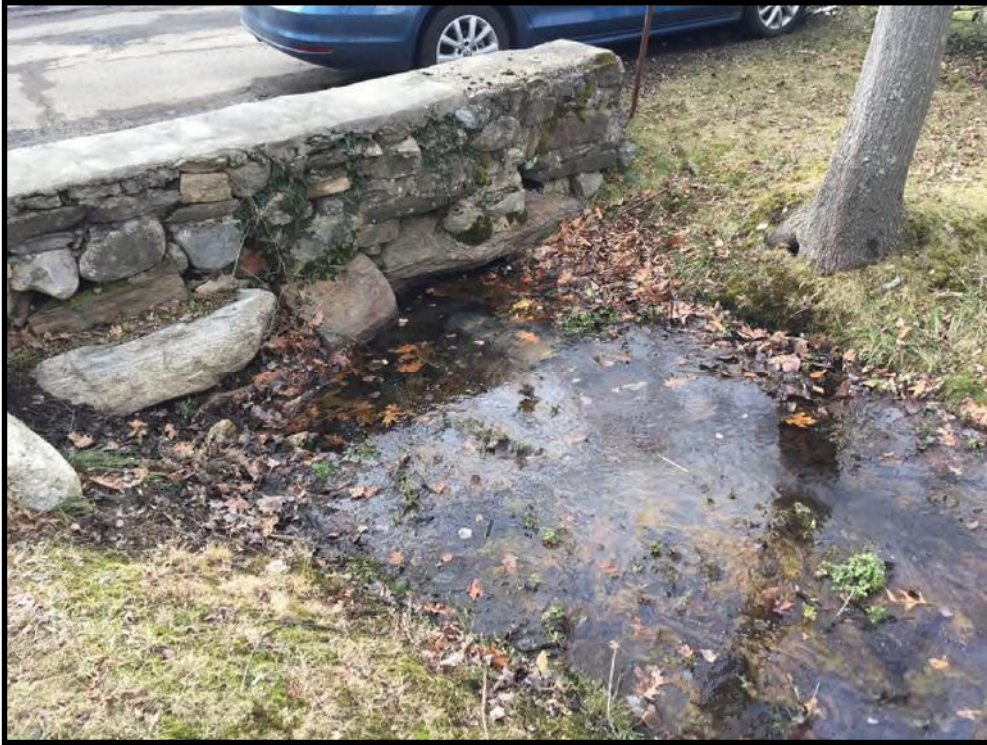
**Photo No. 56**

Sue Terrace <sup>(4)</sup> [Photo #56]	RCP Culvert	Single opening; 0.5' diameter	Dimensions and construction material were assumed to be the same as nearby culverts, because structure was not measured in field. Invert elevations from contours. Length from aerials/contours.
Yard Culvert <sup>(5)</sup> [No Photo Available]	CMP Culvert	Single opening; 0.5' diameter	Dimensions and construction material were assumed to be the same as nearby culverts, because structure was not measured in field. Invert elevations from contours. Length from aerials/contours.
State Street E [Photo #57]	CMP Arch Culvert	Single opening; 4' height with 7.8' span	Invert elevations from contours. Length from aerials/contours.
Spicer Road [Photo #58]	CMP Arch Culvert	Single opening; 2.5' height with 3' span	Length from aerials/contours. Assumed a 90-degree elbow in culvert due to opposite orientation of inlet and outlet.
Iron Gate Hill [Photo #59]	RCP Culvert	Two openings; 2' diameters	Length from aerials/contours.

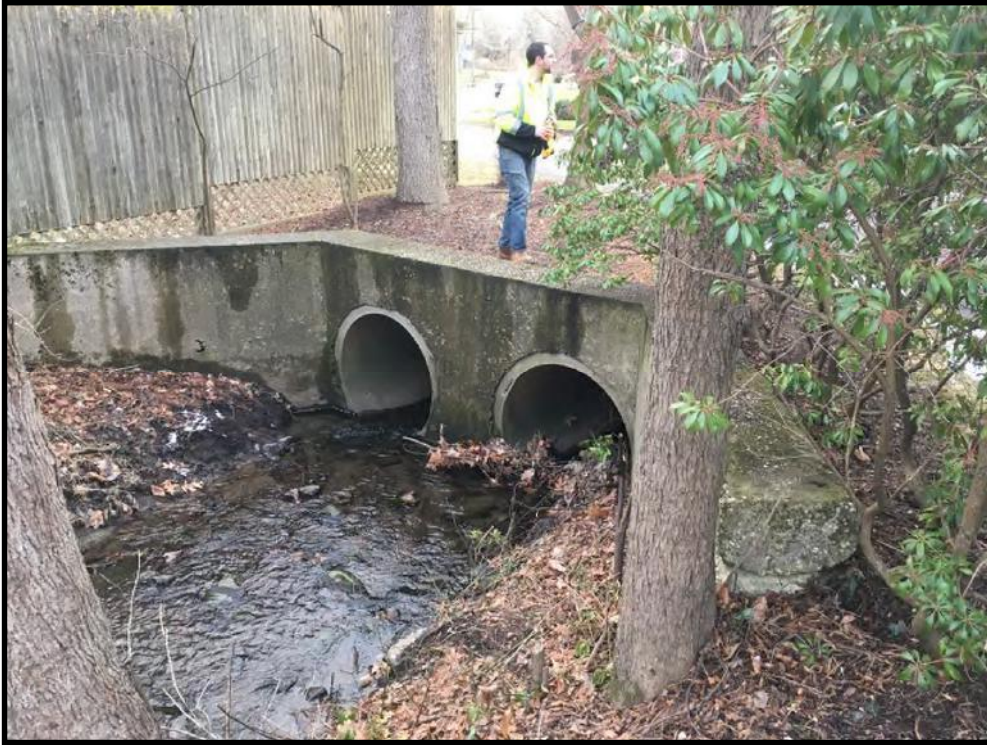
**Photo No. 60**

Valley Road [Photo #60]	RCP Culvert	Two openings; 3' diameters	Length from aerials/contours.
Guyer Road [Photo #61]	Elliptical RCP Culvert	Single opening; 2.8' height with 6.8' span	Length from aerials/contours.
Office Park [Photo #62]	CMP Arch Culvert	Single opening; 4.3' height with 7' span	Length from aerials/contours.

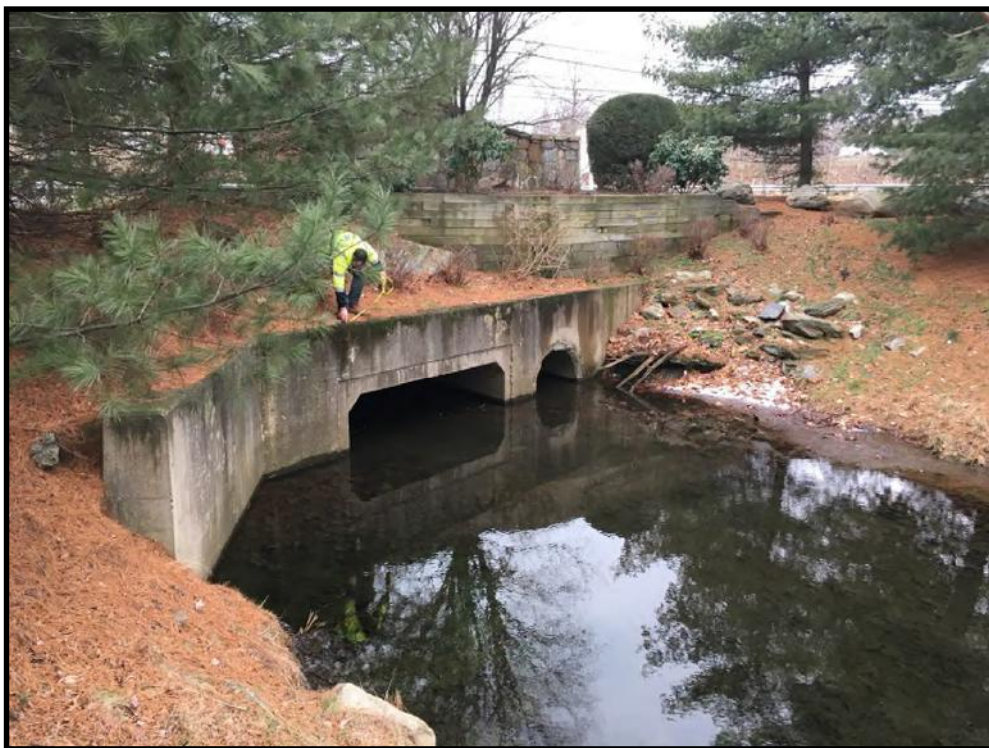
**Photo No. 63**

Green Farms Road <sup>(6)</sup> [Photo #63]	Concrete Culvert (Box and RCP)	Box Culvert: 4' height with 10' span; RCP Culvert: 4' diameter	Dimensions, length, and construction material from plan drawings in CTDOT inspection report. Invert elevations from contours.
Hillspoint Road <sup>(7)</sup> [No Photo Available]	RCP Culvert	Single opening; 6' diameter	Dimensions, length, and construction material from CTDOT inspection report. Invert elevations from contours.
Interstate 95 <sup>(8)</sup> [In background of Photo #64]	RCP Culvert	Single opening; 6' diameter	Dimensions, length, and construction material from Town Engineer. Invert elevations from contours.
Railroad <sup>(9)</sup> [Photo #64]	RCP Culvert	Single opening; 6' diameter	Dimensions and construction material from field photos. Invert elevations from contours. Length from aerials/contours.

5. **Yard Culvert:** Structure was not measured in the field; however, GZA assumed it is similar to nearby culverts.
6. **Green Farms Road:** Road to streambed distance was 11' in CTDOT inspection report (Bridge # 158-007), however, 6" of sediment was noted to be present in culvert.

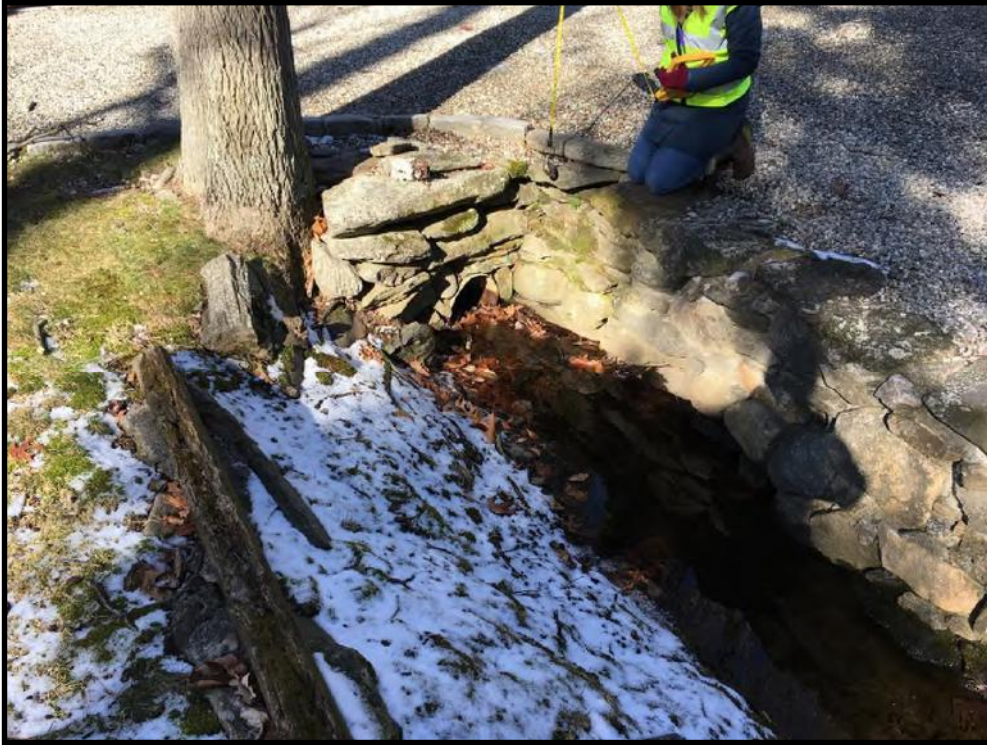
**Photo No. 65**

Crossing Name	Conveyance Structure Type	Approximate Opening Dimensions (feet)	Data Sources Other Than Field Data
Near Bayberry Ln [Photo #65]	CMP Culvert	Single opening; 1' diameter	Length from aerials/contours. Driveway to streambed distance from photos.
Bayberry Drvwy [Photo #66 and 67]	RCP Culvert	Single opening; 1' diameter	Length from aerials/contours.
Bayberry Lane [Photo #67]	RCP Culvert	Single opening; 2' diameter	Length from aerials/contours.
Charcoal Hill Cm [Photo #68]	RCP Culvert	Single opening; 1.2' diameter	Length from aerials/contours.
Charcoal Pool <sup>(1)</sup> [No Photo Available]	Circular Plastic Culvert	Single opening; 1.1' diameter	Dimensions and construction material were assumed to be the same as nearby culverts, because structure was not measured in field. Invert elevations from contours. Length from aerials/contours.
Charcoal Hill Rd [Photo #69]	Circular Plastic Culvert	Two openings; 1.1' diameters	Length from aerials/contours.

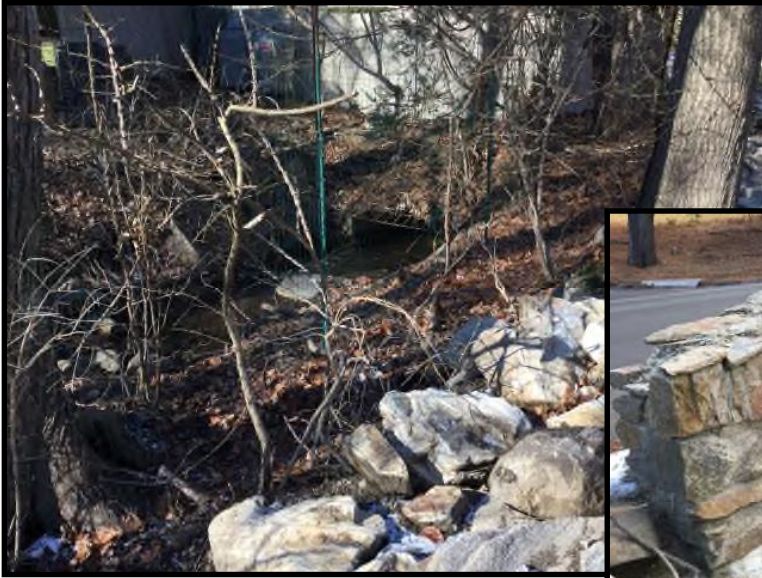
**Photo No. 70**

Charcoal Hill Ln [Photo #70]	RCP Culvert	Single opening; 2.7' diameter	Length from aerials/contours.
North Avenue <sup>(2)</sup> [Photo #71]	RCP Culvert	Single opening; 2' diameter	Length from aerials/contours. The culvert was assumed not to be straight due to opposite orientation of inlet and outlet. The upstream invert elevation from terrain.
Easton Road <sup>(3)</sup> [Photo #72]	CMP Culvert	Two openings; 2' diameters	Length from aerials/contours.
Brooklawn Dr Dam [Photo #73 and 74]	Dam	14' total span; 1' height with 0.3' thickness	Dam thickness from photos. Top of dam elevation from terrain.
Brooklawn Drive [Photo #74]	Concrete Box Bridge Culvert	Single opening; 2.4' height with 9.8' span	Length from aerials/contours.
Pony Lane <sup>(4)</sup> [No Photo Available]	Concrete Box Bridge Culvert	Single opening; 4' height with 10' span	Dimensions were assumed to be the same as Town Crier Lane structure, because structure was not measured in field. Invert elevations from contours. Length from aerials/contours.

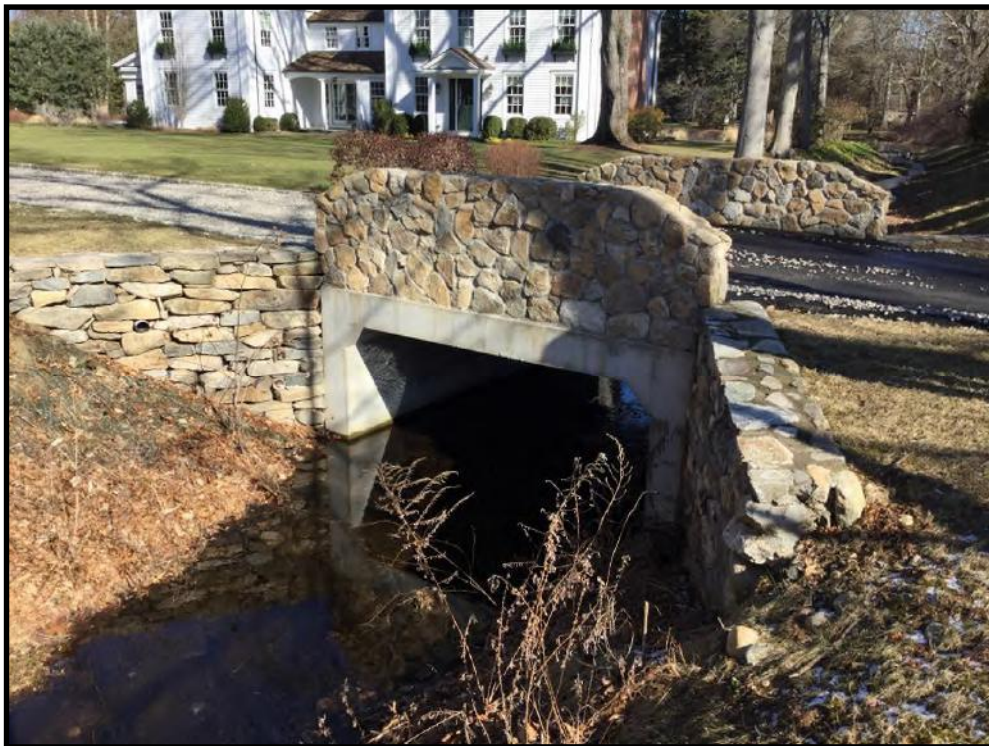
**Photo No. 75**

Town Crier Dam <sup>(5)</sup> [Photo #75 and 76]	Dam	7' total span; 1' height with 0.3' thickness	Dimensions were assumed to be the same as Brooklawn Dr Dam, because structure was not measured in field. Top of dam elevation from contours/terrain.
Town Crier Lane [Photo #76]	Concrete Box Bridge Culvert	Single opening; 4' height with 10' span	Length from aerials and the Town of Westport.
Bonnie Brook Rd1 [Photo #77]	Concrete Box Bridge Culvert	Single opening; 2.2' height with 12' span	Length from aerials/contours.

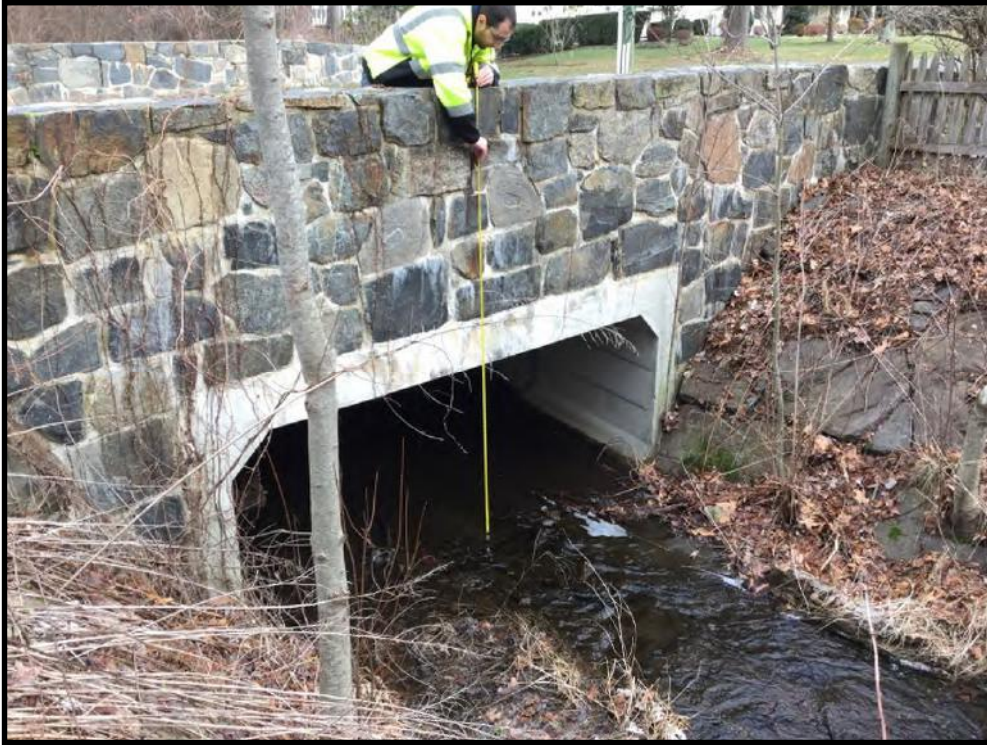
**Photo No. 78**

Bonnie Brook Dam [Photo #78]	Dam	13.4' total span; 0.25' spillway depth and 1.5 spillway span	Length from terrain/contours.
Bonnie Brook Ln [Photo #79]	Concrete Box Bridge Culvert	Single opening; 3.9' height with 10.1' span	Length from aerials/contours.
Bonnie Brook Rd2 [Photo #80]	Concrete Box Bridge Culvert	Two openings; 2.8' height with 7' span	Length from aerials/contours.
Lyons Plains Rd [Photo #81]	Concrete Box Bridge Culvert	Single opening; 3.0' height with 12' span	Length from aerials/contours.

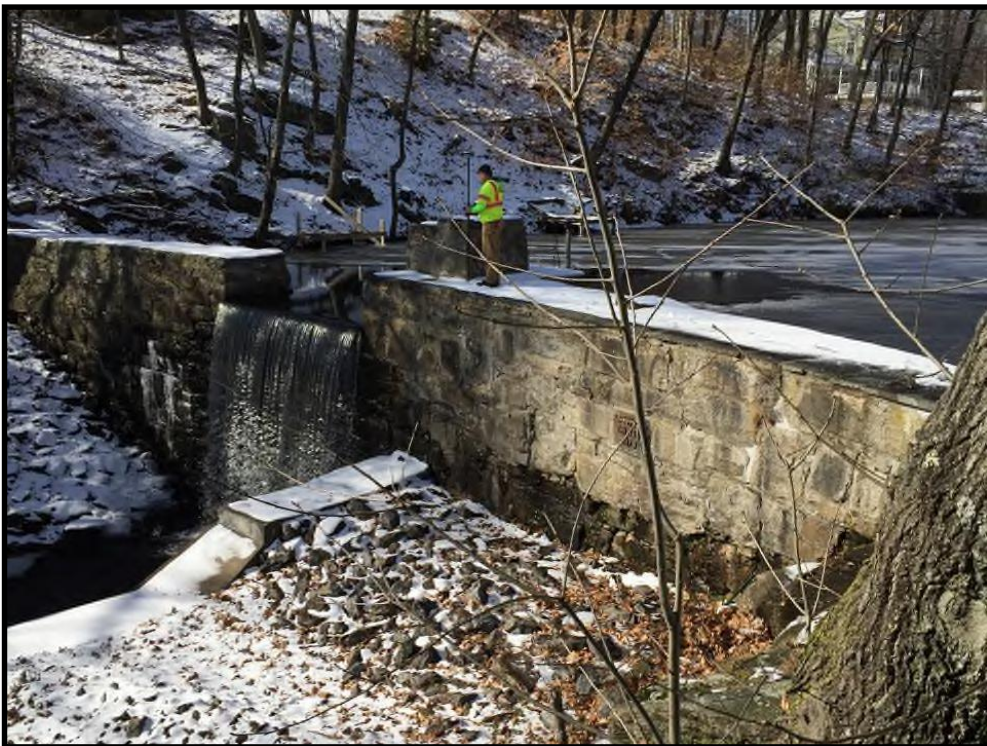
**Photo No. 88**

S Blind Brook [Photo #88]	Mason Bridge	Single opening; 5' height with 8.8' span	Length from aerials.
Nash Pond Dam [Photo #89]	Dam	115' total span; 15' spillway span; 3.4' spillway height; 4' depth	Dimensions and length from aerials/field photos.
Kings Highway [Photo #90]	Concrete Bridge	Single opening; 4.4' height with 12.5' span	Length from aerials.
Post Road (US Route 1) [Photo #91]	Concrete Bridge	Single opening; 6.8' height with 23' span	Dimensions from CTDOT inspection report. Length from aerials.
Sylvan Road [Photo #92]	Concrete Bridge	Single opening; 5' height with 26.1' span	Dimensions from CTDOT inspection report. Length from aerials.
Highway 33 [Photo #93]	Concrete Bridge	Single opening; 8.5' height with 16' span	Dimensions from CTDOT inspection report. Length from aerials.

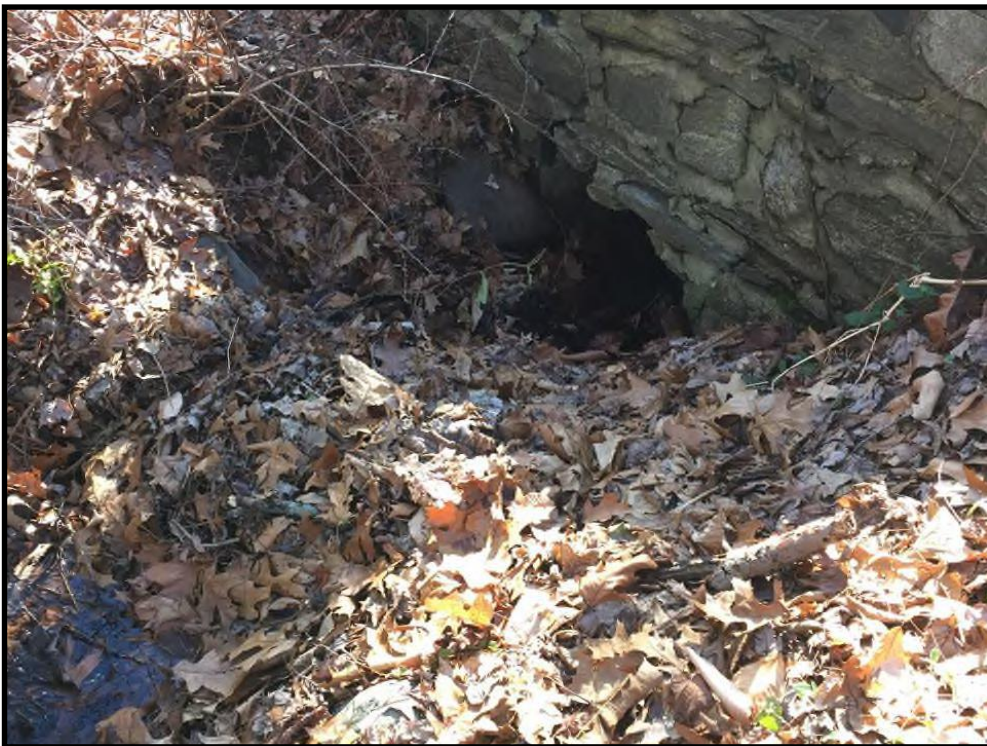
**Photo No. 94**

Crossing Name	Conveyance Structure Type	Approximate Opening Dimensions (feet)	Data Sources Other Than Field Data
N Ridge Drvwy [Photo #94]	RCP Culvert	Single opening; 2' diameter	Length from aerials.
North Ave [Photo #95]	RCP Culvert	Single opening; 1' diameter	Length from aerials.
Northside Drvwy [Photo #96]	CMP Culvert	Single opening; 4' diameter	Length from aerials.
Northside Yard [Photo #97]	Plastic Culvert	Single opening; 2' diameter	Length from aerials.
Northside Lane [Photo #98]	RCP Culvert	Single opening; 2' diameter	Length from aerials.
Merritt Parkway <sup>(1)</sup> [No Photo Available]	RCP Culvert	Single opening; 2.5' diameter	Length, diameter, and construction material from Town Engineer. Invert elevations from terrain.
15 Bushy Ridge (Driveway) [Photo #99]	RCP Culvert	Single opening; 2' diameter	Length from aerials.
Bushy Ridge Road [Photo #100]	RCP Culvert	Single opening; 2' diameter	Length from aerials.

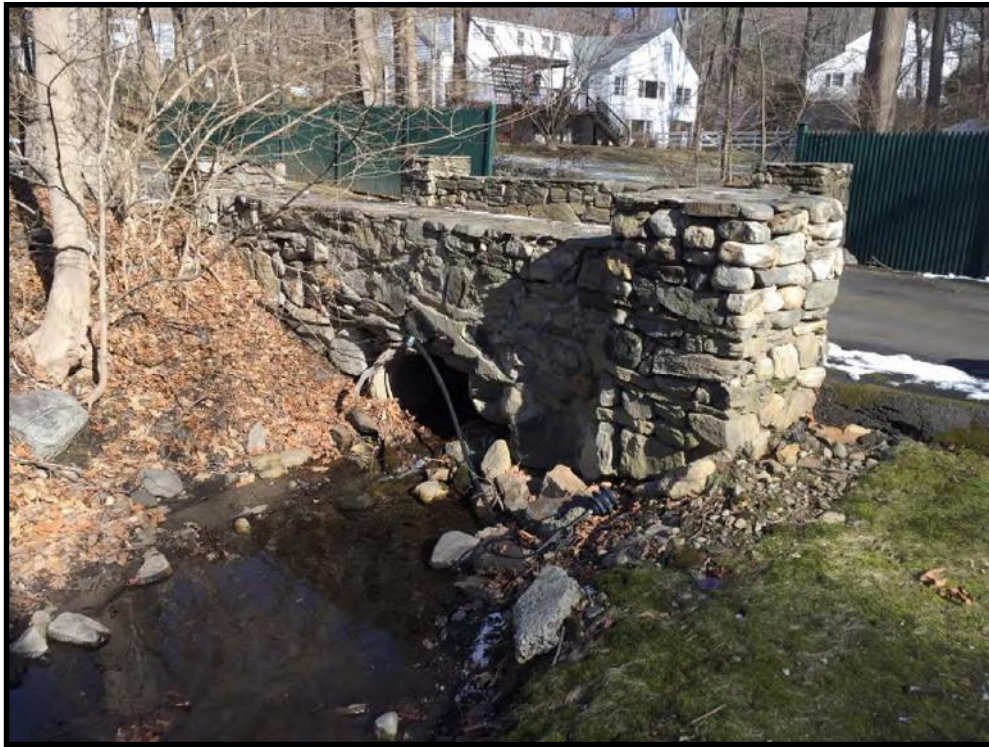
**Photo No. 101**

12 Bushy Ridge (Driveway) <sup>(2)</sup> [Photo #101]	RCP Culvert	Two openings; 1' diameters	Length from aerials.
The Glen [Photo #102]	Elliptical RCP Culvert	Single opening; 1.8' height with 3.1' span	Length from aerials.
Glen Drvwy [Photo #103]	Concrete Bridge	Single opening; 1.8' height with 5' span	Length from aerials.
Punch Bowl Drive [Photo #104]	RCP Culvert	Single opening; 2' diameter	Length from aerials.
Gault Park Drive [Photo #105]	RCP Culvert	Single opening; 2' diameter	Length from aerials.
Hockanum Road [Photo #106]	RCP Culvert	Single opening; 2' diameter	Length from aerials.
Weston Road [Photo #107]	RCP Culvert	Two openings; 1.5' diameters	Length from aerials.
Campo Road [Photo #108]	Box Culvert	Single opening; 3.5' height with 5.7' span	Length from aerials.
Main St Drvwy [Photo #109]	RCP Culvert	Single opening; 2.9' diameter	Length from aerials.
Main Street [Photo #110]	Concrete Arch Culvert	Single opening; 2.7' height with 5.2' span	Length from aerials.

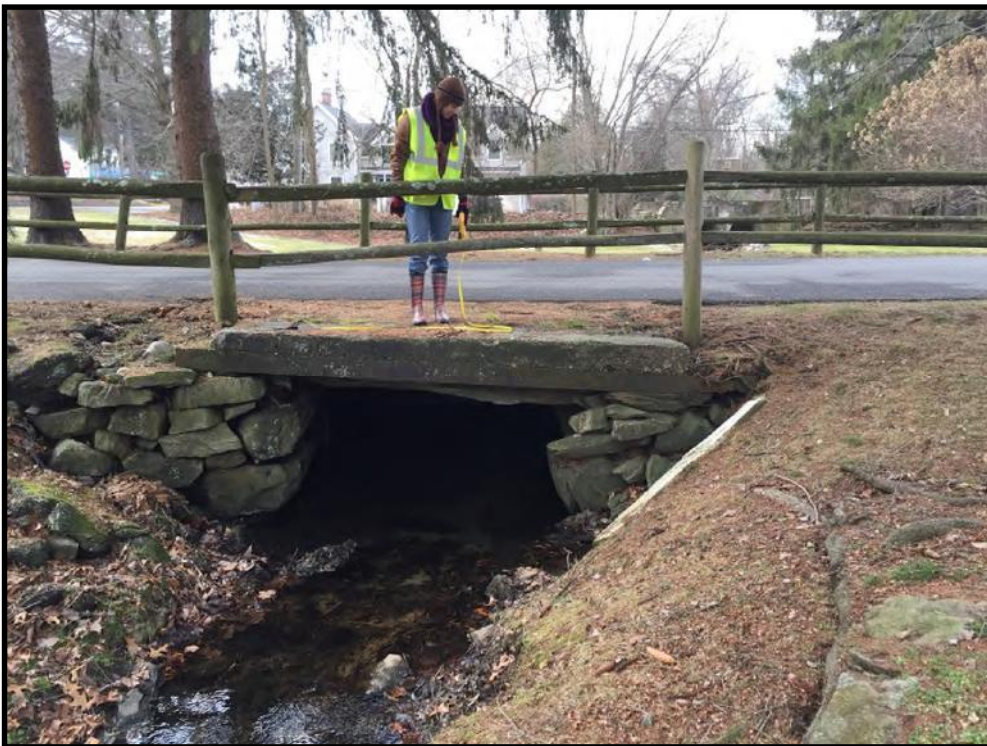
**Photo No. 111**

Cemetery Drvwy [Photo #111]	Mason Bridge	Single opening; 2.9' height with 5.9' span	Length from aerials.

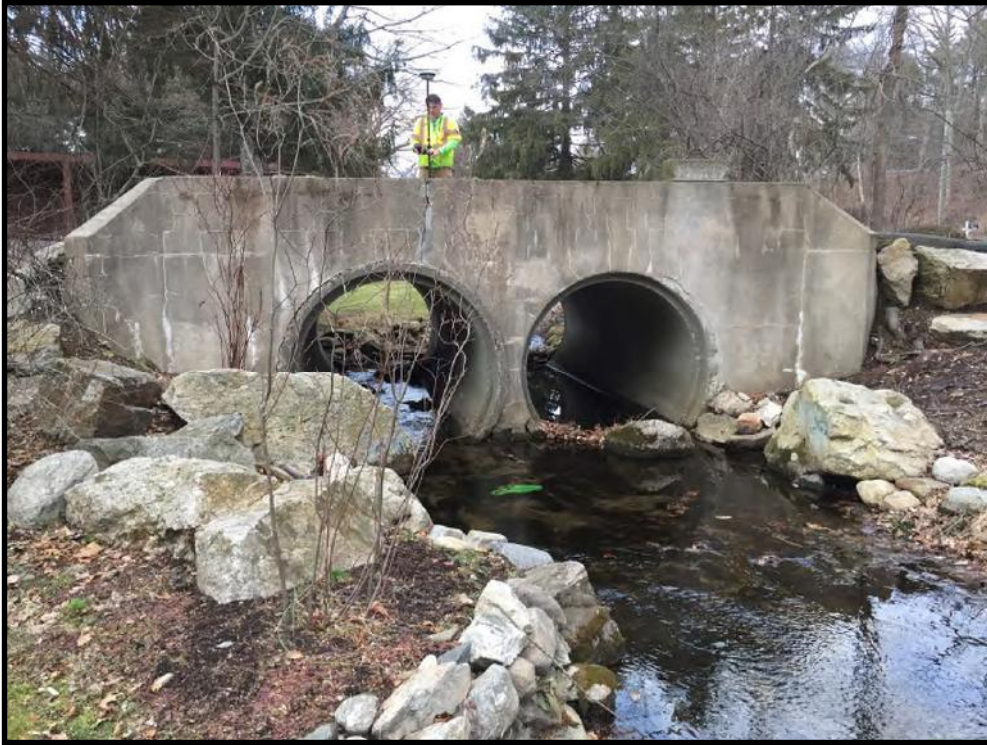
**Photo No. 112**

Carriage Lane [Photo #112]	RCP Culvert	Two openings; 6' diameters	Length from aerials.
Main St Dam [Photo #113]	Dam	21' total span; 10' spillway span; 1.25' spillway height; 1' depth	Total span of dam from aerials/photo.
Richmondville Ave [Photo #114]	Concrete Bridge	Single opening; 2.6' height with 11.8' span	Length from aerials.
Carlisle Drvwy [Photo #115]	Wooden Deck Bridge	Single opening; 4.4' height with 12.2' span	Length from aerials.
