RE: Project 1236 – 12 Oliver Street, Norwalk, CT

This letter is to provide a summary description of the Statutory Checklist for CDBG-DR Project 1236 – 12 Oliver Street.

Figure E-10 Statutory Checklist

**Hazardous Materials
Inspection Report**

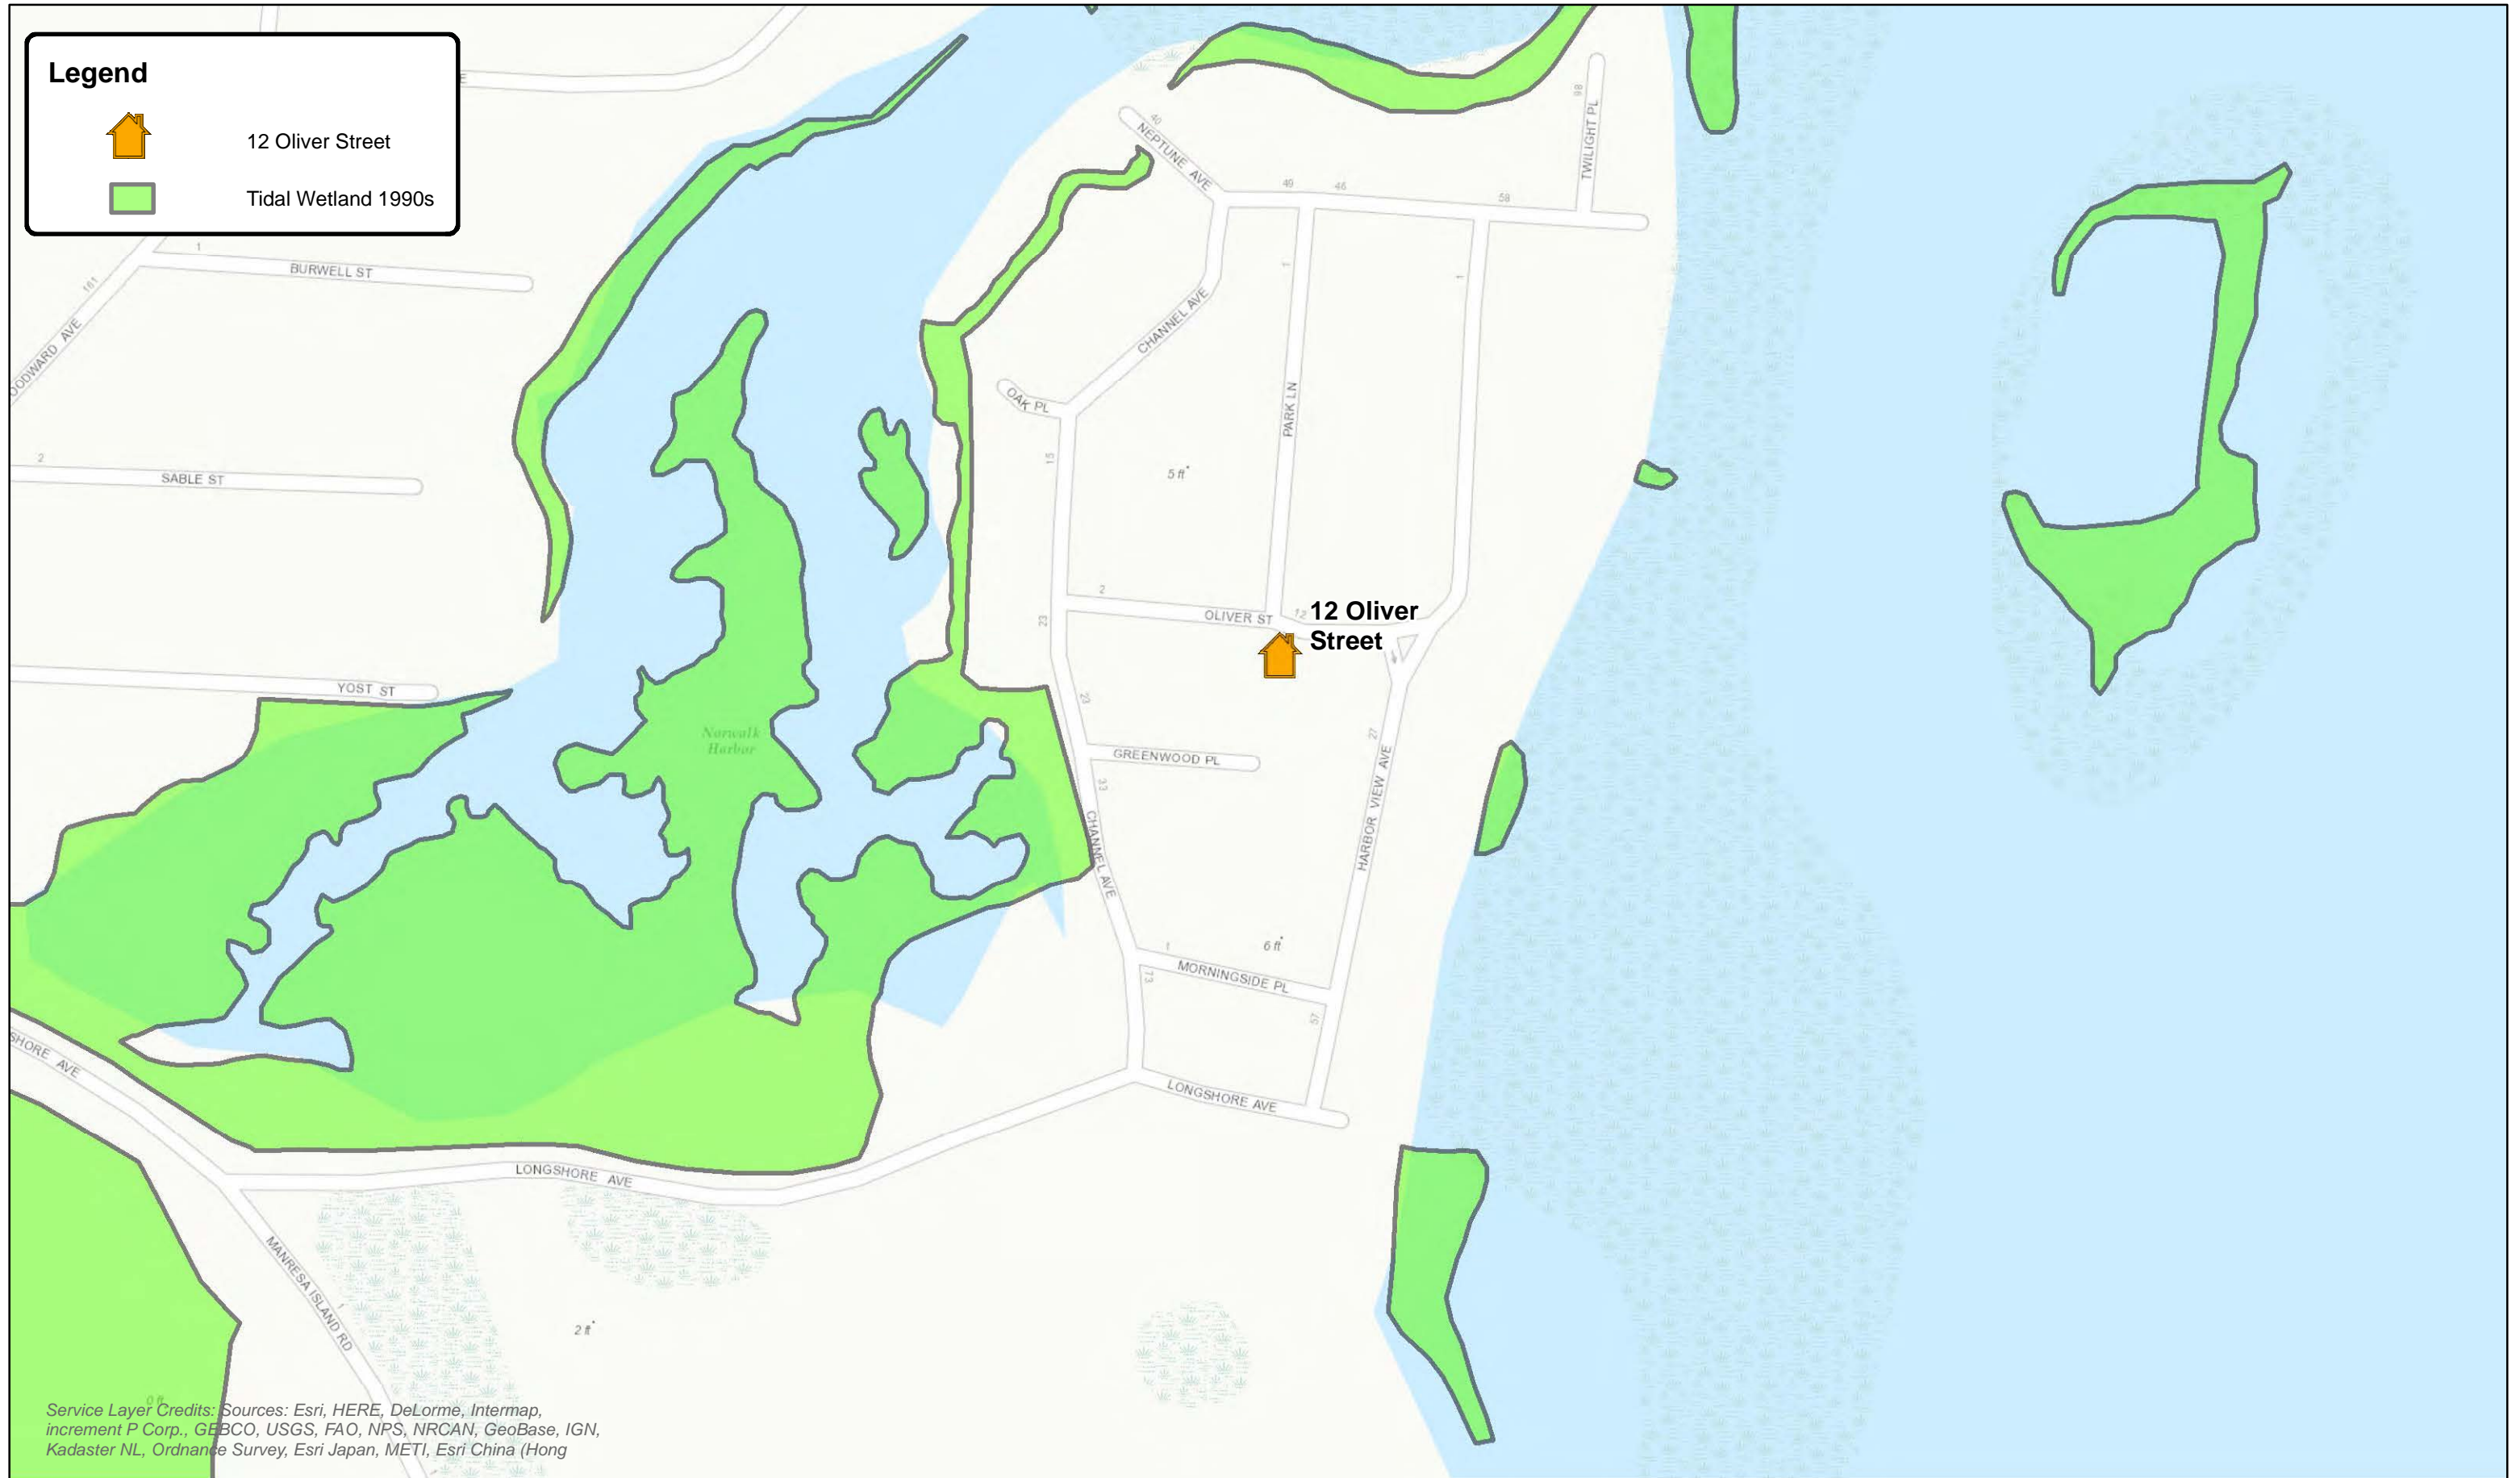
Tidal Wetland 1990s

14 C. Tidal Wetlands Act [CGS 22a-28 to 22a-35]	<input type="checkbox"/>	<input type="checkbox"/>	<input checked="" type="checkbox"/>	<input type="checkbox"/>	<input checked="" type="checkbox"/>	<input type="checkbox"/>	Connecticut Department of Energy and Environmental Protection Tidal Wetlands Mapping as defined in C.G.S. Section 22a-29 and Section 22a-93(7)(e) identifies the project as outside a Tidal Wetland Zone. See attachment 13 for documentation. Mapping is Geographic Information System (G.I.S.) map created using data accessed from CT Environmental Conditions Online (CT ECO) of Tidal Wetlands Mapping accessed from http://www.cteco.uconn.edu/
14 D. Local inland wetlands/watercourses [CGS 22a-42]	<input type="checkbox"/>	<input type="checkbox"/>	<input checked="" type="checkbox"/>	<input type="checkbox"/>	<input checked="" type="checkbox"/>	<input type="checkbox"/>	Project rehabilitation work is not expected to impact wetlands/watercourses.
