# Bloomfield

Bloomfield Avenue (Route 189) and Park Avenue (Route 178) Intersection – Road Safety Audit

November 3, 2016

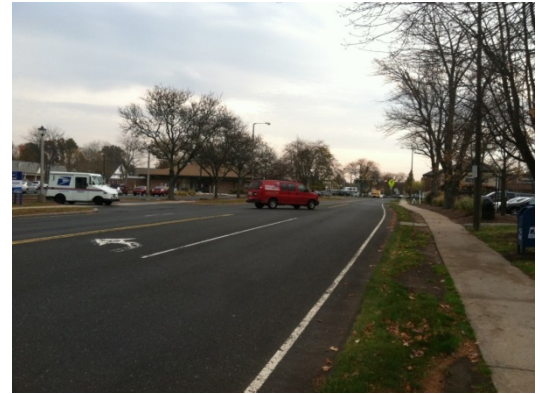
Figure 5. Popular mid-block crossing location on Route 178

- A popular illegal mid-block crossing is often made from in front of Town Hall across Route 178 to the Wintonbury Mall (Figure 5).
- Route 178 has 12-foot lanes in each direction with a one to two foot shoulder.

1. Town to coordinate with CTDOT to evaluate potential mid-block crosswalk on Route 178 at the Town Hall and Town to evaluate potential mid-block crosswalk on Jerome Avenue at the post office. Rectangular rapid flashing beacons (RRFB) or other advanced pedestrian safety measures should be considered as part of mid-block crossings (Figure 16).

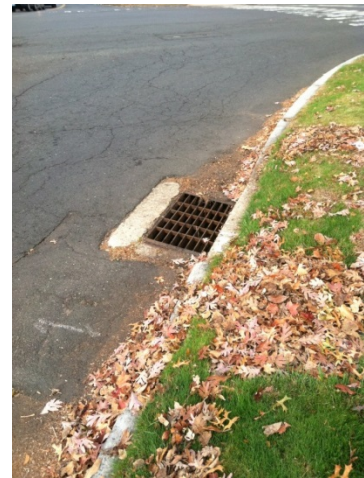
Figure 6. Catch basin grate at intersection

- The intersection does not have detectable warning strips, audible pushbuttons or countdown pedestrian signals (Figure 7; Figure 10).
- Catch basins around the intersection are the old style grate that is not bike friendly (Figure 6).

2. Restripe Route 189 and Route 178 with 11-foot lanes to provide wider shoulders.
3. Replace any of the non-bike friendly catch basin grates on state roads and Town to replace any of the non-bike friendly grates on town roads.
4. CTDOT and Town to continue to evaluate and pursue Route 189/Route 178 roundabout concept.

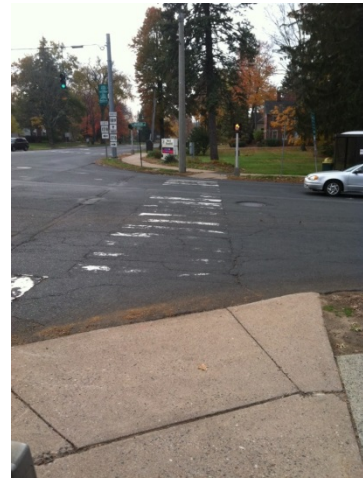
Figure 8. Faded crosswalk at intersection

- Crosswalks in the intersection are faded (Figure 8).
- Sidewalk widths at the intersection are 4-5 feet.
- The crosswalk at the Wintonbury Avenue intersection is diagonal and is 74-feet long (Figure 9).

- Sidewalk condition is poor and should be upgraded.
- Crosswalks are faded and need to be re-stripped (Figure 8).
- ADA standards are not currently being met at all of the pedestrian facilities.
- The current use of the exclusive pedestrian phase is required for pedestrian safety, due to the intersection geometry. This includes the adjacent intersection of Wintonbury Avenue and Route 189. As a result, a single pedestrian call will stop vehicle traffic at all intersections. This configuration, while essential for pedestrian safety, highlights the limitations of the current

1. Restripe the crosswalks at the intersection of Route 189 and Route 178 with reflective paint.

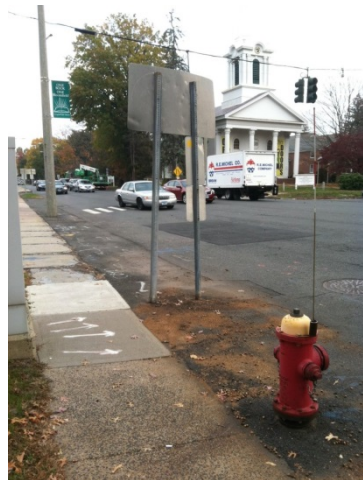
Figure 9. Diagonal crosswalk at intersection; poor sidewalk condition

- Several of the handicap ramps and the sidewalks are in poor condition (Figure 9; Figure 10).

2. Town to coordinate with CTDOT to consider realigning the skewed crosswalk on Tunxis Avenue at Wintonbury Avenue.
3. Town to coordinate with CTDOT to consider advanced pedestrian safety features such as RRFB as part of any roundabout design at the intersection of Route 189 and Route 178 (Figure 16).

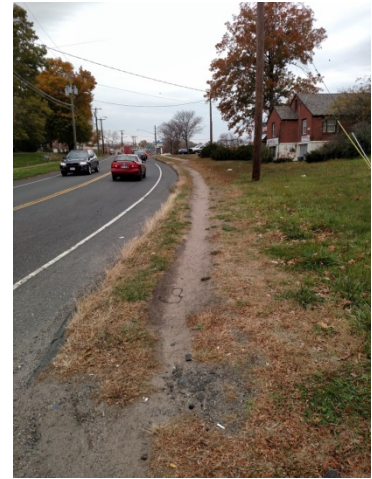
Figure 14. Worn path on Park Avenue

- The Town would like to use decorative lighting, stamped crosswalks, granite curbing and other aesthetically pleasing amenities to enhance the Town Center area.
- The East Coast Greenway may come off the railroad alignment and come through the Town Center area but the final route has not been determined yet.
  - A 12-foot multi-use trail is proposed for the greenway.
- The sidewalk on the north side of Park Avenue ends before the High School (Figure 14).
  - Students do not cross Park Avenue to use the sidewalks on the south side, creating a worn path on the north side (Figure 14). The Town would like to extend the sidewalk on the north side of Park Avenue to accommodate these users.

6. Town to extend the sidewalk on the north side of Park Avenue to connect with the High School.
