COMMUNITY
connectivity program

Bridgewater

Route 133 and Center Street – Road Safety Audit

August 2, 2016

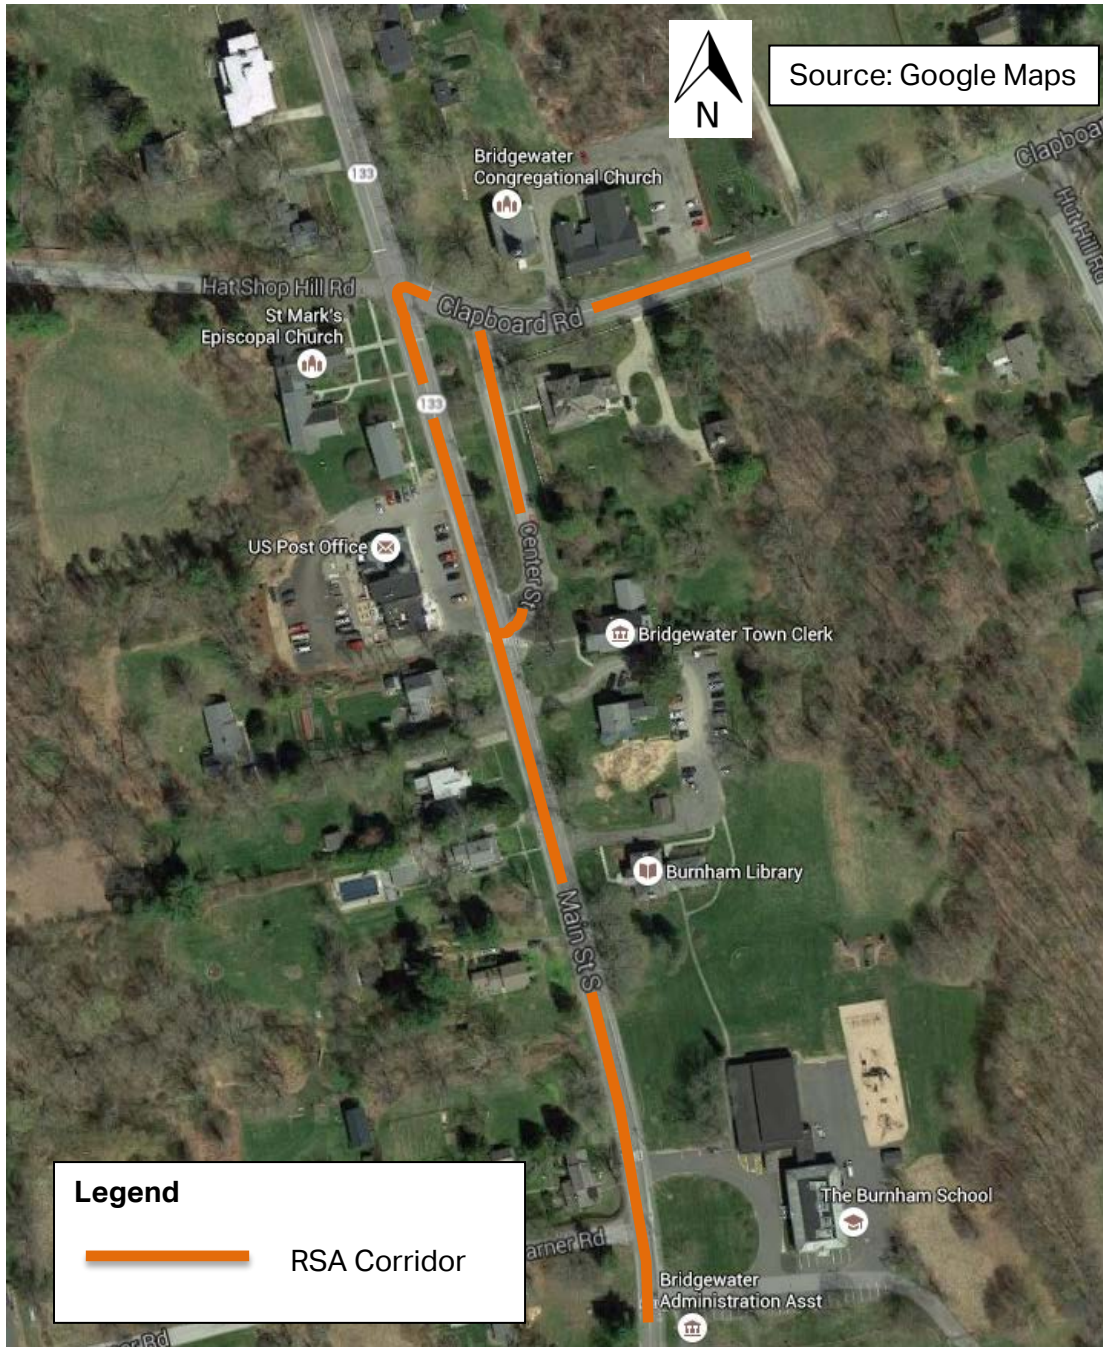
Figure 1. Route 133 (Main Street), Center Street, and Clapboard Road, Bridgewater CT

The audit corridor (Figure 1) consists of the following streets and associated intersections within Bridgewater’s town center:

- Route 133 (Main Street) from the Burnham School to Clapboard Road;
- Clapboard Road from Route 133 to the Bridgewater Congregational Church’s auxiliary parking lot; and
- Center Street.

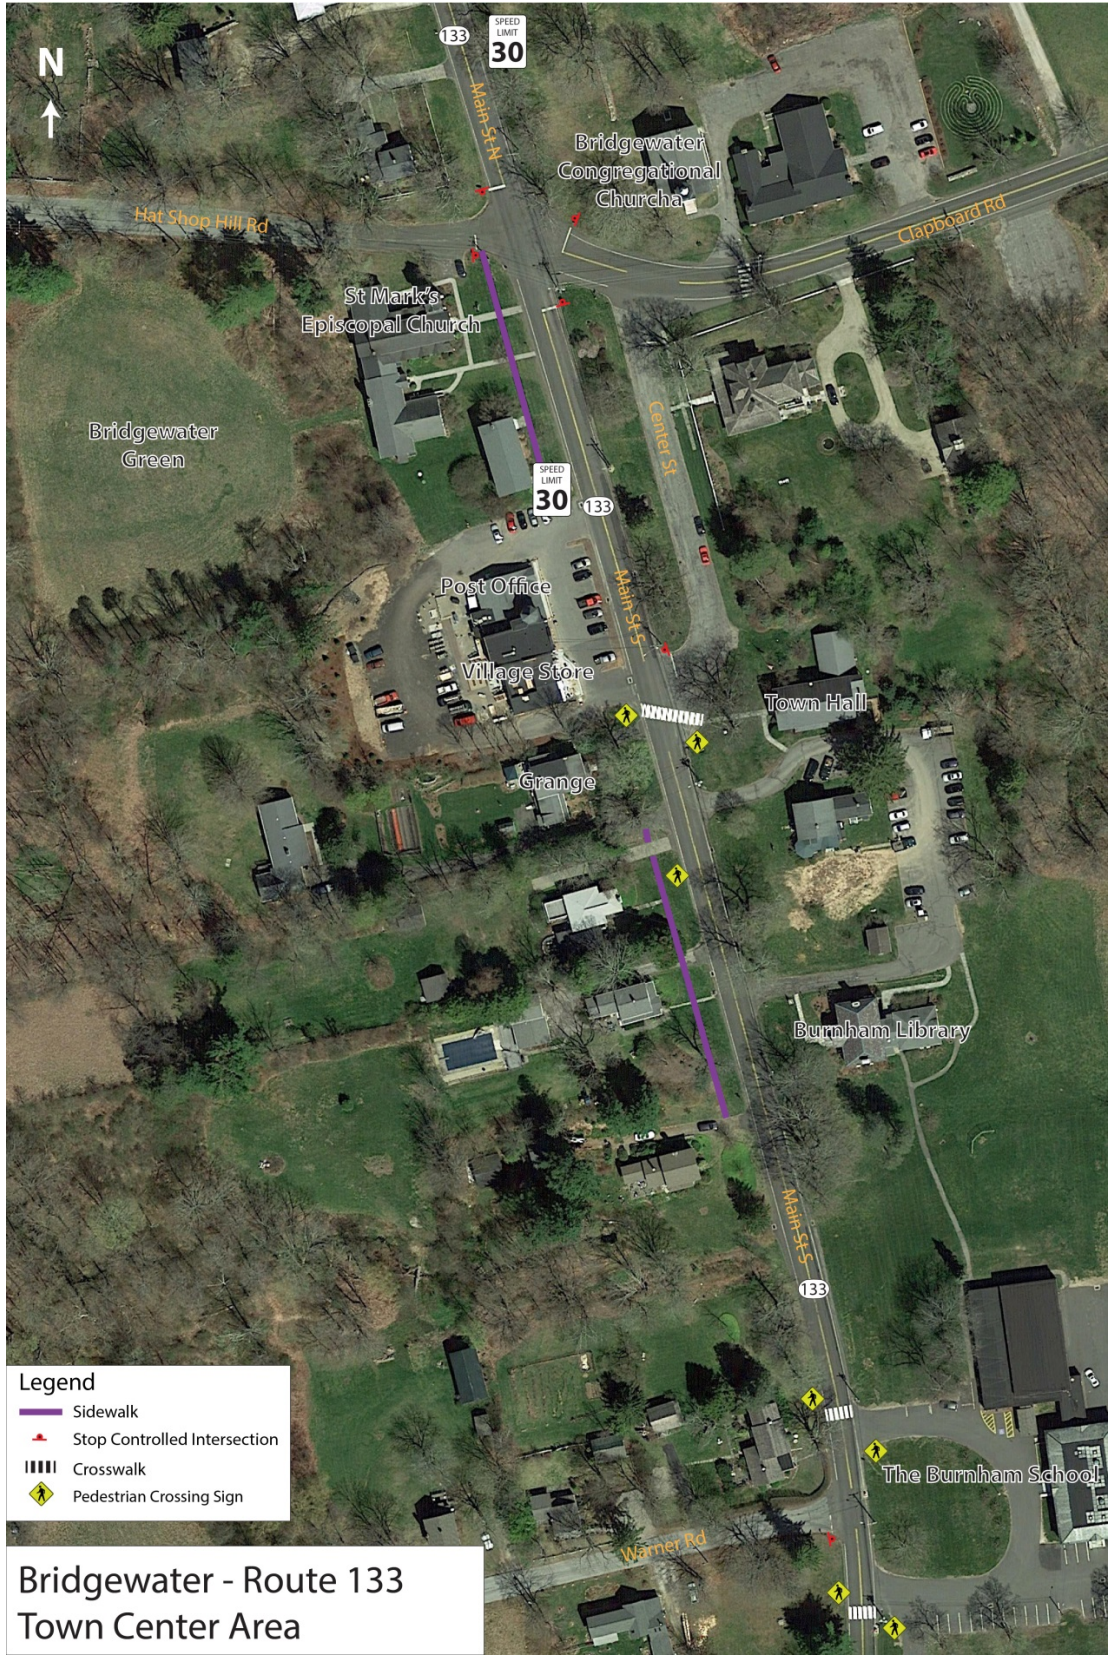
Figure 4. Roadway Geometrics

Roadway geometrics for the audit corridor roadways and intersections are shown in Figure 4. An inventory of corridor streets is provided in Table 3.

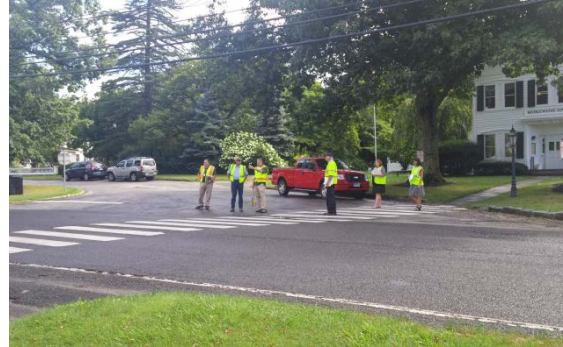
Figure 5. Intersection of Route 133 and Center Street

- A bump-out on the southeast corner of Center Street was discussed (Figure 5) and (Figure 6). It would:
 - Create a much tighter T-intersection.
 - Force vehicles to slow down before making the turn onto Center Street.

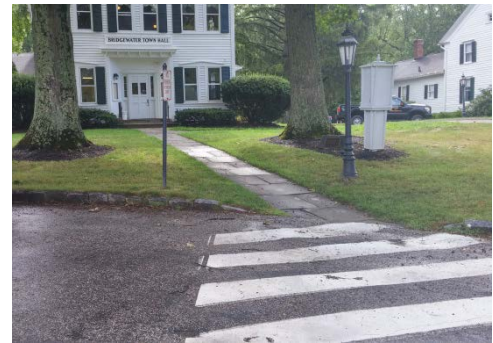
Figure 6. Wide radius at southeast corner of Route 133 and Center Street

- Shorten the pedestrian crossing distance across Route 133.
 - Reduce impervious pavement area.
- The existing curb radius is very large.
 - This encourages drivers to make this turn at high speeds.

- Drivers may be less likely to stop for pedestrians who are waiting to cross.
- The stop sign is set further back than the stop bar on Center Street (Figure 7).

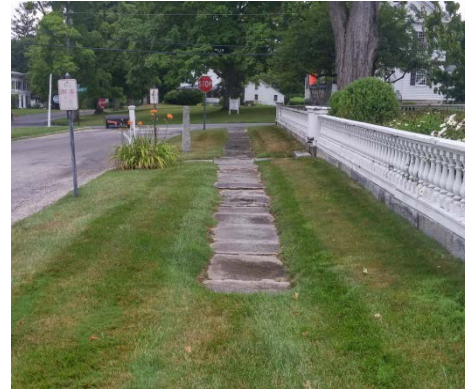
Figure 8. Existing granite sidewalk on Center Street

- Granite block curbing on east side would need to be reset or replaced.
- Current Widths of Center Street (Figure 10) and (Figure 8):
 - Roadway = 27 feet

- Curb to fence = 15 feet
 - Existing Sidewalk = 2.7 feet wide
 - Curb to existing sidewalk = 9 feet
- Even with a two to three foot widening of road, there should be room for about a five to six foot buffer between a five foot sidewalk and the roadway.

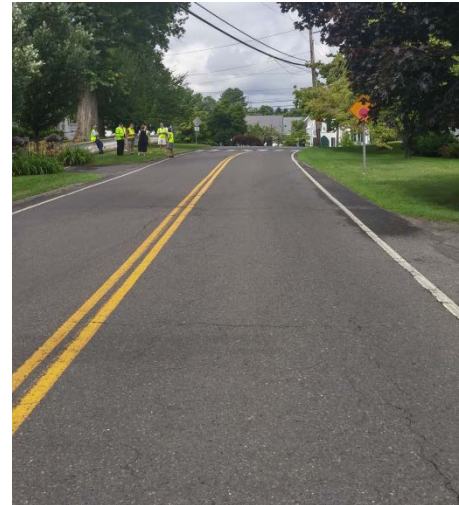
Figure 14. Clapboard Road cross section

- The bump out can also be curbed with grass and sidewalk extension.
- A low cost option would be to install a bollard and chain around the perimeter. This option may also better fit the character of town center
- The width of Clapboard Road consists of two 11-foot travel lanes and two one-foot shoulders (Figure 14).

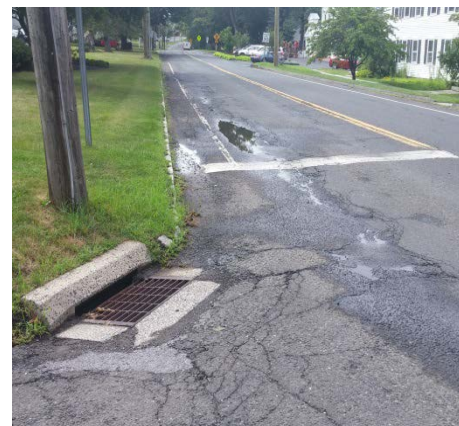
Figure 15. Drainage issues and pavement rutting on northbound Route 133 approach to Clapboard Road.

- There is poor drainage on the southeast corner (Figure 15).
- There is deteriorating pavement at the intersection with severe deterioration on the northbound Route 133 approach. It is experiencing rutting (Figure 15).
- The right turn from Route 133 northbound onto Clapboard Road has a very tight turn radius. Trucks making a right turn from Route 133 onto Clapboard Road need to cross the center line.
- The crossing distance from the Episcopal Church to the town green is 30 feet. No crosswalk is provided. Two sidewalks connect from the church to Route 133 and both have steep slopes that are not ADA compliant.

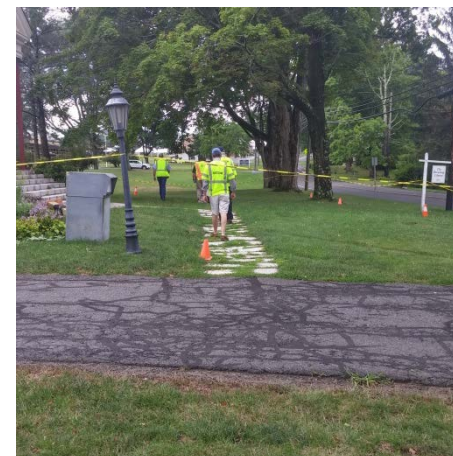
Figure 16. Proposed Sidewalk alignment on east side of Route 133

- There is adequate right of way for the proposed sidewalk on the east side of Route 133 (Figure 16).
- There is a minor grade issue between the Burnham Library and the Burnham School.

9. Town to construct a sidewalk on east side of Route 133 to connect Center Street to the Burnham School.
10. Town to reconstruct walkway between Burnham School and Burnham Library.

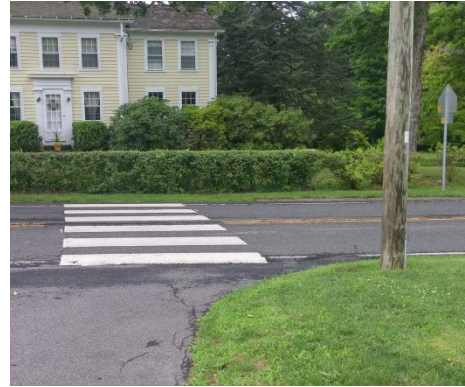
Figure 17. Burnham School (north) driveway crosswalk

- The existing crosswalks at the Burnham School (Figure 17) and (Figure 18):

- The crosswalks do not connect with sidewalk and direct pedestrians into the school driveways or grass since there are no sidewalks.
- There are no handicap ramps.
- The crosswalk signs appear to meet the retroreflective requirements

- There are no advance crossing signs provided.

- It was discussed that the north crosswalk at the Burnham School driveway can be eliminated.
- The south crosswalk at the Burnham School driveway can be relocated to the south side of the Warner Road and Route 133 intersection.

1. Coordinate with CTDOT to remove the crosswalk and pedestrian signs on Route 133 at the north Burnham School driveway.
2. The Town plans to provide a new bike rack on the south east corner of the Route 133 and Center Street intersection in front of Town Hall.

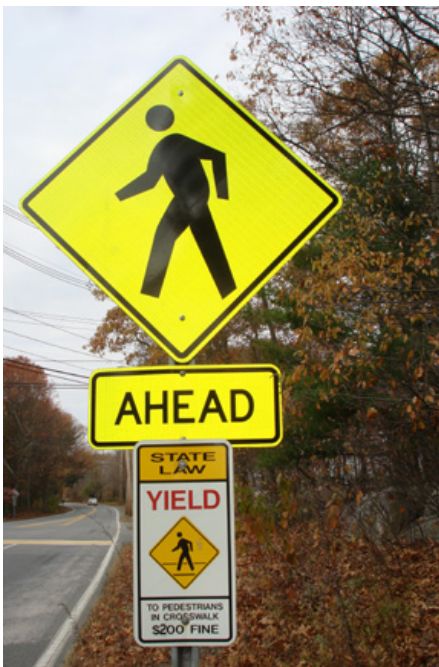
Figure 20. Advance pedestrian sign

1. Coordinate with CTDOT to relocate the crosswalk and signs on Route 133 at Burnham School south driveway to align with the side street intersection of Warner Road. Install advance pedestrian crossing ahead signs (Figure 20) on Route 133.
2. Town to re-construct Center Street to provide new sidewalk on the east side. Angled parking will also be provided on the east side for automobiles and on the north end striped parallel spaces for trucks and trailers (Figure 21).

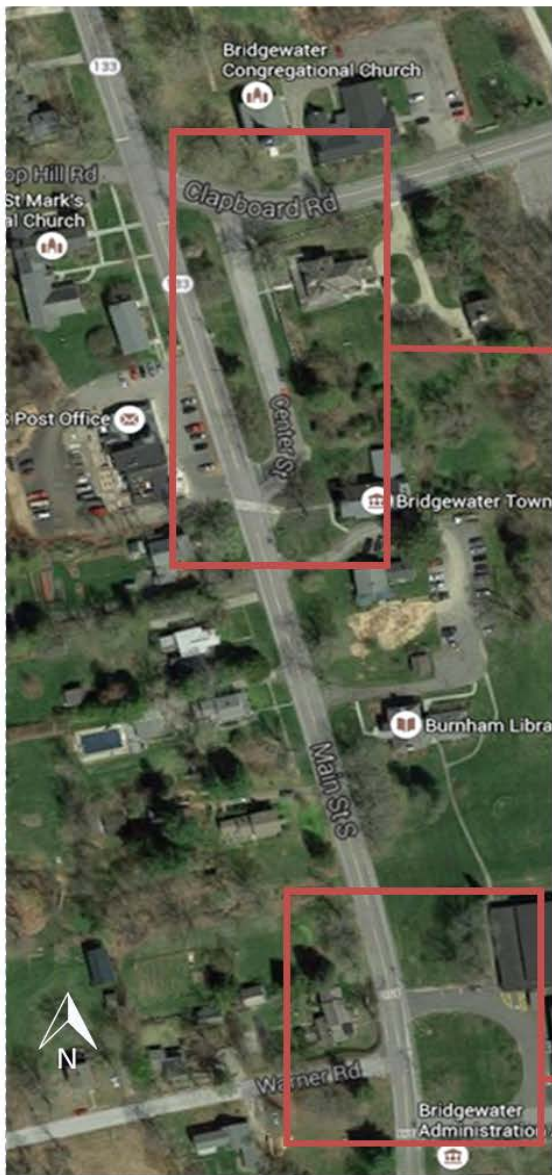
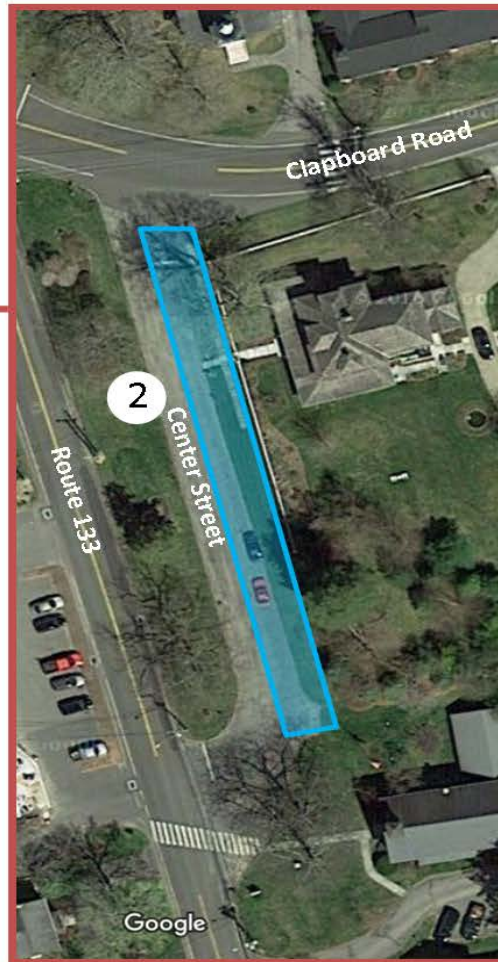
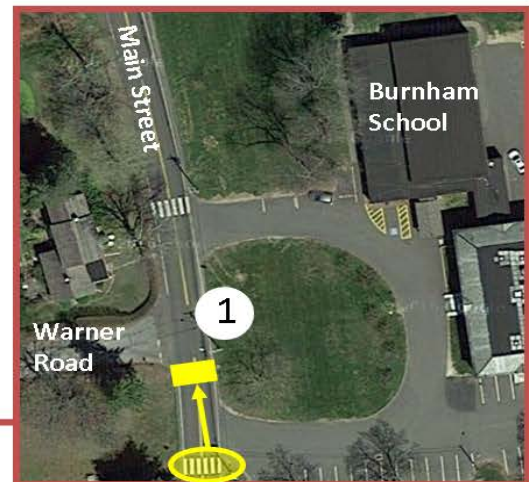
Figure 22. Medium Term Recommendations Map

Figure 22 depicts these recommendations.

1. Relocate crosswalk and pedestrian signs to align with Warner Road.

2. Provide new sidewalk and angled parking on the east side of Center St.

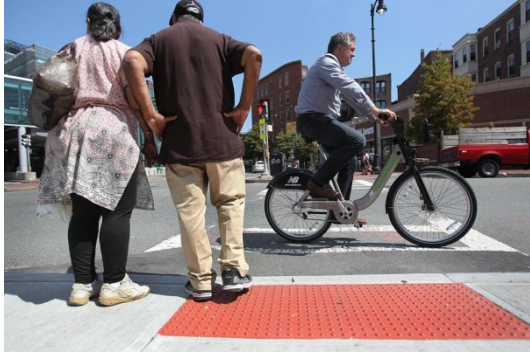
Figure 23. Pedestrian detectable warning strip

- b. Would require installation of a handicap ramp with pedestrian detectable warning strips (Figure 23).
 - c. Catch basin may need adjustment.
4. Construct a new sidewalk between the auxiliary lot across from the Congregational Church and Route 133:
