# Brookfield

Still River Greenway Connection

May 10, 2016

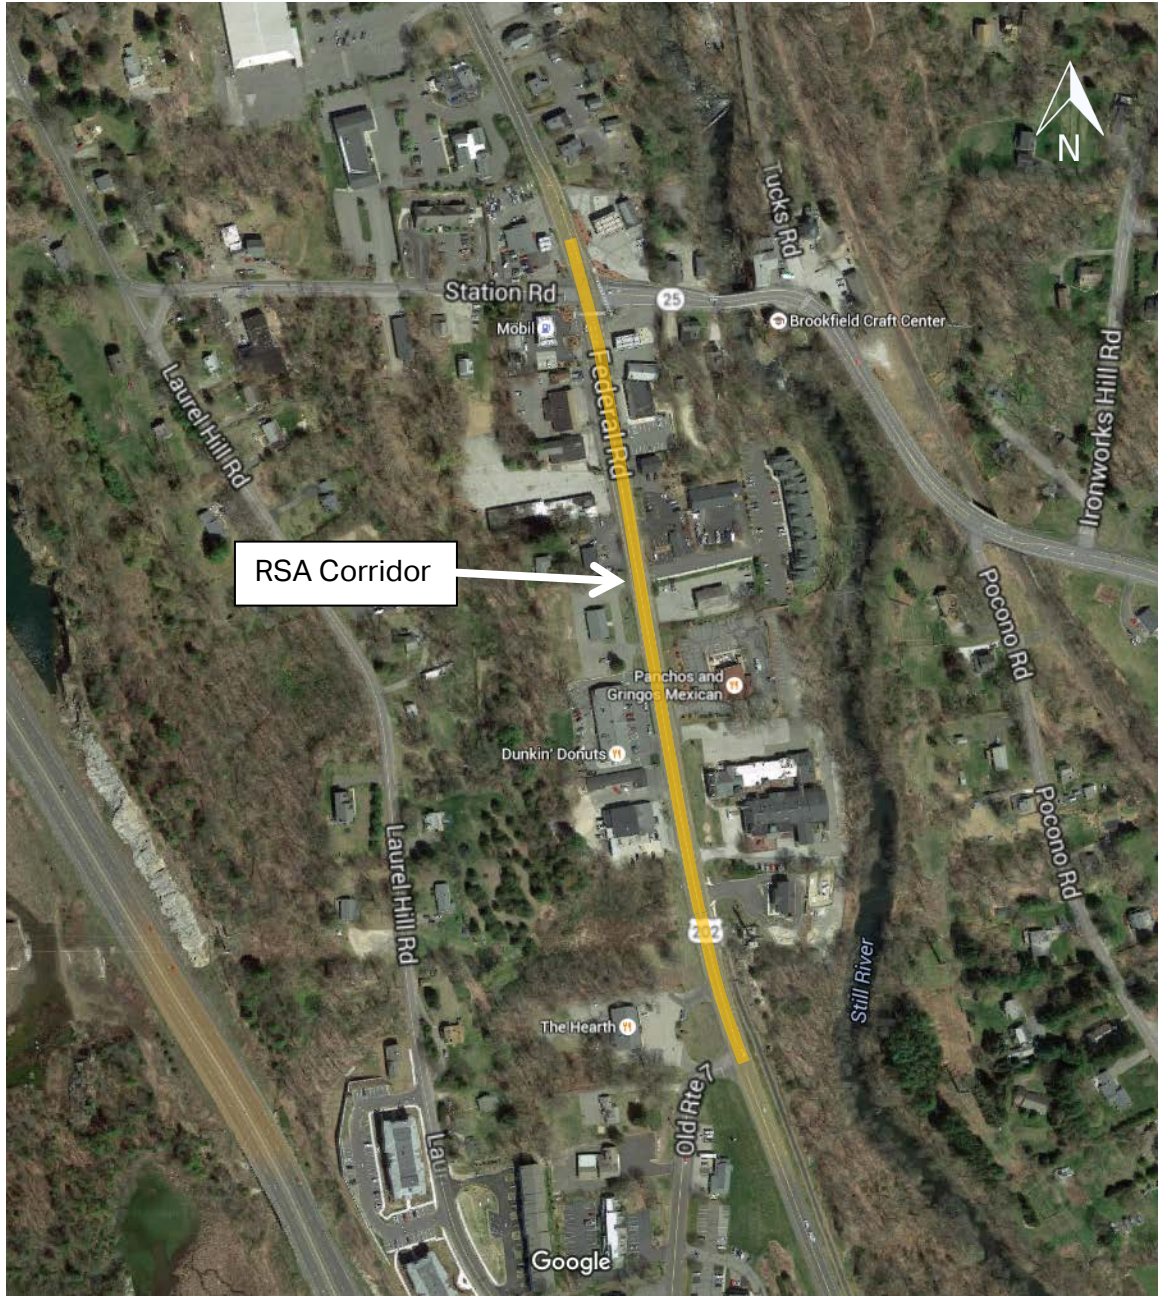
Figure 1. Federal Road (US Route 202), Brookfield

The RSA site is the section of Federal Road (State Route 202) between Whisconier Road (State Route 25) and Old Route 7 (Figure 1 and Figure 2). The Average Daily Traffic (ADT) on Federal Road between Route 25 and Old Route 7 is between 6,100 and 9,000 vehicles per day (vpd). Federal Road consists of a single lane in each direction, separated by a double yellow center line. There are striped shoulders on each side of the road with widths that vary from two to ten feet. There are exclusive left turn lanes at the north and south approaches to the intersection of Federal Road and Route 25.

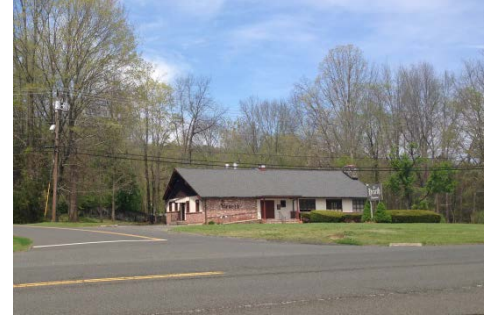
Figure 5. Hearth Sign Set Back

- The Hearth Restaurant sign is set far back from the roadway; it could be moved closer to the road. The sign may be on town property, but the exact location of the State and Town right-of-way lines is not clear (Figure 5).

1. Close the north driveway to Hearth Restaurant unless both driveways are required by fire department, or precluded by some type of agreement with CT DOT.
2. Install a crosswalk in the area of the Brookfield Deli, Subway and Dunkin Donuts.
3. Add a bus stop at the intersection south of Poncho's Gringo's.
4. Install crosswalk at the end of the Still River Greenway Trail. This will require adequate signage along with ADA compliant sidewalk ramps. (Figure 9)
5. Move the Hearth sign out closer to the street.

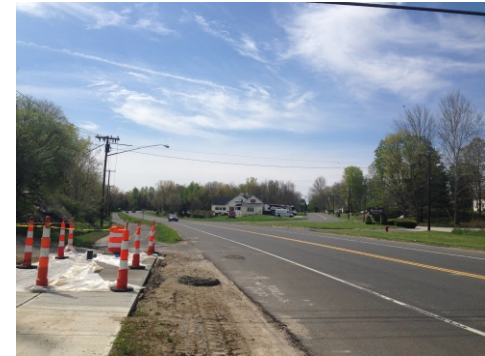
Figure 6: Trail Way Crosswalk

- A crosswalk may be necessary at the trail end. (Would be more feasible than further north) (Figure 6).
- Parking at the Scalzo property across from the Hearth Restaurant might be a feasible option. The possible issues are that tree clearing might be required and proximity to wetlands can delay the process. Crosswalk will be required with adequate signage and ADA compliant sidewalk.

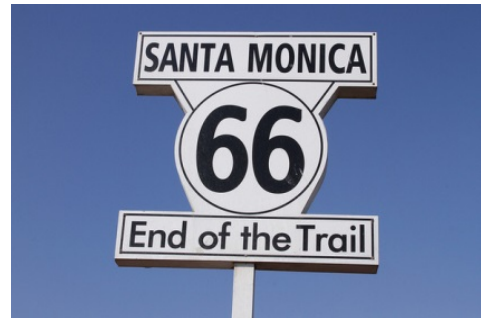
Figure 7: Trail Way Terminus Signage

- There is no existing signage to clarify where the Trail ends.
- Most pedestrians were observed to be walking on the east side of the road.

1. Add on-street parking on Old Route 7 (west side), there seems to be room for five to six spaces. However, being in front of residential property may create concerns.
2. Install "Trail Ends" signage. (Figure 7).
3. Look into use of portions of existing parking lots at the Hearth or nearby properties for the trail, at least on a temporary basis until additional parking facilities can be constructed.

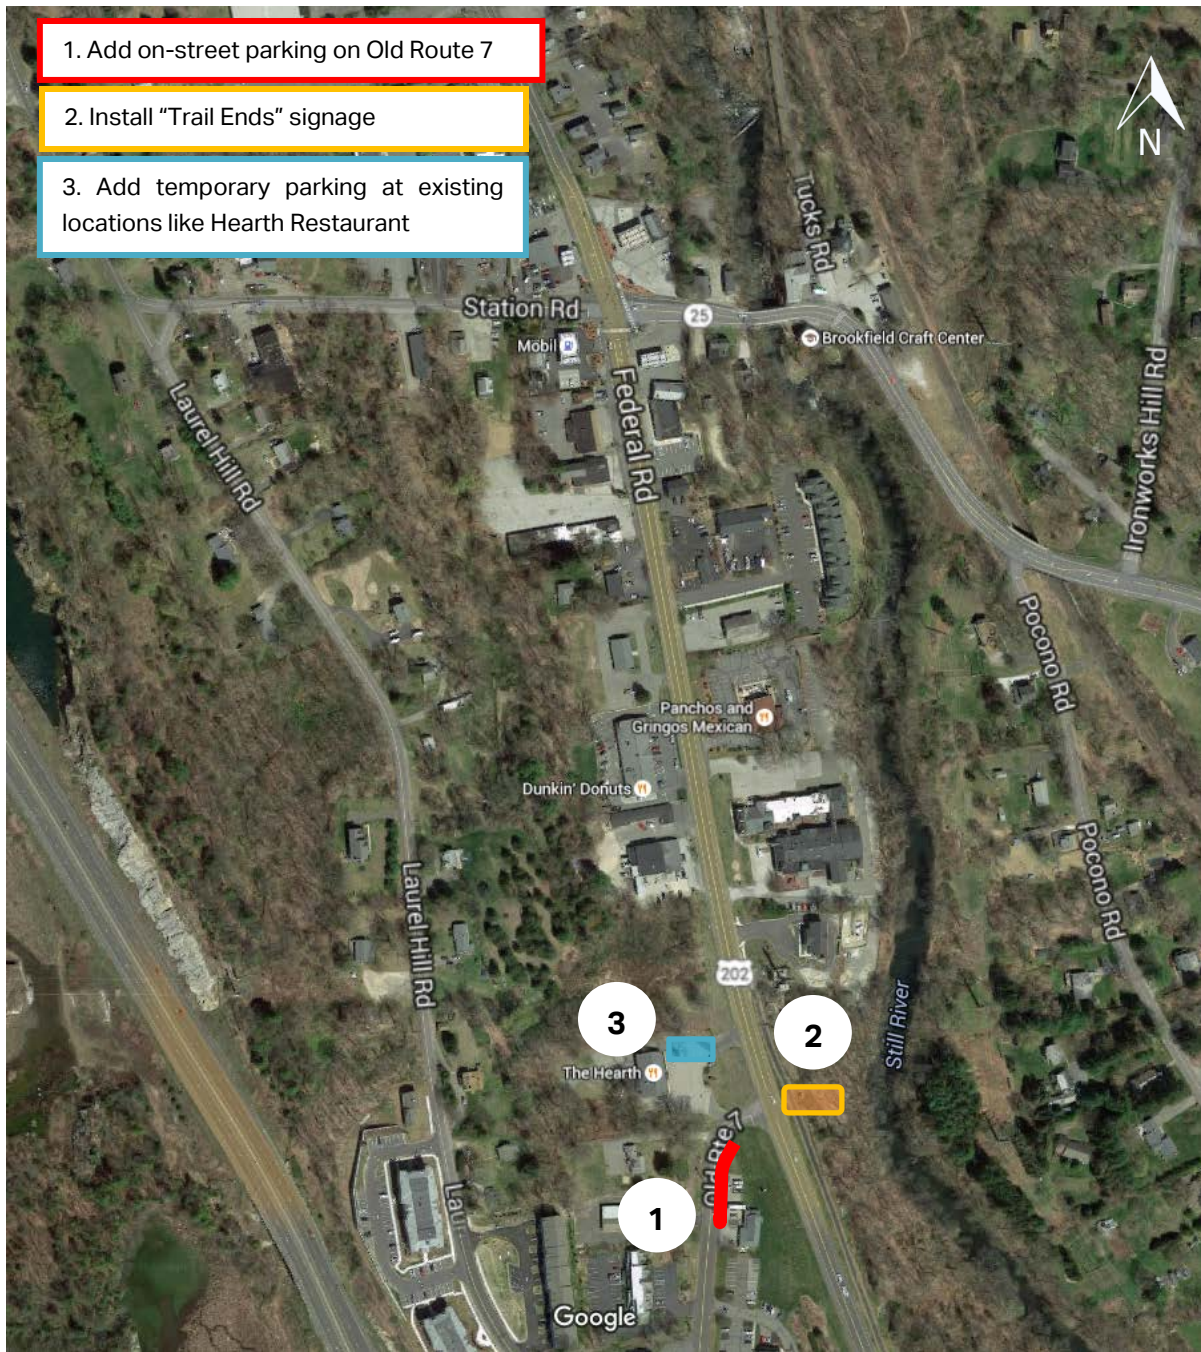
Figure 8. Short Term Recommendations

Figure 8 depicts these recommendations.

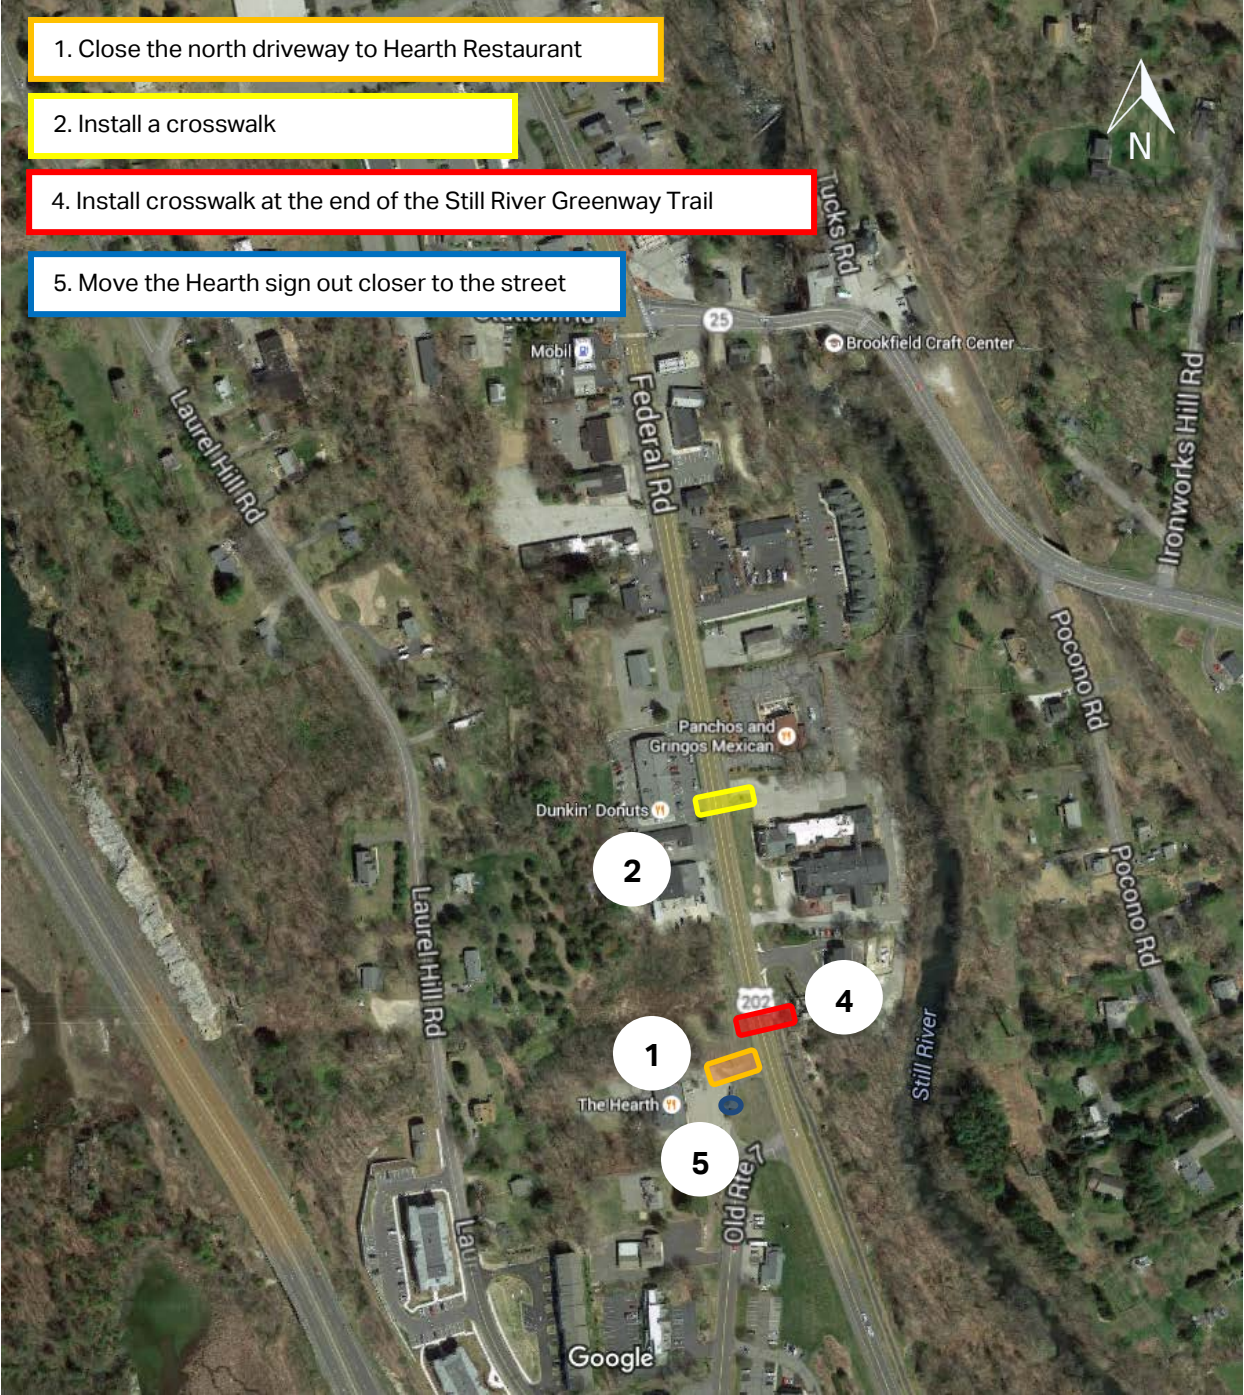
Figure 10. Medium Term Recommendations

Figure 10 depicts some of the recommendations along Main Street.

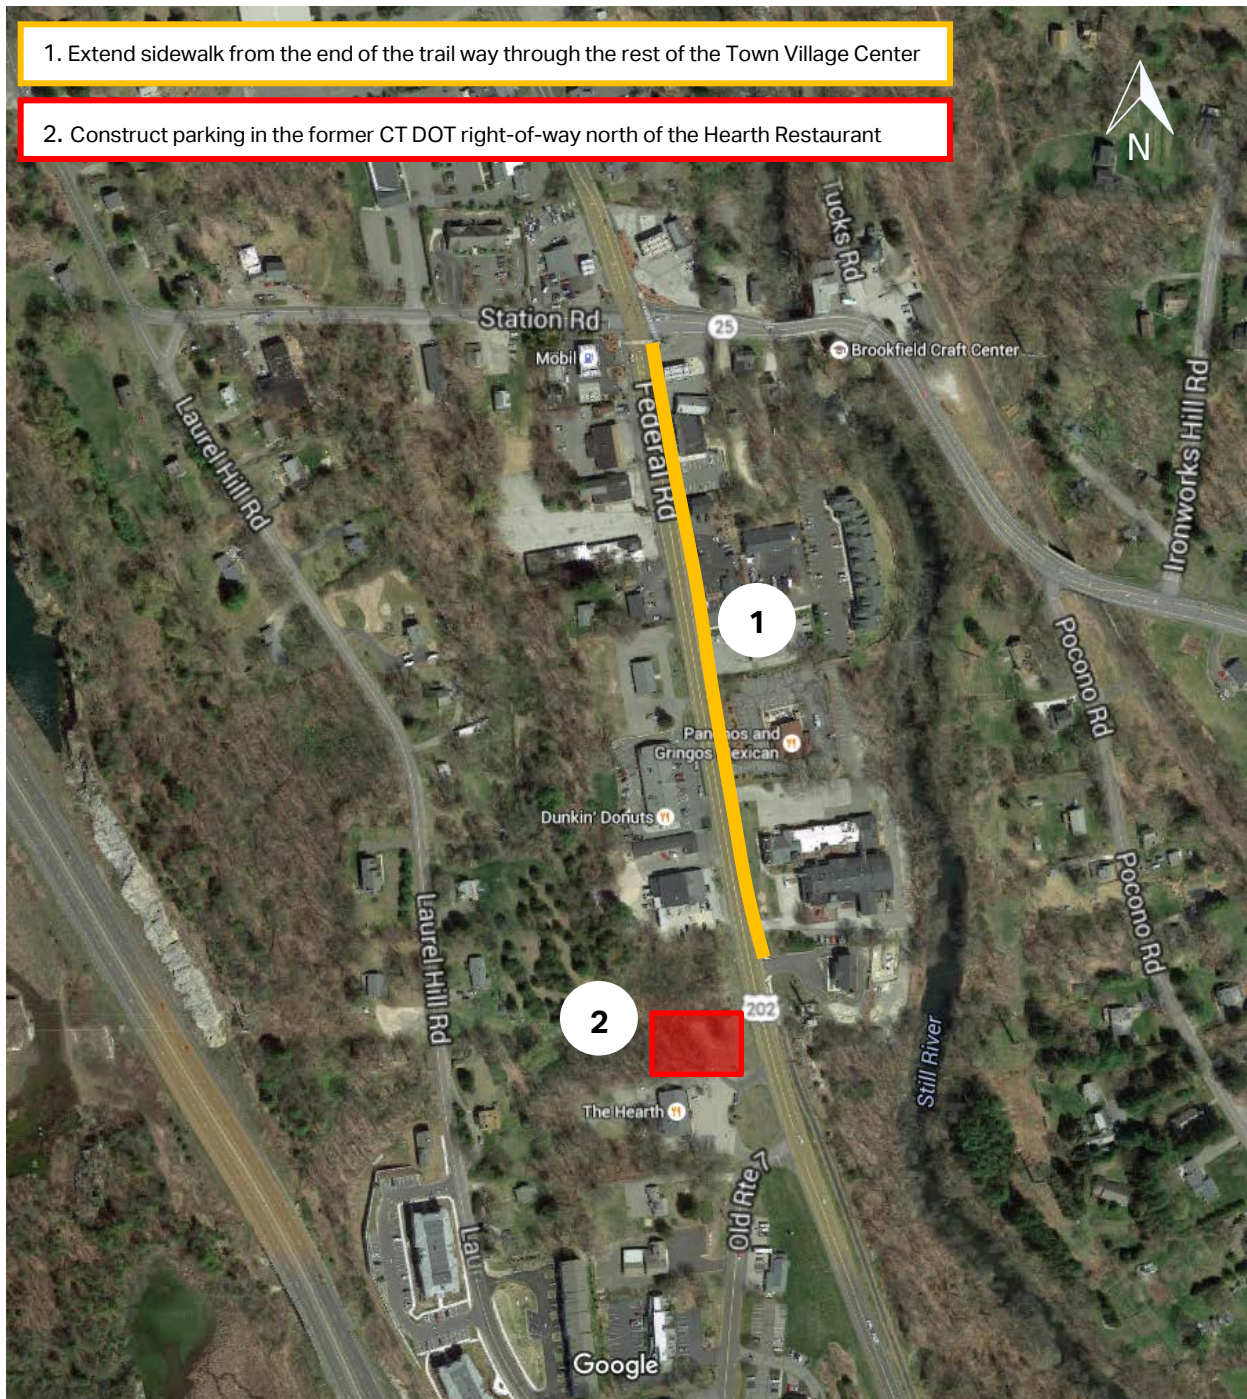
Figure 11. Long Term Recommendations

Figure 11 depicts these recommendations.

1. Extend sidewalk from the end of the trail way through the rest of the Town Village Center.
2. Construct parking (possibly gravel surface) in the former CT DOT right-of-way north of the Hearth Restaurant. This will require discussions with the Hearth Restaurant and CT DOT regarding the ownership/transfer of the land, easements, and access to Federal Road.
