COMMUNITY
connectivity program

Colchester

Halls Hill Road– Road Safety Audit

June 28, 2016

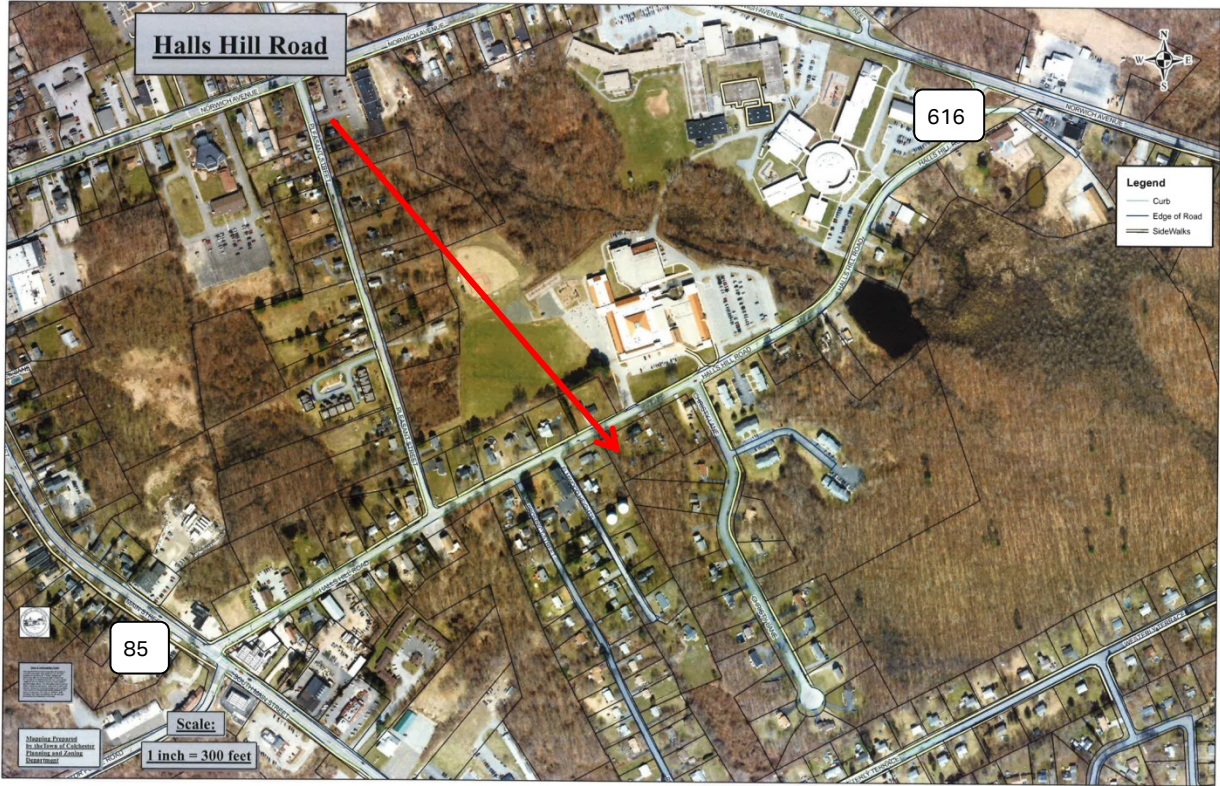
Figure 1. Halls Hill Road

Halls Hill Road in Colchester is classified as a rural major collector, and provides a connection between two State Routes 85 and 616. The Average Daily Traffic (ADT) at the eastern end of Halls Hill Road is 2,600 vehicles per day (vpd.) and at the western end is 4,700 vpd¹.

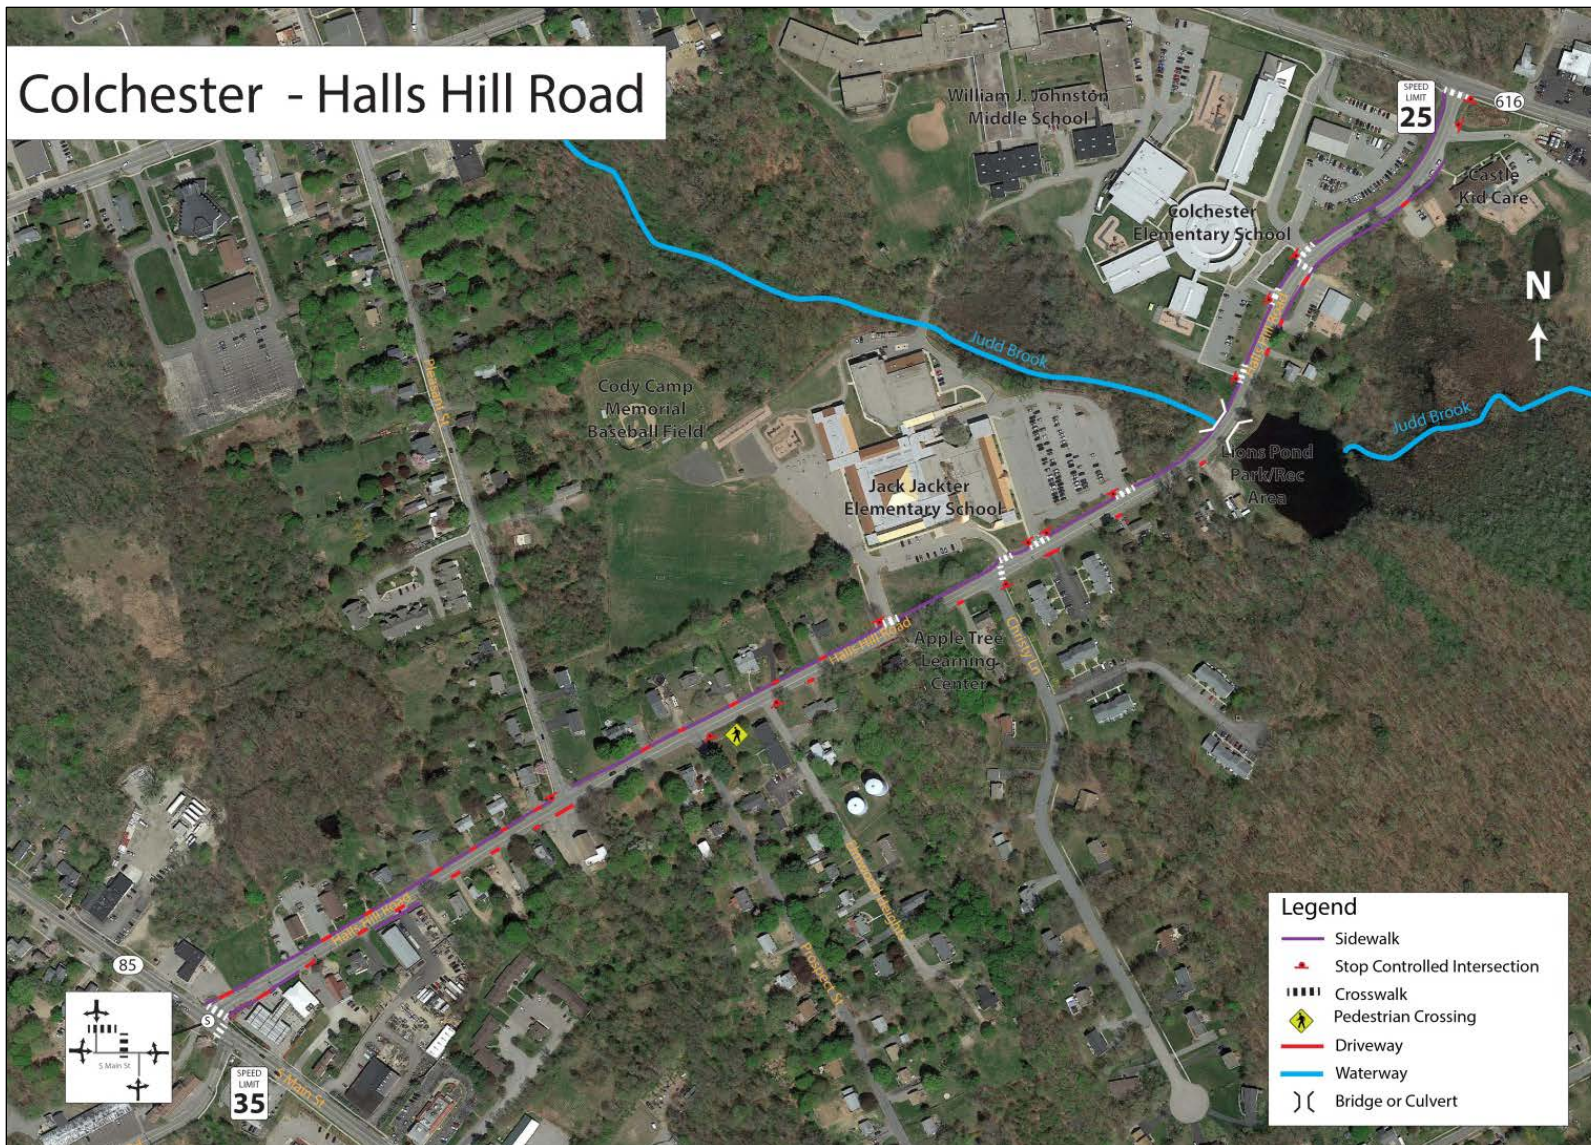
Figure 4. Halls Hill Road Geometrics

The only signalized intersection is at Route 85; all others are stop controlled. The Route 85 and Halls Hill Road intersection is a "Dog-leg" intersection with Dr. Foote Road (Figure 4).

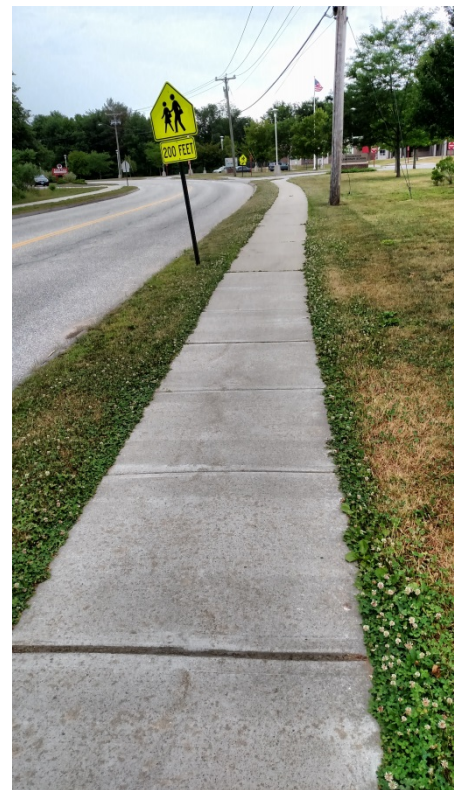
Figure 5. Sidewalk Along Halls Hill Road

- The speed limit on Halls Hill Road is 25 MPH, but traffic travels much faster.
- The sidewalks along the northern side of Halls Hill Road are concrete, in good condition, have asphalt curbing and a snow shelf (Figure 5). The snow shelf is grass and at least 2 feet wide but as wide as 4 feet in some locations. The sidewalk appears narrower in front of the Jack Jackter Intermediate School because the grass has overgrown into the walkway giving the appearance of 3 feet.

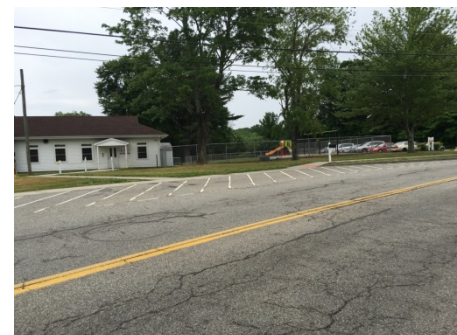
Figure 6. Pullout in Front of Daycare

- There are pedestrian crossing signs with "200 feet ahead" plaques.
- Most driveways have driveway aprons.
- There are no crossing guards.
- In front of the Castle Day Care there is a curb pull out that is used by buses dropping of children and parents picking up children (Figure 6). It is a curb pull out but vehicles are still required to stop when school bus lights are on. Vehicles often think they can pass the bus.

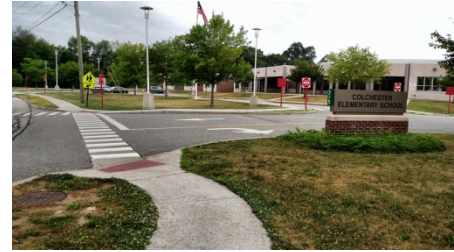
Figure 7. Crosswalk in Front of Elementary School

- There are crosswalks across all of the school driveways (Figure 7).
- The signs are generally in good condition.
- Most of the curbing is asphalt and in good condition. There are a few locations where it is concrete; these are the sections where damage exists (Figure 8).

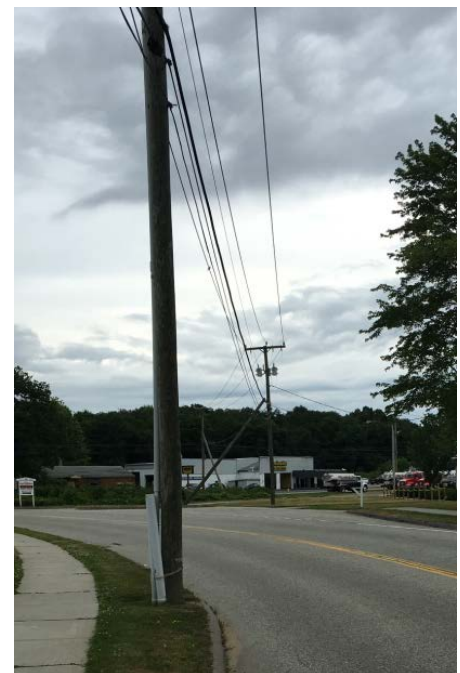
Figure 9. Sidewalk on the North Side

- Four walkers, two runners and three bicyclists were observed in the corridor. It was a cloudy day with intermittent rain.
- The utility poles on the north side are located in the grass buffer strip or behind the sidewalk (Figure 9). The utility poles on the south side are located in the grass buffer strip.

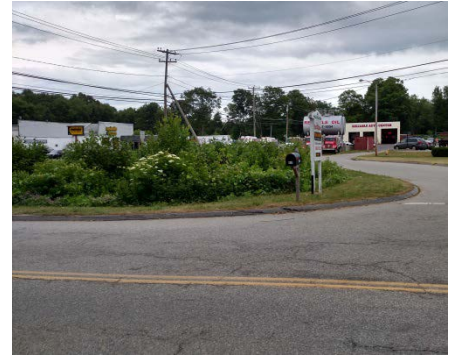
Figure 10. Wetlands Designed to Help with Drainage

- Colchester does not have an ordinance against riding bicycles on the sidewalk.
- There is a drainage consideration at the intersection of Halls Hill Road and the Norwich-Colchester Turnpike. There are wetlands on either side of Halls Hill Road with a culvert running under the road and a wetlands basin on the south side (Figure 10).

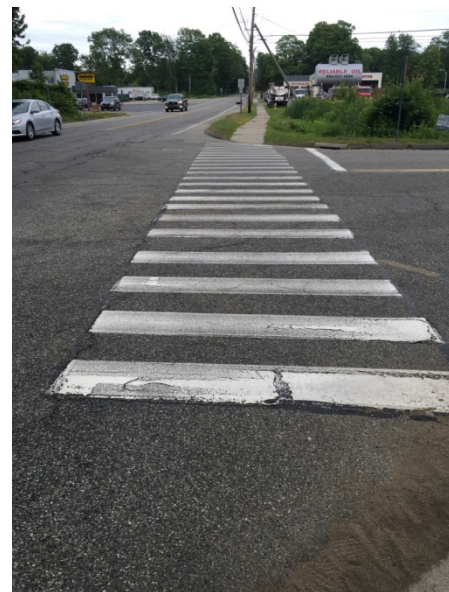
Figure 11. Crosswalk at Norwich Avenue

- There is a crosswalk across Halls Hill Road at the intersection with Norwich Avenue (Figure 11).
- When busses are dropping and picking up children at Colchester Elementary School they block the entrance for any other large vehicles. In the event of an emergency while buses are present there would be no access point for emergency vehicles. An alternative entrance or mountable curb is needed, which would be gated at other times.

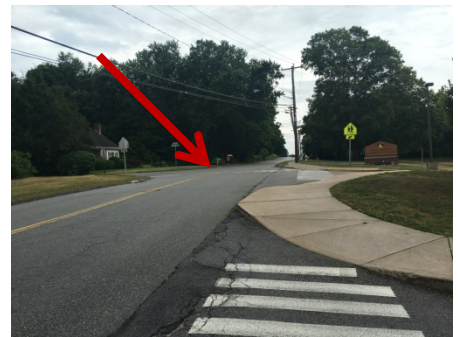
Figure 14. Crosswalk from Christy Lane

- The crosswalk from Christy Lane is not visible to westbound motorists due to the horizontal geometry of the roadway. There is no advanced warning for the crosswalk. The crosswalk is not perpendicular, creating a longer walking distance. There is also a bump in the sidewalk due to the driveway lip, this could create a tripping hazard and may not be ADA compliant. The paint is also faded and lacks retro reflectivity (Figure 14).

13. Add "Ahead" under the pedestrian crossing sign.
14. Fix (jack up) sections of the sidewalk where it has sunk below the curb.
15. T-up the crosswalk from Christy Lane to Jack Jackter Intermediate School and make it ADA compliant (Figure 24).

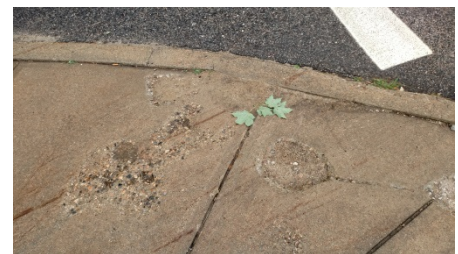
Figure 15. Broken Sidewalk Ramp

- In front of Jack Jackter Intermediate School sidewalk passing stations have been installed.
- The sidewalk ramp for the exit to Jack Jackter Intermediate school is in need of repair (Figure 15).

9. Investigate why there is horizontal cracking
 - a) Perform structure rehabilitation (2 feet) around the crack to remove the hump in the road.
10. Repair broken sidewalk ramps (Figure 23).

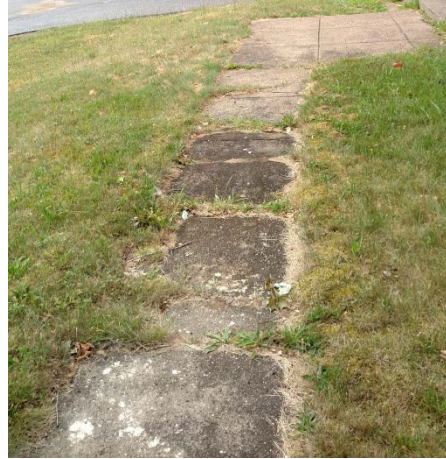
Figure 16. Sidewalk Between Prospect Street and Elmwood Heights

- There is only a short segment of sidewalk on the south side of Halls Hill Road between Prospect Street and Elmwood Heights. It is made of stone and is approximately 2 feet wide. It is in extremely poor condition (Figure 16). The sidewalk elevation is at least eight 8 above the roadway, with a steep embankment in the over-wide grass buffer.

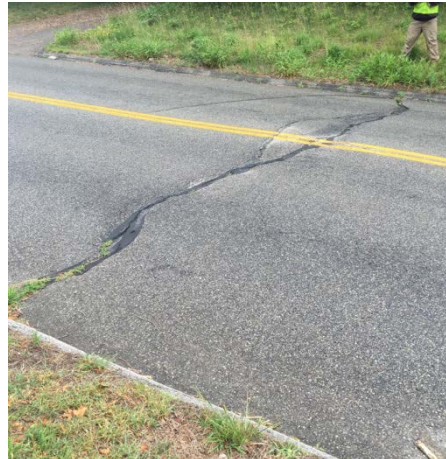
Figure 17. Horizontal Crack in Road

- There is a large horizontal crack in the road between Prospect Street and Pleasant Street which developed from either frost heaving or groundwater issues. The crack poses an impediment to cyclists and creates a bump in the roadway (Figure 17).

- The crack in the road between Pleasant Street and Prospect Street is an issue. It creates a heave in the road.
- Police enforcement (for speed on Halls Hill Road) would be difficult because the department is small (usually only 2 officers on patrol at a given time).

1. Widen the sidewalks to 6 feet on the north side of Halls Hill Road in-between Jack Jackter Intermediate School and Route 85.
2. Conduct a geotechnical analysis of the horizontal crack and repair it in accordance with the analysis recommendations.
3. Fill in the missing sidewalk gaps on the south side of Halls Hill Road.
4. Hire crossing guards (subject to other improvements).
5. Create an emergency entrance between the Elementary School and Norwich Avenue.
6. Add a left turn lane from Route 85 to Halls Hill Road and restripe the lanes to be 11 feet wide.
7. Improve the geometry of the crest in the hill on Halls Hill Road.
 - a) Install a crosswalk across Halls Hill road at Prospect Street.

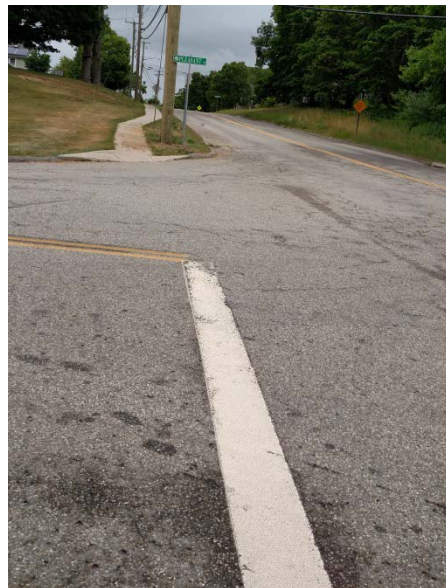
Figure 18. Lack of Crosswalk at Pleasant Street.

- There is no crosswalk across Pleasant Street (Figure 18).
- The stop bar was moved forward on Pleasant Street approximately 8 to 10 feet in order to provide better sight distance. The stop sign was not moved up. This was done about 5 years ago.

4. Cut vegetation blocking signs, particularly the "No Parking Signs" between Lions Pond and Jack Jackter Intermediate School.
5. Add a crosswalk across Pleasant Street (Figure 21).

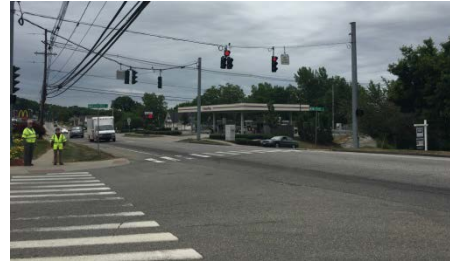
Figure 19. Route 85 and Halls Hill Road Intersection

- The intersection with Route 85 is a “dog-leg” intersection with Halls Hill Road and Dr. Foote Drive being offset. Because of this the side streets have split phases.

- There is a “no turn on red” sign from Route 85 onto Halls Hill Road or Dr. Foote Rd.
- The signal at Route 85 has an advance left turn phase for southbound Route 85, an exclusive pedestrian phase, and split (protected) side street phases.
- The pedestrian signal heads do not have a countdown but are audible.
- The signal timing provides 12 seconds of clearance time for Halls Hill Road. This appears to be less than the newest standard of 3.5 feet per second.
- The crosswalk across Dr. Foote Drive is faded and does not have a pedestrian push button on the south side.

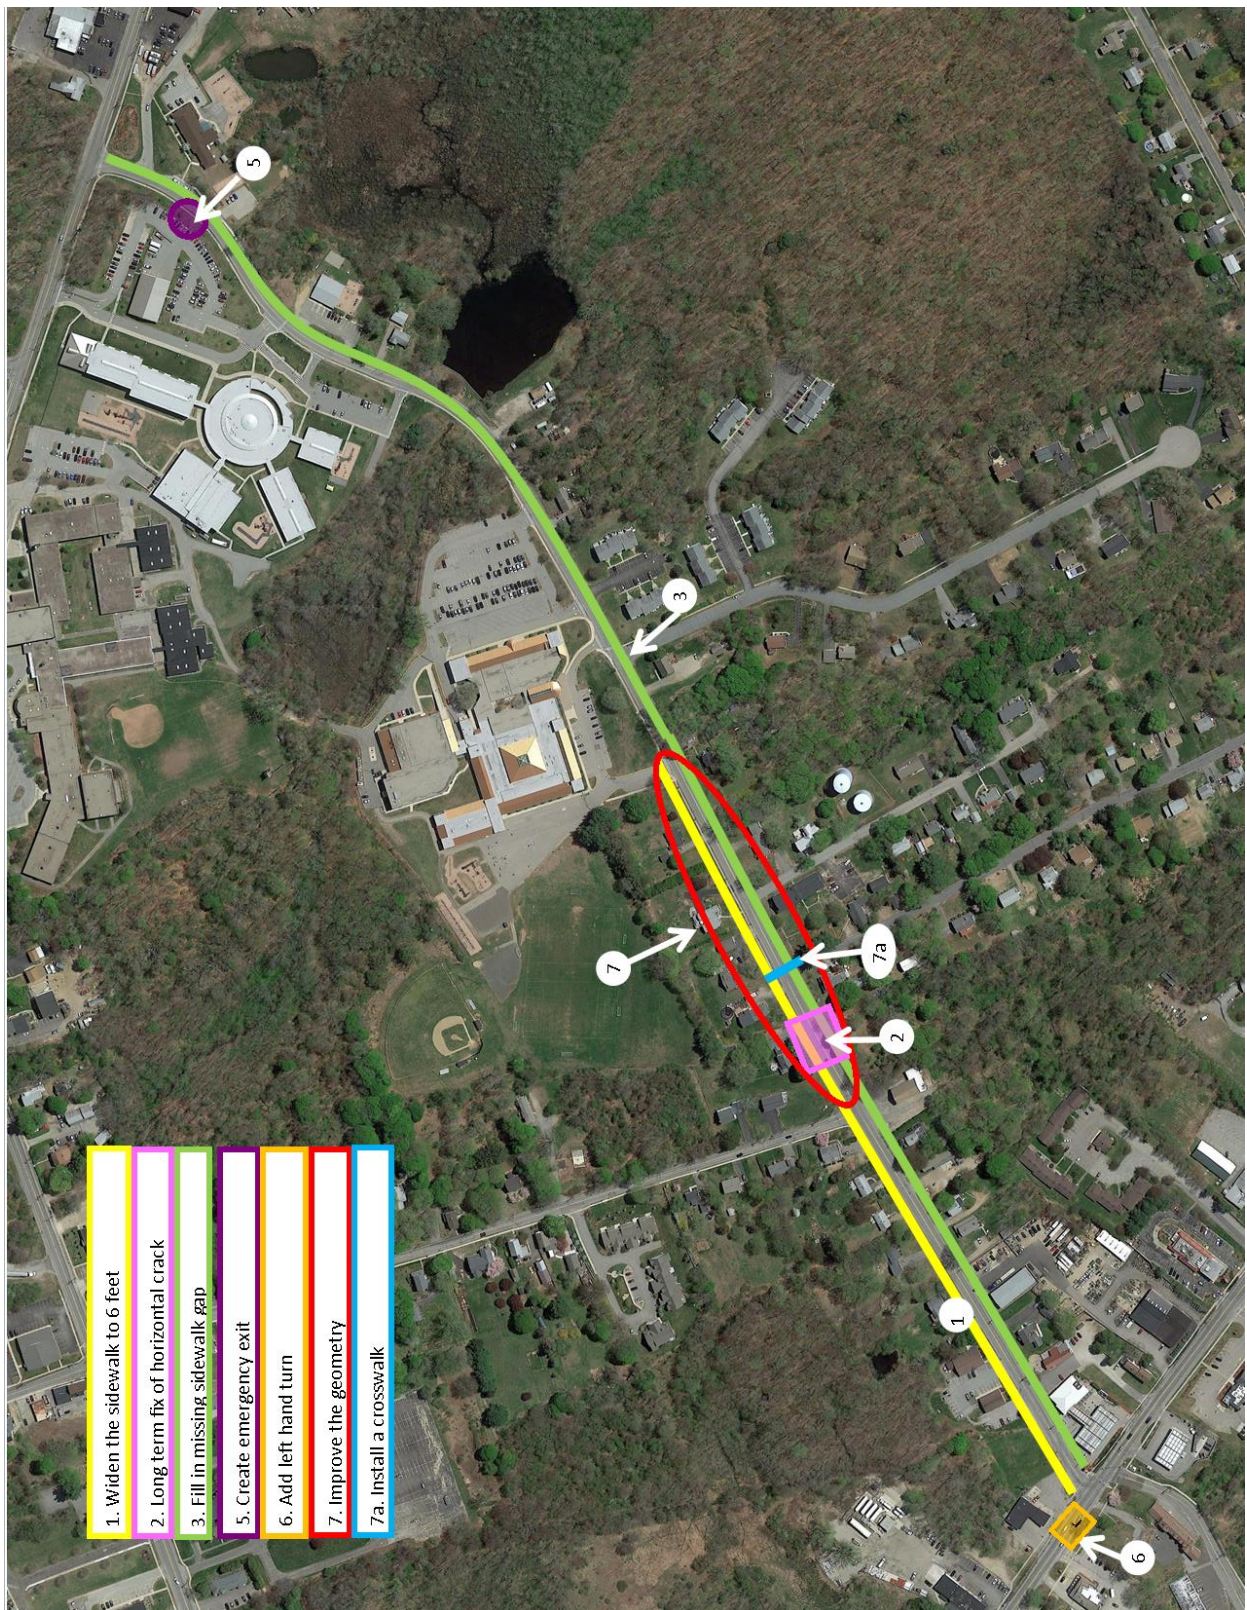
Figure 30. Long Term Recommendations

Figure 30 depicts these recommendations.
