# EAST HADDAM ROAD SAFETY AUDIT

Route 149 (East Haddam Moodus Road/  
Falls Road) between Grove Street and  
Great Hillwood Road

NOVEMBER 2023

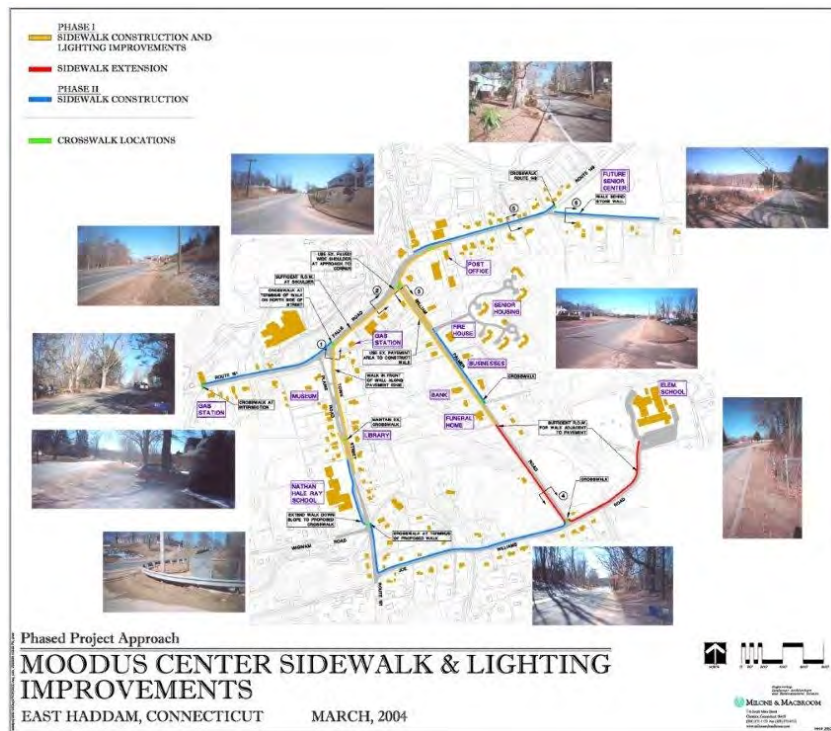
Exhibit 6: Conceptual Sidewalk Plan Developed in 2004

A sidewalk plan was developed for the vicinity of Moodus Center in 2004. The plan, shown in Exhibit 6, identified a phased approach for sidewalk construction and extension throughout the study area. Sidewalk construction and pedestrian scale lighting has been installed along the south side of Route 149 (East Haddam Moodus Road) between Route 151 (Town Street) and the Post Office.

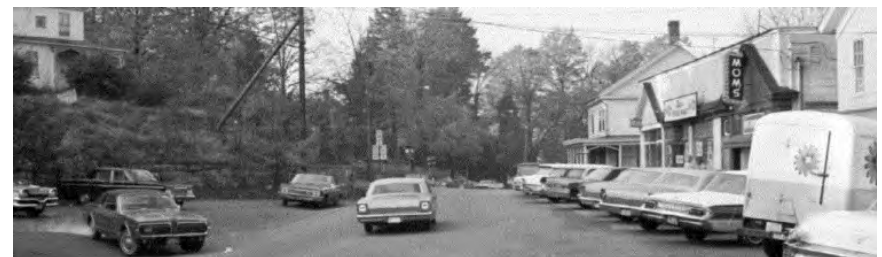
Exhibit 8: Moodus Center in the late 1960's

In 1968, using the Federal Government's urban renewal program, the East Haddam Redevelopment Agency created a new plan for Moodus Center that removed blighted buildings, created a new roadway (William F. Palmer Road) and designed a new shopping center, as shown in Exhibit 7 and Exhibit 8. Much of this plan was completed and altered the character of Moodus Center drastically.

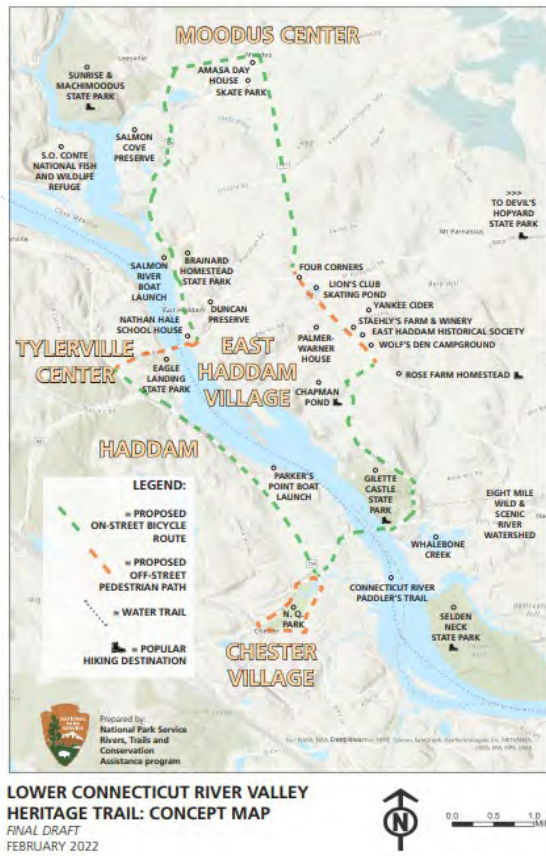
Exhibit 9: Heritage Trail Concept Map

Moodus Center is included in the National Park Service’s Lower Connecticut River Valley Heritage Trail Concept Plan. This plan seeks to connect the Towns of East Haddam, Haddam, and Chester through a combination of on-street bicycle routes, off-road pedestrian paths and water trails, all connecting popular hiking destinations and Village Centers. See Exhibit 9 for a map of the concept plan.

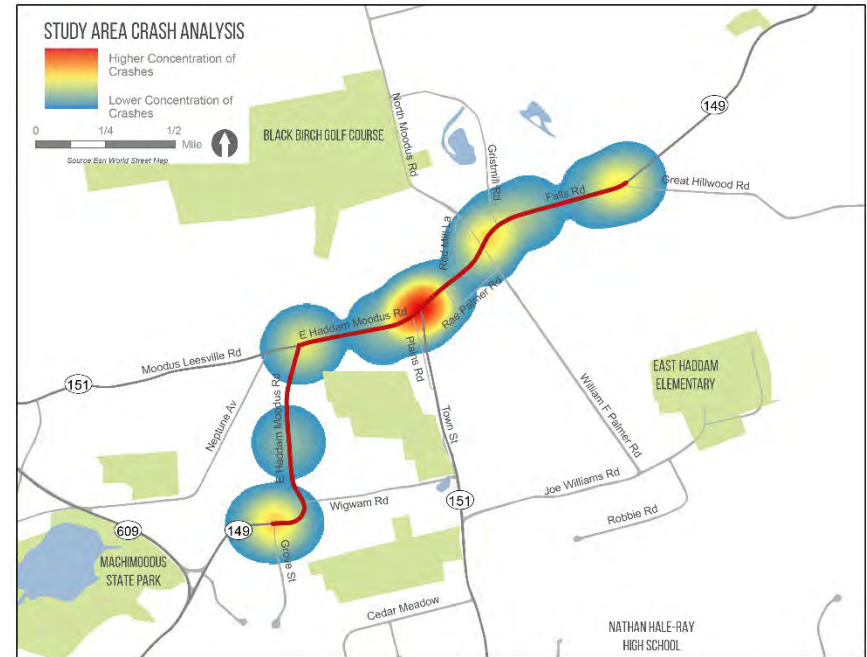
Exhibit 13: Study Area Crash Heatmap

**Crashes:** Based on data retrieved from the Connecticut Crash Data Repository (CTCDR) for the five-year period between January 2017 through December 2021, there were a total of 19 crashes in the East Haddam RSA study area. Crashes were concentrated in the vicinities of the Route 149 (East Haddam Moodus Road / Route 151 (Town Street) intersection, the intersection of Route 149 (Falls Road) and North Moodus Road and William F. Palmer Road, the intersection of Route 149 (East Haddam Moodus Road) and Moodus Leesville Road, and the intersection of Route 149 (East Haddam Moodus Road) and Grove Street.

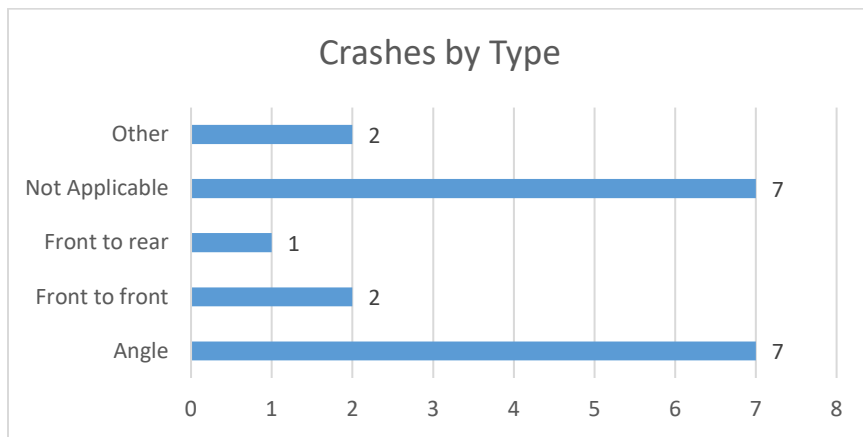
Exhibit 14: Crashes by Type

**Crashes by Type:** The majority of crashes single vehicle (Not Applicable) or angle crashes. Single vehicle crashes are indicative of crashes where motorists veered off the road, ran into a fixed object. Angle crashes and sideswipe crashes are common in areas with ingress and egress movements such as business areas. Exhibit 14 and Exhibit 15 display the location and breakdown of crashes by type in the corridor.

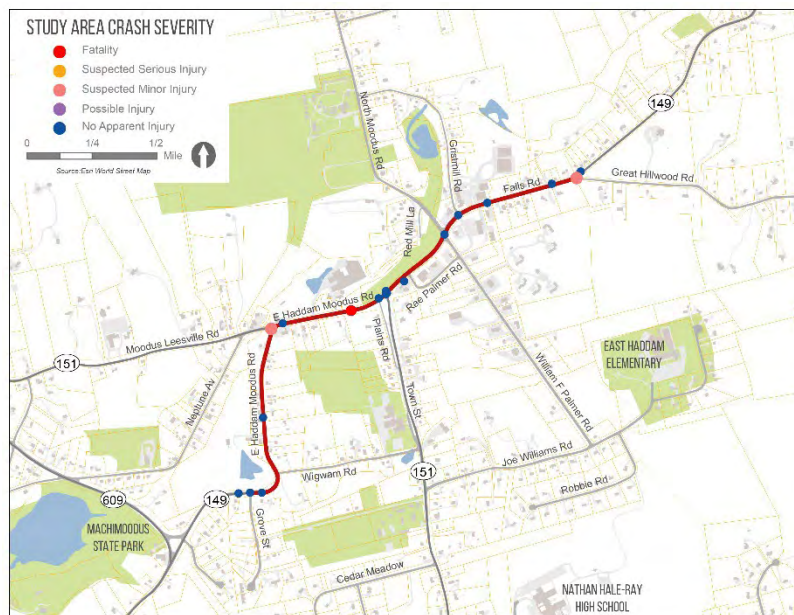
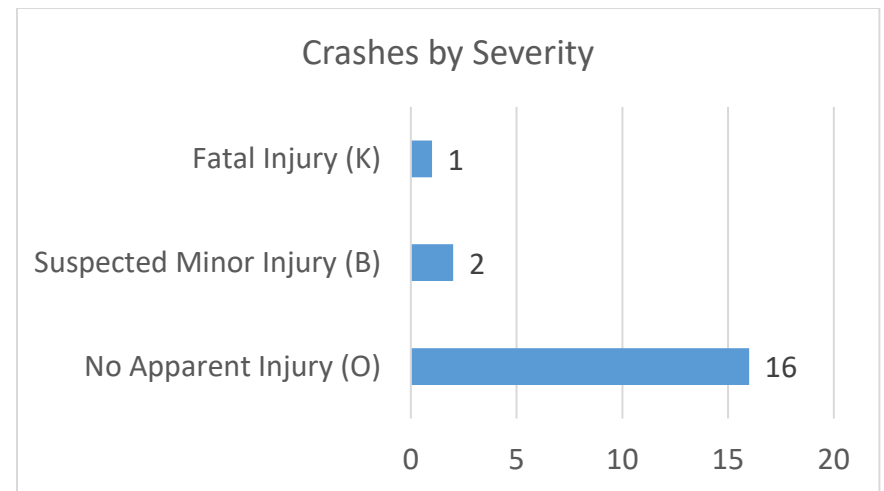
Exhibit 16: Crash Severity by Location

**Crash Severity:** The majority of crashes (16) are classified as no apparent injury/property damage only. This is typical for single vehicle crashes that are prevalent in the study area. Suspected minor injuries occurred during two crashes. There was one fatality reported in the past five years. The fatality was a westbound motorcyclist who hit a deer west of North Moodus Road. Exhibit 16 and Exhibit 17 show crash severity by location and a summary of total crashes by severity.

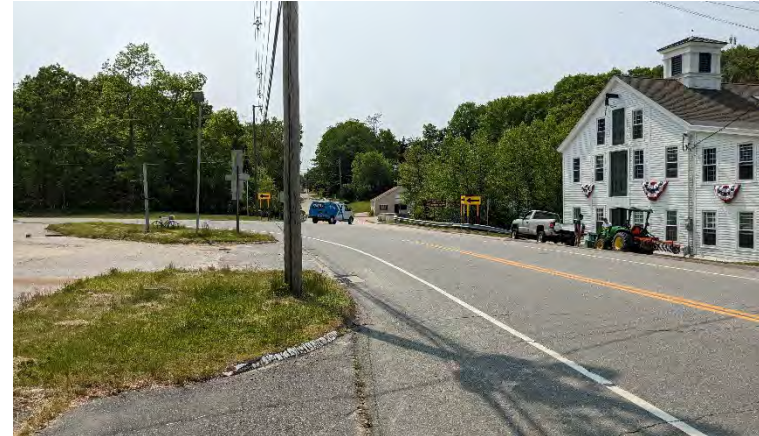
*Exhibit 20: View southeast on Route 149*

- Town officials generally felt that conditions on Route 149 south of the intersection of Route 151 were good and that the roadway and intersection functioned well.
- Route 151 eastbound is stop controlled at this location, with Route 149 southbound/northbound having the right-of-way. See Exhibit 20 for a picture of this location.

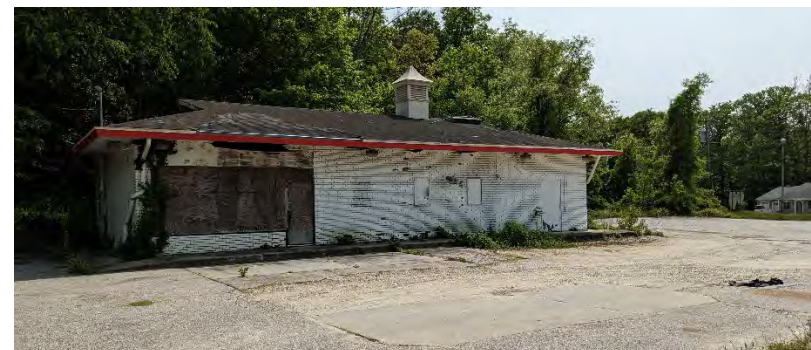
*Exhibit 21: Former gas station that is slated for redevelopment.*

- Development plans have been proposed for a new gas station at this property. Plans include a drive-thru, building, fuel pumps, parking spaces, and three entrance/egress locations. See Exhibit 21 for a picture of the site.

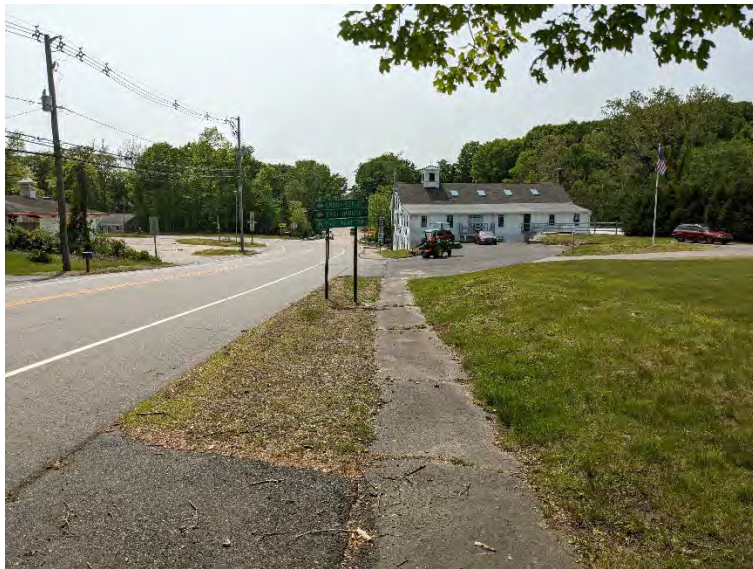
Exhibit 22: Route 149 west of Plains Road. View looking west.

- Town officials noted that speeding is an issue in this area, particularly in the westbound direction (downhill).
- The roadway is over 32 feet wide in this area.
- There is an asphalt sidewalk on the north side of Route 149 in this location. It is in poor condition with vegetation encroachment and noticeable heaving. It extends from Dutch Oil Company driveway to just east of Moodus River Road. See Exhibit 22 for a photo of the sidewalk.

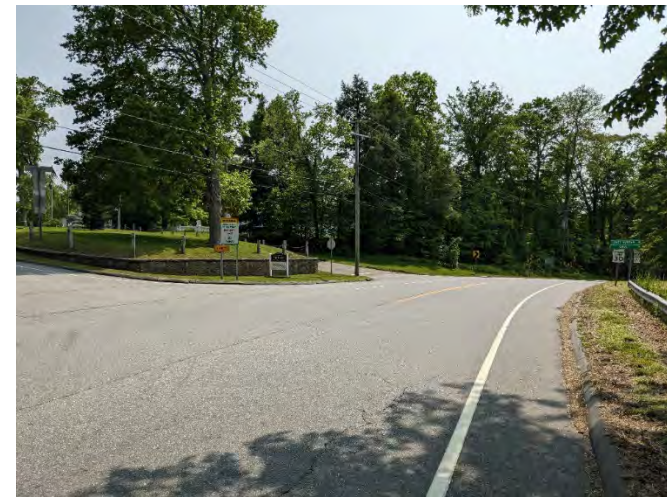
Exhibit 23: Intersection of Route 149 and Route 151 and Plains Road

- The intersection generally functions well for vehicular traffic, but it was noted that sight lines can be challenging.
- A concept plan was developed that would abandon Plains Road and convert it to a combination of sidewalk, lawn area and residential driveways.
- Speeding is often observed at this location on Route 149. Speed limit is 30 mph throughout this area, but the downhill grade contributes to increased speeds. 85<sup>th</sup> percentile speeds are 42 MPH.
- Turning radius onto Route 151 from Route 149 eastbound is wide.
- There is no crosswalk across Route 149 at this location, as shown in Exhibit 23.

- 1) Consider abandoning Plains Road, eliminating its intersection with Route 149 to reduce conflicts and direct traffic to the adjacent intersection with Town Street. The former roadbed could be replaced by grass and a potential sidewalk connection to serve buildings on the west side of Town Street.
  - **Next Step:** Contact LTA to send request to [DOT.TrafficEngineering@ct.gov](mailto:DOT.TrafficEngineering@ct.gov) for next resurfacing project.
  - **Next Step:** Contact [info@rivercog.org](mailto:info@rivercog.org) for funding.

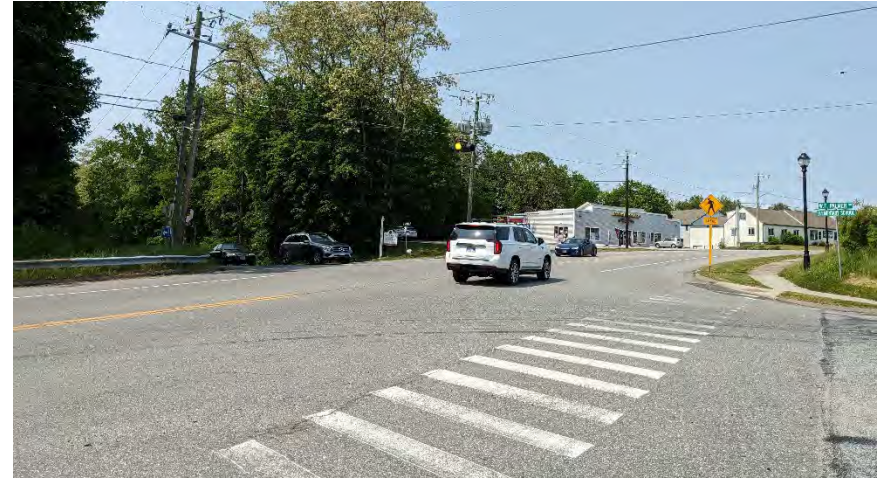
Exhibit 25: Crosswalk at the intersection of Route 149 and William F. Palmer and North Moodus Road

- Elevation changes, vegetation, and a retaining wall on the southeast corner make the sight lines challenging for vehicles approaching Route 149 from the south and looking at traffic approaching on Route 149 from the east. See Exhibit 25 for a view of the intersection.
- Vehicle speeds are an issue at this location.
- A crosswalk exists at the William F. Palmer Road approach to the intersection. Crossing distances are long at over 100 feet.
- Pedestrian scale lighting and sidewalks are present on the south side of Route 149.
- William F. Palmer Road is very wide (26-feet) and has sidewalks along both sides of the roadway, as shown in Exhibit 26.

Recommendations in this area primarily focus on improving visibility at the intersection by realigning Route 149. Pedestrian improvements to reduce crossing distances at the intersection are part of the realignment. Additionally, access management techniques are utilized to vehicular conflicts near the intersection. Exhibit 33 displays the intersection and crosswalk at this location. Exhibit 34 depicts these recommendations as a conceptual plan.

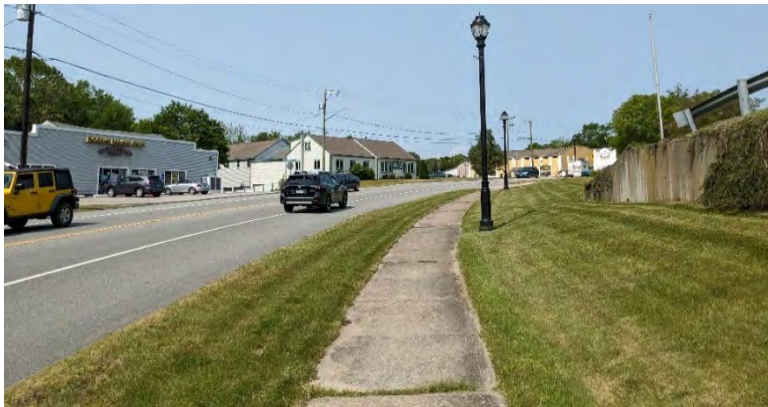
Exhibit 27: View east on Route 149

- Driveways to the business in this area are poorly defined and opportunities exist for access management.
- A sidewalk exists along Route 149 at this location; it is in fair condition.
- Exhibit 27 shows the sidewalk and pedestrian scale lighting at this location.

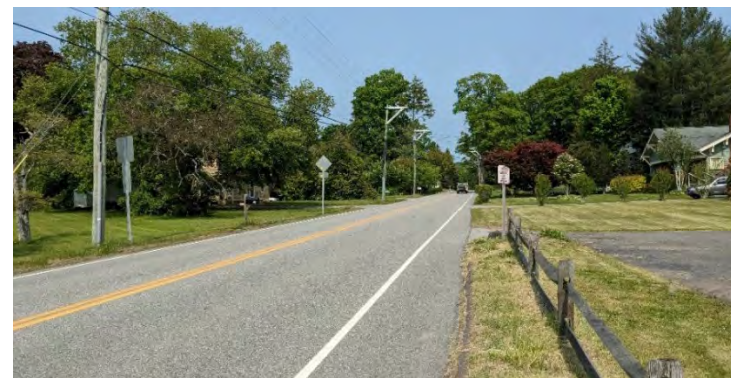
Exhibit 29: View of Route 149 looking east towards Great Hillwood Road

- The entrance to the Nathan Hale Plaza is busy in this area.
- Route 149 narrows considerably east of the Post Office. Shoulders are narrow. See Exhibit 29 for a photo of this area.
- There is no sidewalk between the commercial area (Hometown Market, Post Office, Nathan Hale Plaza) and the senior center located on Great Hillwood Road.

The recommendations included here seek to create comfortable accommodations for bicycle and pedestrian travel while improving connections to the East Haddam Senior Center.

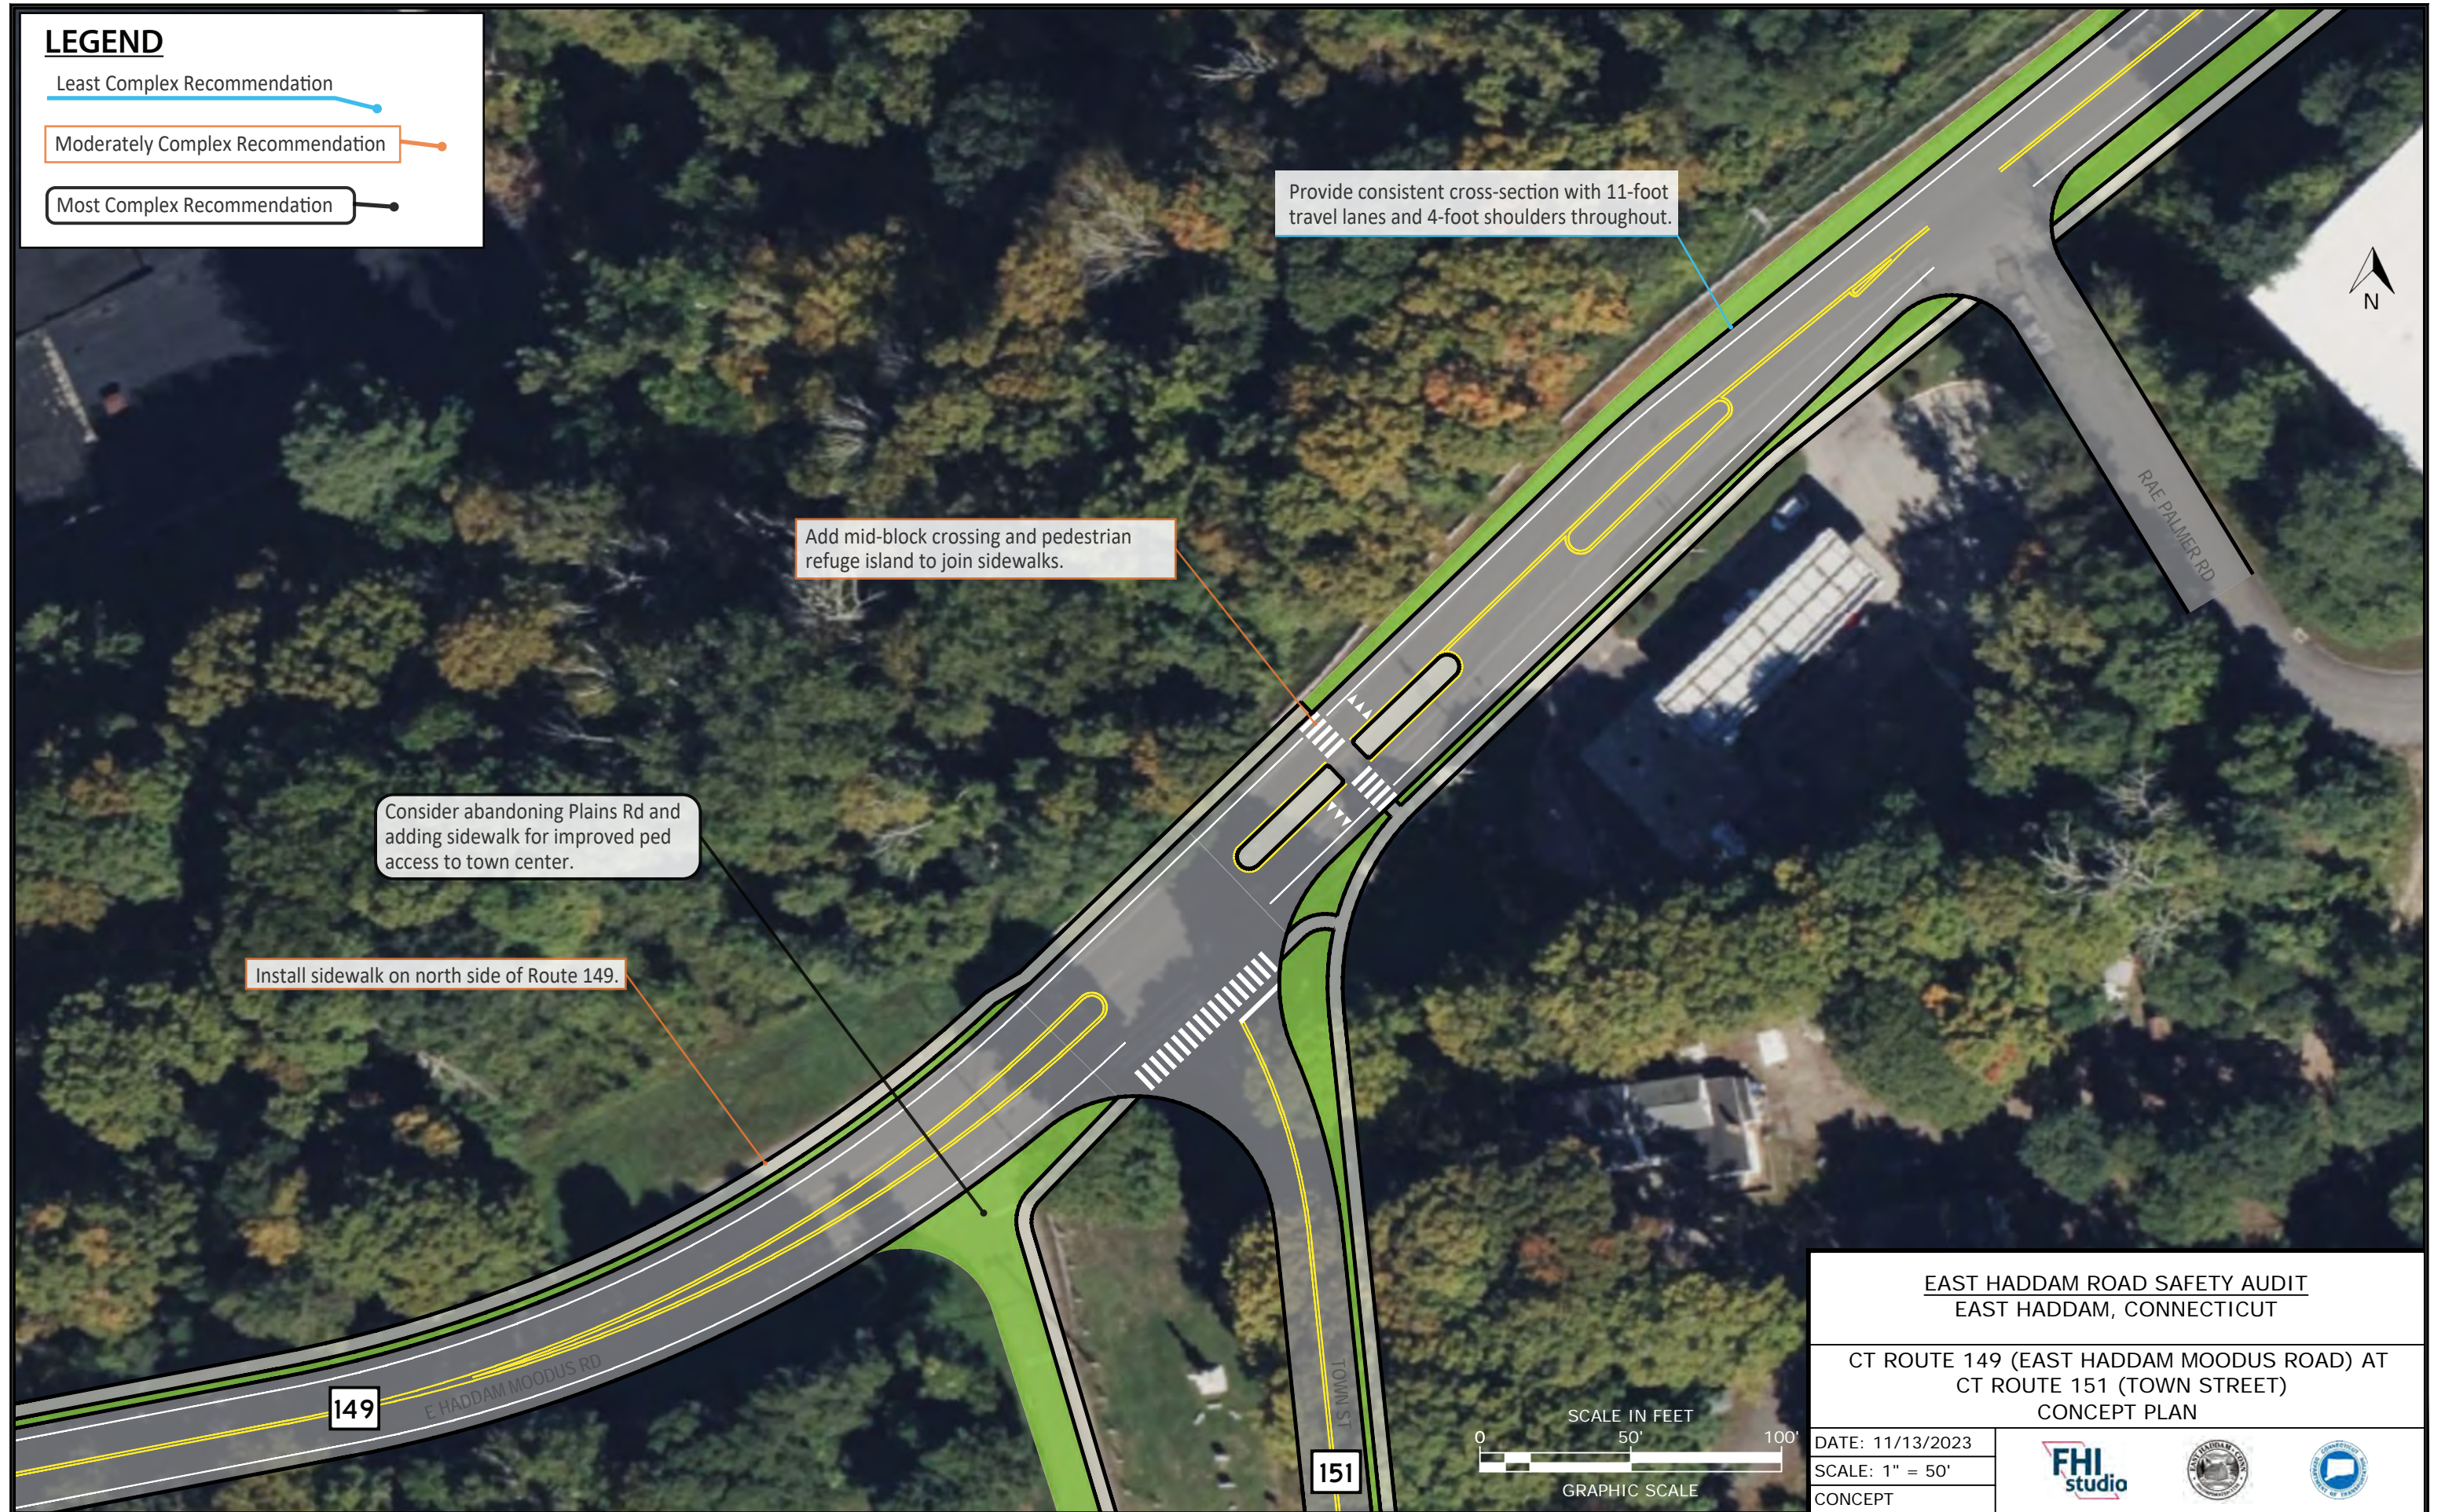
The recommendations at this intersection are three-fold: first, to extend the pedestrian network along Route 149 and to provide safer pedestrians connections between Route 151 and the existing sidewalks on Route 149 (Main Street), and second, to explore additional redesign options at this intersection which would shorten pedestrian crossing distances on Route 151. Thirdly, by abandoning Plains Road, access is restricted which could reduce vehicle conflict points at the intersection. Finally, a sidewalk can be provided along Plains Road to enhance pedestrian connectivity in the area. These recommendations are show in greater detail in Exhibit 32.

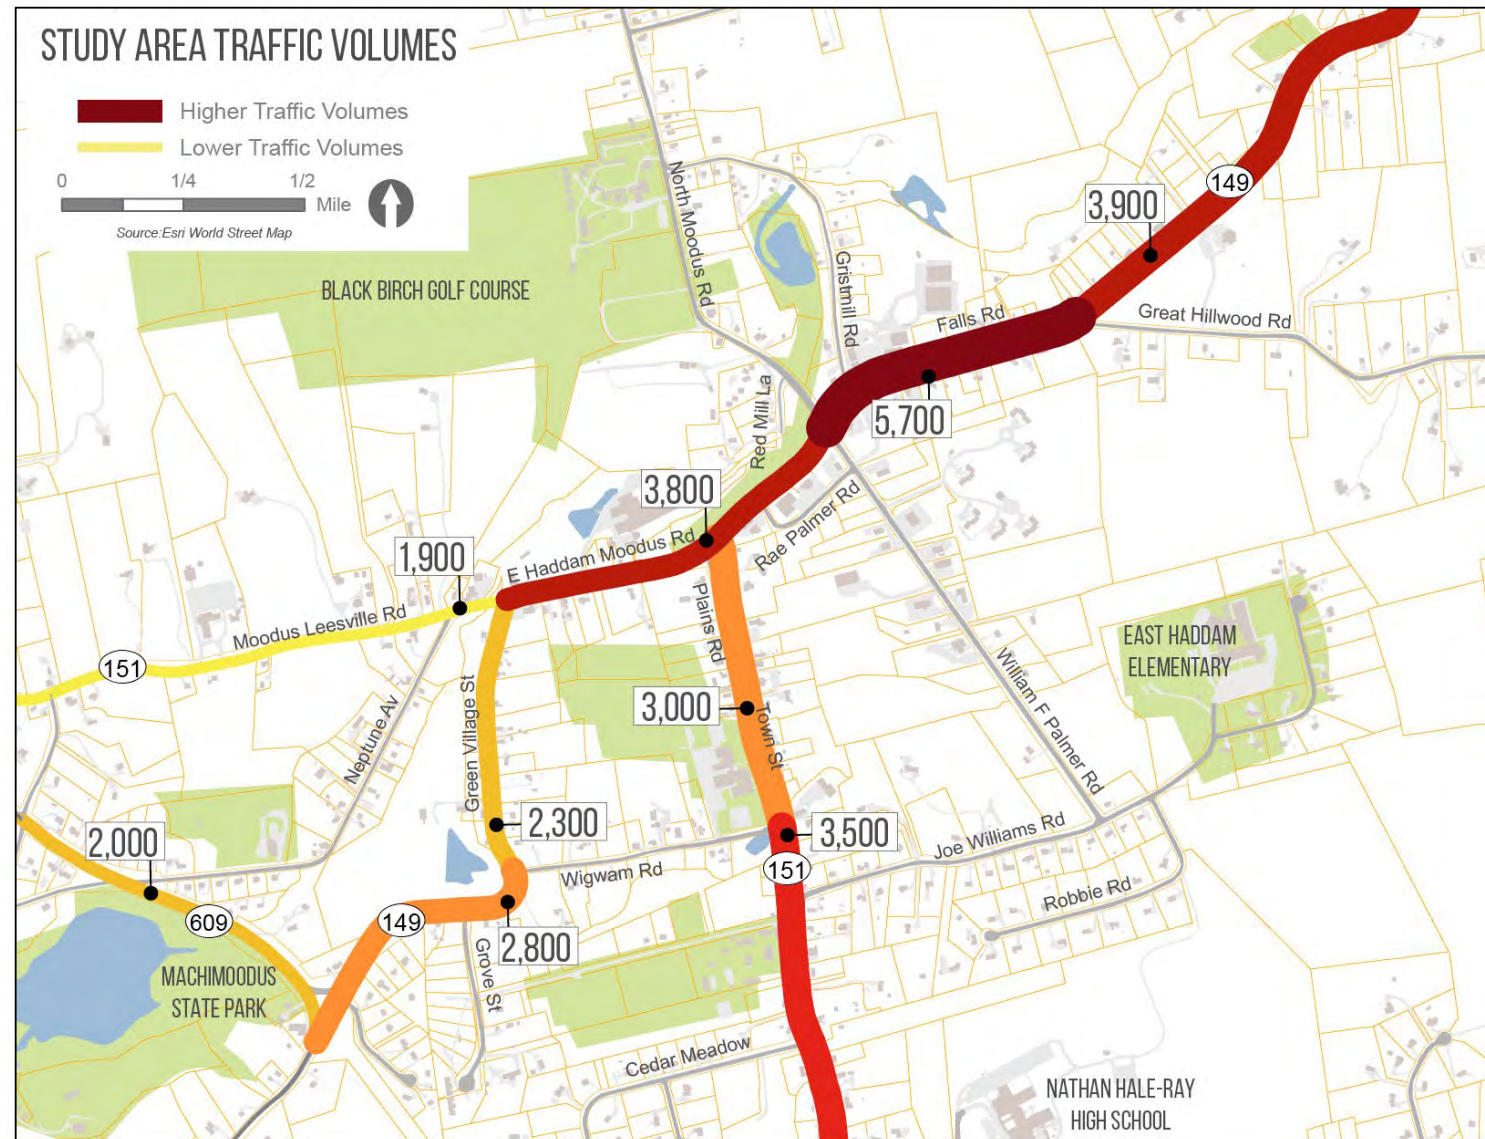
- Highest traffic volumes found on Route 149 between North Moodus Road/William F. Palmer Road intersection and Great Hillwood Road
- Wigam Road appears to be a cut-thru between Route 149 and Route 151
- Lowest volumes found on Route 149 east of Leesville Road

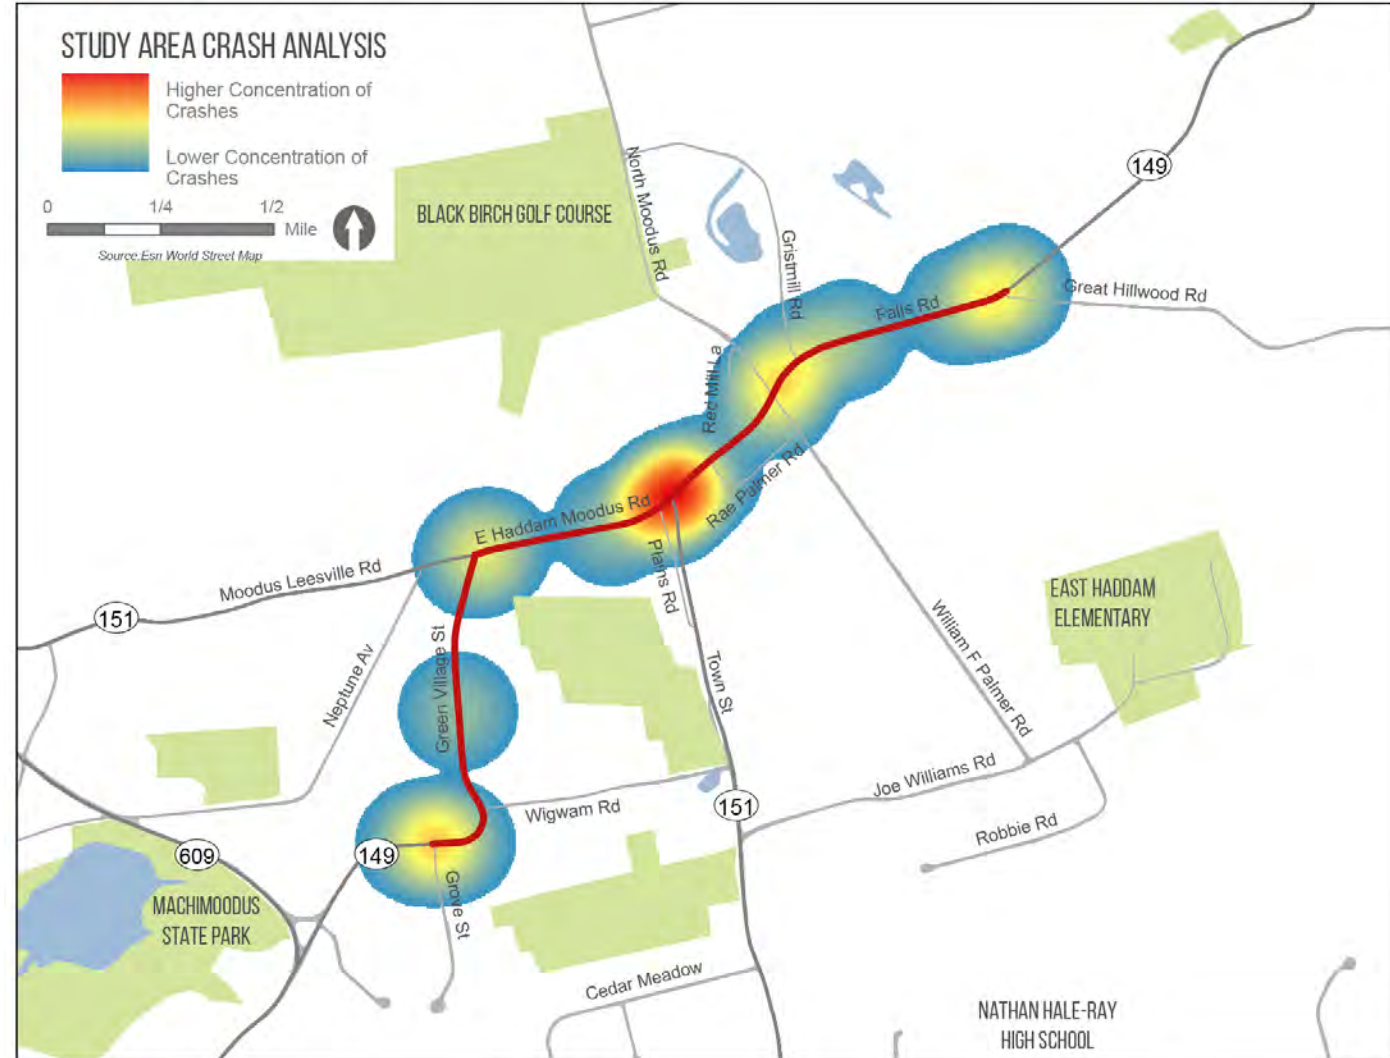
19 Crashes Total

- Approximately 4 crashes in the vicinity of Route 149 / North Moodus Road
- Approximately 3 crashes in the vicinity of Route 149 / Grove Street
- Approximately 3 crashes in the vicinity of Route 149 / Great Hillwood Road

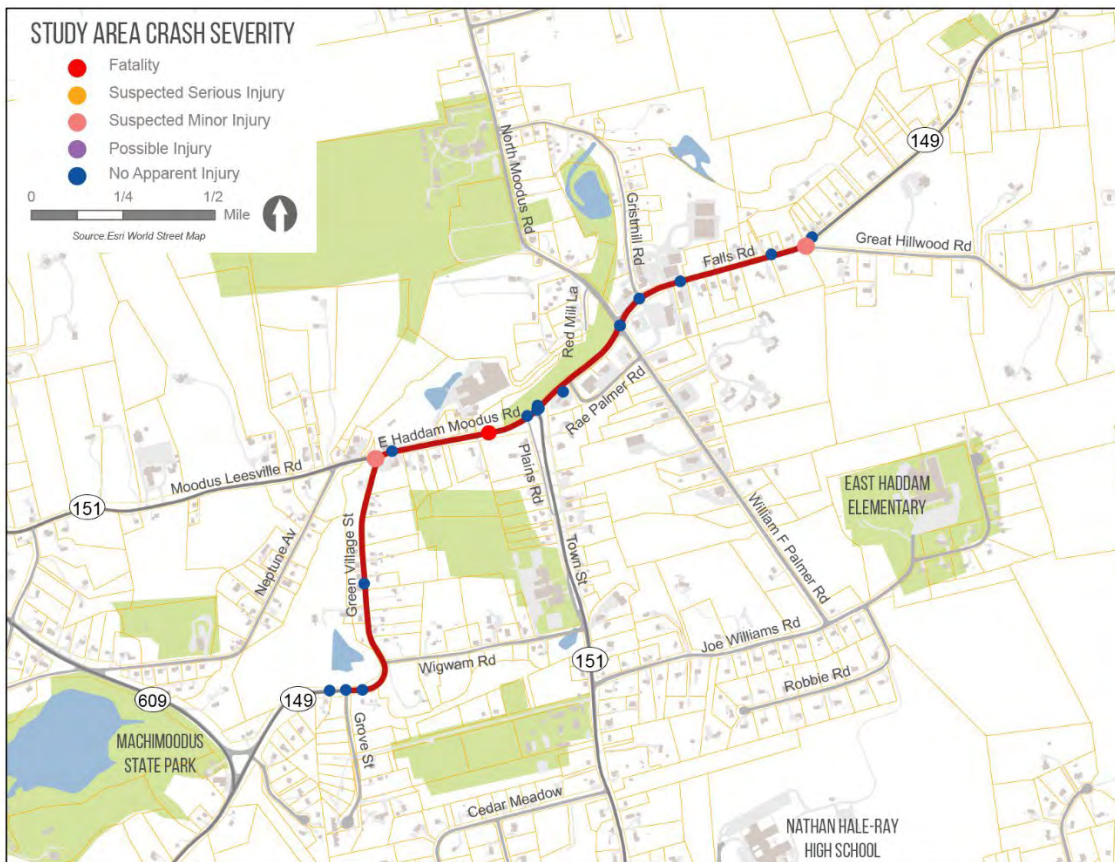
## East Haddam Road Safety Audit Crash Summary - Crash Severity

- Majority of crashes (16) are classified as No Apparent Injury- Property Damage Only
- There were 2 crashes resulting in a minor injury
  - 1 fatality was reported in the past 5 years, Note – Fatality was westbound motorcyclists who hit deer west of North Moodus Road

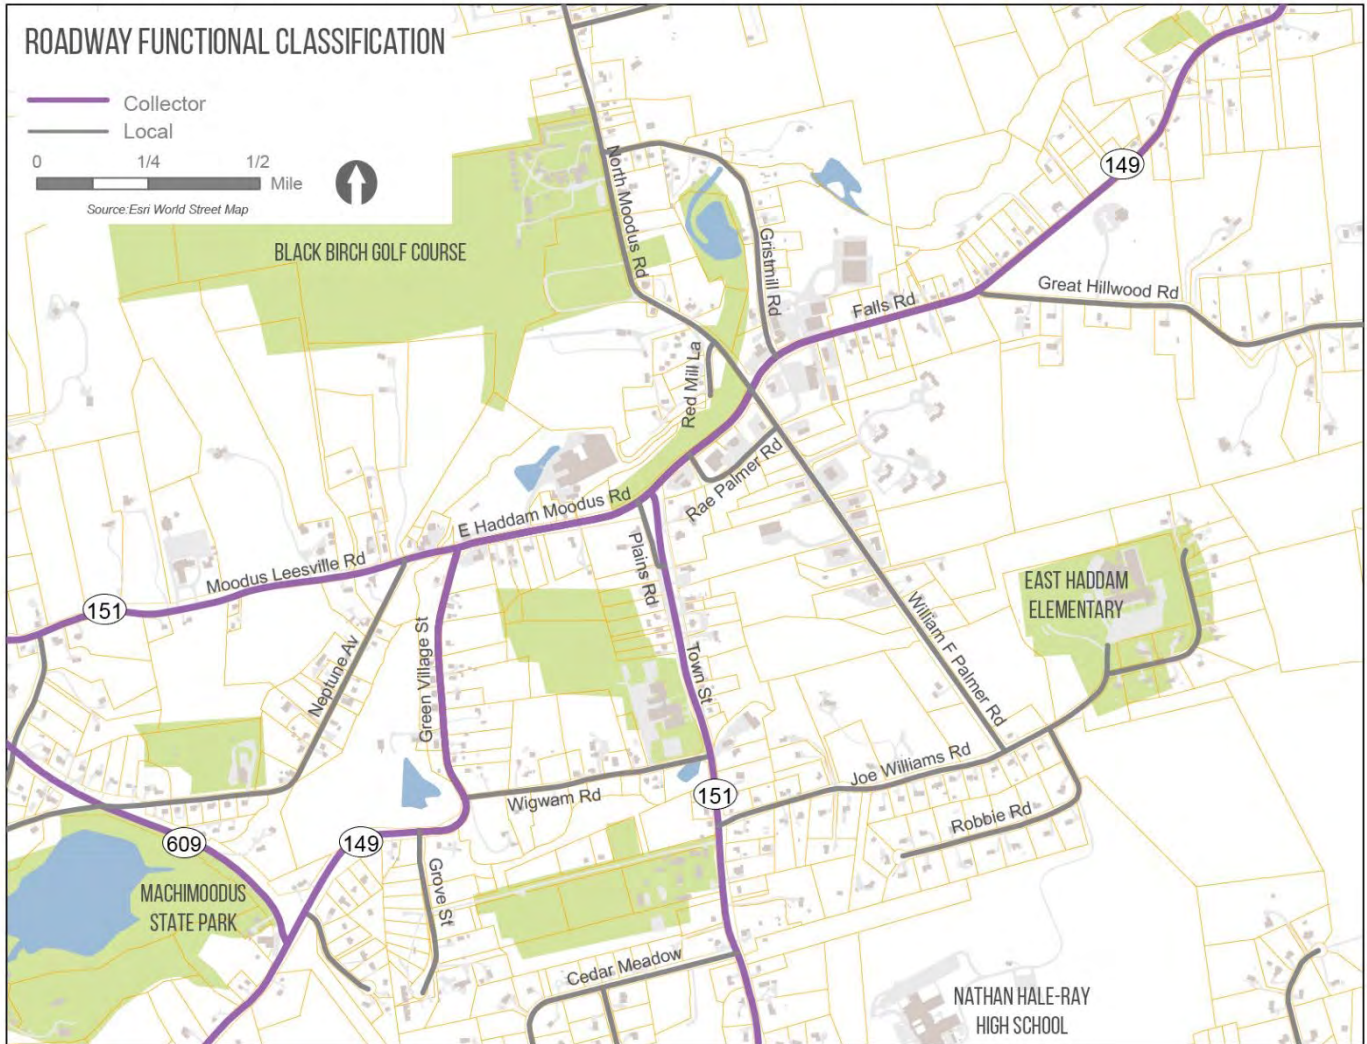
## East Haddam Road Safety Audit – Roadway Functional Classification

- State roadways in the Study Area are collector roadways
