COMMUNITY
connectivity program

Glastonbury

House Street to Welles Street – Road Safety Audit

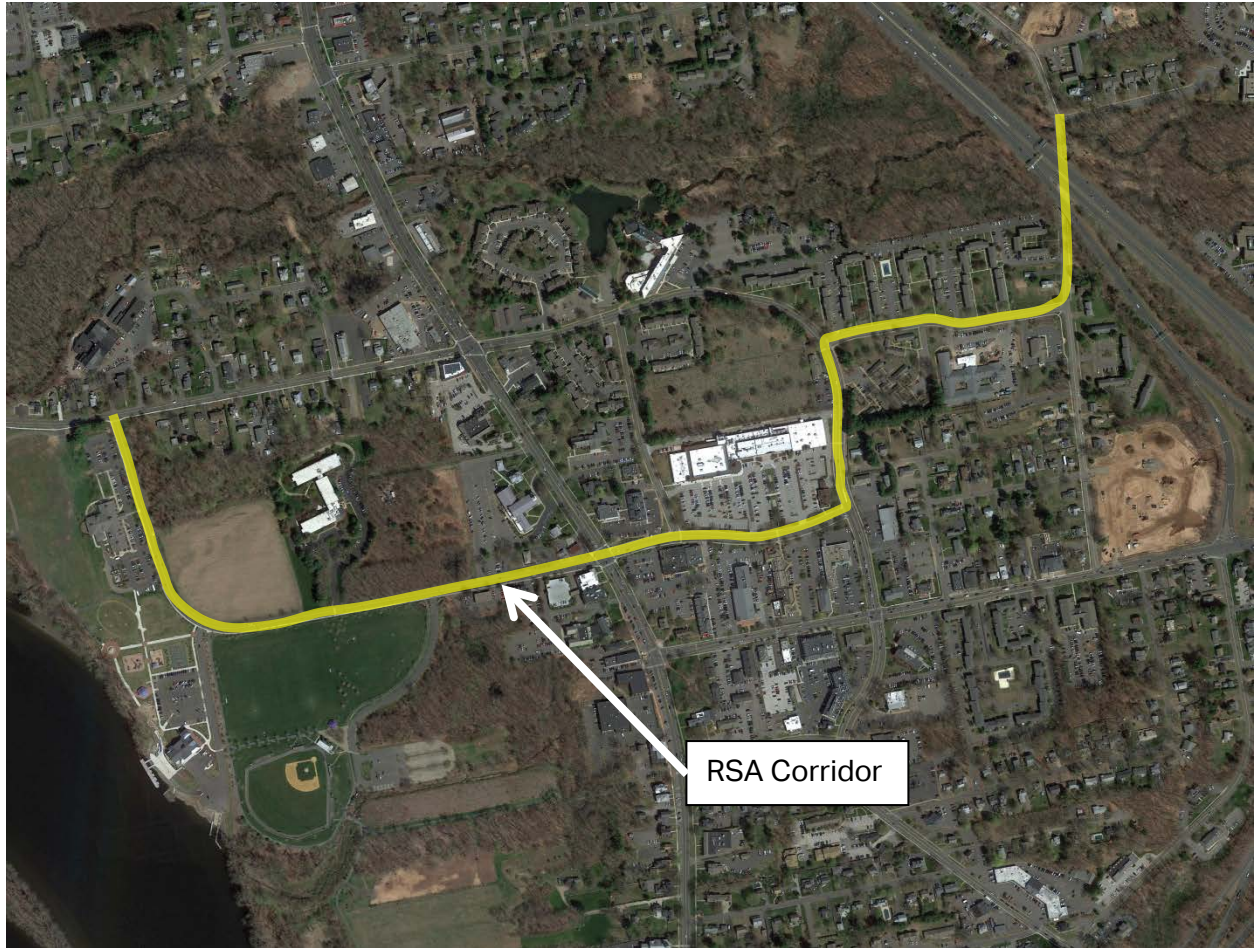
Figure 1. House Street to Welles Street, Glastonbury

The RSA site is the section of Welles Street between the Community Center and the future multi-use trail at House Street (Figure 1). The Average Daily Traffic (ADT) on Welles Street in the study area is between 2,735 and 6,407 vehicles per day (vpd). Welles Street consists of a single lane in each direction, separated by a double yellow center line and no striped shoulders. There is sidewalk on at least one side of the road throughout the corridor.

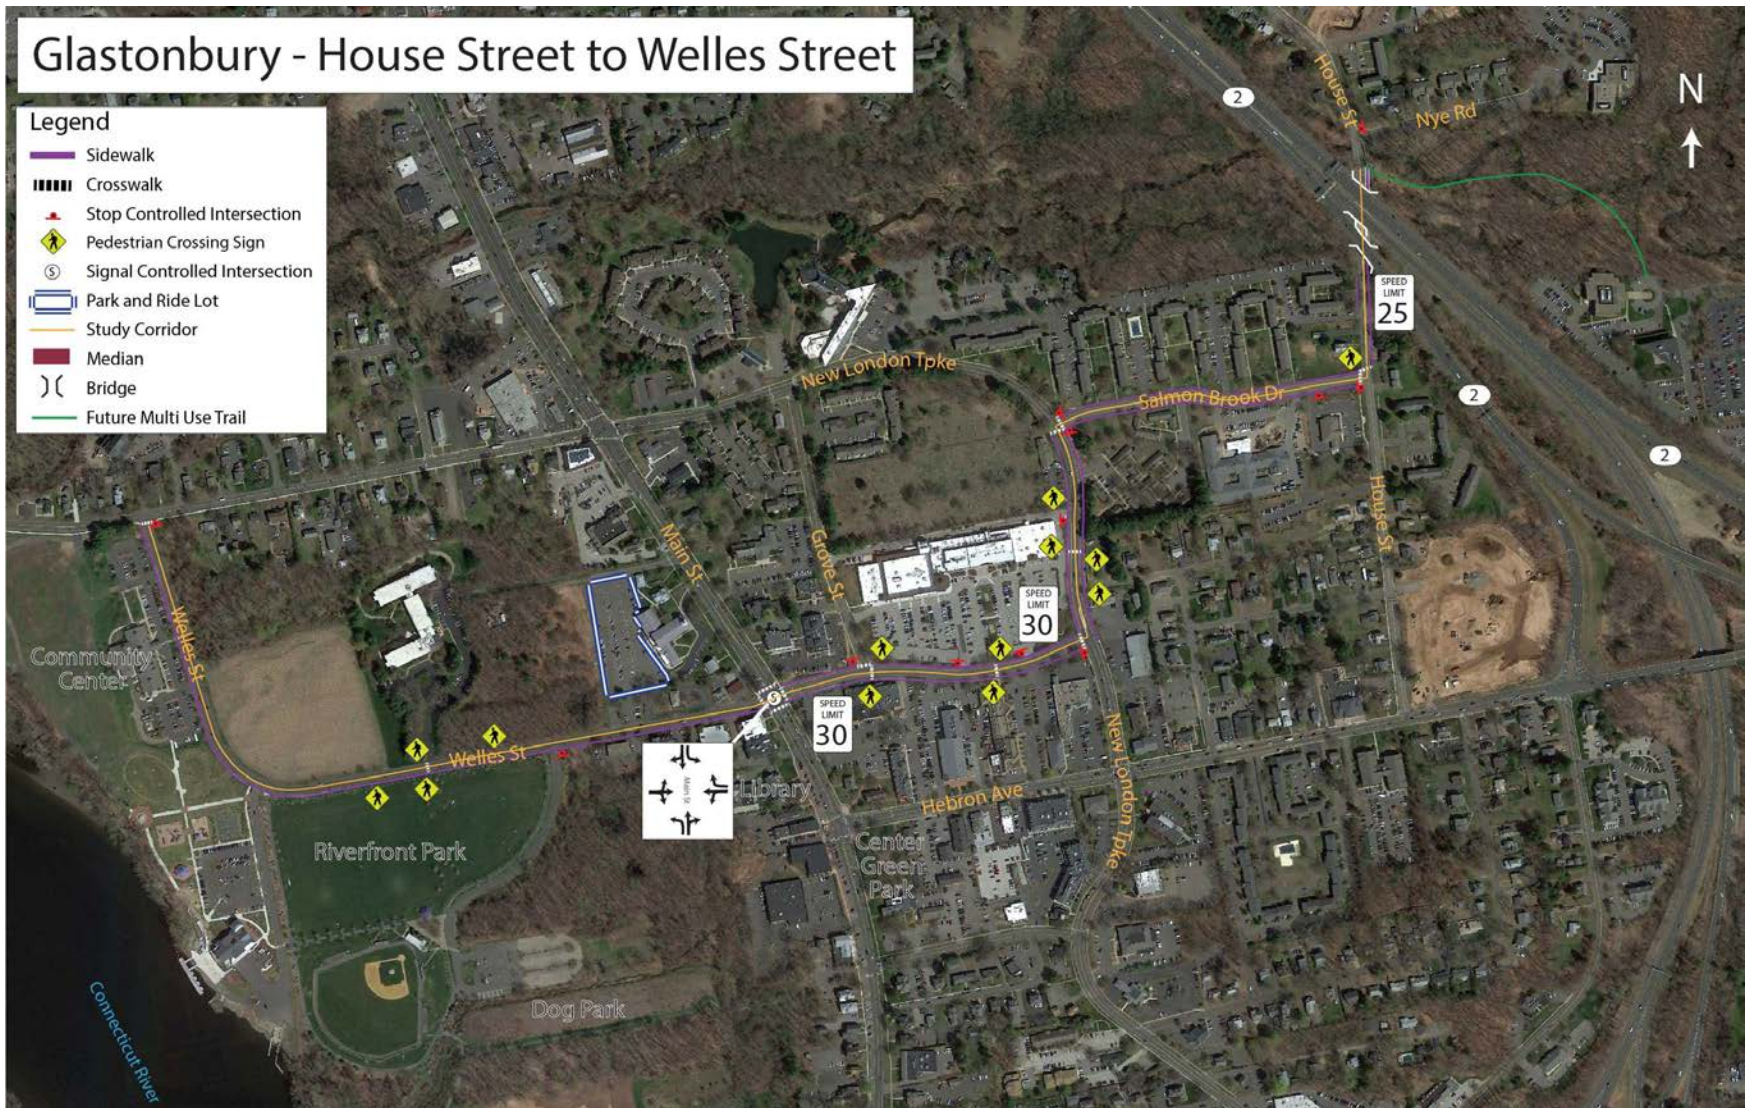
Figure 4. Main Street Road Geometrics

Welles Street is a busy street with access to two recreational park facilities, the Town's Riverfront Community Center and a variety of businesses. Currently the multi-use trail does not connect with Welles Street. Any enhancements on Welles Street to House Street will improve safety for bicycle and pedestrian access (Figure 4 and Table 3).

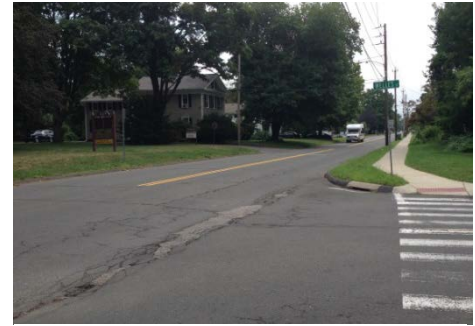
- The roadway pavement is deteriorating in some areas, such as Naubuc Avenue and Welles Street (Figure 5).
- The pavement markings are deteriorating in some areas, such as Grove Street and Welles Street (Figure 6).

Figure 5: Deteriorating Pavement

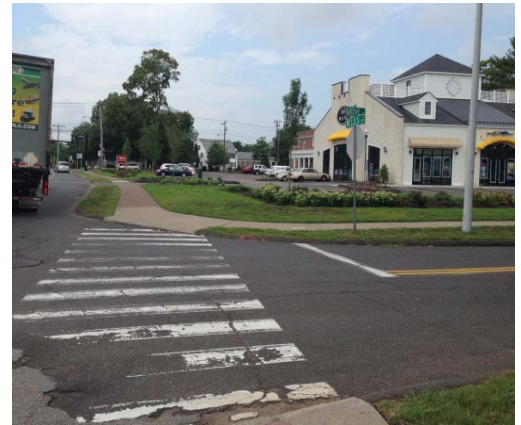
Figure 6: Deteriorating Pavement Markings

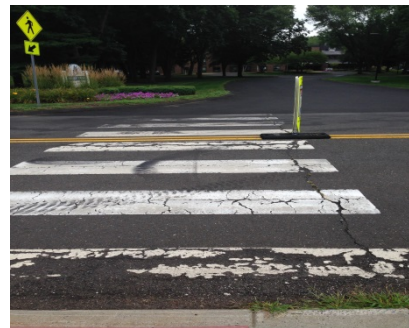
- Lanes appear to be 12' or more in width, and shoulders are mostly unstriped.
- The crosswalk at Naubuc Green apartments is directed into the driveway, there is no refuge area for pedestrians (Figure 7).

Figure 7: No Refuge Area

4. The crosswalk at Naubuc Green apartments should be re-oriented to provide a refuge area out of the driveway.

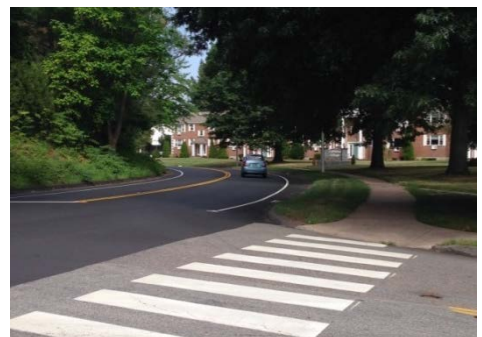
- Detectable Warning Strips are missing at some locations, such as Salmon Brook Drive and New London Turnpike (Figure 8).
- A cyclist was observed on House Street (Figure 9).

Figure 8: No Detectable Warning Strips

- 1. Detectable warning strips can be added to sidewalk ramps that are not presently ADA compliant. All ramps should be checked for compliance and upgraded, as necessary (Figure 15).
- 2. The catch basin on Salmon Brook Drive can be moved out of the driveway.
- 3. The crosswalk at Naubuc Green apartments can be extended into the apartment complex via a new sidewalk or painted protected area on the west side of the driveway.

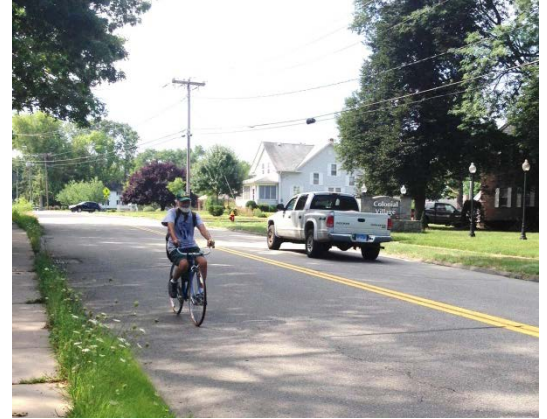
Figure 9: Bicyclist on Unstriped Road

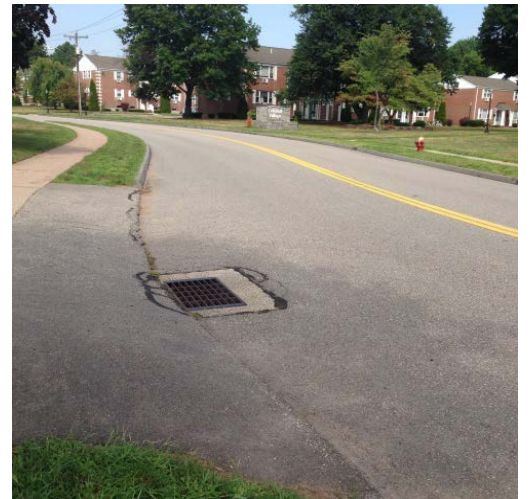
Figure 10: Catch Basin in the Driveway

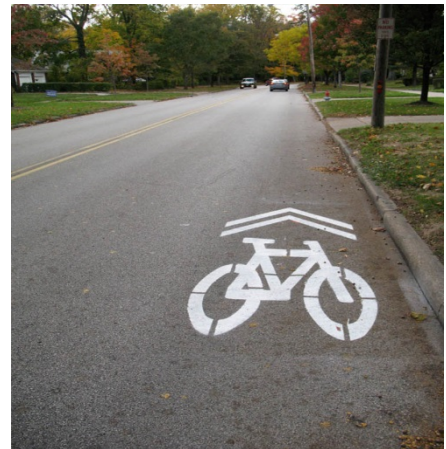
Figure 11: Sharrow Markings

1. Shoulders can be striped on Welles Street to maximize shoulder width. For the portion of Welles Street west of Main Street, the 32 foot roadway width can either be striped as sharrows, or 5 foot wide bike lanes can be striped next to 11 foot wide travel lanes. Where there is insufficient width to provide a striped bicycle lane, sharrow striping can be incorporated. Appropriate signing can be installed to support the bicycle facilities (Figure 11, Figure 12 and Figure 13).

2. Shoulders on New London Turnpike can be striped as bike lanes, or sharrow markings can be added to the through traffic lane. Appropriate signing can be installed to support the bicycle facilities (Figure 11, Figure 12 and Figure 13).

3. Salmon Brook Drive is not wide enough to provide separate bicycle lanes. Because of the relatively low traffic volume on this street, sharrows, with appropriate signing and pavement markings, should be considered (Figure 11 and Figure 12).

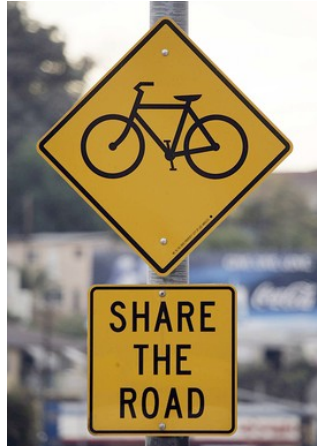
Figure 12: Share the Road Signage

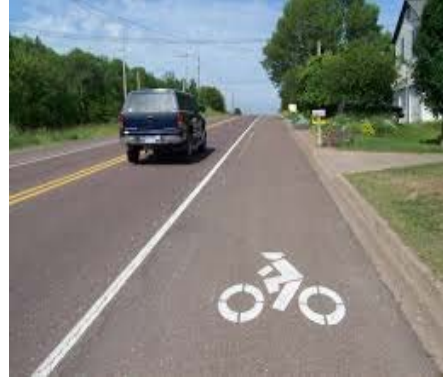
Figure 13: Bike Lane

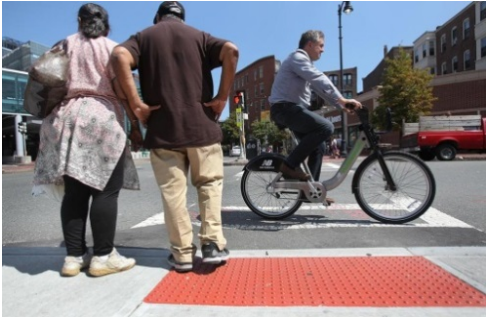
Figure 15: Pedestrian Detectable Warning Strips

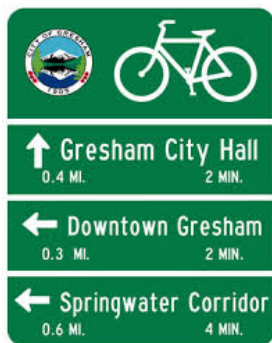
Figure 17: Bike Route Signage

1. The existing path through the Riverfront Community Center can be signed as the bicycle route from Naubuc Avenue, around the rear of the Center to Riverfront Park, turning easterly to the south side of Welles Street. Pedestrians can use the existing sidewalk on the west side of Welles Street from Naubuc Avenue to join the path at Riverfront Park (Figure 17).
2. A multi-use trail can be constructed along the edge of Riverfront Park on the south side of Welles Street.

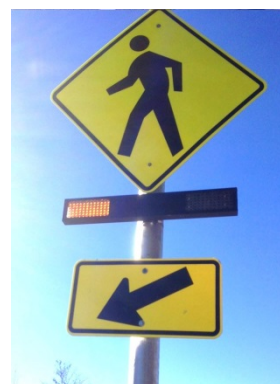
Figure 18: RRFB

4. A crossing for the bicycle traffic will be required. It can be installed at the existing crossing for the Naubuc Hills Apartments. Appropriate signing or Rectangular Rapid Flash Beacon (RRFB) should be utilized at this location (Figure 18).
