# Kent

Main Street (Route 7), Bridge Street and Maple Street  
(Route 341) and Maple Street Extension– Road Safety  
Audit

November 2, 2016

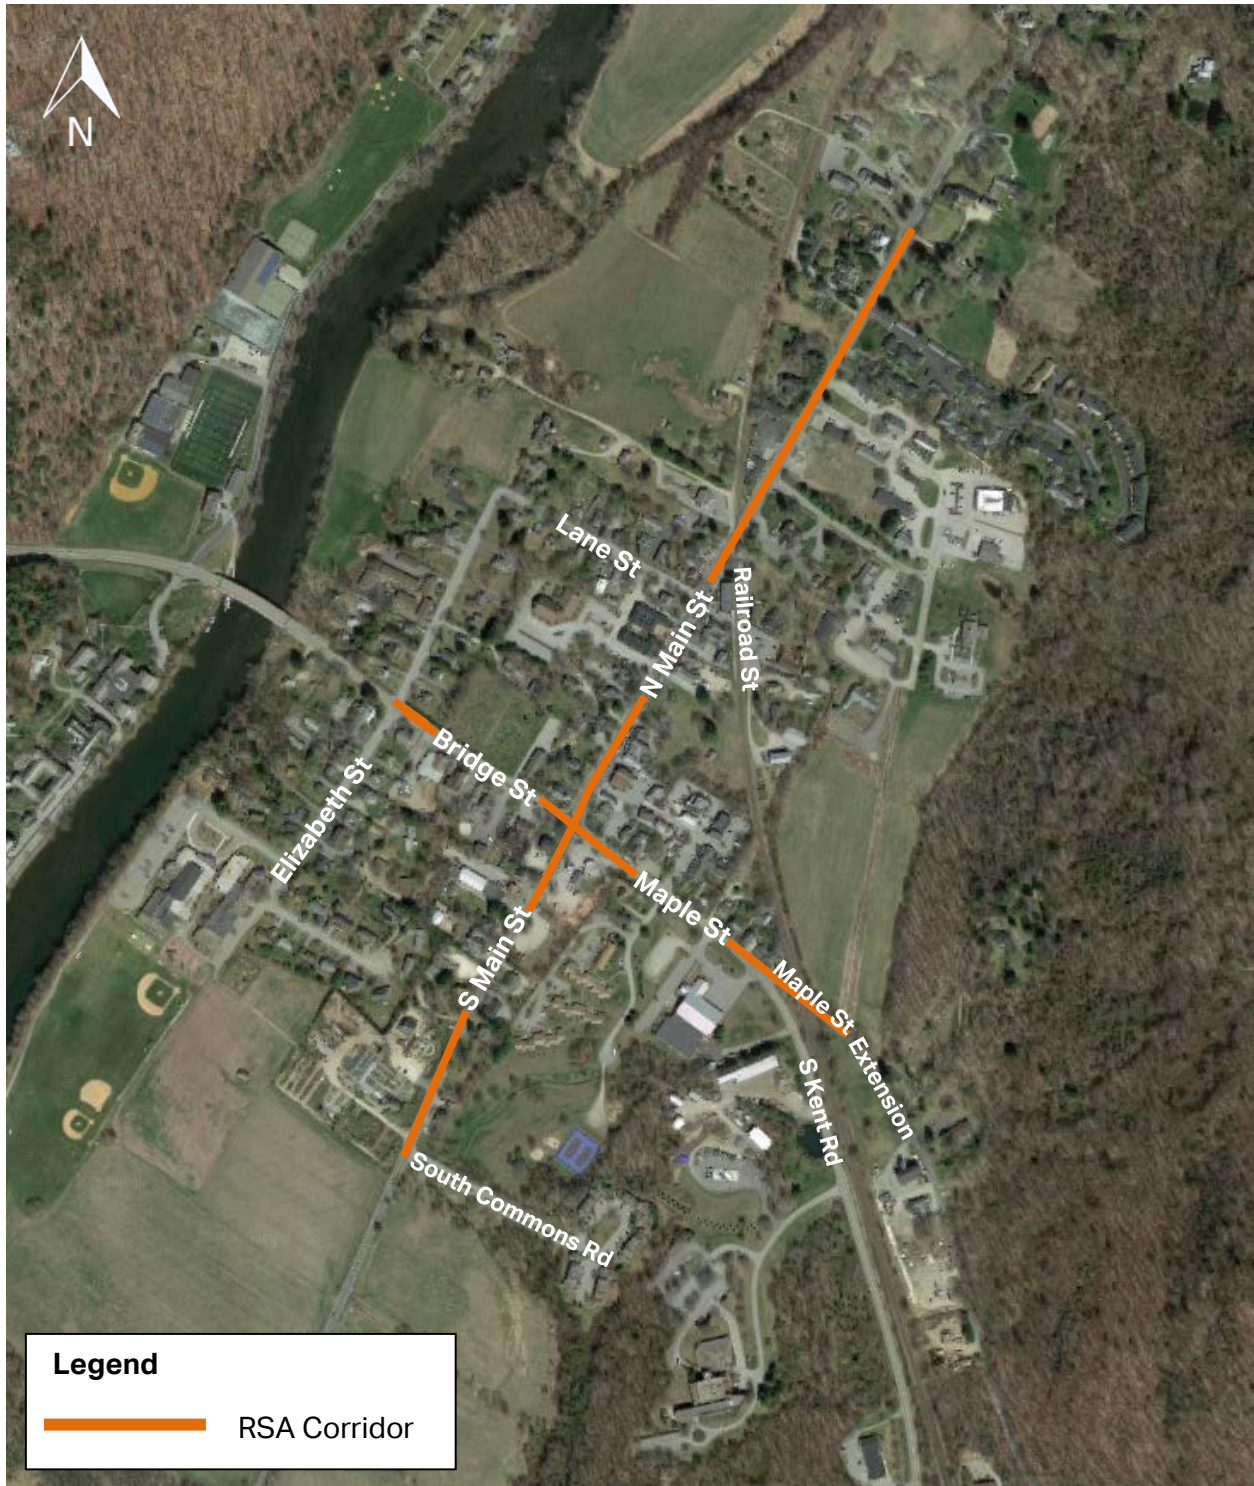
Figure 1. Main Street and Route 341, Kent

The RSA site includes the section of Main Street (Route 7) from South Commons Road to the First Congregational Church; Route 341 from Elizabeth Street to Maple Street Extension; and Maple Street Extension between Maple Street and the access to the field southwest of Town Hall (Figure 1). Route 7 is a U.S. Highway running in a north-south direction through Connecticut and connects to Massachusetts to the north. Route 341 is a state highway running in an east-west direction from the New York State Line to the Town of Washington, Connecticut. North Main Street and South Main Street are classified as Minor Arterials. The Average Daily Traffic (ADT) on North Main Street ranges from 5,500 to 5,800 vehicles per day (vpd) and on South Main Street the ADT is 4,300 vpd. The Average Daily Traffic (ADT) on Route 341 ranges from 3,800 to 4,000 vpd. There is one signalized intersection in the study area at Routes 7 and 341; the remaining intersections are stop controlled. Figure 2 shows the regional context of the study area.

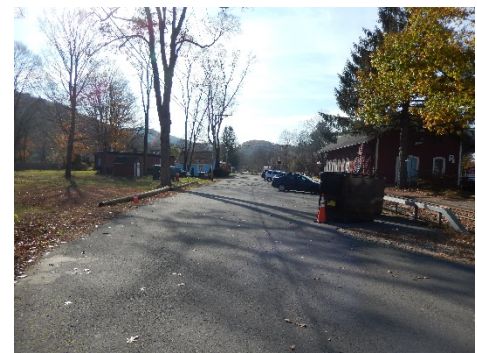
Figure 6: Future site of Welcome center

1. The Town will be constructing a Welcome Center on Railroad Street in the downtown, including off-street parking and restroom facilities (Figure 6).
2. The Town is discussing converting Library Street to one-way eastbound and Railroad Street to a one-way westbound, exiting onto Main Street. This is in the preliminary discussion phase. There may be sight line issues for vehicles exiting from Railroad Street and turning radius issues with trucks entering on Library Street.
3. The Town is discussing providing a new roadway between the Town Hall and Maple Street Extension (Figure 7).

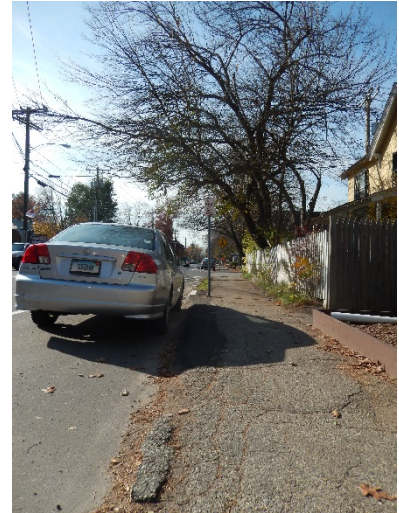
Figure 8: Main Street

- Issues in the downtown area include: crumbling sidewalks, poor lighting, limited sight distances at intersections, congestion, lack of sidewalk connectivity north of the railroad crossing, speeding, lack of wayfinding, limited parking lack of adequate striping, and non-functioning railroad gates (Figure 8).

1. Town to request CTDOT to work with the railroad to repair the railroad active warning device and gates on North Main Street and request evaluating the addition of pedestrian crosswalks and ADA elements as part of the current CTDOT project at this location.

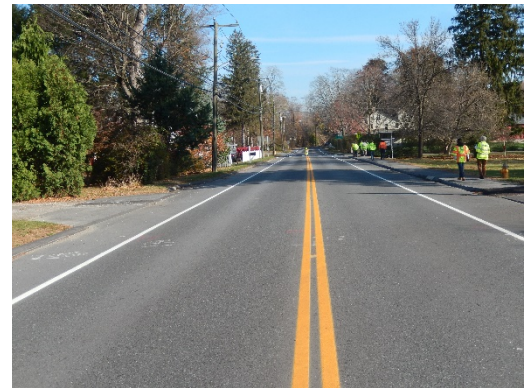
Figure 9: Route 7 north of center

- There is only one designated handicap parking space on Main Street in downtown.
- In 2015 Route 7 was repaved from center of town northbound and in 2016 the south section was repaved (Figure 9).

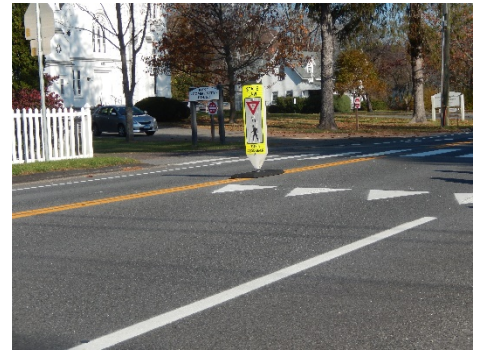
Figure 11: Crosswalk at Main Street and Congregational Church

- Road widths: 11-foot travel lanes in both directions, 5-foot shoulders.
- There is an unsignalized, mid-block crosswalk in good condition connecting to the Kent Community House on the west side. There are yield line (“shark teeth”) pavement markings on both approaches to the intersection (Figure 11).

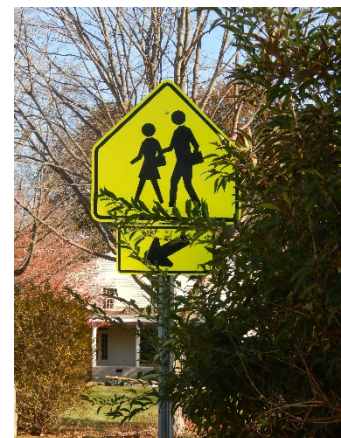
Figure 12: Pedestrian crossing sign

- The pedestrian crossing signs and advance signs are new. One is blocked by vegetation (Figure 12).
- Street lighting is provided on the west side. The street lights will be replaced with LED bulbs in 2017.

9. Town to trim vegetation in Right of Way that blocks signage. Locations include the crosswalk on North Main Street at the Kent Community House and the westbound advance pedestrian crossing ahead sign on Bridge Street (Route 341) approaching the crosswalk at Elizabeth Street.
10. The Town, in coordination with the CTDOT, should consider adding one-way pavement markings, and possibly additional signage to the Kent Green Boulevard one-way pair intersections at North Main Street. The existing signage is very low and not MUTCD

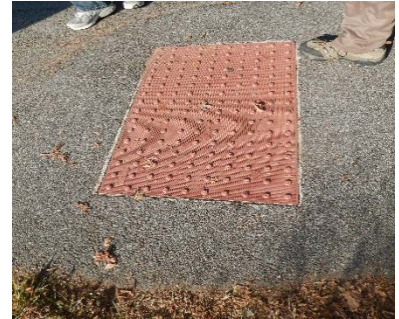
Figure 13: ADA compliant curb ramp

- Kent Green Boulevard (north) forms an unsignalized T-intersection with Main Street on the east side. It is a one-way exit-only driveway approaching Main Street. There is no stop sign or stop bar on the Kent Green Boulevard (north) approach.
- Kent Green Boulevard (south) forms an unsignalized T-intersection with Main Street on the east side. It is a one-way entrance-only driveway, departing Main Street. There is only one small, low entrance sign (not MUTCD compliant) and no pavement markings.
- There are handicap ramps and detectable warning strips at both driveways (Figure 13).
- Neither driveway has crosswalks.

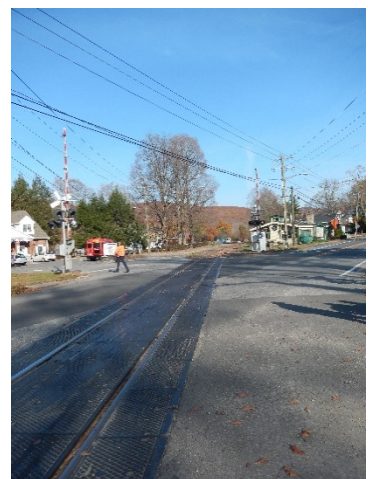
Figure 15: Main Street and at-grade railroad crossing

- The railroad tracks cross Main Street diagonally as a skewed four-way intersection with Johnson Road on the west and Railroad Street on the east (see Figure 15).

- There are flashing red beacons, drop gates and stop bars at all four intersection approaches. Town staff indicated that the beacons are operational, but that the gates do not always drop down.
- There are no crosswalks, handicap ramps or gates for pedestrians.
- There is a wide curb cut north of the railroad tracks for Webster Bank.
- South of this intersection, Main Street has 9-foot wide shoulders (for on-street parking), an 11-foot northbound lane and a 15-foot southbound lane.
- Sidewalks are between 5 and 5.5 feet wide on both sides south of the tracks. The sidewalk is generally in fair condition. The curbing is poor, with little reveal.
- The active warning gates are broken, the flashing light warning system works.
- There are two to three trains daily.

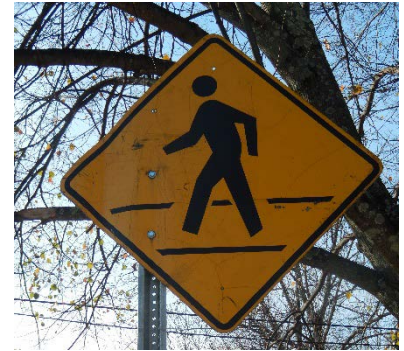
**Figure 16: Outdated pedestrian crossing sign**

- There is a long angled crosswalk on Main Street south of Library Street.
- There are no handicap ramps.
- There is an outdated pedestrian crossing sign for southbound Main Street (Figure 16).
- A pedestrian bollard is placed on Main Street.
- There are de-facto handicap ramps at Library and Lane Street, but no detectable warning strips.
- Catch basins are full of leaves.
- There is a section with pavers on west side in front of the retail shop.
- There is one designated handicapped parking space on Main Street.
- The sidewalk in this area is generally in fair condition on both sides with some poor sections.

- g. Route 341 (Bridge Street) and Elizabeth Street.
  - h. Town to coordinate with the CTDOT to replace outdated pedestrian crossing signs along the North Main Street corridor and install new standard retro-reflective MUTCD compliant signage, disaggregate signs on poles, and raise sign height as needed. Locations include at Library Street/Lane Street and at the Golden Falcon lot.

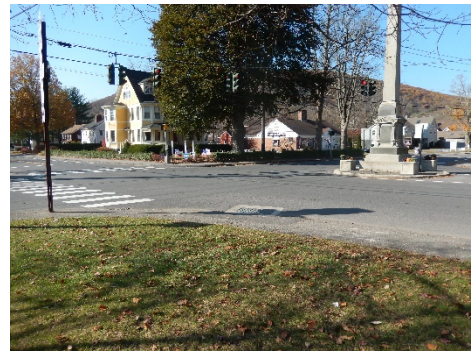
Figure 17: Route 341 and Route 7

- This is a four-way signal controlled intersection with an exclusive pedestrian phase.
- The southbound Main Street approach has two lanes, one for right turns and one shared through-left turn. These two lanes are separated by the memorial monument (Figure 17).

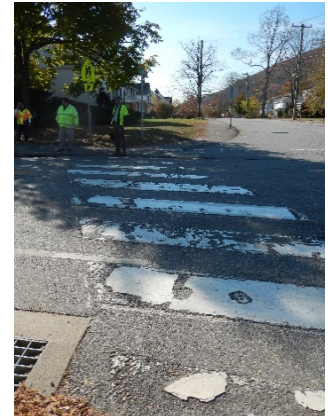
Figure 18: Crosswalk at Route 341 and Elizabeth Street

- This is a four-way, unsignalized intersection, with the Elizabeth Street approach under stop sign control.
- There is a faded thermo-plastic crosswalk on the Bridge Street east leg (Figure 18).
- There are de-facto handicap ramps, but no detectable warning strips.
- The pedestrian crossing and advance signs are new.
- Kent Center School is located off of Elizabeth Street to the south. Stakeholders stated that there was a crossing guard assigned to assist students at arrival and dismissal times. A pedestrian bollard has been used in the past at this location.

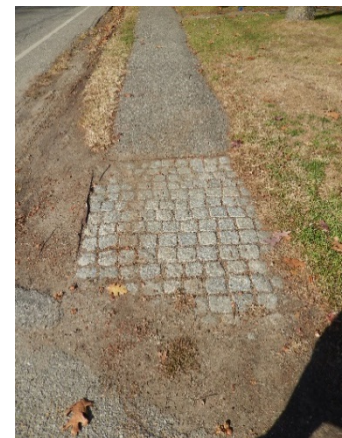
Figure 19: Sidewalk along Route 341

- There are sidewalks on both sides of Maple Street that are four feet wide. The sidewalk on the north side is in poor condition (Figure 19).
- There are snow shelves on both sides. The snow shelf on the north side is rutted.
- There is minimal to no curb reveal.
- 35 MPH is the posted speed limit.
- Lighting is provided on south side of road.

6. Town to coordinate with CTDOT to improve the condition of sidewalks along Route 34.
  7. Town to provide bike racks in the downtown area. The Town may want to consider coordinating with local businesses to provide funding.

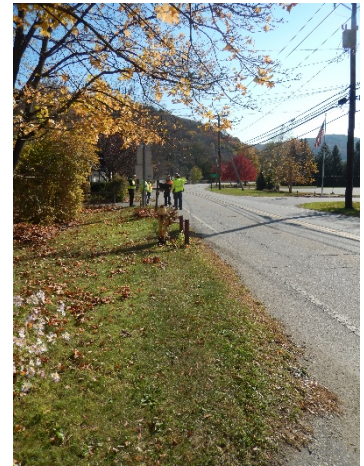
Figure 20: Route 341 approaching senior housing facility

- There is no crosswalk on Maple Street.
- The Templeton Farms senior housing complex is located on Swifts Lane. Many residents cross Maple Street here to avoid the driveways at the Patco Gas Station.
- High speeds for westbound traffic on Maple Street and limited sight distance are a concern (Figure 20).

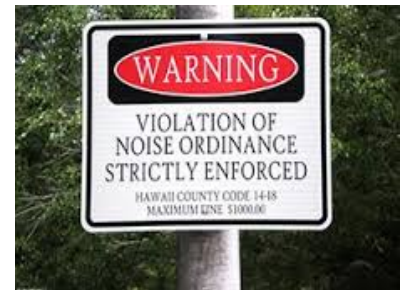
Figure 22: Sample noise ordinance sign

- The Town has requested the CTDOT install signs to slow down and quiet motorcycles. There is no town noise ordinance. Stakeholders commented that motorcyclists cause a lot of clamor in the summer. The Town could pass a noise ordinance and install a “Violation of Noise Ordinance Strictly Enforced” sign.
- Emergency services have an issue with the congestion on weekends, which affects the ability of emergency vehicles to access sites.
- The Town will construct a new Welcome Center with rest rooms on Railroad Street near the railroad station. Approximately 15 new parking spaces will be created.

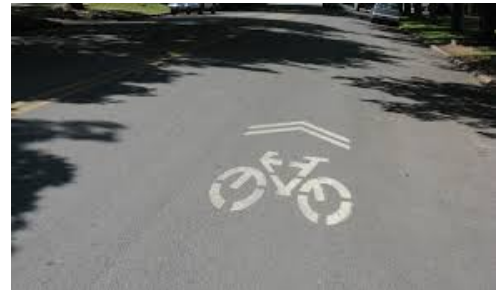
Figure 25: Sharrows

4. Town to coordinate with CTDOT to consider installing sharrows on Main Street in the downtown area (Figure 25).
5. Town to coordinate CTDOT in conjunction with the Streetscape Plan for Main Street to evaluate the number and location of crosswalks in the downtown area. Locations for crosswalks include:

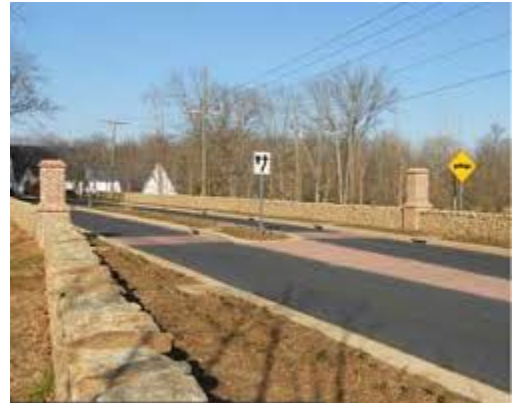
Figure 27: Sample of town gateway

- a. Identification and concept of Gateways for motorists approaching the downtown on Route 7. The gateways would make motorists aware they are approaching an area with slower speeds and pedestrian and bicycle activity. Gateways would include signage, pavement markings and often consist of monument type signage with architectural/historic features that are consistent with the town character. A potential gateway location to the north would be north of the First Congregational Church.
- b. A wayfinding signage program should be developed to direct visitors both in the downtown area and other nearby attractions (state parks, museums, etc.). The wayfinding signage should use a consistent logo, such as the PASSPORT TO KENT CONNECTICUT logo developed by the Kent Chamber of Commerce.

1. Town to coordinate with CTDOT to construct the Streetscape Plan for the Main Street corridor to improve pedestrian connectivity and slow and calm traffic. Elements will include consistent widths of travel and parking lanes; driveway access management; new asphalt sidewalk and granite curbing; curb extensions and flashing beacons at select crosswalk locations; ADA facilities; lighting and landscape features; wayfinding, and gateway locations (Figure 27).

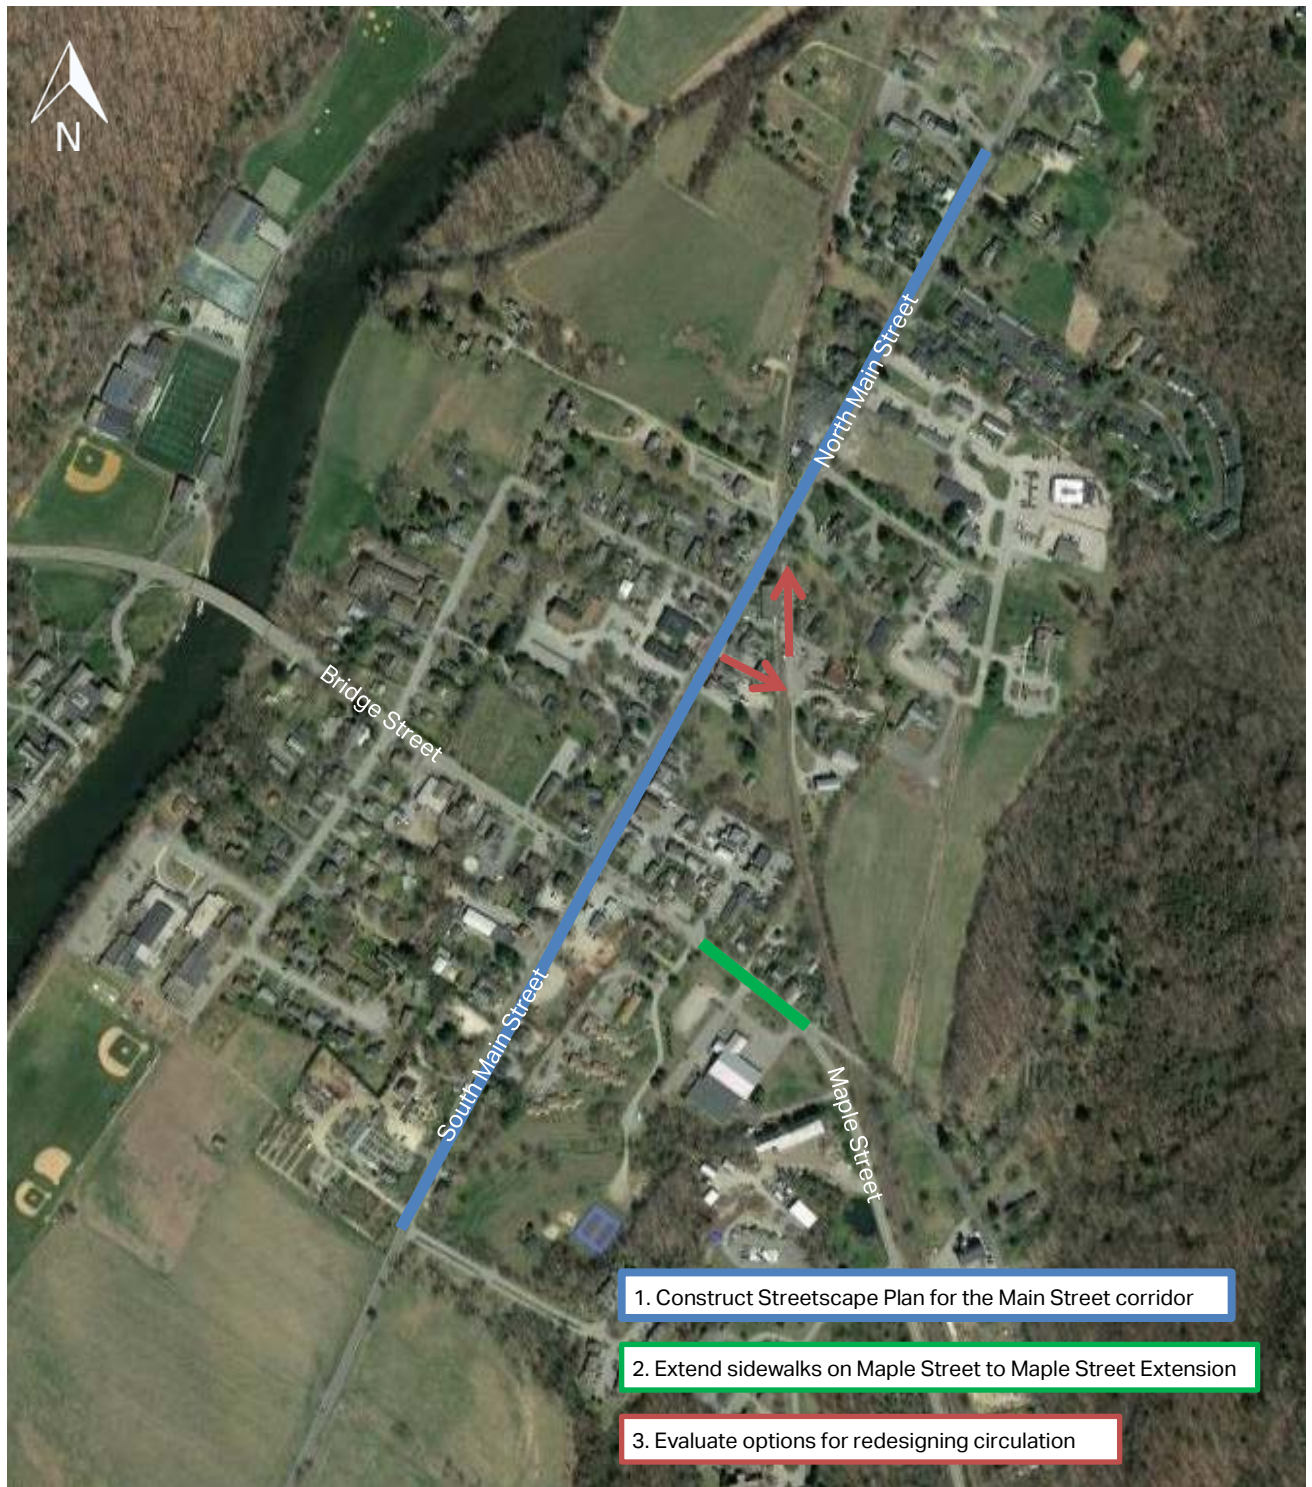
Figure 28: Long-Term Recommendations

Figure 28 depicts these recommendations.

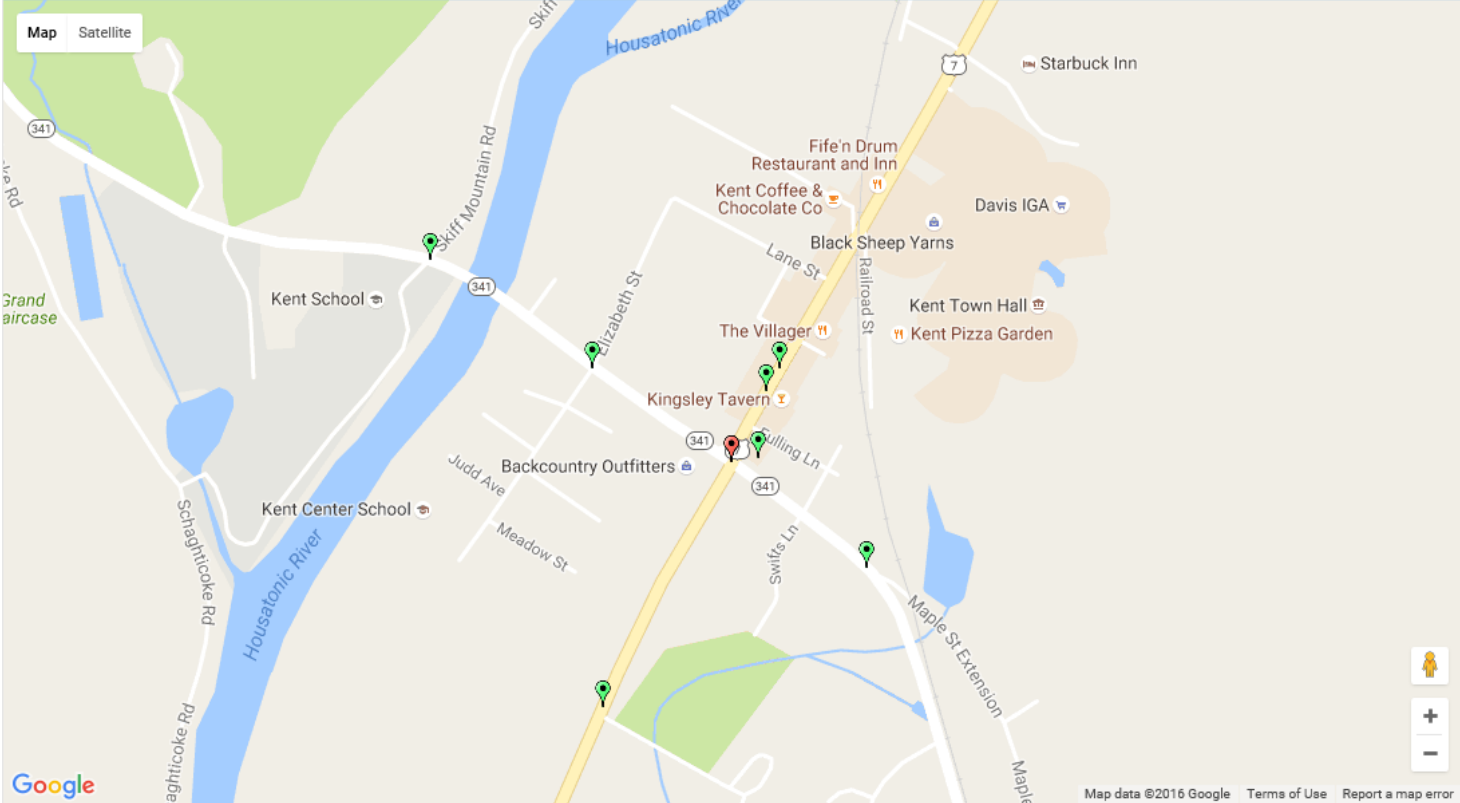
# 2015 Crashes

Figure 3 displays crashes that occurred in this area during 2015. As shown in the figure, crashes are evenly distributed in the study area with four clustered along North Main Street near the intersection with Route 341. All the crashes during 2015 resulted in property damage only except for one, which resulted in injury.

Search Criteria:	
Dataset:	mmucc
Towns:	Kent
Crash Severity:	Injury of any type (Serious, Minor, Possible), Fatal (Kill), Property Damage Only
Case Status:	Complete
