LITCHFIELD

ROAD SAFETY AUDIT

LITCHFIELD ROAD SAFETY AUDIT

Findings and Recommendations Report

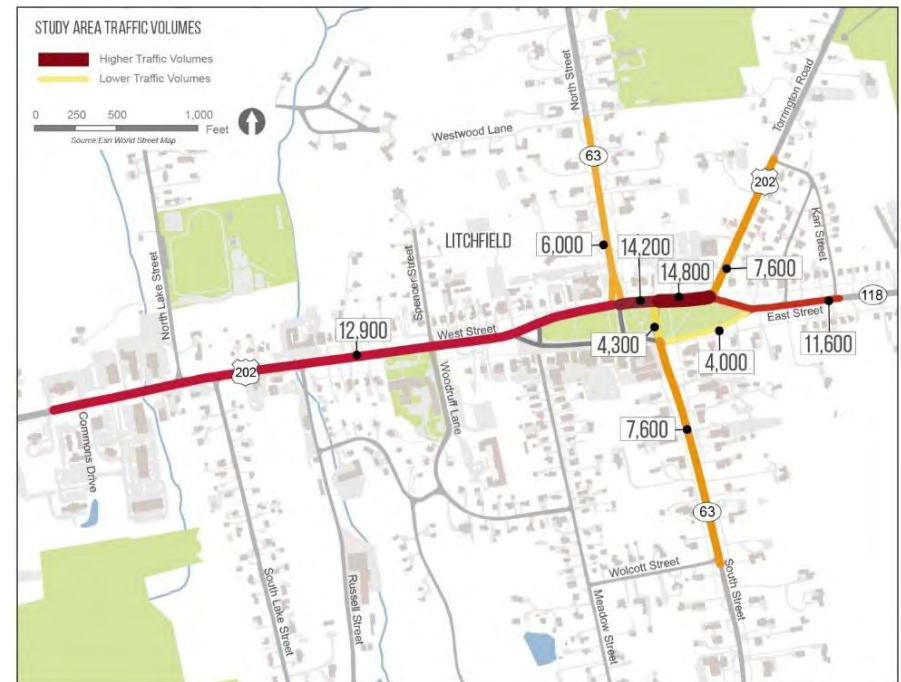
Figure 4: Average Daily Traffic Volumes

Average Daily Traffic (ADT) in the study area ranges between 14,800 vehicles per day in the middle of the study area (West Street (Route 202) between South Street (Route 63) and Torrington Road (Route 202)) to 4,000 vehicles per day on East Street (Main Street) east of South Street (Route 63). See Figure 4. The study area has single lanes in each direction except for segments of West Street (Route 202) between Commons Drive and North Lake Street, and West Street (Route 202) eastbound between North Lake Street and Woodruff Lane where two lanes are present.

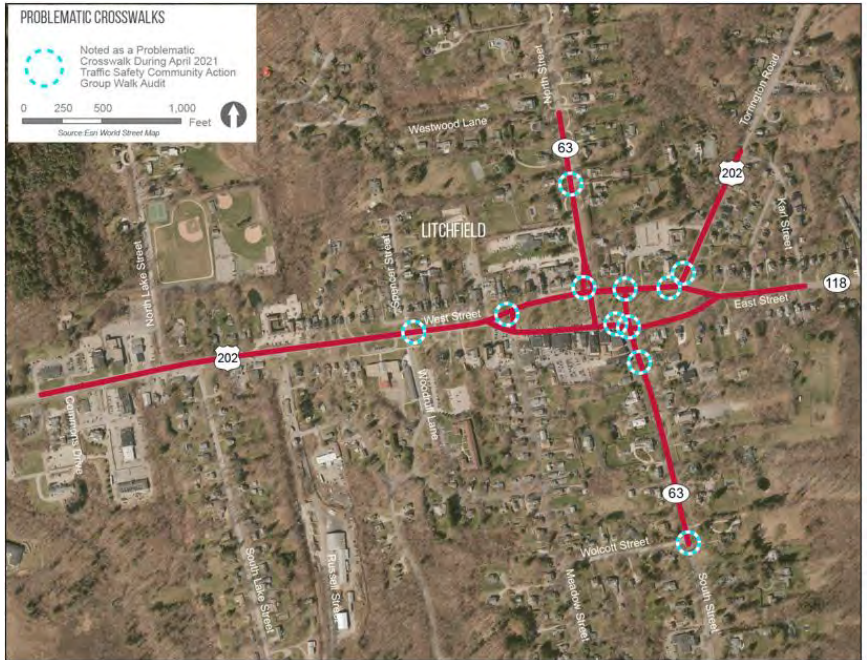
Figure 5: Crosswalks Identified by the Litchfield Traffic Safety Community Action Group as Problematic

Additionally, crosswalks which were identified by the group as challenging to cross due to vehicles failing to yield or those that posed potential safety concerns were identified in the Action Group’s report as problematic. These include most of the crosswalks located throughout the Town Green area and the downtown commercial center. See Figure 5.

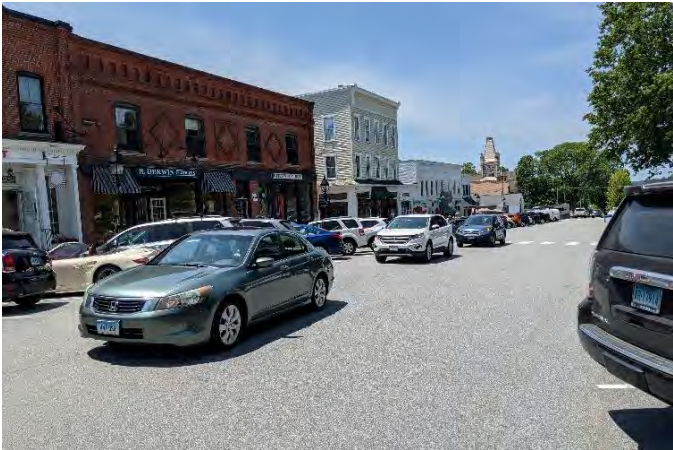
Figure 12: West Street (Main Street)

- Difficult to see pedestrians crossing due to on-street parking
- Vehicles often speed and use the street as a cut through to avoid Route 202 signals.
- Recent work installed granite curbing and improved crossings in area
- Utilities and fiber optic located in roadway adjacent to sidewalks

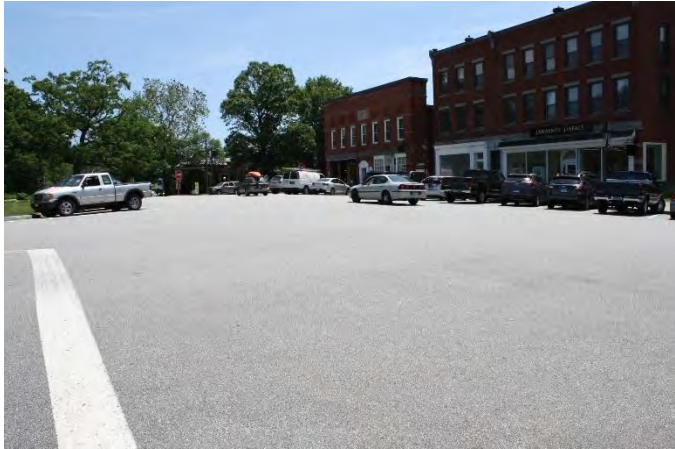
Figure 16: Intersection of West Street (Main Street) and North Street Extension

- Long crossing distances for pedestrians with an approximate 60-foot crossing
- Mid-block crossing on North Street Extension separated from other crosswalks
- Wide unmarked roadway with lack of shoulder and pavement markings
- Westbound traffic does not have stop-control
- Sightline concerns between southbound approach and westbound traffic
- Often used as cut through route for South Street (Route 63) roadway traffic, especially truck traffic which is unable to complete the turn at the intersection of East Street (Route 202) and South Street (Route 63) due to a traffic island.

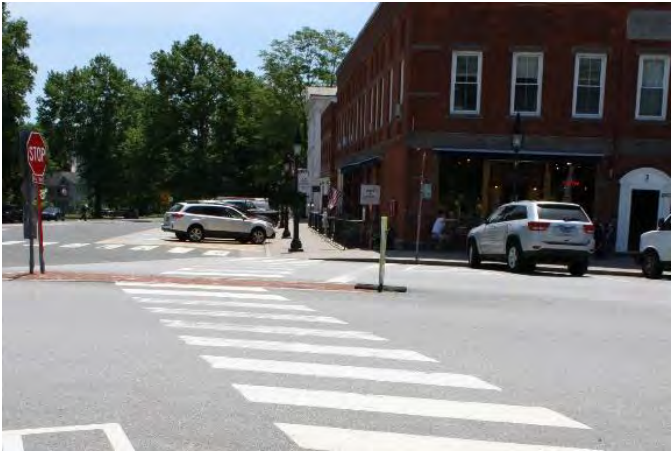
Figure 17: West Street (Main Street) at South Street (Route 63)

- Through traffic observed stuck behind left-turning traffic for many cycles due to on-coming traffic
- Vehicles frequently by-pass queued traffic in the southbound approach by using the shoulder. This leads to conflict between right-turning traffic waiting in the travel lane.
- Pedestrians frequently do not wait for pedestrian signal at the intersection.
- The left-turns for the North Street southbound approach and North Street Extension northbound approach interlock due to the wide median on the southbound approach.

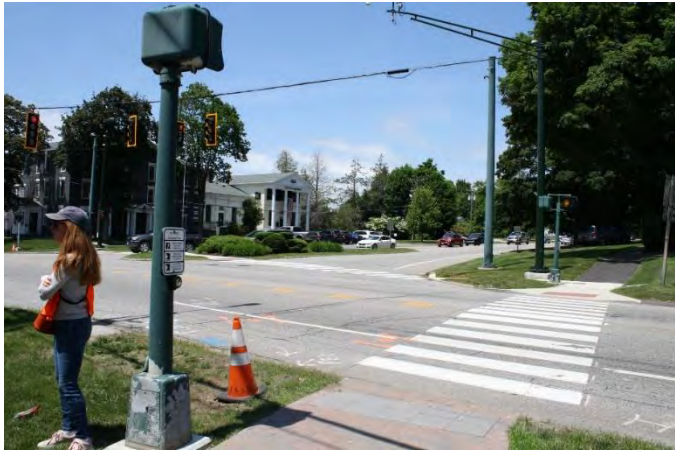
Figure 18: Intersection of West Street (Route 202) and North Street (Route 63)

- Intersection leads to much of the delays and queues in the study area.
- Left-turns from Route 202 do not perform efficiently because they are shared lane with through traffic.

- 8) Conduct further traffic study of intersections of Route 202 at North Street (Route 63), South Street (Route 63) and Route 118 to evaluate long-term options. Include potential impacts on nearby local roadways and cut-through traffic. Options may include but not limited to:
 - a) Traffic signal relocation
 - b) Roundabout at Route 202 and North Street (Route 63)
 - c) Realignment of Route 202 at Route 118
 - d) Closure of North Street Extension
 - e) Access restrictions on South Street (Route 63) (e.g. right in/out only)
- 9) Remove mid-block crosswalk on North Street Extension following upgrade and addition of crosswalks at West Street (Route 202) and North Street (Route 63) based on further study of this intersection.

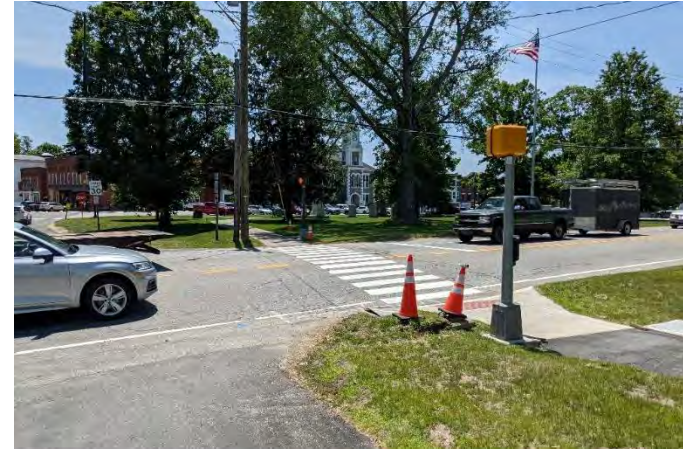
Figure 20: Crosswalk on West Street (Route 202) west of South Street (Route 63)

- Crosswalk on western side of the intersection is a concern for pedestrians. Drivers frequently roll through the stop-signs in this intersection and pedestrians report it sometimes is difficult for motorists to yield at crosswalks.
- Difficult crossings for pedestrians.
- Long crossings for pedestrians.

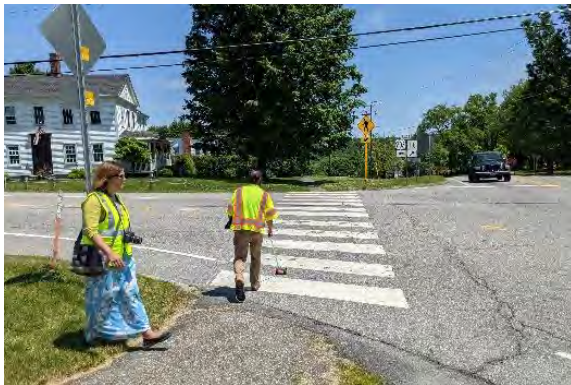
Figure 21: Crosswalk across Torrington Road (Route 202) at East Street (Route 118)

- Stop-control movement from East Street (Route 118) to East Street (Route 202) is difficult for motorists to make due to sightline concerns and traffic volumes. Frequently vehicle queues on East Street (Route 202) also cause sightline concerns for all motorists approaching this intersection.
- Many westbound vehicles from East Street (Route 118) were observed by-passing the intersection via East Street (Main Street).
- Westbound queues on East Street (Route 202) frequently extend from the intersection of South Street (Route 63) past this intersection.
- Historic properties and Church adjacent to roadway.
- Crosswalk locations have poor sight-lines.
- Drainage issues for the Litchfield Green near intersection was noted
- Drivers in the southbound direction occasionally fail to navigate the curve at this intersection, especially at night.

- 7) Replace existing yellow one-direction large arrow (ODLA) with fluorescent yellow ODLA (right) at the intersection of Torrington Road (Route 202) and East Street (Route 118) to increase its night-time conspicuity.

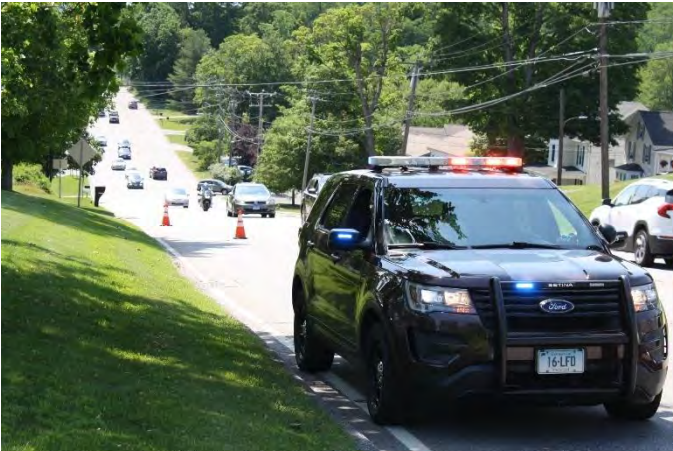
- Some speeds in the eastbound direction were observed by Litchfield Police during the RSA to be up to 45 MPH (in a 25 MPH school zone)
- There are locations with limited bike facilities, especially in the eastbound direction where there is no shoulder.

Figure 22: Police block right-lane on West Street (Route 202) west of Woodruff lane during school release hours to reduce traffic speeds

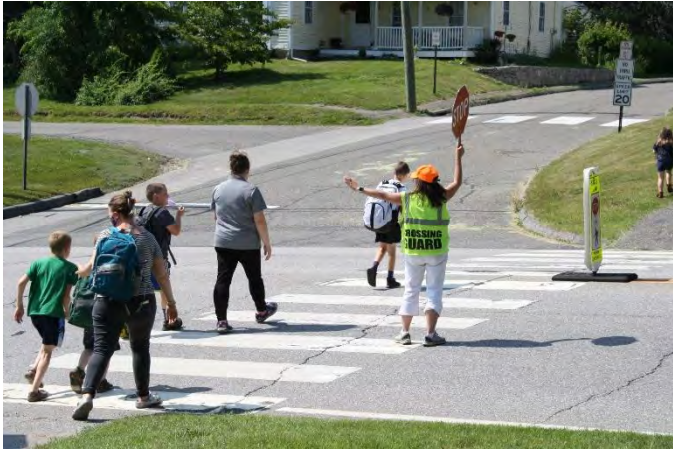
Figure 23: Crossing guard at the crosswalk across West Street (Route 202) at Woodruff Lane

- School traffic pattern converts Woodruff Lane to northbound only (except buses) and reduces a lane in the eastbound direction on West Street (Route 202.)
- The location has experienced three cyclist and pedestrian crashes in the five-year history.
- Drivers are very unwilling to stop for pedestrians at this location. Crossing guard noted difficulty in stopping vehicles for children crossing street to and from Litchfield Center School.
- Wide eastbound travel lane and wide westbound shoulder causes vehicles behind vehicles waiting for pedestrians to attempt to pass using shoulder.
- During school hours, the eastbound merging movement works well west of Woodruff Lane. However, vehicles were observed forming two lanes to the east of Woodruff Lane after the merge.

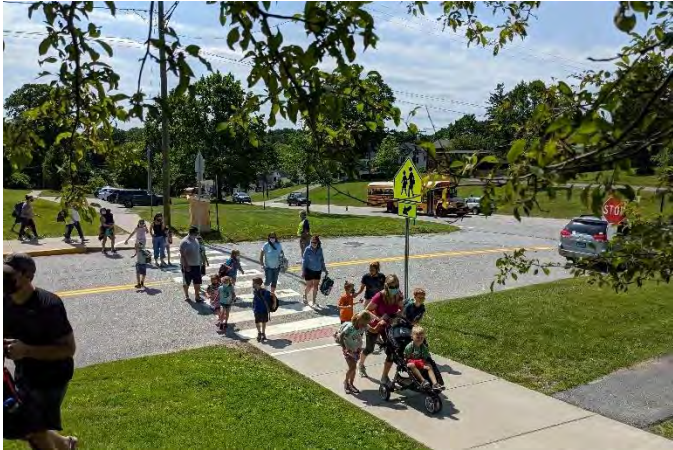
Figure 24: School children from the Litchfield Center School crossing Woodruff Lane during release hours

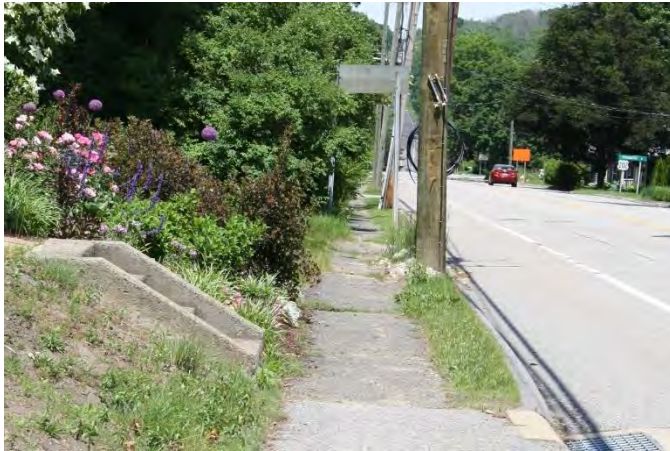
- The sidewalk to the east side of Torrington Road is in very poor condition and of narrow width.

Figure 25: Sidewalk conditions on Torrington Road (Route 202) north of East Street (Route 118)

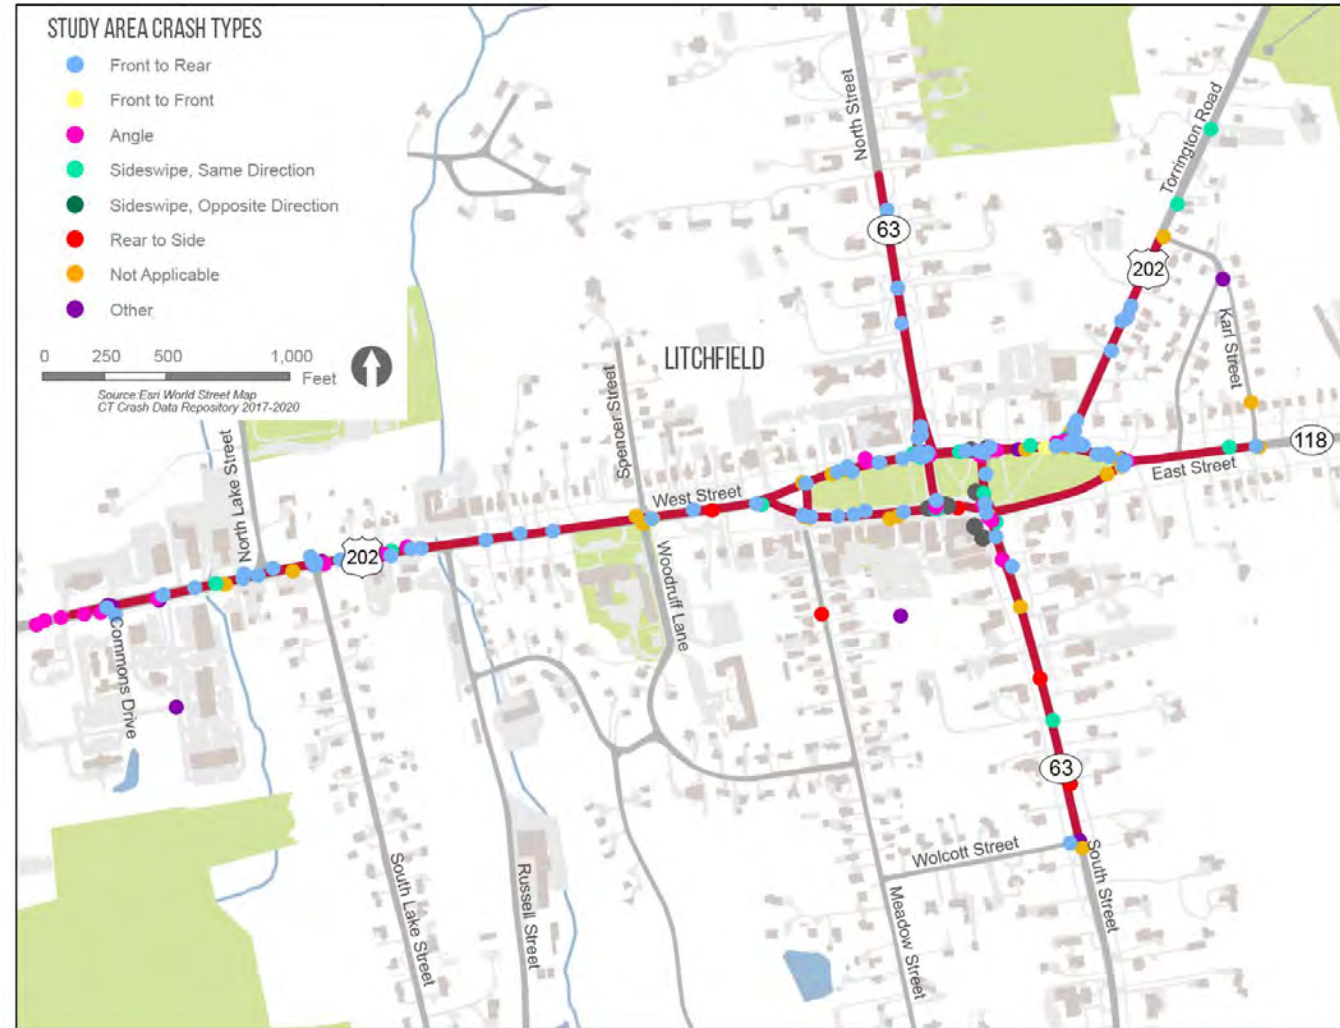
Crashes by Type

- Majority of Crashes are Front to Rear (Rear End) Crashes that are typical of an area with many intersections and curb cuts, driveways, etc.

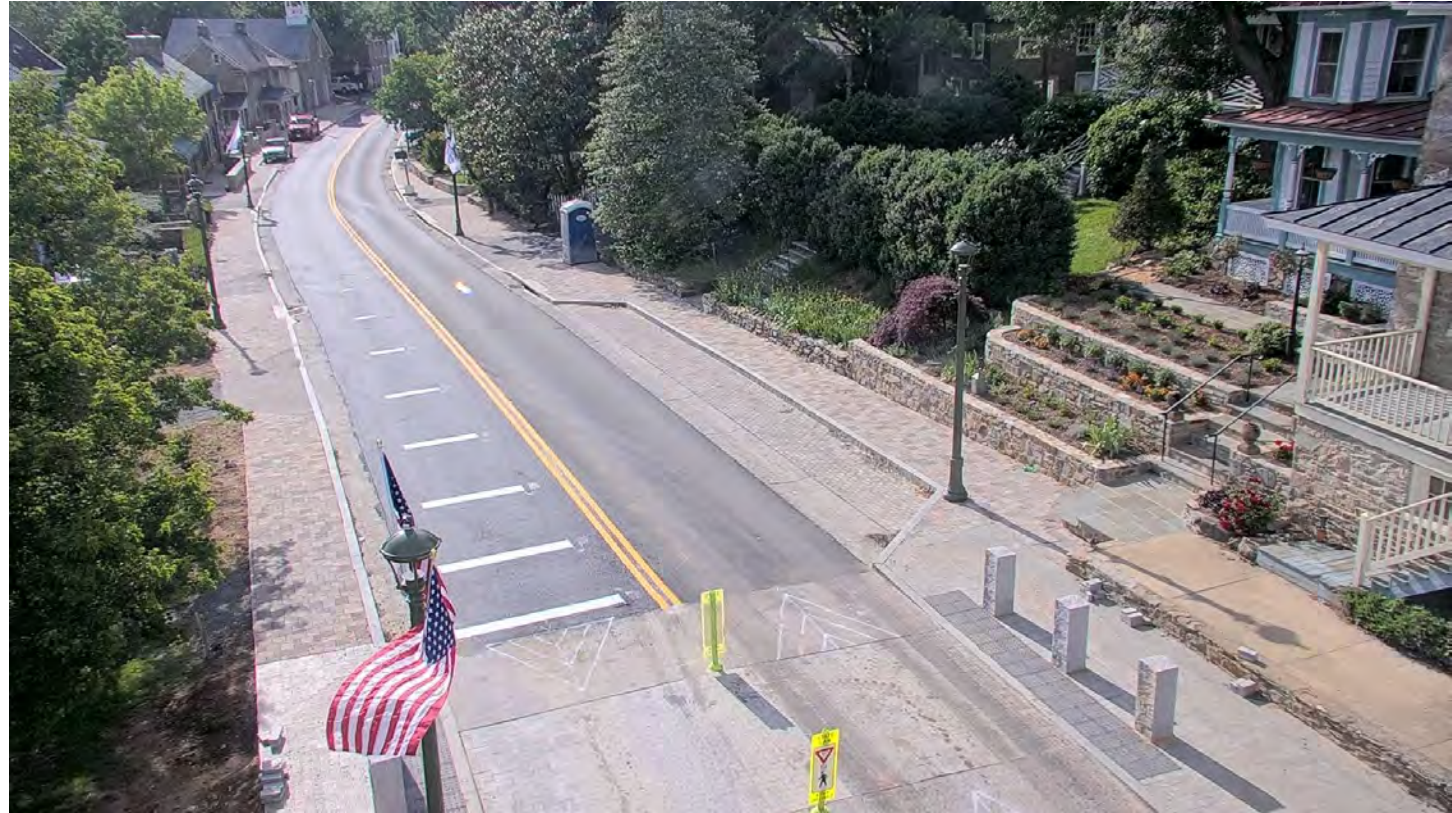
RAISED CROSSWALKS

- Improves pedestrian safety by causing motorist speeds to decrease at the crossing.
- Typically between 3 and 6 inches above street level. It is common for a raised crosswalk to be level with the street curb.
 - Height increases the visibility of a pedestrian in a crosswalk to a motorist.

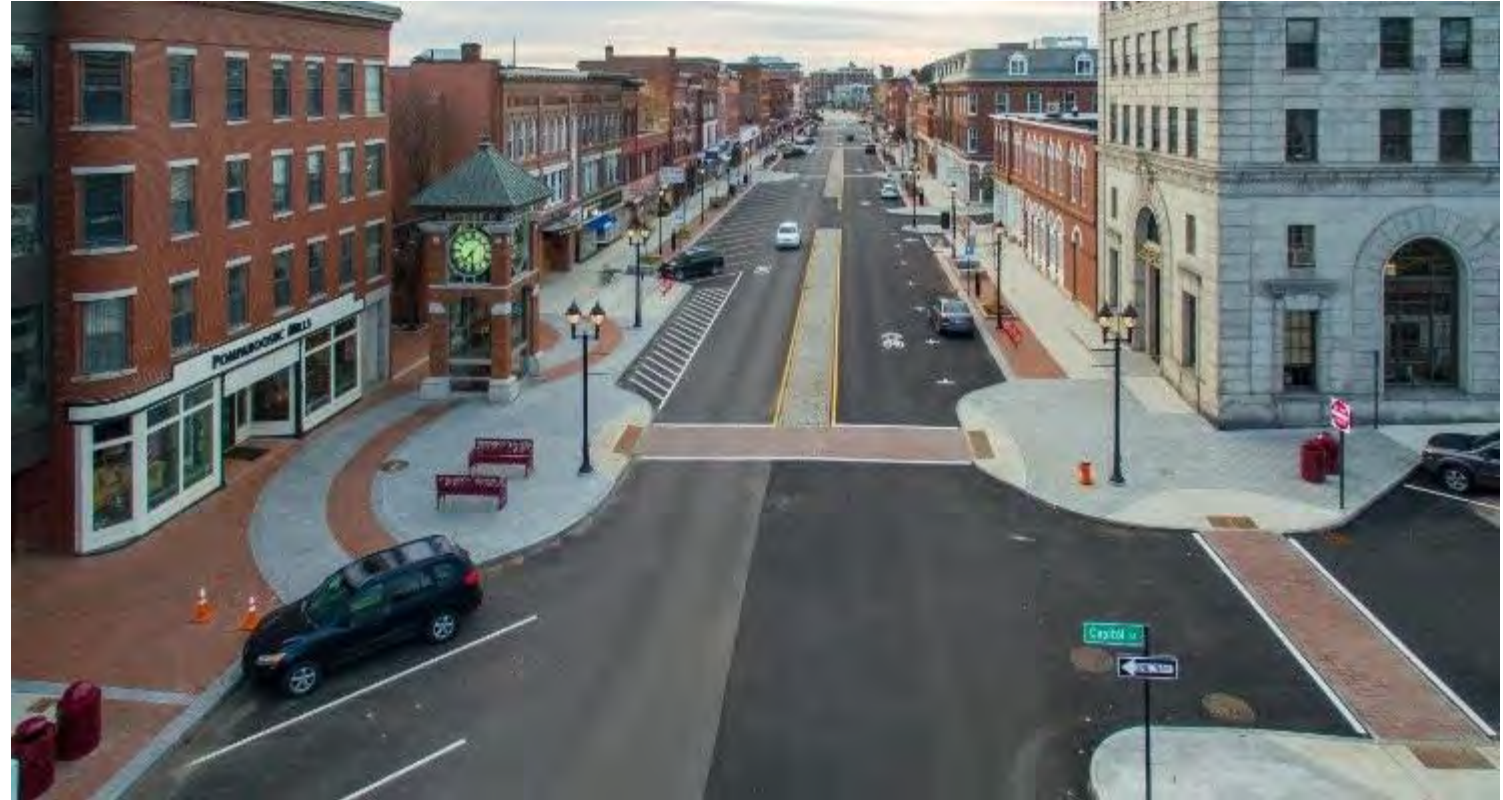
CORNER EXTENSION/BULBOUT

- A curb extension is a horizontal extension of the sidewalk into the street resulting in a narrower roadway and a shorter crosswalks.
- Slows automobile turning speeds, shortens pedestrian crossing distance, and increases pedestrian visibility

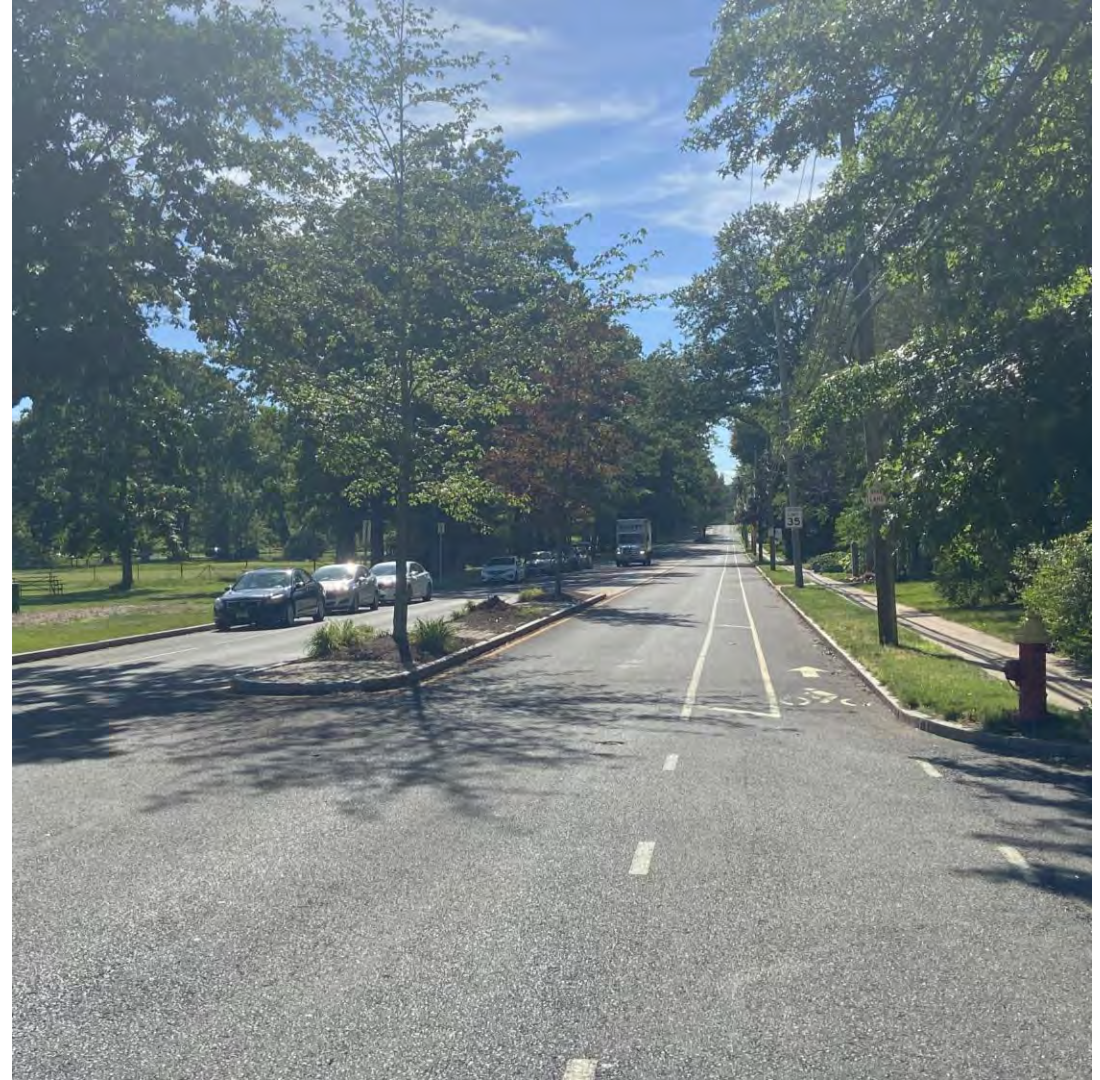
MEDIAN ISLAND

- Raised island located along a street centerline.
- Narrows the travel lanes at that location
 - Visual appearance of narrowed lanes encourages a motorist to slow.

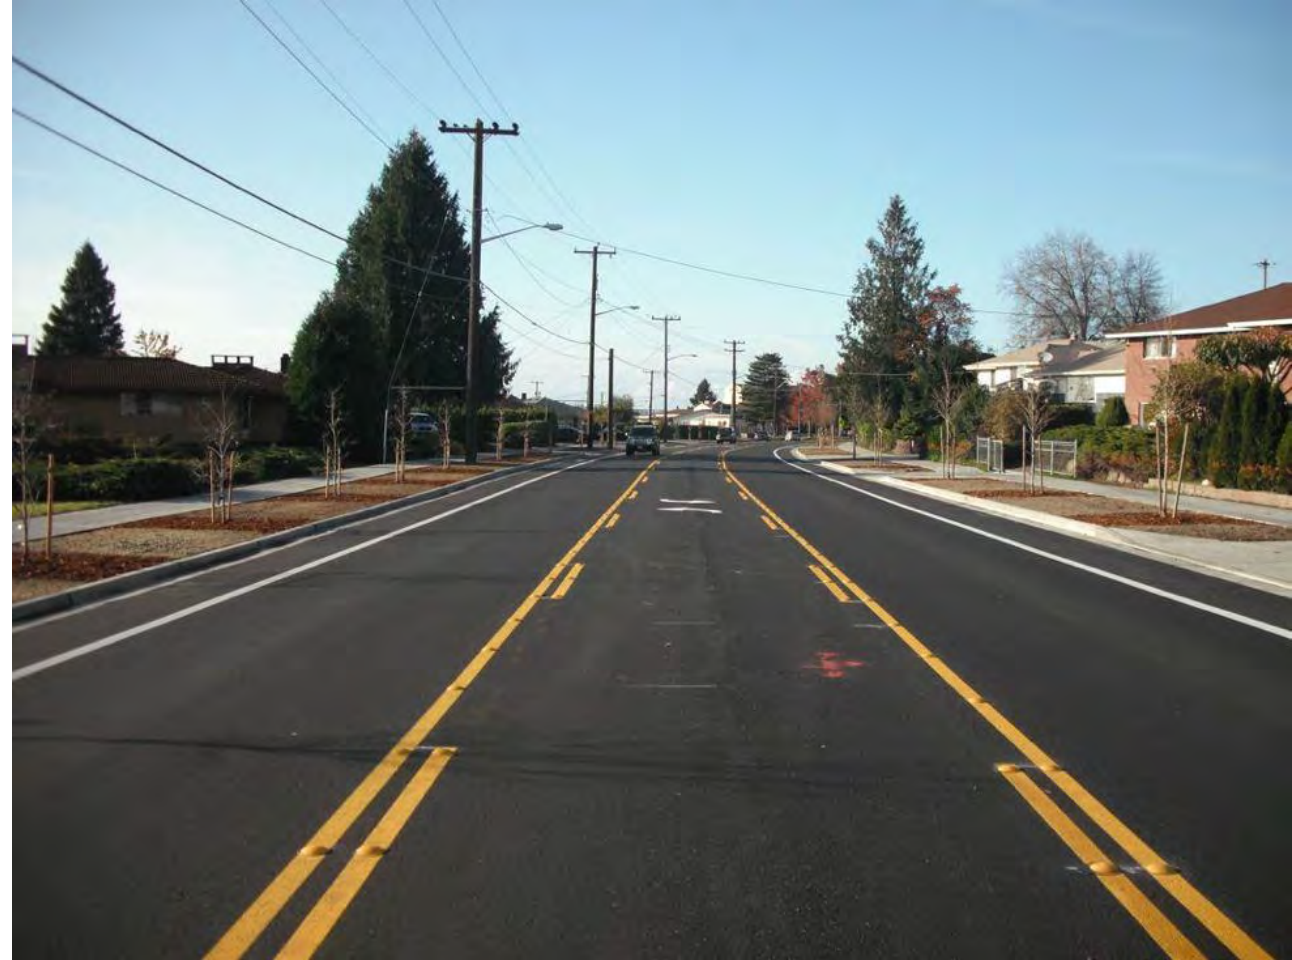
ROAD DIET - TWO WAY LEFT TURN LANE

- A road diet reduces the number of lanes on a roadway
- Commonly, a road diet provides dedicated space for left turns where only shared left/through lanes previously existed
- A road diet can be implemented using a two-way left-turn lane or alternating left-turn lanes
- Increases a road's efficiency by channeling turning vehicles out of the through lanes.
- A road diet can *improve* traffic flow and reduce conflicts with turning vehicles

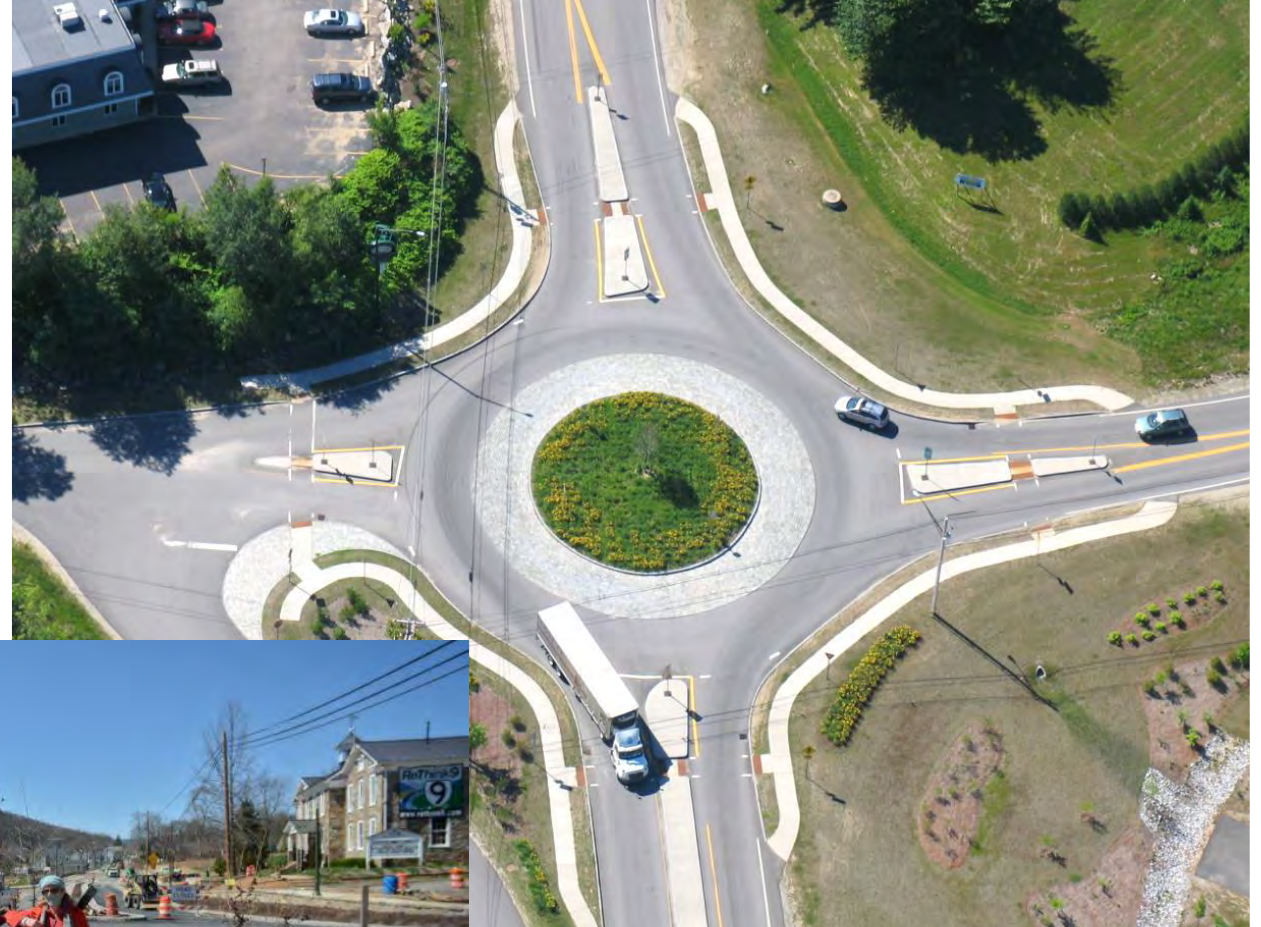
ROUNDAABOUT

- Slows traffic by requiring horizontal deflection for entering vehicles
- Modern roundabout requires entering vehicles to yield to circulating traffic
- Roundabout provides opportunity for greenspace or gateway signage
- Roundabouts reduce vehicles speeding to make green lights etc.

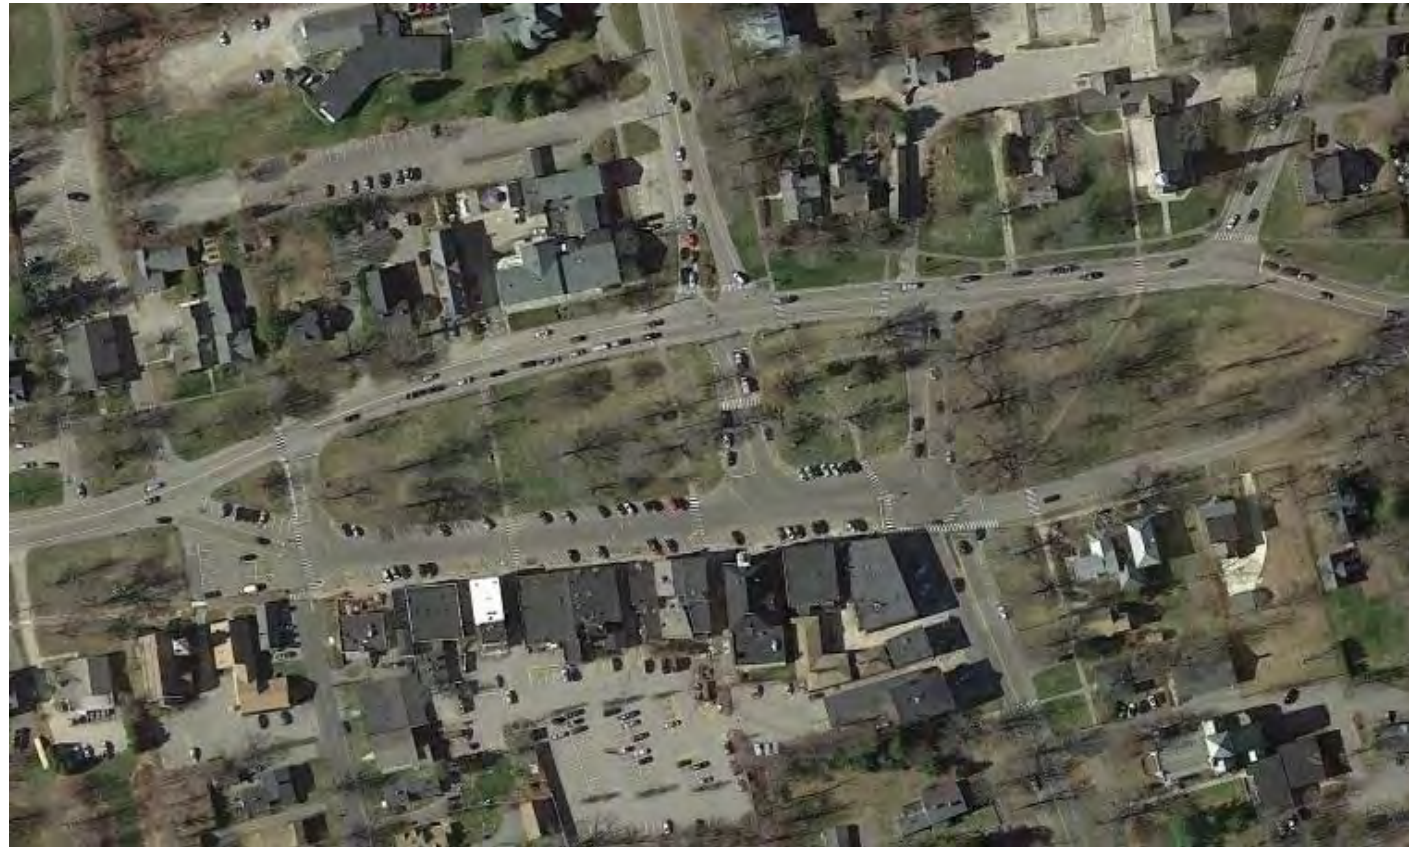
ONE-WAY RESTRICTIONS

- One-way restrictions could result in less curb width required when parking is provided
- Note West Street near businesses

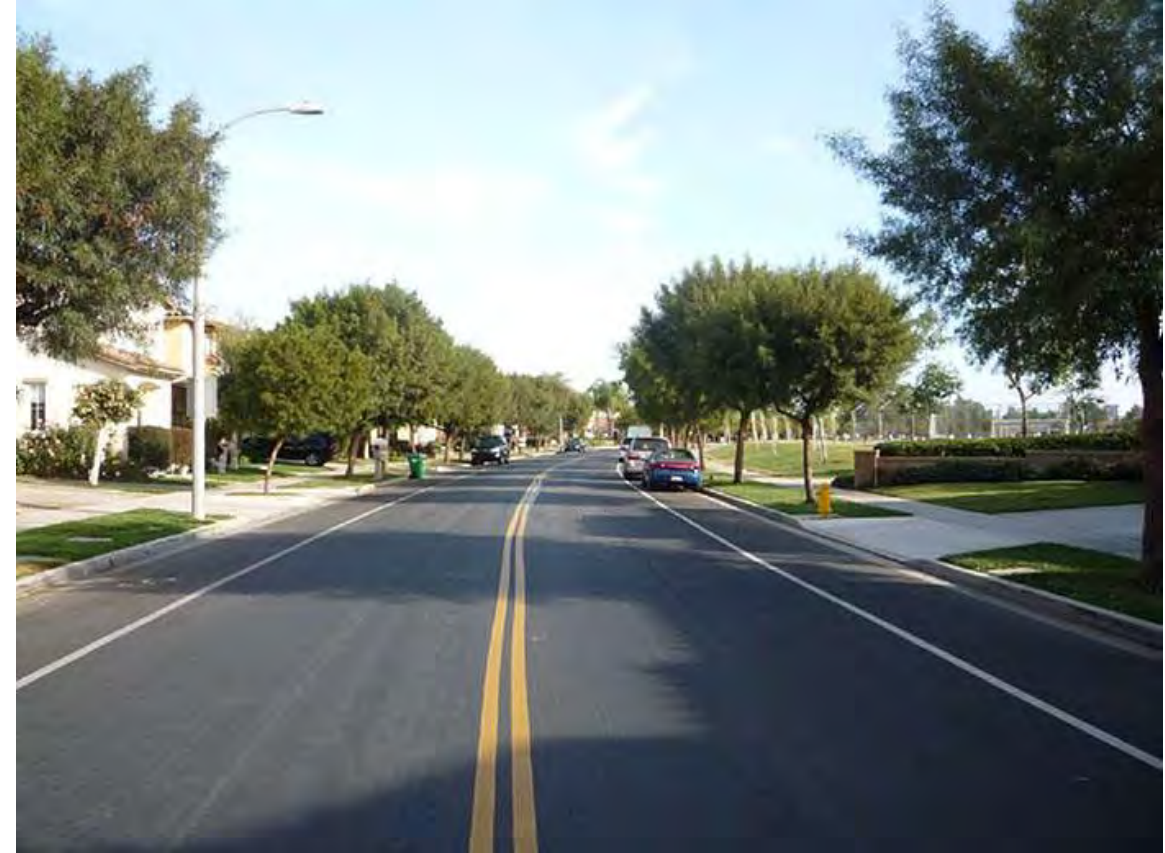
ON-STREET PARKING

- On-street parking can narrow roadway travel lanes by adding friction to traffic flow
- Parking can provide buffer for pedestrian zones

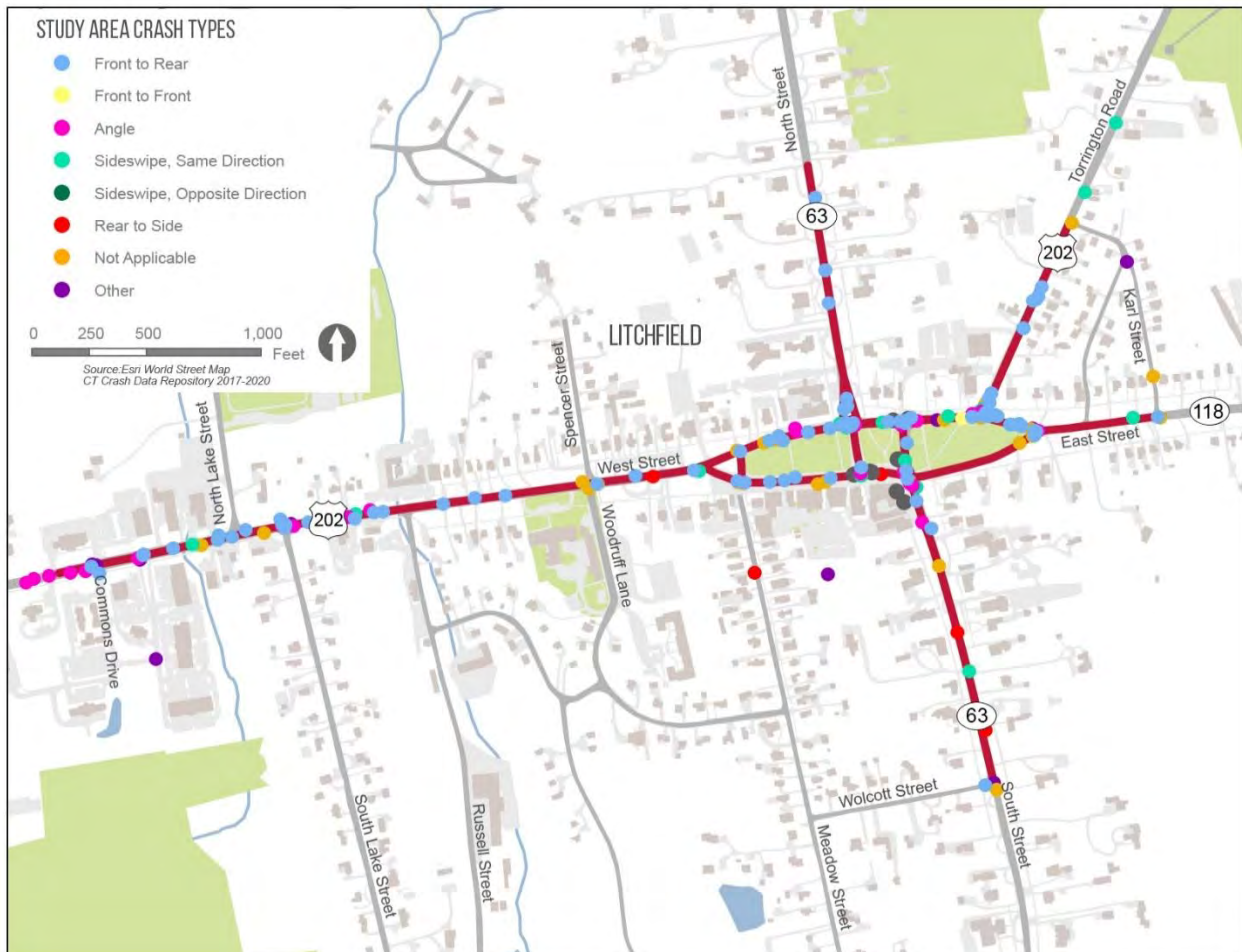
Litchfield Road Safety Audit Crash Summary - Crashes by Involved Person

- There were two crashes involving bicyclists in the Study Area
- There were eight crashes involving pedestrians in the Study Area
