Meriden

Camp Street Corridor: Colony Street to Pratt Street Road

Safety Audit

June 2, 2016

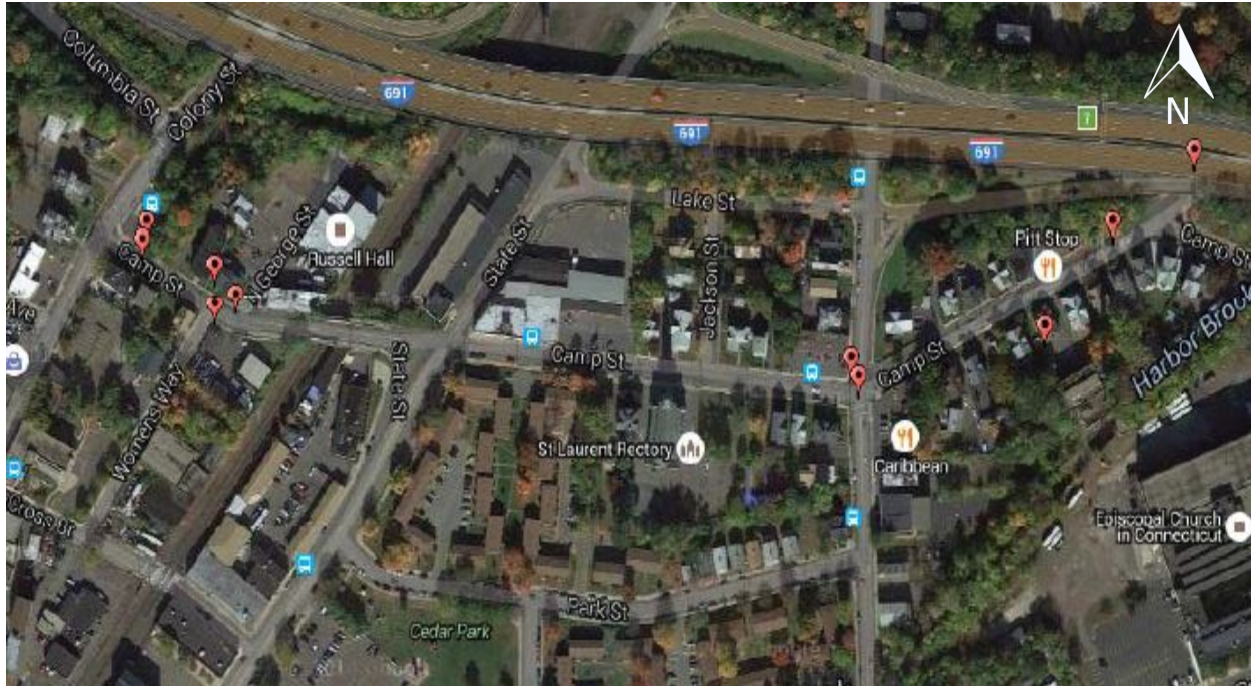
Figure 3. Crashes that Occurred in 2015 (Connecticut Crash Data Repository)

Crash history shows that the most frequent crashes are rear-end and turning-intersection paths crashes on the approaches to the intersections. Figure 3 displays crashes that occurred in this area during 2015. The peak crash rate is in the afternoon, which can be attributed to the higher traffic volumes resulting from commuting, shopping, and school activities.

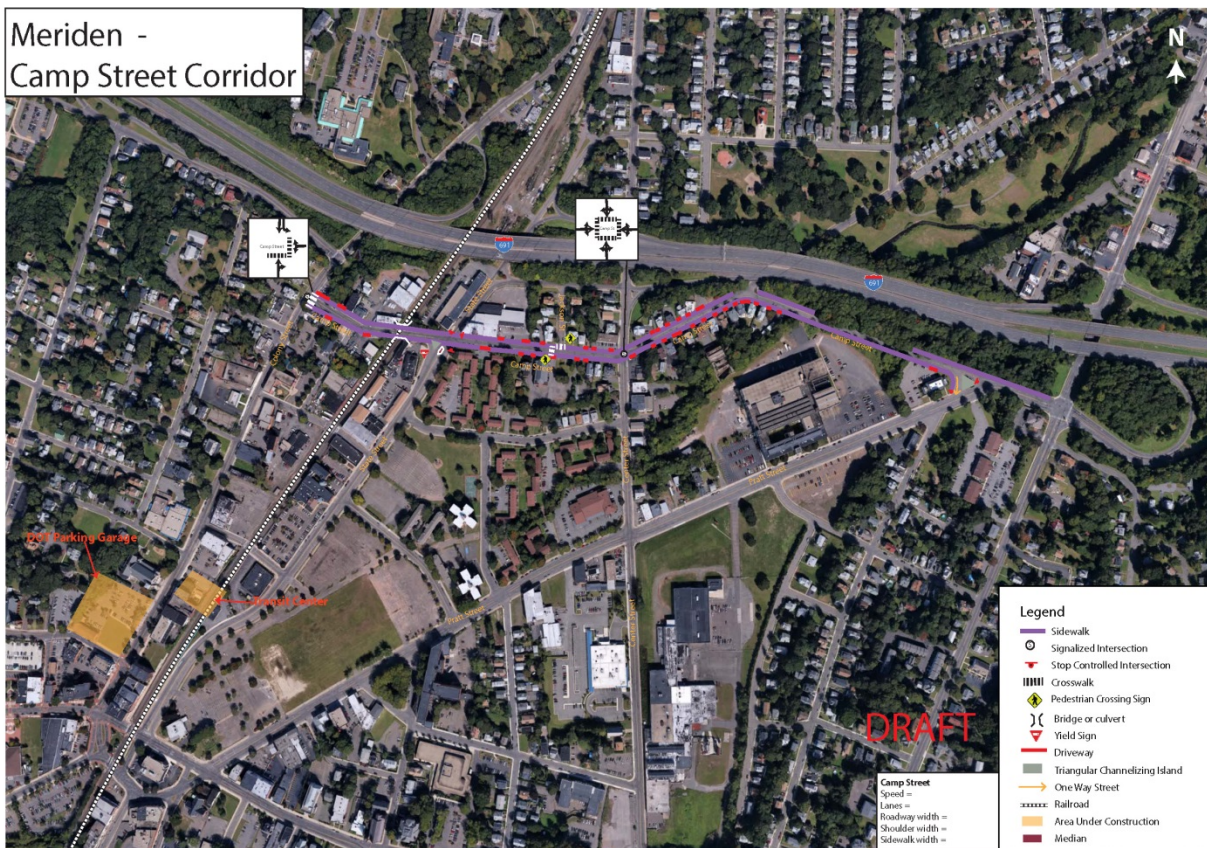
Figure 4. Camp Street Corridor Geometrics

Figure 4 provides more details on existing conditions along Camp Street including driveways, sidewalks, crosswalks and pedestrian signs.

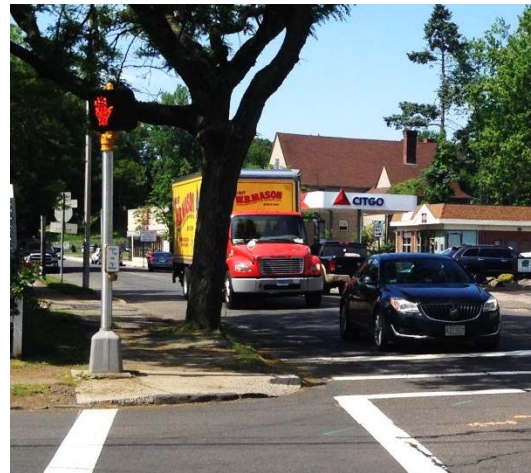
Figure 5. Tight Turns –No shoulder striping, No ADA Ramps.

- The sidewalks do not have ADA complaint sidewalk ramps (Figure 5).
- The pavement markings are worn out.
- There is no shoulder striping (Figure 5).
- Lane width at Colony Street is very tight. Curb radii are extremely small. Trucks frequently traverse the curb to make right turns onto Camp Street from Colony Street.
- The sidewalk changes from concrete to asphalt to slate abruptly. The sidewalk is in poor condition (Figure 6).
- The curbing is in poor condition, and missing entirely in some places.

1. Stripe shoulders on Camp Street and restripe worn out pavement markings.
2. Sidewalks/Crosswalks:
 - a. Repaint crosswalks.
 - b. Repair damaged sidewalk areas.
 - c. Add missing detectable warning strips.
3. Bunker Avenue and Camp Street
 - a. Clean vegetation encroaching on the sidewalks.

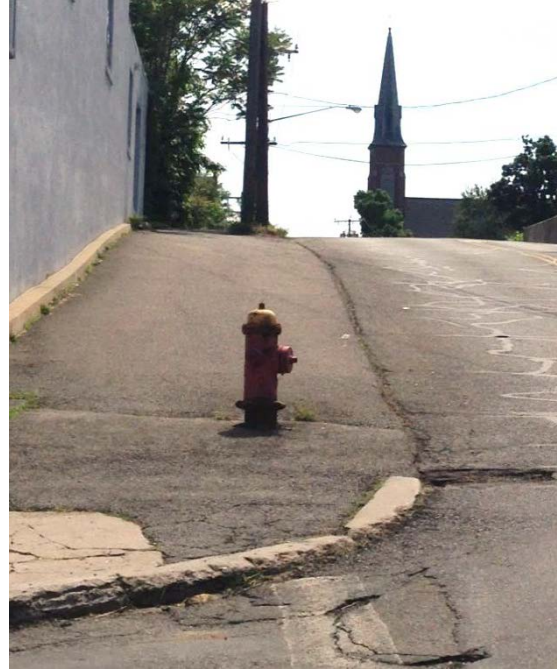
Figure 7. Tight turn for trucks to negotiate

- The sidewalk changes from concrete to asphalt abruptly. The sidewalk is in poor condition.
- The right turn onto North George Street from Camp Street Bridge is very tight for trucks going to Russell Hall. They encroach on the opposite side of the road in order to negotiate this turn. (Figure 7).
- Condition of the bridge is not inviting with respect to walkability. There is encroaching vegetation and debris. Grades are steep.
- The sidewalks do not have ADA complaint sidewalk ramps.
- The pavement markings are worn out.
- There is no shoulder striping.
- More signage needs to be added to slow down traffic before they arrive at the State Street intersection.

3. Improve intersection curb radii for safer turning movements. This will require property acquisition in many areas.
4. Revise intersection geometry at North George Street to provide better curb radii for turns to Russell Hall. This may have impacts to surrounding properties or may require property acquisition.

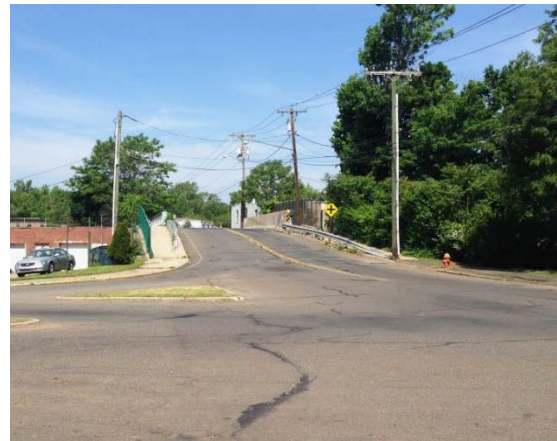
Figure 8. Steep grades on Camp St. Bridge

- The intersection is three-way stop controlled. This is unconventional. A suggestion was made to investigate making it a four-way stop.
- A team member suggested looking into a roundabout. This might be difficult unless the road is raised to match the grade on the bridge. Close-by buildings may also be a problem.
- Grade on the Bridge, sightline issues and stopping issues are not safe for pedestrians. (Figure 8)
- Utility Poles are too close to the roadway.
- Limited visibility and stopping sight distance eastbound from Colony Street due to steep grade over Amtrak bridge. Stop-controlling this leg could create a safety issue.

5. At Camp Street/State Street intersection, evaluate:
 - a. Raising the intersection grades to match the steep grades of the Amtrak Bridge.
 - b. Removal of the traffic island on south side of State Street to improve intersection alignment and sight distance. See Appendix D for concept plan developed by Meriden.

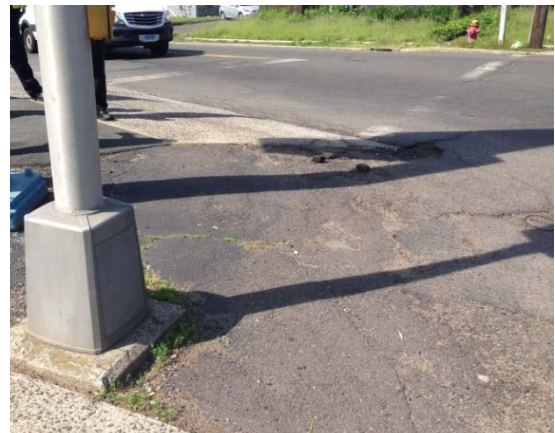
Figure 10. No sidewalk ramps

- The sidewalks do not have ADA compliant sidewalk ramps.(Figure 10)
- There is no shoulder striping.
- The overall width of Center Street is approximately 30 feet and Camp Street is 33 feet.
- The pavement markings are worn out.
- Pedestrians cross in non-designated areas, also pedestrian ramps are not properly oriented.

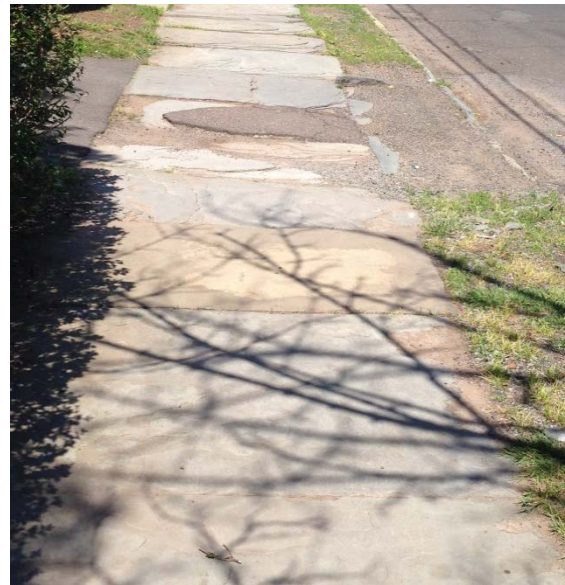
Figure 11. Sidewalk in poor condition

- Properties at Bunker Avenue are in the floodplain, removing the structures would reduce the environmental impact. (Figure 12).
- The curb and sidewalk is in poor condition. (Figure 11).
- There is no striping at this intersection.

1. Re-align crosswalks to be more perpendicular.
2. Construct new sidewalk to fix broken sections and make sidewalk types and cross section materials consistent.

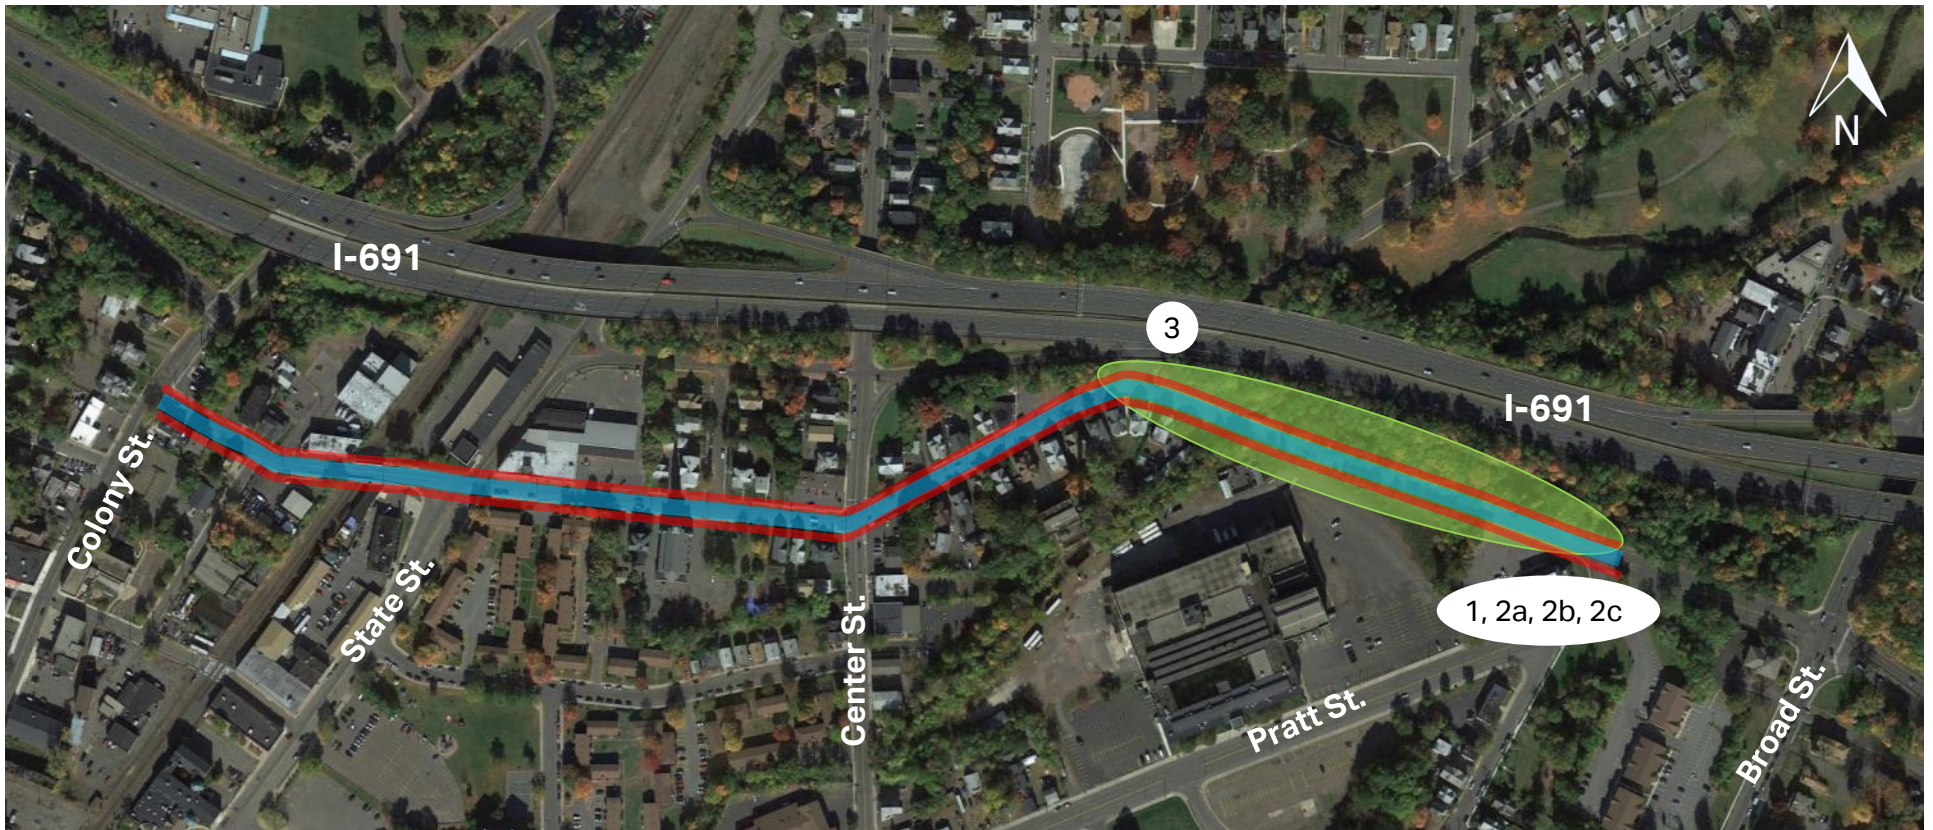
Figure 13. Short Term Recommendations

1. Stripe shoulders and restripe worn pavement markings

2a. Repaint crosswalks
2b. Repair damaged sidewalk areas
2c. Add detectable warning strips

3. Clean encroaching vegetation

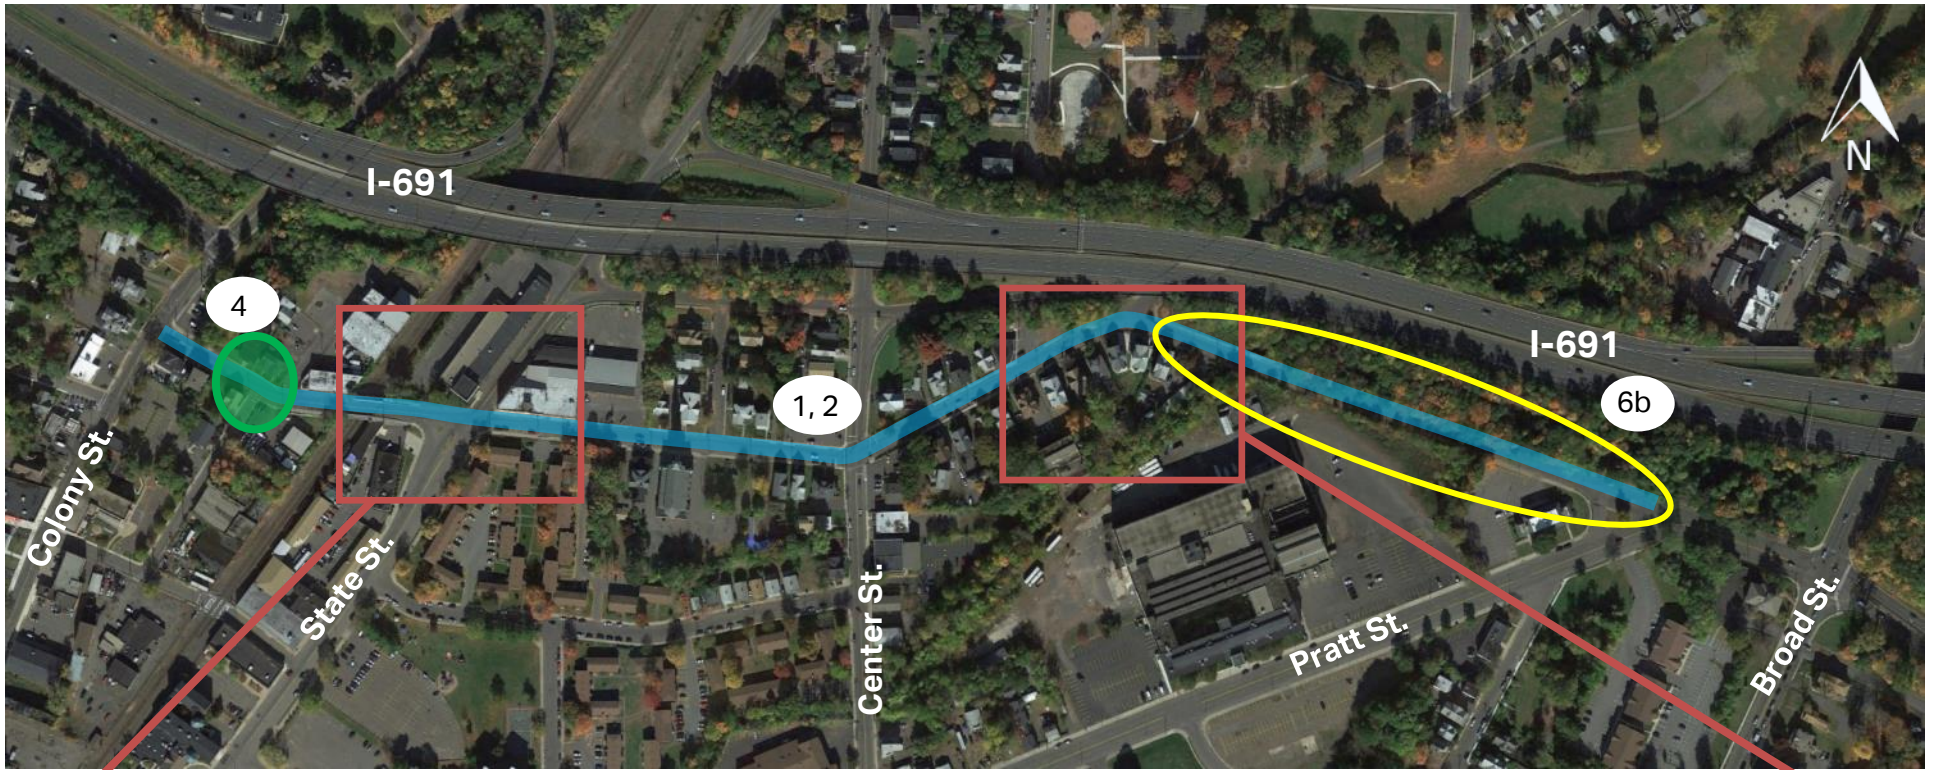
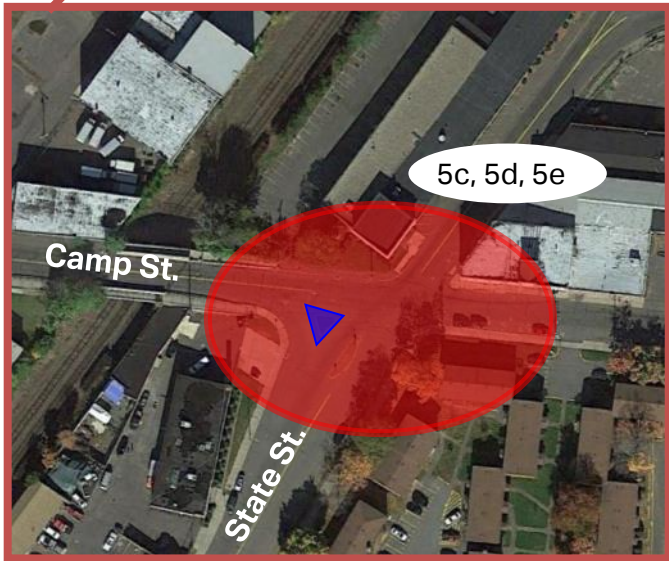
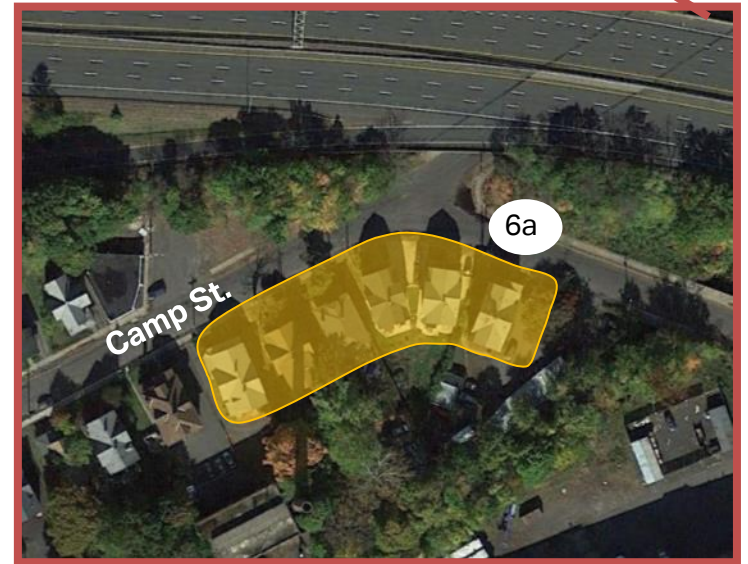
Figure 18. Long Term Recommendations

- 1-2. Realign crosswalks; construct sidewalks
- 4. Improve curb radii for turns
- 5b. Remove traffic island
- 5c – 5e. Reconfigure intersection
- 6a. Remove homes in floodplain
- 6b. Add way-finding signs
- 8. Widen roadway to 34 feet.

- c. Possibility of re-design of the intersection to be two-way (north/south) stop controlled.
 - d. Installing a roundabout.
 - e. Reconfiguration of the geometry to "square up" the intersection and reduce overall pavement width. See Appendix E for concept plan developed by Meriden.

6. Bunker Avenue and Camp Street
 - a. Remove the homes in the floodplain; parking for the proposed linear trail can be constructed.
 - b. Way-finding signs should be added to provide information on destinations for traffic coming through the proposed Gateway Boulevard at Pratt Street.

7. Formulate/Implement access management plan.
8. Widen roadway to a consistent 34 feet section to allow for on-street parking.
