Naugatuck

Downtown Area – Road Safety Audit

October 20, 2016

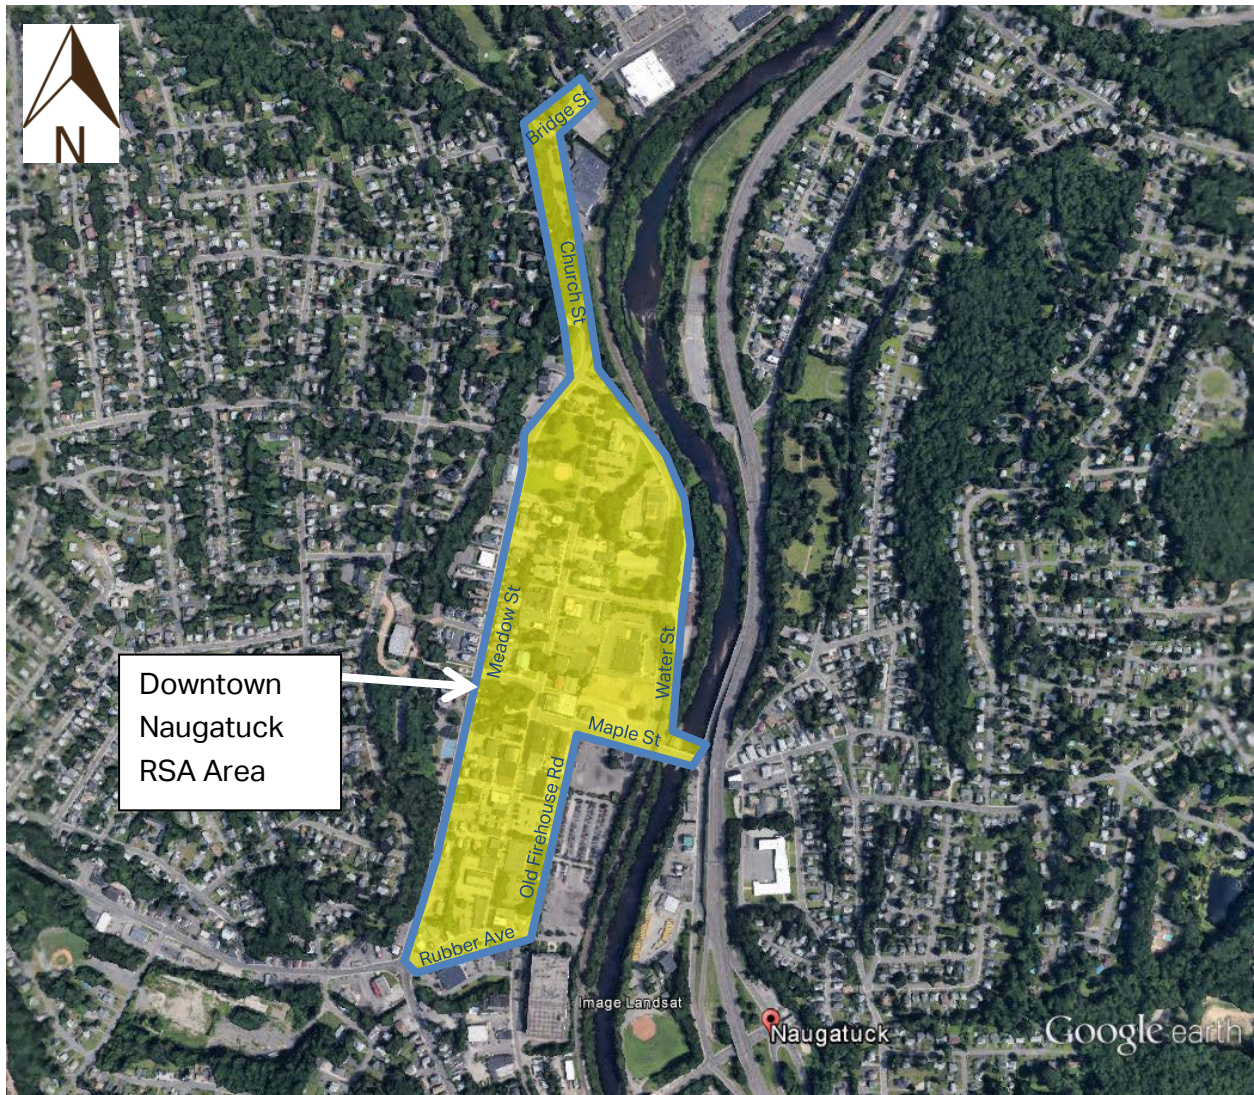
Figure 1. Downtown Area, Naugatuck

The RSA site is the downtown section of Naugatuck between Meadow Street and the Naugatuck River, from Rubber Avenue at the south end to Bridge Street at the north end (Figure 1). The Average Daily Traffic (ADT) in the study area ranges from 3,500 vehicles per day (vpd) on Water Street to 18,100 vpd on the Maple Street bridge. The roadways in this area generally consist of a single 10 foot to 12 foot travel lane for each direction with a 7 foot to 10 foot shoulder or parking lane in each direction. Park Place, Meadow Court and a section of Water Street are one way streets.

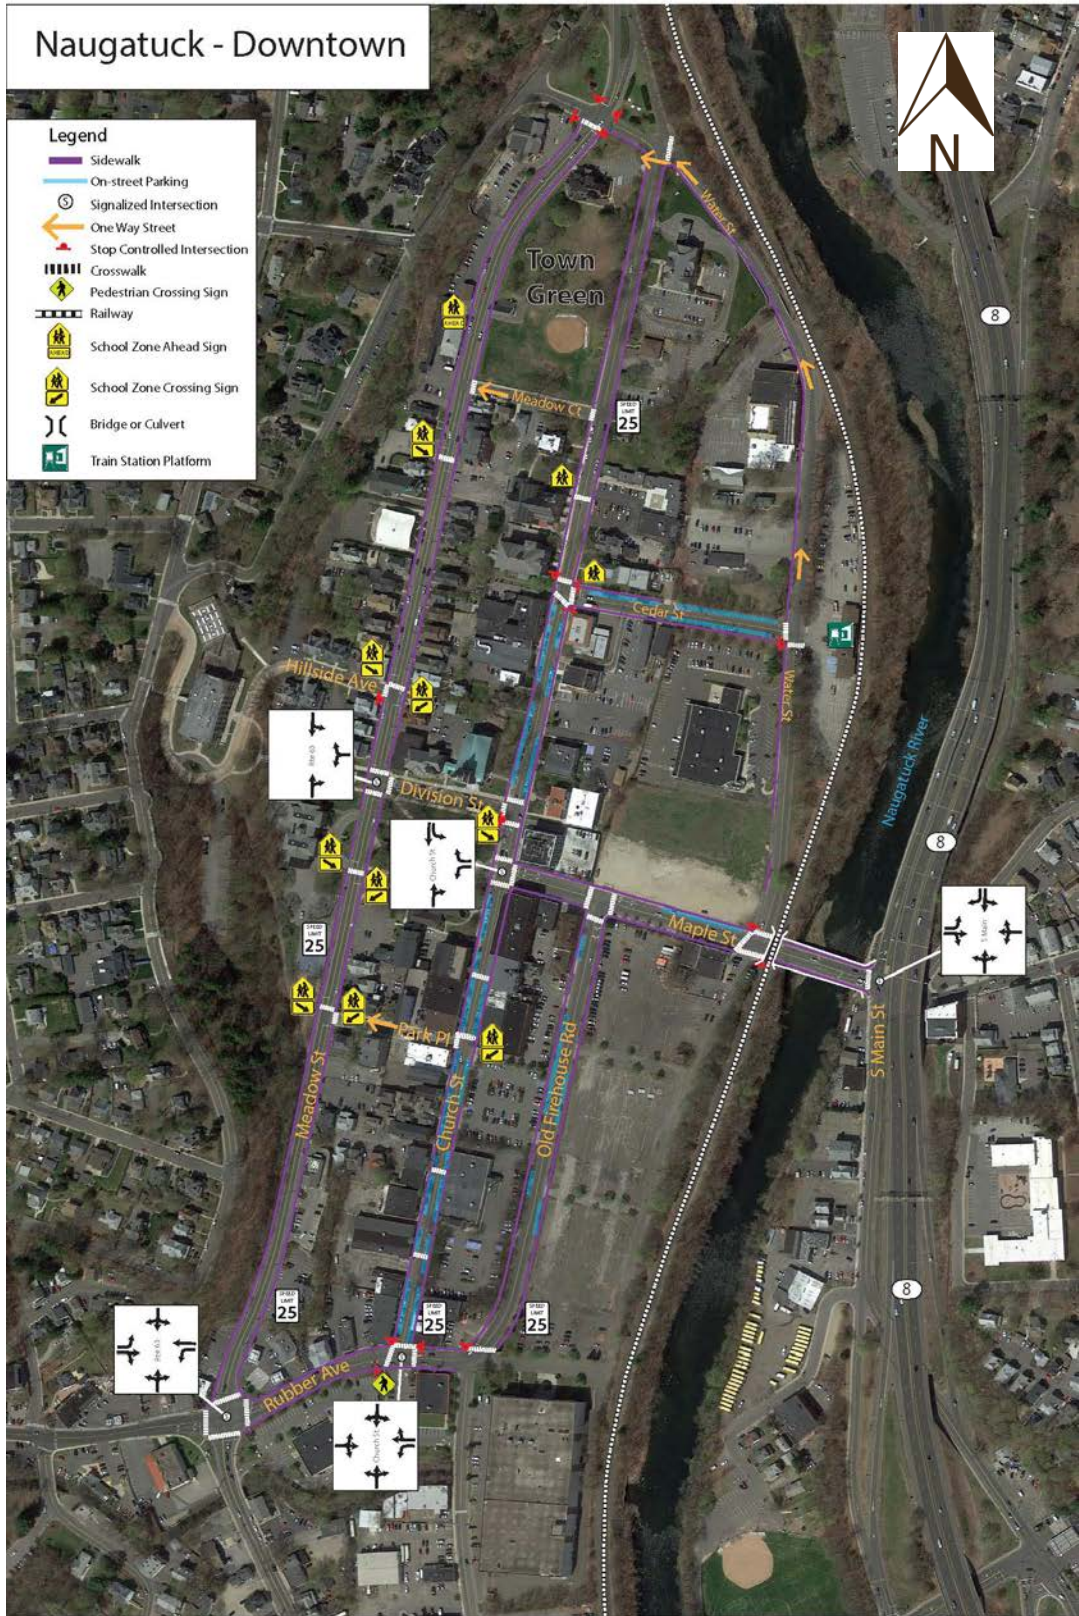
Figure 4. Downtown Naugatuck Geometrics

Roadway geometrics are shown in Figure 4 and a street inventory is provided in Table 3. The entire length of the study area has a single travel lane in each direction and shoulder widths vary as shown in the street inventory table. The majority of the study area consists of a grid street network with straight alignments. The speed limit throughout the study area is 25 mph.

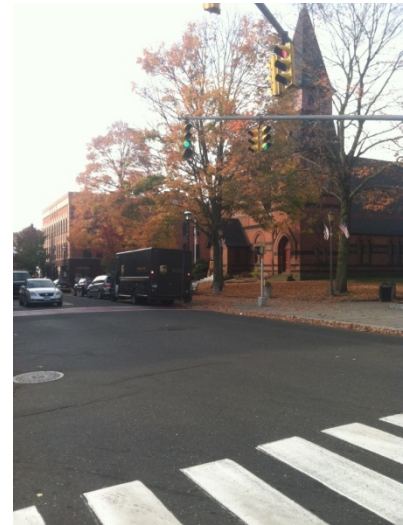
Figure 5. Church Street and Maple Avenue signal

- The Town-owned signal at Church Street and Maple Street is antiquated and in need of an upgrade (Figure 5).
- The south end of Church Street typically consists of 7-foot parking lanes and 10-foot travel lanes in each direction.

1. Town to replace the traffic signal at the intersection of Maple Street and Church Street.
2. Town to upgrade all pedestrian facilities to meet ADA and MUTCD standards, including the following:

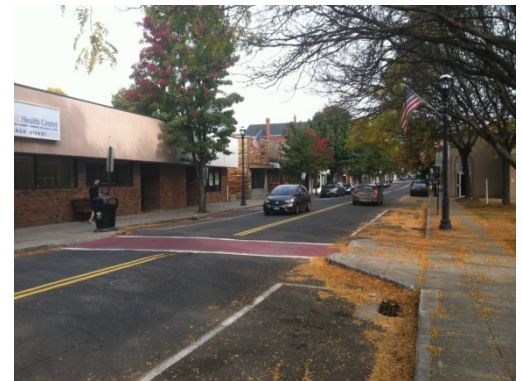
Figure 6. Mid-block crosswalk without pedestrian crossing signs

- Some of the mid-block crosswalks do not have pedestrian crossing signs (Figure 6).
- Vehicles do not consistently yield to pedestrians in the mid-block crosswalks.

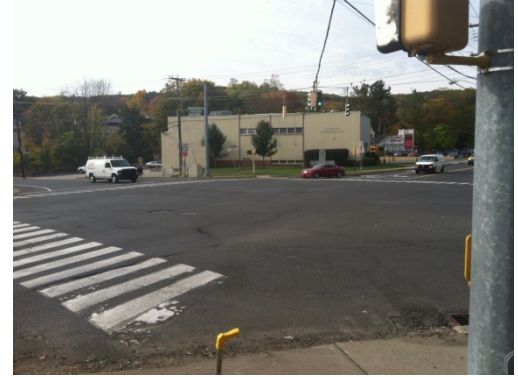
Figure 7. Rubber Avenue and Meadow Street intersection

- The signal phases do not match the lane arrangement (ie. green left turn arrows with no left turn lane or vice versa).
- There are no detectable warning strips at the intersection (Figure 7).

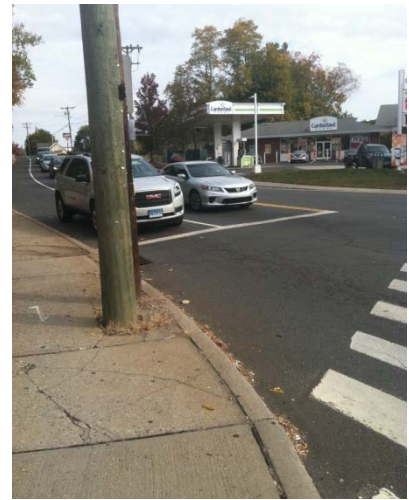
Figure 8. 10-foot shoulder on Meadow Street being used as a turn lane

- The longest crosswalk is 74-feet with a 26-second flashing red pedestrian phase.
- On Meadow Street southbound there is a 10-foot shoulder approaching the intersection which is used as a de-facto right turn lane (Figure 8).

- The southbound shoulder could be changed into a right turn lane. (Figure 17).
- The intersection could be improved geometrically.
 - Reduced turn radii should be investigated.
 - Improving the location of crosswalk landing locations should be investigated.
- Rubber Avenue is scheduled to be re-paved by the State and that may be a good opportunity for the Town to request that the signal also be evaluated.

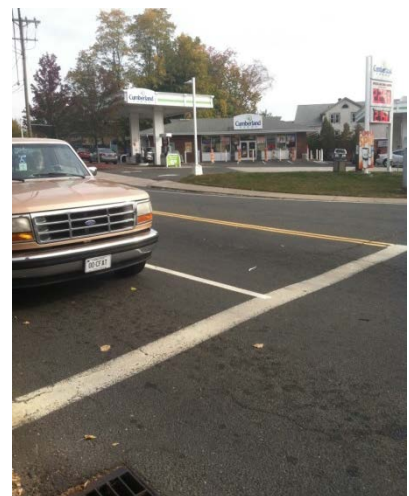
Figure 9. Driveway in close proximity to intersection

- There are many busy driveways in close proximity to the intersection and access management is poor (Figure 9).
- Catch basin grates are not the bike friendly type.

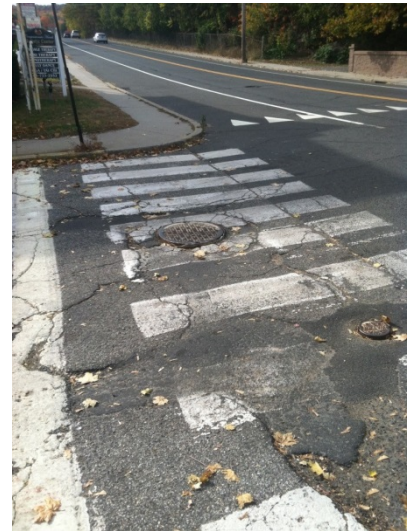
Figure 10. Crosswalk without ADA compliant ramp or warning strips

- ADA compliant ramps and detectable warning strips are missing from most crosswalks (Figure 10).
- The road consists of a single 12-foot wide travel lane in each direction separated by a double yellow centerline with a nine-foot northbound shoulder and a seven-foot southbound shoulder.
- The northbound sidewalk is narrow in some sections (42-48 inches wide) and has obstructions that further reduce the effective width.
- Pedestrian pushbuttons are not audible and the pedestrian signals are not countdown type.

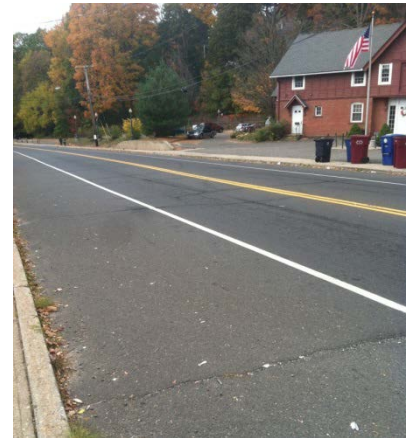
Figure 11. Wide shoulder/parking lane

- The nine-foot shoulder is often used as a turn lane by vehicles (Figure 11).
- Several legs of the intersection are missing crosswalks and there are no ADA compliant ramps (Figure 12).
- The sidewalk on Meadow Street does not continue to the north through the intersection (Figure 12).
- There are worn paths where pedestrians tend to walk and where sidewalks would be appropriate (Figure 12).

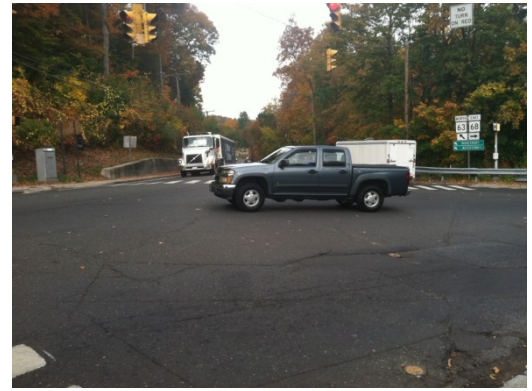
Figure 13. Church Street and Bridge Street intersection

- The curb radii at the intersection are very large (Figure 13).
- There is a driveway in the intersection.
- The signal is scheduled to be replaced by the State next year.
- Pedestrian movements are complicated and pedestrian signal heads do not line up with the crosswalks.

7. Town to coordinate with CTDOT to upgrade pedestrian facilities at the Church Street (Route 63) and Bridge Street (Route 68) intersection as part of the signal replacement project.

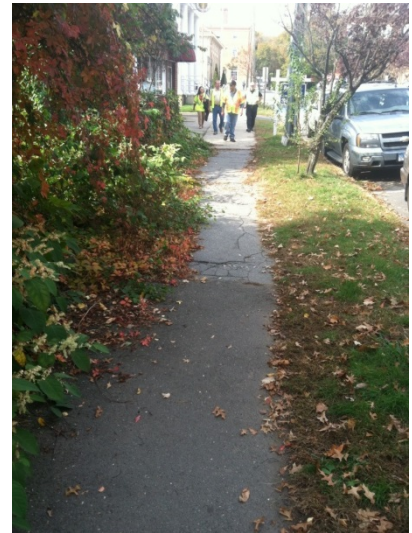
Figure 14. Vegetation growth onto sidewalk on Cedar Street

- There is a six-foot sidewalk that is bituminous in some sections and concrete in other sections.
- Some vegetation is overgrown and infringing on pedestrian space in the sidewalk.
- The road consists of 13-foot wide travel lanes

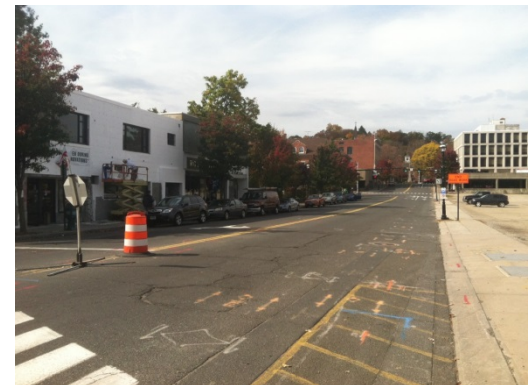
Figure 15. Maple Street facing west

- Maple Street is 48-feet wide and bike lanes could potentially be added with striping changes only as a potential bike connection to the Greenway (Figure 15).

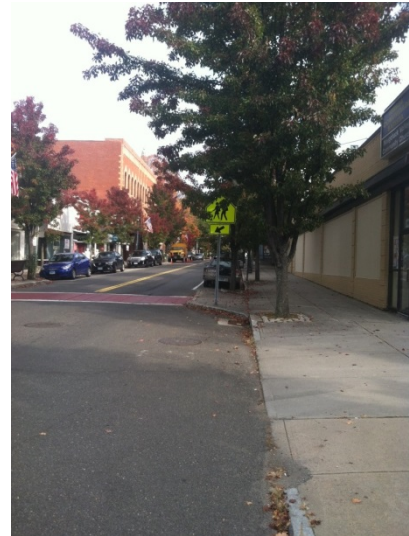
Figure 16. Mid-block crosswalk on Church Street

- There is a need to improve pedestrian visibility at all mid-block crosswalks and rectangular rapid flashing beacons (RRFB) should be investigated as an option (Figure 16).

1. Town to install rectangular rapid flashing beacons (RRFB) at mid-block crosswalks on Church Street as funding becomes available (Figure 21).
2. Town to coordinate with CTDOT to upgrade pedestrian facilities on Route 63, including the following:
 - a. Audible pushbuttons.
 - b. Detectable warning strips.
 - c. ADA compliant ramps.
 - d. Retro-reflective signage.
 - e. Countdown type pedestrian signals at signalized intersections.
3. Town to investigate restriping Maple Street to include bike lanes that connect to the bridge.
4. Town to coordinate with CTDOT to evaluate the signal at the Meadow Street and Rubber Avenue intersection as part of its program to re-pave Rubber Avenue.

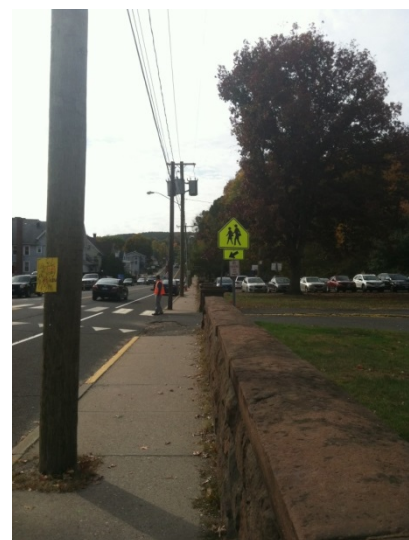
Figure 18. Mid-block crosswalk on Meadow Street

- There are several mid-block crosswalks where RRFBs would potentially be an effective way to alert drivers of pedestrians (Figure 18).
- Several crosswalks are missing ADA compliant ramps and detectable warning strips.

9. Town to coordinate with CTDOT to install rectangular rapid flashing beacons (RRFB) or other advanced pedestrian measures at the mid-block crosswalks on Meadow Street (Figure 21).

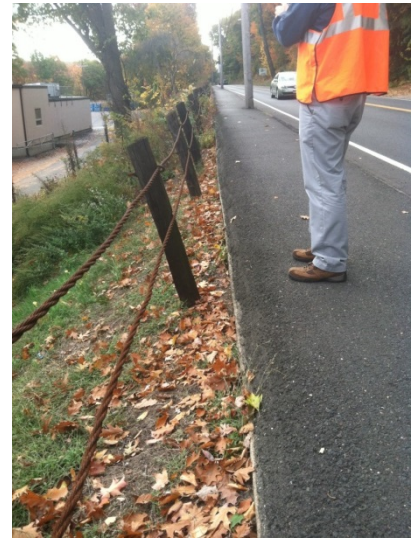
Figure 19. Drop-off adjacent to Church Street sidewalk

- There are drop-offs next to the sidewalk that could be a hazard to pedestrians (Figure 19).
- There are utility poles in the sidewalk that reduce the effective width.
- A long term goal may be to construct a retaining wall and widen the sidewalk.
- Shoulder widths can be increased by re-striping to 11-foot lanes.

6. Town to coordinate with CTDOT to construct a retaining wall on the east side of Route 63-Church Street and widen the existing sidewalk.
7. Town to investigate the possibility of constructing a sidewalk on the east side of Water Street and construct if applicable.
