COMMUNITY
connectivity program

New London

Route 32 (Mohegan Avenue) – Road Safety Audit (RSA) Route 32 – Road Safety Audit

April 14, 2016

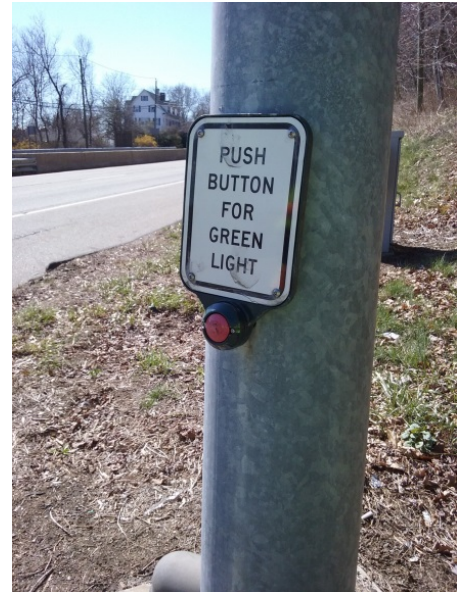
Figure 6. Pedestrian Push Button for Crossing

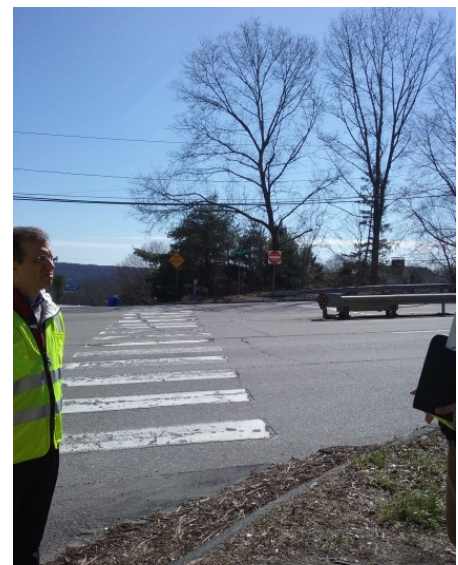
Figure 7. Crosswalk at Benham Avenue

- Painted crosswalks and stamped concrete ones would be more apparent to motorists.
- Lighting would be needed for any new sidewalk.
- Southbound speed limit is 45 mph but northbound is 35 mph. This appears inconsistent.
- Southbound traffic on Route 32 has a visual cue from the traffic speed sign to slow down.
- There is considerable available roadway width here to make improvements.
- The pedestrian bridge can be seen from this intersection.

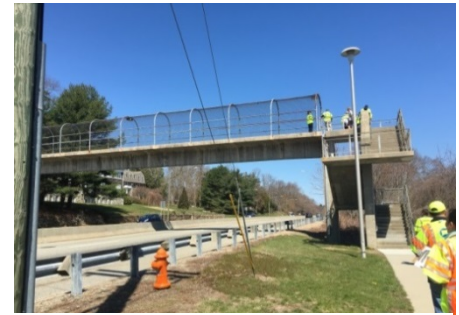
- The pedestrian bridge is at the crest in the road.
- The bridge is not ADA accessible (Figure 8).
- The bridge could be used as a gateway with student art.
- Crosswalk ramps lack detectable warning strips.
- The push button in the northeast corner of the intersection for the pedestrian crossing is placed where it is inaccessible to those in a wheelchair (Figure 9).
- Utility poles are located within the sidewalk making it difficult to plow and reducing the available walking path (Figure 10).
- The guard rail is broken (wooden blocks) in places.
- There is no crosswalk on Reservoir Street (Figure 11).
- Fences should be placed along the property to direct students to crossings.

Figure 8. Pedestrian Bridge, not ADA Compliant

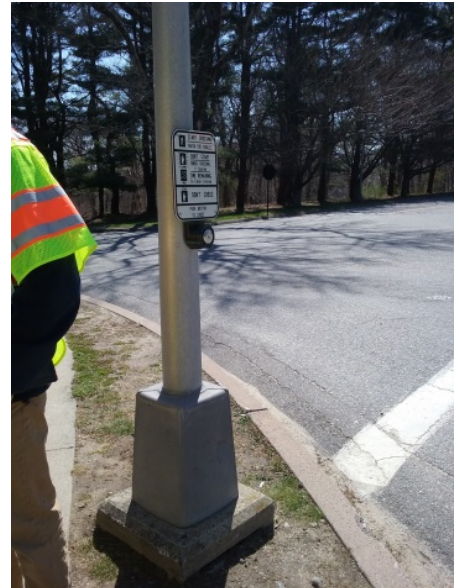
Figure 9. Push Button is not ADA Accessible

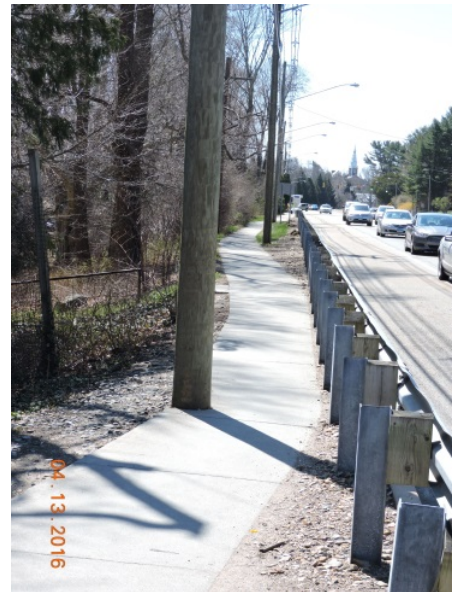
Figure 10. Utility Poles in the Sidewalk Path

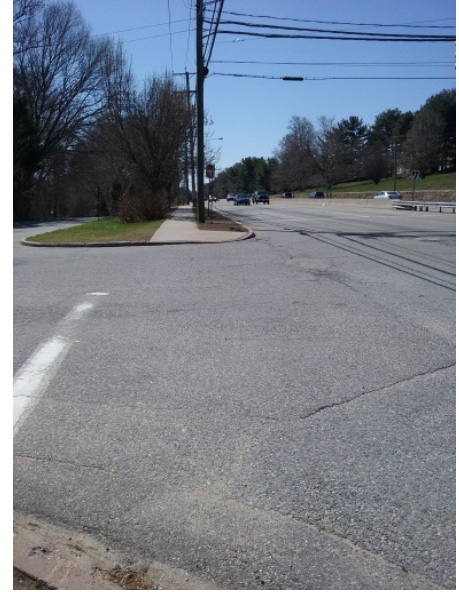
Figure 11. Lack of Crosswalk Across Reservoir Street

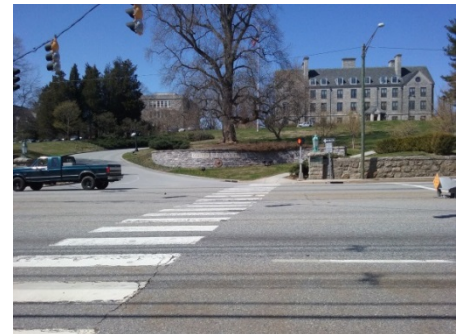
- The gateway is hard to see to Connecticut College (Figure 12).
- Campus cameras to have surveillance of this area would be helpful in case of events.
- The stop bars are set far back on the northbound side of Route 32.
- Would a roundabout work here?
- There are no detectable warning strips.
- The paint should be restriped with epoxy resin.
- Traffic calming is needed here.
- Some traffic signs are dull and old.
- There is a lack of consistency in signing.

Figure 12. Gateway to Connecticut College

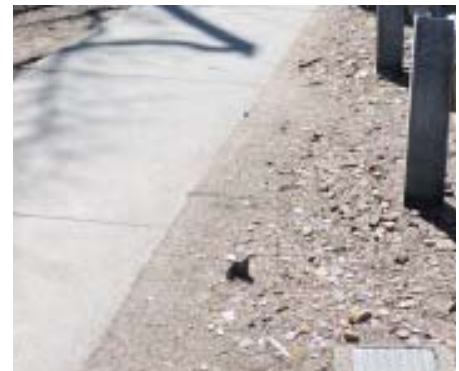
Figure 13. Old Sign Stub

- Vegetation encroaches on the sidewalk on the northbound side of Route 32.
- Old sign stubs stick out in the grass buffer area along the northbound side of Route 32 (Figure 13).
- There are high pedestrian counts at this crossing; they are likely even higher in warmer weather.

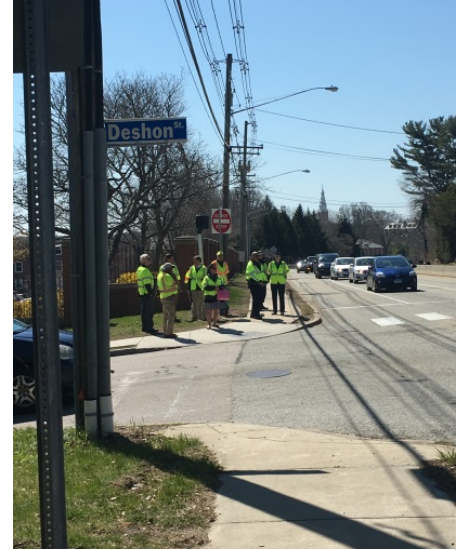
Figure 14. Lack of Sidewalk Across Deshon Street

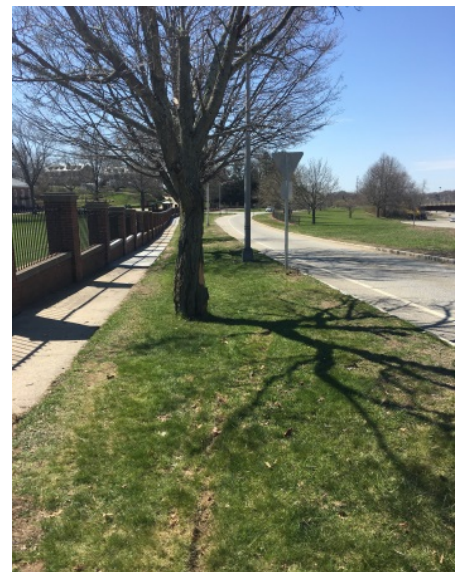
Figure 15. Lack of Visual Cues to Slow Down

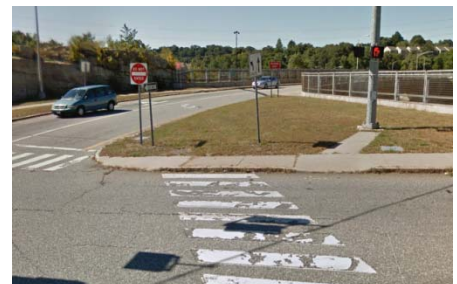
- The crosswalk on the north side of SR 635 (Williams Street) does not end at a ramp but there are ramps on either side of it (Figure 16).
- The crossing distance across SR 636 (Mohegan Avenue) on the eastern side is a long distance.

Figure 16. Crosswalk at Williams St. & Mohegan Ave. in NW Corner

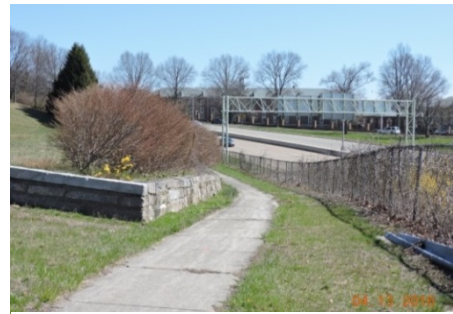
- The catch basin grates in this area are not bicycle friendly.
- The sidewalk is narrow.
- There is no pedestrian wayfinding (Figure 17).
- There are no painted shoulder lines.

Figure 17. Lack of Pedestrian Wayfinding

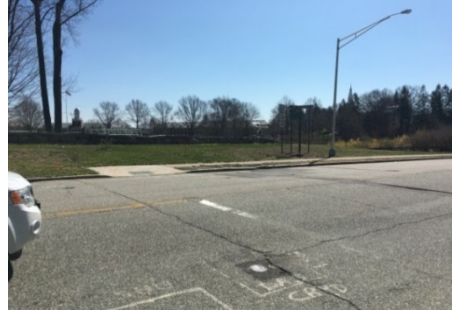
Figure 18. Crossing with Ramps but no Painted Crosswalk

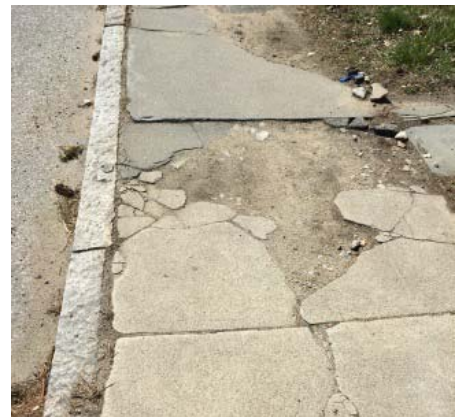
- This is a three leg intersection but only two directions are stop controlled.
- The sidewalk ends here and pedestrians are forced to cross, about 150 feet down the road it picks back up again for a short distance.
- The crosswalk ramps are ADA compliant but there is no painted crosswalk (Figure 18).
- There is no pedestrian crossing signage.
- This may be a good candidate for a flashing beacon crosswalk; this intersection is heavily used by student athletic groups.
- A pedestrian crossing sign is needed.
- The sidewalk begins to break down after Briggs Street (Figure 19).

Figure 19. Poor Sidewalk Conditions Along Williams Street

- The sidewalk is in poor condition along most of Williams Street. It is heavily cracked, chunks are missing and tree roots have caused upheavals in sections. The sidewalk is nearly impassable for those using a mobility device.

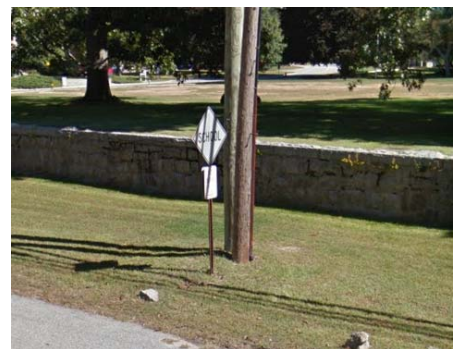
Figure 20. Faded Traffic Signs

particular, a few of the no parking signs are below the minimum required per the MUTCD. There are also a few “for sale” or other private signs whose posts are not within the right-of-way but signs hang in it.

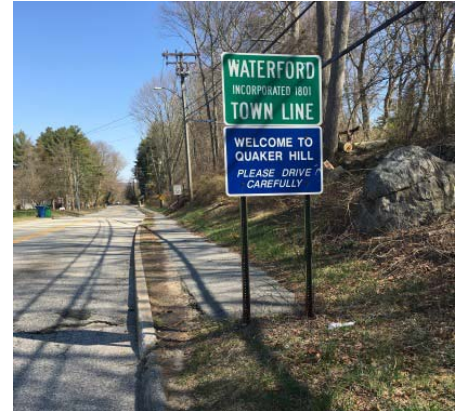
Figure 21. Start of Sidewalk on Williams St at Waterford Town Line.

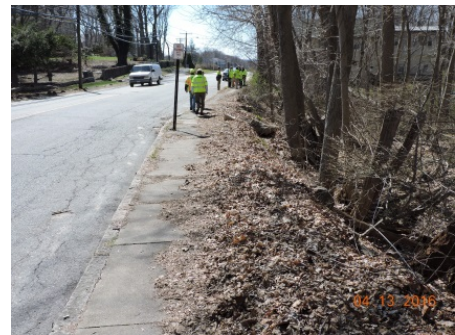
- Along the sidewalk, across from the entrance to the Lyman Allan Museum on Williams Street #2, there is a steep drop in grade that is a safety hazard for pedestrians (Figure 22).

Figure 22. Steep Drop-off Adjacent to Sidewalk

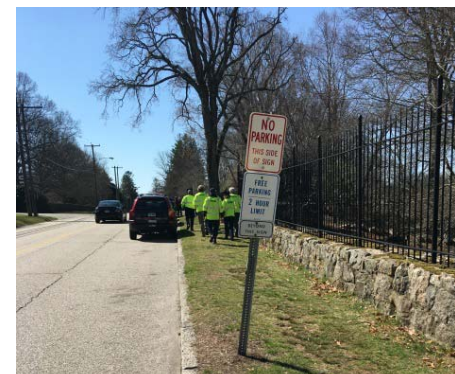
- There are confusing parking signs in front of the arboretum. There is a “no parking this side of sign” sign with a “free parking, 2 hour limit beyond this point” sign stacked on top of each other (Figure 23).

Figure 23. Conflicting Parking Signs

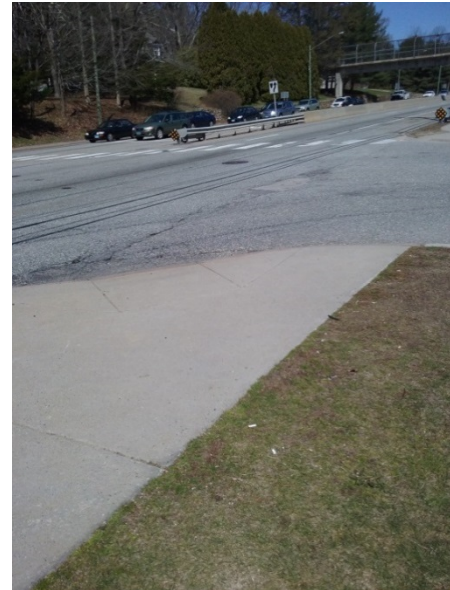
Figure 24. Lack of Traffic Calming

- Rumble Strips can help slow down traffic.
- Reduced lane widths can provide wider sidewalk/ bikeway and act as traffic calming.
- If a screen system was used (instead of guiderails) this might prevent jay walking.
- Multi-use path along the corridor would accommodate pedestrians and bicyclists.
- Most sidewalks are not ADA compliant.
- The college is exploring another Pedestrian Bridge at Deshon Street to reduce pedestrian traffic the Connecticut College Entrance.
- Crosswalk striping can be changed to provide perpendicular crosswalks which provide shorter roadway crossing distance.
- The two college entrance gates are closed in the night – currently have no room for a vehicle that turns in by mistake to get back on the road safely.
- Timed signals – if you drive 35 mph you can drive through with all green lights.

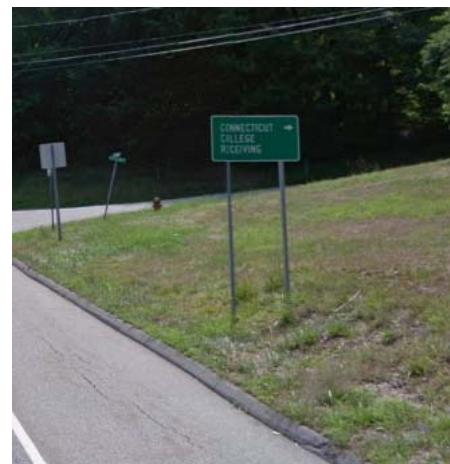
Figure 25. The Only Wayfinding Sign at the Benham Intersection

- Branding the area with signs:
 - Advanced wayfinding signs (for college and CGA) (Figure 25).
 - One group was asked by a car where the college was.
 - Signs at this intersection would improve wayfinding.
 - Should investigate the possibility for adding a sign to the pedestrian bridge to reinforce the message about being in a

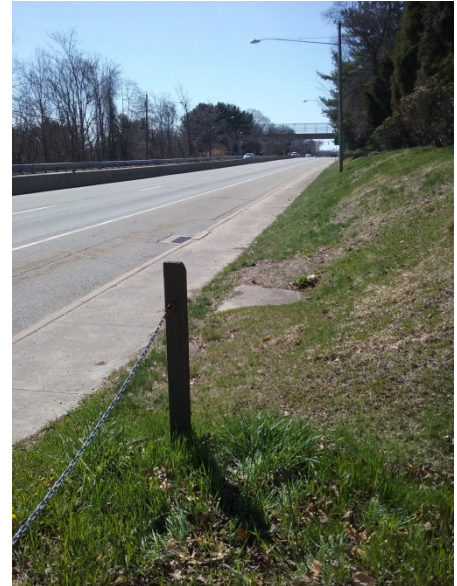
Figure 26. Pedestrian Bridge as you Head South on Route 32 Which Could Become a Gateway

college area. Vertical clearance might be an issue (Figure 26).

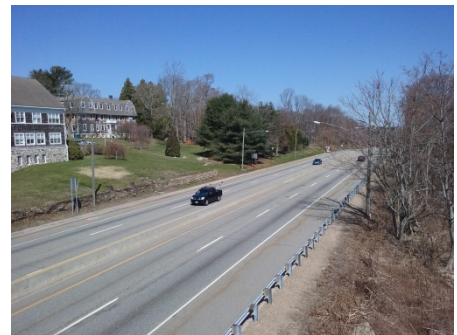
Figure 27. View North From Pedestrian Bridge, Lacks Visual Cues that you are on a College Campus

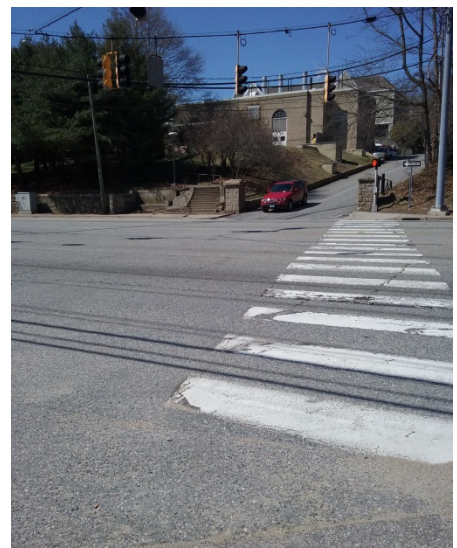
Figure 28. Long Crossing Distance

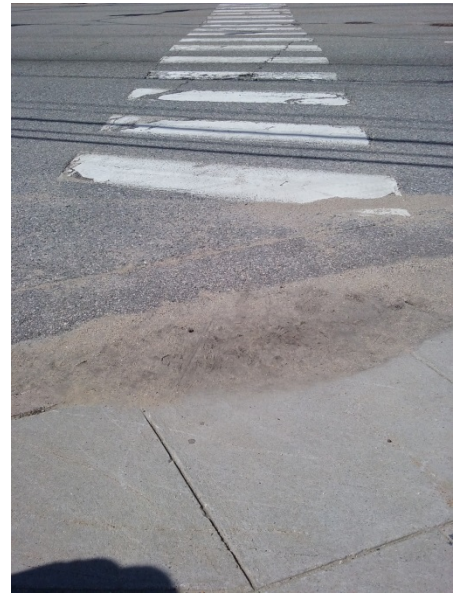
Figure 29. Non-ADA Compliant Crosswalk

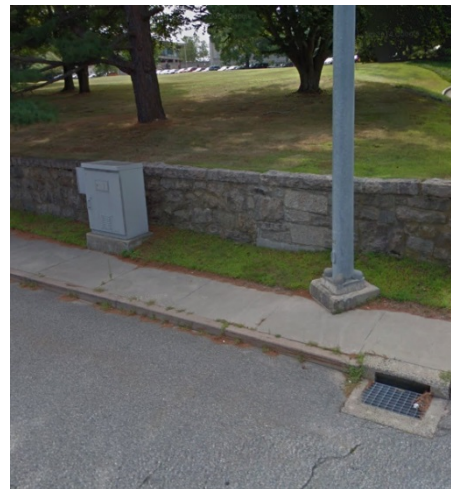
Figure 30. Span Pole in the Sidewalk

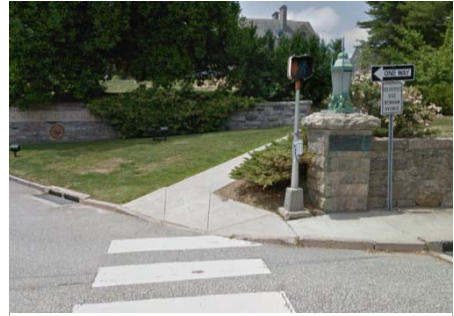
Figure 31. Little Room for Groups to Wait for Crossing

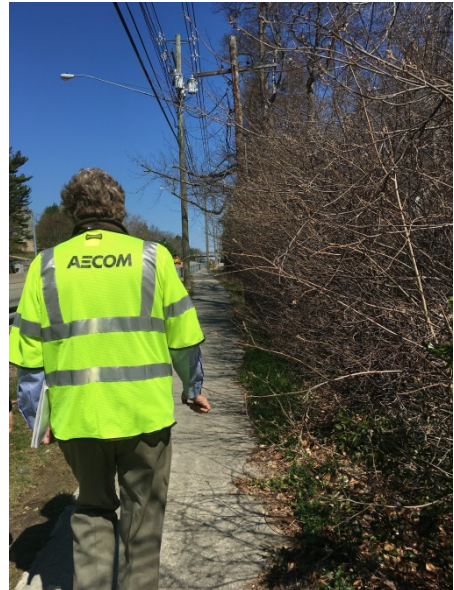
Figure 32. Overgrown Vegetation

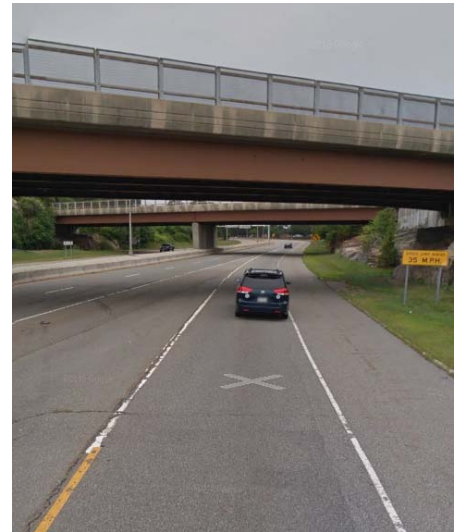
Figure 33. Opportunity for Visual Cues to Slow Down on Bridges

- On-ramp – sends a mixed message that vehicles should speed up to enter Route 32, but then reach a traffic signal .
 - Make this more like a Merritt Parkway ramp.
- Rumble strips could be added.
 - Noise could be an issue for nearby residential areas.
- Long term – modifications to the entrance at CGA from Route 32 would have to consider their security/gate house.
- Both of the southern bridges can be used for signage to let drivers know they are entering the campus area (to slow down) (Figure 33).
- Highway ramps and routes to get to CGA and Connecticut College campus are convoluted.

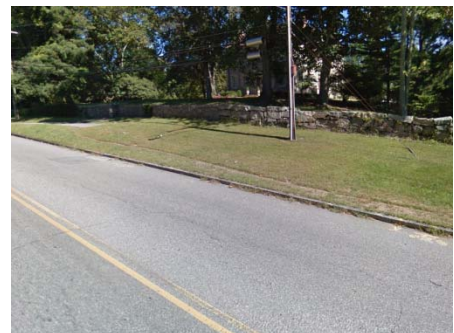
Figure 34. Noticeable pedestrian Path Where Sidewalk Ends

- No crosswalk.
- When sidewalk ends (on eastern side) there is a noticeable path where people walk in the grass (Figure 34).
- Wide lane (Figure 35).
 - Put in line for shoulder.
 - Adjust center line to make room for sidewalks.
- Sidewalks are in bad condition.
- Need for fence/barrier on sidewalk with drop off.

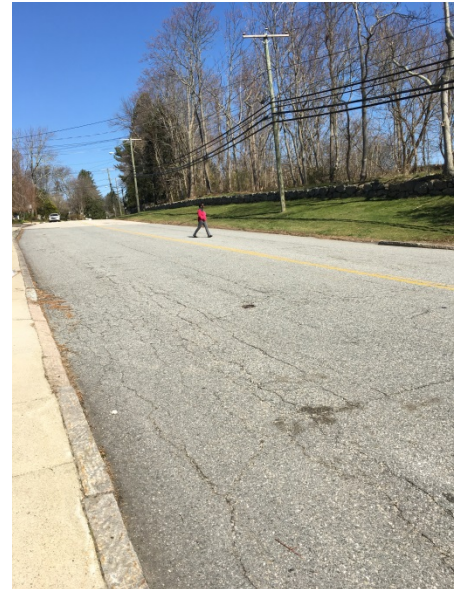
Figure 35. Williams Street has a Wide Cross Section

- More flexibility on this street for lanes to be less than 11 ft. wide.

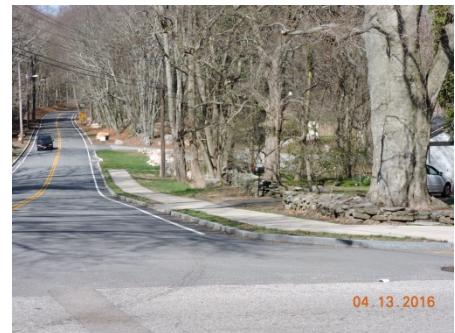
Figure 36. New Sidewalk Extension at Gallows Lane

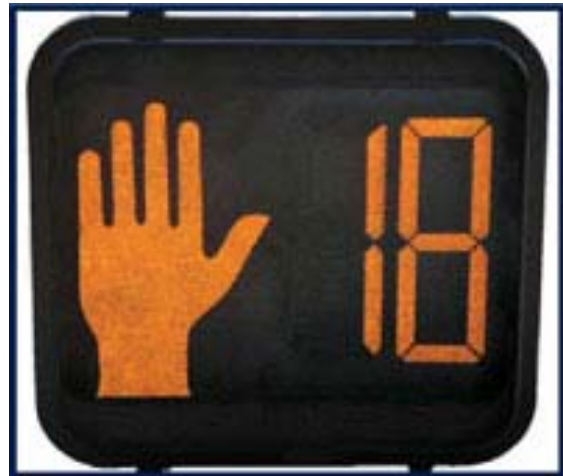
Figure 38. Countdown Pedestrian Signal Head

10. Replace existing pedestrian heads with countdown ones (Figure 38).
11. Realign the crosswalk on the northeastern side of the intersection to align with one of the crosswalk ramps.
12. Paint edge lines along Williams Street, especially on the bridge.

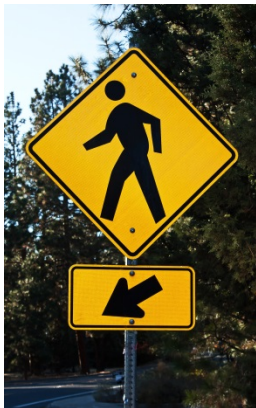
Figure 41. Example of Pedestrian Crossing with Down Arrow Sign at Uncontrolled Approaches

19. Dynamic speed sign to reduce travel speeds.
20. Repaint lane, crosswalk and other markings which have faded.
21. Relocate signing out of the pedestrian way to accommodate proper horizontal and vertical clearances.
22. All stop areas should be evaluated to address visibility/sight lines.
23. Thin vegetation where there are visibility issues and cut back vegetation encroaching into the sidewalk (Figure 40).
24. Replace signs that worn out and not retroreflective.
25. Add pedestrian crossing signs and down arrows to all non-controlled (signal or stop control) pedestrian crossings (Figure 41).

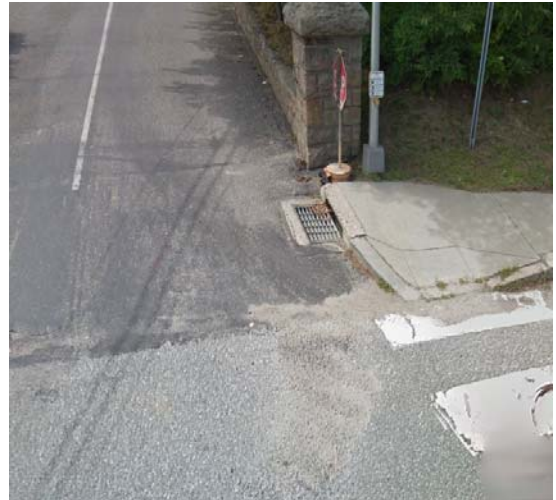
Figure 44. Install Sidewalk Ramps Across Cross Streets

13. Add gateway or visual cues that you are entering a college area. Make it seem that you are not going through Connecticut College but you are at Connecticut College when on Route 32.
14. Add sidewalk ramps where missing (Figure 44).
15. Implement advanced wayfinding for pedestrians, bicyclists and motorists.
16. Paint the shoulders a different color in conformance with the MUTCD so they stand out more (City to maintain - Figure 45).
17. Add rumble strips on Route 32 between the right most travel lane and the shoulder for better vehicle guidance (Figure 46).
18. Investigate the viability of LED streetlights along Route 32 to improve light levels and the uniformity of the lighting for drivers and when pedestrians are using crosswalks.
19. Add detectable warning strips to all crossings where missing (Figure 47).
