New Milford

Route 7 (Danbury Road) – Road Safety Audit

July 27, 2016

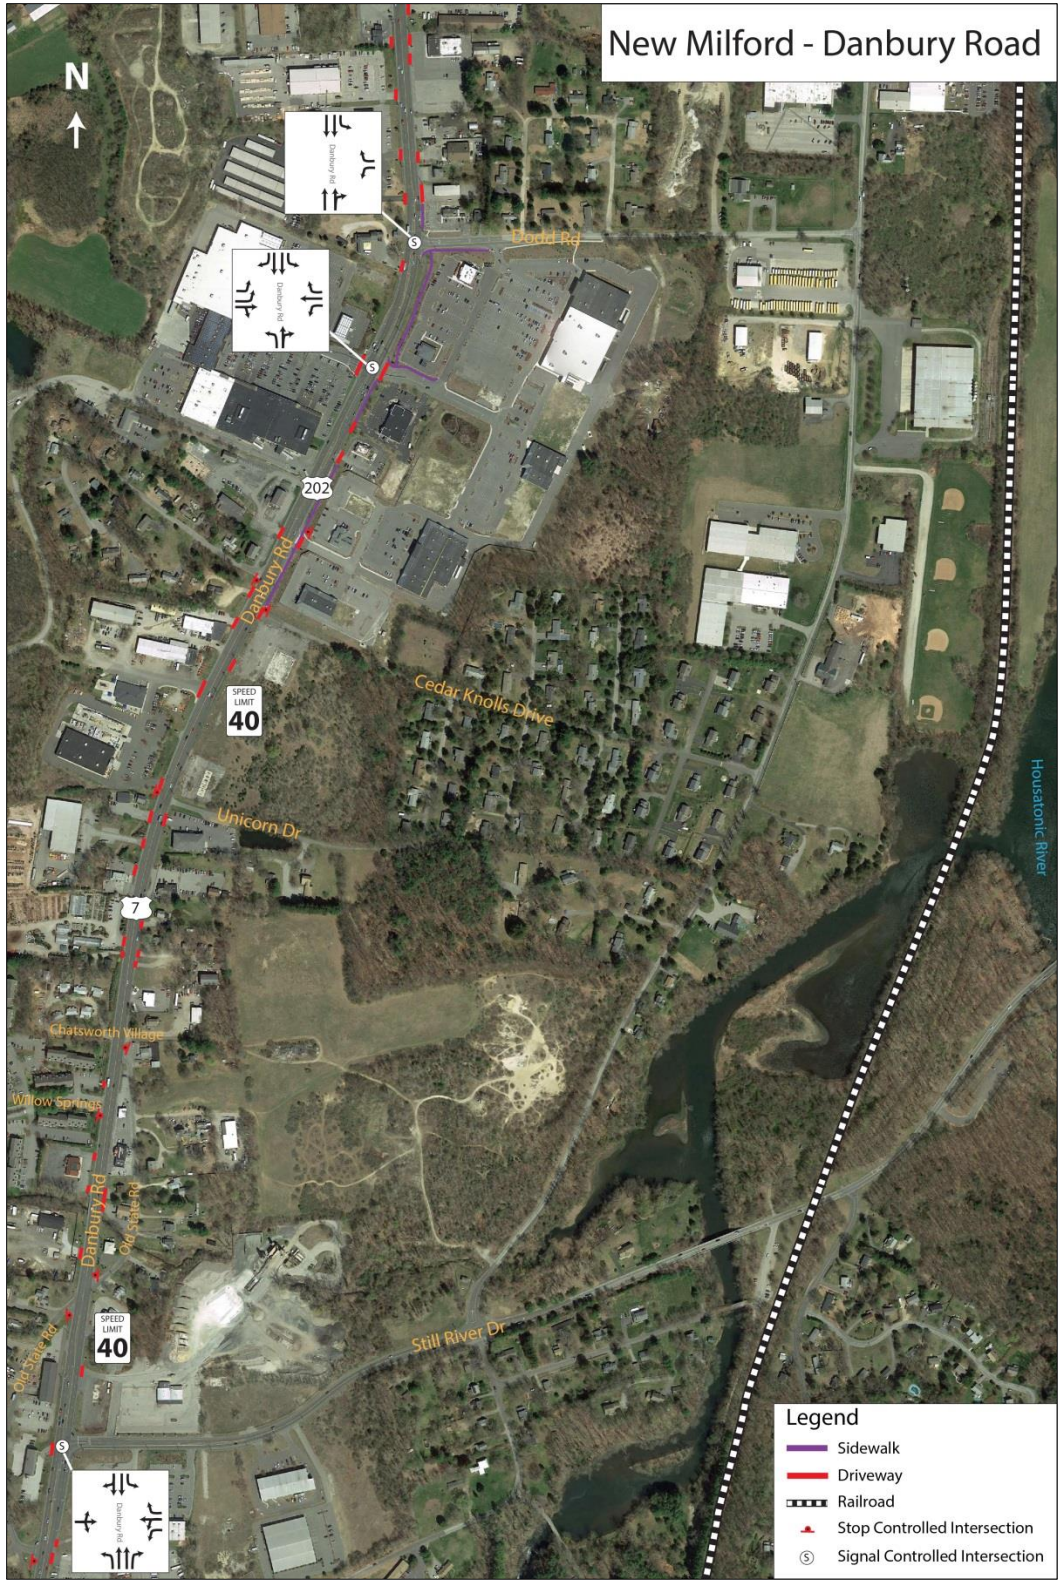
Figure 4. Danbury Road (Route 7) Road Geometrics

Danbury Road (Route 7) has a posted speed limit of 40 mph, with two travel lanes in each direction that are generally 11 feet wide. Dedicated left turn lanes are provided at signalized intersections and at unsignalized driveways serving the shopping plazas north of Cedar Knolls Drive. South of Cedar Knolls Road, there are no turn lanes for driveway access. Shoulders are provided on both sides and are generally four feet wide throughout the corridor; however, shoulders vary from one to seven feet wide between Cedar Knolls Drive and Dodd Road. Sidewalks are not provided for most of the RSA corridor. Four-foot wide sidewalks are provided on the east side of Danbury Road between Cedar Knolls Drive and Dodd Road except that sidewalk is missing in front of the Taco Bell property. There are no striped pedestrian crossings of Route 7 within the RSA corridor. Several retail and commercial facilities and Willow Spring residential condominium complex are located along Danbury Road and generate pedestrian activity.

Roadway geometrics for study area roadways and intersections are shown in Figure 4. An inventory of existing conditions of the intersection can be found in Table 3.

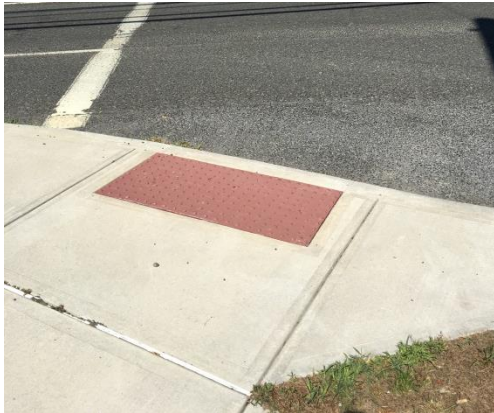
Figure 5. Ramp and Detectable Warning Strips

A number of best practices have already been applied to this area of New Milford. At some intersections, upgrades have been implemented, including ramps, detectable warning strips and pushbuttons. The Kohl's plaza driveway includes a painted crosswalk, ramps, and detectable warning strips. (Figure 5 through Figure 7).

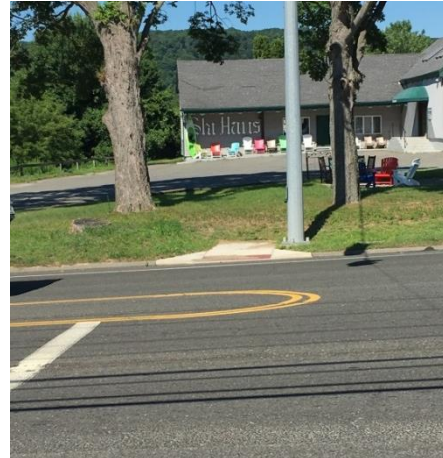
- On the southwestern side of this intersection, the crosswalk ramp is not connected to any sidewalks (Figure 8).
- Near the Walmart and Stop & Shop plaza intersection, the crosswalk ramps and detectable warning strips are situated at a 45° angle directing pedestrians diagonally into the intersection.

Figure 8. Ramp at Dodd Rd. is not Connected to a Sidewalk.

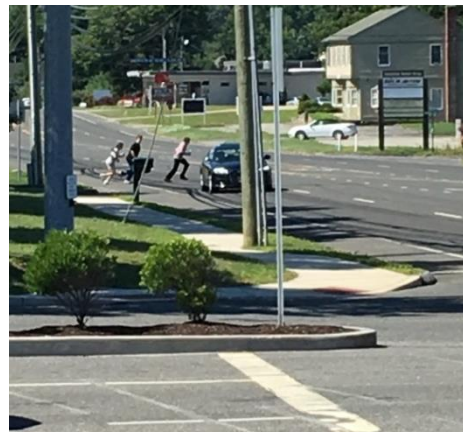
- Pedestrians were observed running across Route 7 mid-block (Figure 9).
- There is no sidewalk in front of the Taco Bell on Route 7.
- The shoulder areas on Route 7 vary in width throughout the corridor. Some areas are as wide as 7 feet (Figure 10), while others are as narrow as 1 foot.

Figure 9. Pedestrians Running Across Route 7 near Taco Bell

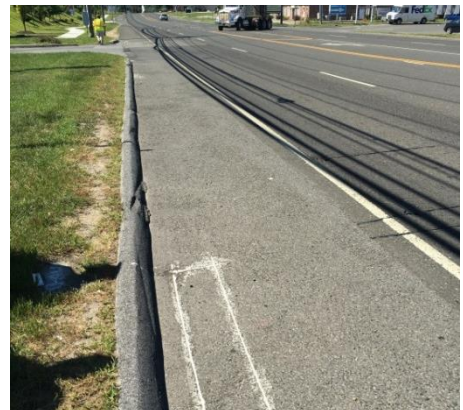
Figure 10. Section of Wider Shoulders on Route 7

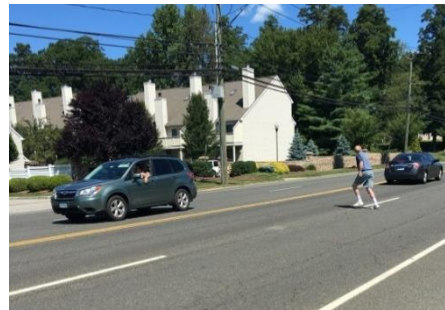
- The Willow Spring complex on Route 7 has many residential units. The driveway for this complex is controlled by a stop sign. Several vehicles turning left onto Route 7 were observed queuing in the development waiting for a gap in traffic to safely make their turn.
- Pedestrians were observed crossing Route 7 mid-block at the Willow Spring complex (Figure 11).
- The traffic light at the Still River Drive intersection is located on the crest of the hill, which creates sight-line limitations.
- At the Still River Drive intersection there are pedestrian pushbuttons on the southeast and southwest corners but no ramps, crosswalk signals, or painted crosswalks.

Figure 11. Elderly Man Crossing Traffic on Route 7 at Willow Springs Complex

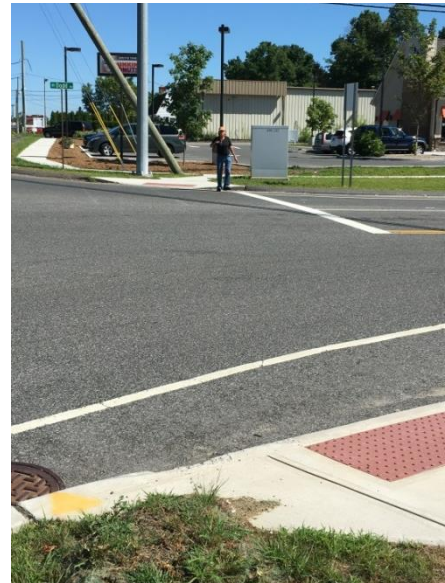
Figure 12. Intersections do not have Painted Crosswalks

1. The Local Traffic Authority (LTA) should submit a letter of request to CTDOT to paint crosswalks at the following intersections:
 - a. Dodd Road.
 - b. Walmart and Stop & Shop plaza (Figure 15).
 - c. Still River Drive.
- 2) Coordinate with CTDOT Maintenance District to find out when Route 7 is being repaved.
 - a. When Route 7 is repaved, request that lanes are narrowed to 11 feet.
- 3) LTA should request pedestrian counts to be conducted on Route 7.
- 4) Investigate feasibility of opening up Cedar Knolls Drive for recreational use (bikes and pedestrians) (Figure 16).
- 5) Review and update town plans, such as the Plan of Conservation and Development and Access Management Plan.
- 6) Map existing sidewalks on Route 7 to identify areas to expand and/or connect existing sidewalks.

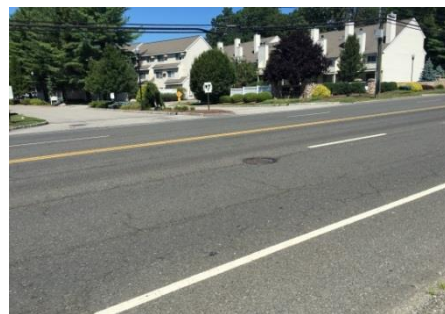
Figure 13. Willow Springs Complex Entrance and Exit

6. The Town is concerned with vehicles having difficulty turning left onto and off Route 7, particularly at the Willow Springs complex (Figure 13).
7. Sidewalks are fragmented along Route 7 (Figure 14). There are topography challenges that make it difficult to create a network of continuous sidewalks.

1. Evaluate access to Willow Spring condominium complex:
 - a. Investigate feasibility of installing traffic signal at the Route 7 intersection.
 - b. Evaluate feasibility of providing an alternative access to the development.
2. Where possible, construct sidewalks to complete gaps along Route 7 (Figure 21).
3. Install lighting along Route 7 to improve visibility at night.

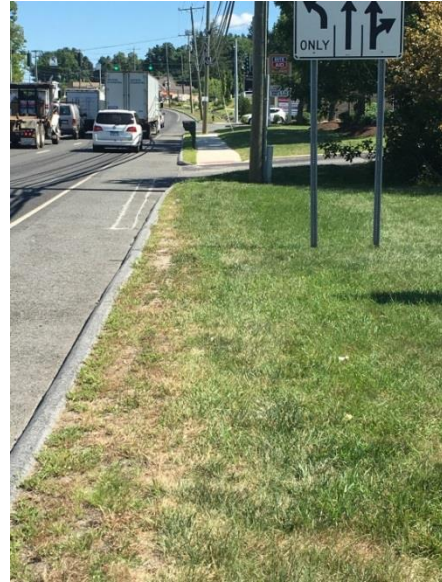
Figure 14. Missing Sidewalks

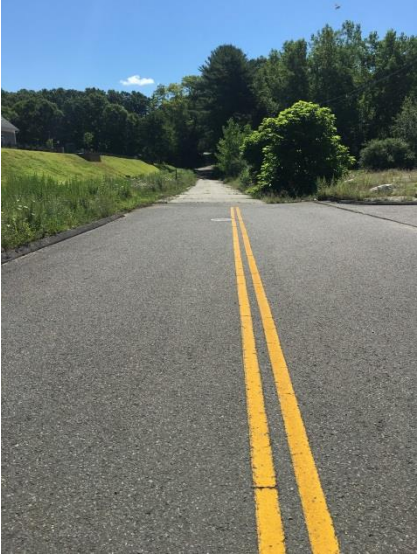
Figure 16. Cedar Knolls Drive

- Cedar Knolls Drive was closed around 2005. The property on the southeast corner of this intersection is vacant after a planned shopping center development was not constructed. Further east on this road, a gate was installed to prevent vehicles from using it.
