Newington

Town Center – Road Safety Audit

July 27, 2016

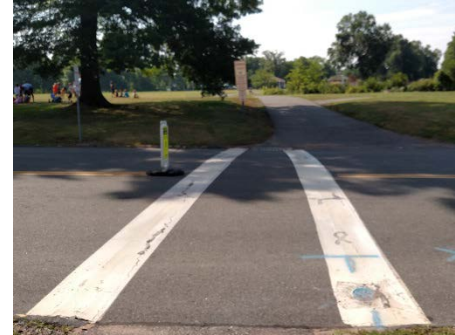
Figure 5. Crosswalk in Front of Town Hall

- The crosswalk across Garfield Street, in front of the Town Hall, is used heavily in the summer by children attending the summer camp crossing between Mill Pond Park and the restrooms at the Town Hall (Figure 5).
 - This crossing has an in street yield crossing sign.
 - This is a mid-block crosswalk.
 - There are no tactile warning strips.
 - The south end of the crosswalk ends in a catch basin.
 - The crosswalk pattern used at this location is the traditional parallel line type.
 - This location would be a candidate for a flashing beacon.
 - There is no sidewalk connection to Mill Pond Falls.

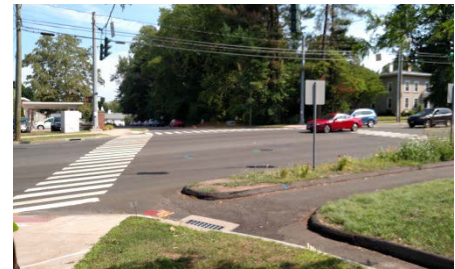
Figure 6. Traffic Signal at the Senior Center

- The signal along Route 175 at the senior center has an exclusive pedestrian phase (Figure 6).
 - The pedestrian signal does not have a count down. It is audible.
 - The travel lanes are 11 feet wide on Route 175 with one foot shoulders.
 - The sidewalks are five feet wide with four foot grass buffers.

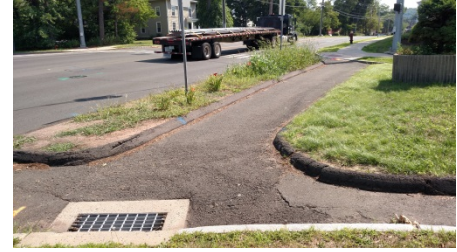
Figure 7. Mazzaccoli Street Connection to Route 175

- The crosswalk on the west side of the intersection is diagonal.
- There is significant pedestrian activity at this location. Six pedestrians were observed crossing within a ten minute period during mid-morning.
- There are tactile warning strips on all ramps.
- Mazzaccoli Street used to connect to this intersection but was closed off and plantings added. A paved strip remains to connect the sidewalk on either side. It is not ADA compliant (Figure 7).
- The Stop sign in the library-town hall parking lot is located on the far side of the pedestrian crossing. It should be relocated to the near side.

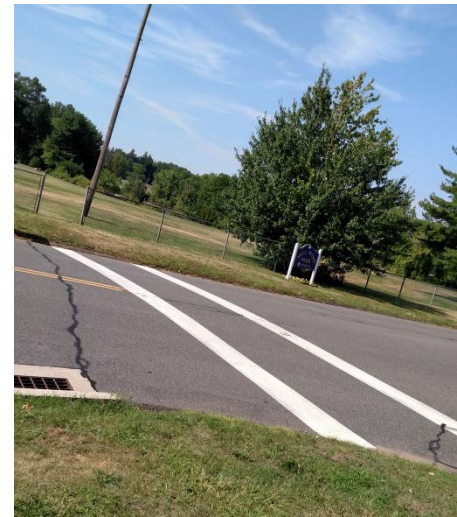
Figure 8. Crosswalk Ends in Grass

- The crosswalk across Garfield Street at Mazzaccoli Street does not have a ramp on the south side. It does not connect to any sidewalk and ends in the grass. On the north side the crosswalk is not aligned with the ramp (Figure 8). There are no tactile warning strips or pedestrian crossing signs.
 - This crossing does not have an in street yield crossing sign.
- The crosswalk across Mazzaccoli Street at Garfield Street is not aligned with the ramp on the east side. There are no tactile warning strips.
- In front of Mill Pond Park there is no parking on either side of the road.

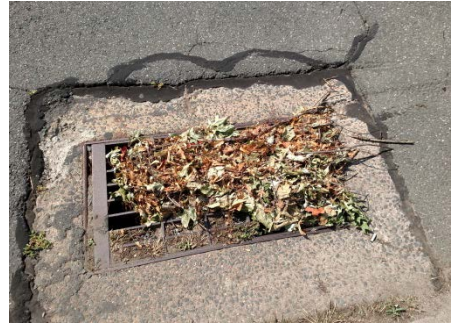
Figure 9. Clogged Non-Bicycle Friendly Catch Basin

- Garfield Street is 34 feet wide. The eastbound lane is 16 feet wide, the westbound is 18 feet.
 - There are no shoulder lines painted on Garfield Street.
 - Utility poles are on the south side (eastbound) of the road.
 - The sidewalk is on the north (westbound) side of the street. It has no buffer/snow shelf or shade east of Mill Pond Park. It is five feet wide and concrete.
 - The curbing is concrete on the north side, and bituminous asphalt on the south side.
 - On-street parking is allowed on both sides of the road west of Mill Pond Park.
 - Garfield Street has a mix of catch basin grate styles, including the non-bicycle friendly style (Figure 9).

10. Replace catch basin grates that are not bicycle friendly with ones that are (Figure 28).
11. Evaluate parking options on Main Street in front of Goldburgers. This should include removing up to four perpendicular spaces and considering reverse angle parking. This will require vehicles to back into the parking stalls instead of backing out into traffic. This may require moderations to the sidewalk bump outs (Figure 29).

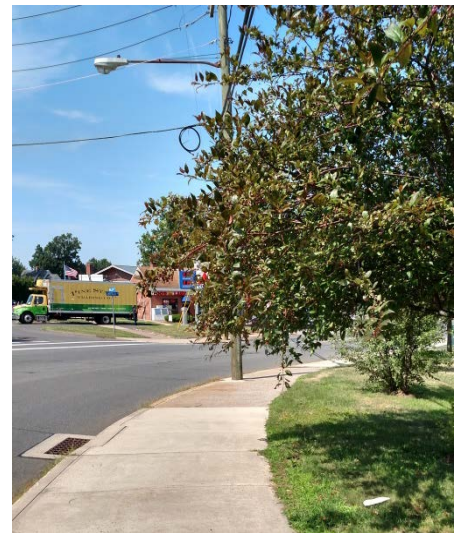
Figure 10. Overgrown Tree branch

- Where Garfield Street becomes Walsh Avenue there was a tree branch overgrowing into the sidewalk path (Figure 10).

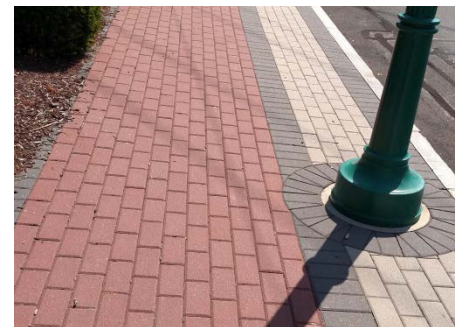
Figure 11. Recent Streetscaping on Market Square

- Market Square was recently reconstructed with bulb outs, raised crossings, streetscaping, parking, and wide sidewalks (Figure 11).

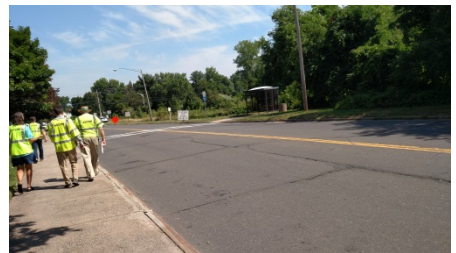
Figure 14. Constance Leigh Drive

- Constance Leigh Drive is a two lane road and has 19.5 foot wide lanes (Figure 14).
 - There are no shoulder lines.
 - There is a mid-block crossing to the CTfastrak bus stop.

13. Provide pedestrian crossing signs on Garfield at Mazzaccoli Way.
14. Paint shoulder lines on Constance Leigh to help reduce speed and provide bicycle accommodation.

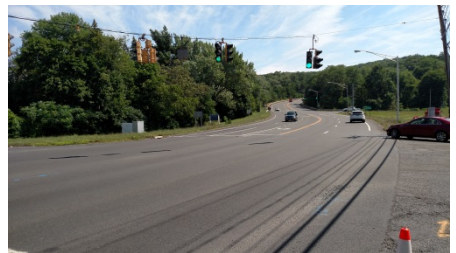
Figure 15. Intersection of Cedar Street and Constance Leigh Drive

- The sidewalk is 6 feet wide, concrete with granite curbing.
- The Route 175 (Route 175) and Constance Leigh Drive intersection is a wide intersection (Figure 15).

- The outside lanes on Route 175 are wider than the inside.
- There are crosswalks across Constance Leigh Drive and on the west side of East Route 175. The crosswalk across Route 175 is on a diagonal.

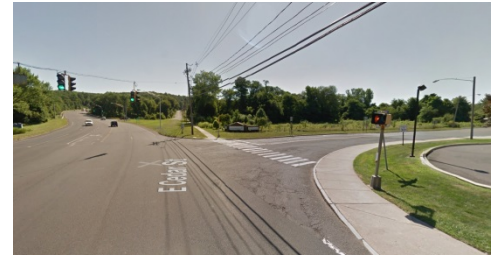
Figure 16. Wide Turning Radius at Route 75/Constance Leigh

- The intersection is wide with larger turning radii on the southwest and northwest corners (Figure 16). This results in long crosswalks and vehicles turning at high speed.

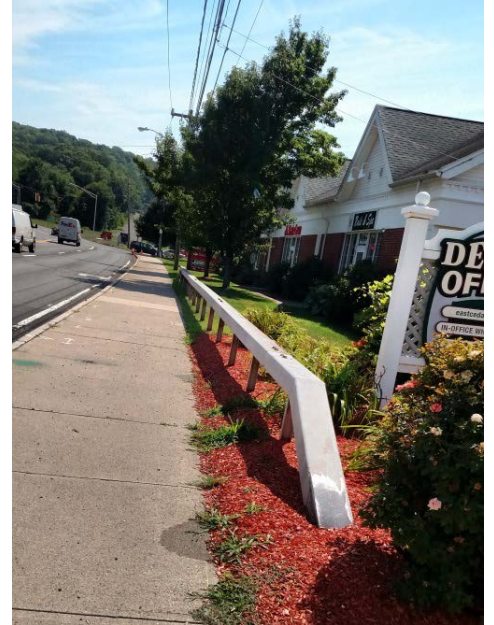
Figure 17. Lack of Buffer/Snow Shelf on the South Side of Route 175

- Along the south side of Route 175 the sidewalk does not have a grass buffer/snow shelf (Figure 17), and the shoulder is only one foot wide. Traffic travels at high speed along Route 175, providing an uneasy feeling for pedestrians on the sidewalk (Figure 18). Figure 18. Route 175 looking west showing little separation between sidewalk and traffic.

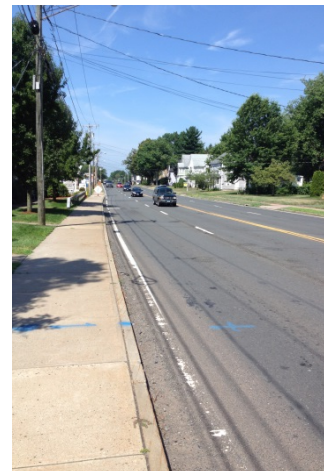
Figure 18. Sidewalk on the South Side of Route 175

Riding bicycles on the sidewalk on Route 175 is not currently discouraged. The sidewalk on Route 175 slopes toward the roadway which is an issue for pedestrians.

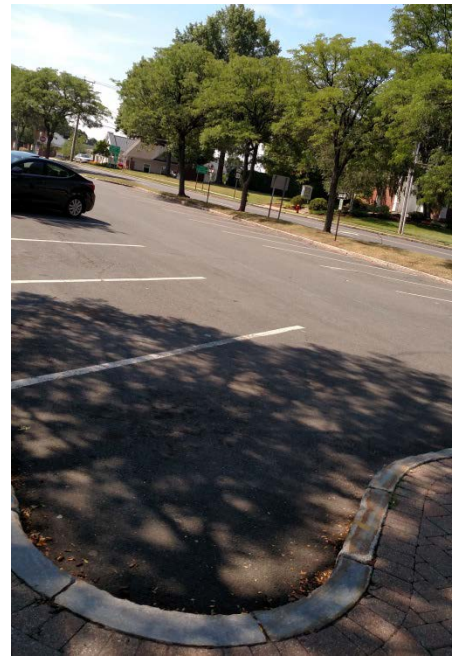
Figure 22. Parking Area Off Main Street Vehicles Use as a Cut Through

- Vehicles attempt to avoid the Route 175 and Main Street intersection by cutting through the one way northbound parking area on Main Street, to turn right onto Route 175.

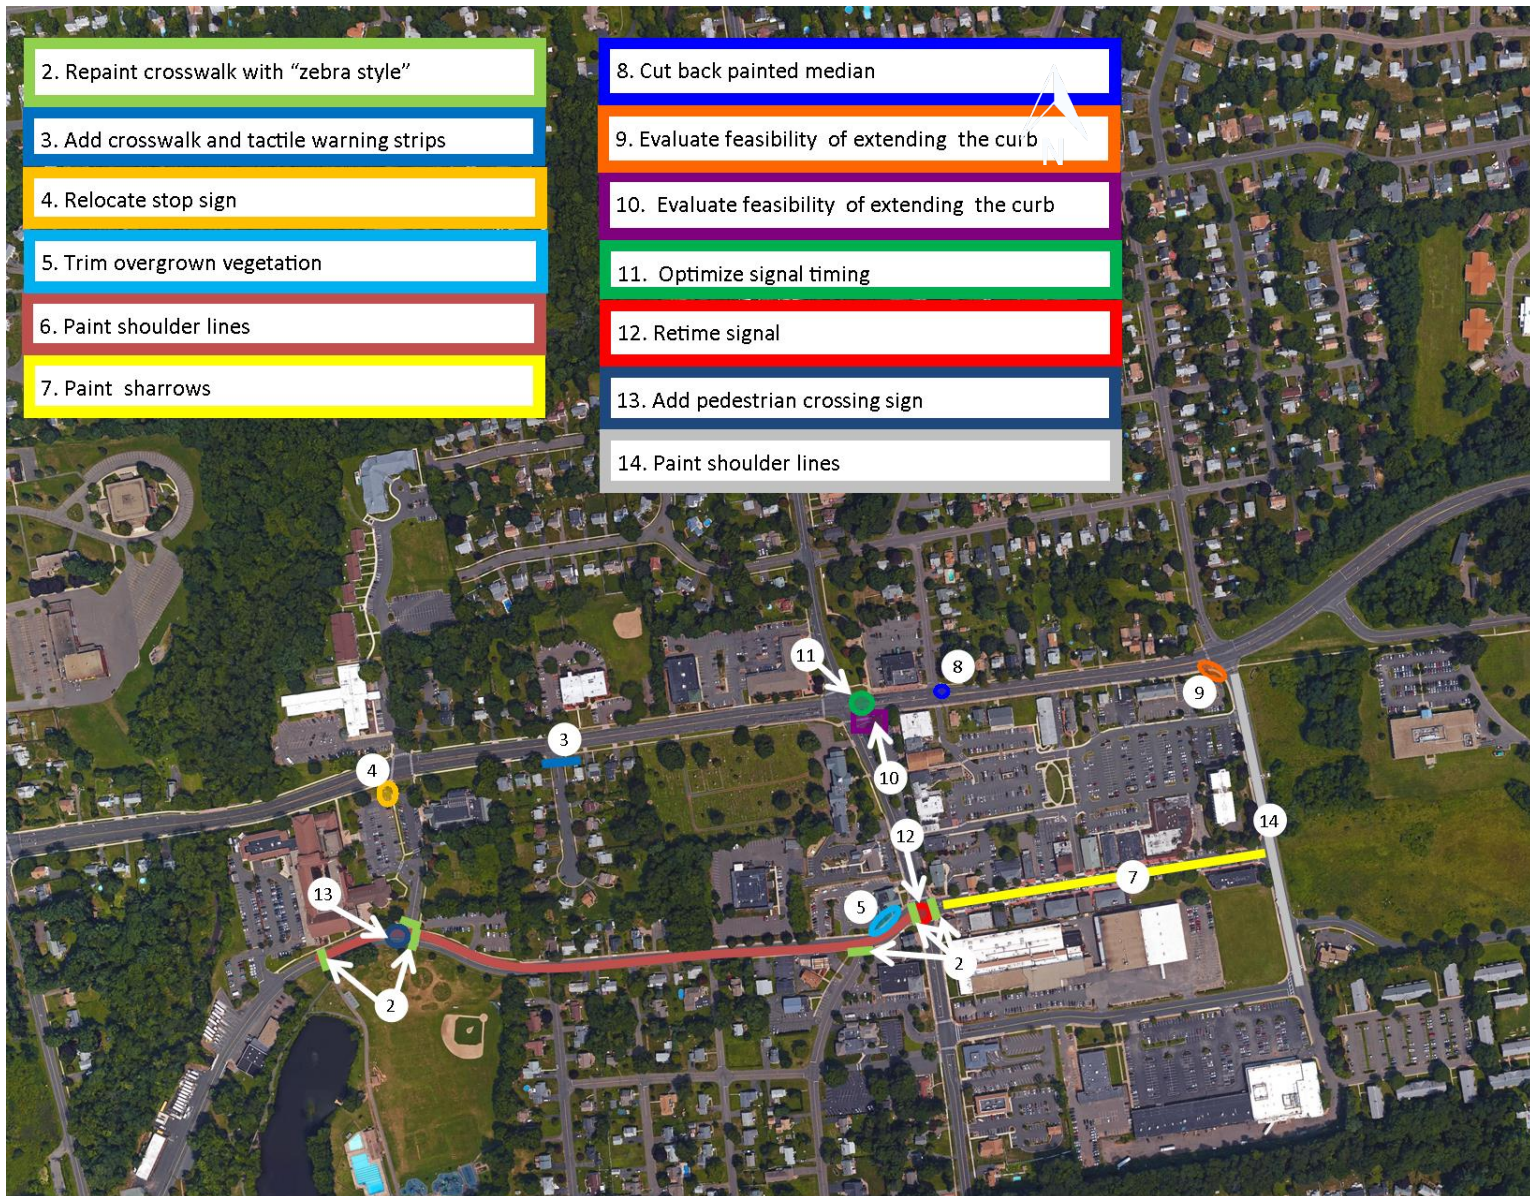
Figure 25. Short Term Recommendations

Figure 25 displays short term recommendations.

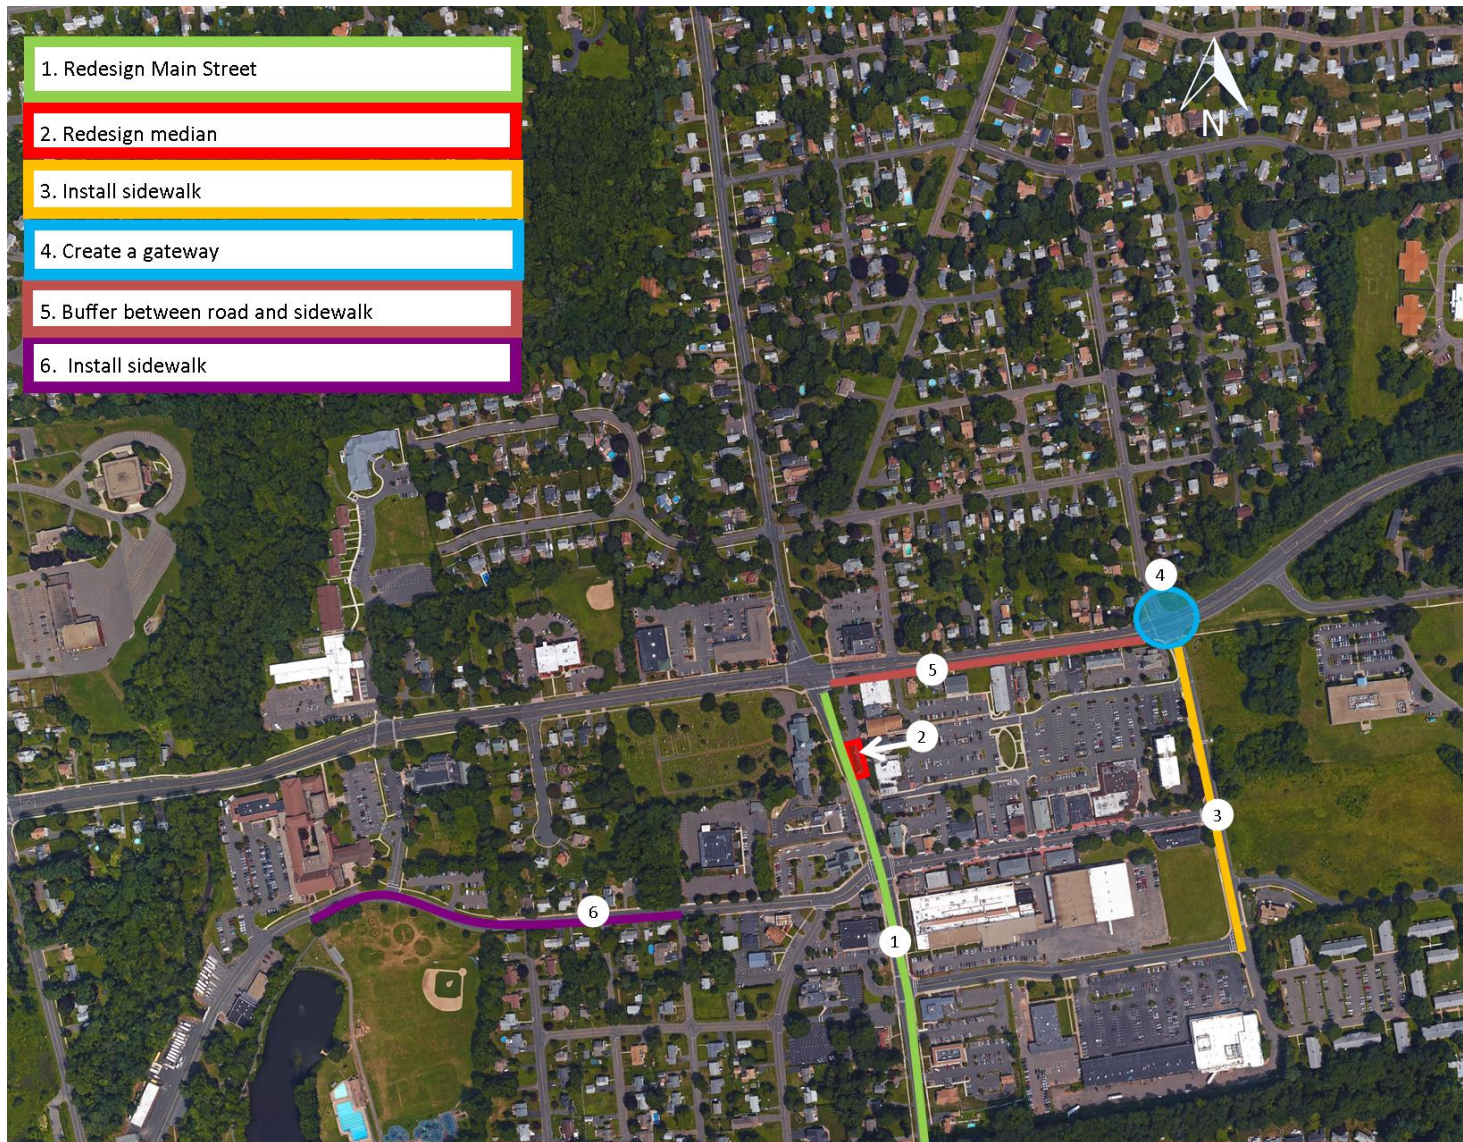
Figure 31. Long Term Recommendations

1. Redesign Main Street between Route 175 and Market Square to eliminate one northbound travel lane and increase bicycle and pedestrian amenities.
2. Redesign the island/median separating traffic from parking on Main Street so that it is not straight making it difficult for motorists to use as a cut through.
3. Install missing sidewalks on Garfield Street.
4. Create a gateway into town at the East Cedar and Constance Leigh intersection.
5. Evaluate options for creating a buffer on the south side cedar Street between the sidewalk and the roadwayRoute 175.
6. Provide sidewalk connection to Mill Pond Falls along Garfield Street.

Figure 31 displays long term recommendations.
