# NORTH BRANFORD ROAD SAFETY AUDIT

ROUTE 22 (FOREST ROAD) & ROUTE 17 (MIDDLETOWN AVENUE)

JUNE 2023

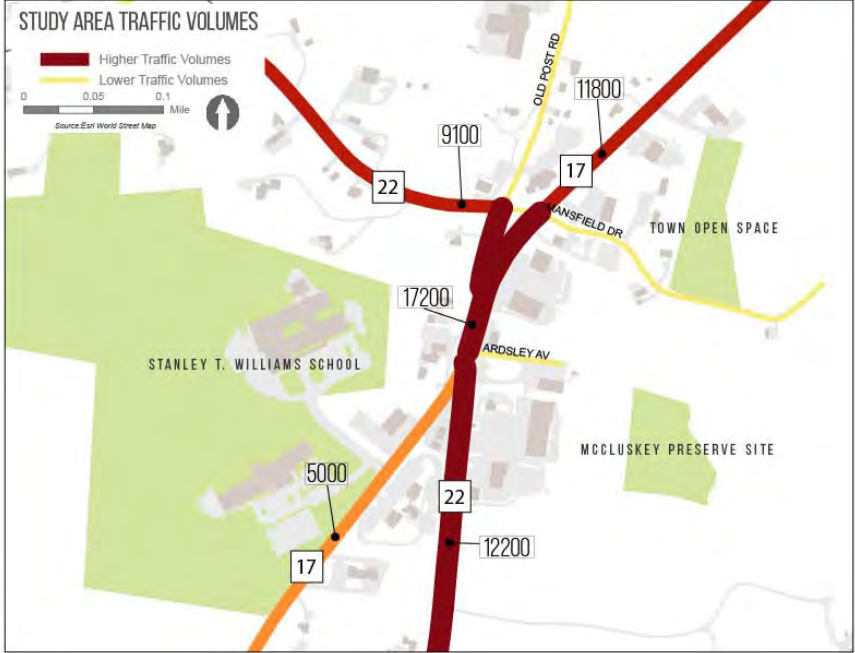
Exhibit 4: Average Daily Traffic (ADT) volumes

Exhibit 4 displays daily traffic in the study area. There are two signalized intersections in the study area, at the intersection of Route 22 and Route 17 at Ardsley Avenue and the intersection of Route 17 and Mansfield Drive near the library. All other intersections are two-way stop controlled, including the intersection of Route 22 with Route 17 north of Ardsley Avenue.

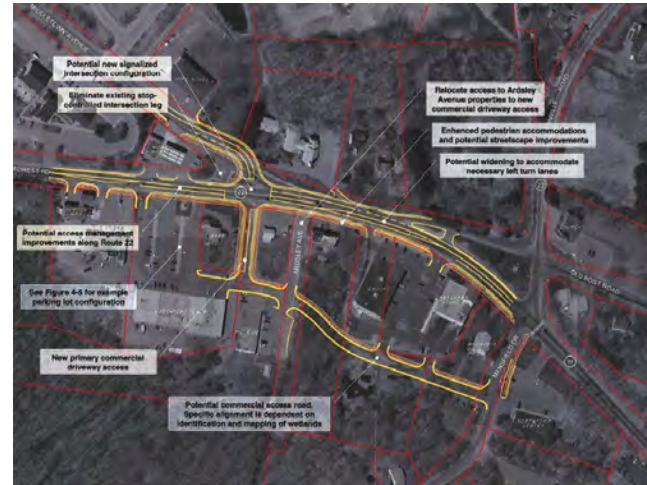
Exhibit 5: Concept A improvements at Route 22 – Route 17 intersection at Northford Center from the SCRCOG Route 22 Corridor Planning Study

The study area has been studied in 2006 by the South Central Regional Council of Governments (SCRCOG) as part of their Route 22 Planning Study. This plan identified issues at both the Old Post Road and Forest Road intersections citing “undesirable and unusual geometry”. The Route 22 and Route 17 intersection at Forest Road and Middletown Avenue cites safety issues for pedestrians and insufficient storage space for tractor trailers resulting in impeded through traffic movements. The study resulted in two concepts for the Forest Road intersection and three concepts for the Old Post Road intersection, see Exhibits 5 and Exhibit 6 for concepts in that plan. Ultimately, none of the concepts at Old Post Road proved feasible. The Forest Road intersection concepts included options for a roundabout and a parallel commercial street to Route 22 and Route 17. The plan can be accessed at [https://scrcog.org/wp-content/uploads/2023/03/2006\\_route-22-Corridor-Planning-Study.pdf](https://scrcog.org/wp-content/uploads/2023/03/2006_route-22-Corridor-Planning-Study.pdf)

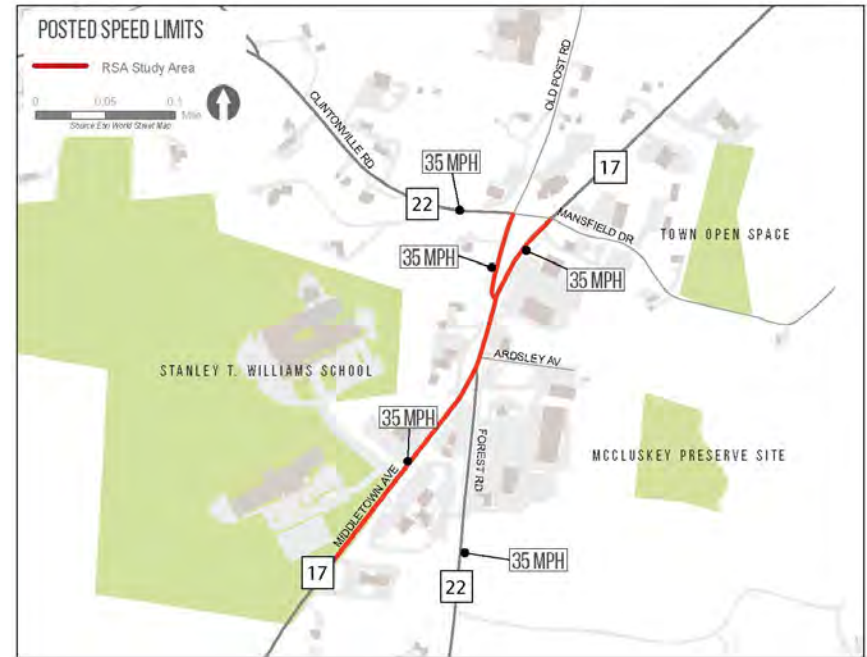
Exhibit 8: Study area speed limits

85<sup>th</sup> percentile speeds were consistent at 38.0 mph on Route 22 throughout the study area from the Recreation Department to Old Post Road. The highest speeds are found on Route 17 near Mansfield drive, where 85<sup>th</sup> percentile speeds are 48 mph.

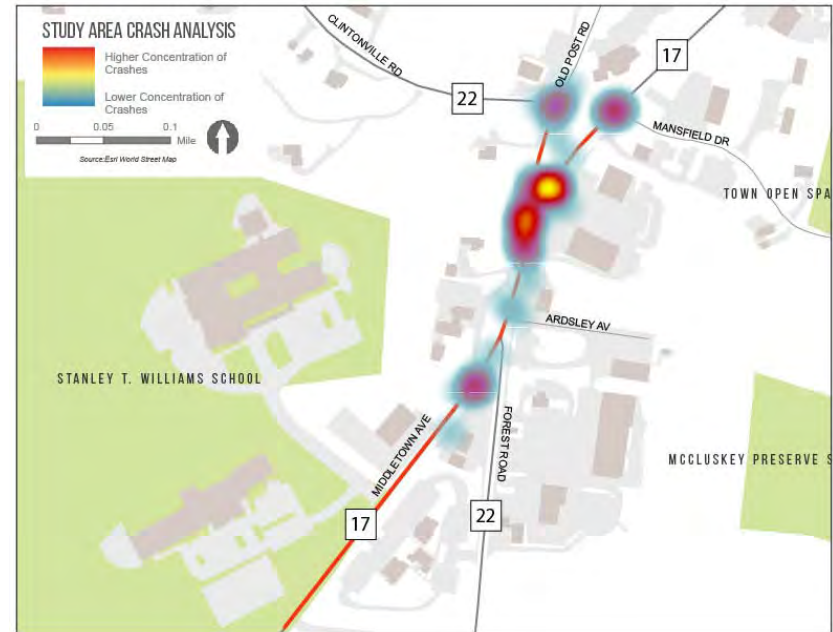
Exhibit 10: Study area crash heatmap

- This area is a crash hotspot on the study area heat map. See Exhibit 10.
- RSA participants noted that they would like to connect this area to the rest of Northford Center for pedestrians.
- CTDOT's Americans with Disabilities Act (ADA) team gave input on how to make access to the school ADA-compliant. See Exhibits 18 and 19.
  - Need for better visibility
  - ADA-compliant ramps and landing areas should be installed at the existing crosswalk shown in Exhibit 19.

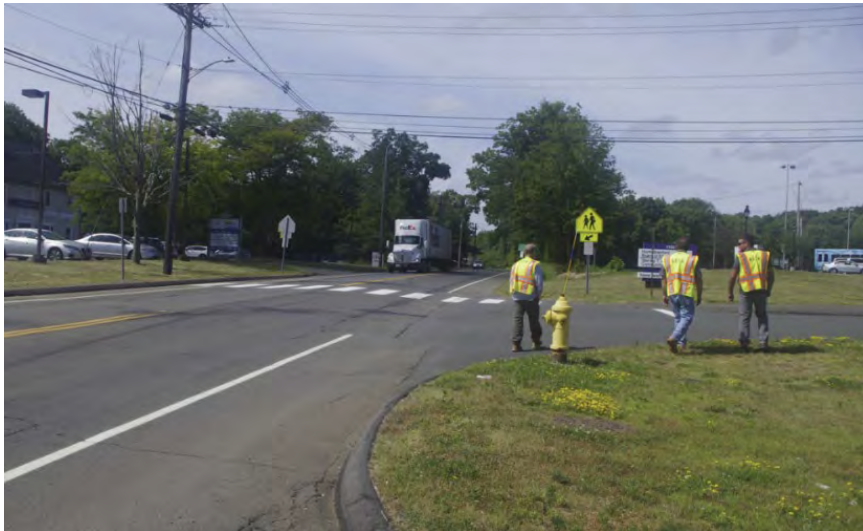
Exhibit 18: Route 17 entrance to Totoket Elementary School and North Branford Recreational Department

- Taking width from the west side of Route 17 should be considered to allow for an expanded sidewalk and bike lane network.
- The RSA team noted at the firehouse on Route 17 and lighting should be considered for better visibility.

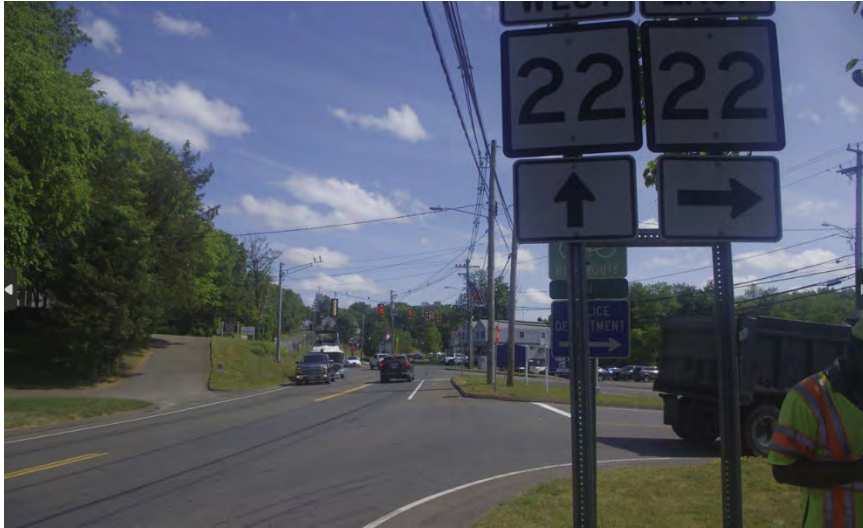
- This intersection is the southern intersection of Route 17 and Route 22 in the study area.
- Participants asked about the amount of curb cuts at the gas station and minimizing access to allow for a better geometry at the intersection.
- Participants also noted the signs at the intersection blocking the bike route sign and their desire for the bike route on Route 17 to be more visible. Exhibit 20 displays the signs.

Exhibit 20: State road markers blocking bike route sign

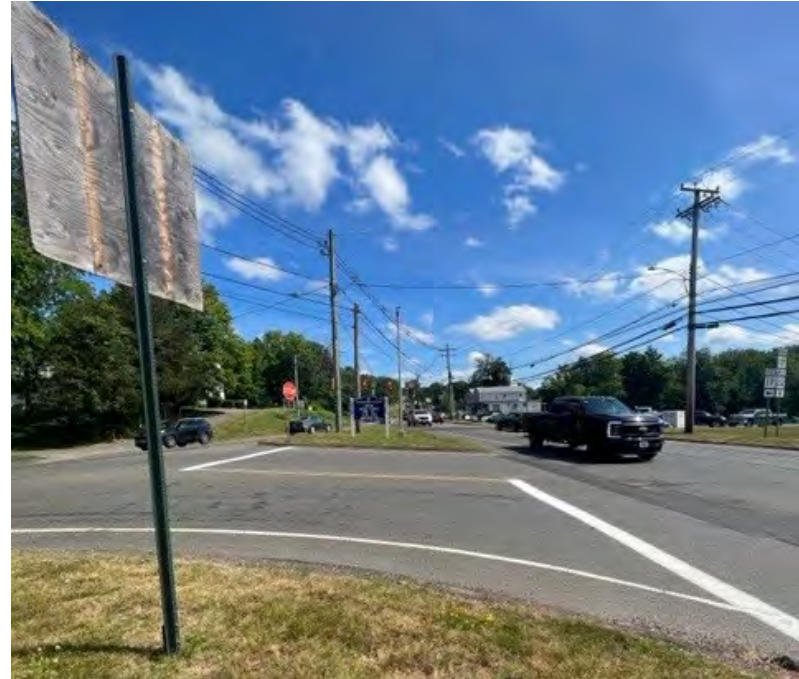
Exhibit 21: Current road geometry of Route 22 and Route 17 southern interchange at Shell gas station

Recommendations at this intersection are focused on providing a safe crossing for non-motorized users, as well as a review of intersection geometry. RSA participants noted results in longer delays for Route 17 vehicles. The gas station at this corner has four driveways and should consider removal or relocation of the driveways to provide space for the reconfiguration of the intersection. Exhibit 36 details an alternative configuration for the Route 22 and Route 17 intersection that could increase safety for vehicles and pedestrians from the nearby school. Route 17 is a state designated bike route, RSA participants noted the need for more bicycle infrastructure to help riders feel safe along this route.

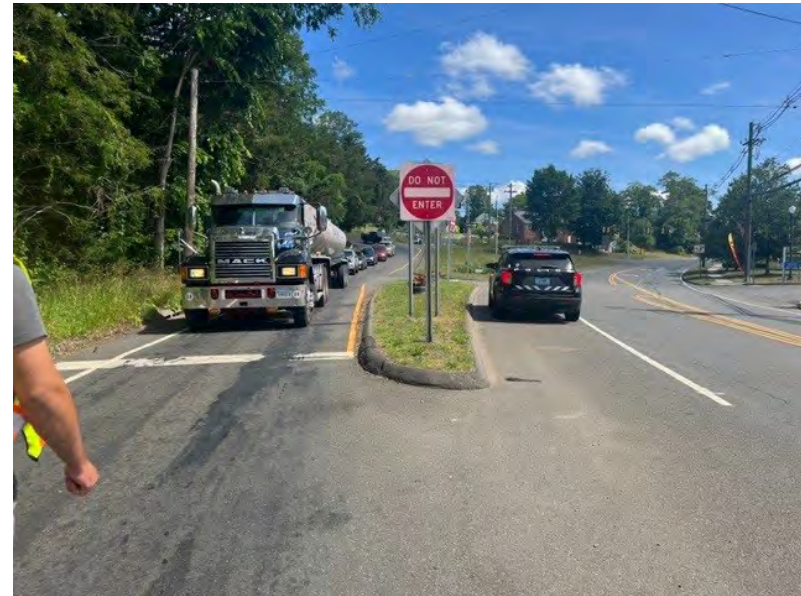
Exhibit 24: Route 17 and Route 22 northern Intersection across from Rite Aid driveway; Left turn lane from Route 22 southbound to turn onto Route 17 northbound

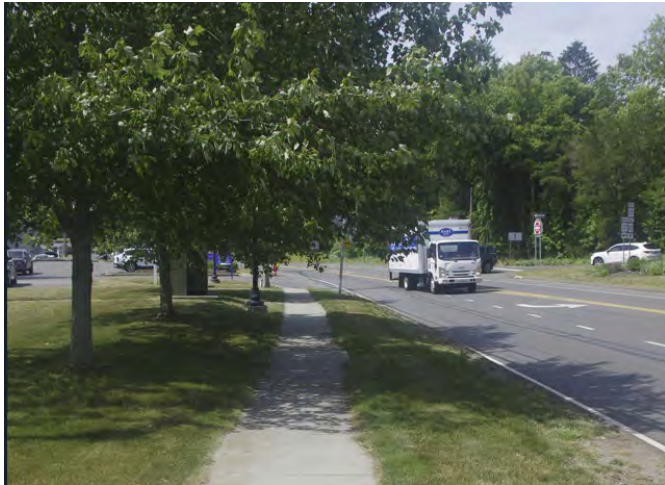
Exhibit 25: Overgrown trees on the sidewalk network approaching Northford Center

- Currently the sidewalk network has both old and new concrete with gaps along the walking route. RSA participants shared concerns about the safety of bicyclists and pedestrians on some areas of Route 22. Exhibit 25 and 26 show obstructions on the sidewalk network that create difficulties for pedestrians in the corridor.
- There is a desire to complete the sidewalk network on the east side of the corridor. Exhibit 27 displays a gap along the east side of the study area.

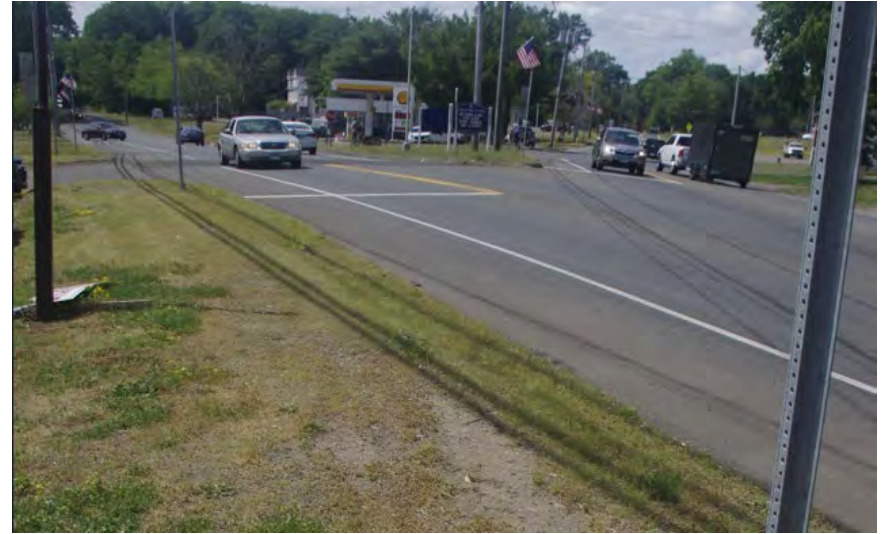
Exhibit 27: No sidewalks near the Ardsley Avenue intersection

Recommendations in this area provide a complete sidewalk network that connects Northford Center to other destinations for pedestrians including the elementary school and the library. This area of the study corridor has multiple curb cuts, and the recommendations include an elimination of a number of curb cuts. Currently the sidewalk network between Mansfield Drive and Ardsley Avenue is in good condition but needs to be extended to Forest Road to the south.

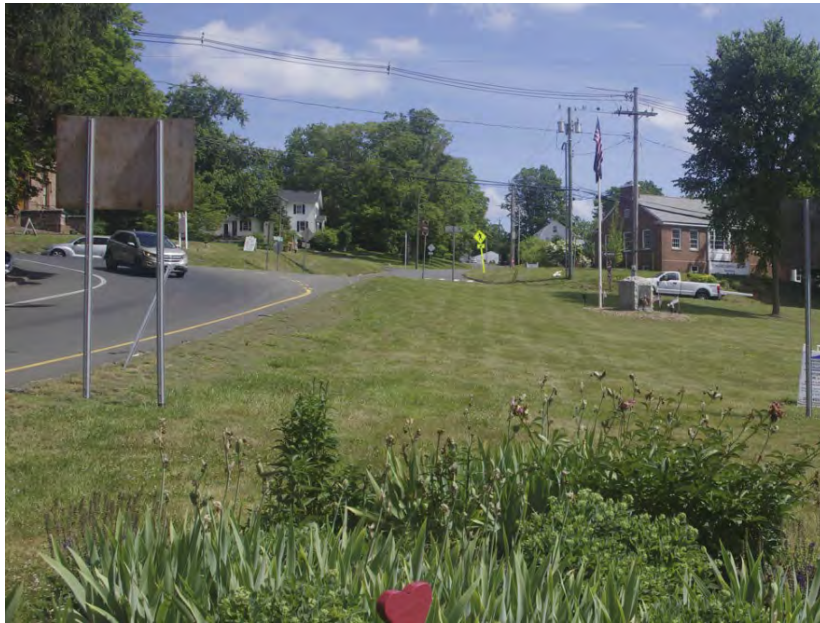
*Exhibit 28: Route 22 Clintonville Road and Old Post Road intersection (Left)*

- 4.7 Route 22 (Clintonville Road) and Old Post Road intersection
- Clintonville Road slopes downward toward the curb near Old Post Road. RSA participants said that this leads to higher speeds along this curve. Sightlines are also a concern at this intersection, as displayed in Exhibit 28.
  - Route 22 southbound experienced long queues during our field audit during non-peak hours. Storage capacity should be reviewed.

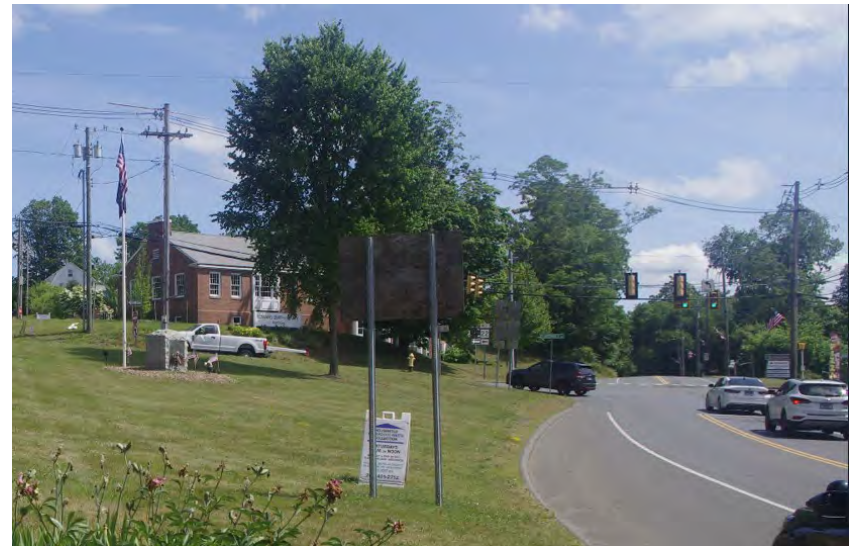
*Exhibit 29: Route 17 and Mansfield Drive intersection on the right*

- The driveway configuration at 1409 Middletown Avenue (Guilford Savings Bank) is located near the stop light causing drivers to not stop at the “stop here on red” sign and block the drive through entrance.
- There is a school bus stop near this intersection that serves about 30+ children per day (*Exhibit 28*)

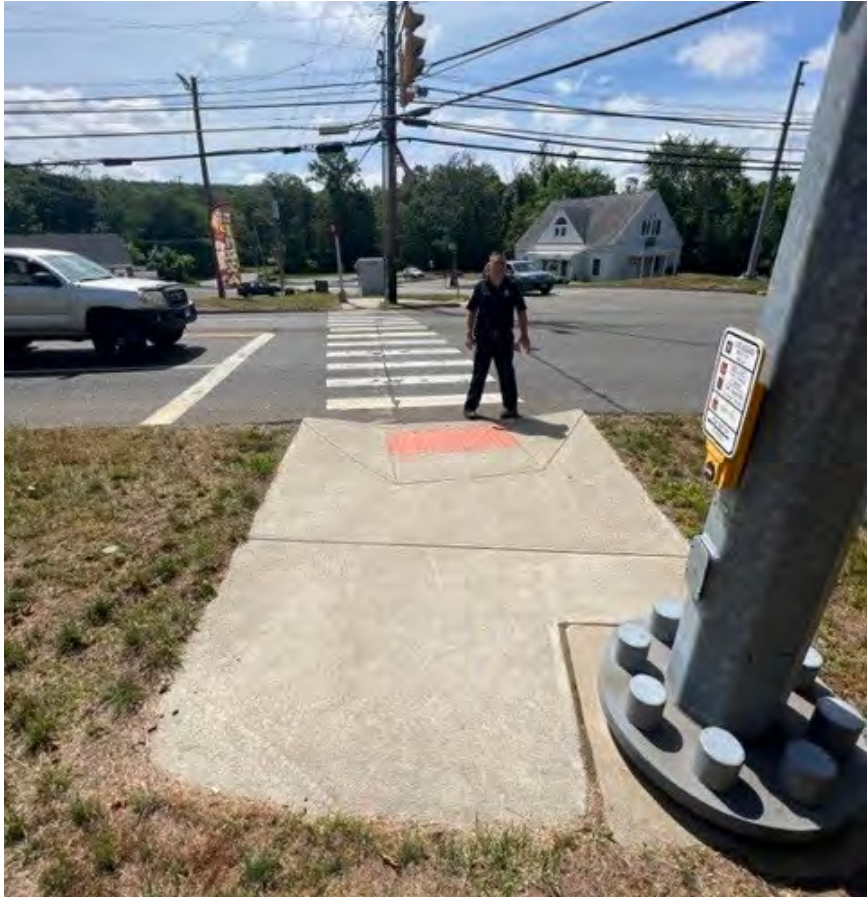
Exhibit 30: View of the crosswalk at Route 17 intersection at Mansfield Drive and bank in the background

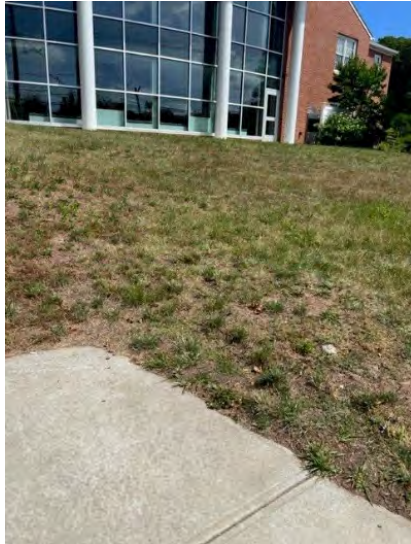
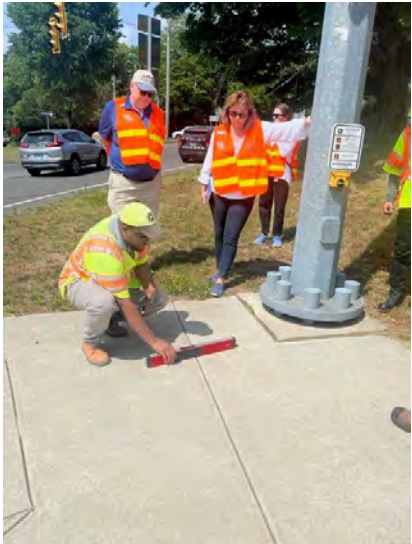
Exhibit 31: Sidewalk connection to the library doesn't exist on the northwest corner of the intersection (left). CTDOT's ADA team checking the slope at the northwest corner

Connect sidewalk to library.

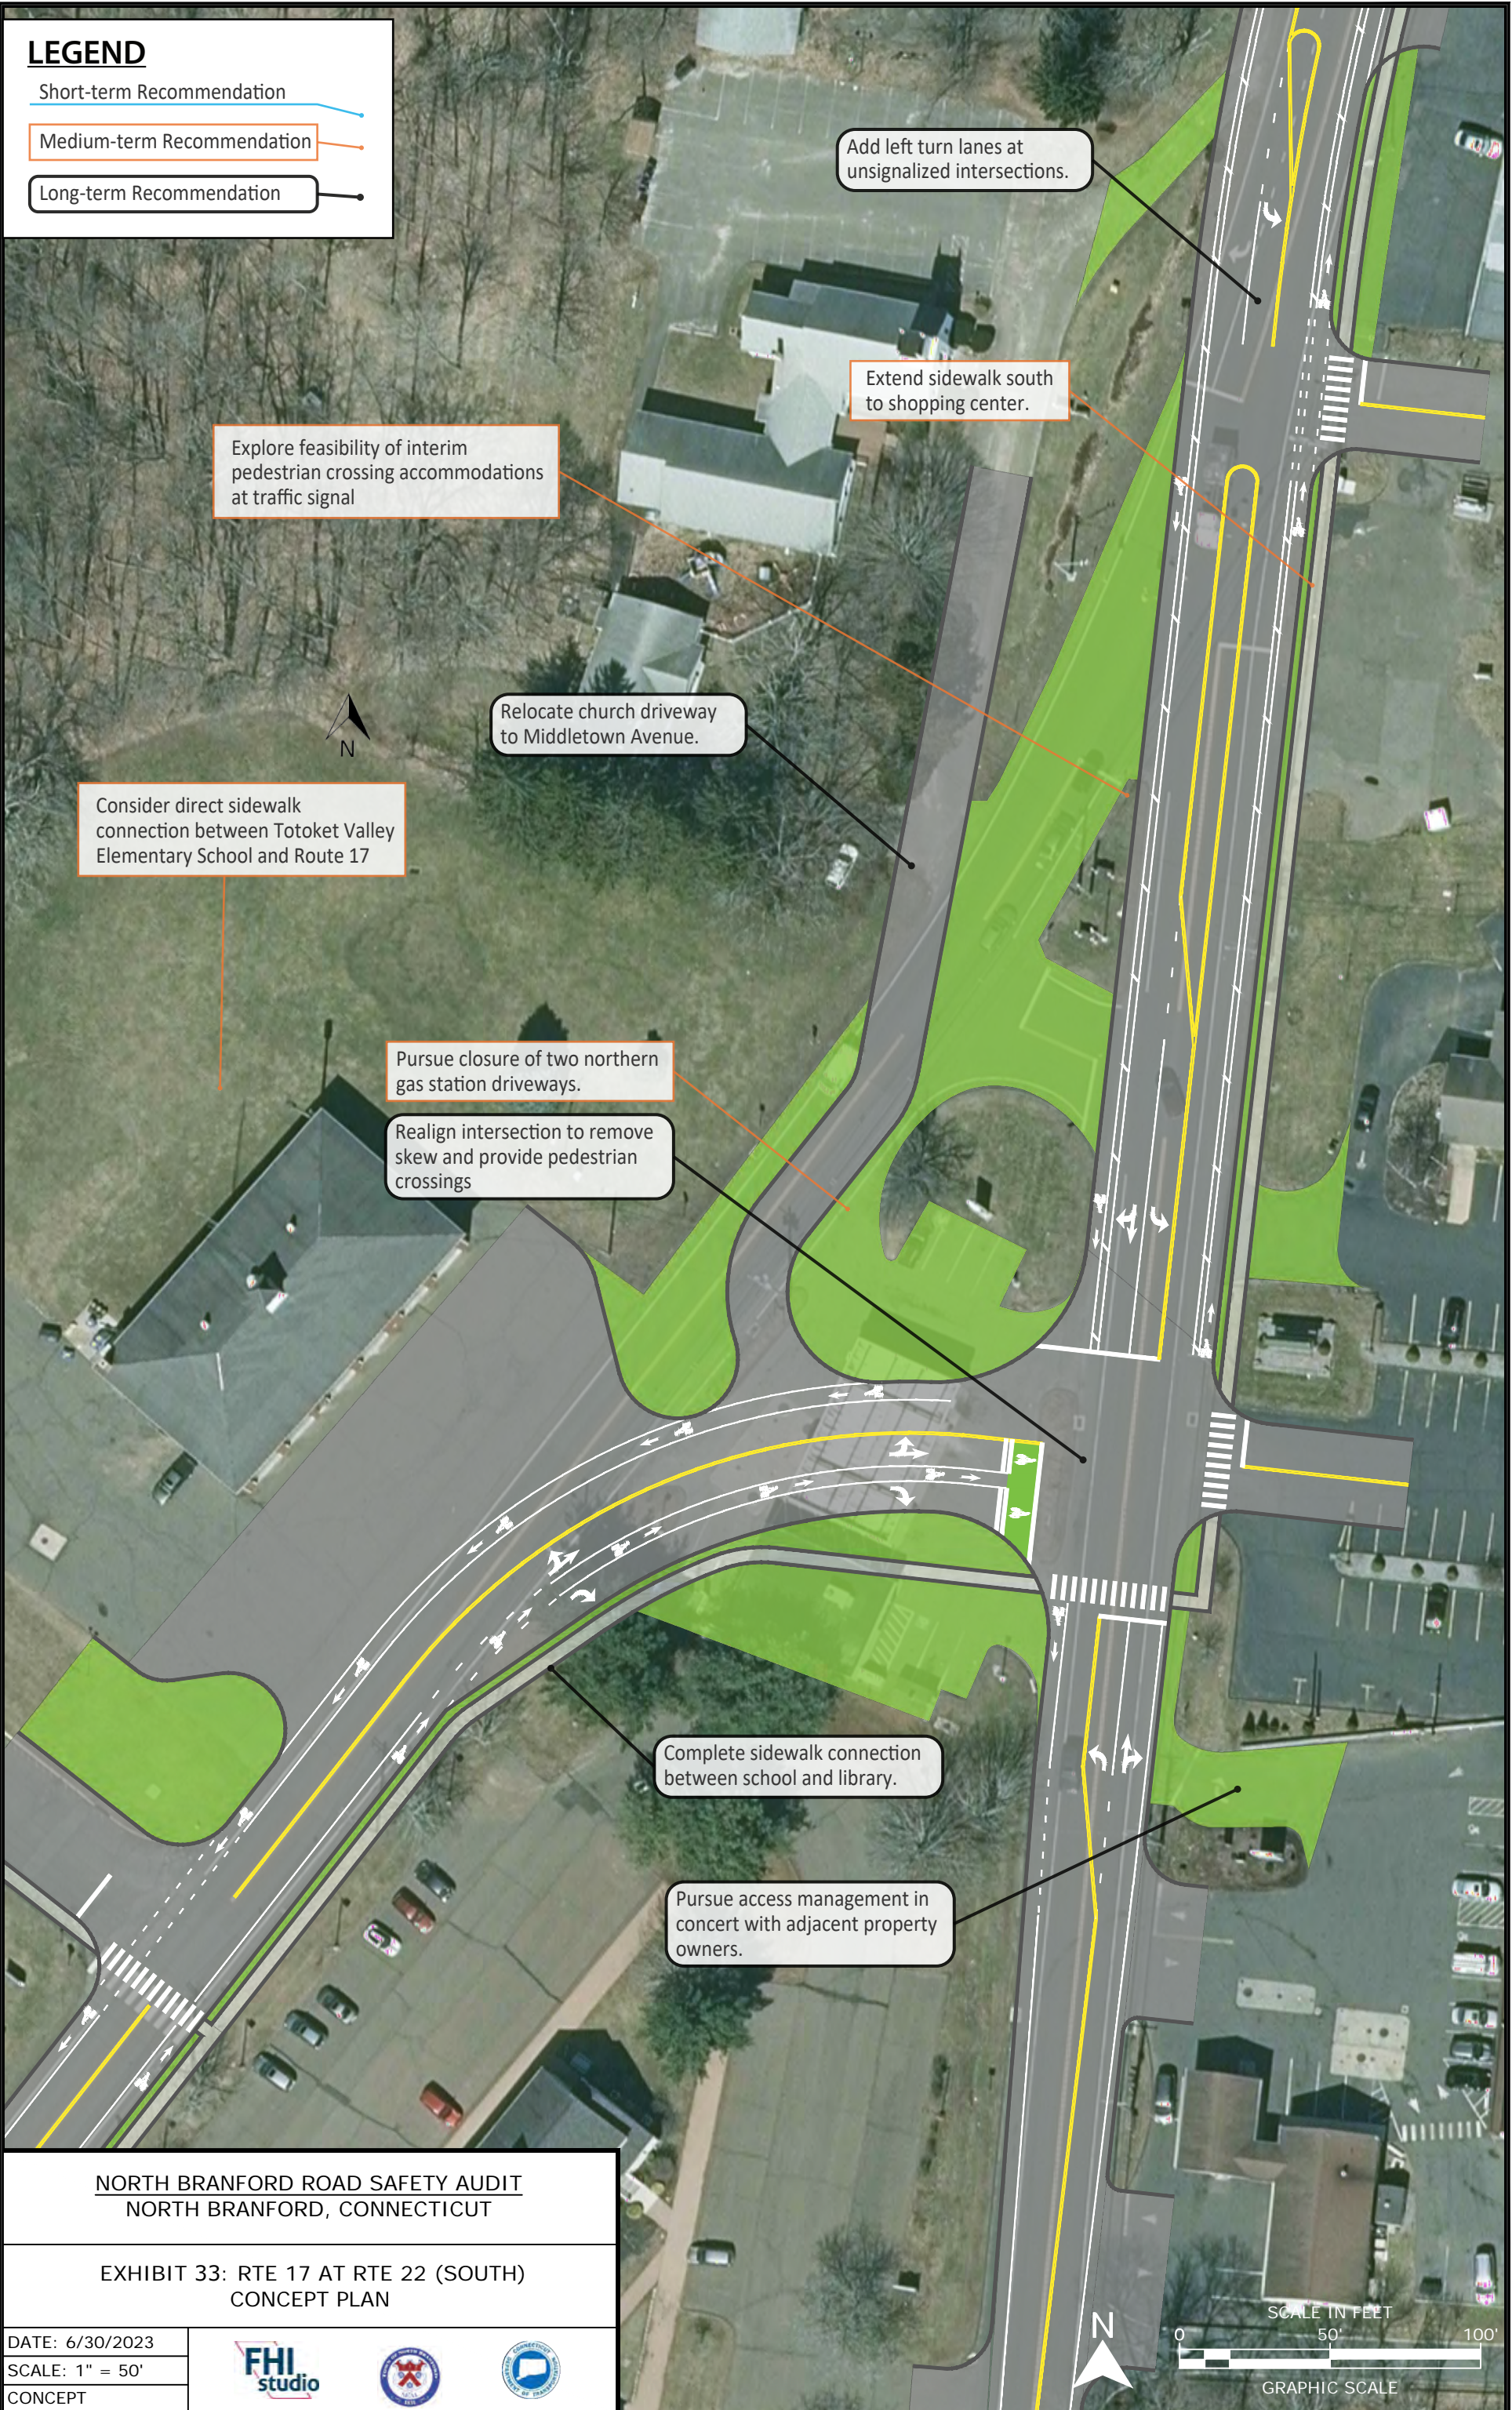
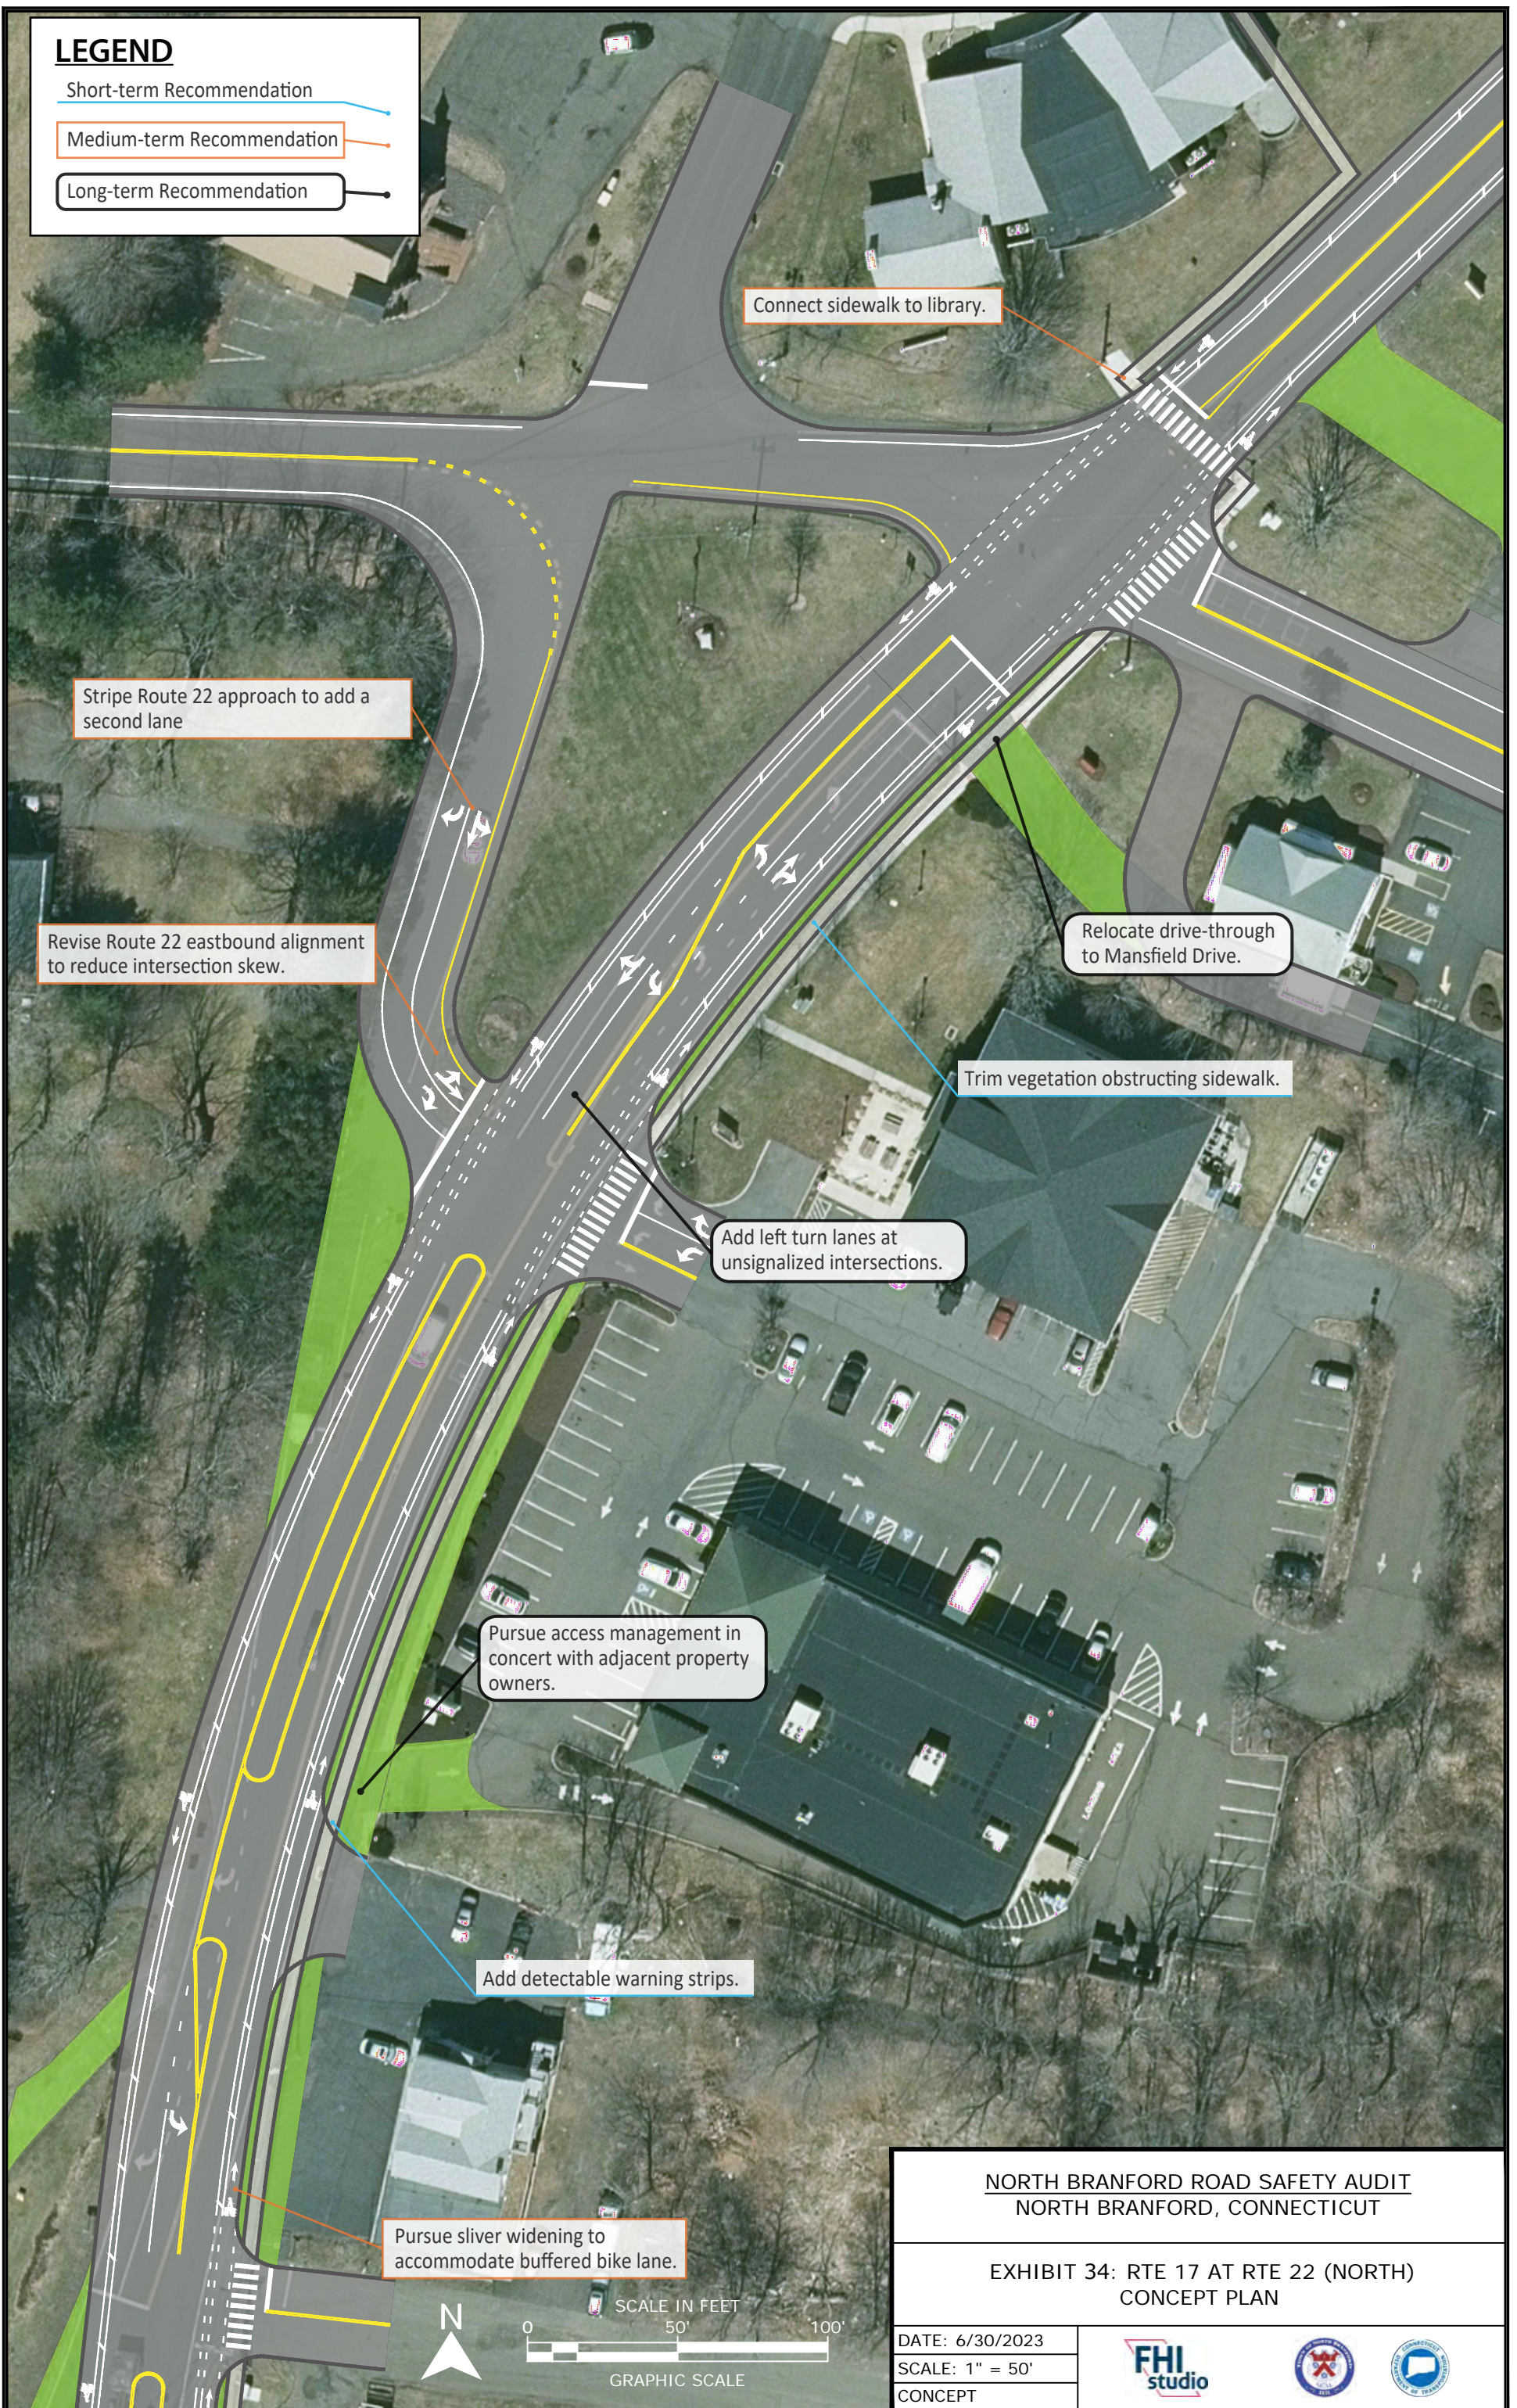
### CT ROUTE 22 (CLINTONVILLE ROAD/FOREST ROAD) AT ROUTE 17 (MIDDLETOWN AVENUE) STUDY AREA RECOMMENDATIONS

Stripe Route 22 approach to add a second lane

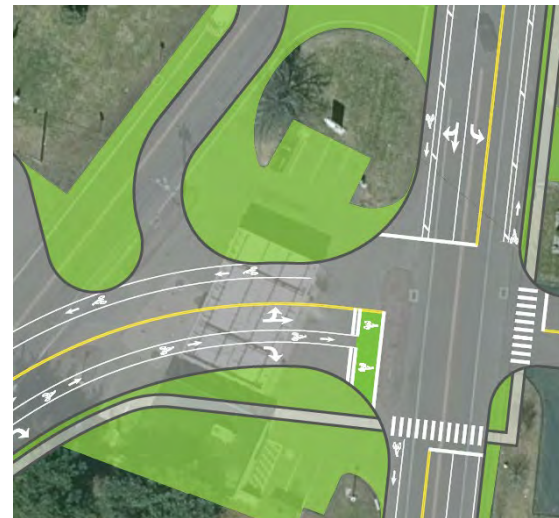
Exhibit 36: Conceptual Plan of the Forest Road and Middletown Avenue intersection

- 1) Add left turn lanes and realign intersection no. 098-201.
- 2) Pursue access management with the gas station.
- 3) Realign southern Route 22 and Route 17 intersection to remove skew and provide pedestrian crossings. This concept is shown in Exhibit 36 and requires a full taking of this property.

This section of the study area is between the Route 17 intersections along Route 22. RSA participants stated the need for church patrons to cross the road for overflow parking. A long-term connection to the east side of the corridor from the church would be safest from the suggested sidewalk network configuration in Exhibit 36.

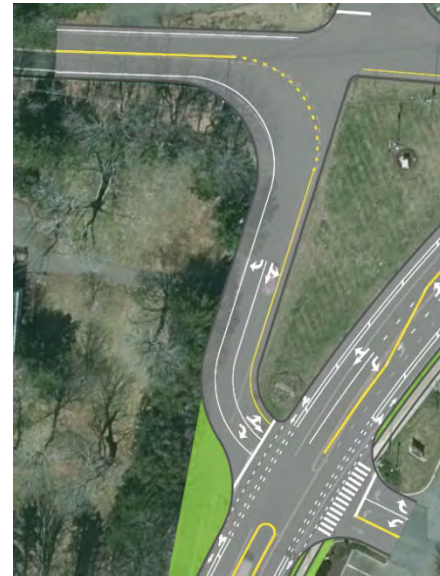
The Route 22 eastbound approach currently gets backed up to Old Post Road. Driver behavior is also a concern with the current configuration of the Route 22 approach to Route 17 with drivers using the slip lane to take a right onto Route 17. A long-term recommendation of reconfiguring this approach should be considered. See Exhibit 37 for a conceptual plan of this approach.

*Exhibit 37: Conceptual plan of the reconfiguration of the Route 22 approach to Middletown Avenue*

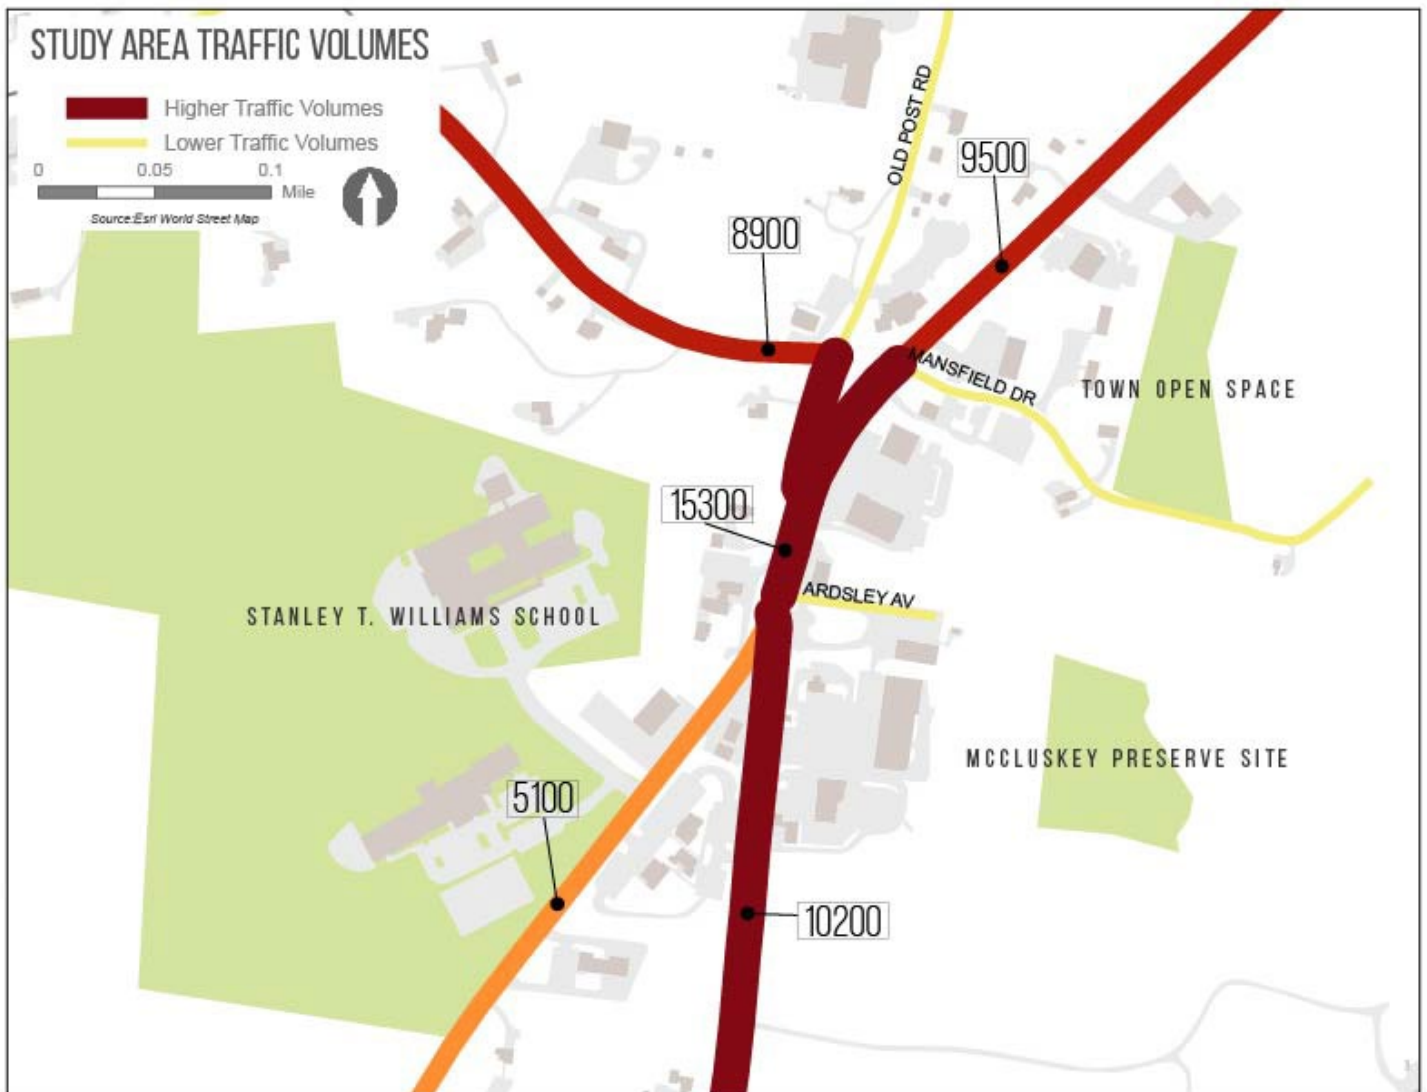
## North Branford Road Safety Audit - Average Daily Traffic Volumes in 2019

- Highest traffic volumes on Route 17 south of Mansfield Drive and Route 22 south of Clintonville Road and south of Ardsley Avenue
- On Route 17 and 22, north of the interchange, volumes decrease. Volume also decreases south of the interchange, towards the recreation department.
- Lowest volumes found on local roads

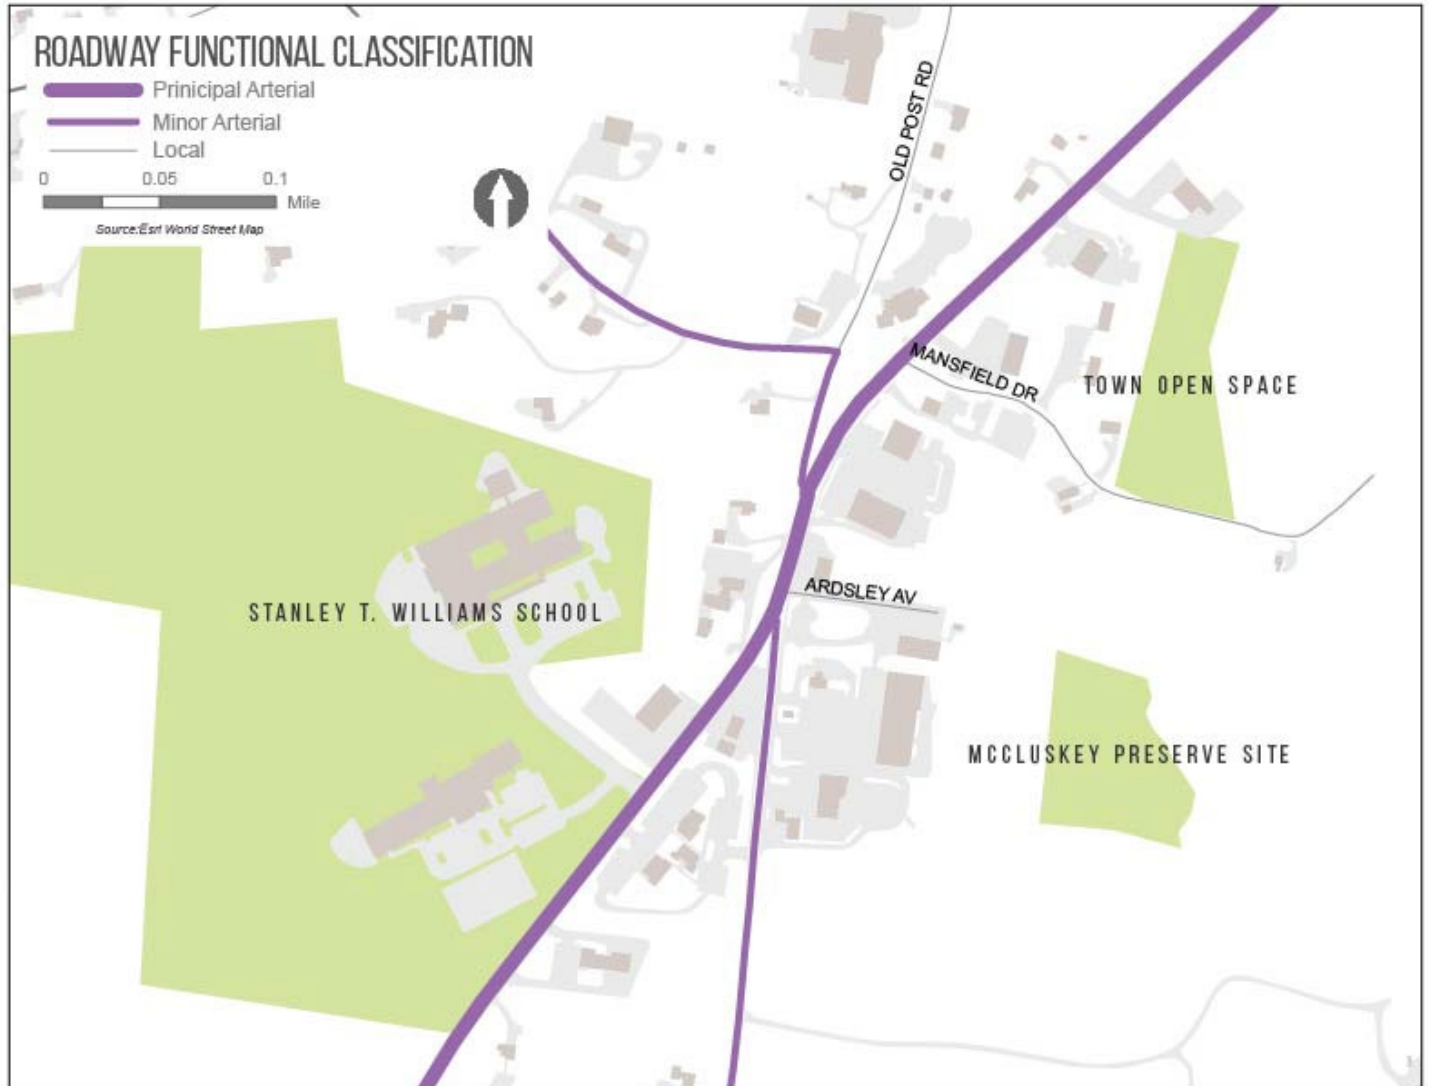
## North Branford Safety Audit – Roadway Functional Classification

- Route 22 is a Minor Arterial and Route 17 is a Principal Arterial
- Many other roadways that intersect the Study Area are local
