U.S. Route 1 – Road Safety Audit

Post Road West, Post Road East, and State Street East

September 12, 2018

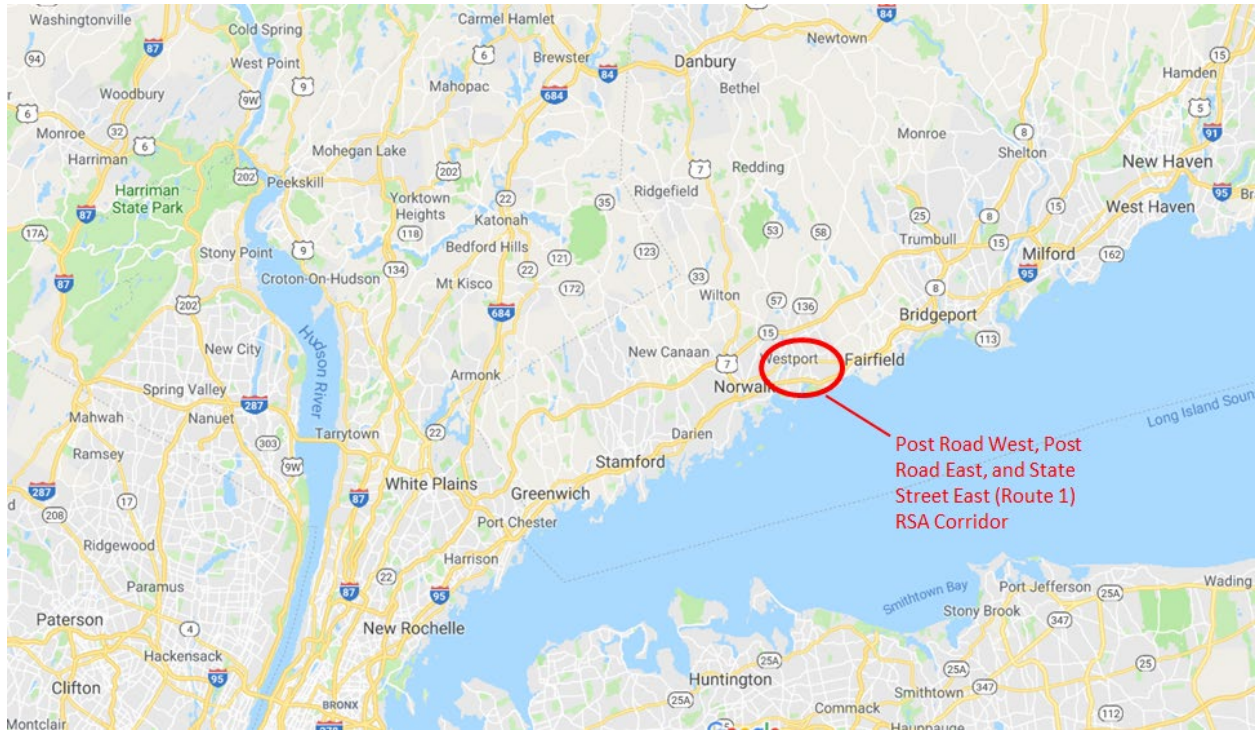
Figure 2. Study Area – Regional Context

The RSA corridor includes Post Road West, Post Road East, and State Street East (Figure 1). Figure 2 shows the study area in a regional context. Route 1 is classified as a principal arterial and runs parallel with Interstate 95. The Average Daily Traffic (ADT) on Post Road West is between 13,200 and 23,400 vehicles per day (vpd), Post Road East is between 21,700 and 24,500 vpd, and State Street East is 22,900 vpd. These are considered moderate to high volumes for suburban/urban roadways. The corridor has two lanes in each direction. All major intersections throughout the study area are controlled by traffic signals.

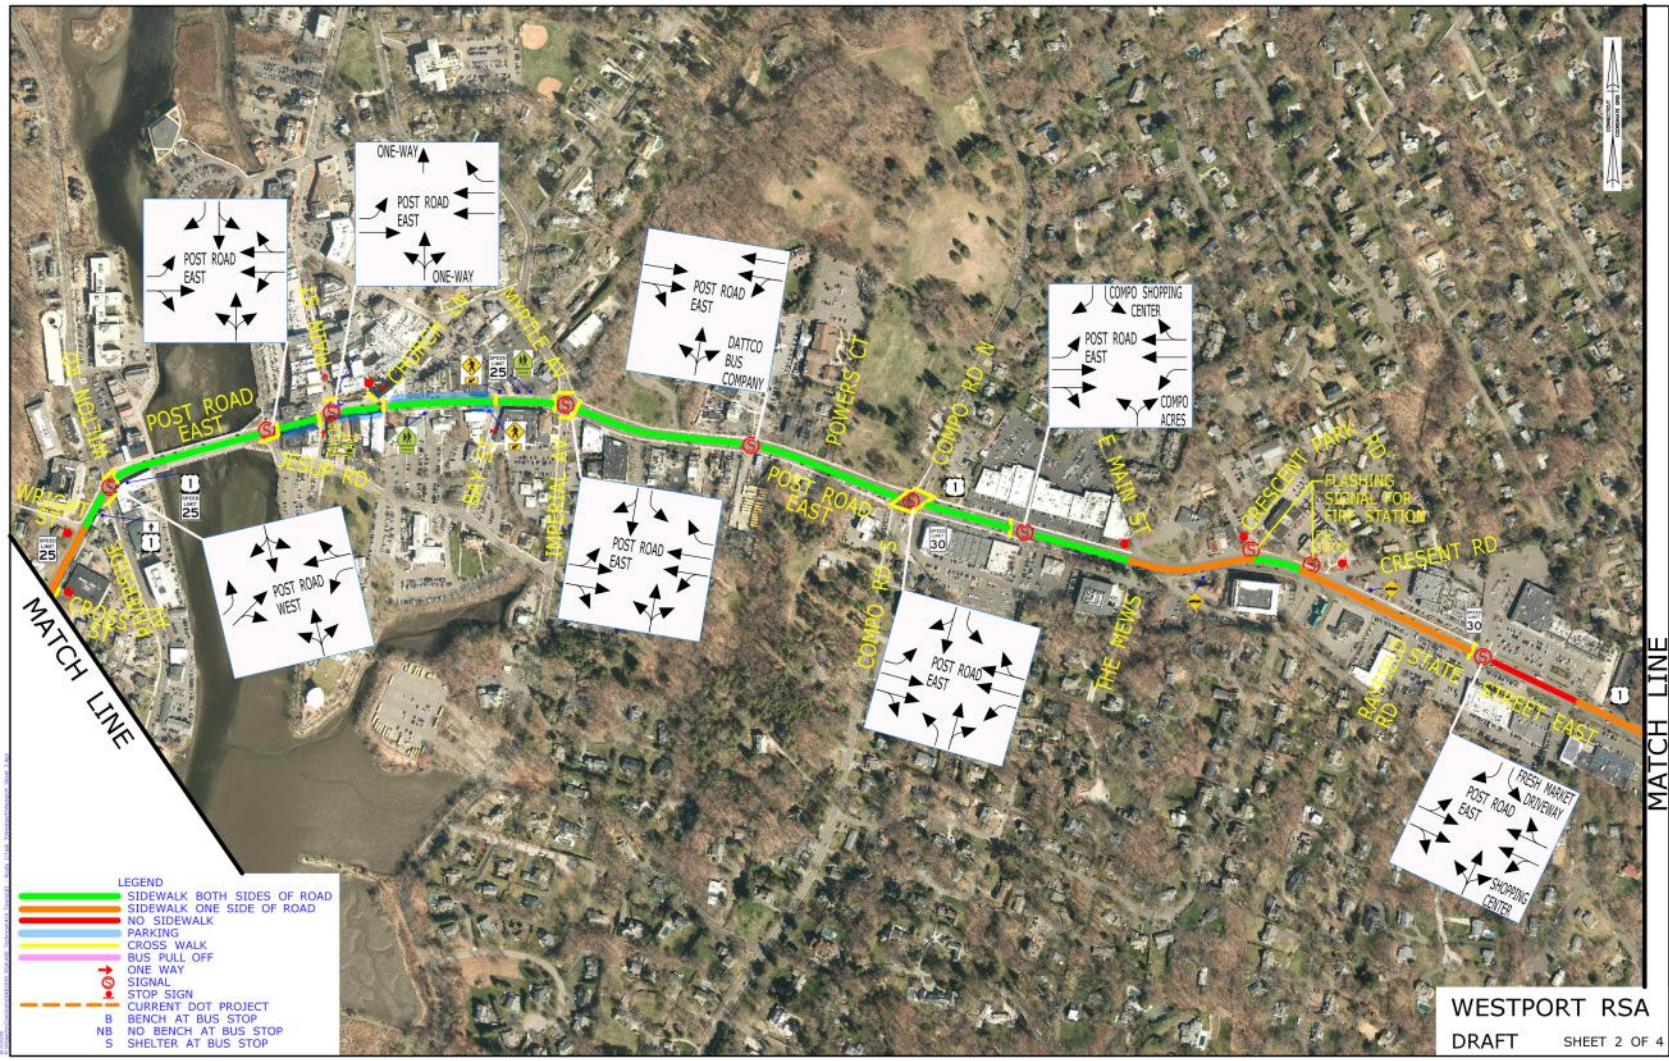
Figure 6. Post Road East, Westport Route 1 - Road Geometrics

Roadway geometrics for study corridor roadways and intersections are shown in Figure 5, Figure 6, Figure 7, and Figure 8. An inventory of existing conditions of the intersections can be found in Table 3 and Table 4.

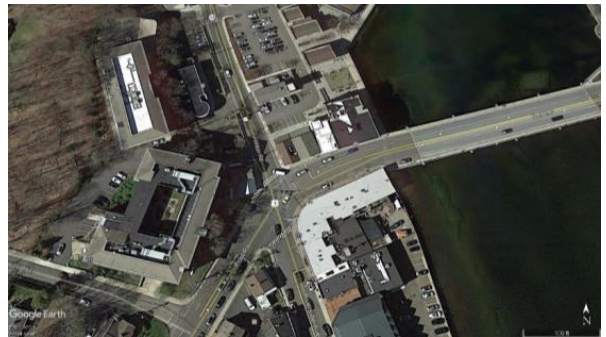
Figure 9. Aerial of Wilton Intersection

- Four-way signalized intersection.
- Eastbound US-1 congestion due to the single through lane.
- Travel lane reduction and high vehicular volume causes bottle necks.
- Westbound US-1 left turn only lane causes back up and is a major site of traffic violations. Thru traffic illegally uses exclusive left turn only lane. This is enforced daily according to local law enforcement.
- Some traffic violations in westbound lanes are due to lack of adequate advanced traffic signage and pavement markings. Signage and pavement markings don't alert drivers as to which lane they need to be in for the direction they wish to go.

- b. Restripe for two lanes for eastbound traffic east of signal (2019 CTDOT VIP program to improve markings).
 - c. Continue to enforce traffic violations at intersection.

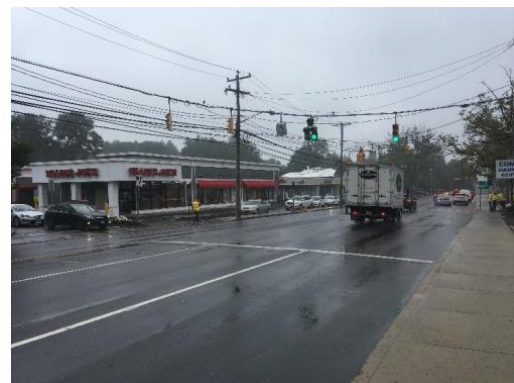
Figure 10 Skewed four-way intersection

- Skewed four-way signalized intersection (Driveways are located opposite and offset from each other) (Figure 10).
- There is a crosswalk with push buttons to call the side street phase. There are auxiliary

pedestal mounted signals placed to provide visibility for the pedestrians.

- Signal timing appears to be inefficient.
- Poor drainage noted at crosswalk.
- Ramp on north side is not ADA compliant.
- Signal equipment encroaches on useable sidewalk area.
- District office will be contacted for information on age and plans of signal at Trader Joe's.

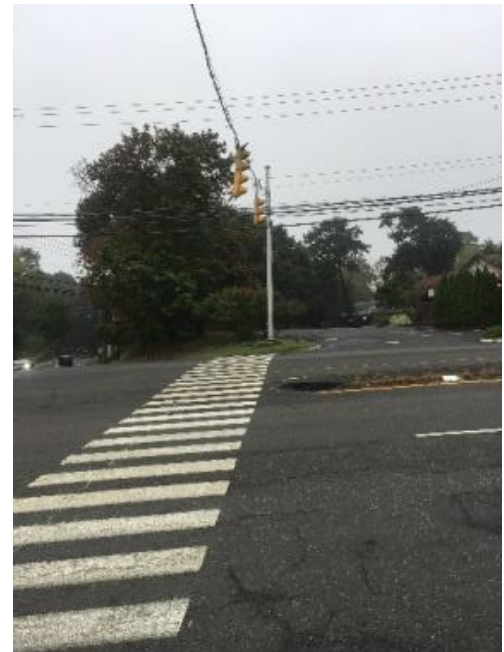
Figure 11. Crosswalk Missing ADA Ramp

- No ADA compliant ramps installed at this time (Figure 11).
- The pushbuttons are not accessible, and are set back from the paved surfaces. Pushbuttons call the side street phase. Auxiliary pedestrian signals are not provided since side street signal faces are visible to crossing pedestrians.

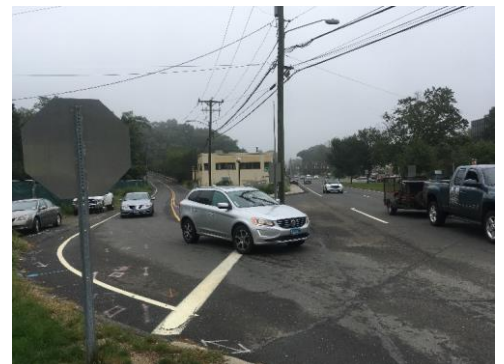
Figure 12. Skewed Stop-controlled T-Intersection

- US-1 is bifurcated between the Sherwood Island Connector and Roseville Road.
- Skewed stop-controlled T-intersection (Figure 12). Traffic can enter Long Lots Road from

either direction, but traffic onto US-1 must turn right. Channelizing island on Long Lots Road has very low curbs and a utility pole in the center of the island.

6. US-1 and Long Lots Road
 - a. Present development on the north side of US-1 on the east and west sides of Long Lots Road should improve the geometry of the intersection, remove the utility hazard and complete a significant amount of missing sidewalk.

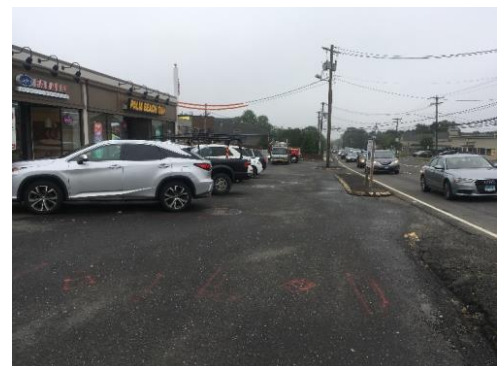
Figure 13. Nose in Parking

- Crosswalks do not align properly with ramps; some miss the ramp location completely. No tactile warning strips are provided.
- Parking at stores on north side of Post Rd is nose-in, angled (Figure 13), separated from US-1 by a paved median roughly 4 feet wide. There is no dedicated pedestrian path.

- There is also perpendicular parking on Maple Street, with parked vehicles pulling in and out directly from the roadway.
- There is also no sidewalk in front of the retail stores.

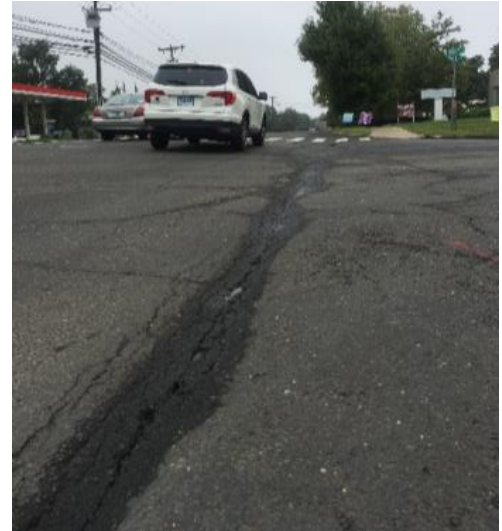
Figure 14. Uneven Cracked Pavement

- There is an elementary school to the north of US-1 on Maple Avenue.
- Congestion is heavy on southbound Maple Avenue at arrival and dismissal times.
- Pavement is uneven and there is a significant dip travelling from Maple Ave over US-1 (Figure 14).
- There are multiple, large curb cuts for retail access on north side of US-1.
- The north-east corner radius is undefined. The store parking continues around the building with no definition of a corner edge of road. Plans are to close off the parking area and to add sidewalks along US-1 as part of the redevelopment of this site.

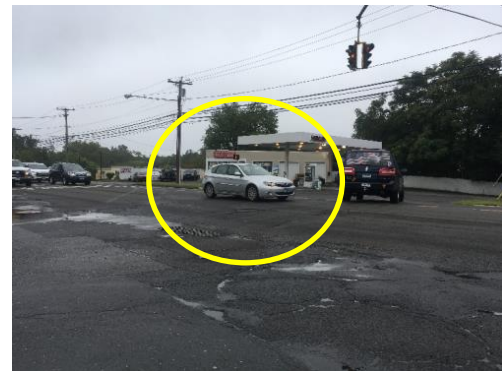
Figure 15. Vehicle Mid-Intersection When signal Turns Red

- Four way skewed, signalized intersection with exclusive pedestrian phase.
- US-1 measures 56' across
- Stop bars on US-1 are set back because of the offset at the intersection.
- There is a gravel median on Bulkley Avenue north of US-1. It seems feasible to relocate the island to the west and revise the geometry to align the intersection. Utility pole looks as though it would not need to be moved.
- Marked crosswalks on Bulkley Avenue are not provided.
- US-1 has pedestrian countdown signals; the pedestrian heads do not show all countdown functions such as the walk symbol.
- Cars weave at north side of intersection due to the island.
- Current crosswalk is not level enough for ADA compliance.
- Cars were seen to be trapped mid-intersection when the signal turns red (Figure 15).

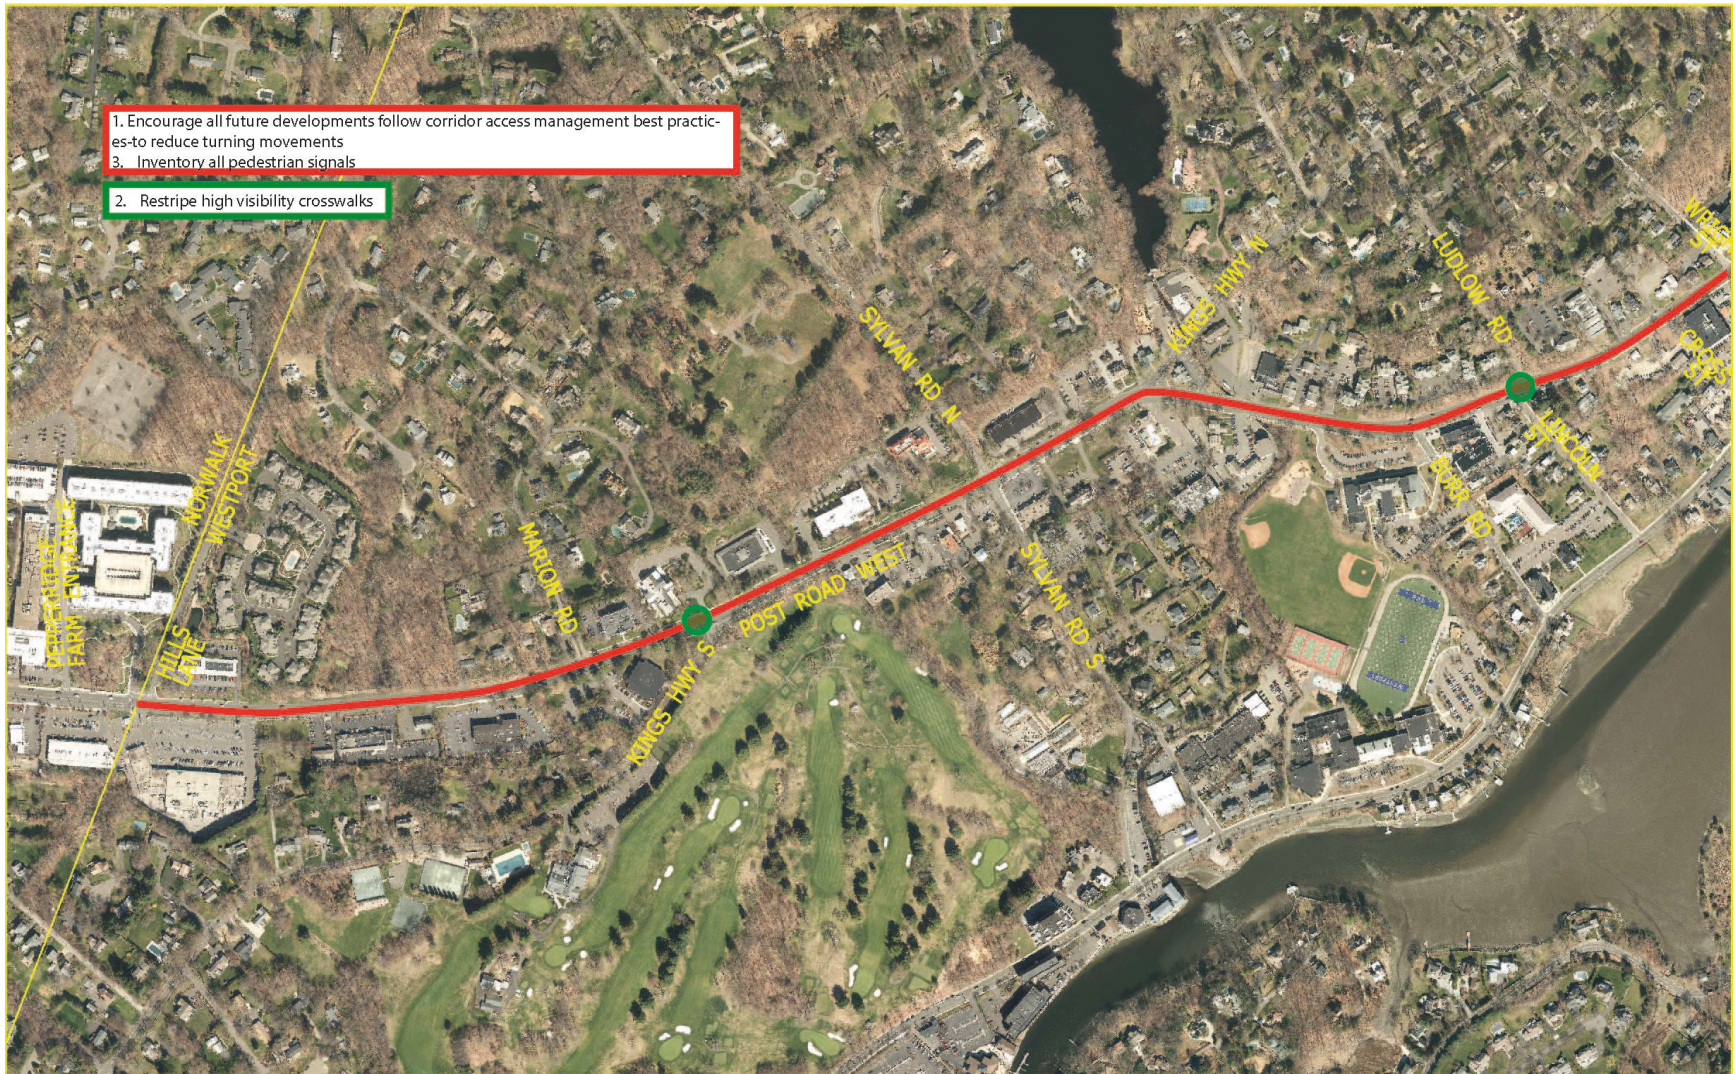
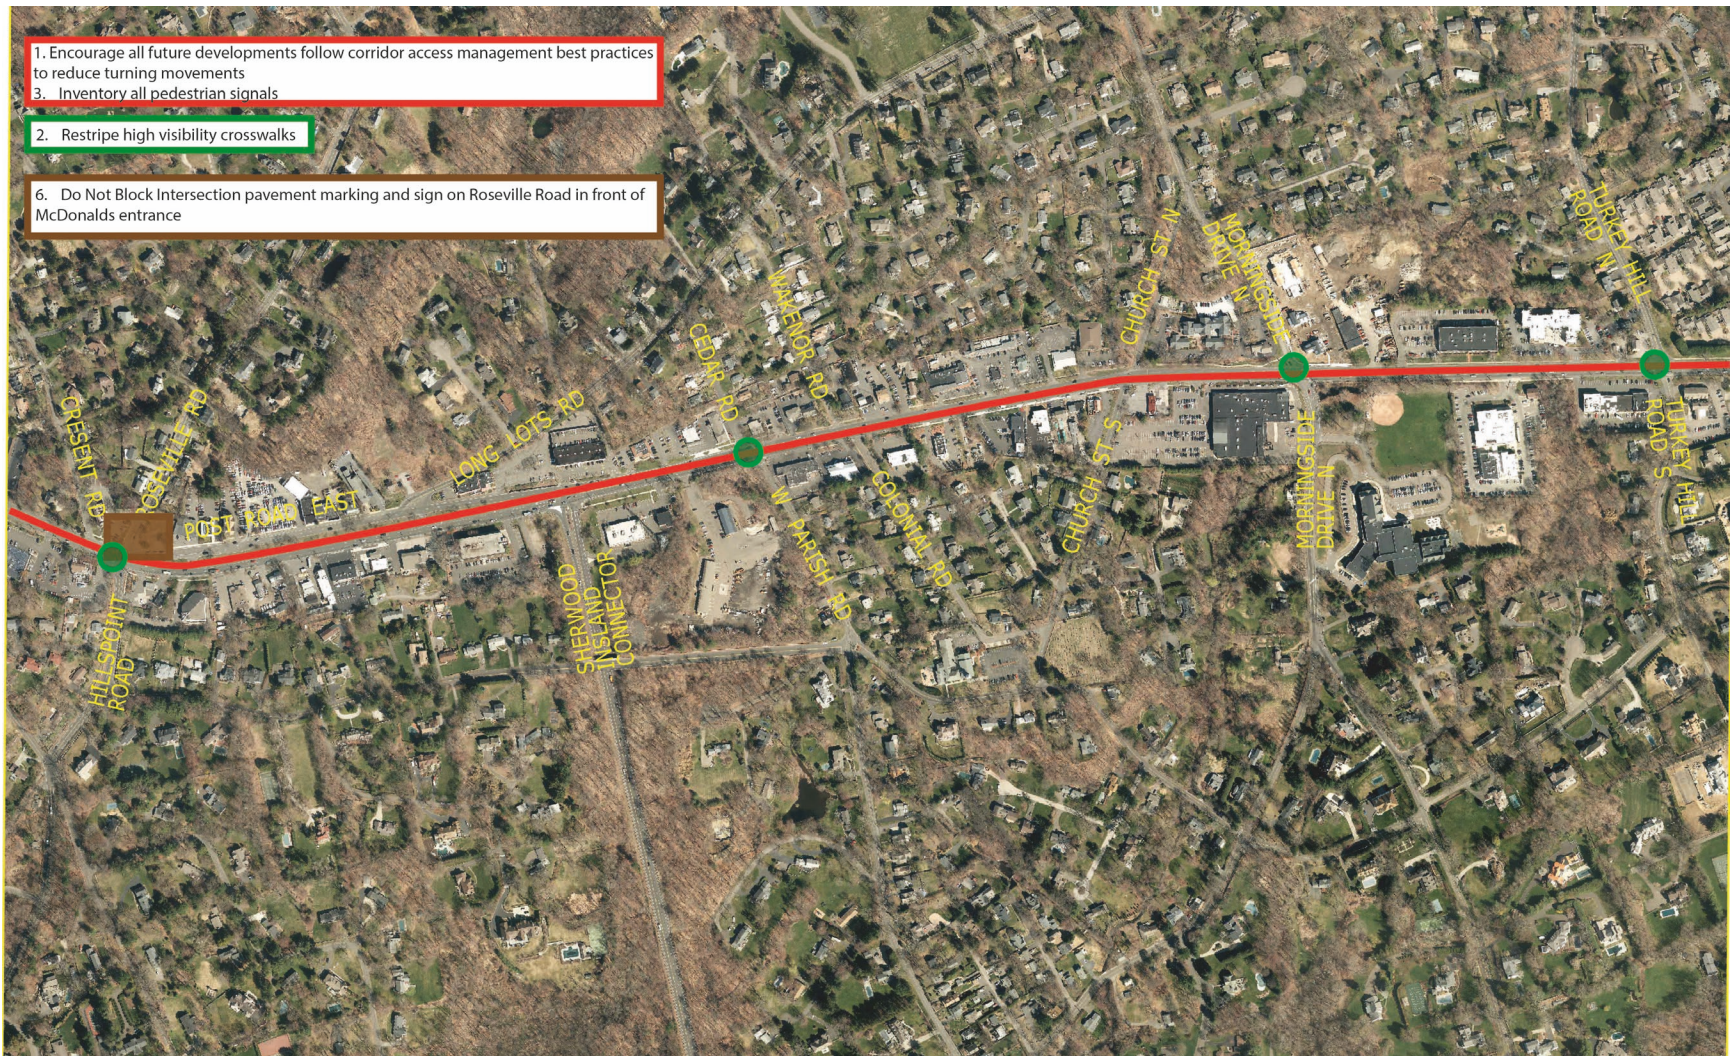
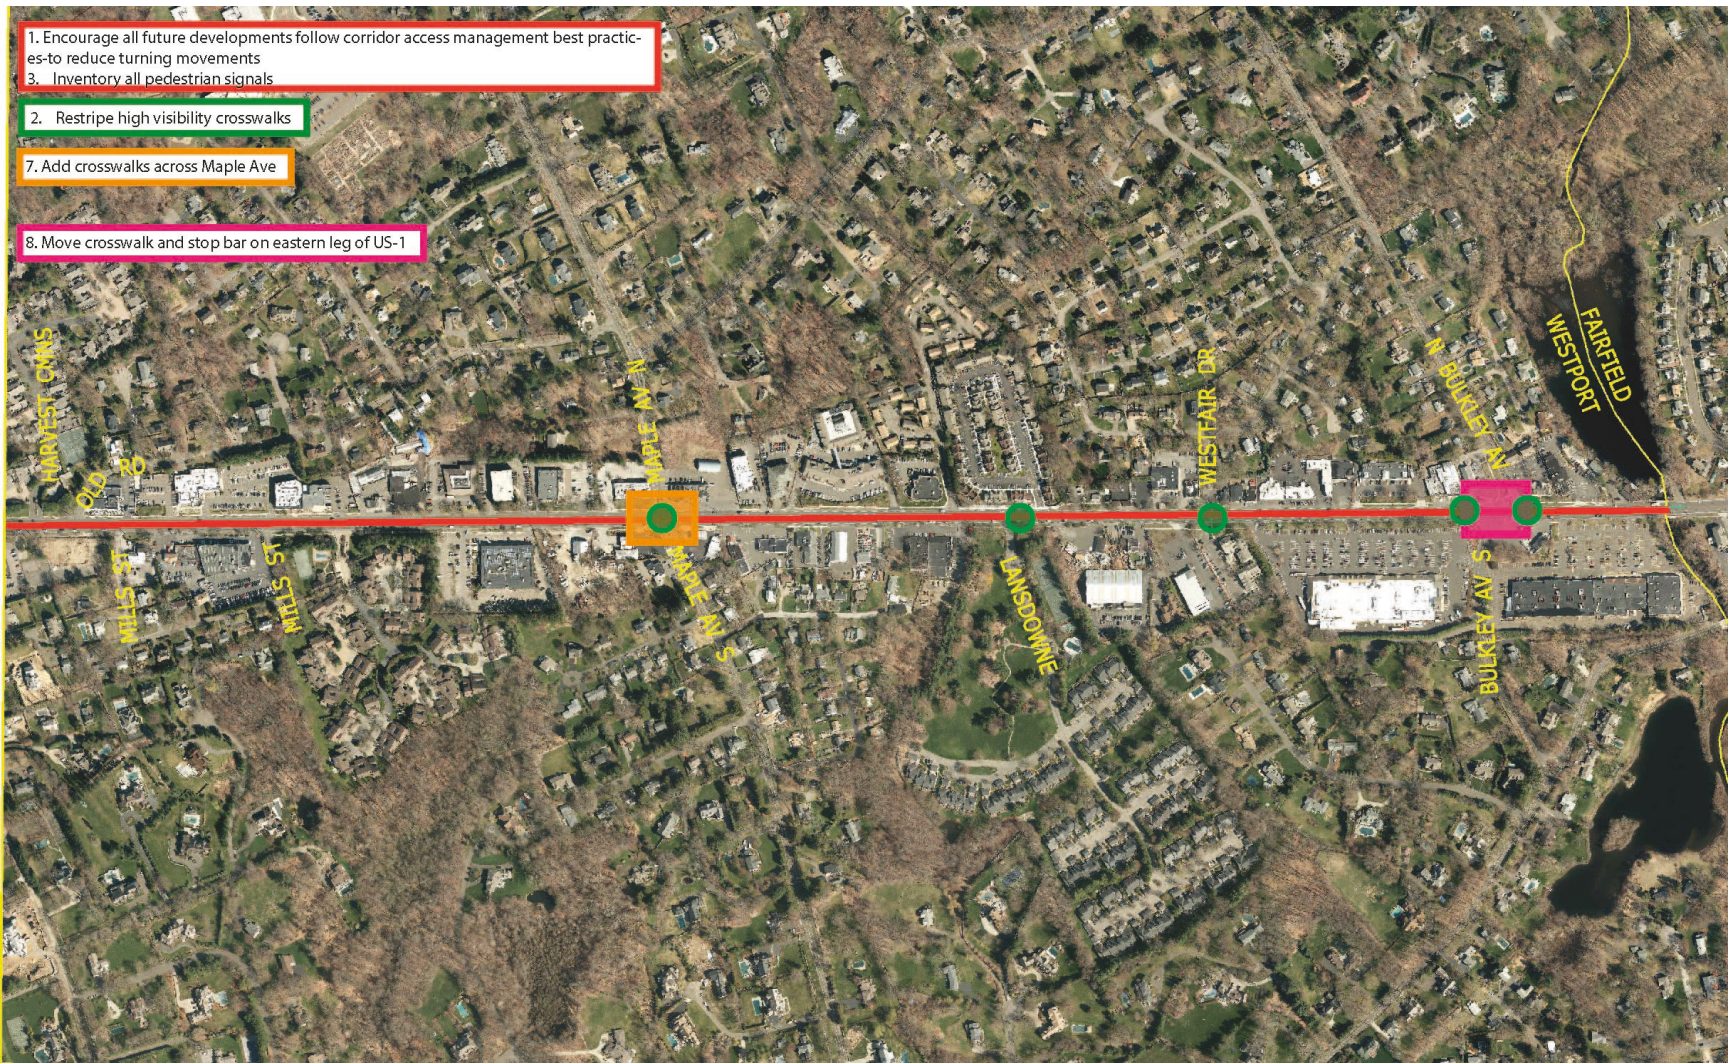
Figure 17, Figure 18, Figure 19, and Figure 20 depict these recommendations.

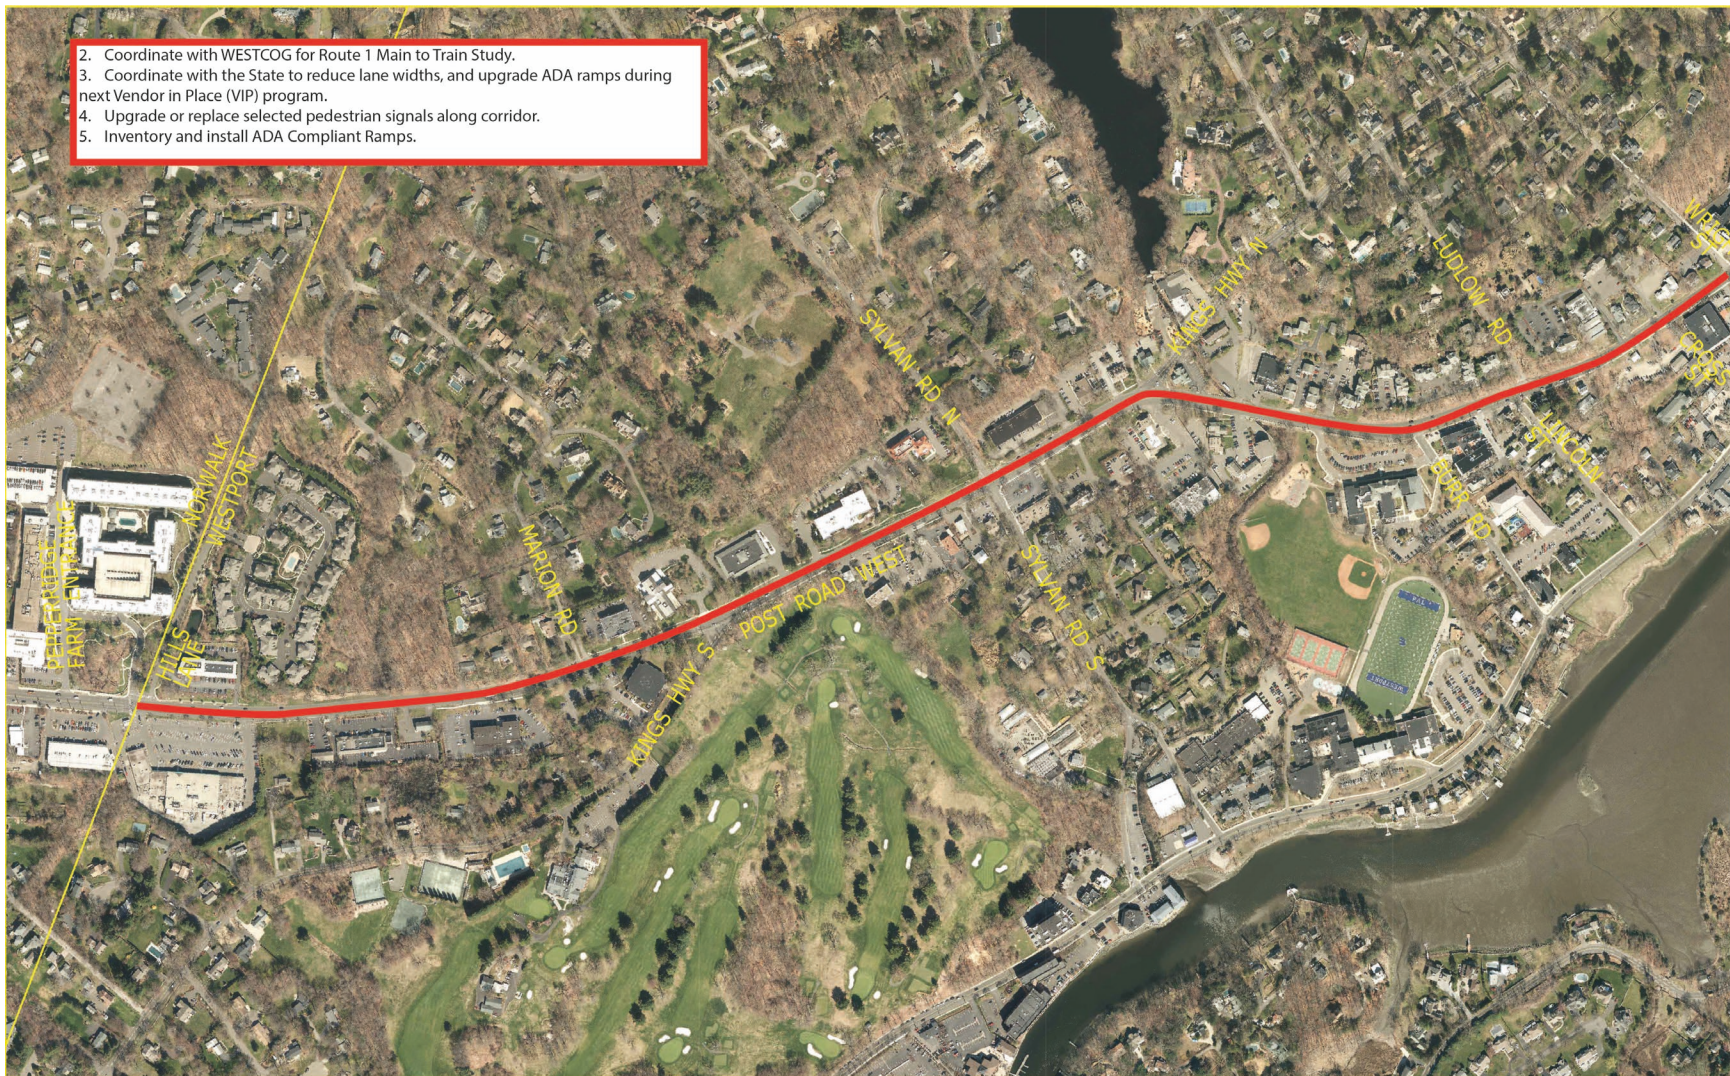
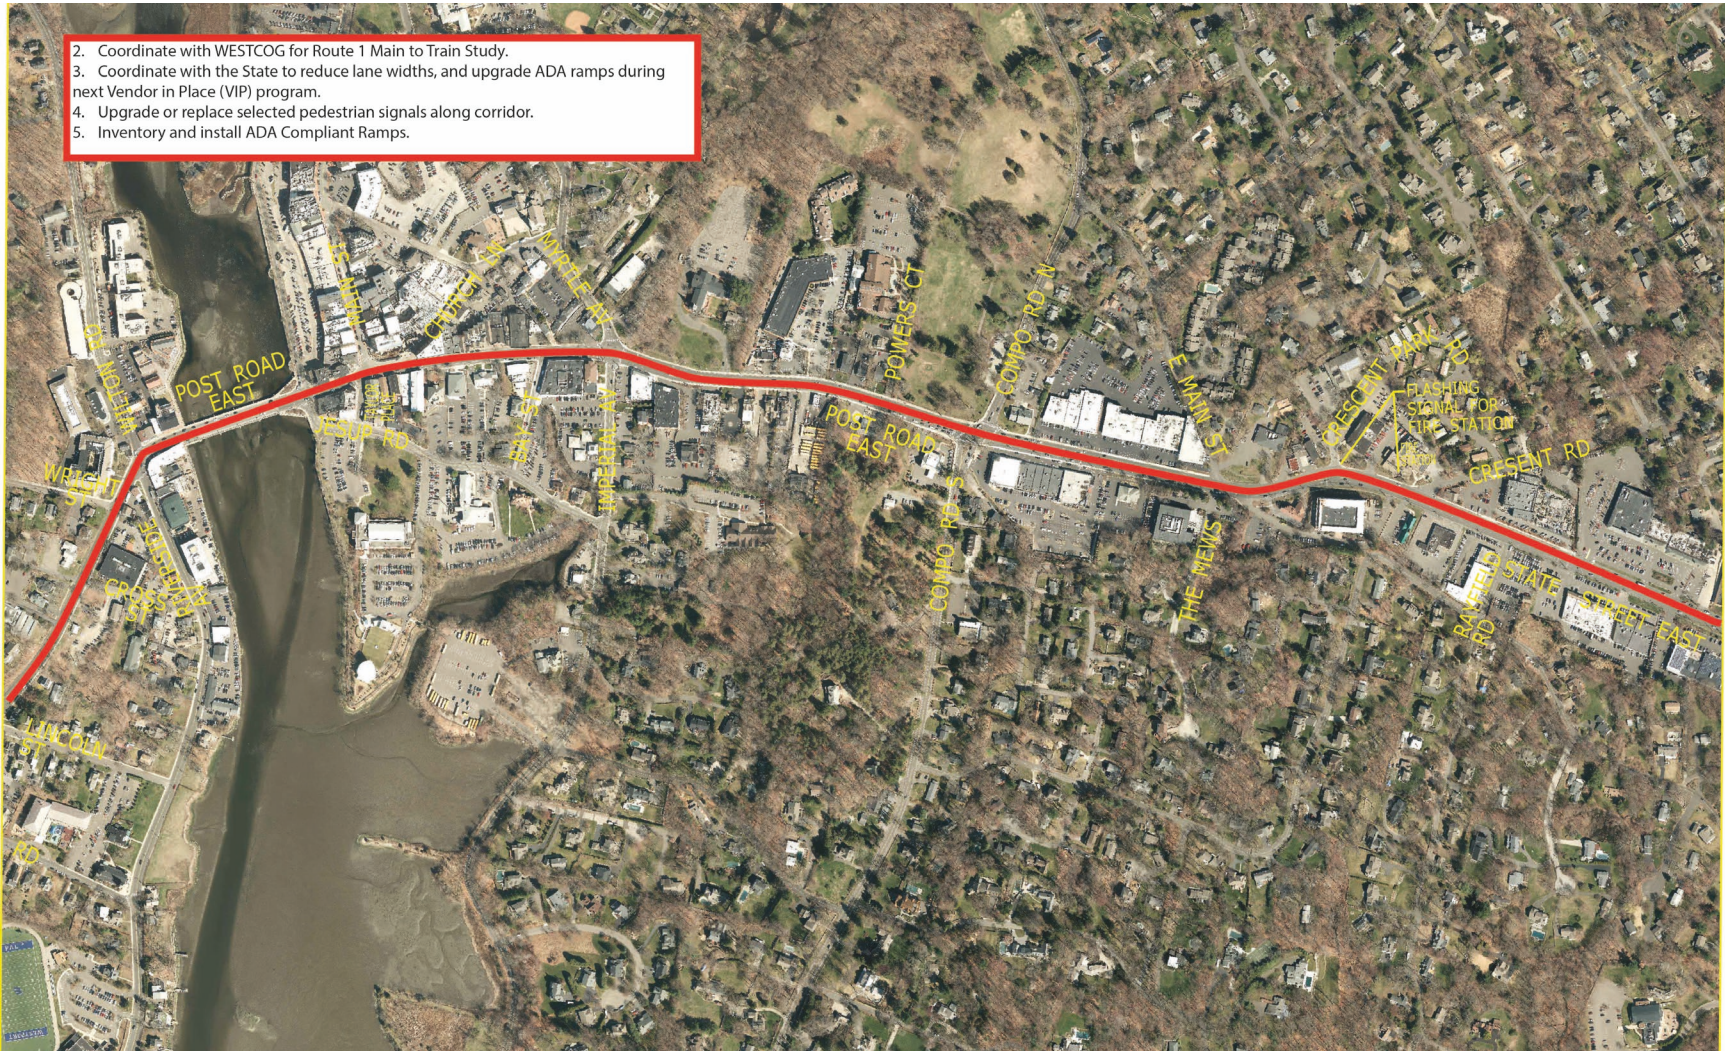
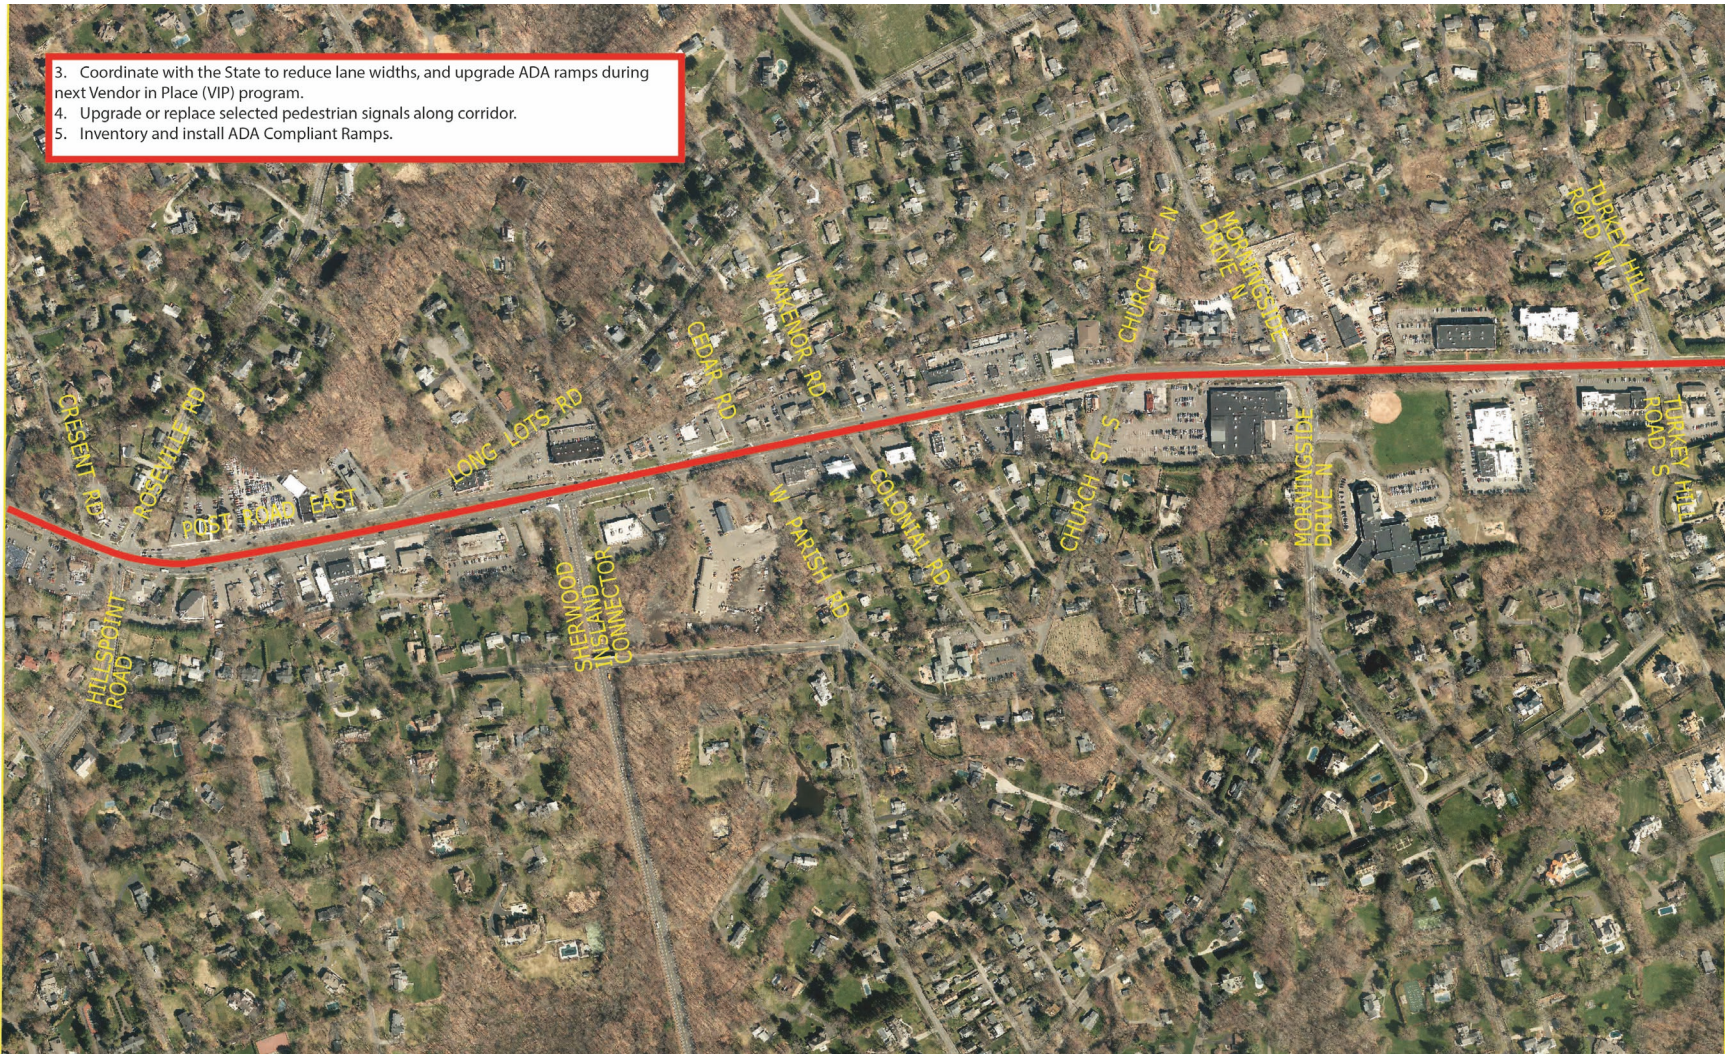
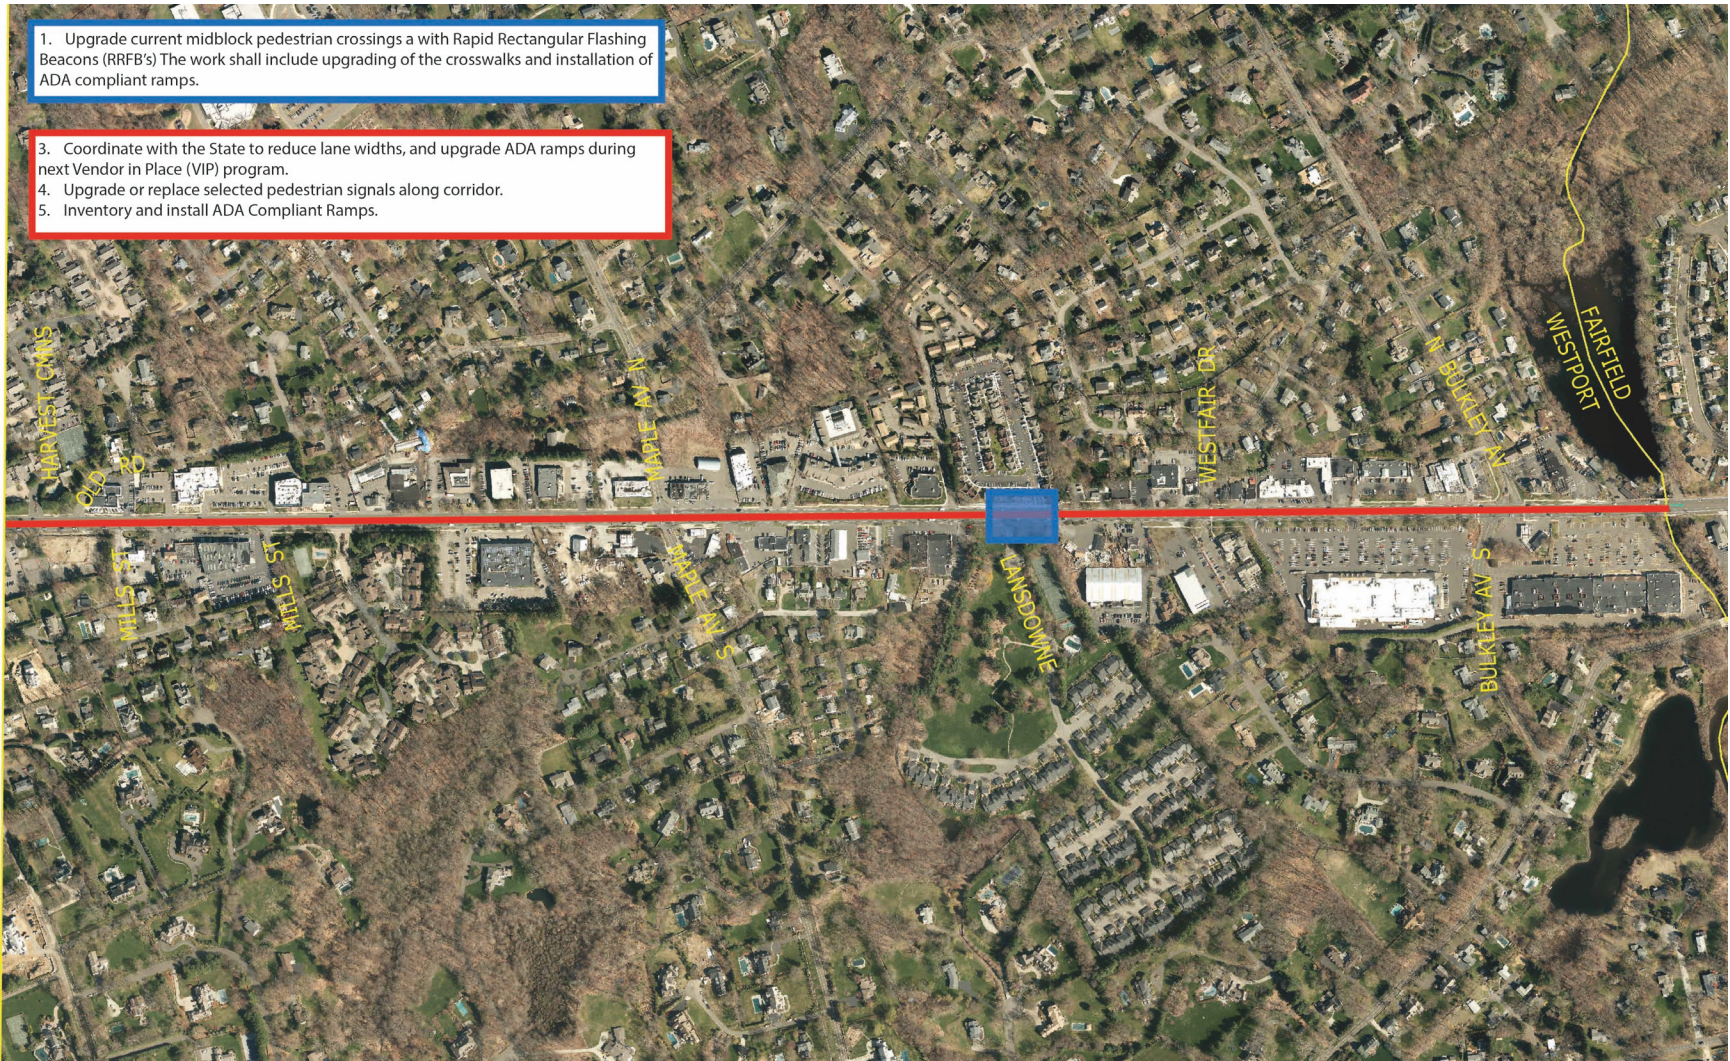
Figure 24, Figure 25, Figure 26, and Figure 27 depict these recommendations.
