COMMUNITY
connectivity program

U. S. Route 1 Road Safety Audit

West Putnam Avenue and East Putnam Avenue

May 15, 2018

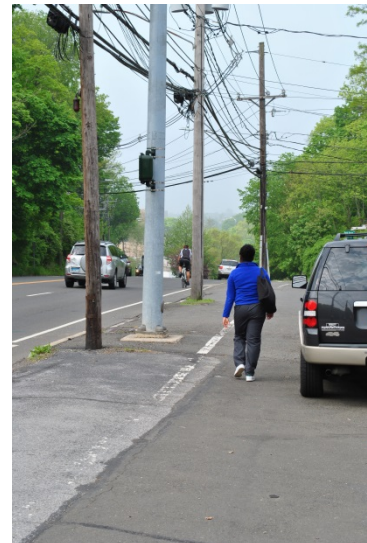
Figure 11 No formal sidewalk

- Site of fatal crash.
- Town has considered changing exclusive pedestrian phase to concurrent.
- Crossing guard is present during school arrival and dismissal.
- No formal sidewalk on north side; just bituminous pavement with white stripe. No plans for new sidewalk (Figure 11).
- Concrete curb on north side.
- Could use better access management to reduce curb cuts.
- Prefer 6' concrete sidewalk, 4' grass buffer strip.
- On south side, there is no sidewalk to west beyond the bus stop. There is sidewalk east of Western Jr. Highway.
- On north side, sidewalk ends at Byram Terrace Drive, and does not continue easterly.

- Pursue access management improvements with deli owner. Town check with P&Z as to legal status of driveways.
- Provide sidewalk.
- Talk with CT Transit about moving bus stops closer to intersection. Obtain ridership numbers.

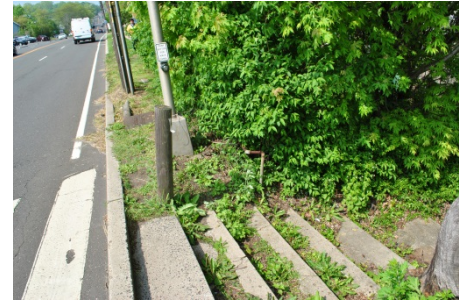
Figure 12 Sidewalk constrained by slope

- North side sidewalk ends before reaching the crosswalk.
- South side sidewalk is undefined asphalt pavement delineated by a white stripe. East of the intersection, south side sidewalk continues.
- Town will move crosswalk from west side to east.
- Town has considered changing exclusive pedestrian phase to concurrent.
- New pedestrian ramps.
- Will provide new crosswalk on Harold Avenue.
- No sidewalk on the north side due to constrained Right of Way (ROW) at house and grade – may need retaining wall (Figure 12).
- Remove old pedestrian head and button on north side.

- Investigate providing new sidewalk on north side on the street.
- Need to consider ROW of residential property and providing a new retaining wall.

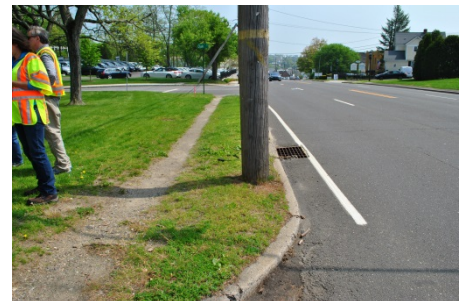
Figure 13 Worn pedestrian path

- Worn path in park area on north side (Figure 13).
- Town would like to provide new sidewalk.

- Provide new sidewalk on north side to close gap
- Add to sidewalk master plan

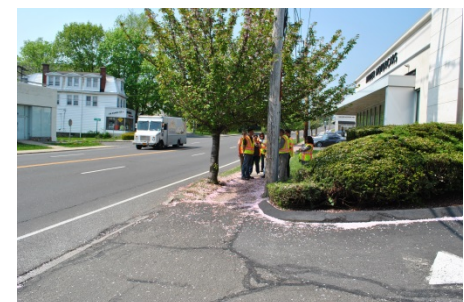
Figure 14 Sightline issue at driveway

- Many crashes due to turns in and out of driveways.
- Potential for Road Diet location, may be

difficult to provide a safe pedestrian crossing at this location.

- Sightline issues due to roadway grade and vegetation (Figure 14).
- Discuss with property owners in the area about restricting left turns out of their driveways

- New sidewalk needed.
- Potential location for full signal.
- Conduct pedestrian counts and intersection turning movement count.
- Trim trees to improve sight distance near Dunkin Donuts.
- Evaluate for signal warrants.

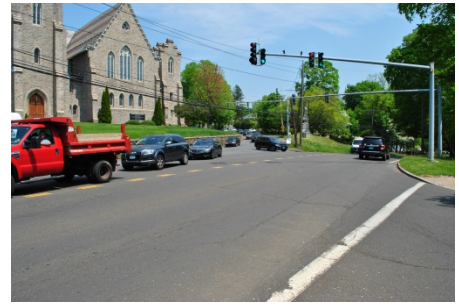
Figure 15 Short storage areas at intersection

- Complex closely-spaced multi-leg intersection with short storage areas (Figure 15).
- Crosswalks across Milbank and right-turn jug-handle do not have pedestrian signals. Consider adding.
- No Right Turn sign on Milbank northbound approach is located too far east to be beneficial.
- Consider roundabout for long-term solution?

- Install new pedestrian signal heads at Milbank approach and right-turn jug-handle as part of existing signal system.
- Consider extending curb on northeast corner of Millbank Ave approach to better define left –turn movement and reduce pedestrian crossing distance.
- Town to consider initiating evaluation of roundabout alternatives.

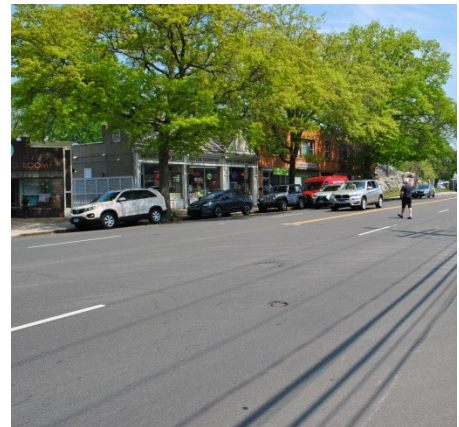
Figure 16 High frequency of mid-block crossing pedestrians

- 60'+/- curb-to-curb, 4 lanes, wide shoulders
- Many pedestrian cross here, no mid-block crosswalks (Figure 16).
- Think about options such as median, pedestrian refuge island, RRFB.
- Look at providing crossing near Suburban Ave.
- The Town does not support removing the on-street parking.
- There are some curbed bulb-outs as well as painted bulb-outs.

- Town and CTDOT to evaluate options to provide a new mid-block crosswalk to improve safety. Locations include east and west of Suburban Avenue. Options may include:
 - Reduce travel lane width to 11'.
 - Narrow shoulder width on both sides.
 - Provide minimum 6' wide median.
 - Provide pedestrian refuge island/slow point.
 - Include Bulb-outs to reduce width.
 - Provide RRFB control.

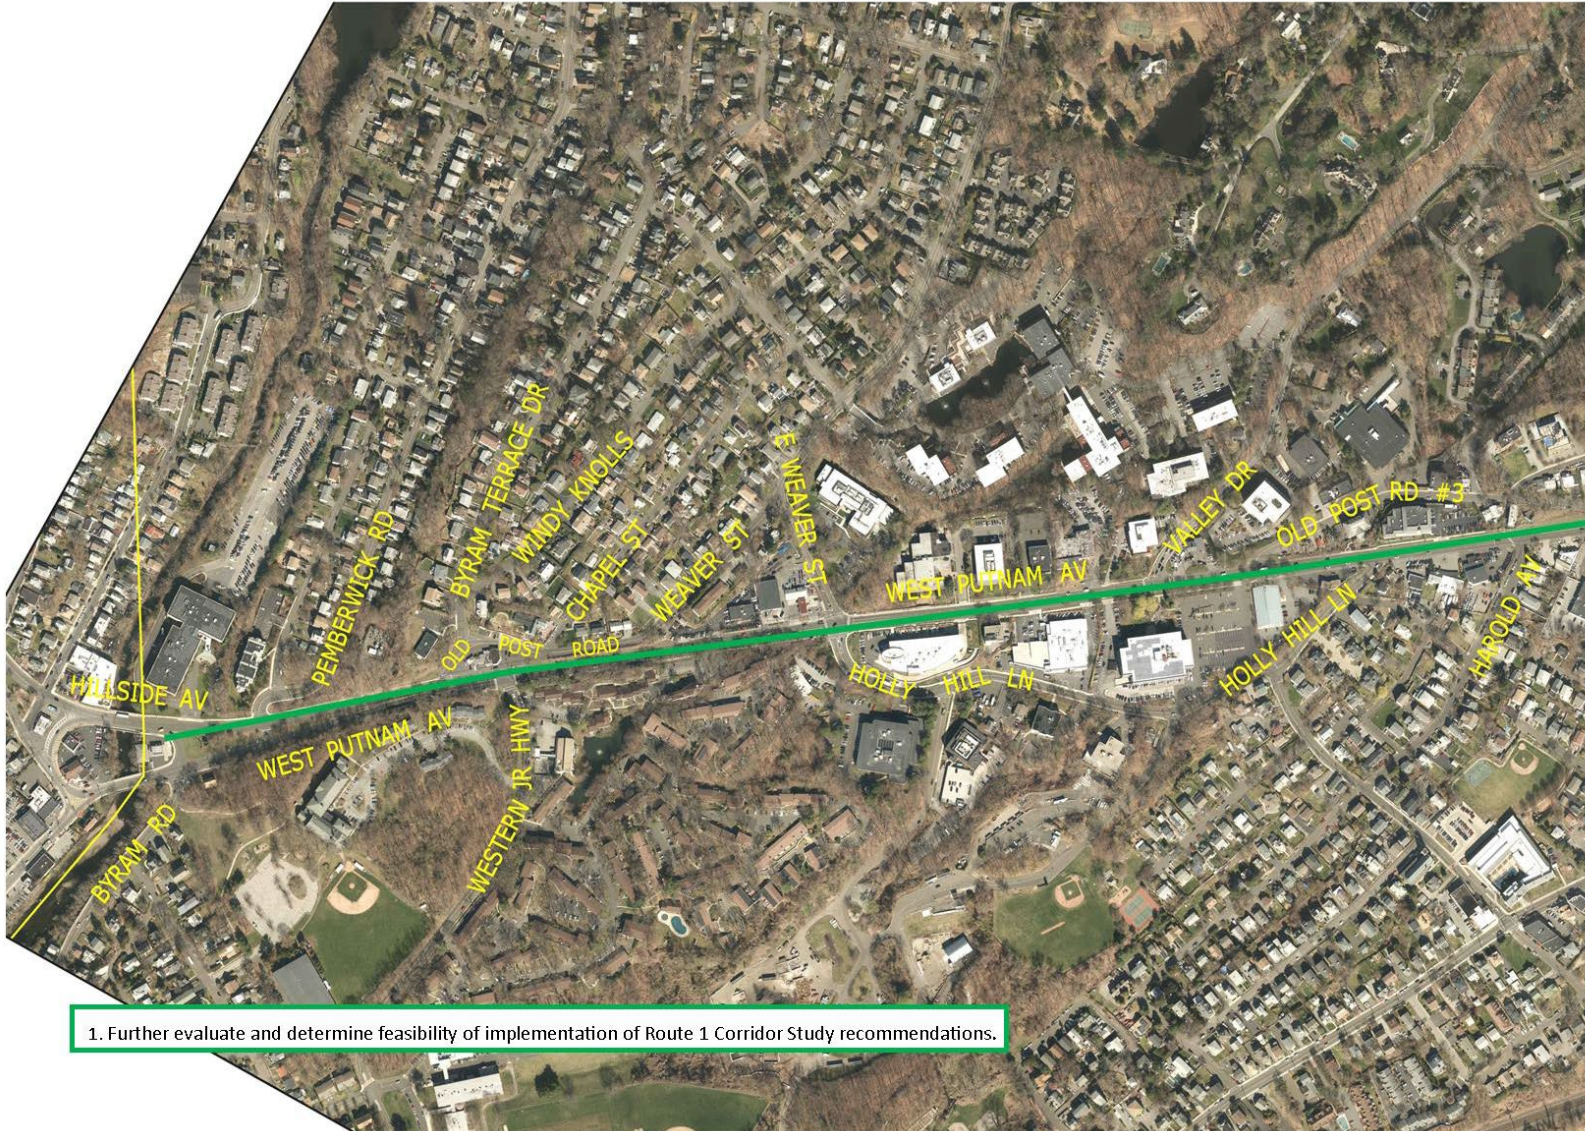
Figure 27. Long Term Recommendations Map 1

1. Further evaluate and determine feasibility of implementation of Route 1 Corridor Study recommendations.

1. Further evaluate and determine feasibility of implementation of Route 1 Corridor Study recommendations.
2. Study and evaluate a roundabout alternative at Millbank Avenue.
