City of Stamford

U. S. Route 1 Road Safety Audit

West Main Street, Tresser Blvd. and East Main Street

April 19, 2018 and July 12, 2018

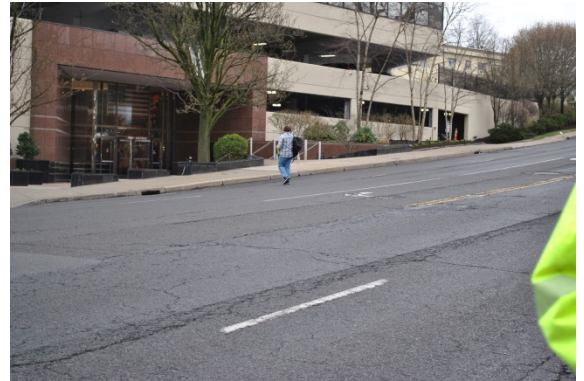
Figure 7: Pedestrians crossing mid-block

- Observed frequent mid-block crossings from World Wrestling Entertainment (WWE) buildings at this location (Figure 7).
- Possible mid-block crossing at this location with RRFB, however, steep eastbound grade may be issue.

10. Add parking meters on the south side of West Main Street at Wilson street intersection.
11. Study a possible RRFB mid-block crossing at the WWE building locations.

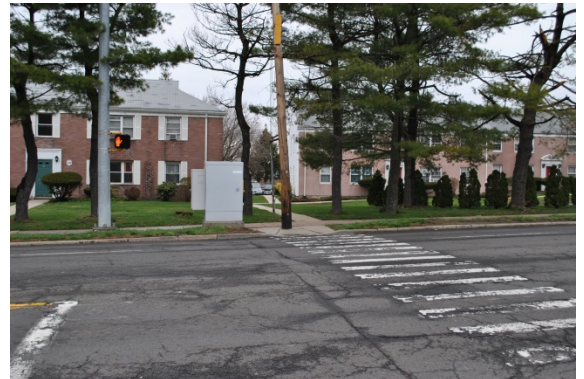
Figure 8: Utility poll blocking pedestrian sidewalk ramp

- Concurrent pedestrian signal phasing.
- Utility poles and or pedestrian ramps relocation is needed to remove poles from the center of the current pedestrian ramps (Figure 8).
- Starting at Blachley Road, a road diet was discussed (starting at Blachley and heading west towards the downtown).
- Left turns into the right-in/right-out only McDonald's driveway was witnessed on several occasions.

10. Investigate relocation of utility poles and pedestrian ramps at Blachley Road and East Main Street intersection.

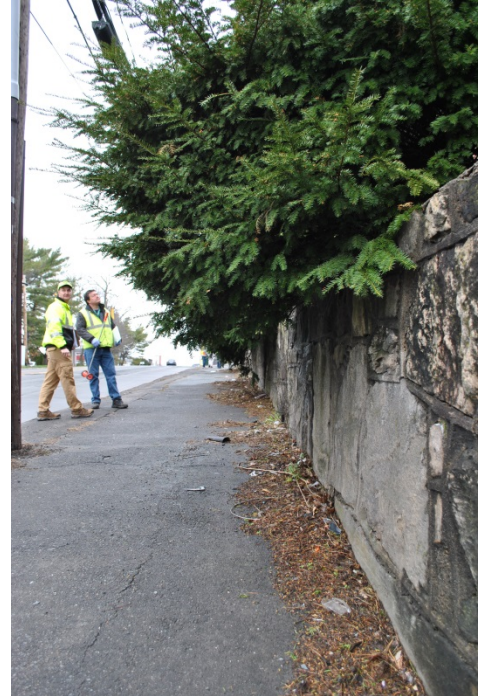
Figure 9: Tree trimming needed

- Crosswalk and ramps needed across Maher Road.
- Tree trimming needed along sidewalks (south side of East Main heading east from Maher road) (Figure 9).
- Road diet.
 - Terrain concerns:
 - Starting from Blachley Road, East Main Street has a significant downhill grade heading towards downtown until you reach Lockwood Ave.
 - Higher vehicle speeds observed in this area.

17. Tree trimming needed along sidewalks (south side of East Main Street heading east from Maher Road).

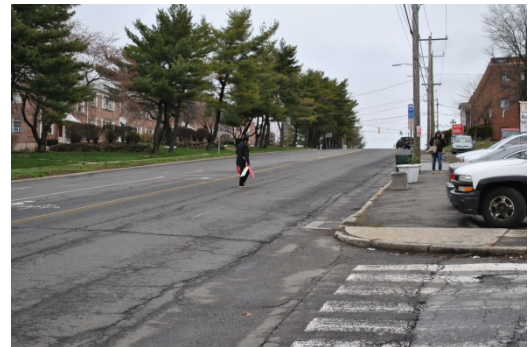
Figure 10: Pedestrians crossing mid-block

- Higher vehicle speeds observed in this area.
 - Lawn Ave. has a very steep grade and sharp angle coming off of East Main Street.
 - Drainage Issues.
- Frequent mid-block crossings observed – mid-block crossing was discussed but issues with sightlines to the east could be problematic. (Figure 10).

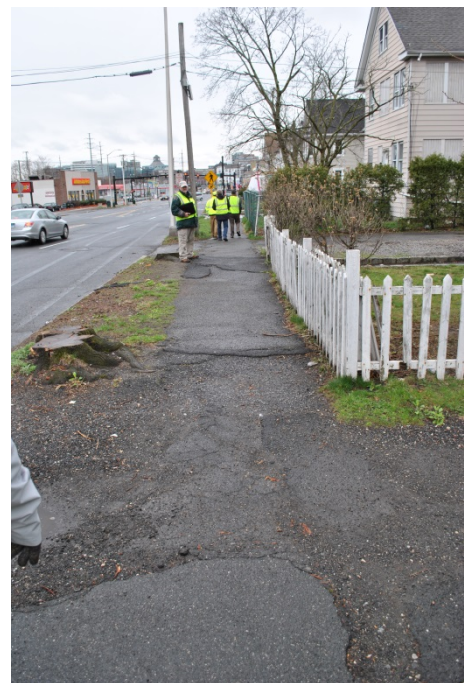
Figure 11: Poor sidewalk condition

- Deteriorating sidewalk (Figure 11).
- Non ADA compliant ramps.
- Poor pavement here.
- Going through the intersection, lane drops after East Main.
- Tractor trailers fit in the shoulder in front of Walgreens.
- Shared left/U-turn lane.
- Ideal tile has parking in front that blocks the sidewalk.
- Lafayette is very narrow to have on-street parking.
- North parking lot has closed so parking has been a problem in this area.

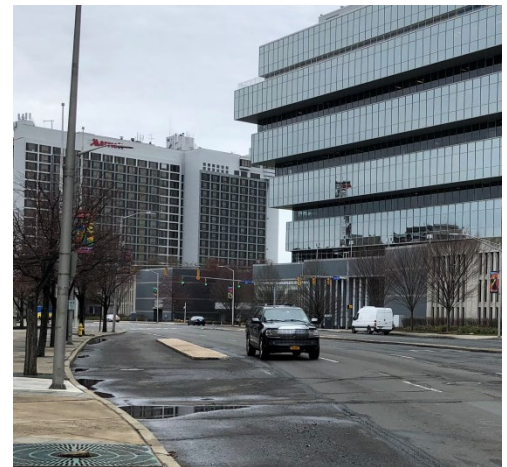
Figure 12: Island not necessary

- Median is in poor shape.
- Remove the island and add on-street parking (Figure 12).
- There are sight distance issues with the private town center sign (Figure 13).

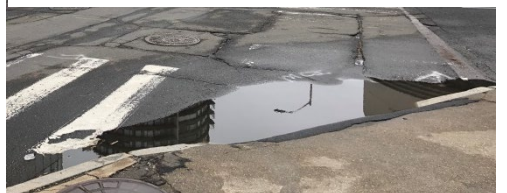
Figure 14: Detectable warning strip missing and poor drainage

- Right turn lane is completely blocked when there is a show at the Jerry Springer Show venue.
- Design guidelines for the city need to be worked on for detail on type of trees, seating area etc.
- Drainage and ADA issues around crosswalks (Figure 14).

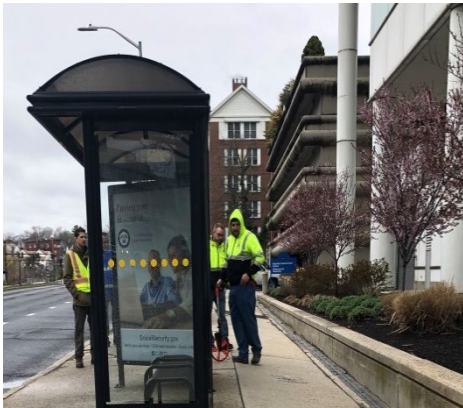
Figure 15: Bus Shelter - Back slope not ideal

- Fix the driveway – streamline sidewalk and curb.
- Placement of Bus Shelter and back slope is not ideal; it reduces the actual usable sidewalk (Figure 15).
- As part of an ongoing project, Pedestrian Signals are being added with Leading Pedestrian Interval (LPI) and new ADA compliant sidewalk ramps.
- Median refuge islands are very narrow (Figure 16).

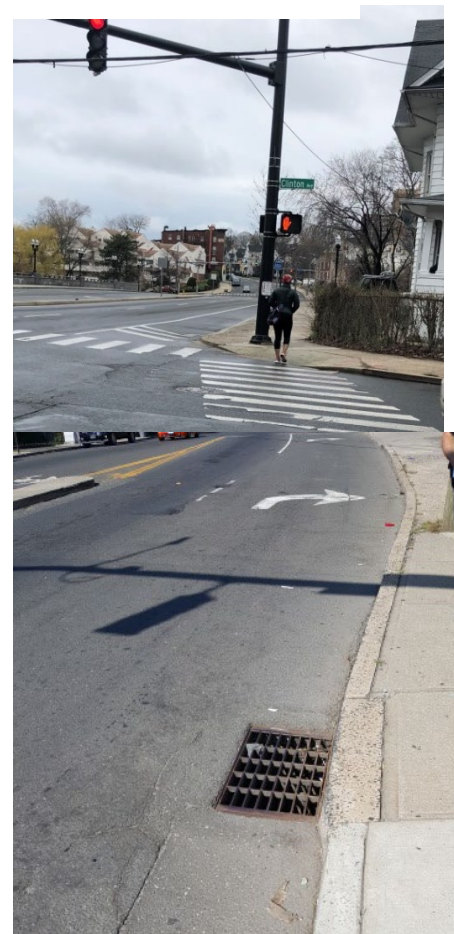
Figure 18: Storm drain covers are not bicycle friendly

- Curbs on pedestrian islands are damaged from being hit - need some reflective materials to make them more visual at night.
- Town mentioned pedestrians don't always obey the signals.
- Storm drain slots too large for bicycle tires to go over without getting stuck/damaging them (Figure 18).
- Suggestion to add a bumpout at Greenwich Avenue.

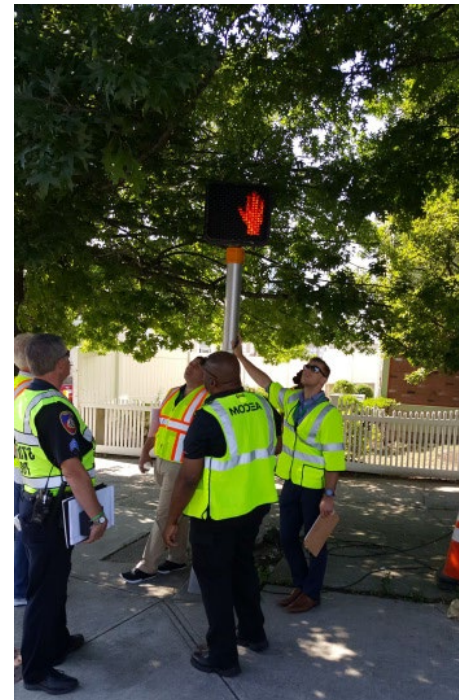
Figure 19: Tree is blocking pedestrian signal

- Tree on corner could potentially block seeing signal for crosswalk (Figure 19).
- Many of the sidewalk ramps have uneven curbs and could be trip hazards.
- Signalized T- Intersection.
- Faded pavement Markings.
- Crosswalk on Stillwater is faded on northern and western legs.

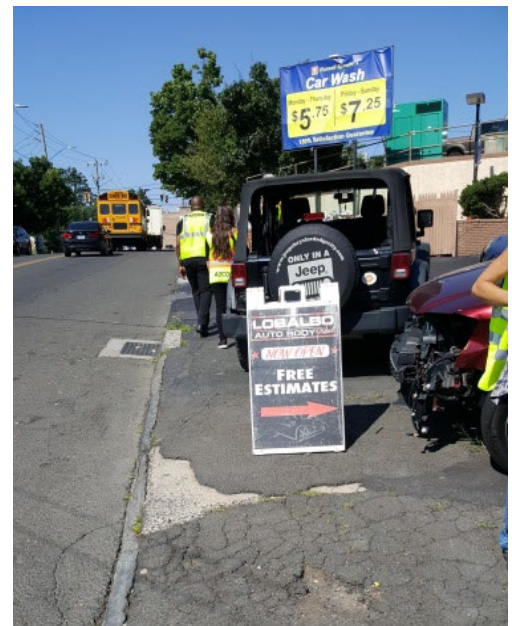
Figure 21: Cars parked where the sidewalk should be located

- We found that parking and the sidewalk are an issue in this portion of the route; the sidewalk ends in front of the auto body shop/car wash and there are no markings to show that it should continue (Figure 21).
- Customers of the auto body shop park directly where the sidewalk should be, making it difficult for pedestrians to get by.
- The same issue occurs down the street by the Citgo gas station; the sidewalk continues but it does not stop people from parking on it because there is limited parking in this lot.
- 39' street width.
- On-street parking on south side.
- Vertical curvature issue impacts sight lines.
- Parked cars also impede sight lines.

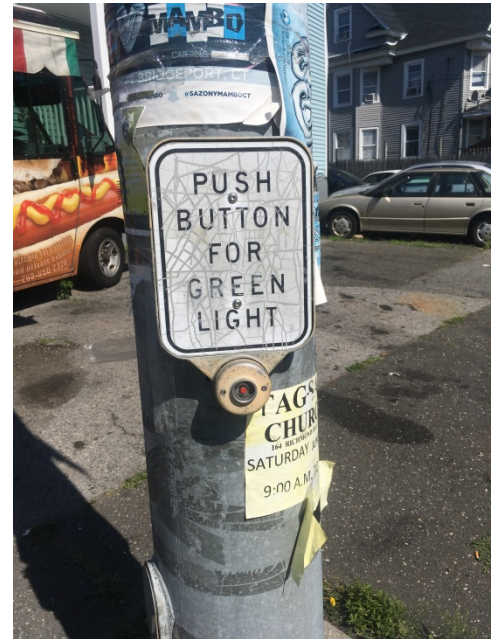
- Four-way signalized intersection.
- Bus stop at intersection.
- Green phase activated push button (Figure 22).
- No pedestrian signals.
- Faded crosswalks on all legs.

Figure 22: Push for green pedestrian crossing

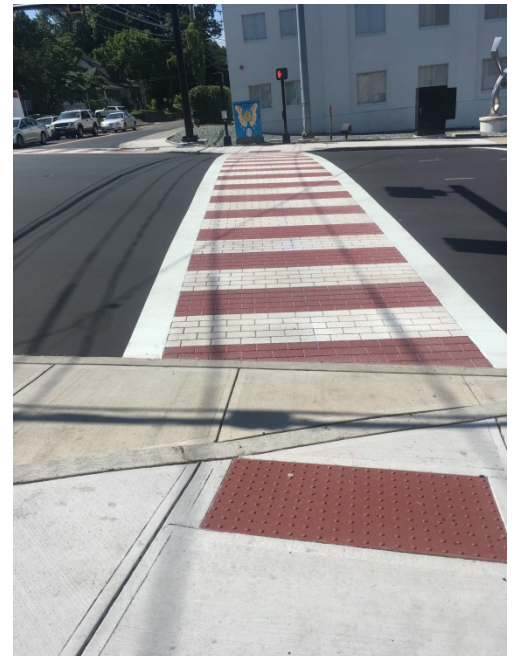
Figure 23: New stamped crosswalks

- Stamped crosswalks on US-1(Figure 23).
- 60' across West Main Street.
- 11' left turn lane.

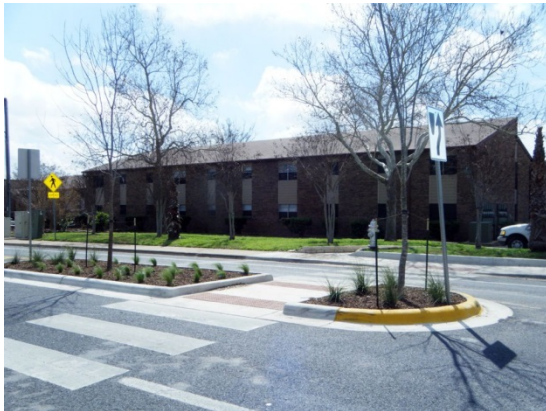
Figure 24 Example of median island

8. Fix the median island on Tresser Boulevard at the intersection with Edith Sherman Drive (Figure 24).
9. Add detectable warning strips at Northwest and Southeast Corners of Tresser Boulevard and Edith Sherman Drive intersection.

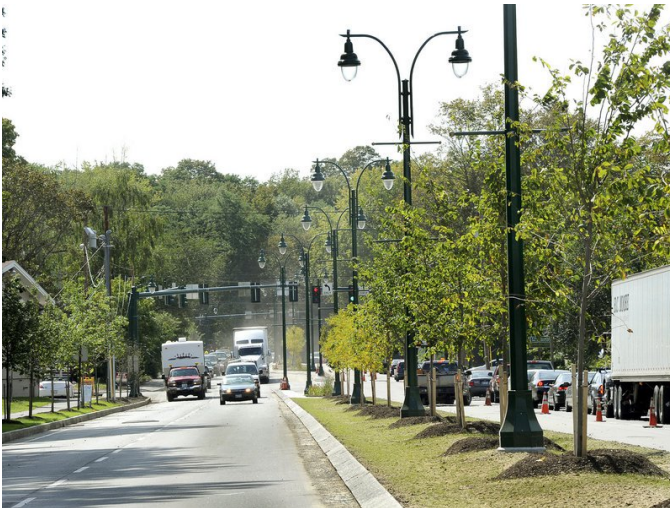
Figure 33 Example of wide median islands

1. Implement a Road Diet on East Main Street starting at Blachley Road and heading west towards downtown.
2. Widen the median island at the intersection of Tresser Boulevard with Washington Boulevard (Figure 33).
