COMMUNITY
connectivity program

Town Village District, Route 14 – Road Safety Audit

May 9th, 2016

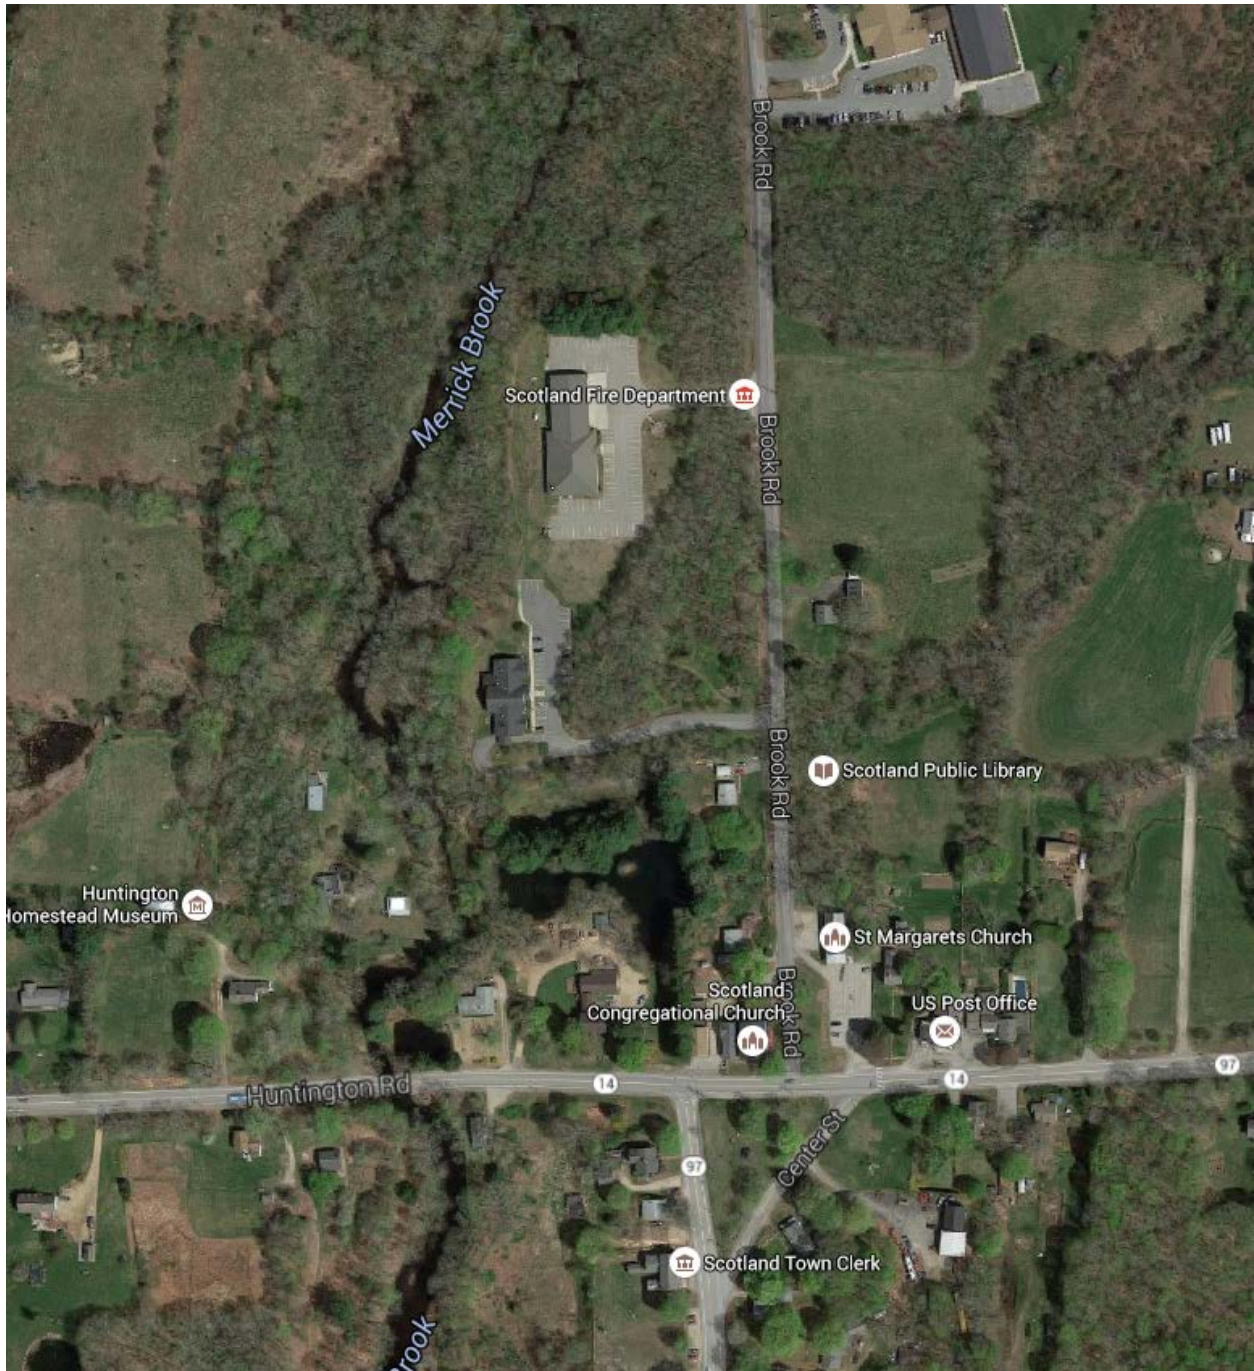
Figure 1. Town Village District, Scotland Town Green

The RSA site is located in the Town Village District of Scotland which includes the section of Huntington Road (State Route 14) between the Huntington Homestead Museum and approximately 500 feet east of the post office (State Routes 14 and 97) (Figure 1). The Average Daily Traffic (ADT) on Route 14 just west of the Route 14 and Route 97 intersection is 4,400 and just east of the post office is 4,200. This indicates that most traffic is through traffic. This section of Route 14 contains a number of driveways, adding complexity to walking and bicycling maneuvers through the area. The section of Devotion Road (Route 97) includes the parking area for the town hall to the intersection with Route 14. The ADT on Route 97 is 1,500. Both Routes 14 and 97 consist of a single travel lane in each direction, separated by a double yellow center line and painted shoulder lines. The striped shoulders range from 3 feet to 4 feet wide.

The site also includes two local roads; all of Center Street and Brook Road from the intersection with Route 14 to the Scotland Elementary School. Center Street has a double yellow centerline but no shoulder lines. Brook Road has no lane markings.

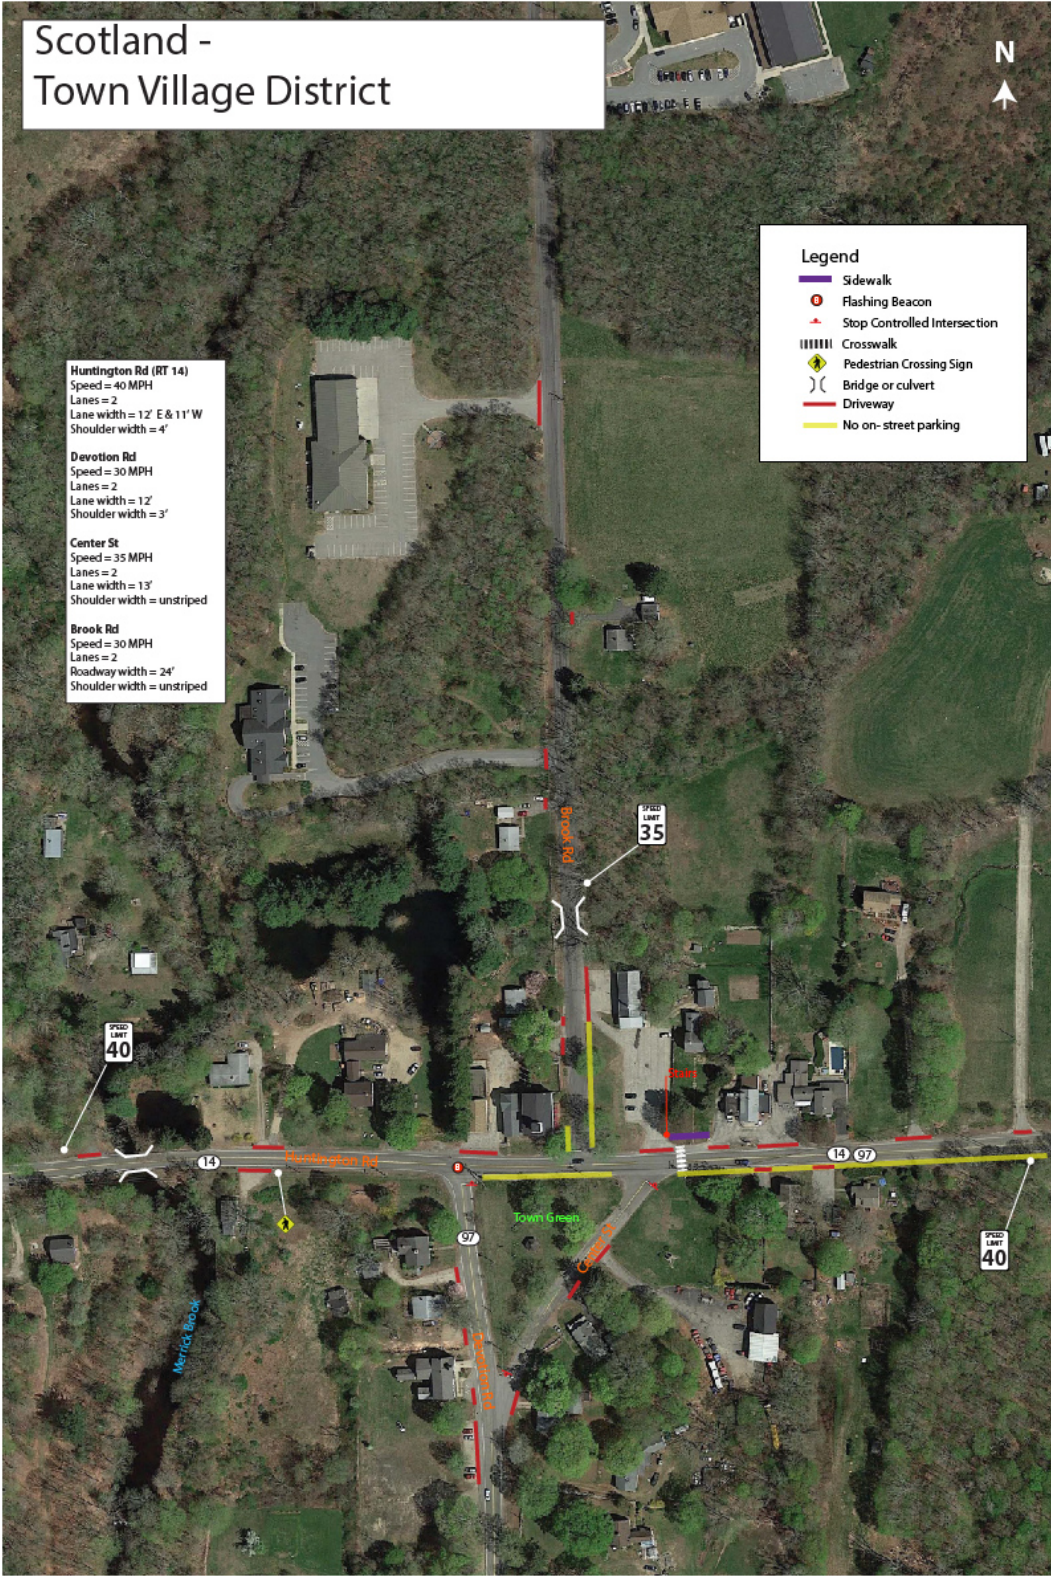
Figure 3. Scotland Town Village Center Road Geometrics

Figure 3 and Table 3 summarize the roadway geometrics in the study area.

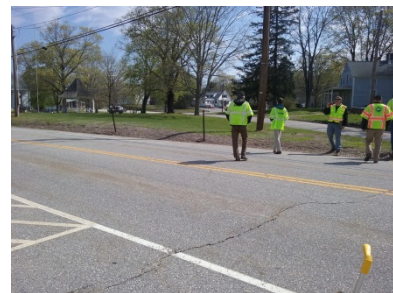
Figure 4. Lack of Crosswalk in Front of Town Hall

- The posted speed limit on Route 97-Devotion Road is 30 MPH.
- There is no crosswalk in front of the town hall, it would need to be ADA compliant and connect to the ramp into the town hall in some way (Figure 4).

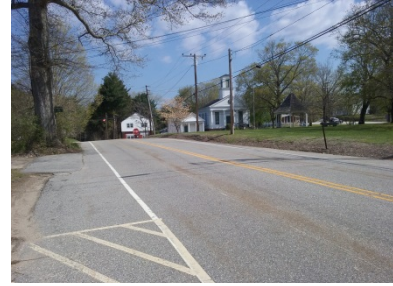
Figure 5. Sightline Issue From Devotion Road

- The sightline approaching the Route 14 and Devotion Road intersection from Devotion Road is restricted due to a horizontal curve (Figure 5).
- There are no pedestrian crosswalk signs or advance pedestrian warning signs at the crosswalk across Route 14.

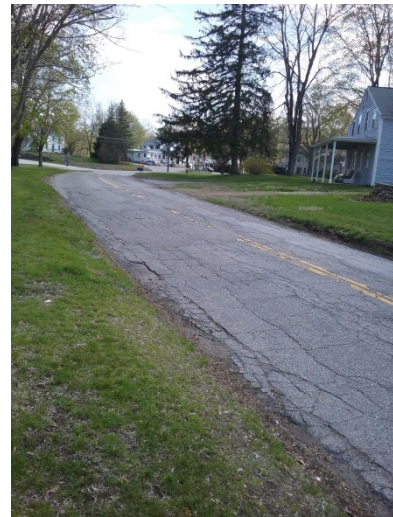
Figure 6. Center Street

- There are opportunities to reduce conflicting traffic movements in the center by changing the access/circulation of Center Street. It cannot be closed to traffic completely since it serves three driveways. Dead ending it after the last driveway, realigning it with Brook Road, and converting it to one-way travel were discussed (Figure 6).

4. Evaluate options for redesigning Center Street including:
 - a. Make it one-way northbound.
 - b. Dead end after the last driveway and convert the last section to greenspace to extend the town green.

- c. Realign Center Street to intersect Brook Road as a four-way intersection. The disadvantage is that it would fragment a section of the town green.

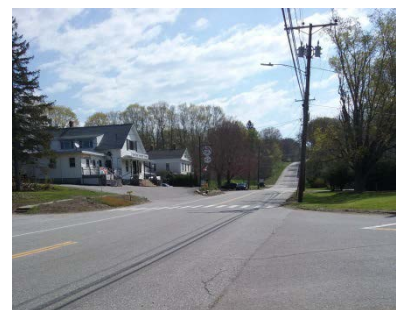
Figure 7. Crosswalk on Route 14

- There are no visual cues to motorists to slow down approaching the center.
- There is a high percentage of large commercial vehicles on Route 14.
- The current crosswalk across Routes 14/97, east of Center Street, is not located optimally to encourage pedestrian use. Currently, pedestrians cross Routes 14/97 from the north side to the town green on the south side and do not use the crosswalk. Relocating the crosswalk west of Center Street would encourage more use, eliminate the conflict for vehicles turning right from Center Street to Route 14 and increase the stopping sight distance for vehicles traveling westbound on Routes 14/97 Road (see Figure 7). Due to the curvature of the roadway advance pedestrian warning signs and pedestrian signs and arrow plaques should be in place at the crosswalk. The current crosswalk is not visible in the eastbound direction due to the vertical curvature of the roadway.

4. Place removable bollards at the center of the crosswalk to calm traffic during events. Scotland will need to maintain these bollards. They could be put up just for events or left for the entire summer.

5. Install advance pedestrian and crosswalk signage for both directions at the existing Route 14 crosswalk.
6. Update signage, in particular route markings, with proper retro reflectivity.

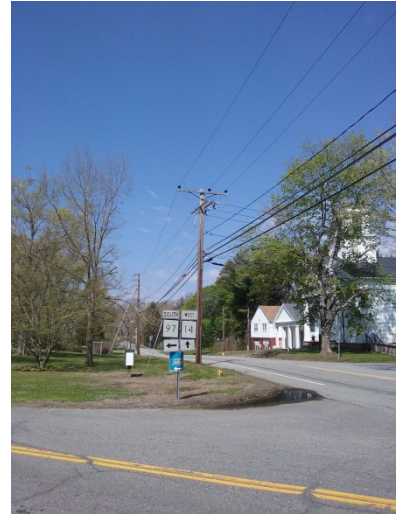
Figure 8. Sign Cluster at Center Street and Route 14 Intersection

- The route sign cluster directs vehicles to Center Street to connect with Route 97 (Figure 8). The sign cluster may restrict sightlines for vehicles looking left, turning right from Center Street onto Route 14.

- The sign cluster on Route 14 facing eastbound, east of Route 97, blocks the sight line for motorists. It blocks the view of motorists turning right from Route 97 to Route 14 eastbound.

1. Relocate the destination sign cluster by the intersection of Routes 97 and 14 to improve the sight line for motorists.
2. Apply to CT DOT to conduct an Office of the State Traffic Administration Review on Route 14 through the Village Town Center. The results of the study may be used to change the current posted speed limit on Route 14 from 40 MPH to 30 or 35 MPH.
3. Paint triangles (Shark Teeth) leading to the crosswalk across Route 14 so that it is more visible.

7. Relocate the Route 97 signs on Center Street, which currently indicate that Center Street is State Route.
8. Change the formation of the routes signs so they are not as wide, but taller to improve sight lines.

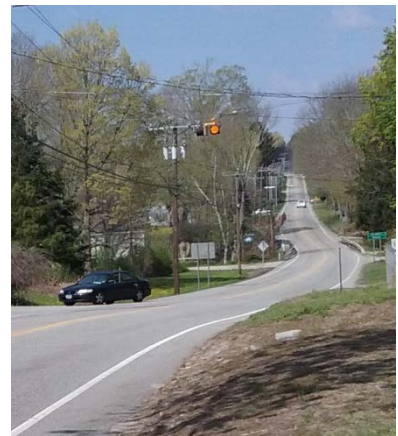
Figure 9. Flashing Beacon at Route 97 & 14

- The left turn out of Center Street is a difficult maneuver.
- The flashing beacon at Routes 14 & 97 is not LED and has an eight (8) inch head (Figure 9).

14. Cut back tree limbs in the right of way that block sight lines, in particular the maple trees in front of the Post Office.
15. Replace the existing flashing beacon at the intersection of Huntington Road (Rt. 14) and Devotion Road (Rt. 97) with larger LED lenses for better visibility.

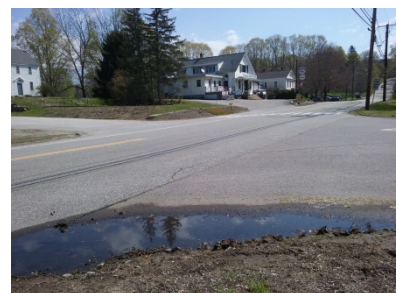
Figure 10. Drainage Issues at Center Street and Route 14

- There are street lights on every other pole.
- There is a drainage concern at the town green northeast corner of the Center Street and Route 14 intersection (Figure 10).

9. Restripe Route 14 to provide 11 foot lanes in both directions.
10. In conjunction with the repaving of Center Street by the town, extend the curb on the town green side out to tighten up the intersection and help with drainage.

- a. Evaluate the right-of-way at the potential curb bump out. Also examine drainage impact if curbing and streetscape was added.
11. The town will coordinate with CTDOT on the redesign of the Merrick Brook Bridge to incorporate pedestrian and bicycle accommodations. This could be achieved through widening shoulders, adding a sidewalk or adding a multiuse path. All options should be looked at and evaluated.

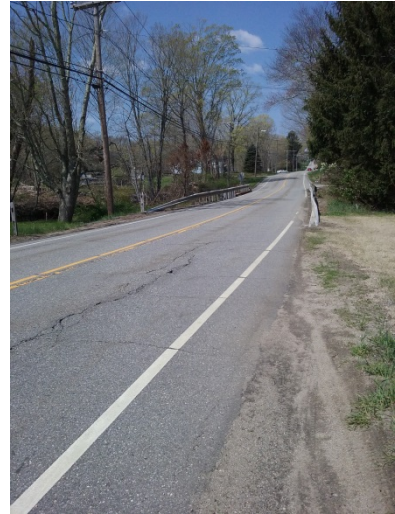
Figure 11. Merrick Brook Bridge

The bridge (bridge number 00681) over Merrick Brook on Route 14 creates a pinch point for traffic and has been struck several times. Because of this, CTDOT plans to replace and improve this structure. The project is currently in the 25% design phase and scheduled to begin construction in 2018.

When events are held at the Huntington Homestead Museum on Route 14 many attendees must park in the village district and cross this bridge to access the museum. The bridge does not provide safe pedestrian or bicycle access due to narrow (less than one foot) shoulders on each side.

- It appears that vehicles have struck the bridge on Route 14 several times. It is a narrow bridge and lacks shoulders. CTDOT elevated its importance and plans to replace and improve the structure. Design of a new bridge is in progress with construction expected to be in 2018. CTDOT has not reached out to the town for their input into the design. The town asked the following questions regarding the bridge:

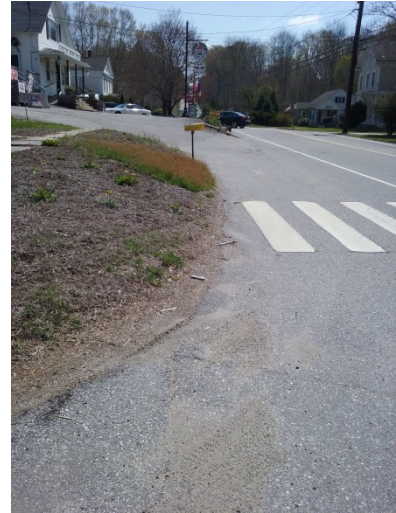
Figure 13. Safety Area for Turning into Church and Store

- The pavement on the north side of Route 14 flares out between the general store and St. Margaret Church driveways to provide a safety area for turning into the church parking lot. However, it encourages motorists to make the turn at high speeds (Figure 13). A bump out would keep the vehicles in the lane longer, which would slow traffic, but due to grades may also increase rear end collisions.

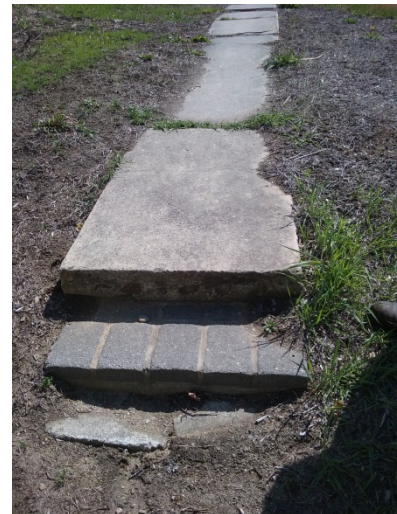
Figure 14. Current Sidewalk Segment

- The shoulders are four (4) feet wide on Route 14.
- The one sidewalk section on the north side of Route 14 is privately owned and is not ADA compliant.

- Four (4) foot (minimum) shoulders must be maintained for bicycle accommodation.
- A two (2) foot grass strip/ between curb and sidewalk is desired. This would create a snow shelf and provide an added sense of security for pedestrians. The short segment of existing sidewalk on Route 14 has a grass strip (Figure 14).

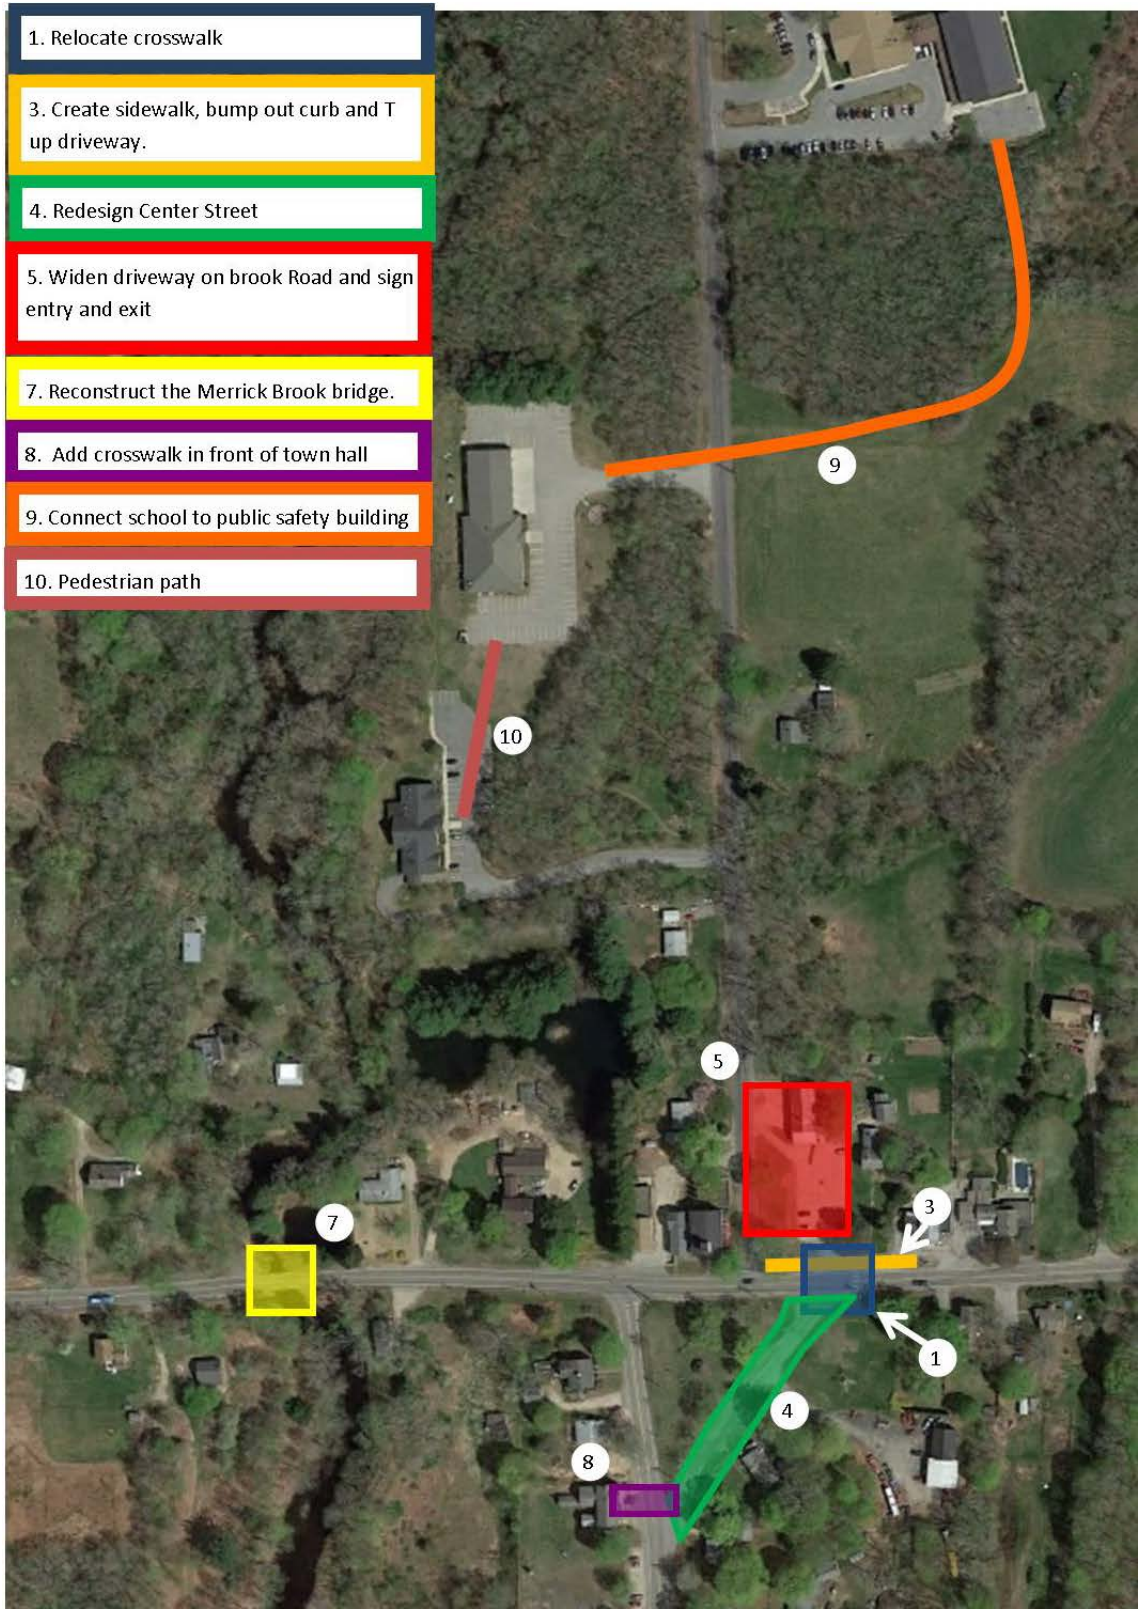
Figure 16. Medium Term Recommendations

Figure 16 depicts some but not all of these recommendations

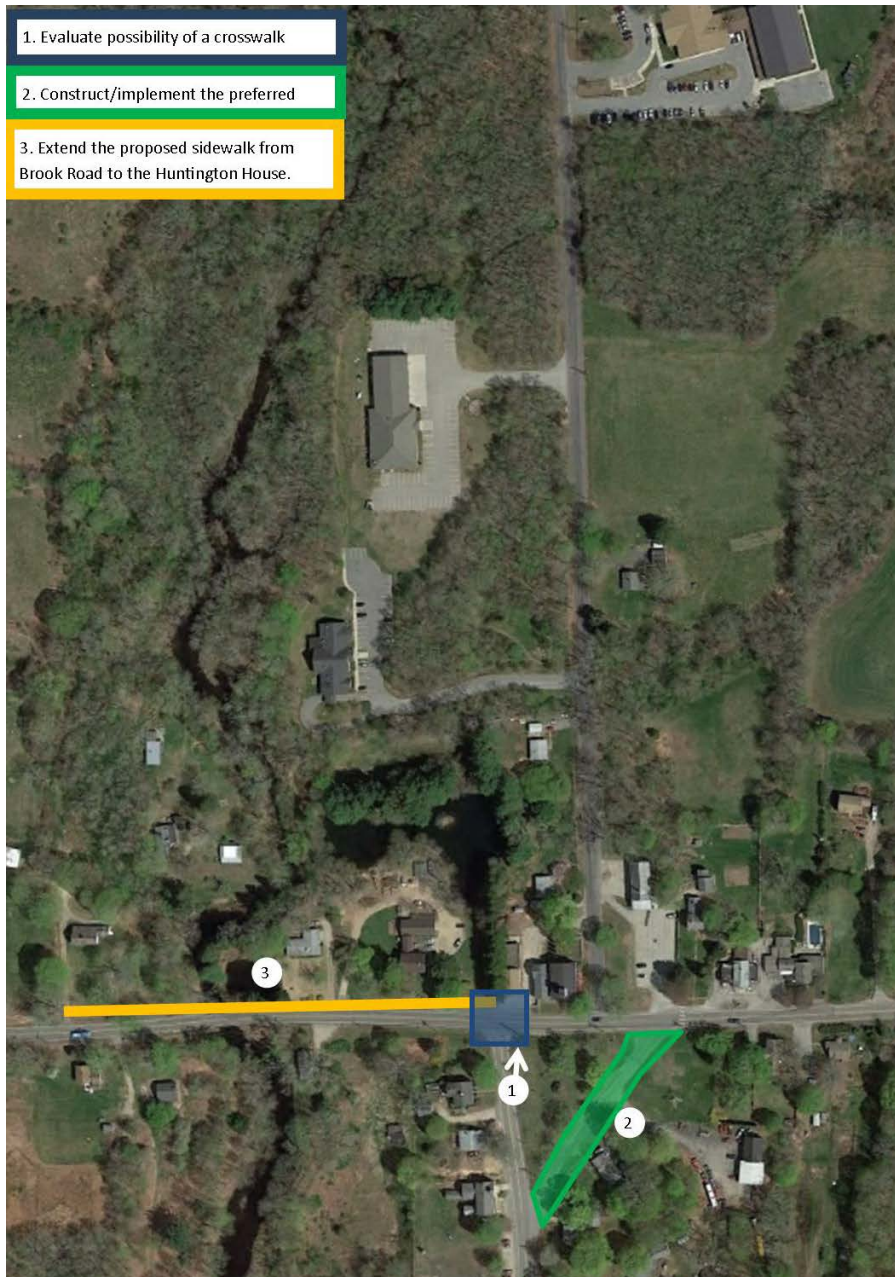
Figure 17. Long Term Recommendations

Figure 17 depicts some but not all of these recommendations.
