TORRINGTON ROAD SAFETY AUDIT

ROUTE 4 (GOSHEN ROAD) AND LOVERS LANE

FEBRUARY 2023

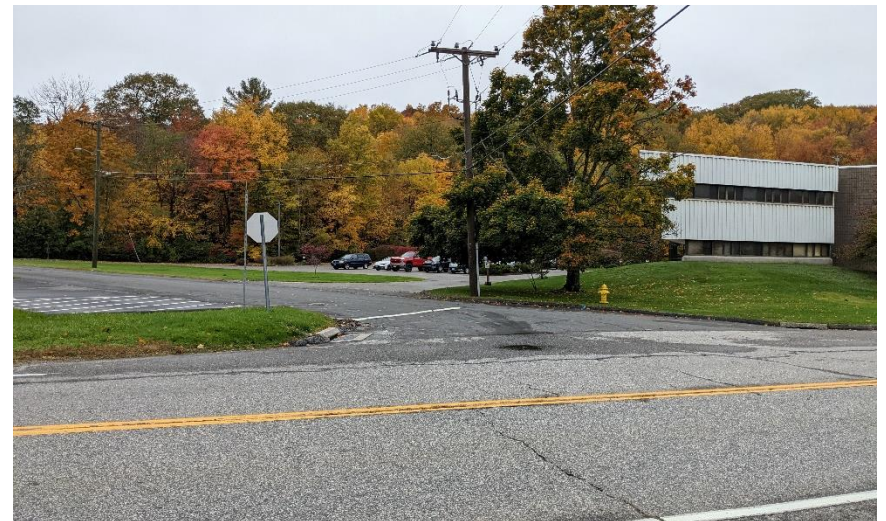
Exhibit 16: The intersection of Route 4 (Goshen Road) and Lovers Lane

- The geometry of the intersection can be challenging. Lovers Lane intersects Route 4 (Goshen Road) at a sharp angle, which can cause operational issues for traffic turning left into Lovers Lane
- The grass area next to the shoulder was observed to be worn down to dirt. Torrington Police indicated that westbound traffic on Route 4 often pass vehicles waiting to turn left onto Lovers Lane by traveling over this grass area. Participants discussed the potential for curbing along this area.
- Participants noted that lighting at this intersection is present, but could be increased

The recommendations at this intersection seek to improve pedestrian safety and reduce conflict points at the intersection of Route 4 and Lovers Lane. The potential exists to T-up the existing intersection and provide a slightly narrowed cross section to facilitate the crossing of pedestrians from The Cottages to Lovers Lane.

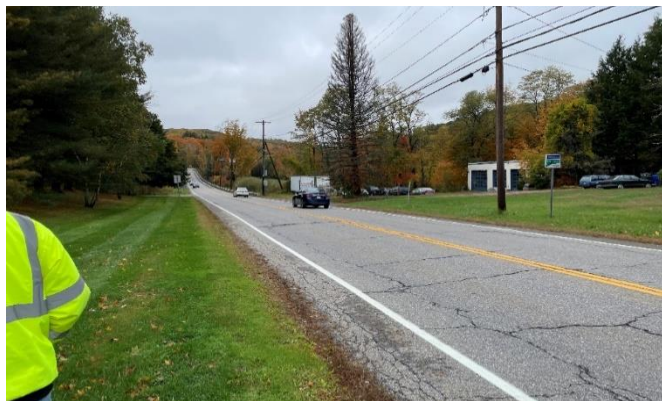
Exhibit 19: Route 4 (Goshen Road) looking westbound past the intersection of Lovers Lane.

- There is a passing zone on Route 4 (Goshen Road) immediately to the west of the intersection of Lovers Lane. RSA participants noted that this should be reviewed due to turning traffic in this area and potential sightline constraints. RSA participants favored converting this to a double-yellow centerline. Exhibit 19 shows the westbound segment of Route 4 (Goshen Road).

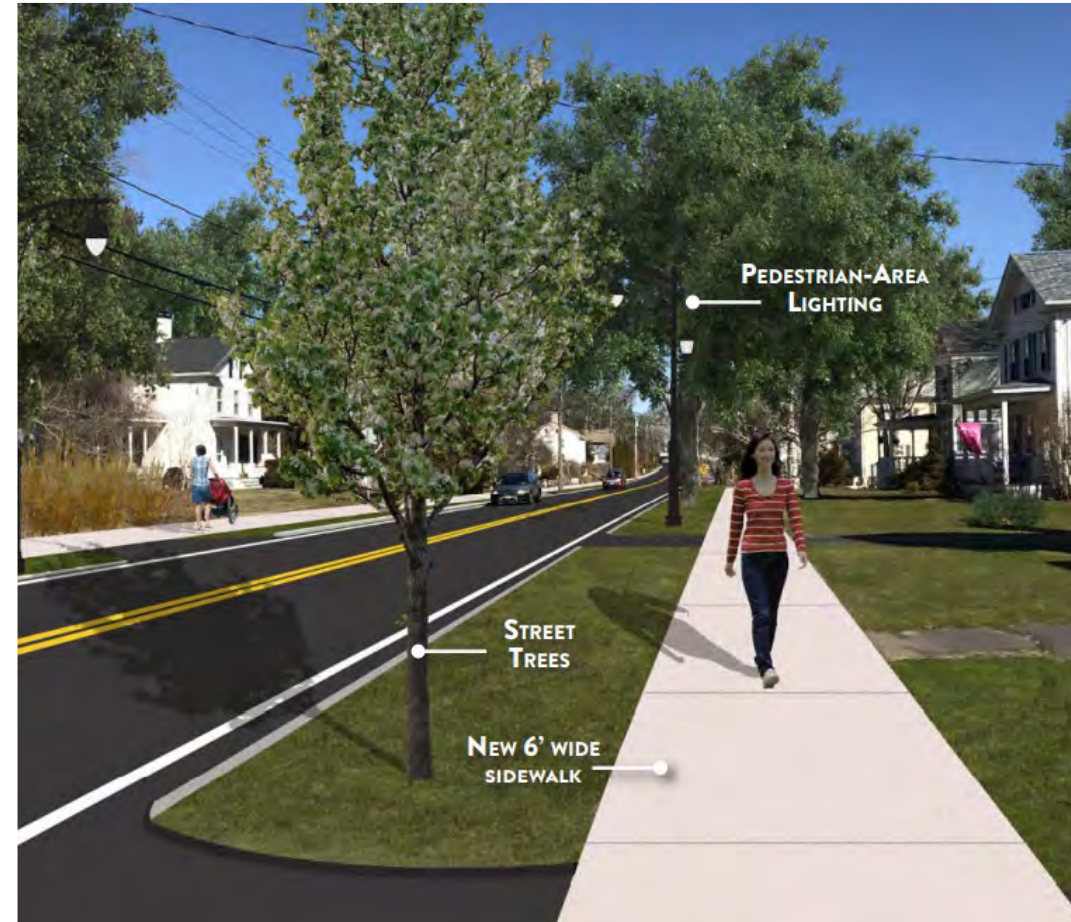
- Sidewalks provide a dedicated space for pedestrians
- 5 feet is preferred minimum width

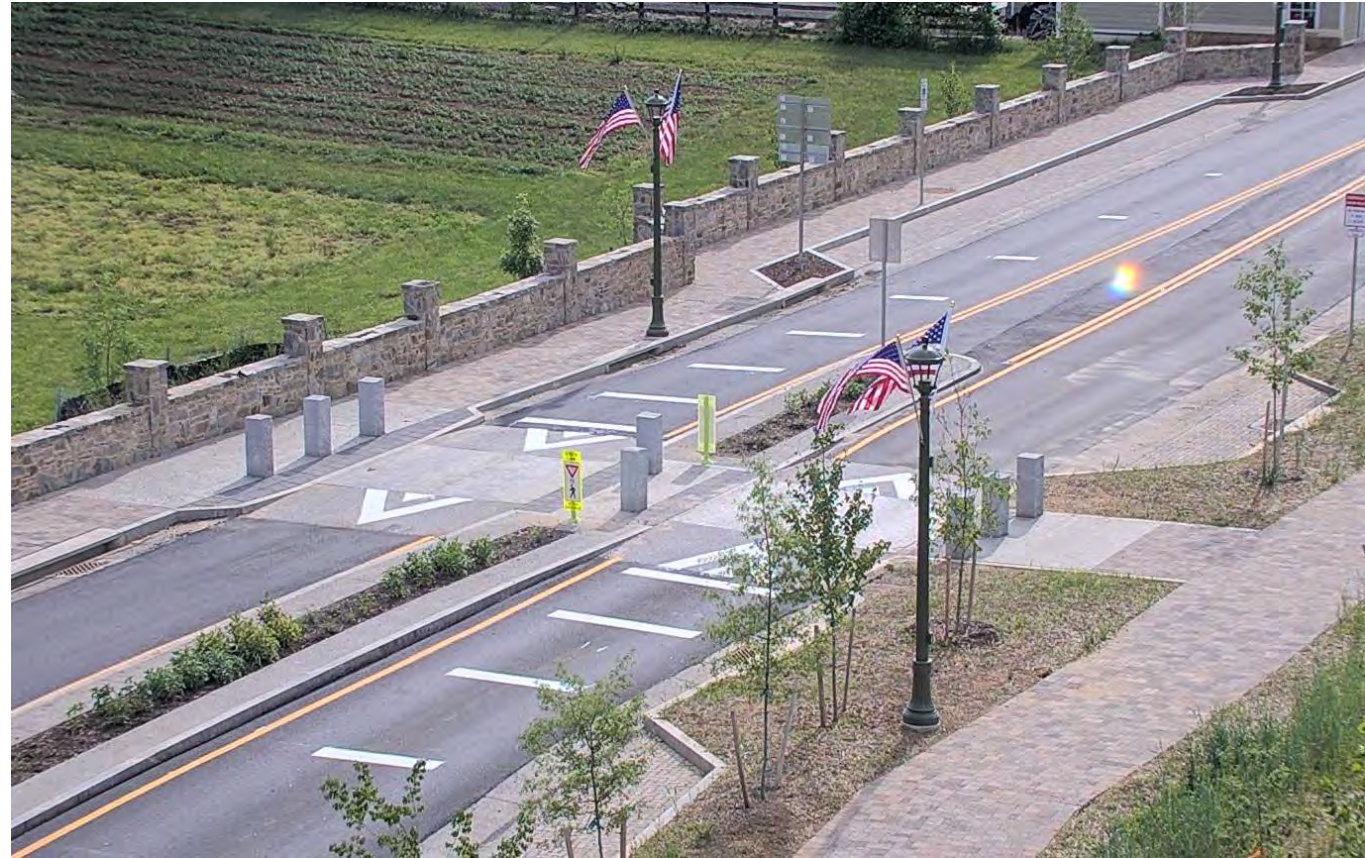
- Raise island wide enough to provide allow pedestrian to cross in two-stages

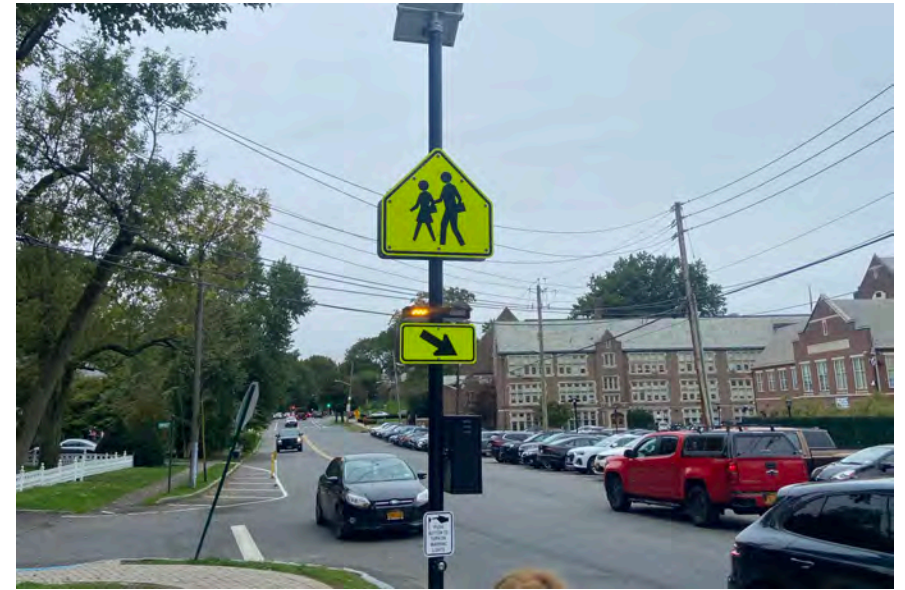
Top – RRFB in Bronxville, NY; Bottom – HAWK in Stamford, CT

- RRFB
 - Rectangular Rapid Flashing Beacon
 - Provides enhanced visibility of crosswalks, but is **not** a regulatory signal
- HAWK = **H**igh Intensity **A**ctivated **C**ross**W**alk
 - Provides a red signal for on-coming motorists

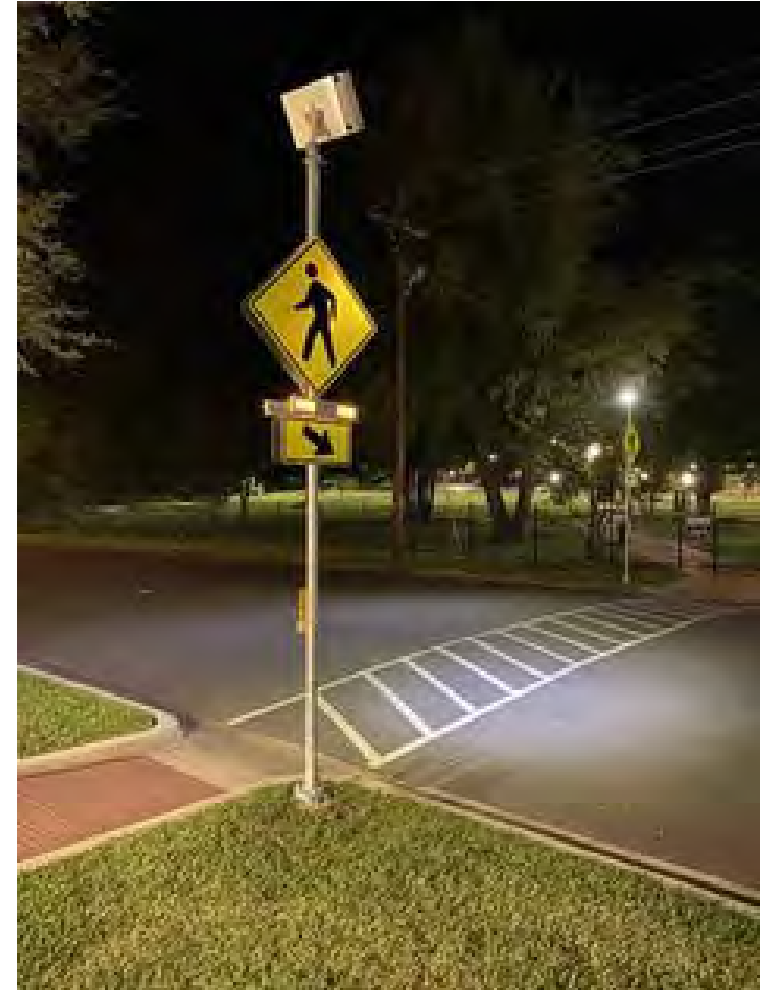
- Lighting conditions at night in areas of pedestrian crossings should be considered
- Lighting can be increased with RRFB systems with a higher intensity light to enhance visibility of crossing

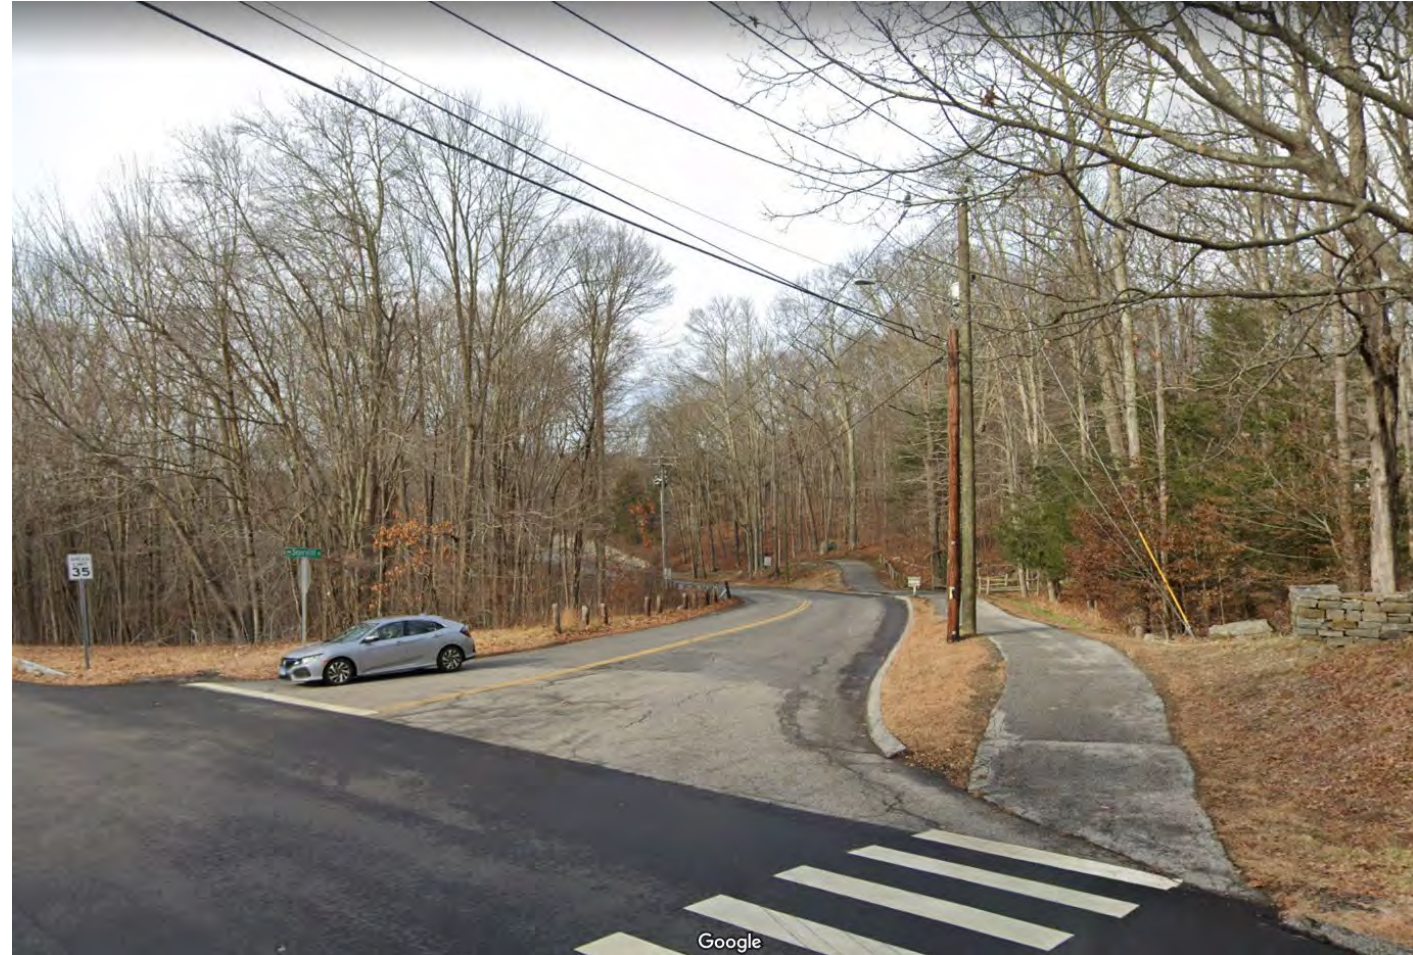
Sidepath in Mansfield, CT

- Sidepaths and Shared Use Paths can provide a dedicated space for bicyclist and pedestrians off the roadway
- Typically 10-12' in width
- Minimum 8' in width
- Consideration for driveway crossings

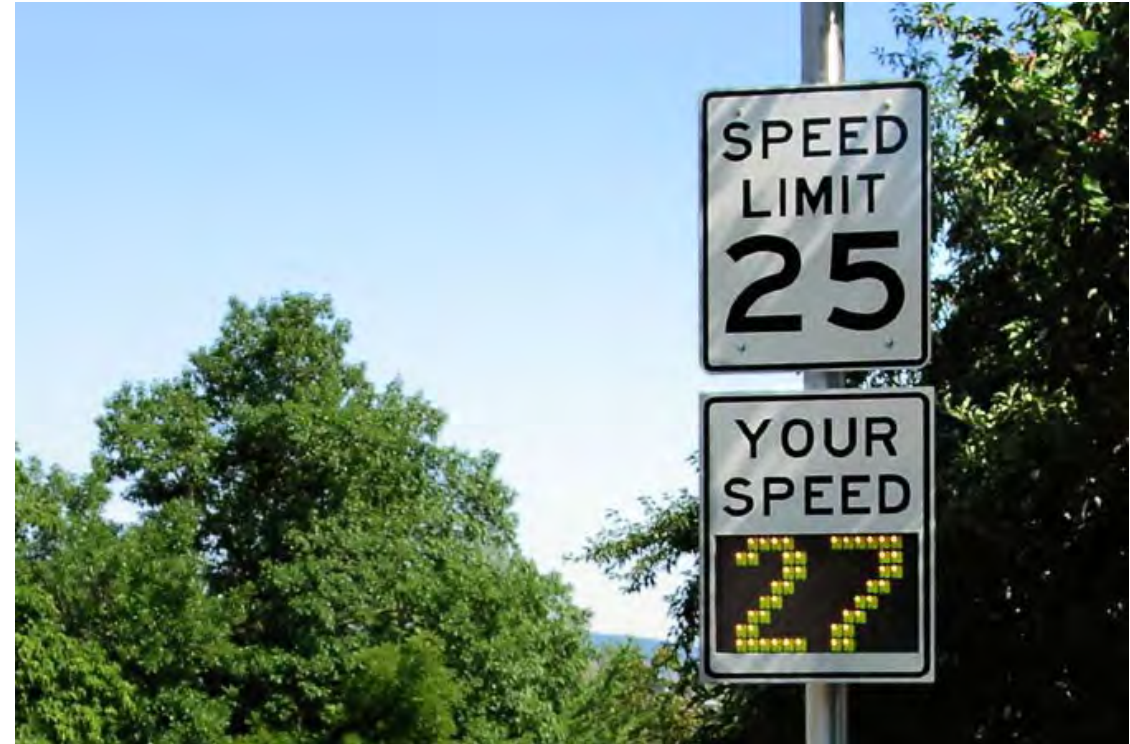
- Dynamic speed feedback signs display speeds of oncoming vehicles
- Must be placed with existing speed limit sign (or include such sign on a mobile unit)
- Requires encroachment permit by CTDOT
- Effectiveness
 - Up to 4 MPH average reduction in passenger vehicle speeds (1)
 - Most reductions from 1,000 ft upstream of sign and 300 ft past sign (2)
 - Decreased effectiveness over time (2)

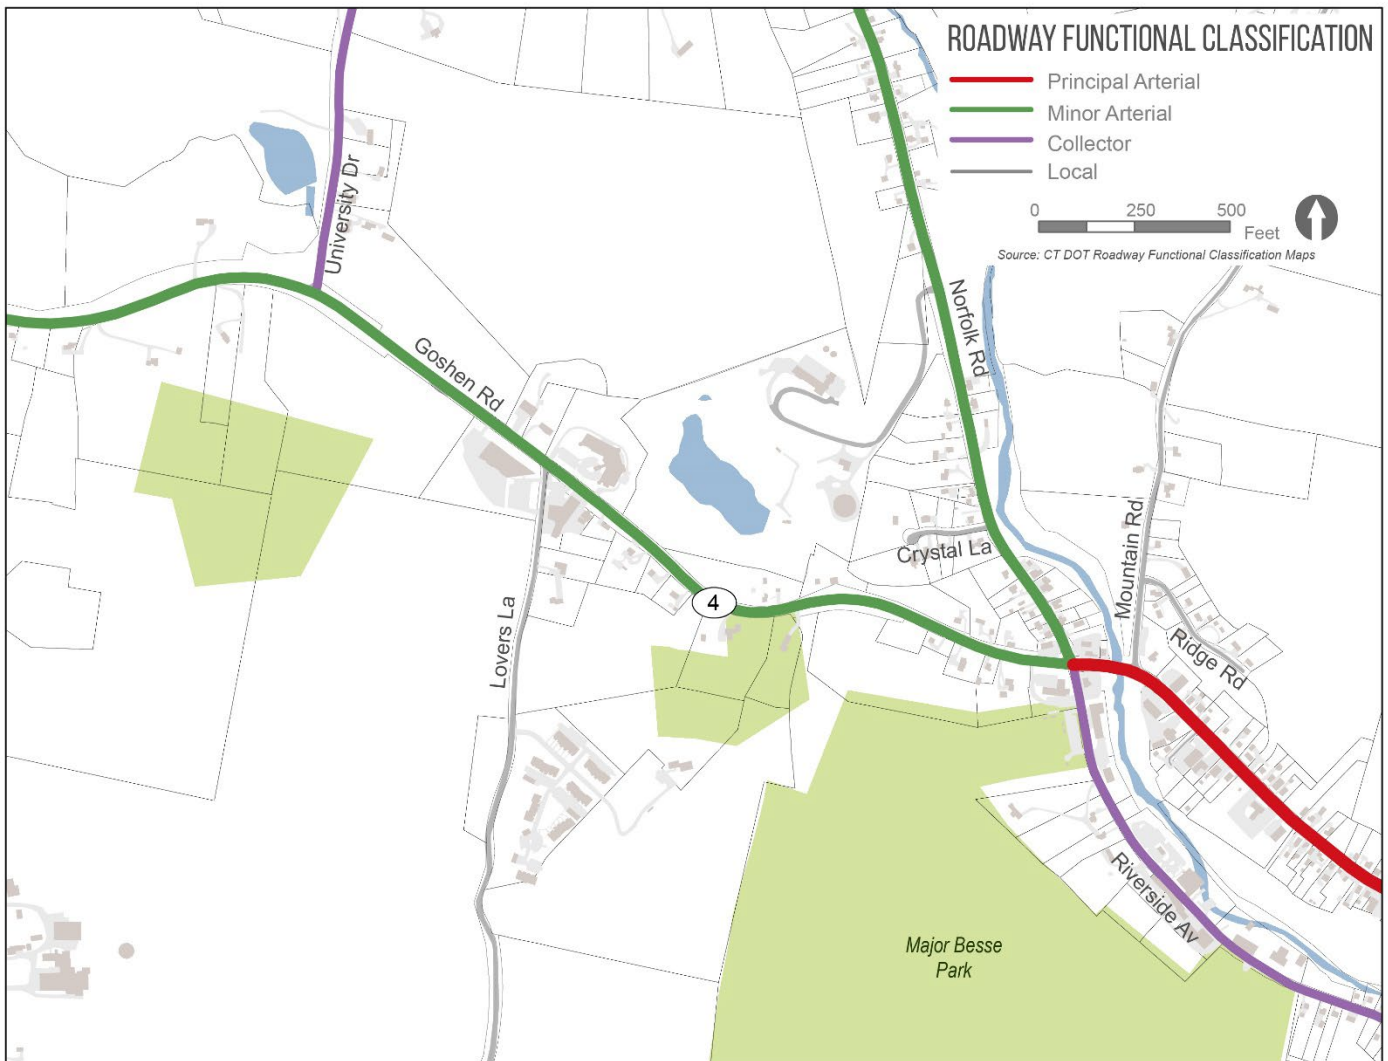
Torrington Road Safety Audit – Roadway Functional Classification

- Route 4 is a Minor Arterial Roadway west of Riverside Avenue
- Route 4 is a Principal Arterial Roadway east of Riverside Avenue
- Norfolk Road is a Minor Arterial
- University Drive and Riverside Avenue are Collector Roadways
- Lovers Lane is a Local Roadway
