COMMUNITY
connectivity program

East Main Street (Route 74), West Main Street, Vernon Avenue and Brooklyn Street – Road Safety Audit

October 18, 2016

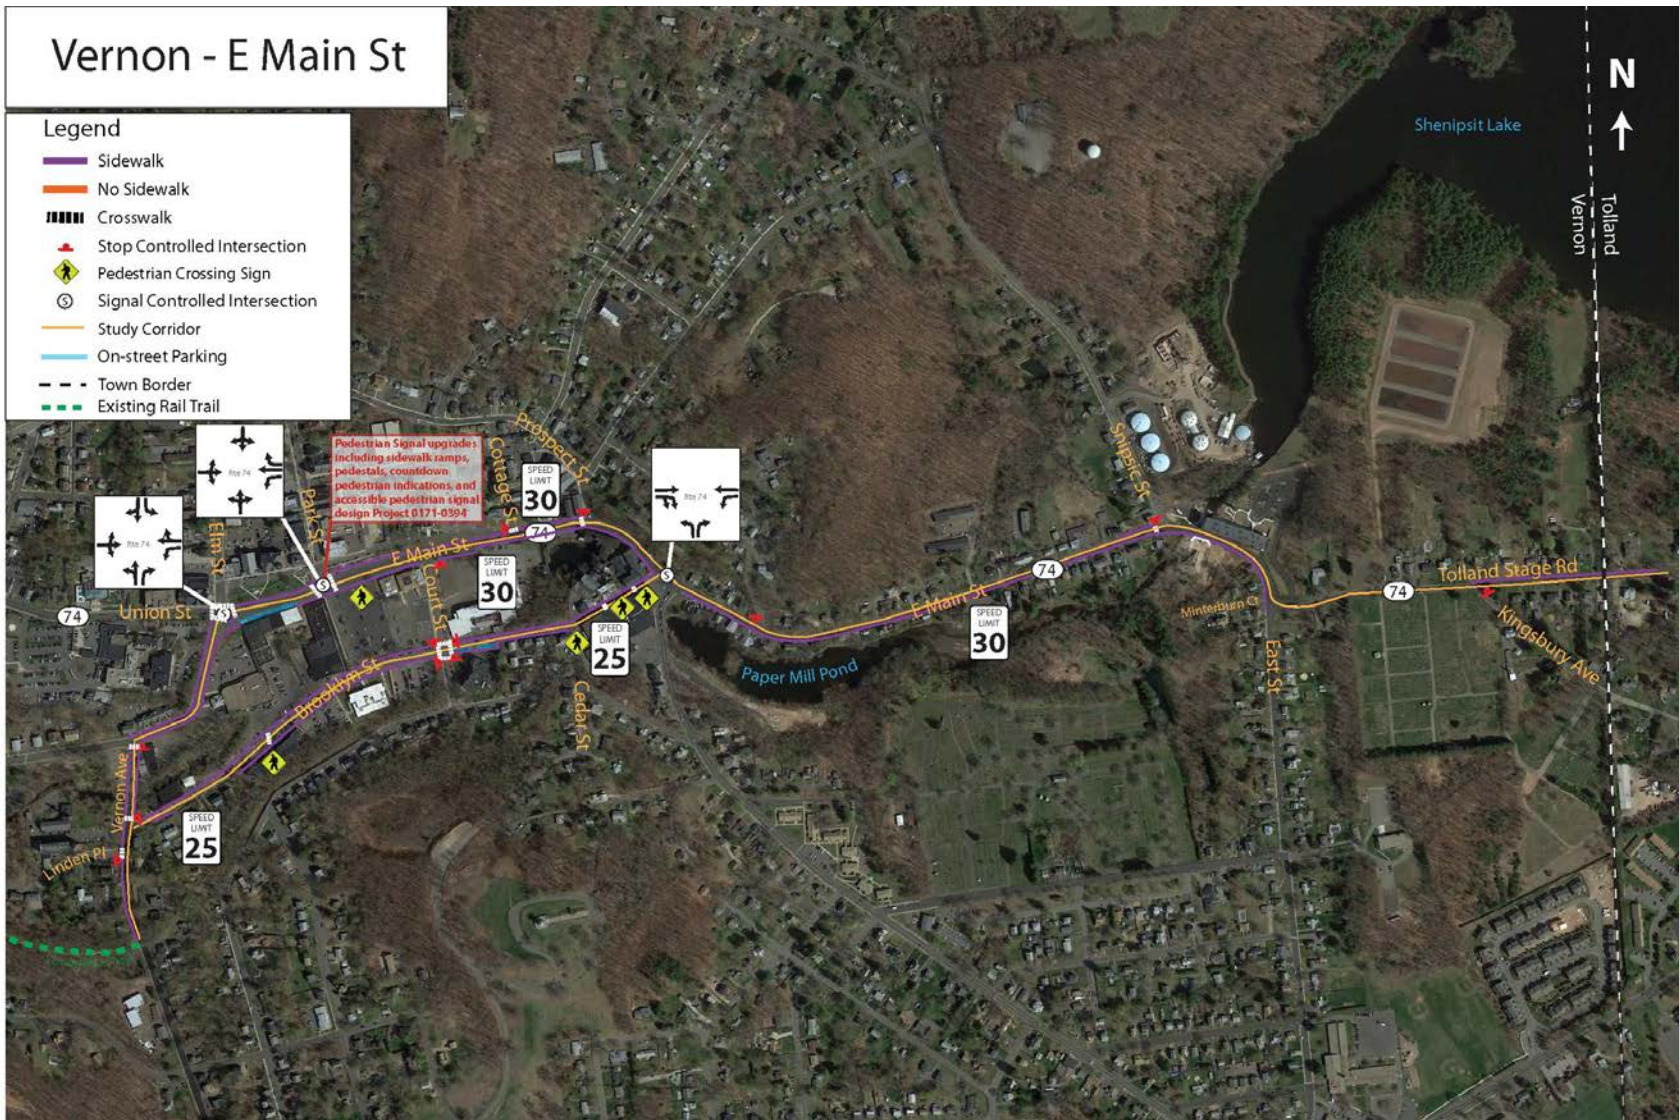
Figure 4. East Main Street, West Main Street, Vernon Avenue and Brooklyn Street Geometrics

Figure 4 and Table 3 summarize the roadway geometrics in the study area.

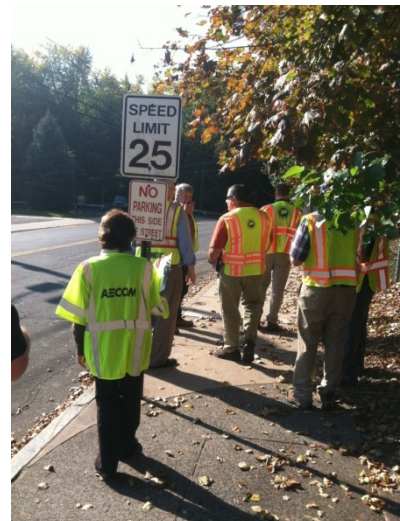
Figure 6. Low Signs on West Main Street

- Some signs do not meet the seven-foot minimum height above a sidewalk (Figure 6).
- There is a seven-foot wide concrete sidewalk.
- West Main Street is 32-foot wide with 16-foot lanes in each direction and no shoulders.
 - At the curve, the width is 30-feet (Figure 7).
- It may be possible to provide a bike lane, striped shoulders or cycle track due to the wide lane widths.
- The granite curb reveal is substandard on the north/west side of the street (Figure 7).

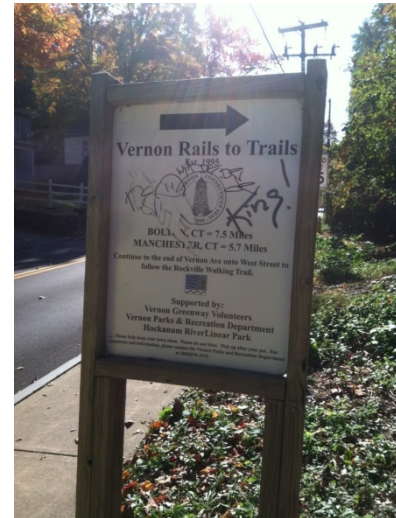
Figure 9. Existing Rails-to-Trails Signage

- The existing signage is not adequate to direct pedestrians and bicyclists to the downtown center (Figure 9).

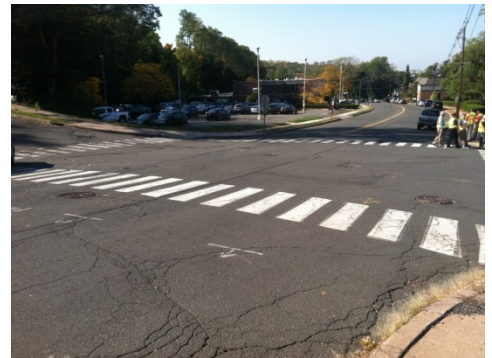
Figure 11. Crosswalks at the Intersection of Brooklyn Street and Court Street

- There are no detectable warning strips at the four apex handicap ramps.
- Curb extensions may be possible at the intersection of Brooklyn Street with Court Street to reduce crosswalks that are up to 64-feet long. Large truck movements may be an issue to installing curb extensions.
- The crosswalk lengths can be reduced by moving crosswalks off the corners (apex ramps) closer to the stop bars (Figure 11).
- The preferred route for the trail extension is via Court Street north to East Main Street.

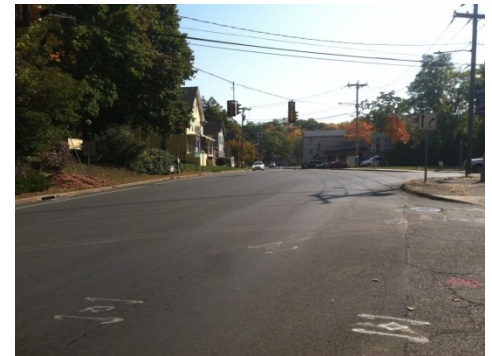
Figure 12. Grove Street, Brooklyn Street, East Main Street Intersection

- Brooklyn Street and Grove Street intersect East Main Street very close to one another (Figure 12).
- There are no crosswalks. Handicap ramps are provided on both sides of the Grove Street leg, but there are no detectable warning strips.
- Pedestrian buttons are provided on the north side of East Main Street and the southwest corner of East Main Street and Brooklyn Street for pedestrians to cross concurrently with traffic. There are no pedestrian signals.
- A long-term solution to provide a round-about was mentioned.

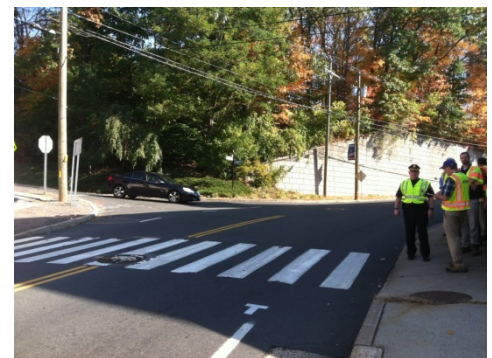
Figure 13. Crosswalk at Prospect Street

- There is limited sight distance on westbound East Main Street approaching Prospect Street due to vertical and horizontal curves.
- A crosswalk is located west of Prospect Street (Figure 13). There are handicap ramps on each side of the crosswalk, but the ramp on the north

side is not ADA compliant. There are no detectable warning strips and outdated pedestrian crossing signs.

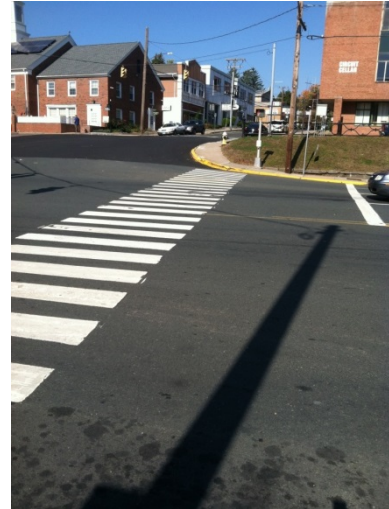
Figure 14. Lack of Sidewalk Ramps at East Main Street/Park Street Intersection

- There are no handicap ramps at the intersection of East Main Street and Park Street (Figure 14).
 - The longest crosswalk length is 76 feet and the exclusive (all-red) pedestrian phase is 27 seconds which appears adequate. The CTDOT will be improving this intersection and signal equipment.
- There are no detectable warning strips at the crosswalk across St. Bernard Terrace at Park Street and Park Place.

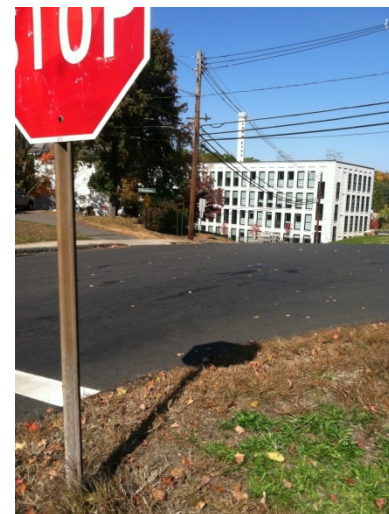
Figure 15. East Street looking West on Route 74

- The sidewalk on the south side of east Main Street in the vicinity of Loom City Lofts is in poor condition.
- There is limited sight distance for vehicles turning from East Street onto Route 74 due to a switchback horizontal curve and a steep hill at the intersection (Figure 15). Several crashes were noted.
- The sidewalk on the south side of East Main Street currently ends at East Street.
- It appears that the north side of Tolland Avenue between East Street and Kingsbury Avenue would be a better place to construct a new sidewalk because the terrain is more level, right of way appears adequate and this is the side with houses. The existing sidewalk in Tolland on Route 74 (Tolland Stage Road) is also on the north side.

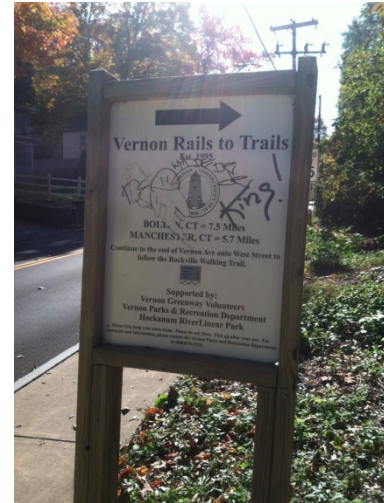
Figure 16. Rails-to-trails Sign on Vernon Avenue

- Vernon Ave. is 30-feet wide at the bottom of the hill and 25-feet wide past the bridge.
- Wayfinding signage and/or a map would be useful at the Rails-to-Trails trailhead (Figure 16).
- Pedestrian handicap ramps and detectable warning devices need improvement.
- The crosswalk at the intersection of Vernon Avenue and Brooklyn Street needs signage.

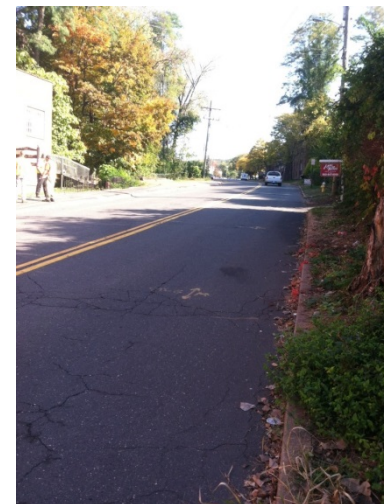
Figure 17. Brooklyn Street facing East

- Some sections of Brooklyn Street are very wide and a bike lane or shoulder could be striped or a multi-use facility path added (Figure 17).
- The sidewalk near the mill building on the west end of the street goes up to the face of the building (Figure 18).

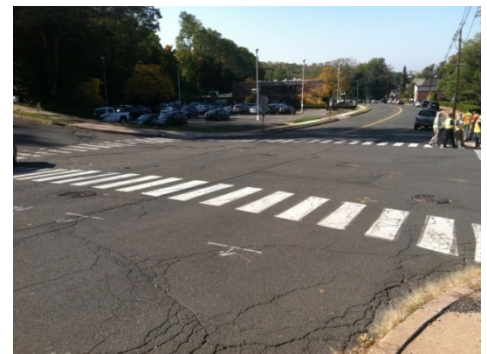
Figure 19. Intersection of Brooklyn Street and Court Street

- The area in front of the mill building is the controlling point to determine whether or not a multi-use path would fit.
- There are long crosswalks at the Court Street intersection and operations would be improved if they were reduced (Figure 19).

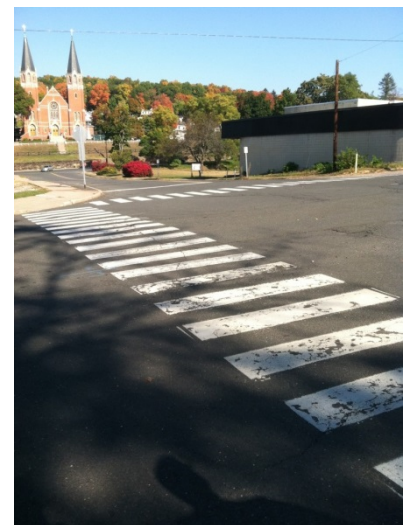
Figure 20. Looking North on Court Street from Brooklyn Street Intersection

- The Town does not want to add curb extensions due to plowing concerns.
 - Court Street is also very wide to accommodate truck deliveries at the Anacoil business on Court St (Figure 20).

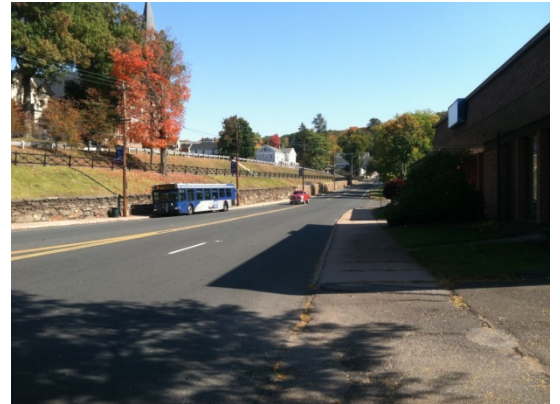
Figure 21. Bus Stop on East Main Street

- Pedestrians need a safe way to cross East Main Street at this location.
 - This is a popular bus stop and generates significant pedestrian traffic.

- CTDOT will coordinate with CT Transit as to why the stop was located here and if it can be relocated or consolidated with an adjacent stop.

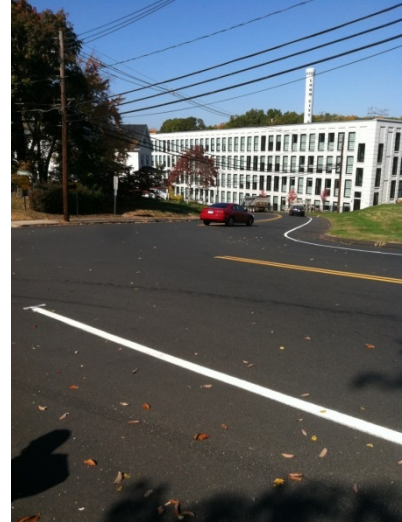
Figure 22. Looking West on East Main Street from just East of East Street

- There is limited sight distance at the crosswalk at Snipsic Street and there are no pedestrian signs.
- At the intersection with East Street sightlines are restricted due to the combination of vertical and horizontal curves.
 - Steep grades may make a roundabout infeasible at this location.
 - Reducing curb radii and realigning East Street to the east across from the Loom City Lofts driveway and at less of a skew could improve operations (Figure 22).
- The best location for a sidewalk between East Street and Kingsbury Avenue is on the north side of Tolland Avenue (Figure 23).
 - A potential pedestrian crossing on East Main Street/Tolland Avenue would need to be evaluated to determine where the safest location would be. This should be done in conjunction with evaluating realignment options at East Main Street and East Street.

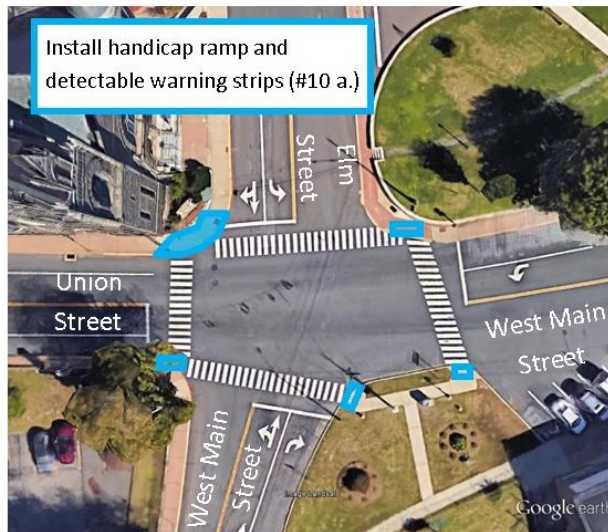
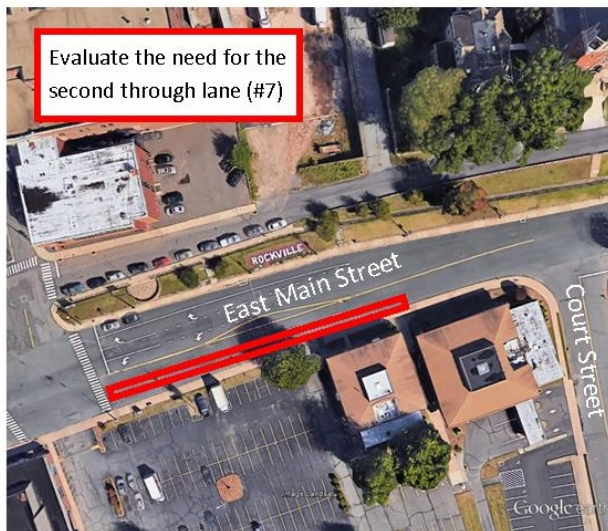
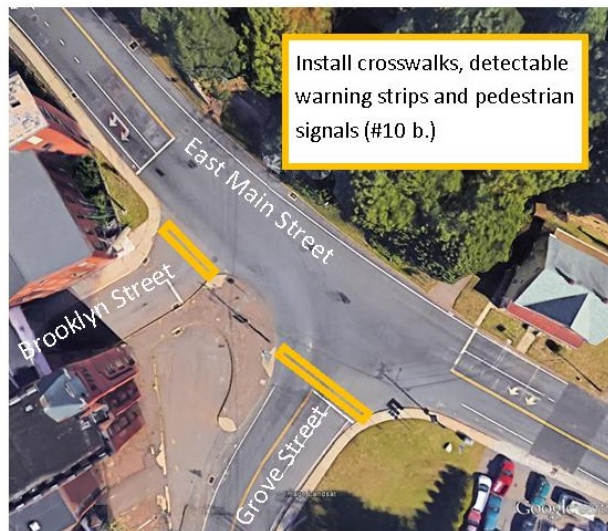
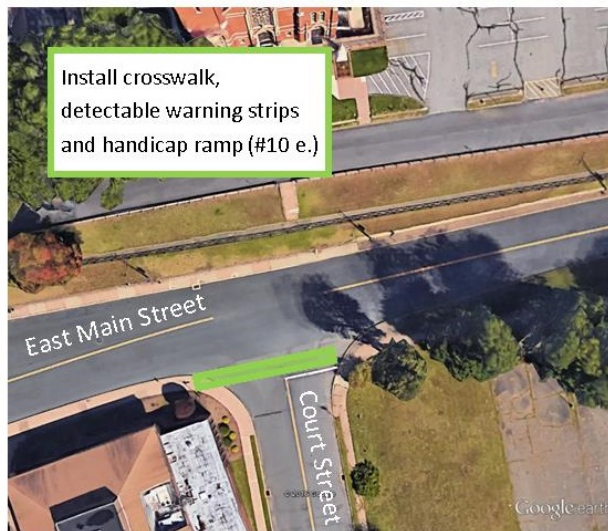
Figure 28. Short Term Recommendations

Figure 28 depicts some of these recommendations.

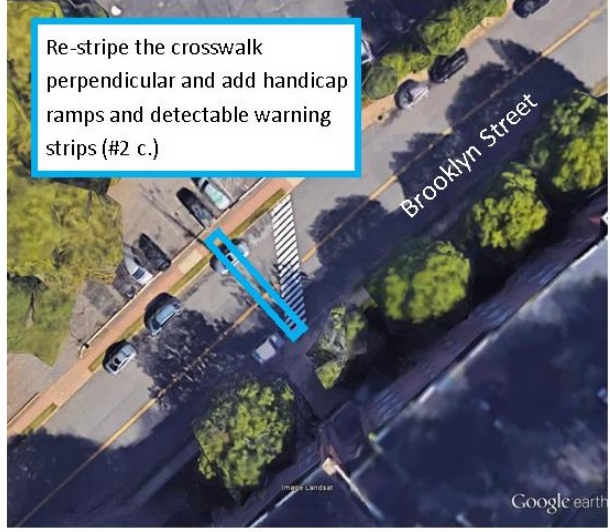
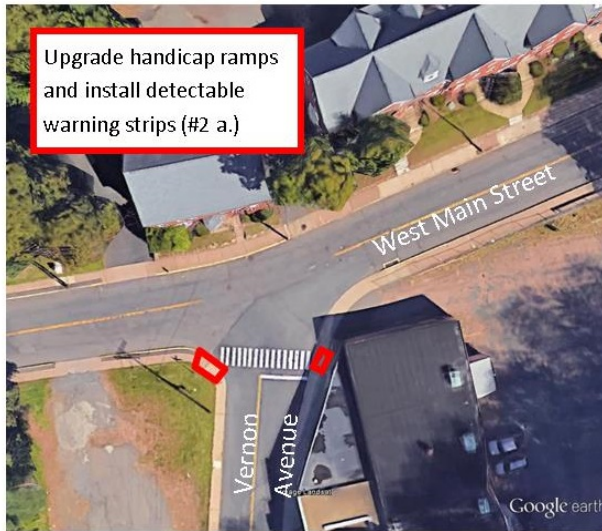
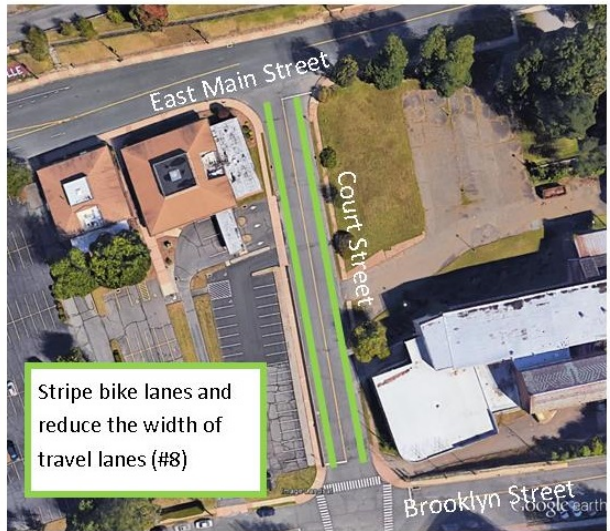
Figure 30. Medium Term Recommendations

Figure 30 depicts some of the recommendations.

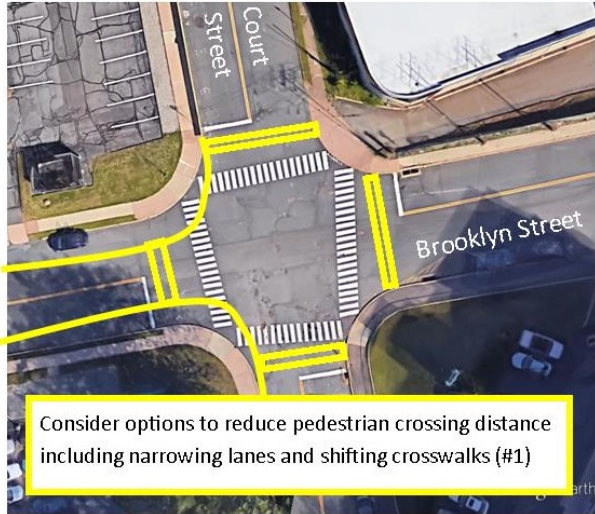
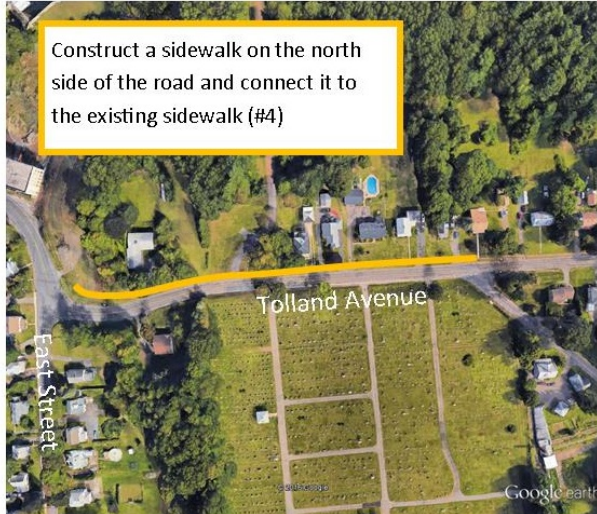
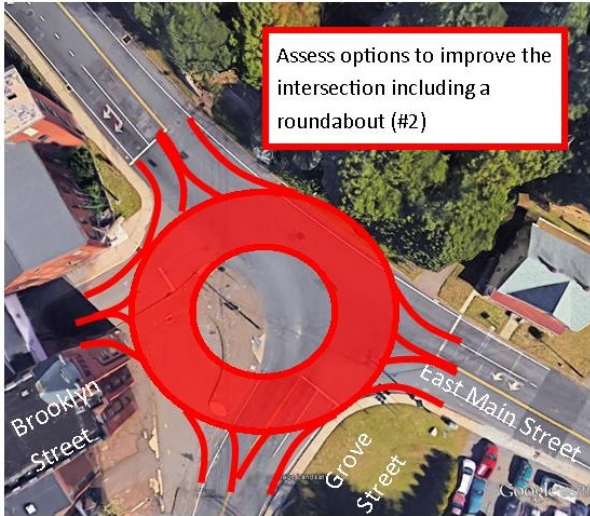
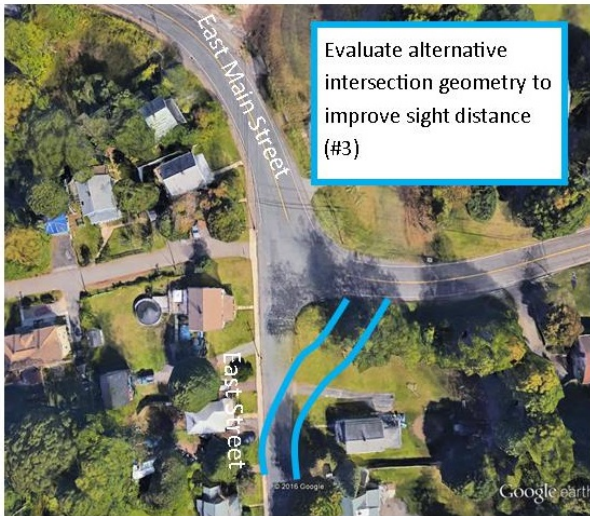
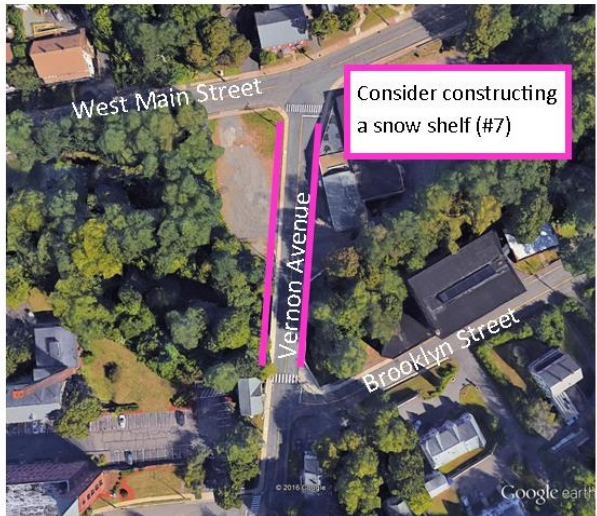
Figure 31. Long Term Recommendations

Figure 31 depicts some of these recommendations.
